Mauao Slope Failures 29 January 2011

Notes on first impressions from the site walk over (s 7(2)(a) - Privacy)
9.30am

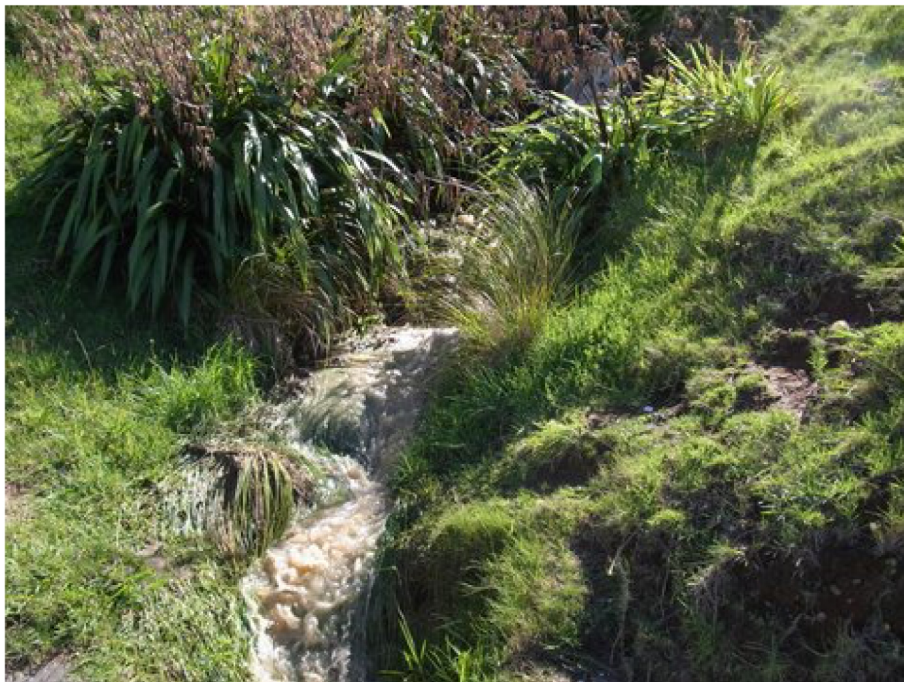
Typical flow

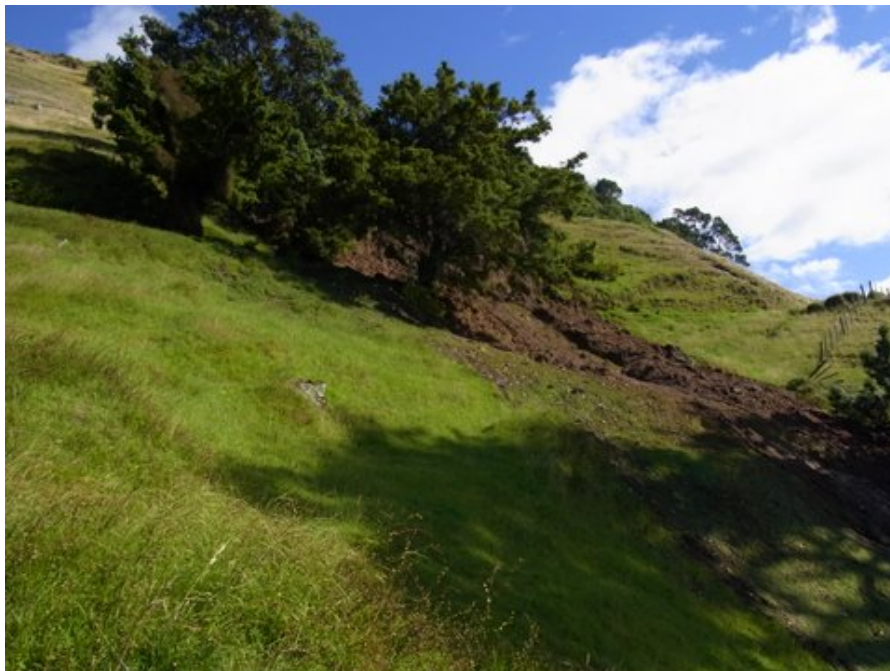
There were several slips in the slope immediately above the reservoir access road. These are considered to be due to the over-steepening of the toe of the slopes due to road formation and the high rainfall. Some occurred in areas of previous instability. Further up the slope were some shallow failures of saturated surface soils. Most of the debris was caught on the road.

Shallow surface failure

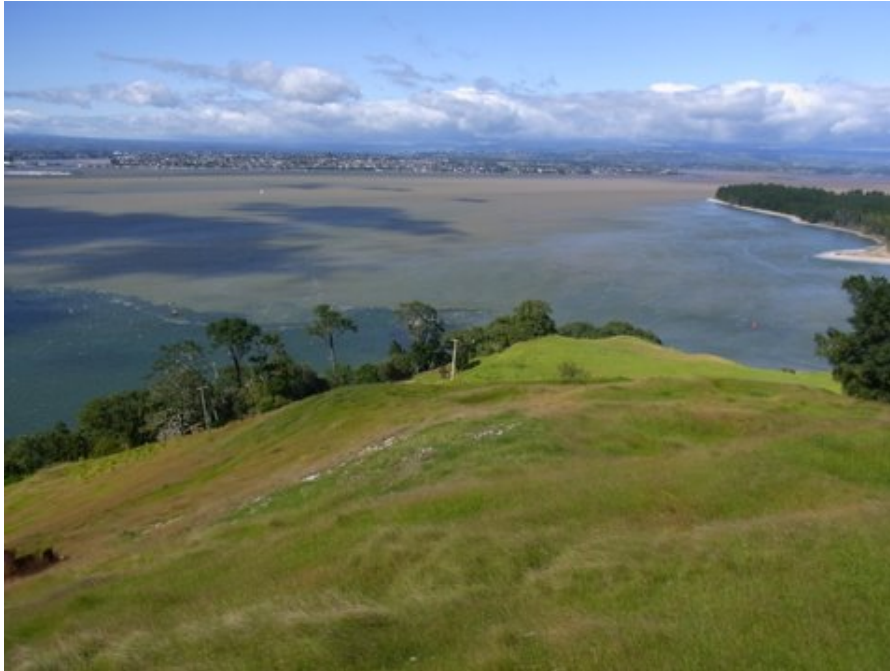
The main, dramatic slip occurred well up the south-west trending spur above the reservoir road. This slope is well terraced and there is a series of kumara/whare pits along the spur, plus an exposed shelly midden just above the slip.

Pits along spur and shelly midden
(top of slip to the left)

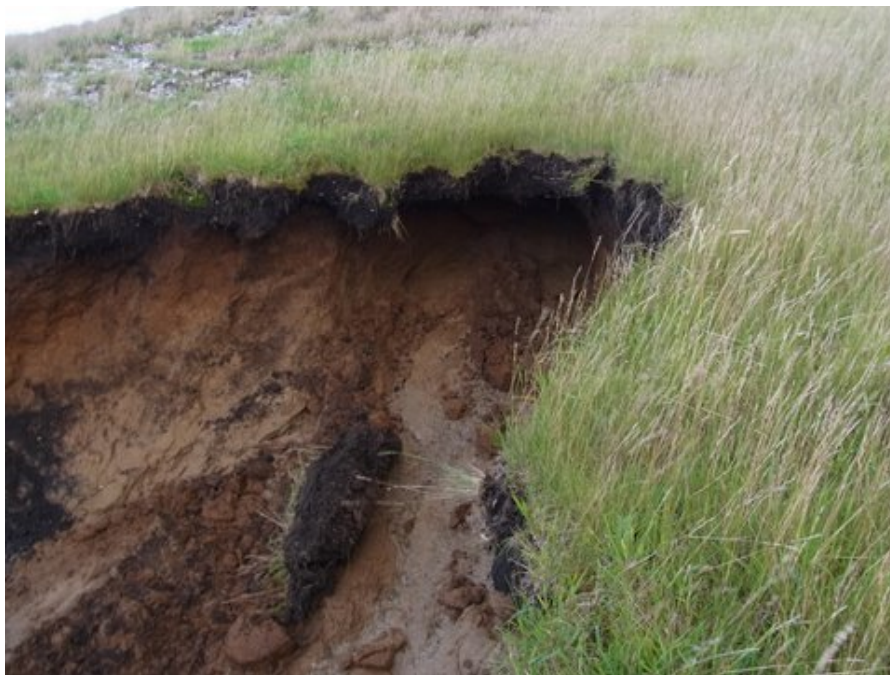
Head scarp

The slip formed about a 2m high head scarp at the top of the slope. There was a deeper gut part way down the slip where it passed through a terrace. There appeared to be some Rotoehu sand towards the base of the head

scarp. The slip appears to have removed the surface soil down through two or three terraces. Below these the slip debris has been washed over the slope and onto the reservoir road. It was considered that there was no movement in the road itself and the buried water mains were undamaged.

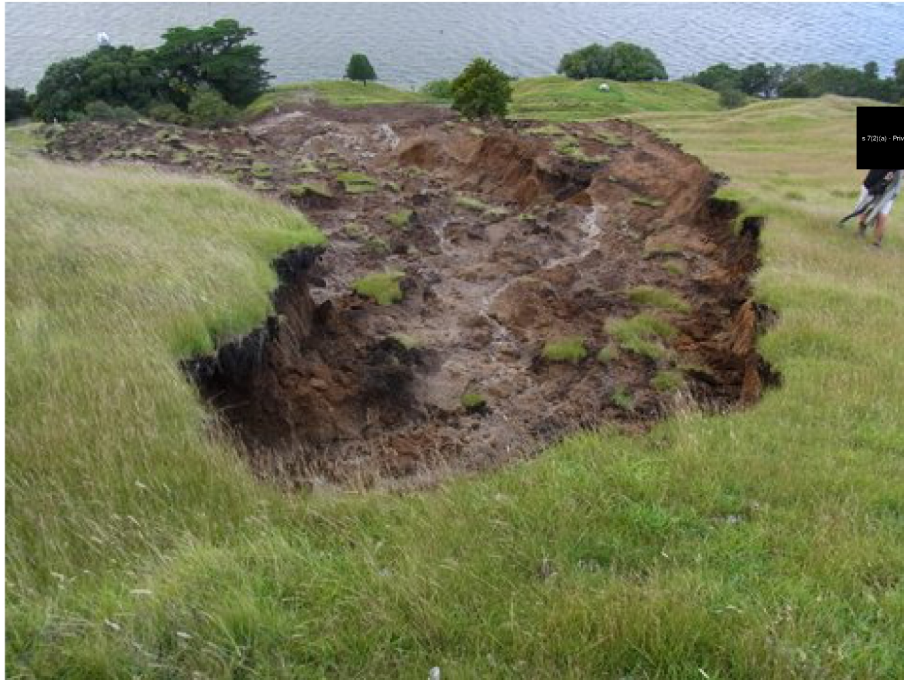
Looking down the slip

It appears that the intense rainfall was concentrated in the pits at the top of the slope (which may have been excavated down to the sand layer), it then rapidly soaked through to the sand layer and caused a blow out further downslope due to the high water pressure. The sand layer may already have been under some pressure due to the previous week's rain. The porous midden at the top of the slip may also have contributed to the seepage. A pit full of water was observed elsewhere on the slopes.

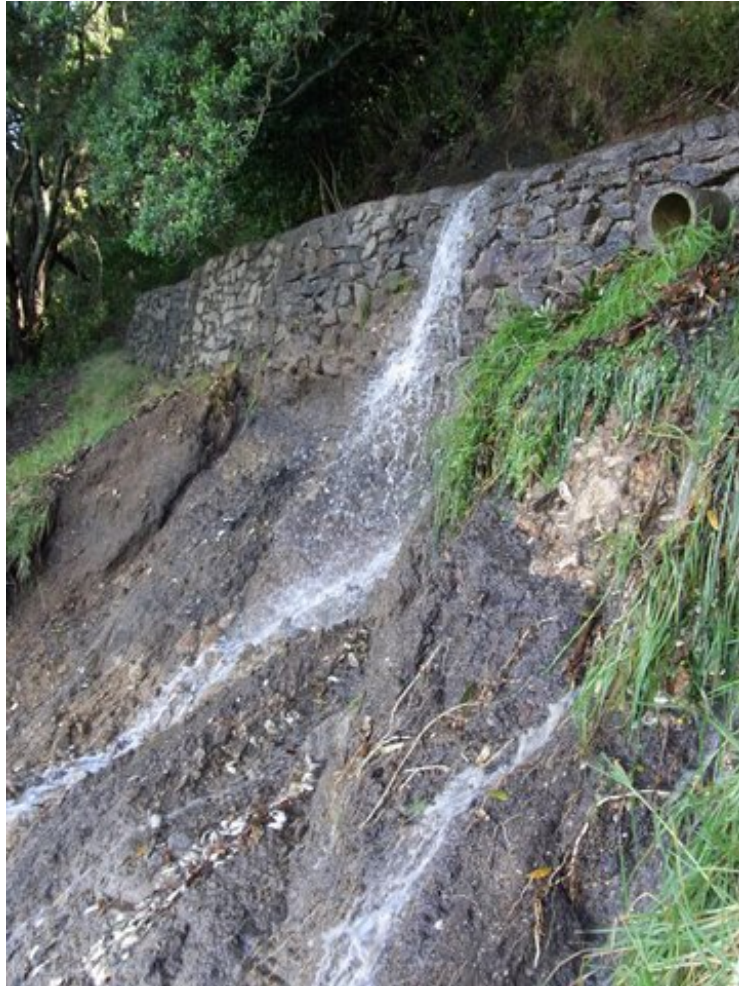
Along the first section of the track there were several small to moderate sized slumps in the cut faces above the track. The first of these was at the gate. Just past the shelly beach area large flows across the track had scoured out the slope below the small stone wall supporting the track, leaving an almost vertical face below the wall foundation. These foundations need to be checked before any machines travel along the track above. It may be necessary to carry out some remedial work on this slope before progressing around the track .

Scoured wall foundations

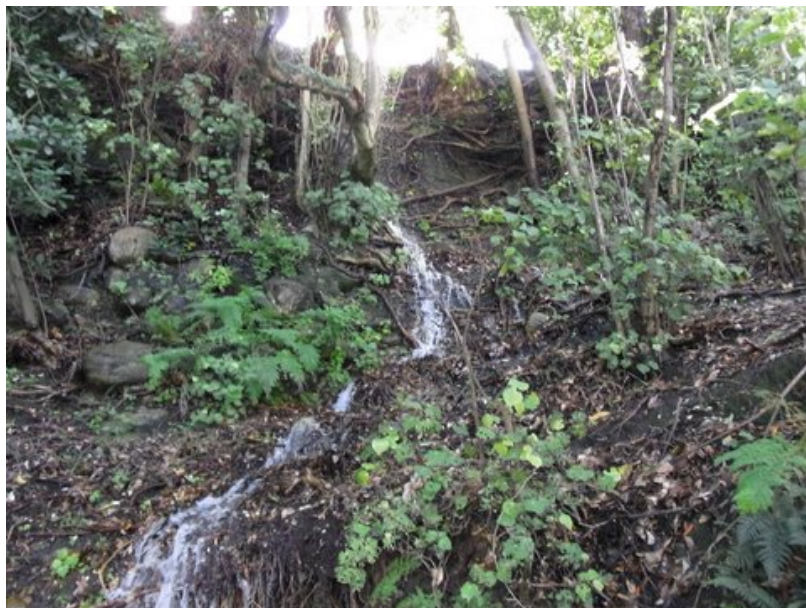
Flow coming down from grassed area above bush
