Rockfall on Mauao; 31 July 2007

Please find set out below a summary of our recent rockfall event and our subsequent investigation.

Description of the rockfall event and site inspection

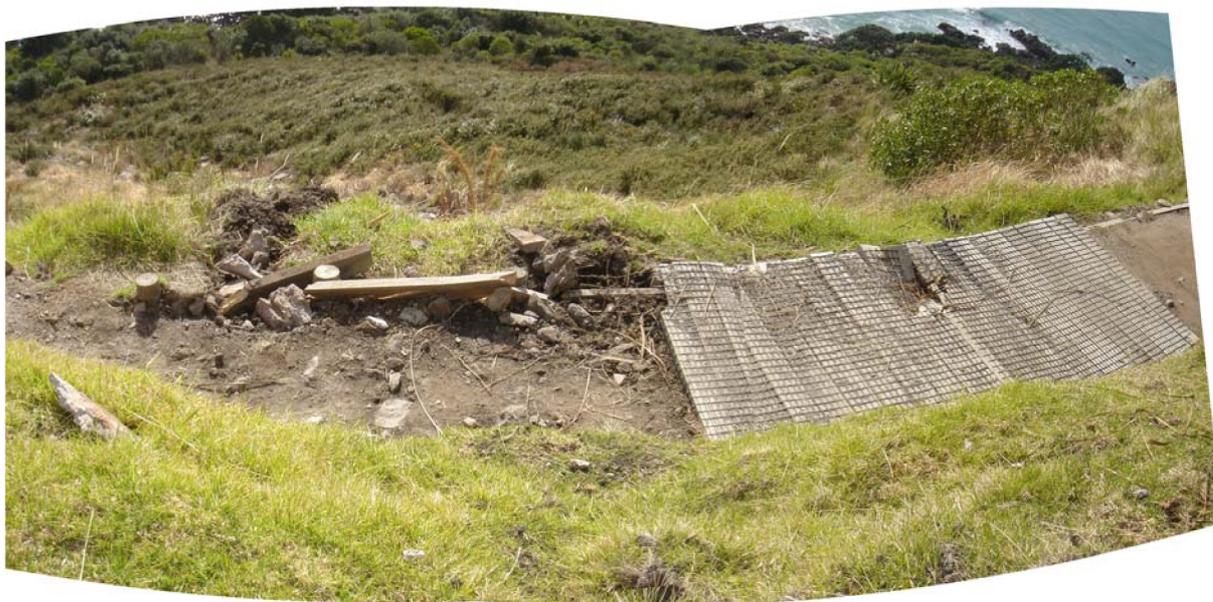
Photograph 1; Oruahine track damage

This track damage was clearly caused by a relatively large rockfall.

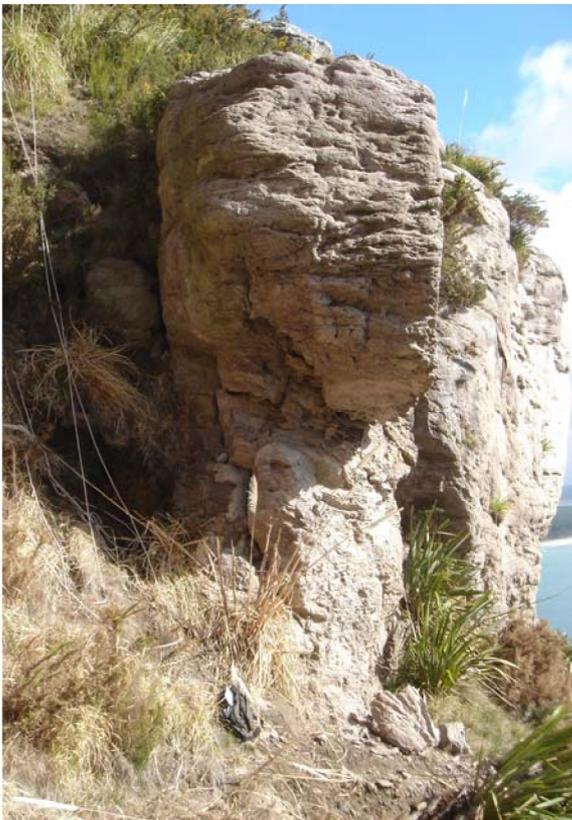
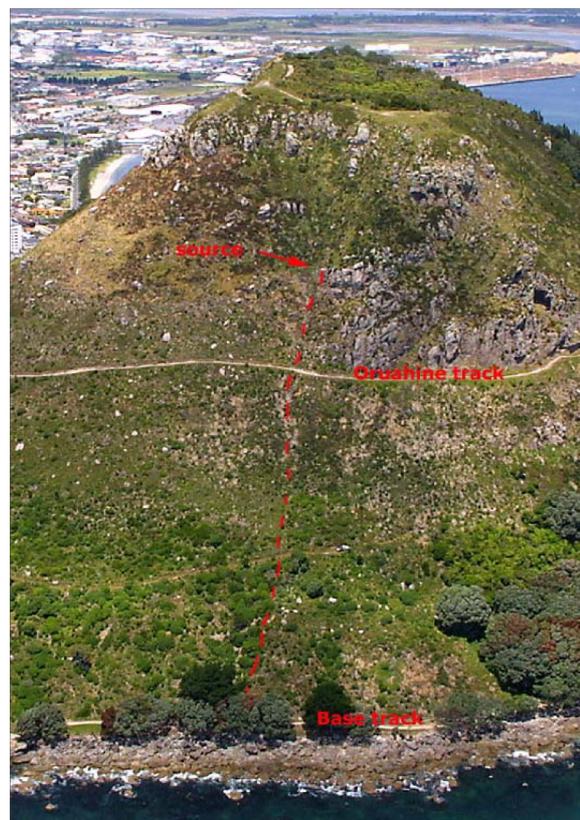
The source of the rockfall was found to be the front area of an overhanging rock outcrop approximately 150m vertically above the Base track, 40m above the Oruahine track.

Photograph 1 & 2; Source outcrop and rockfall path.

Adjacent to the failed outcrop is a gully which guided the rockfall down the slope.

This gully was identified as 3e in previous reports as it was a well known high risk rockfall route, recommended as a possible site for rockfall fencing.

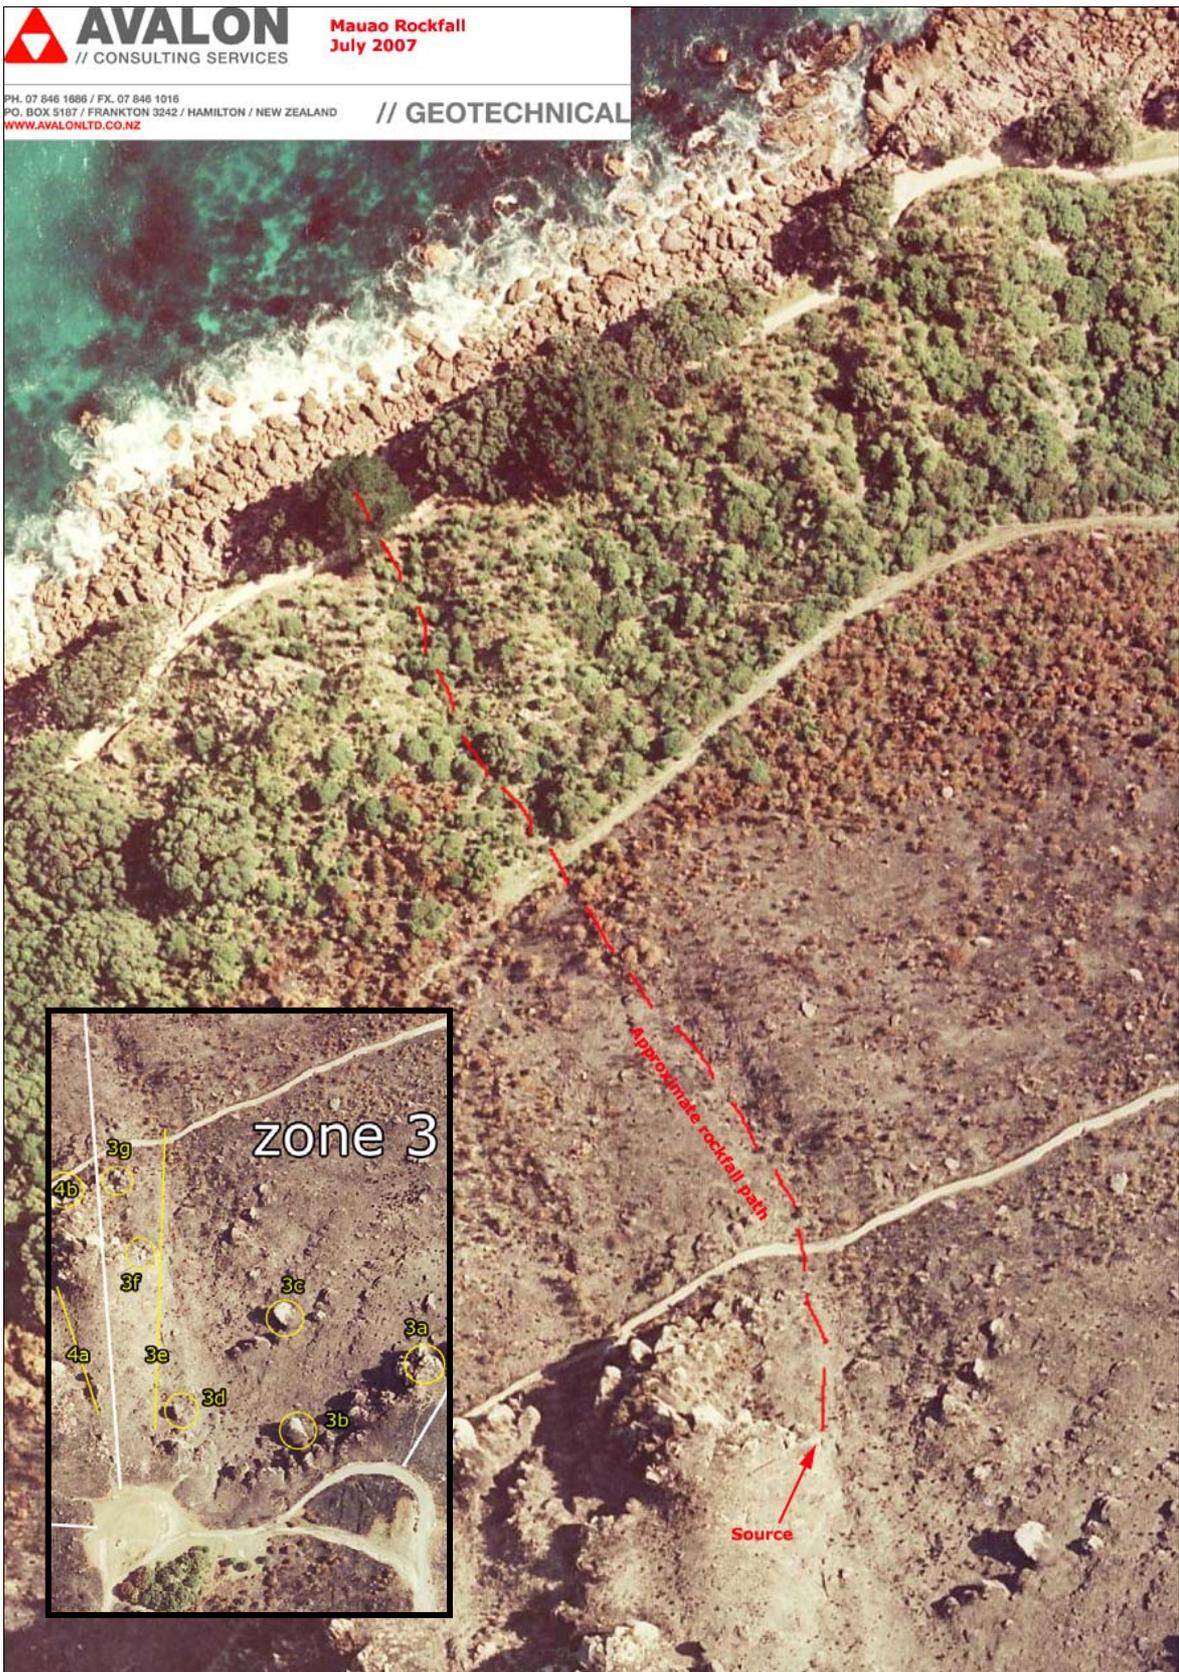
It is unknown exactly how much rock crossed the Base track; however, Avalon's previous rock scaling in this area demonstrated that many rocks falling down this particular gully do reach the shoreline.

Photograph 3; Source location and rockfall path – gully 3e.

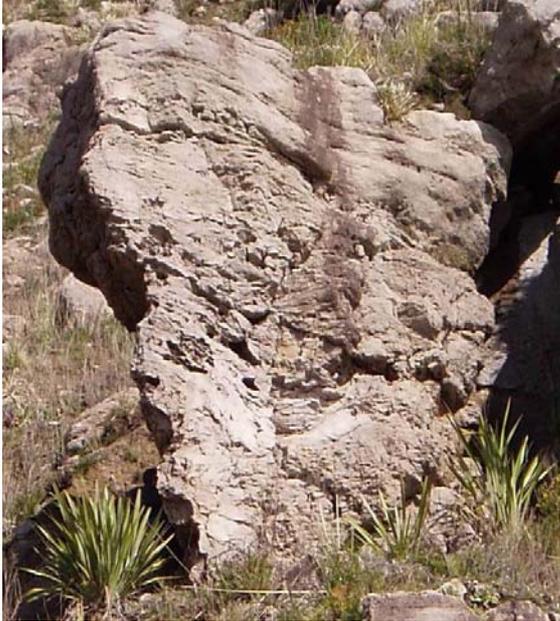
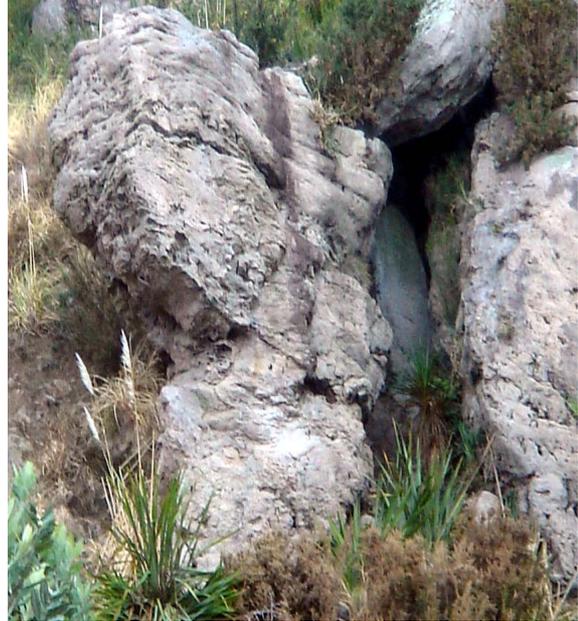
Photograph 3 & 4; 2004 vs. 9 August 2007.

Approximately 3m³ (7.5 tonnes) of rock failed from an area 3m high x 2m wide. Initially the falling rock was probably in two or three large boulders but these continued to break up as they bounced down the slopes.

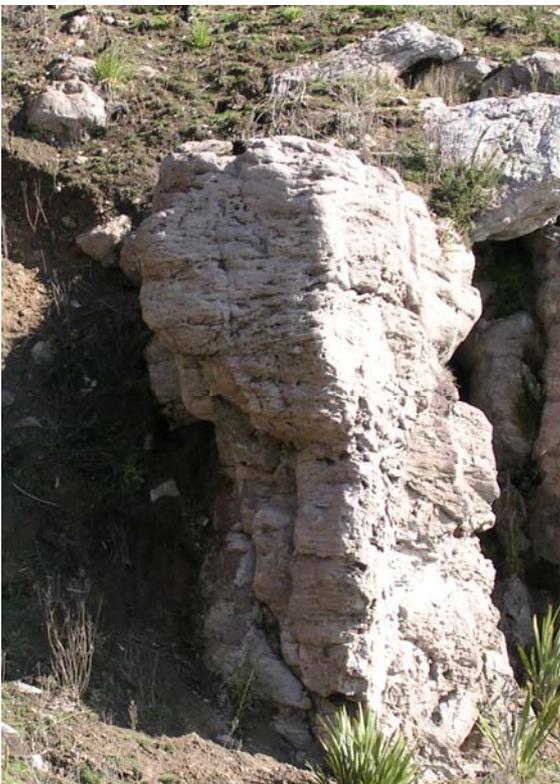
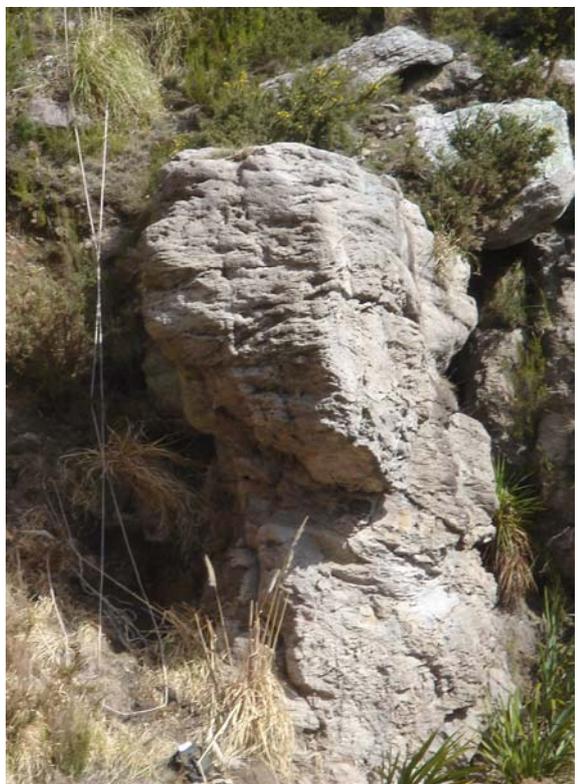
Photograph 5 & 6; 2004 vs. 9 August 2007.

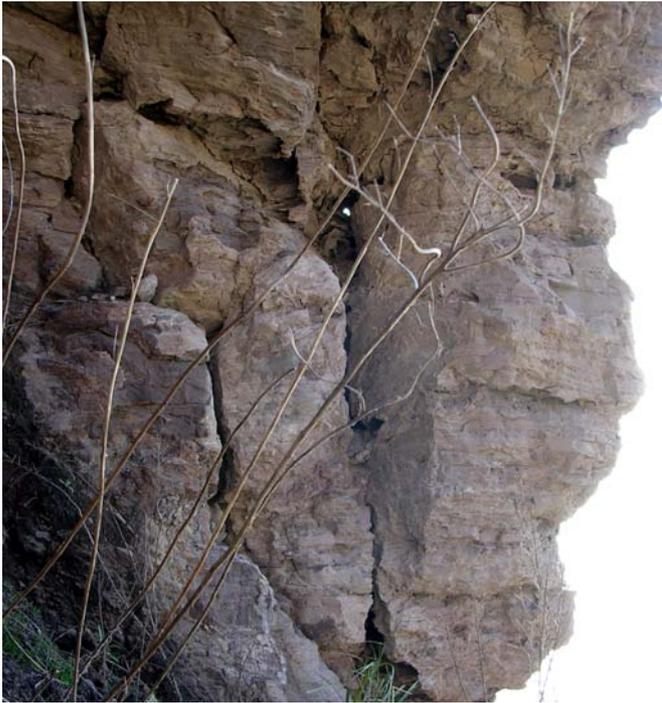
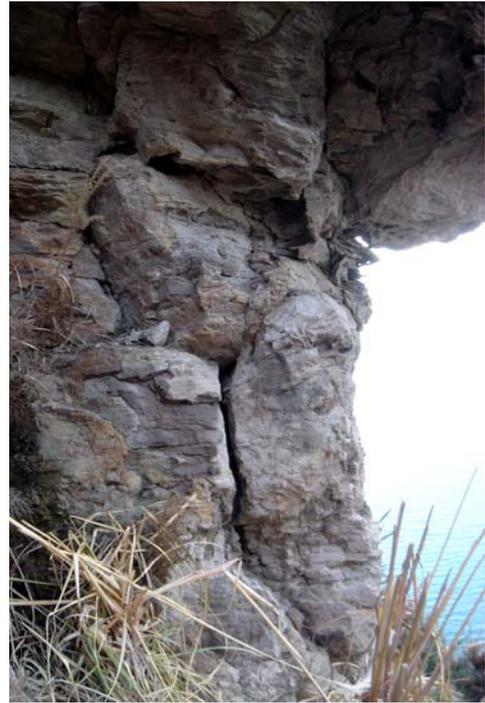
Photograph 7 & 8; 2004 vs. 9 August 2007.

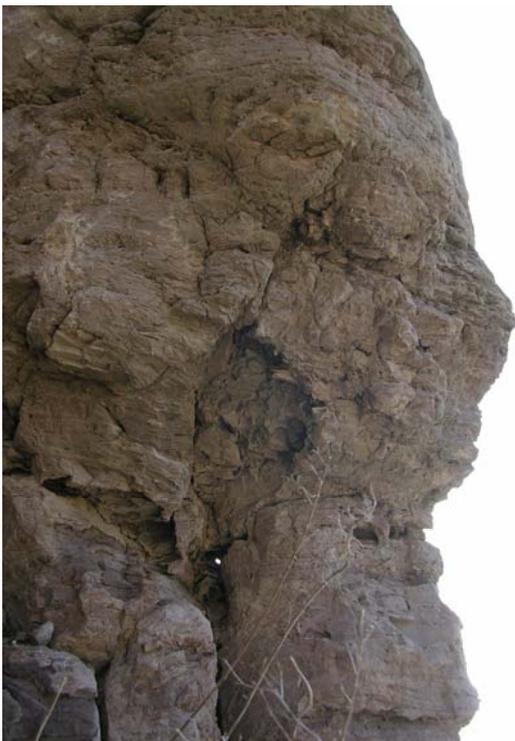
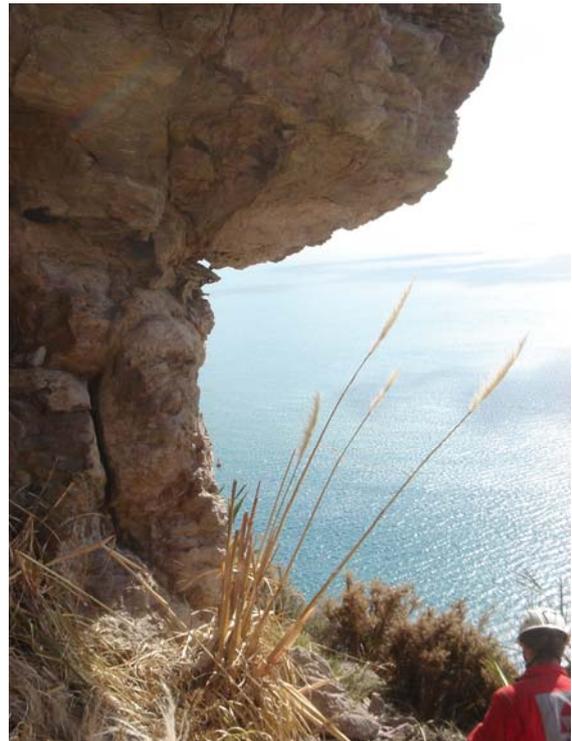
Photograph 9 & 10; 2004 vs. 9 August 2007.

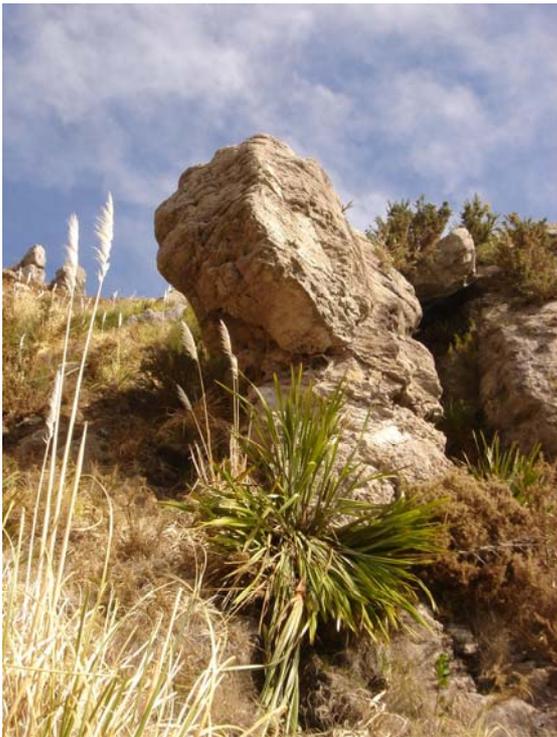
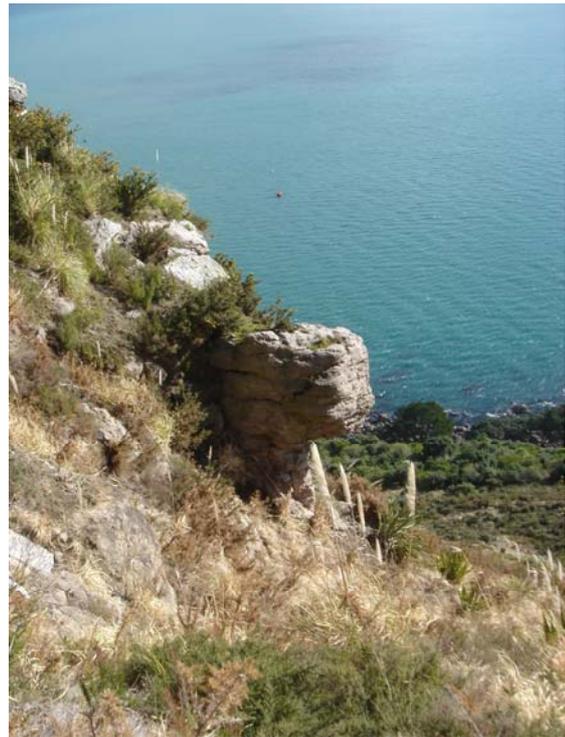
The remaining rock mass is open jointed all around and significantly overhanging. Viewing it from all angles it appears little is keeping it in place.

Assessing the stability is inevitably somewhat subjective, however, given our experience on Mauao, in our judgment the remaining rock mass appears more likely to fail within years rather than decades.

A potential further failure could involve 50 to 100m³ of rock which would break up into many smaller pieces whilst falling the 150m vertically down to the base track.

Photograph 11 & 12; General views.

An option to leave the rock stack and monitor it on a gradually extended time scale i.e. start off fortnightly and then depending on results push it out to monthly and biannually could be seen as an option.

Removing the remaining rock stack by blasting

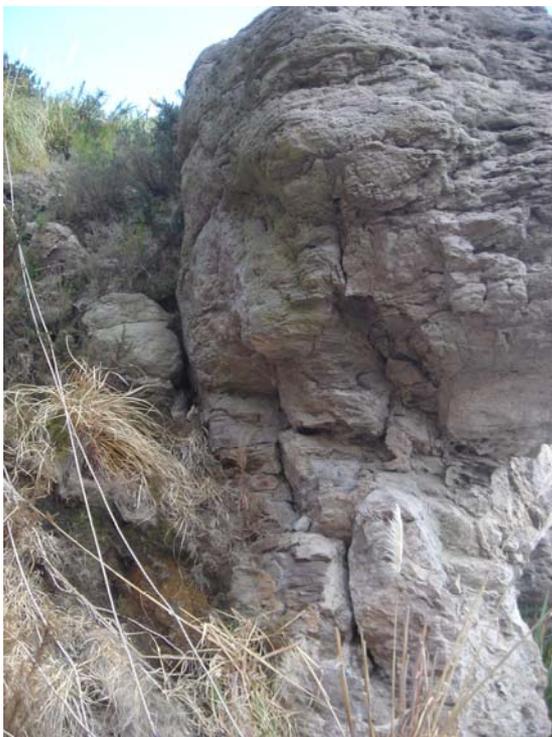
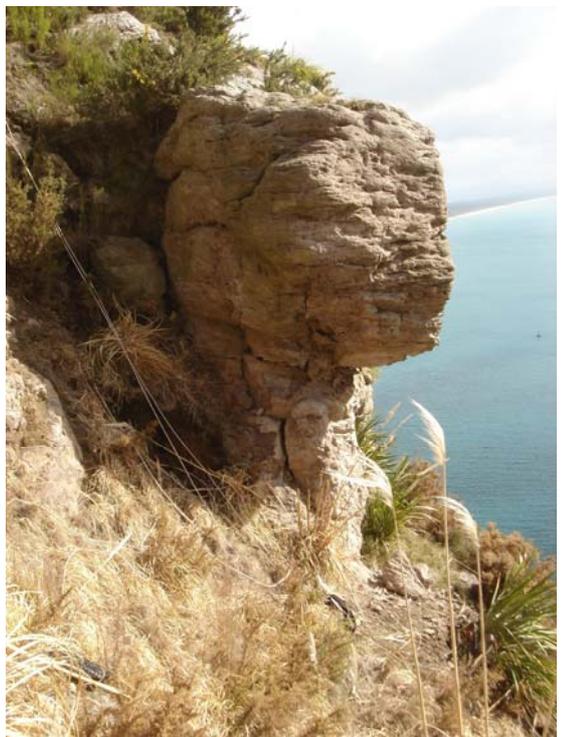
Photograph 13 & 14; General views.
