Rock Engineering Consultant

Report on

**MAUAO STABILITY ASSESSMENT
MOUNT MAUNGANUI, TAURANGA**

Tauranga District Council
Private Bag
Tauranga
Date: 31 May 1999

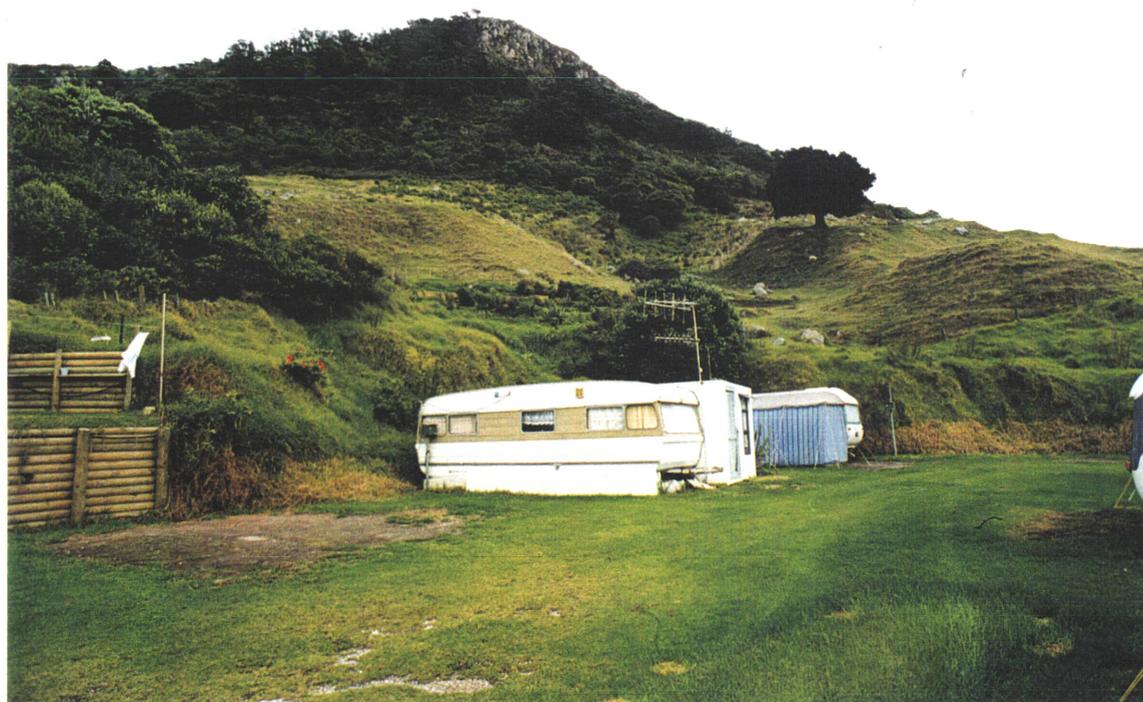
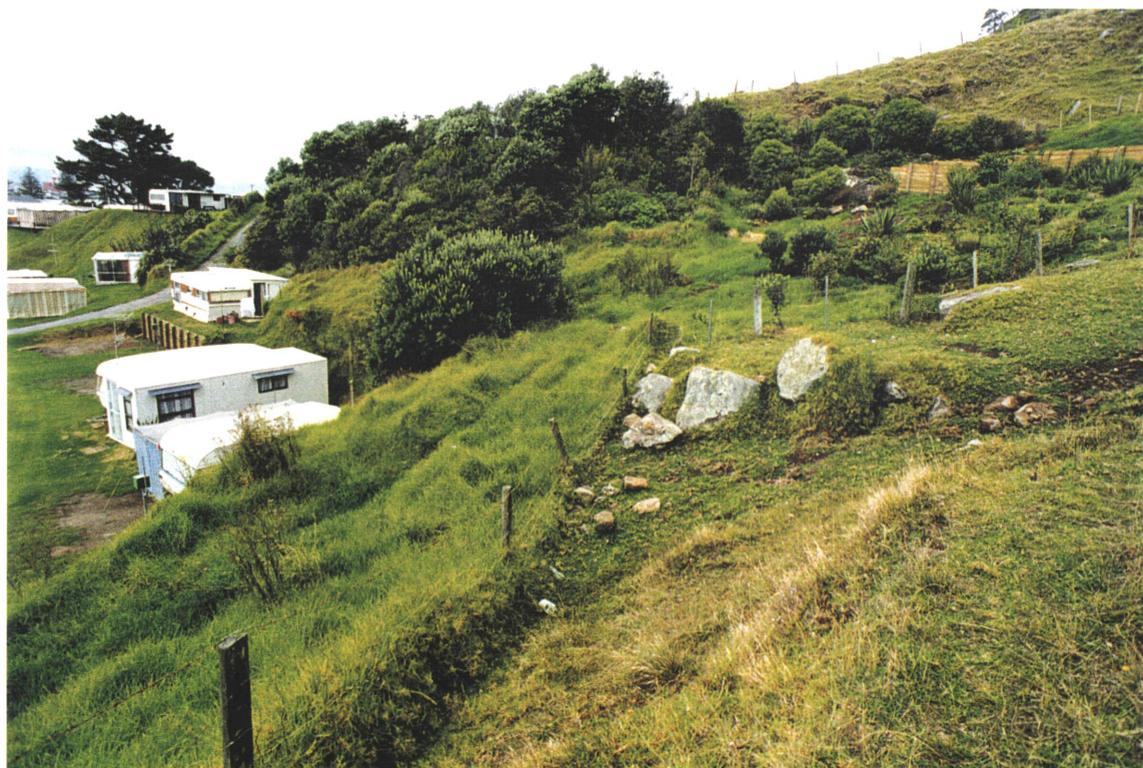
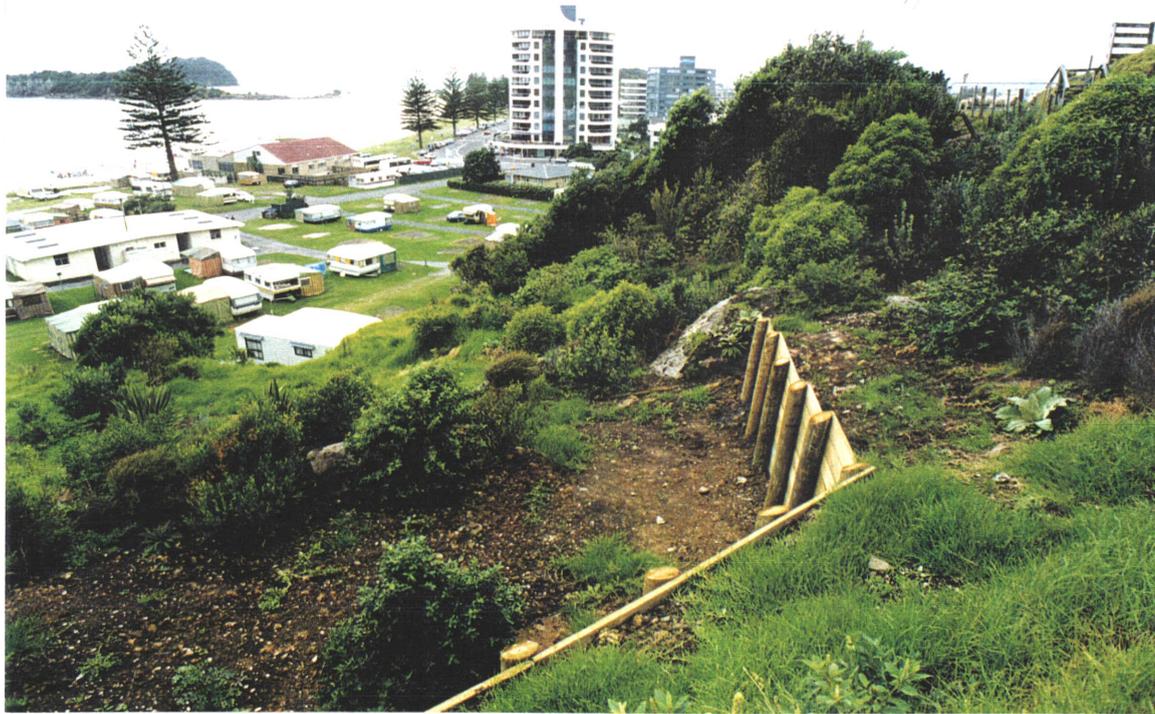
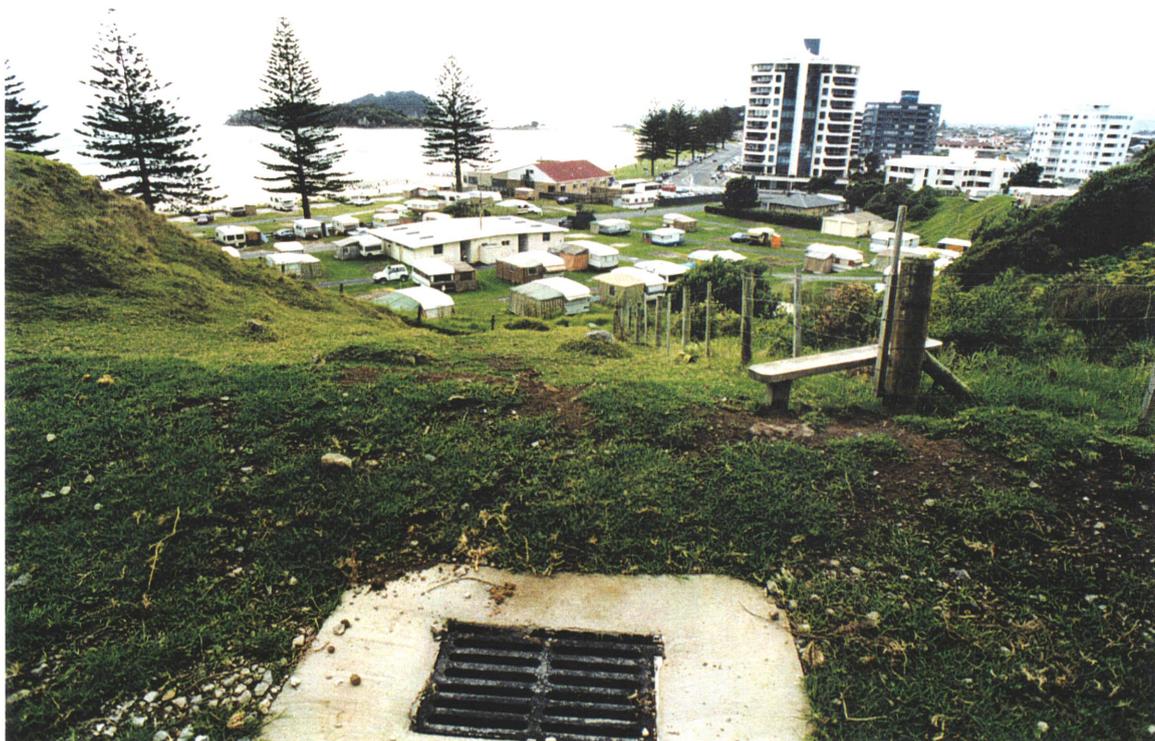
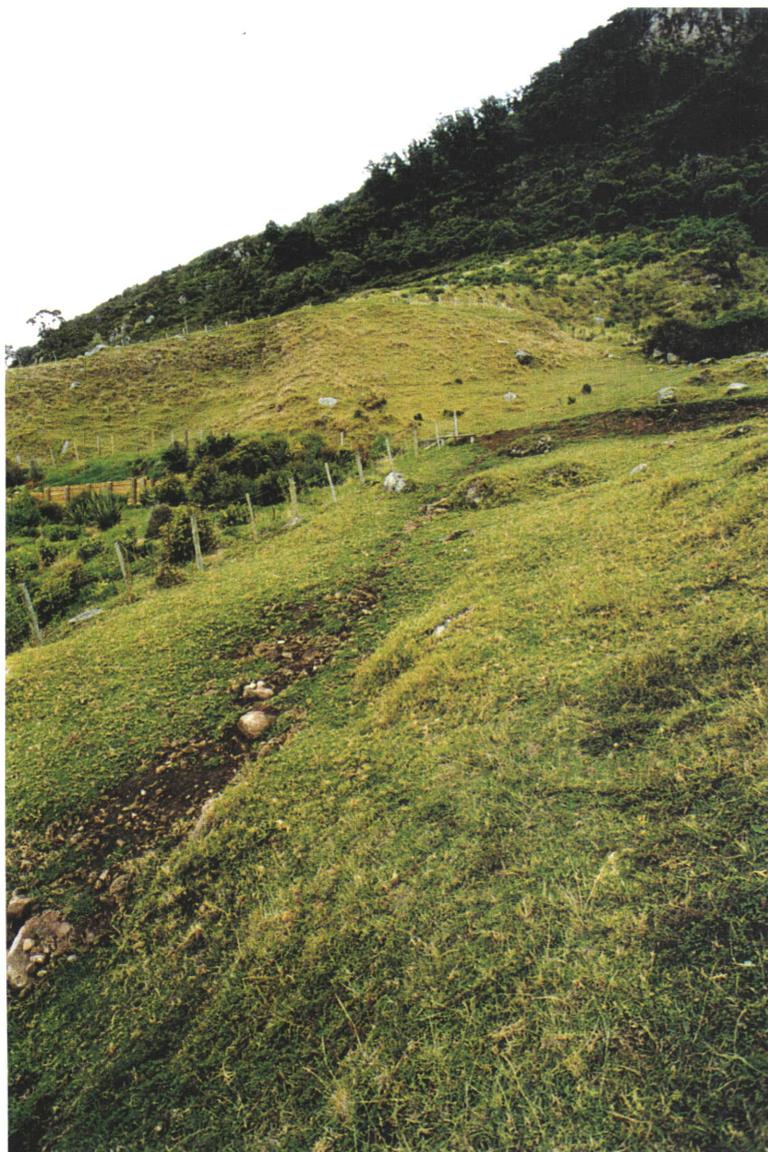
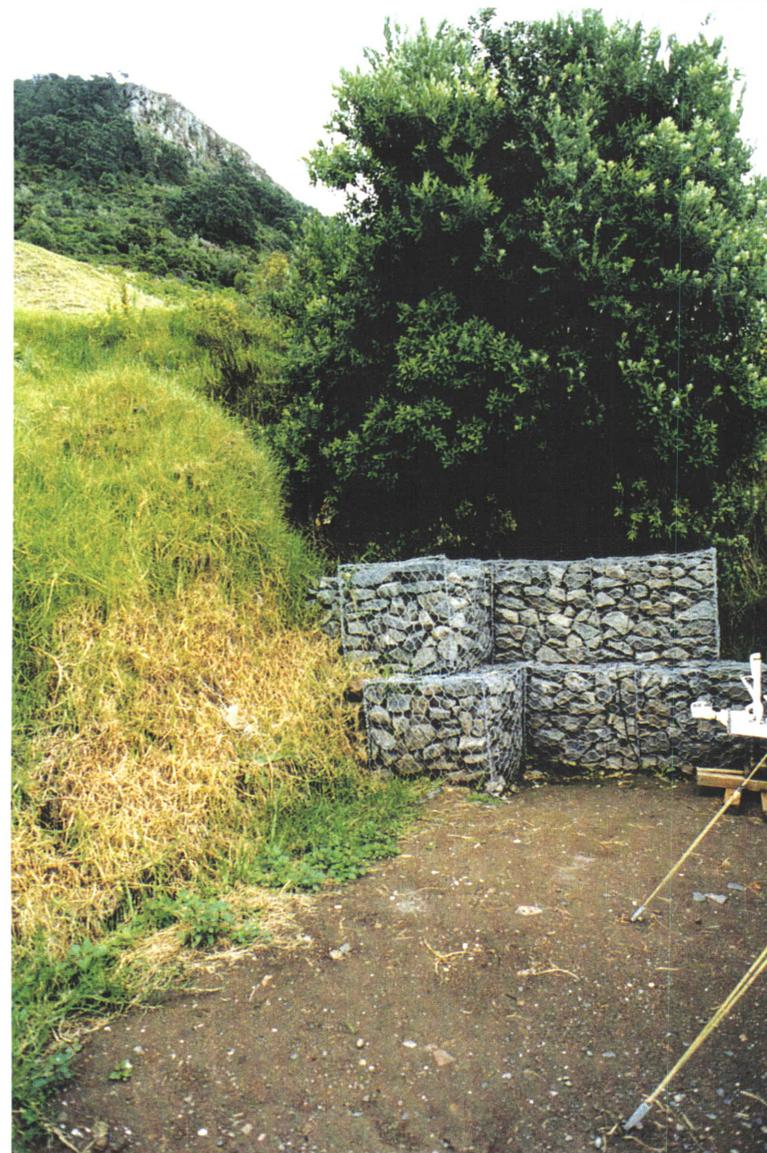
MAUAO STABILITY ASSESSMENT
Photos of 11 July 1998 debris flow area

Debris flow entered site behind caravans and below pohutukawa tree at northern end of camping ground

Debris flow was triggered by water piping from area of new timber retaining wall at top of photo. Landscaping works had been carried out prior to debris flow

New timber retaining wall erected after debris flow. Water pipe was located at vee of wall.

Surface drains installed after debris flow

New drainage line from walking track

Gabion baskets at previous overflow point

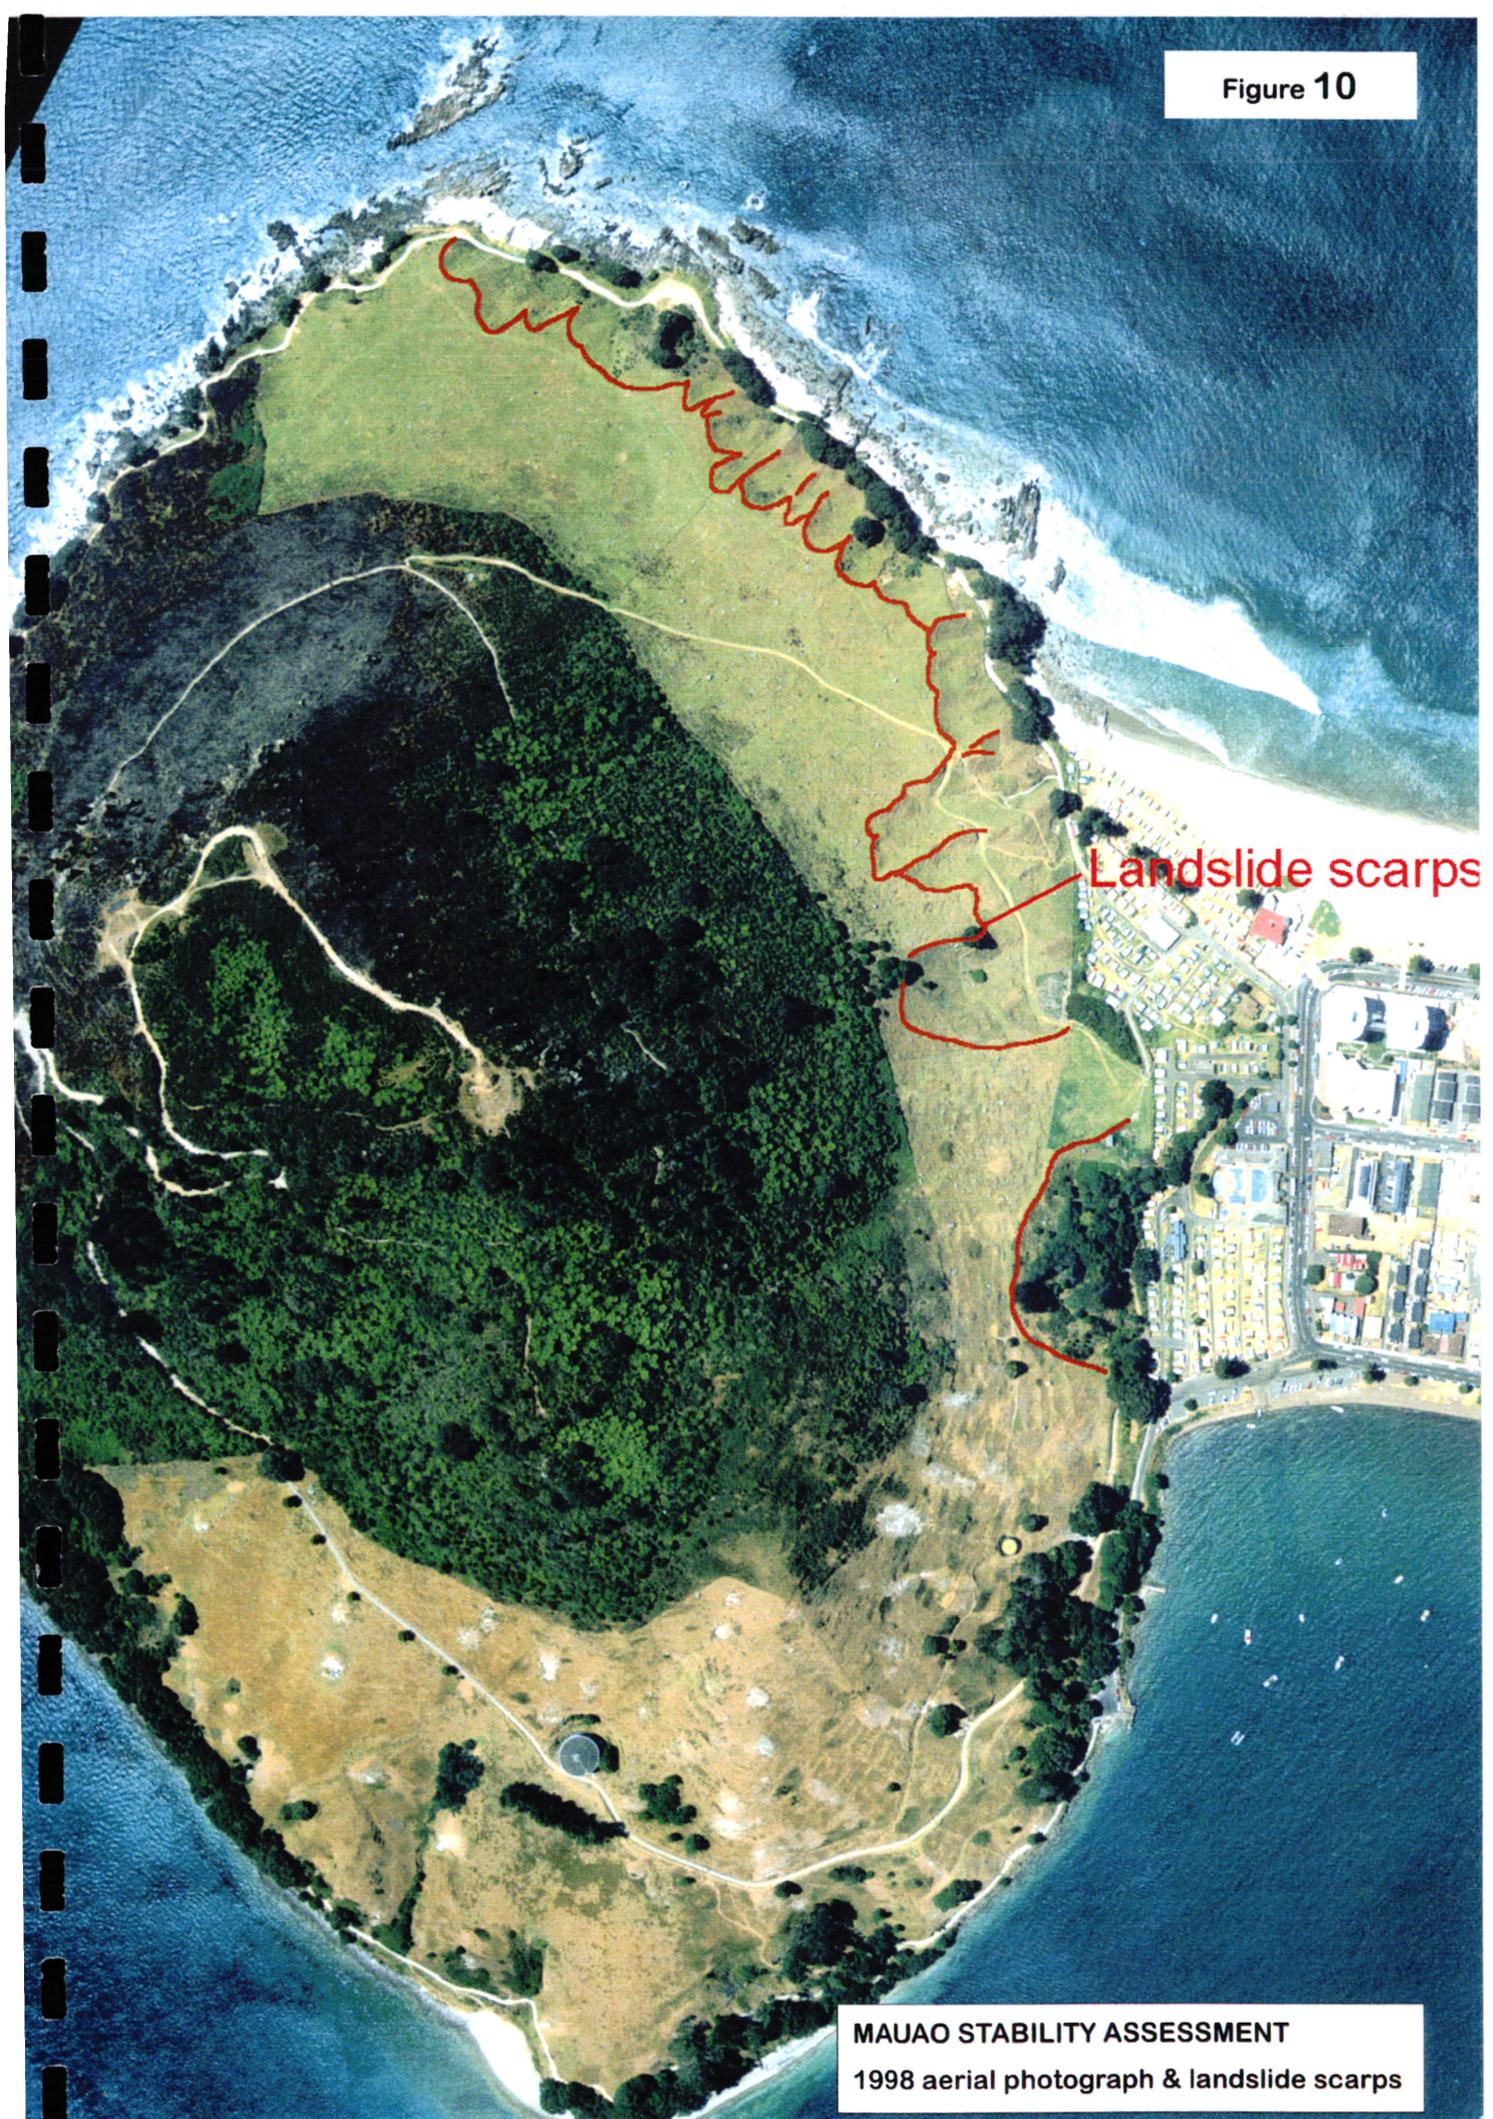
Figure 10

The gross stability of landslides is often very sensitive to small changes in the stability of the frontal lobes. Examination of the aerial photographs has indicated that a number of small slumps directly above the Base Track have been active since at least 1953. Examples of these are shown in Figure 19. These are slow-moving features and are not considered to present any significant hazard to users of the Base Track.

Landslide scarps

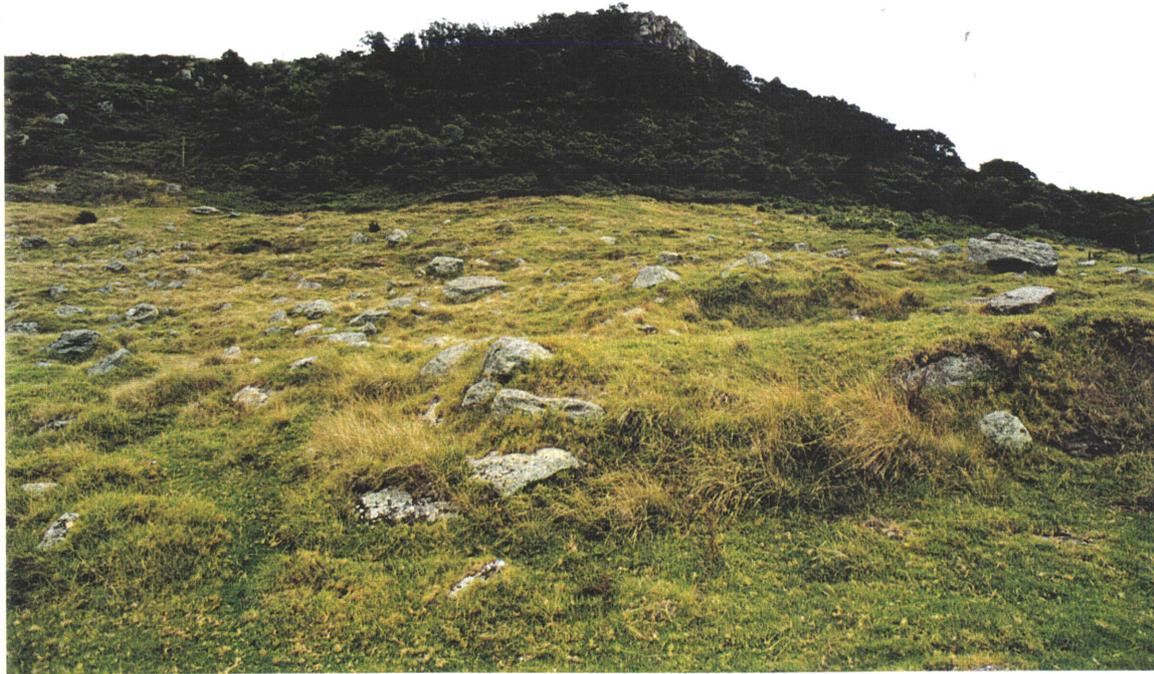
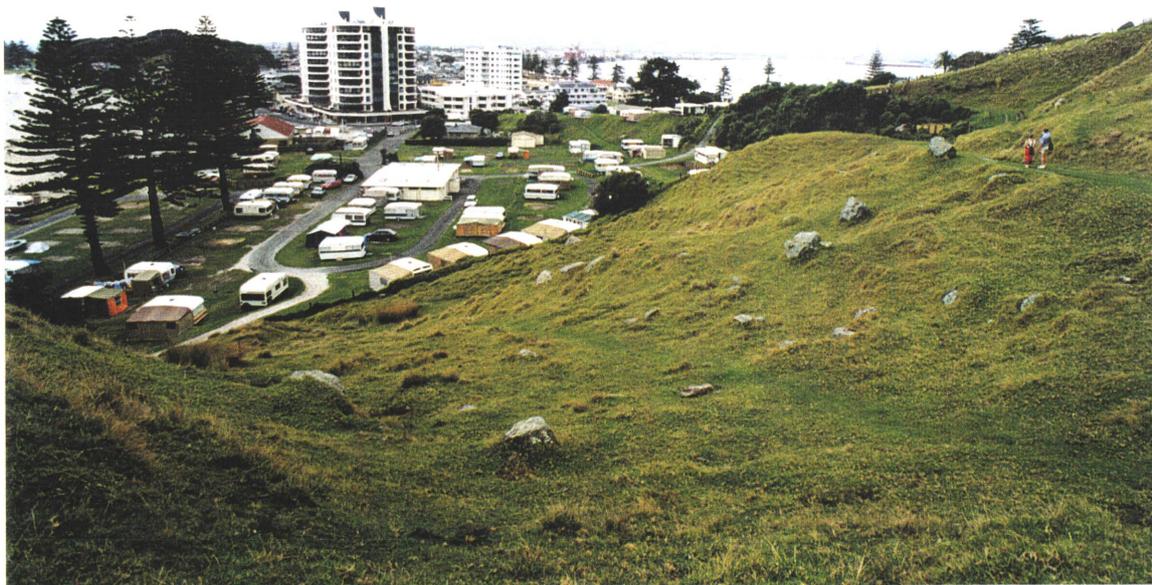
MAUAO STABILITY ASSESSMENT
Boulder fields above camp site

The fence lines around the summit bush and above the camp site were inspected for damage from falling rocks. There was no evidence of recent falls from the cliffs from either scarring in the bush or damage to the fences. No signs could be seen of fresh boulders from the summit cliffs on the grassed slopes below the fence line.

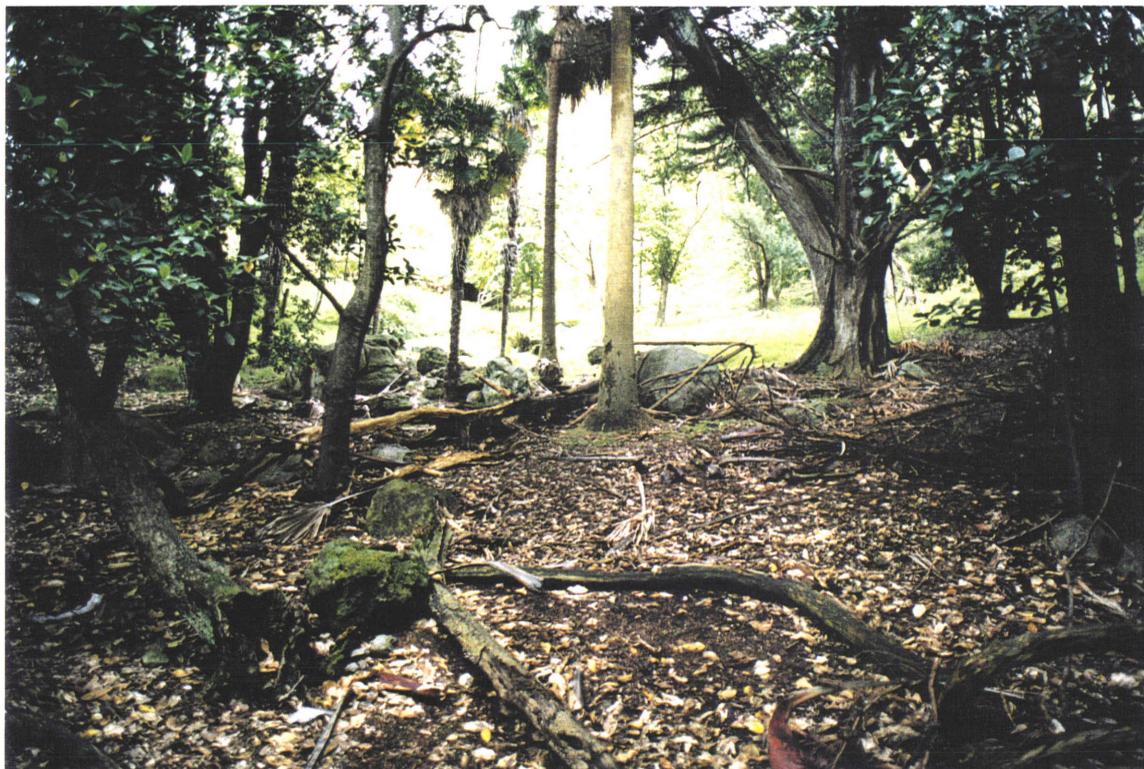
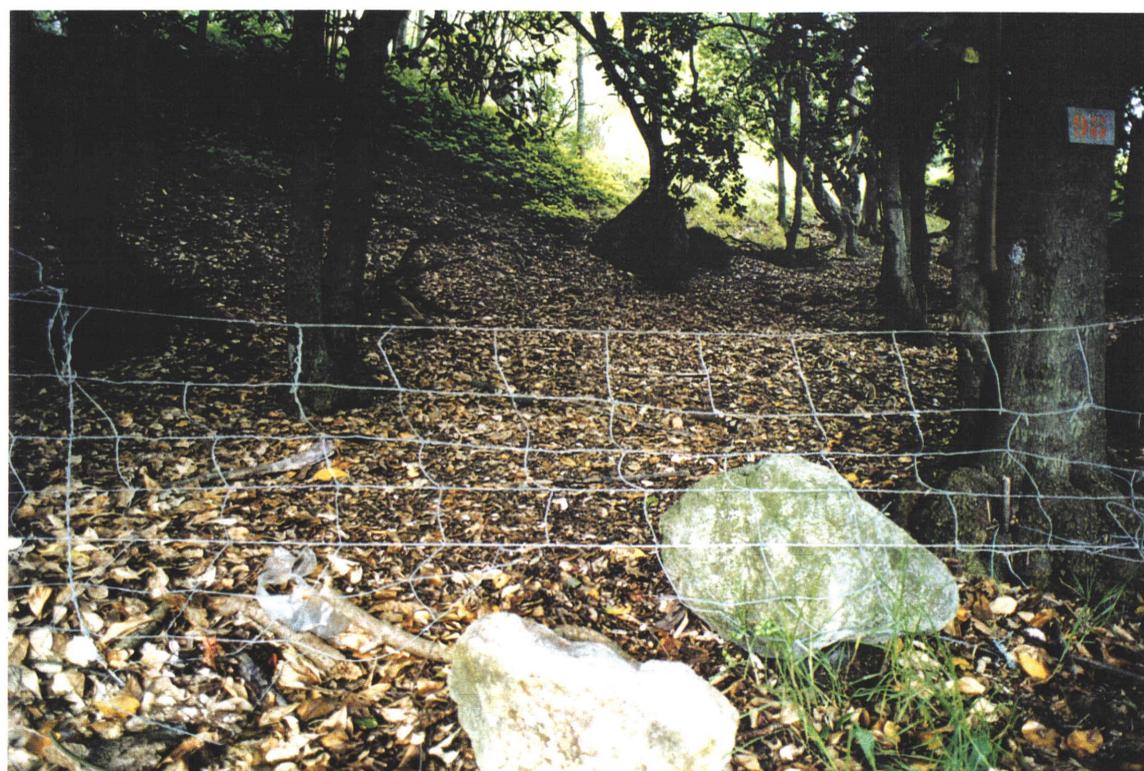
MAUAO STABILITY ASSESSMENT
Boulder falls above sites 93-98

There are a number of local hazards directly around the western edge of the camping sites 93-98 to the south of the Hot Pools complex. The wire fence above this area shows signs of having been hit by boulders and there are a number of small boulders resting against the wires. At site 98, two boulders have come to rest at the fence line, one having broken through the sheep netting; two smaller boulders have travelled on to the caravan/tent site (see Figure 15). The area above the fence has many boulders in amongst the trees and the boulders may have been dislodged by children or animals.

7. The camp grounds should be inspected in detail and a hazard plan prepared showing the nature and location of any potentially dangerous features which may compromise safety in these areas. Based on the brief survey described in this report, several locations of unacceptable hazard have already been noted. Affected camp sites should be vacated until the hazard is eliminated. In particular, any boulders in the immediate vicinity of the camp which could be dislodged by children should be removed.

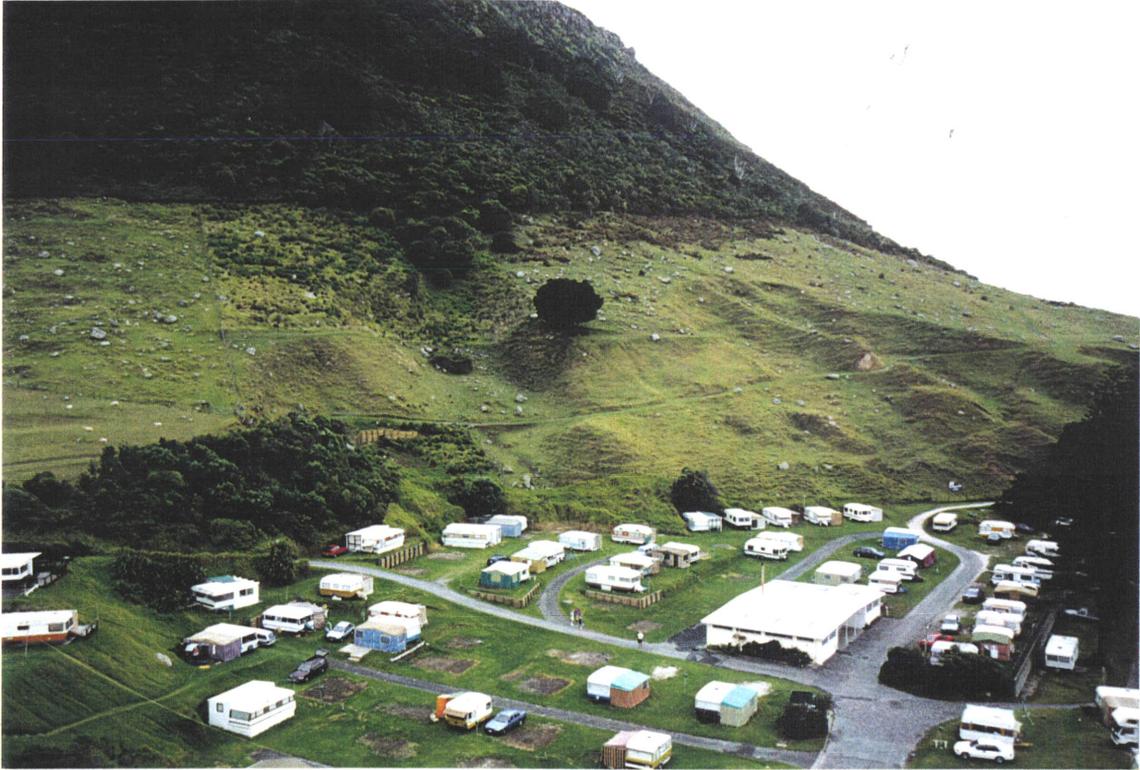
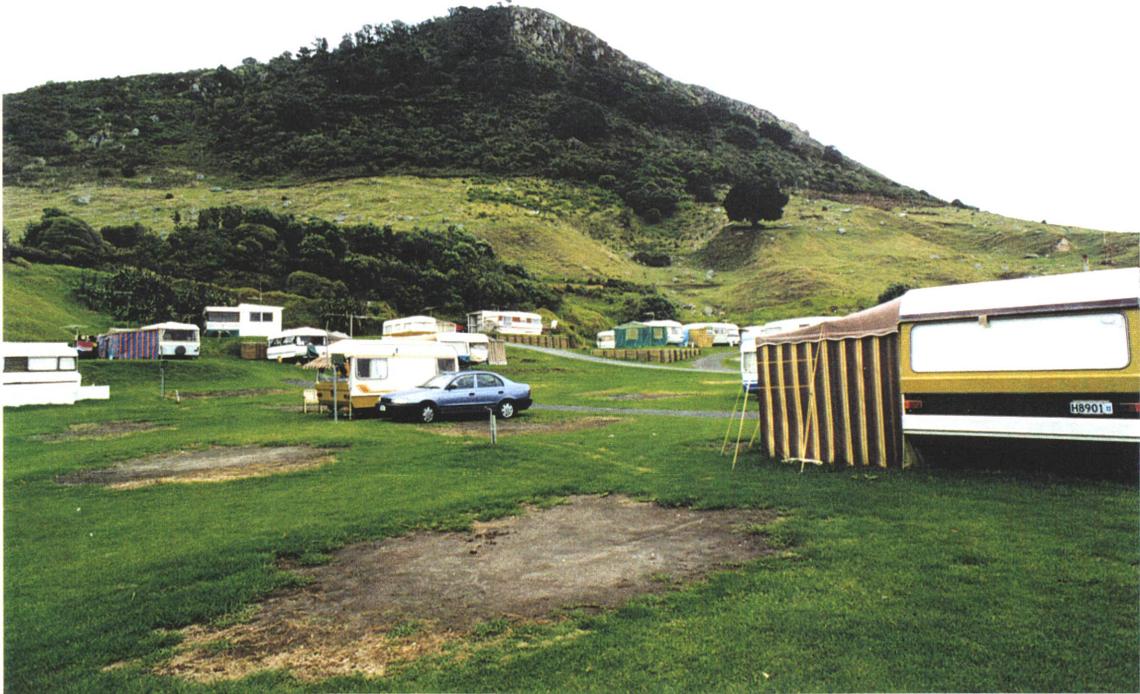
The old landslide surface directly above the Ocean Camp site was inspected (Figure 17). There was no evidence that the landslide was moving at greater than normal creep rates for soil – in particular there were no observable tension cracks or active scarps. The lack of activity in the major landslide zones could also be confirmed from examination of the aerial photographs (Section 3.1).

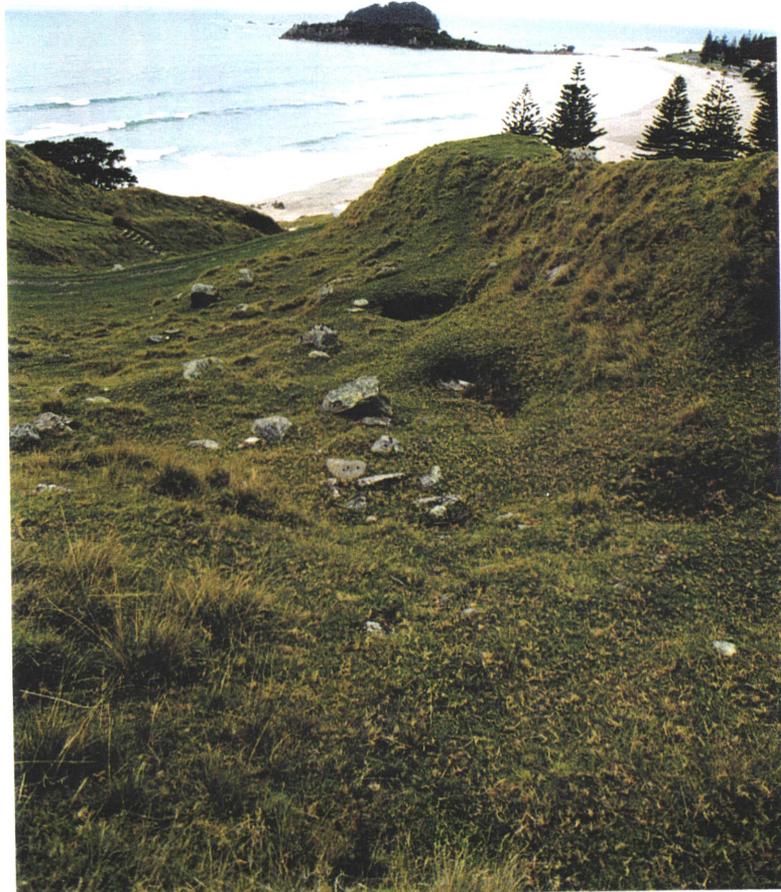
MAUAO STABILITY ASSESSMENT
Sinkhole formation in Stone Steps gully

- Sinkholes or depressions could be seen in a number of locations (e.g. in the Old Stone Steps gully - Figure 18) indicating that piping channels may be eroding through the colluvium and may give rise to blowouts near the toe of the landslide
- The sides of the landslide gullies are often very steep and small failures of the sides would not directly affect the camp site. However during periods of heavy rain, these failures could block the surface runoff and subsequently fail creating high-speed debris flows down into the camp area.

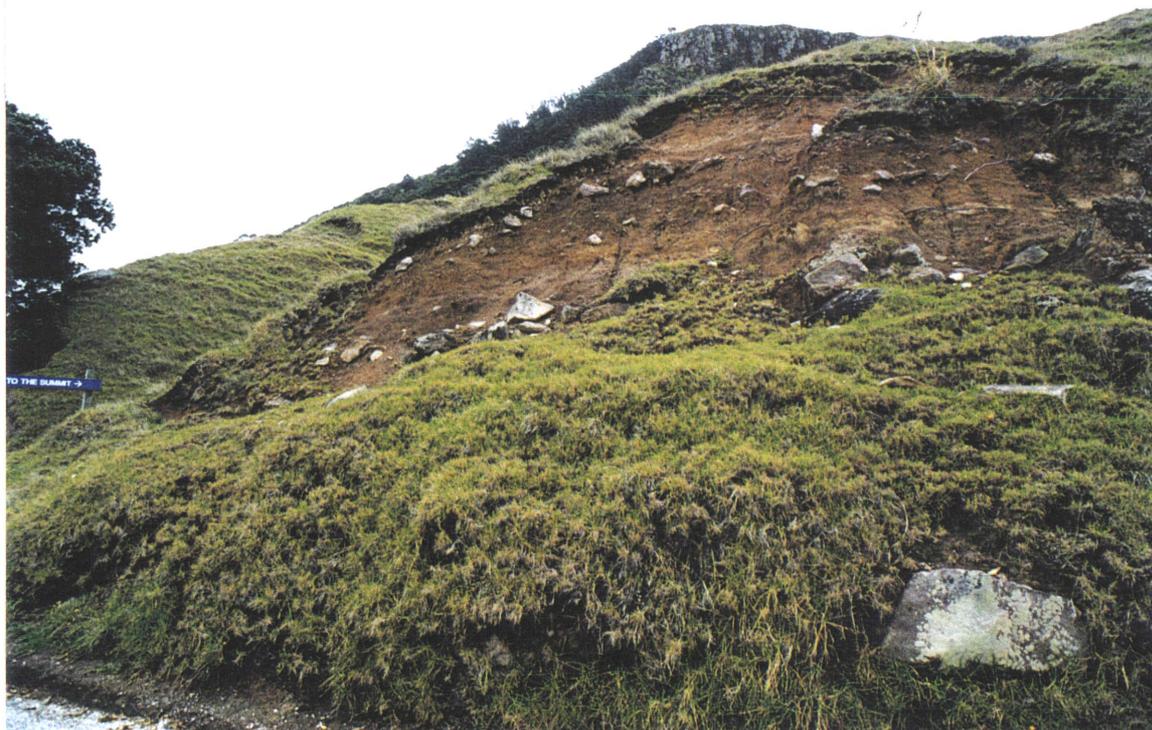
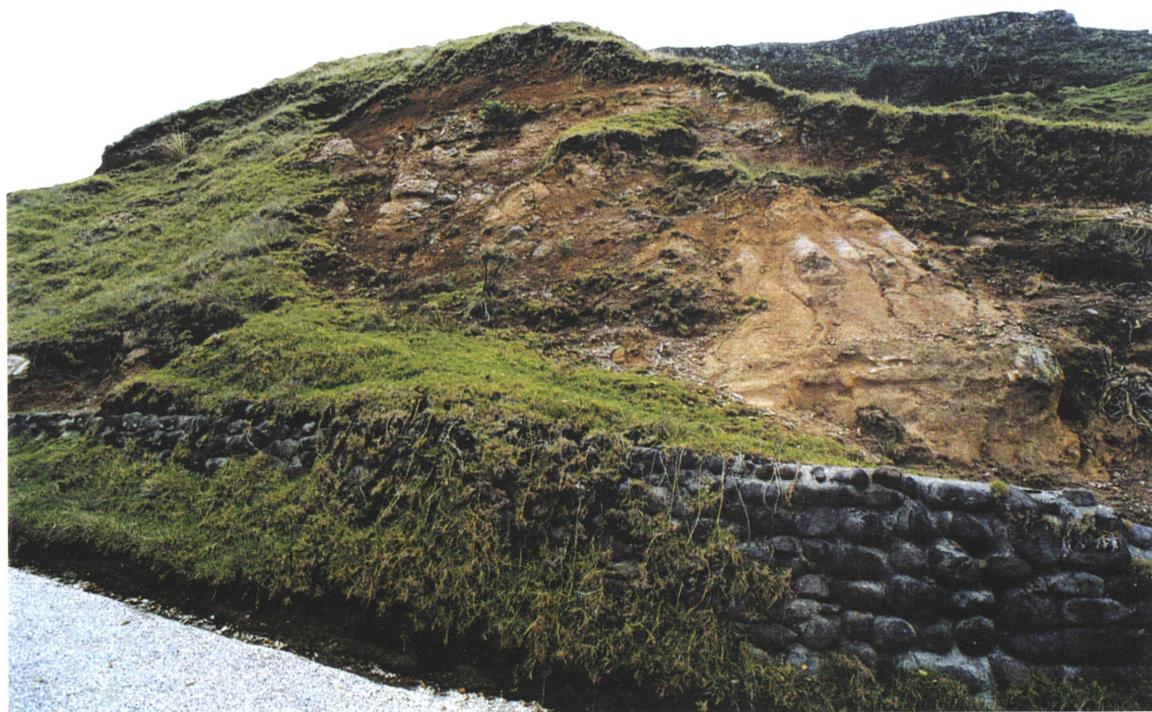
MAUAO STABILITY ASSESSMENT
Examples of active areas directly above the
Base Track

9. There are a number of failures in the frontal lobes of the landslides along the Base Track which indicate that these are prone to failure when oversteepened

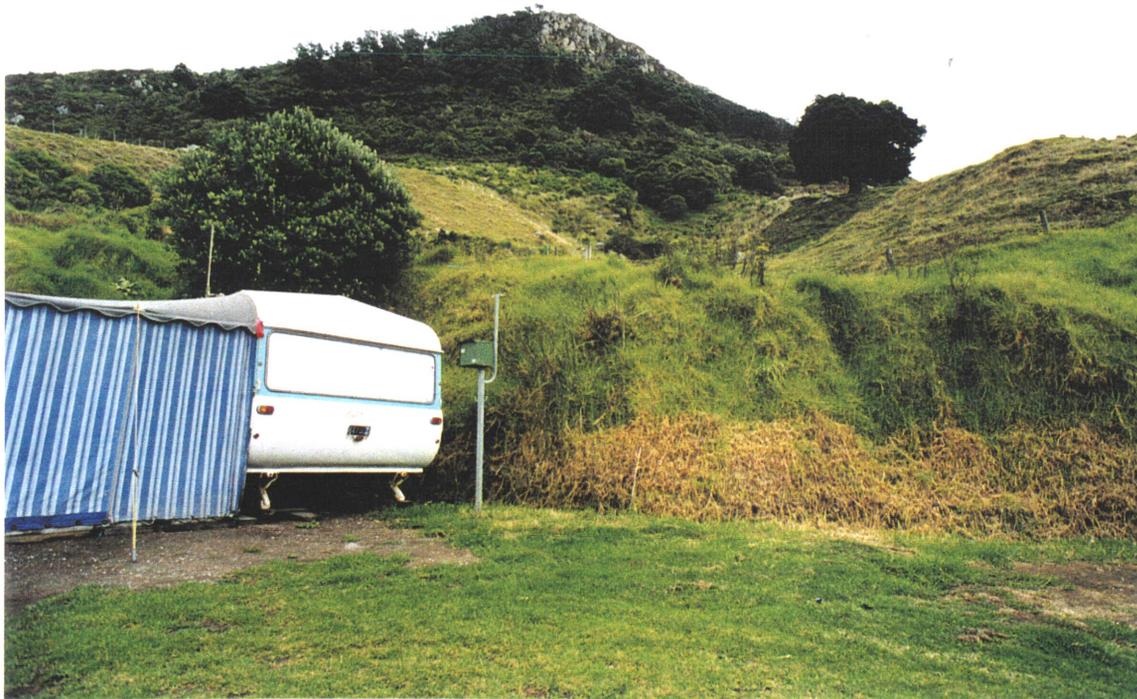
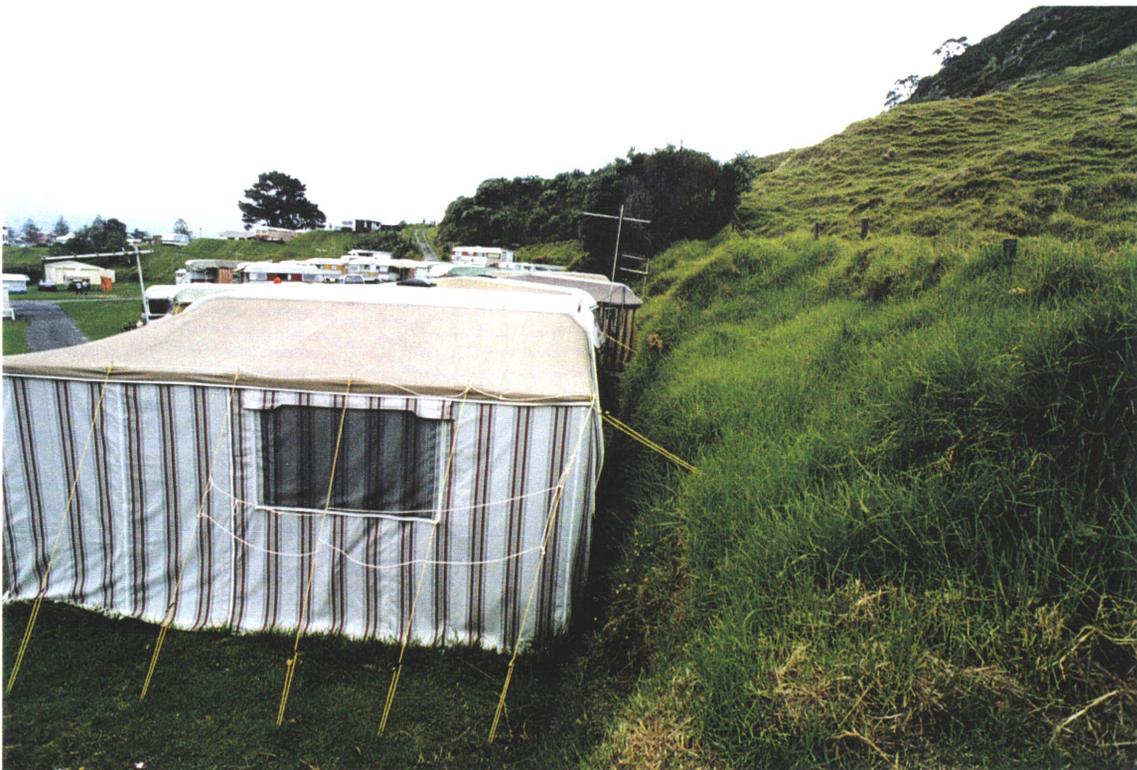
The risks of injury or fatality from slope failures to sleeping persons in fragile accommodation (tents/caravans) is quite high and the owners/operators of such facilities would have a duty of care to ensure their safety. It is likely that there might be a much higher requirement for duty of care to occupiers of camp facilities than to those walking or jogging around the mountain.

Caravan sites directly adjacent to undercut toe of landslide

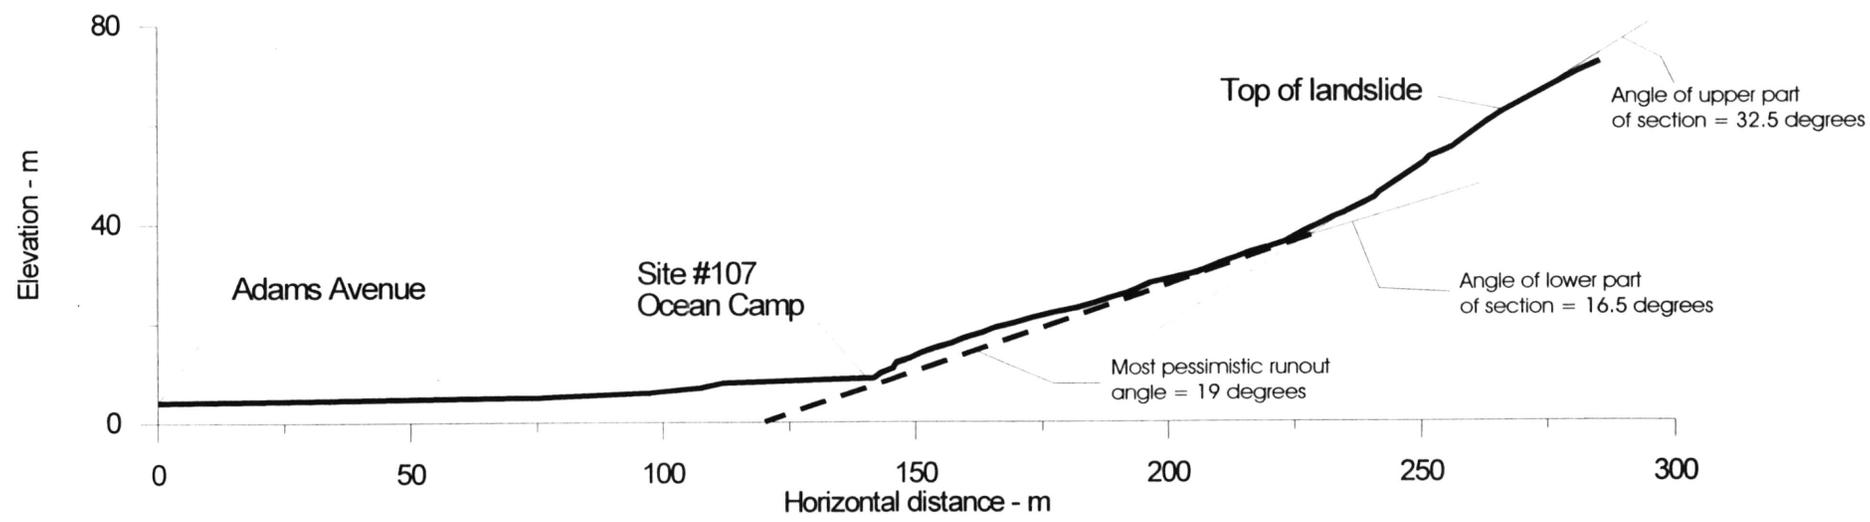
MAUAO STABILITY ASSESSMENT
Section through landslide directly above Site 107 Ocean Camp

The most pessimistic value of Hungr's recommendations for travel angle is for an H/L value of 0.35 for a large (> 2000 m³) confined landslide. This angle of approximately 19° is steeper than the angle of the slope and therefore significant runout from a further large-scale movement of the landslide material would not be expected (see Figure 24).
