## Memorandum

To	s 7(2)(f)(ii)
Copy	s 7(2)(a) - Privacy
From	s 7(2)(a) - Privacy
Office	Tauranga
Date	1 March 2023
File/Ref	2-9B559.00
Subject	TCC Slip Inspections for Council Reserves

This letter relates to our recent site inspections of landslips affecting Council Reserves in Tauranga City. The geotechnical inspections are to inform TCC of any immediate risk to people or property and to provide recommendations for further work to remediate the sites. As part of our assessments, the following sites have been inspected.

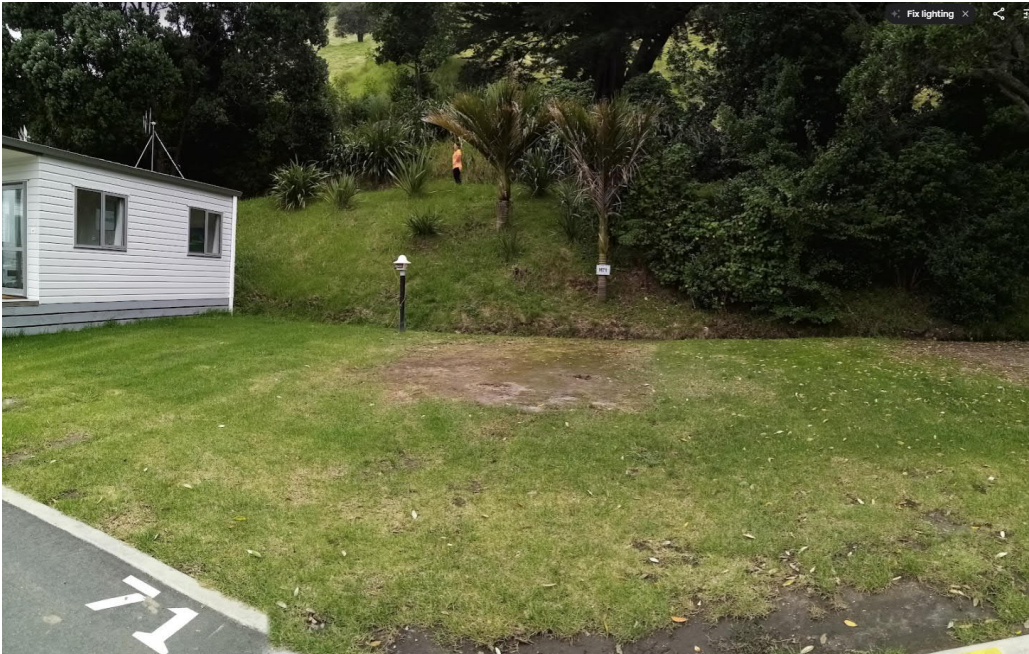
This site is located at the western end of the Mauao campground on the corner of Pilot Quay and Adams Avenue at the foot of Mauao. The slope comprises an approximately 5m high grassed bank with a slope gradient of approximately 40 degrees above the camp site with a swale drain running along the toe of the slope which contained surface water at the time of the inspection. The crest of the slope is flat with a walking track located above and an approximately 50-degree slope above the track. A tension crack has developed along the crest of the slope. The length of tension cracking is approximately 17m long with a vertical offset ranging from 120 to 170mm. The crack was measured to be 600mm deep. There was no evidence of bulging at the toe of the slope, however a Nikau palm located on the slope had a curved trunk which suggests soil creep is occurring over time.

Figure 1: Grassed slope above site.

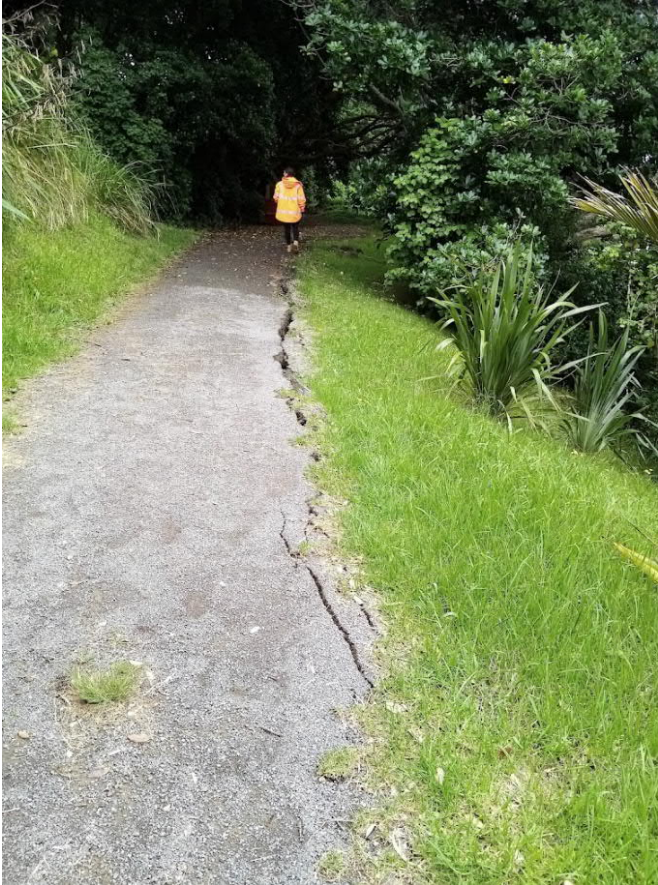
Figure 2: Tension crack along track

Based on our site inspection, it appears that there is an overland flow path which ponds above the site. This, along with saturation of the slope from rapid and persistent rainfall over the slope would have likely resulted in an elevated groundwater table resulting in increased pore pressure in the slope and reduction of the shear strength of the soil. As a tension crack has developed, there has been some shear displacement, however the slope has not completely failed.

We consider the slope to be currently stable under dry weather conditions, however the failure may be re-activated during a high rainfall event (e.g., 100-year storm event) if excess water pressure develops in the slope. The consequence of failure would be moderate for structures situated immediately. However, as the slope is of limited height, we anticipate a potential slump failure would be limited to the toe of the slope.

Following our initial site visit on 31 January 2023, WSP recommended that the site area was cordoned off below the track, including camp sites H72 – H70 followed by monitoring the site. We also recommended that the tension crack above the slope was filled with bentonite clay to prevent water from infiltrating through the slope and that additional drainage measures were implemented above the slope, such as installing an additional culvert above the slope with an appropriate outlet to prevent water ponding above the slope.

Based on our initial appraisal of the site, we recommend that additional hand auger testing is undertaken at the site along with the completion of a topographical survey to enable the accurate development of a ground model, from which slope stability modelling can be undertaken. We anticipate that 3 hand augers drilled to depths of up to 4m would be required.

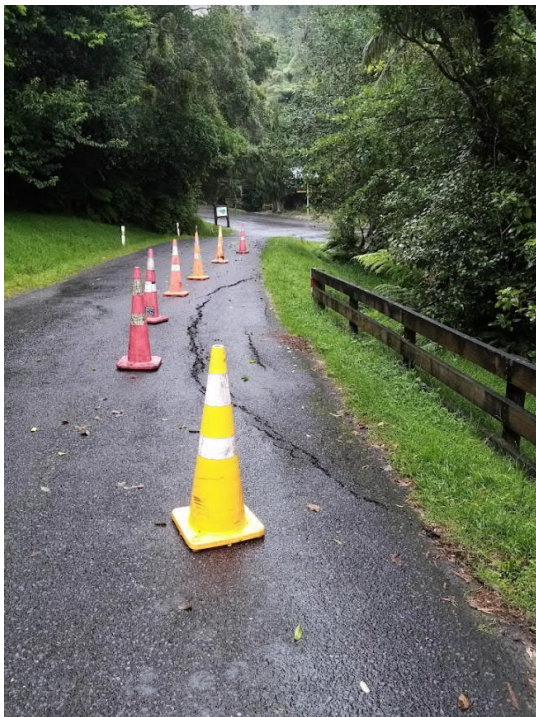
The site is characterised by an arcuate tension crack (13m long) in the road pavement and seal, from which the tension crack then leads to a straight section (9m long) along the edge of seal. There has been slumping and lateral movement towards the stream. Site measurements indicate the tension cracking is approximately 50mm wide with a vertical drop of 80 to 100mm at the maximum location. There is also approximately 50mm of settlement in a localised area of the road on the opposite side of the road. The downslope side of the road drops in elevation by approximately 1.7 to 1.8m over a horizontal distance of approximately 5m (i.e., 1V:3H).

Figure 2: Arcuate section of slump and tension cracking in pavement

Based on our recent site observations and brief desk top study, we consider that the slumping has been caused by the rapid and persistent rainfall, combined with the potential flow of stormwater over the slope which has likely resulted in an elevated, short-term elevated groundwater level.

Currently we believe a future failure is possible as there is a well-developed tension crack, however as the slope is not overly steep or high, we anticipate it would require a very high rainfall event to initiate failure. We anticipate the failure would develop at the current tension crack location leaving an exposed scarp. We therefore consider the risk to be moderate however, a failure may develop in a high rainfall event.

Following our initial inspection, WSP advised that the road could remain open, provided it was monitored each morning for any further slope movements. However, it was advised that the road should not be used during and shortly after heavy rainfall in case of potential further failures.

Based on our initial appraisal of the site, we recommend that additional hand auger testing is undertaken at the site along with a topographical survey. We anticipate that 4 hand augers drilled to depths of 4m would be required.

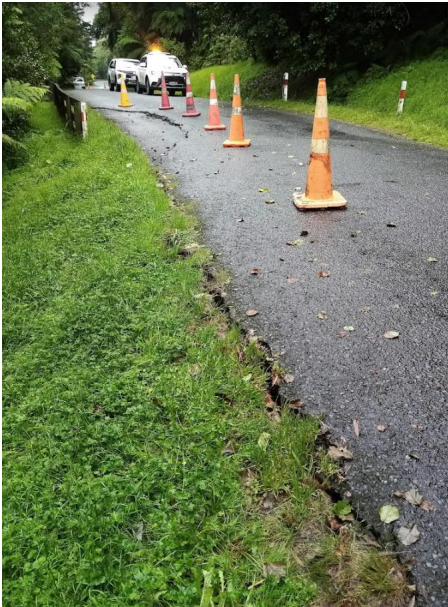
Figure 3: Straight section of tension crack.

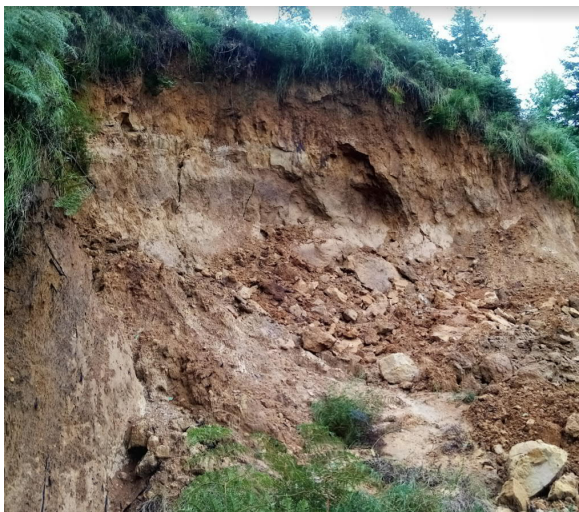
Figure2: Slip site 1

The exposed headscarp at site 1 is approximately 8m across and 3.5m high. The slip has occurred at the edge of a relatively flat terrace below the Hamilton point campsite. The scarp is subvertical to vertical for a height of 3.5m where the slope below flattens to about 18 degrees down to the lake edge. Material exposed in the scarp comprise orange -brown silty clay (ash) material with a sub horizontal coarse sand layer noted at 1.5m below the crest. The failure is indicative of a rotational slip surface.

Based on our observations we anticipate that the failure at both locations is due to the sustained and heavy rainfall which has led to high pore water pressures developing within the slope. There is also evidence of highly permeable sand layers between lower permeability ash layers which could lead to confinement and porewater pressure build up along permeable sand and silt layers. This resulted in reduced effective stresses in the soils and loss of shear strength. In addition, the existing slope had its toe support removed from the original track formation.

Following our initial inspection, WSP advised to cordon off the campsites above due to the current falling hazard and potential for further slippage. WSP understand these sites are currently closed to the public.

Based on our initial appraisal of the site, we recommend hand auger testing is undertaken at the site along with a UAV survey to create a surface and obtain aerial images. We anticipate that up to 3 hand augers per slip site would be required.

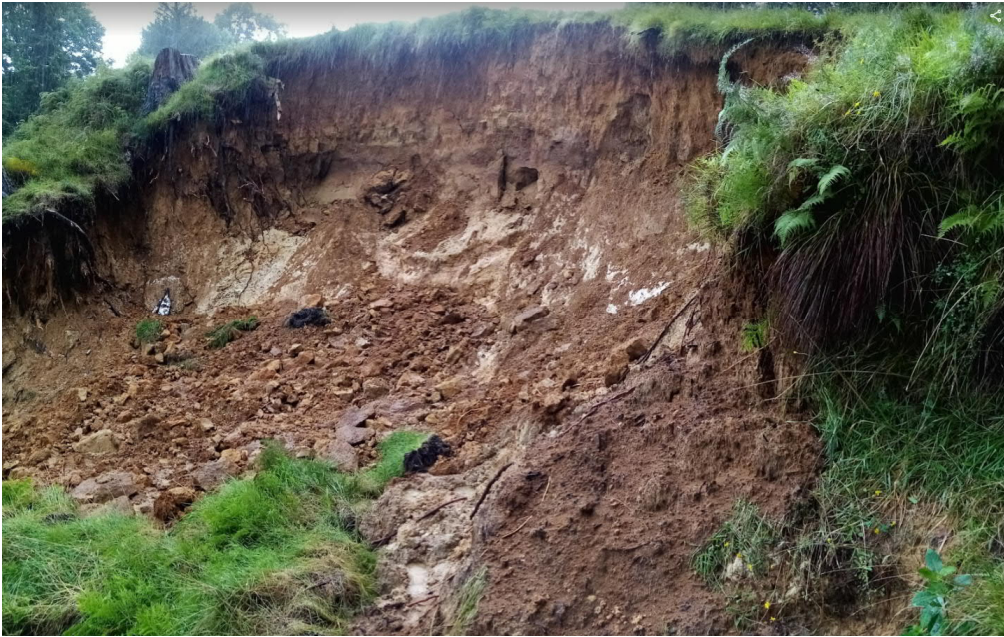
Figure 3: Slip Site 2

Slip 2 is located to the southwest of slip 1 also on the edge of the terrace and as also failed down to lake level. The geometry of the failure surface is similar with a sub vertical to vertical head scarp. The materials exposed in the head scarp from the top down comprise orange, brown clay material overlying sandy layers which are underlain by a brown organic silt and grey/ light orange clay layer. Seepage was observed at the toe of the slope during the inspection. The sequence of ashes is the same for both slip sites with the slips separated by a intact promontory containing tree stumps.

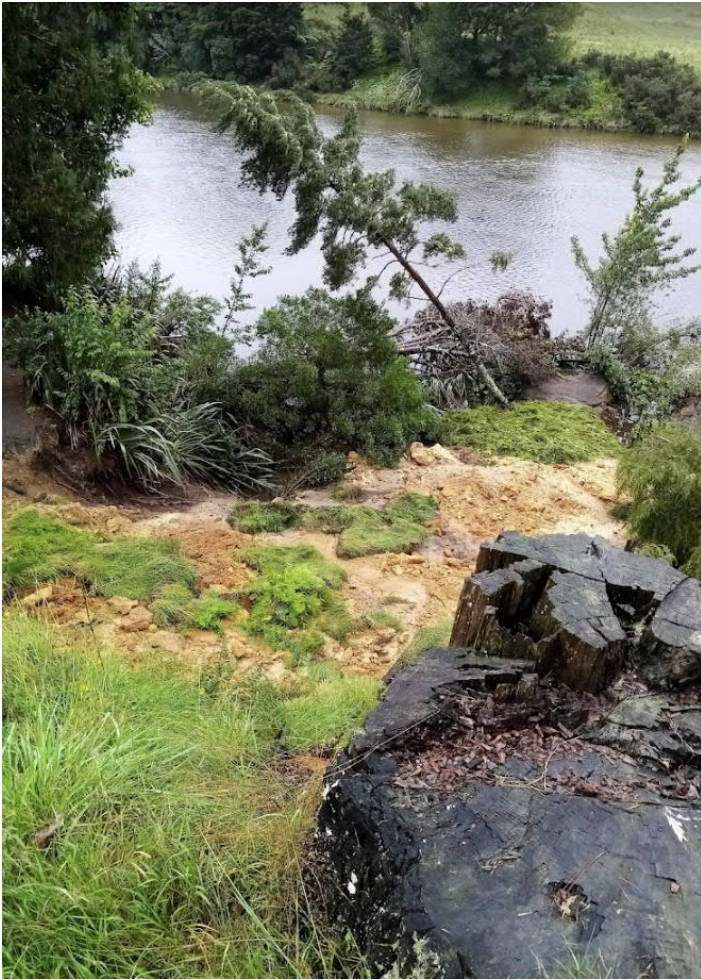
At both slip locations, the original walking track which was cut into the toe of the original slope has been destroyed. An intact section of the track has rafted into the lake by some 15 to 20m. The slip debris runout at both locations extends well into lake McLaren below.

Figure 4: Photo of section of track in lake.

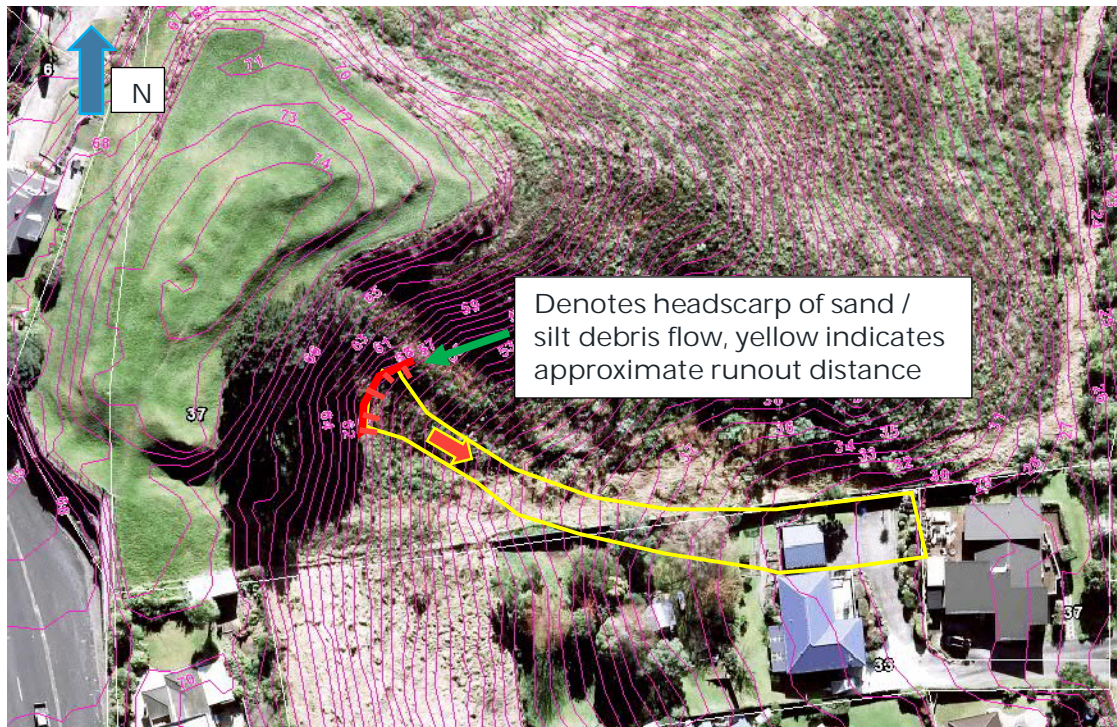
Figure 1: Site location and direction of slip.

The failure has impacted the boundary fence at several locations which has damaged the fence with sediment making its way below the fence onto the property and down between the garage and the house. The garage has been inundated with silt and sand to a depth of approximately 300mm. The slip debris has also affected the boundary of the property located at No.37. Figure 1 above shows the extent of the inundated area.

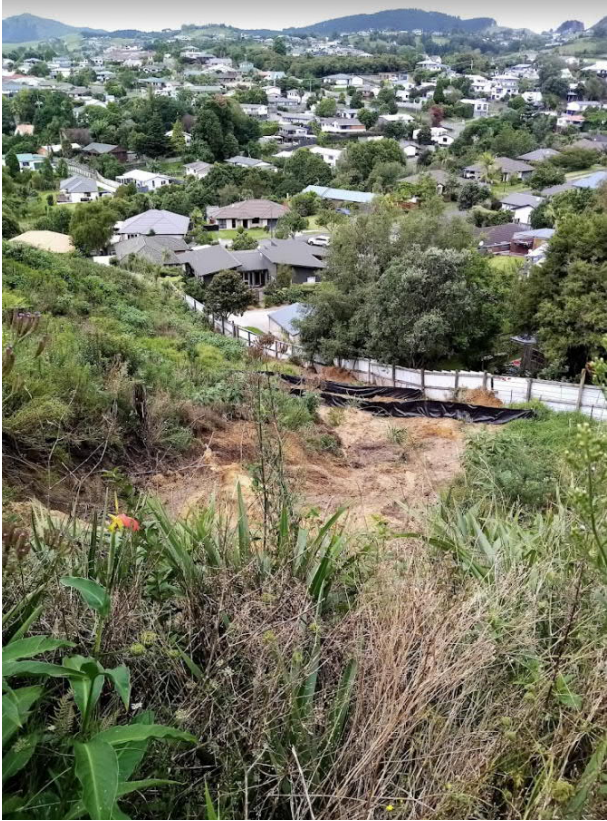
Based on our inspection of the slope, a silt/sand debris flow has occurred midway up the slope. The headscarp is approximately 6m wide with a runout length of approximately 70m which has inundated a portion of the property and the garage at No. 33 Bateleur Close with sand and silt. The slip failure is up to 1.2m deep at its margins and has affected the topsoil and underlying ash/ ignimbrite deposits. The debris is saturated and there are numerous mounds of soil up to 600mm high which have rafted down the slope.

Figure 2: Path of debris flow

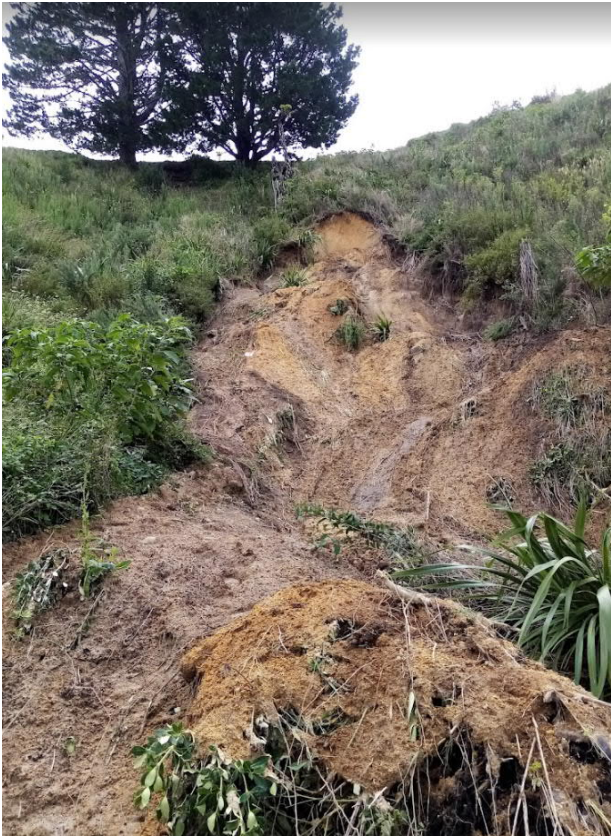
Figure 3: head scarp/ origin of failure

Based on our observation we anticipate that the failure is due sustained and heavy rainfall which has increased pore pressures and seepage within the slope. This has led to a large drop in effective stresses resulting in loss of shear strength. Given the fluidised nature of the failure it is likely the material was at its liquid limit resulting in the large run out length. The geomorphology of the original slope has channel shape depressions which run perpendicular to the slope including hummocky ground which is evidence of historic debris flows and soil movement.

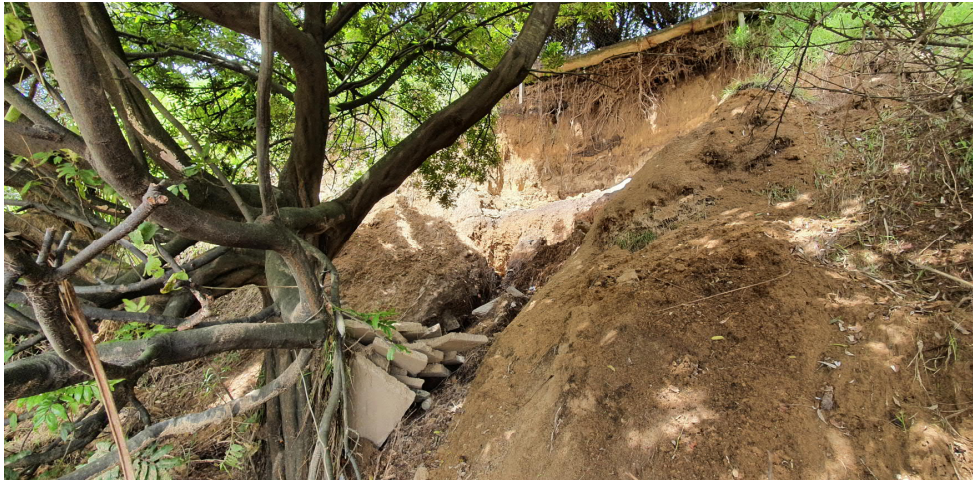
The subject site is located at the western end of the Wharepai Domain, in an area prone to slippage, as indicated on Figure 1 below. At this location, a landslide has occurred at the crest of the slope beyond the existing fencing. The landslide is approximately 12m wide at the top with a runout zone extending out to the guardrail at the edge of Takitimu Drive – State Highway 2 below approximately 20m across. The height of the slope at this location is approximately 8m high.

The debris from the slip comprises orange brown silty clay soils with a large amount of concrete fill material up to 0.5m in diameter. The volume of evacuated material is estimated

Figure 1: Slip failure with fill material below.

Based on our inspection and desktop study, the failure was caused by sustained heavy rainfall which saturated the slope resulting in high porewater pressures which reduced the shear strength of the soil which was already standing at a steep angle. The presence of fill material on the slope would have also added to the weight of the slope increasing the potential driving forces of a potential failure.

Regarding possible further failures of material, we consider the risk to be moderate to high track users due to the presence of fill material and rubble lodged in behind the tree mid slope which may be undermined if further heavy rainfall occurs. We consider the risk to SH2 to be currently low, however there is the possibility of silt runoff during a heavy rain event.
