Project Number: 2-9B497.00

Tauranga City Council – Mauao Base Track

High Level Qualitative Slope Stability Risk Assessment
16 November 2022

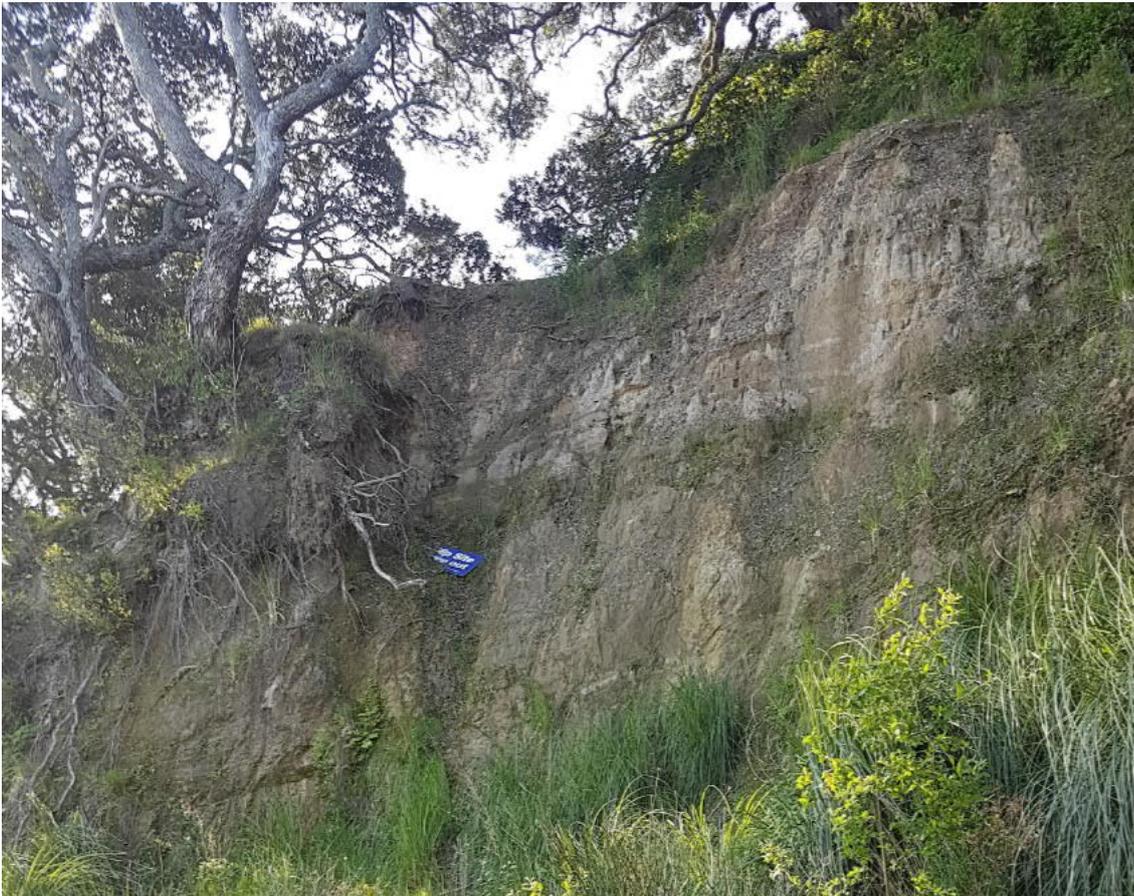
Most recently, a significant 14m wide landslide occurred on the base track approximately 620m south west from the Pilot Bay carpark following several days of sustained rainfall in April 2017 during the passing of ex-tropical cyclone Debbie. The landslide resulted in the closure of the base track through this section with temporary access via a set of stairs around the slip until the track was repaired and reopened in March 2020.

Figure 1. Location of 2017 landslide which closed the base track prior to slope stabilisation works. Buff brown ignimbrite resembling Te Puna Ignimbrite is overlain by possible Matua subgroup deposits with thin layers (pale brown/white layers near crest) of Pahoia Tephras.

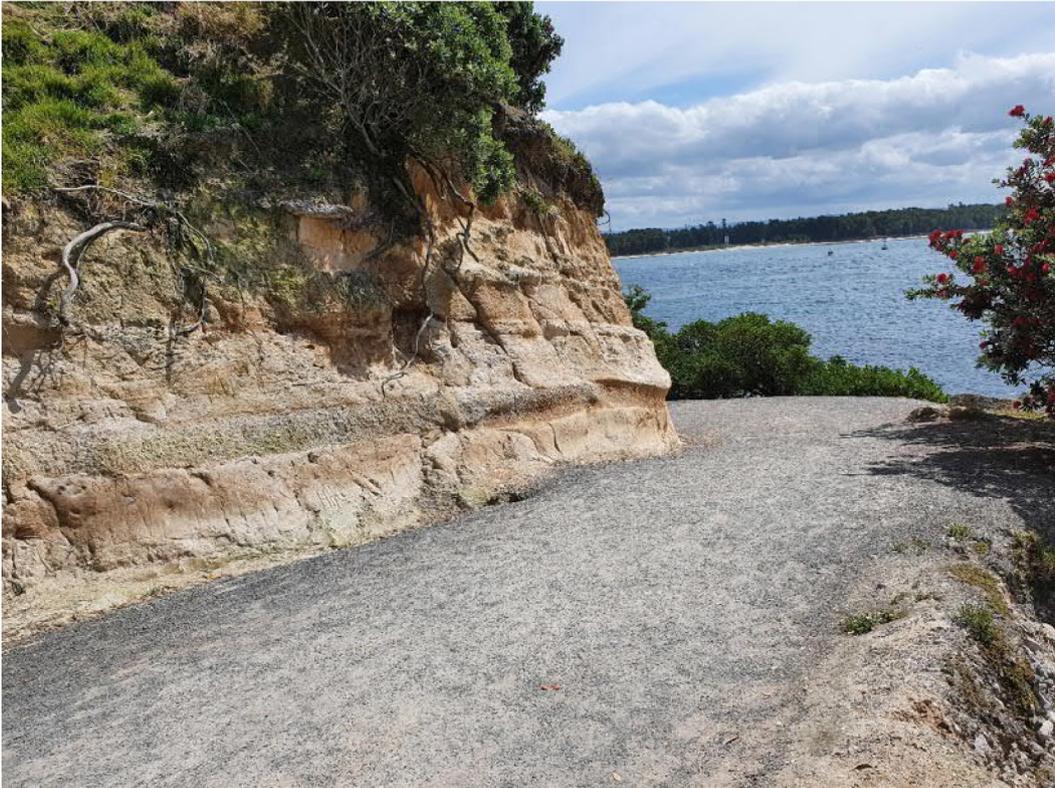
Figure 2: Weathered ignimbrite exposure at the base of the track comprised of ash and pumice lapilli layers.

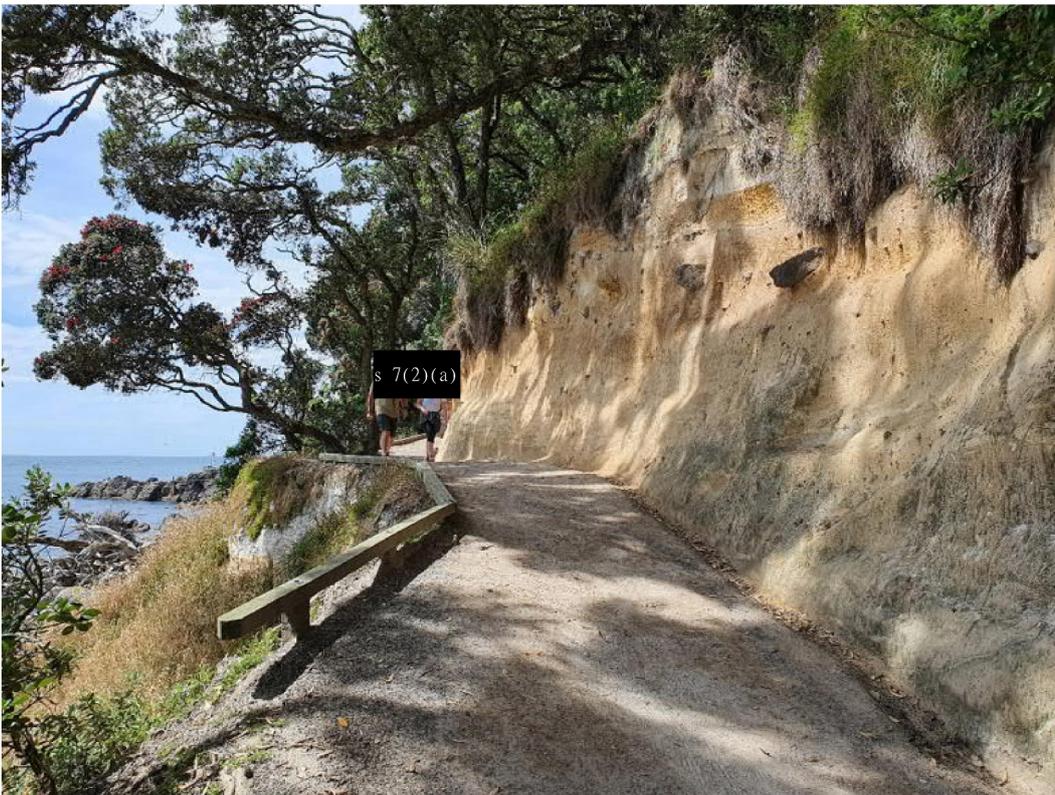
Figure 3: Moderately welded ignimbrite with rhyolite boulders incorporated into matrix.

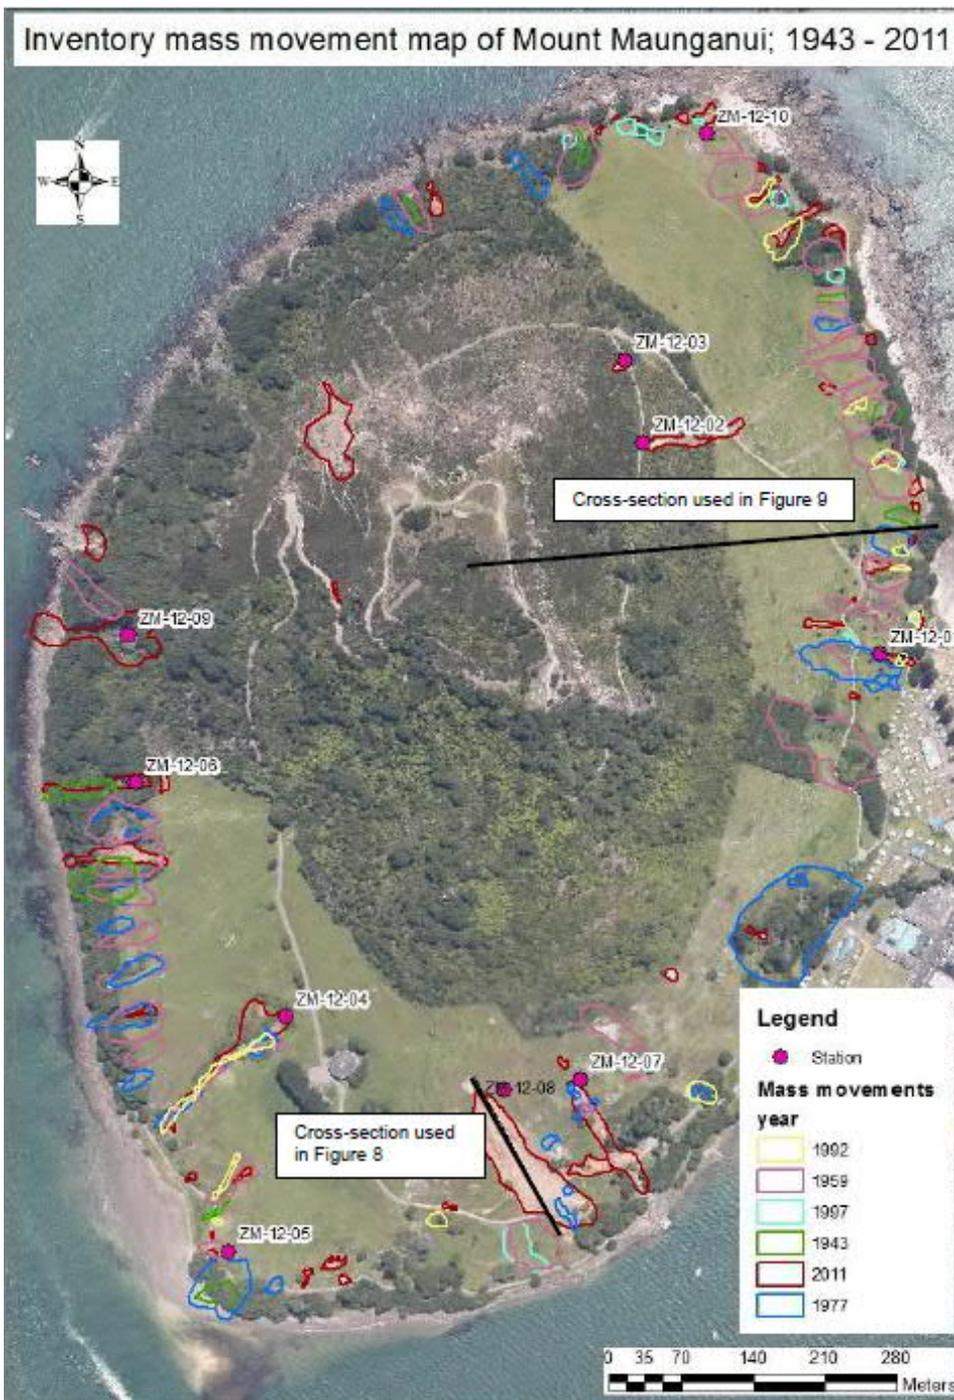
This conference paper reviewed the spatial distribution of landslips by assessing aerial photographs from 1943 to 2011. The study identified several types of mass movements on Mauao, including rotational slides, debris flows, debris avalanches and rock falls. Landslides were spatially

concentrated on lower slopes with little to no vegetation present, where there was high sediment availability (i.e., colluvium / debris is present), and slope angles were between 18 - 32°.

In particular, there was a concentration of shallow circular slides on the south western and north eastern sides of Mauao; these made up the majority of slides over the 68-year analysis period. The paper considered intrinsic factors that influenced stability to be land use change, lack of vegetation cover and extrinsic factors to be heavy rainfall events.

Figure 6: Mass movement (Landslide) map extracted from Brideau & Martin (2014).

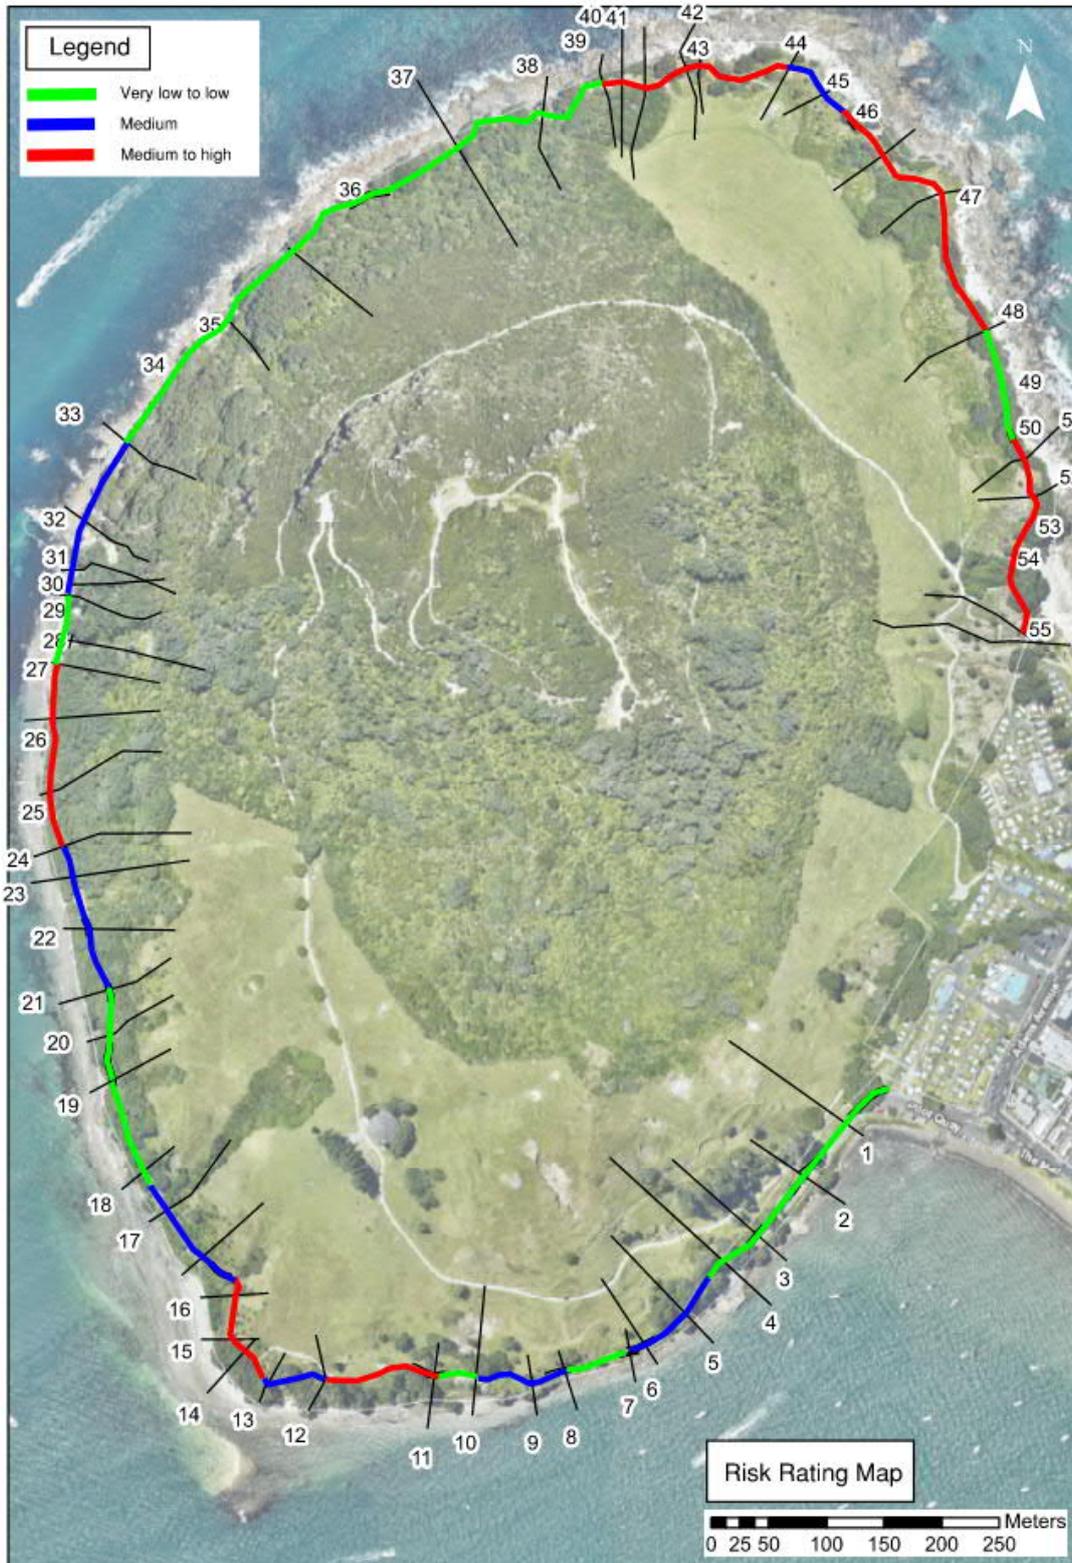
Figure 7: Risk Rating Map

The results of the risk assessment scores for all sites are summarised in Table 1 with the assessed risk rating scores shown on Figure 7 (Risk Rating Map).

Site No. Reference	Comments	Assessed Risk Rating
1	Current vehicle access to jetty, greater than 6m width, slope planted out with grasses. Toe protected with rock rip rap. Likelihood of overslip & underslip considered to be possible in very adverse conditions.	Low
2		Low
3		Low
4	Large car park area with concrete mass block wall upslope. Low likelihood of overslip and underslip.	Very Low
5	Underslip likely under moderate to severe conditions. Narrow track width would make reinstatement more difficult and require closure during repairs.	Medium
6		Medium
7	Underslip considered to be rare as the slope is supported by an engineered gabion wall. Based on our observations, the wall/ slope performed well during the 2017 storm event.	Low
8	Underslip and overslip possible under adverse to very adverse conditions. Narrow track width would make reinstatement more difficult and require closure during repairs.	Medium

9		Medium
10	Track width wide at this location, likelihood of underslips low.	Very Low
11	Site located close to major landslip that occurred in 2017. Steep slope. Track width narrow and underslip expected under adverse to very adverse conditions. Ashes exposed on cliff face.	High
12		High

13	Site stabilised with soil nails and drainage. Possible overslips or tree failure still possible.	medium
13b		Low - medium
14	Close to major landslide that occurred in 2017. Steep slope. Track width narrow and underslip expected under adverse to very adverse conditions. Landslides occurred above the site in 1943, 1977.	High
15	Track width narrow and underslip expected under adverse to very adverse conditions. Landslides above track in 1943, 1977.	High
16	Track width narrow and underslip and overslip possible under adverse to very adverse conditions. Landslides in vicinity of site above track in 1943, 2011, 1992.	High
17	Overslip likely under moderate to severe conditions. Underslip possible.	Medium
18	Underslip and overslip possible with medium consequence to track. Annual probability of occurrence anticipated to be 5% with damage causing closure for up to a month.	Low
19	Non-engineered stone wall in good condition. Rock bolts have been installed retrospectively with some drainage installed.	Low

20	Small timber pole retaining wall installed. Overslip possible and underslip unlikely with medium consequence to track.	Low
21	Non engineered stone wall above and below track. Wall in fair condition, bulging slightly outward. Overslip and underslip likely with medium consequence.	Medium
22	Past underslip noted in track. Underslip and overslip likely with medium consequence.	Medium
23	Underslip and overslip likely with medium consequence.	Medium
24	Underslip and overslip likely with medium consequence.	Medium
25	Underslip and overslip likely to possible under somewhat adverse conditions with medium to major consequences leading to track being closed for months to a year. Track exposed to coastal erosion, some portions of track overhanging.	Medium to high
26		Medium to high
27		Medium to high

28	Stone retaining wall in good condition supporting track. Underslip and overslip possible with medium consequence.	Low
29	Underslip and overslip possible with medium to major consequence. Weakly welded ignimbrite noted above and below track.	Medium
30		Medium
31		Medium
32	Underslip possible and overslip likely. Consequence assessed as medium. A debris flow occurred in 2011 due to sustained heavy rainfall.	Medium
33	Underslip possible and overslip likely. Consequence minor to medium.	Low to medium
34	Underslip unlikely and overslip possible. Coastal erosion possible. Medium consequence as overslip could be cleared.	Low
35		Low
36		Low
37		Low
38		Low
39		Low
40		Low
41	Underslip and overslip likely under somewhat adverse conditions with a medium to major consequence to track. Mass movements have occurred along north to north eastern portion of base track in 1943, 1959 and 1977.	Medium to high
42		Medium to high

43	Underslip and overslip likely with estimated 5 to 20% annual probability of occurrence. Expected to medium to major to repair.	Medium to high
44		Medium to high
45	Underslip possible and overslip likely under adverse conditions. Consequence to track rated as medium.	Low to medium
46		Medium
47		Medium
48	Underslips and overslips possible under moderate to very adverse conditions. Consequence to track rated as medium. Landslides noted above the site in 1943, 1959 and 1977.	Low
49		Low
50	Underslips and overslips possible with slips closure for up to a month.	Low
51	Underslips and overslips likely under somewhat adverse conditions. Consequence to track rated as	Medium to high
52		Medium to high

53	medium to major. Landslides in 1943, 1959 and 1977.	Medium to high
54		Medium to high
55		Medium to high

Based on our assessment, we recommend undertaking further works to manage or reduce the risk to the base track generally based on the risk implications provided above in table 4 above.

This could involve planning of further investigations and planning of risk mitigation options where the risk is considered to be high. This could involve undertaking hand auger borehole investigations and quantitative stability analyses to determine the current stability of high-risk areas. Treatment options could then be implemented to improve the stability of the site if unacceptable factors of safety are obtained. Treatment options could include, drainage improvements, ground retention, stabilisation, or other mitigation options. Options assessments could be undertaken to determine the most cost-effective risk mitigation solution, which could be undertaken in consultation with TCC and the trustees of Mauao.

For low-risk sites, we would recommend continued maintenance procedures, e.g. maintenance of the track condition, drains and swales. For medium risk sites we recommend these are monitored and if practical then works such as drainage improvements in conjunction with regular monitoring may be appropriate.
