ARCHAEOLOGICAL SITE CONDITION MONITORING
REPORT - MAUAO HISTORIC RESERVE, TAURANGA

InSitu Heritage Ltd

29 October 2021

Tauranga City Council
Private Bag 12022
TAURANGA

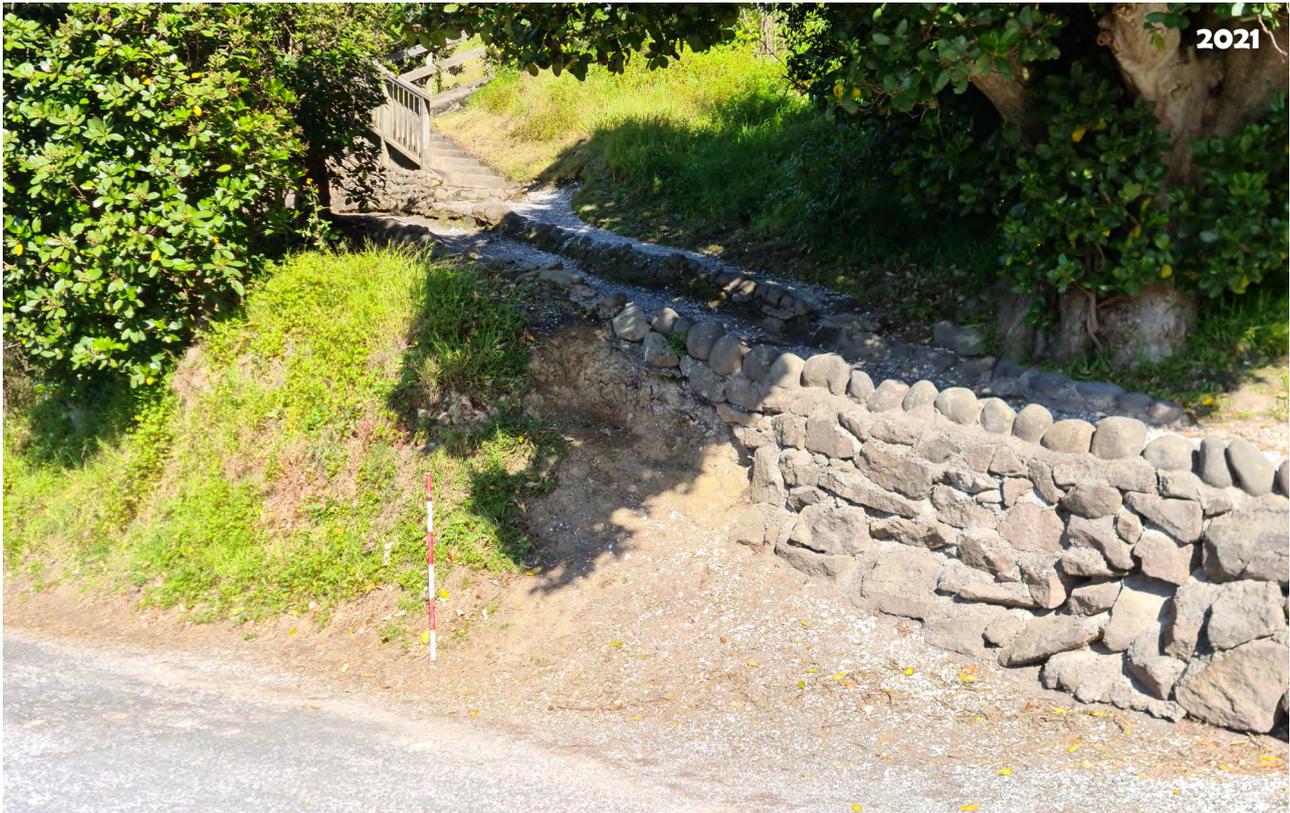
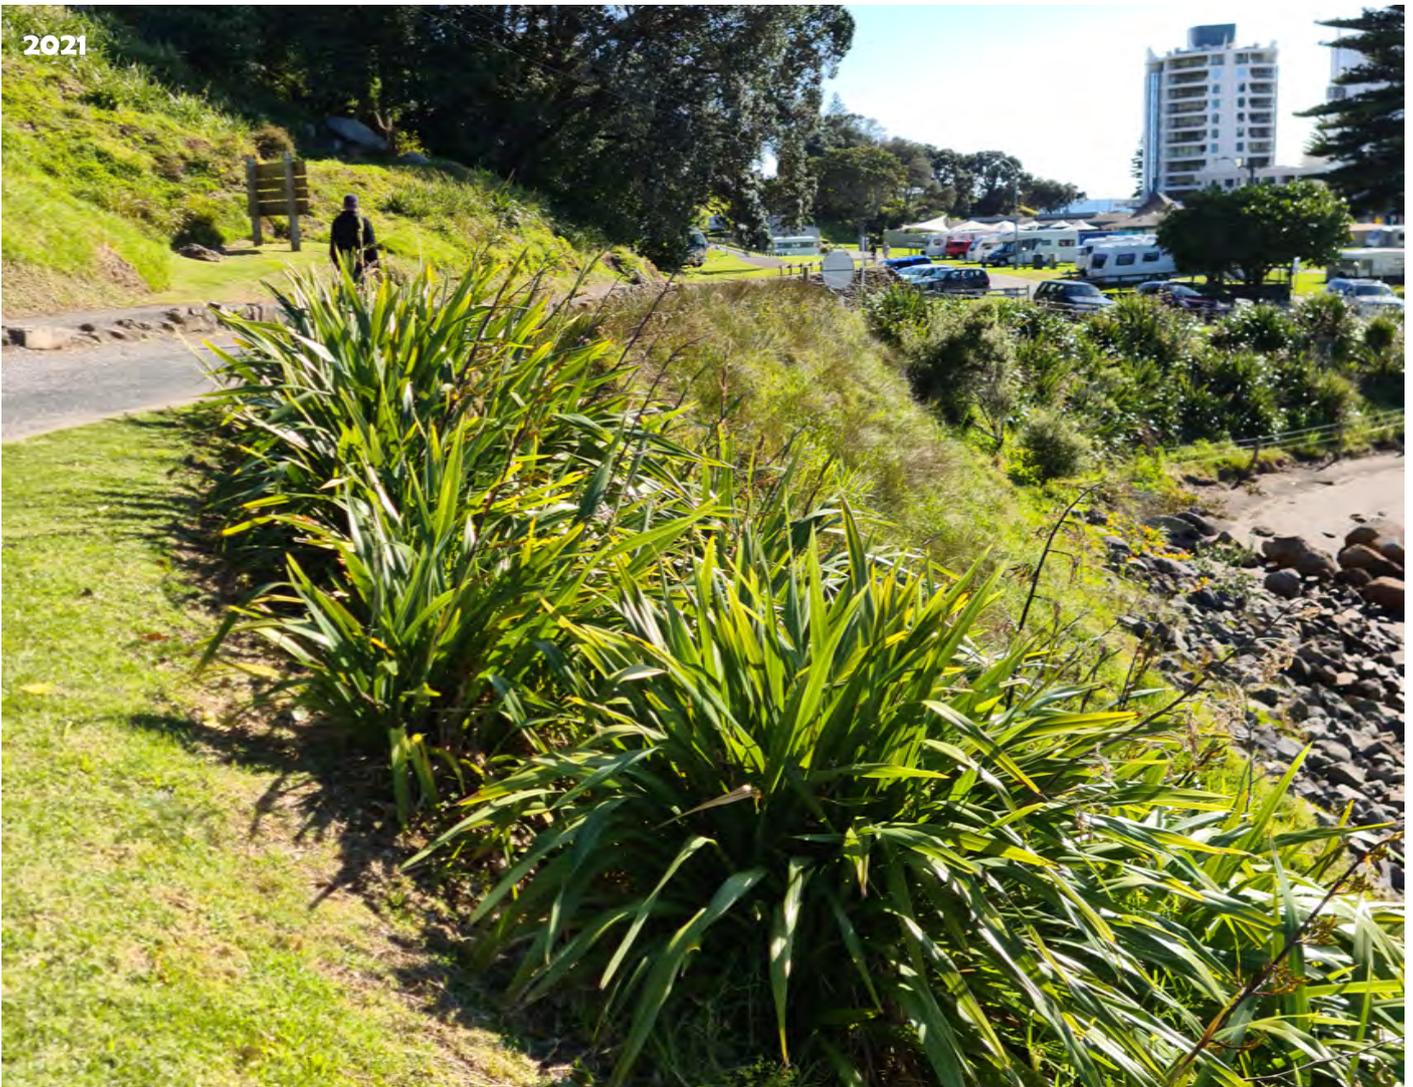
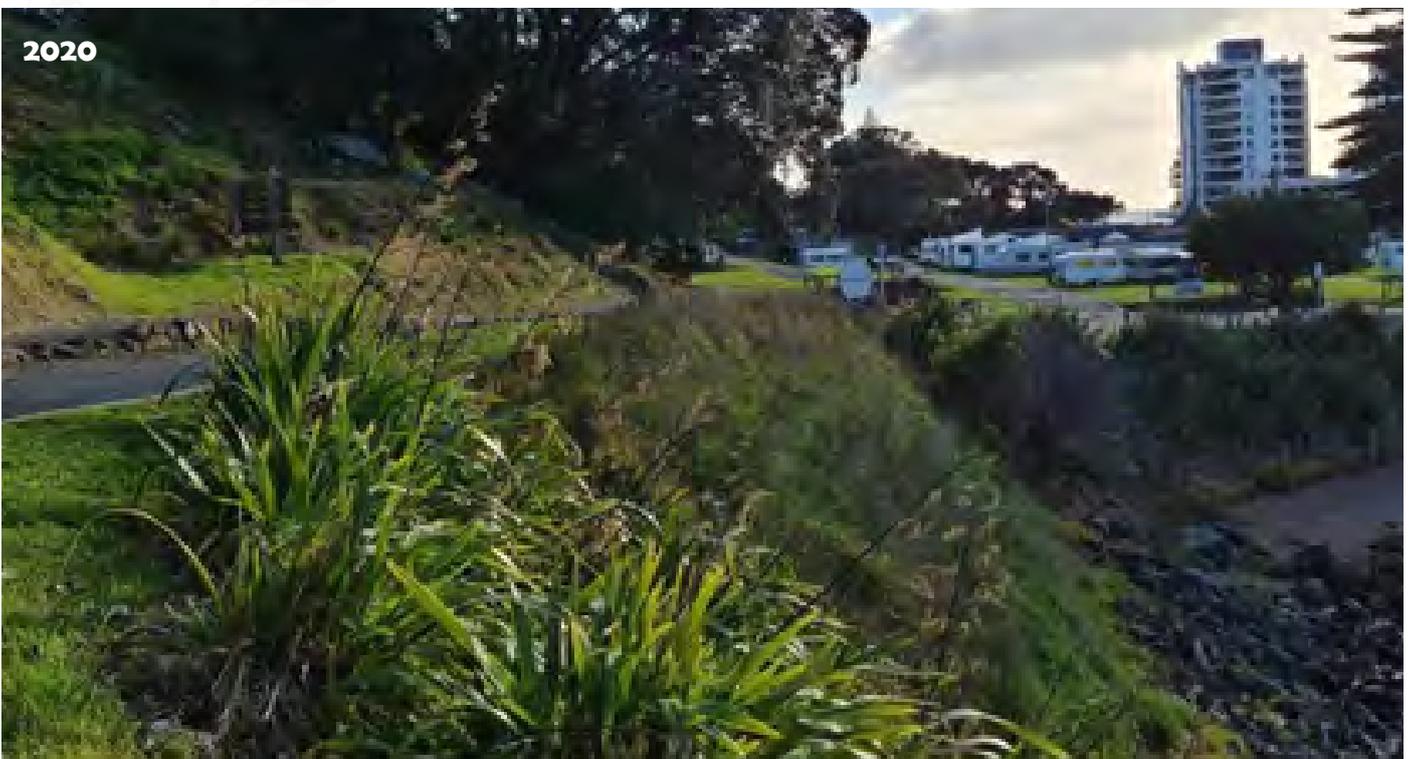
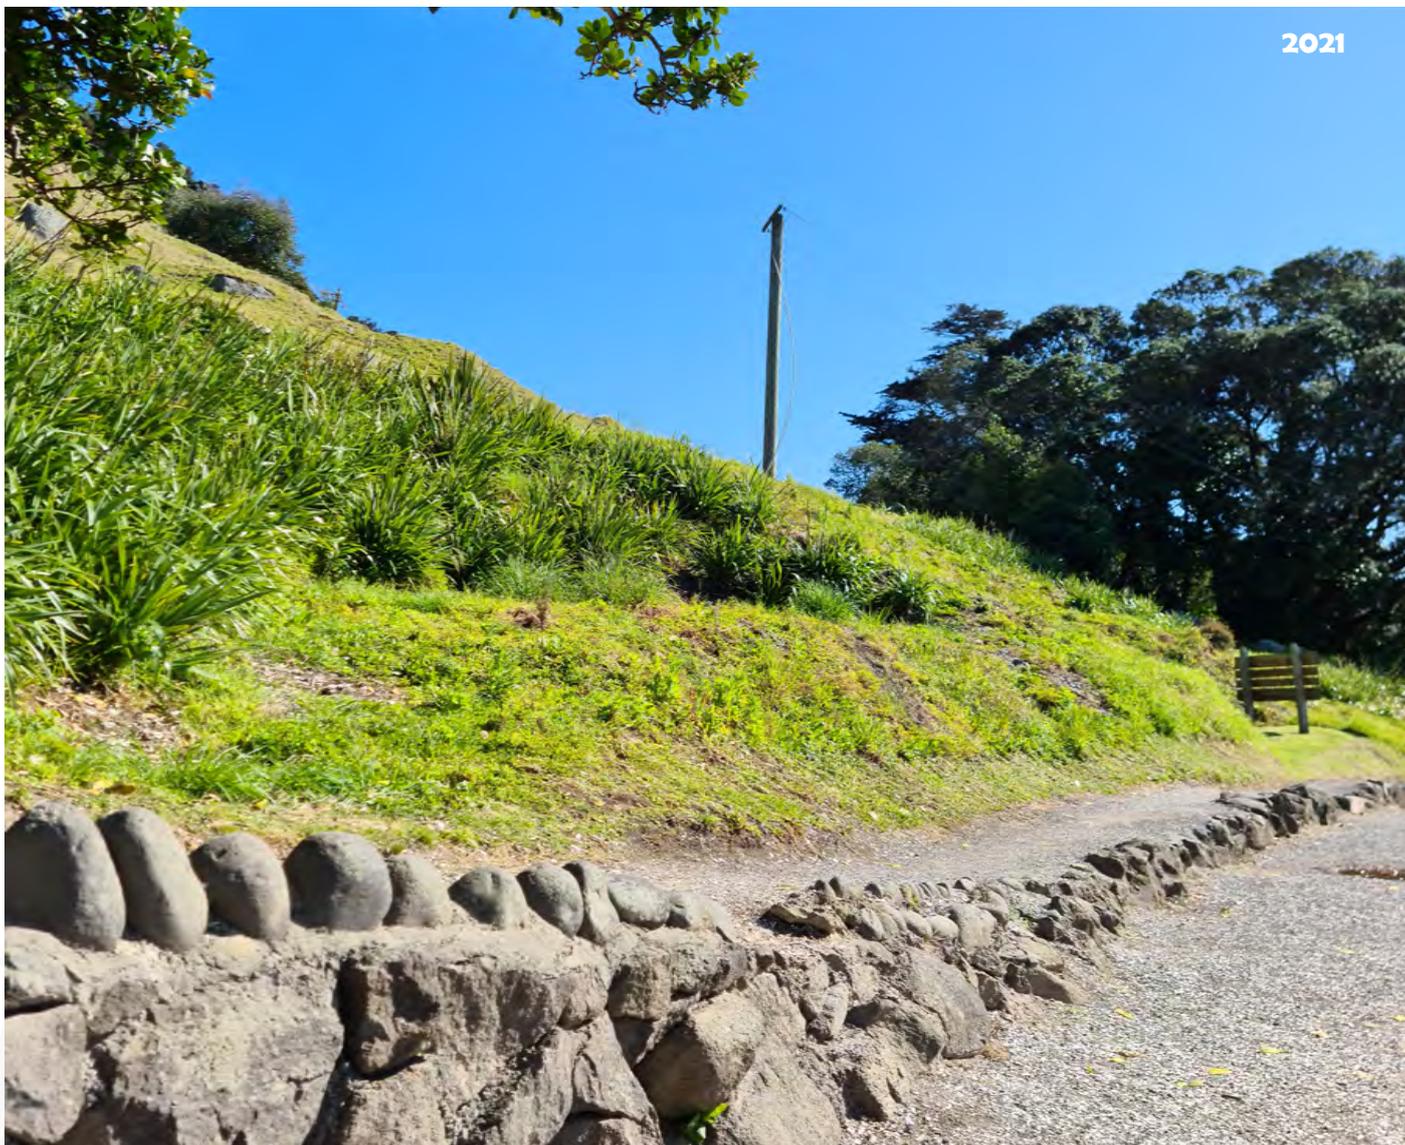
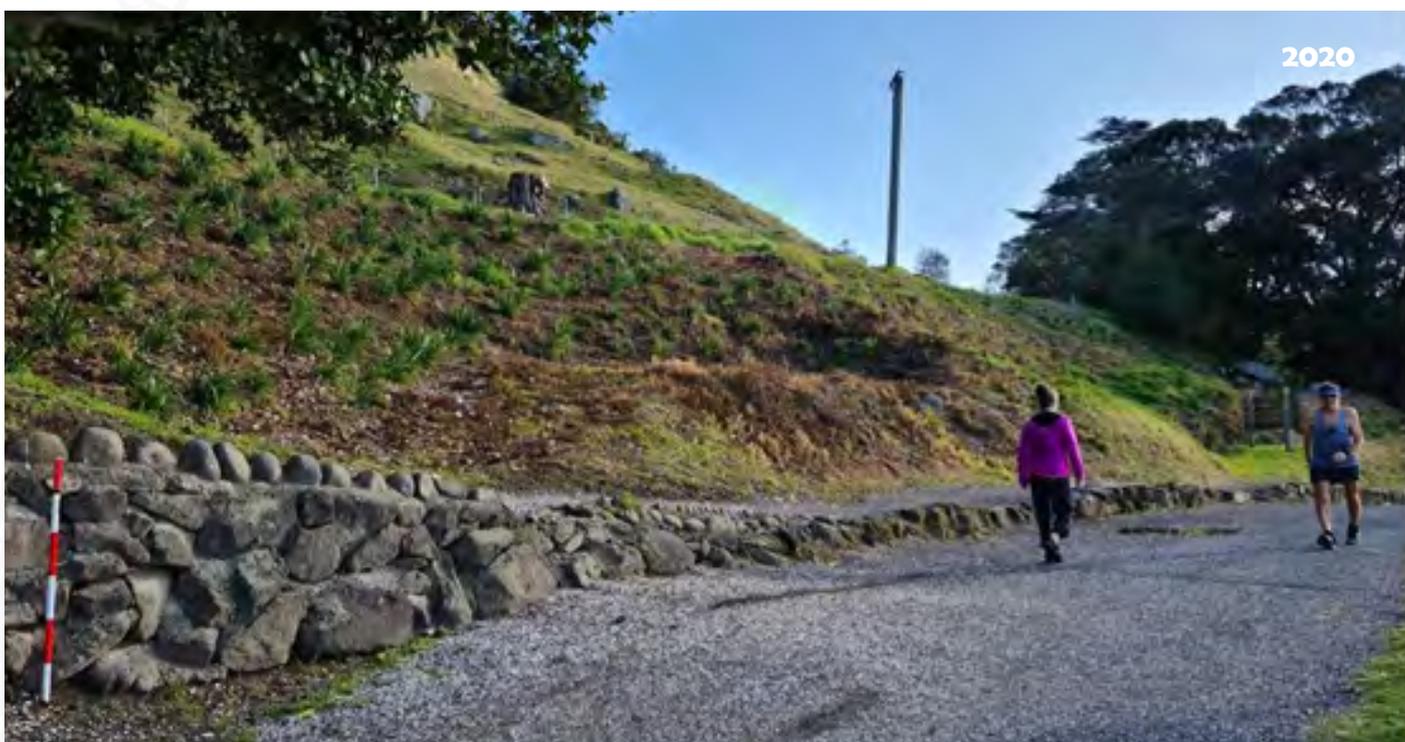
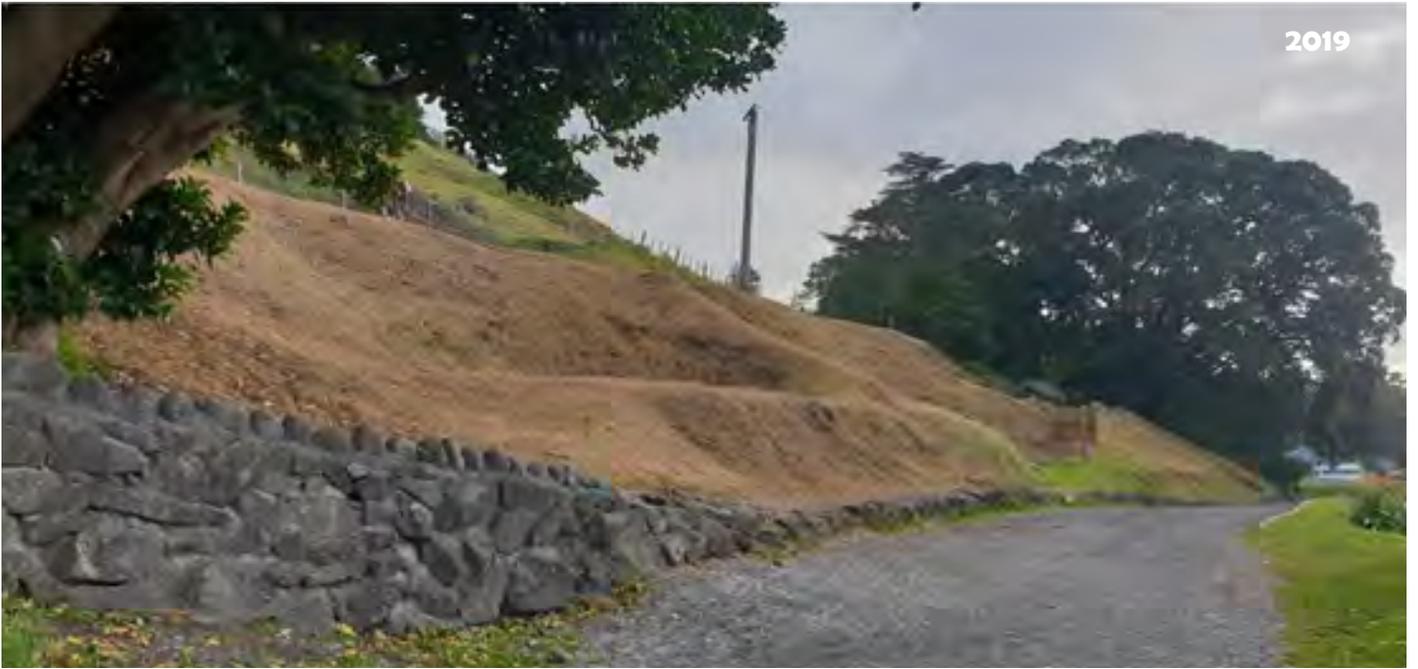
Monitoring Site 1

Stone Jetty surrounds - stone walls

Notes: Erosion is unchanged from 2020, grass cover advancing, but this could be primarily due to seasonal variability. Plants on terraces now well established, but some minor infill planting is required. Introduction of soil and planting along the track margin would assist to restrict visitor access to the formed track.

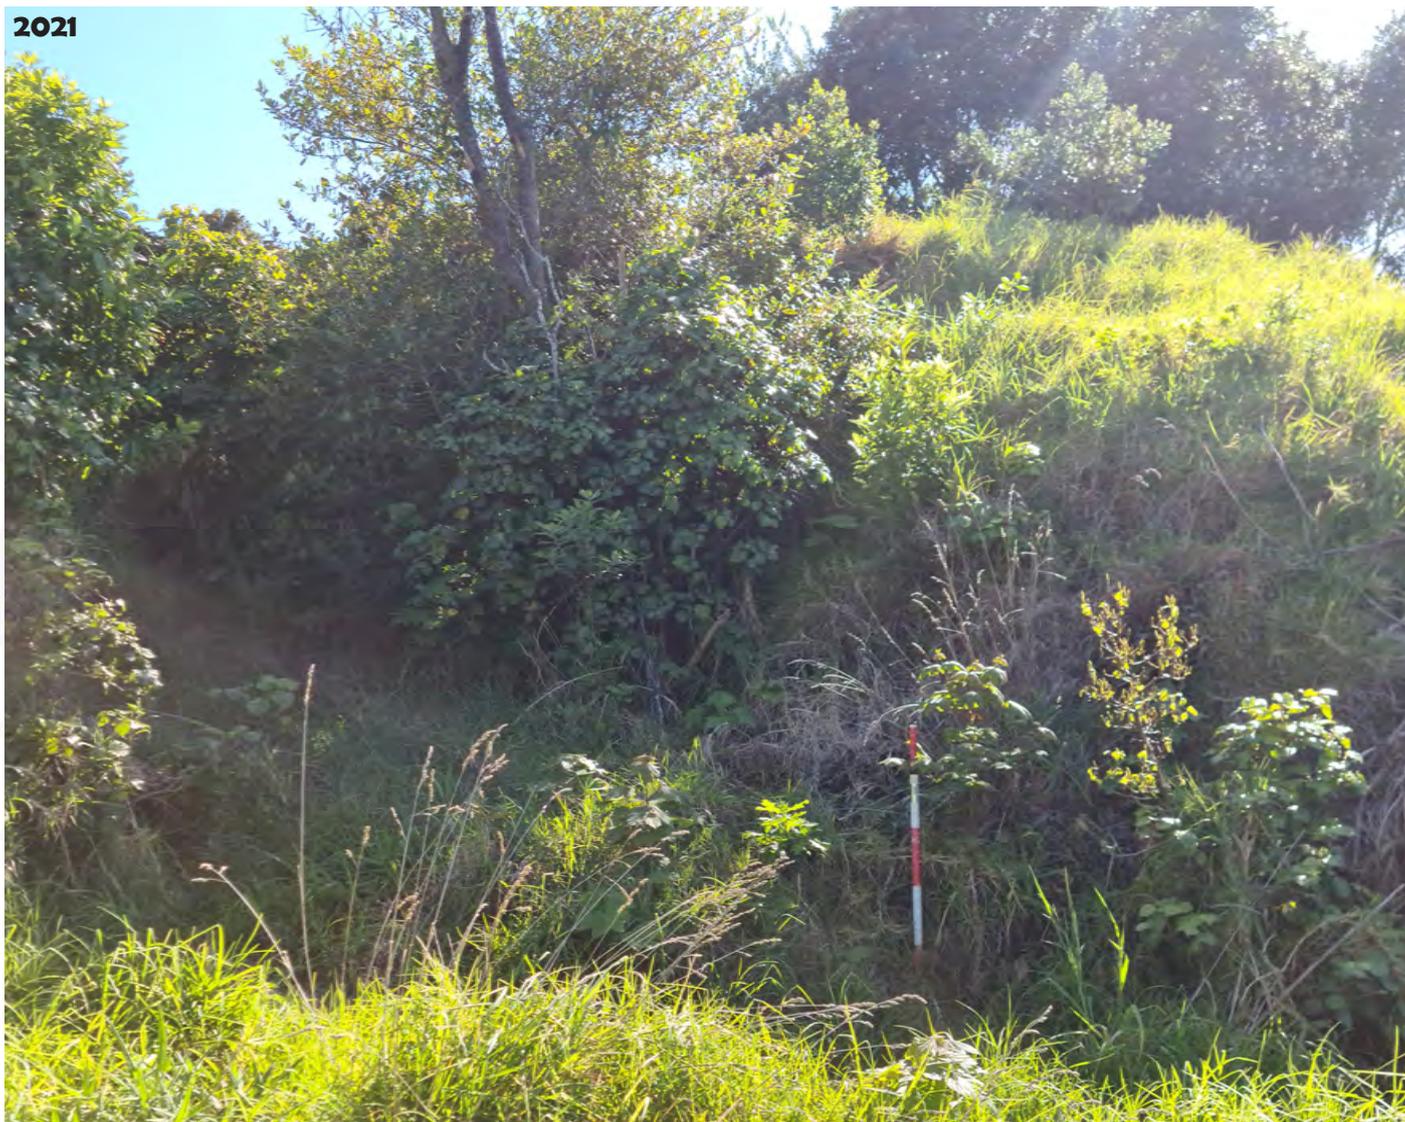
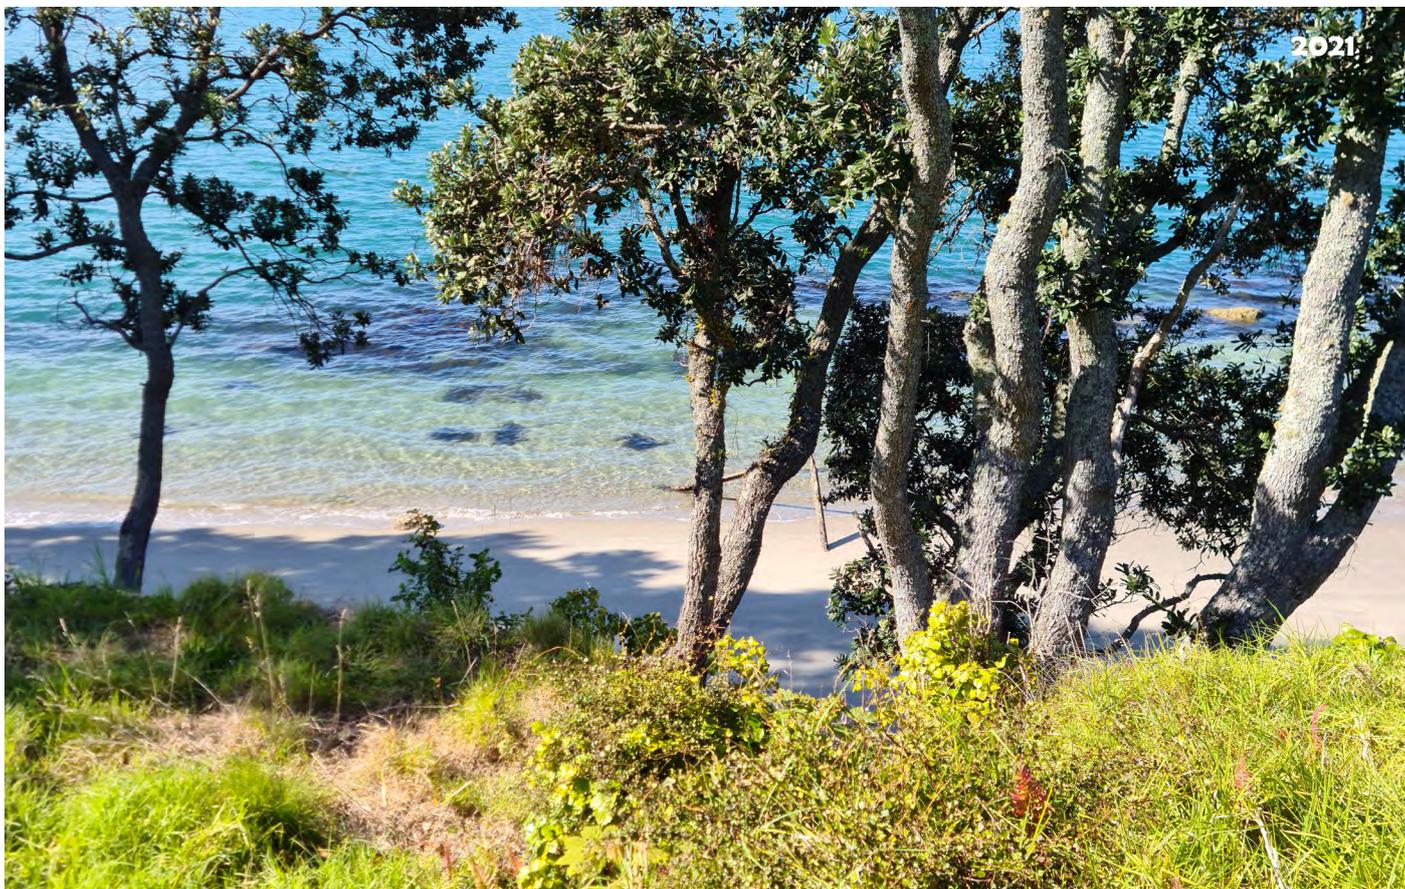
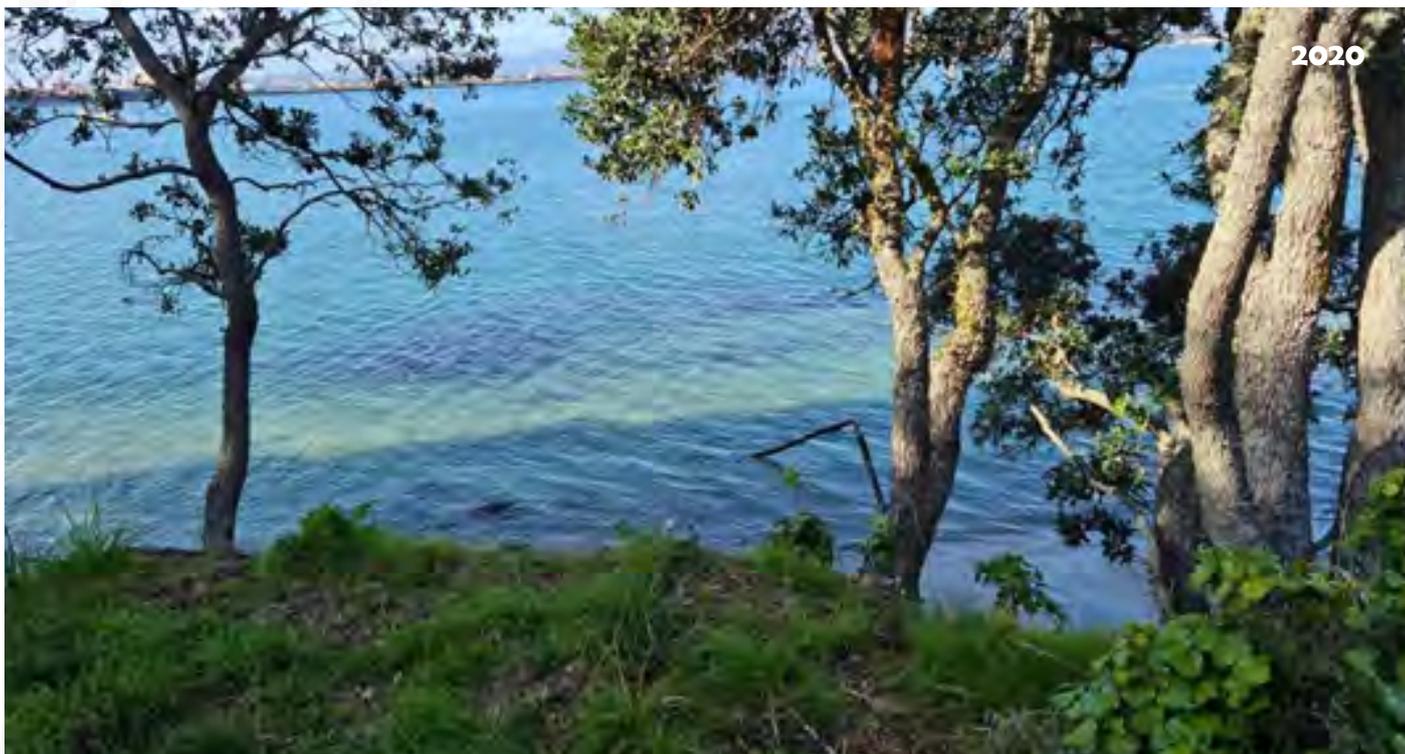
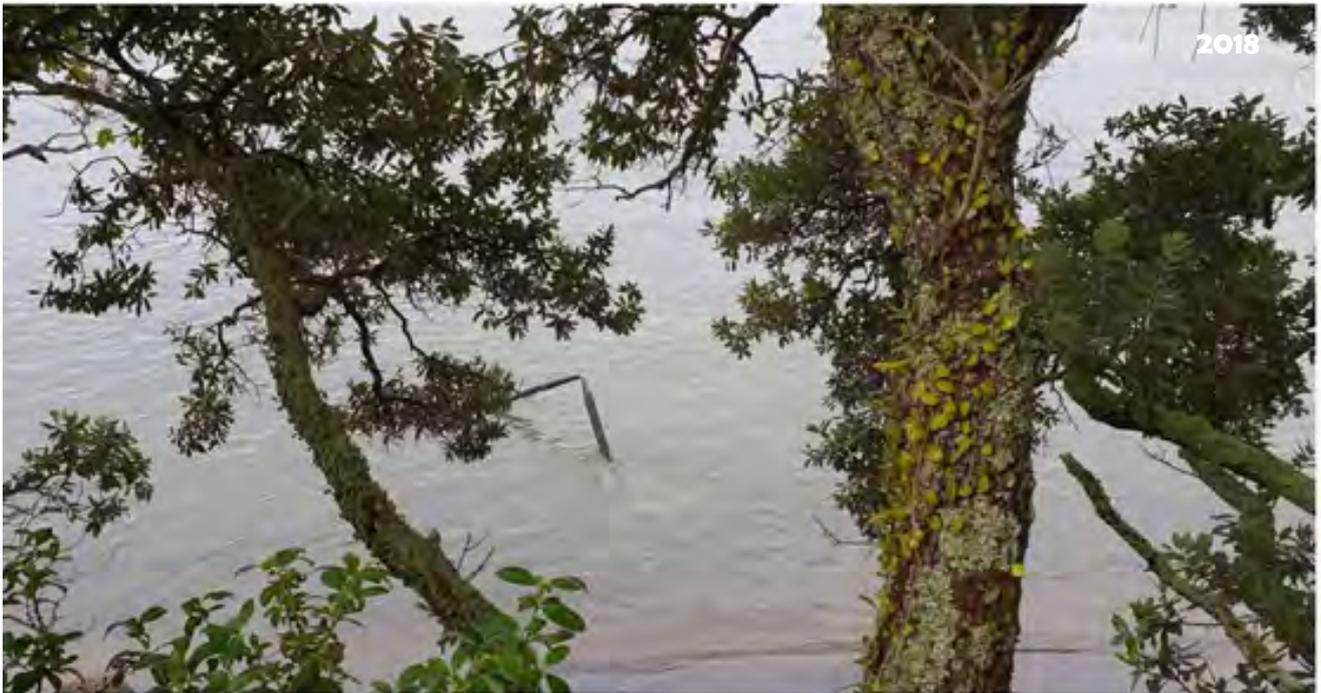
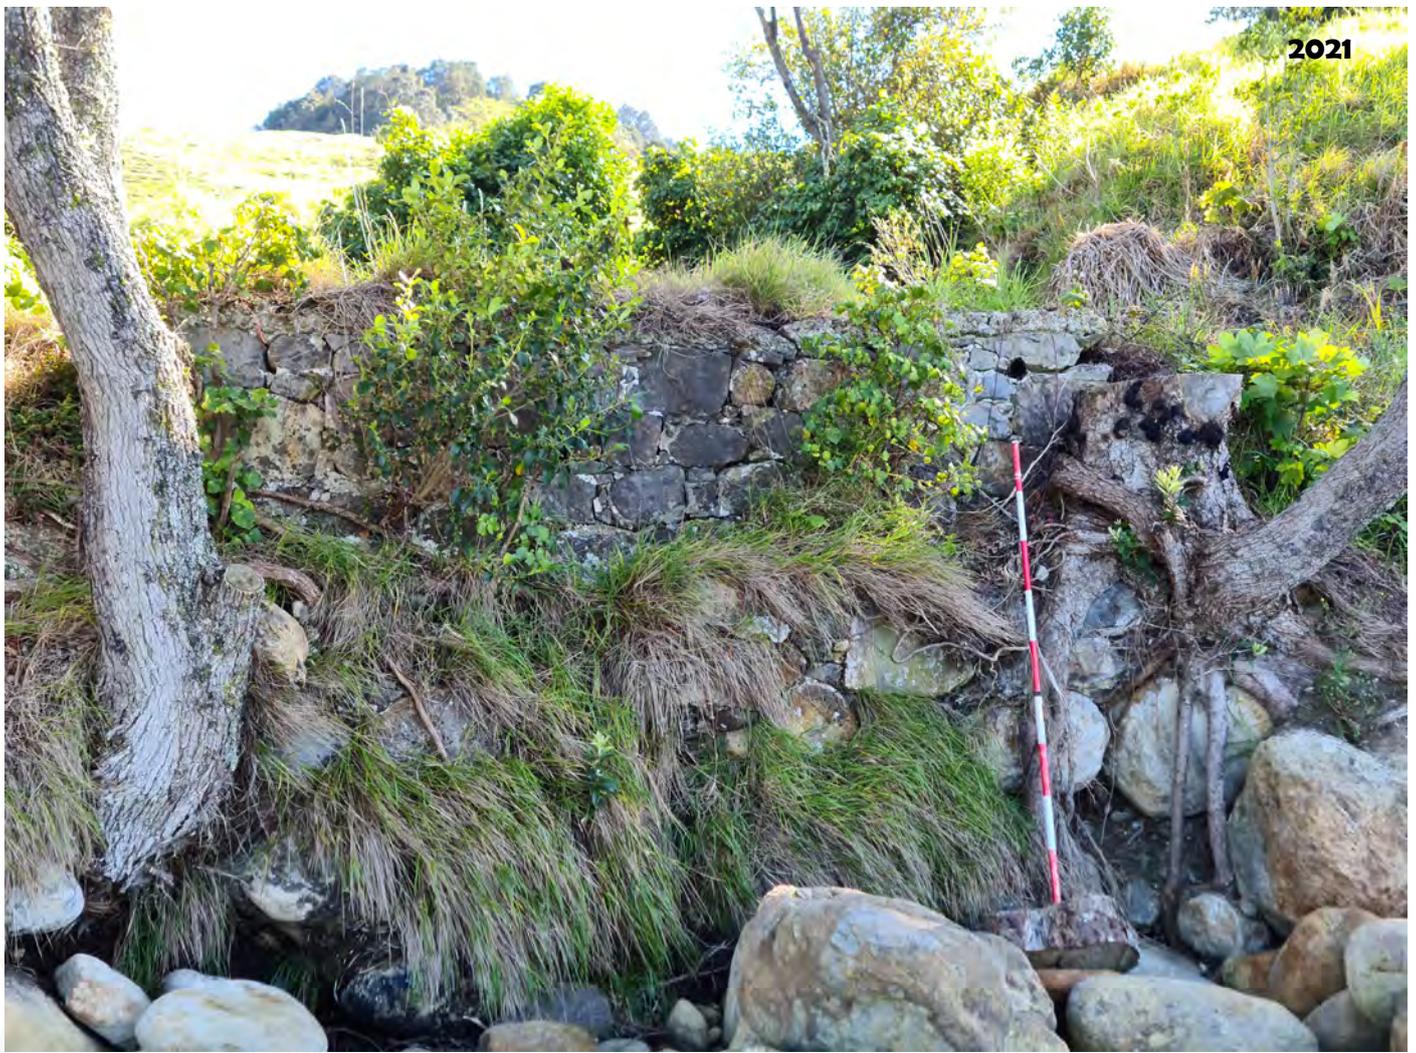
Monitoring Site 2

Iron jetty and surrounds

Notes: Vegetation clearance to reduce pōhutukawa and sycamore growing on the stonework face of the jetty that was done in 2020 needs to be maintained. There is on-going invasion by sycamore and other tree species. Interpretation should be developed at the jetty as part of the current project and the site should continue to be maintained in low vegetation/ferns/rank grass, with periodic weed

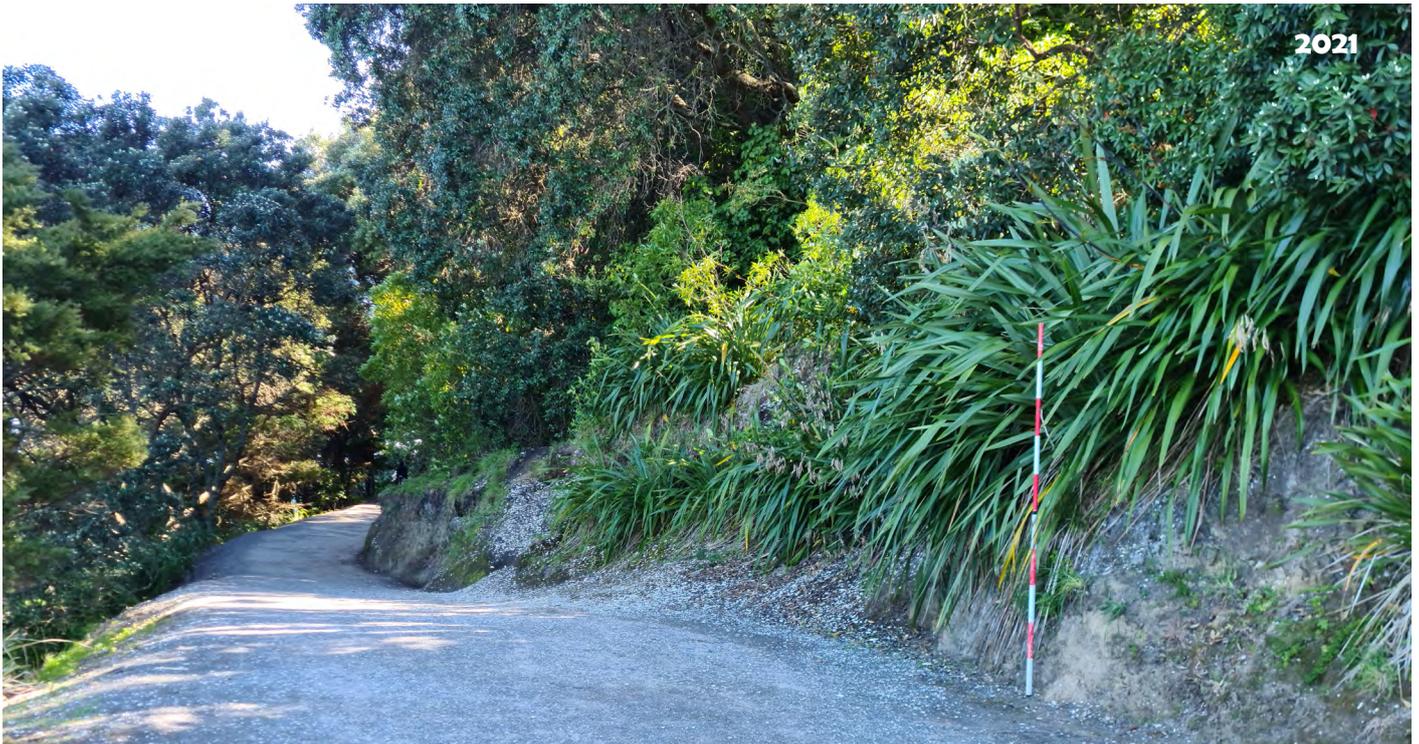
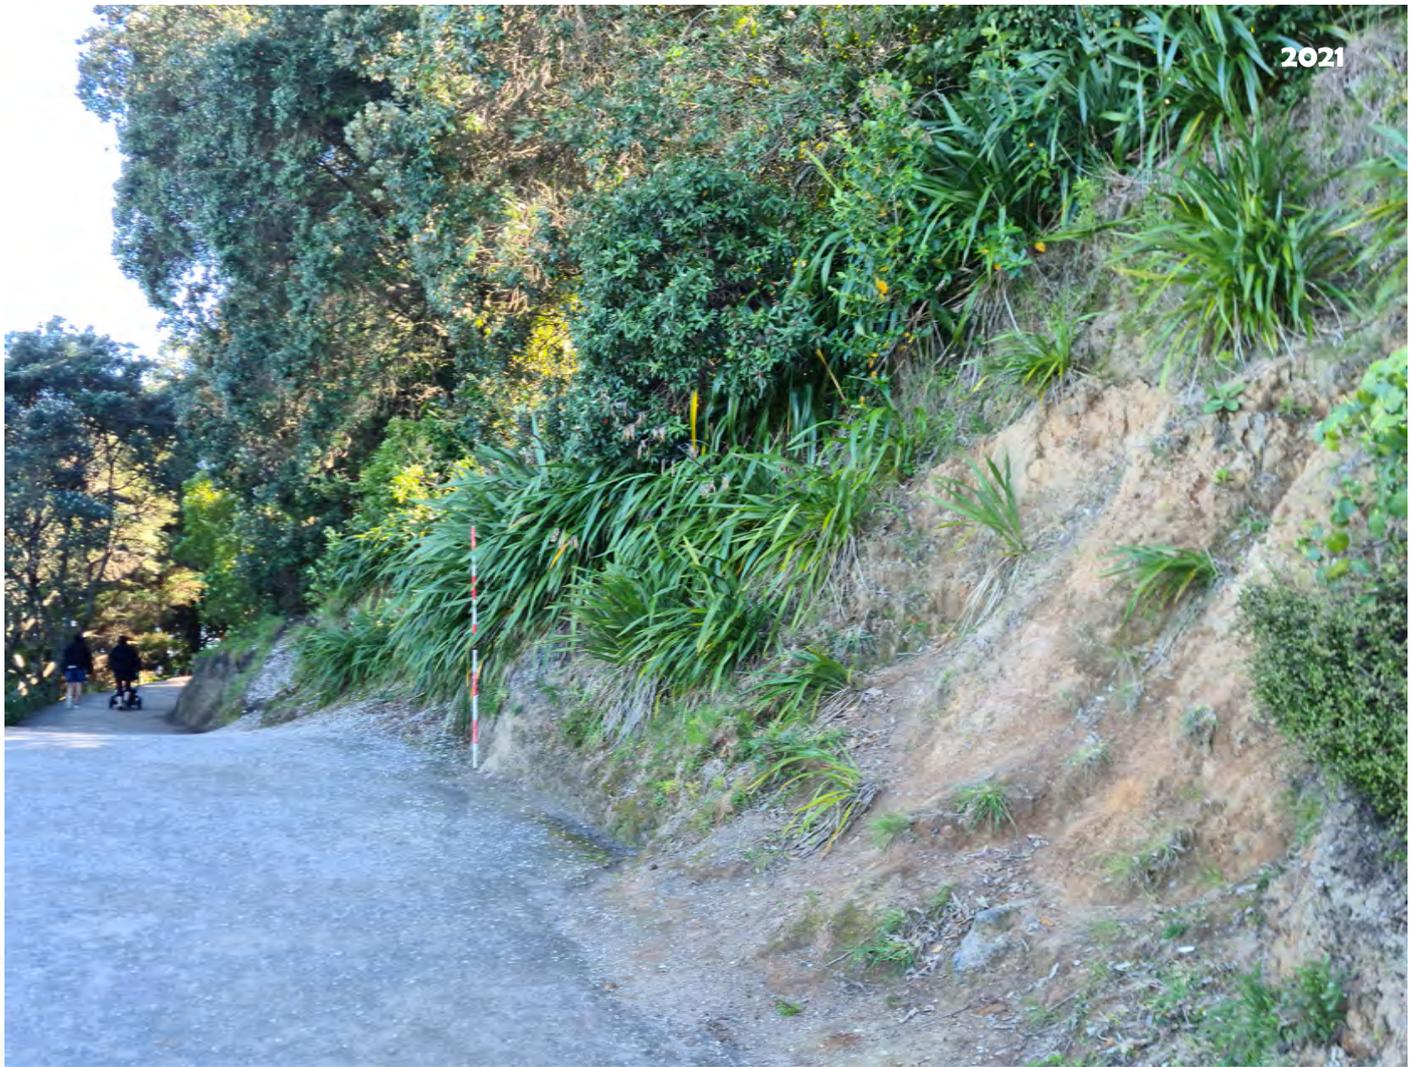
Monitoring Site 3

Base track midden erosion

Notes: There has been no significant advance or improvement in vegetation cover over the monitoring period and the eroded face is still highly visible. Shell is still accumulating at the base of the slope. Introduction of fill material may be required to get plant cover better established.

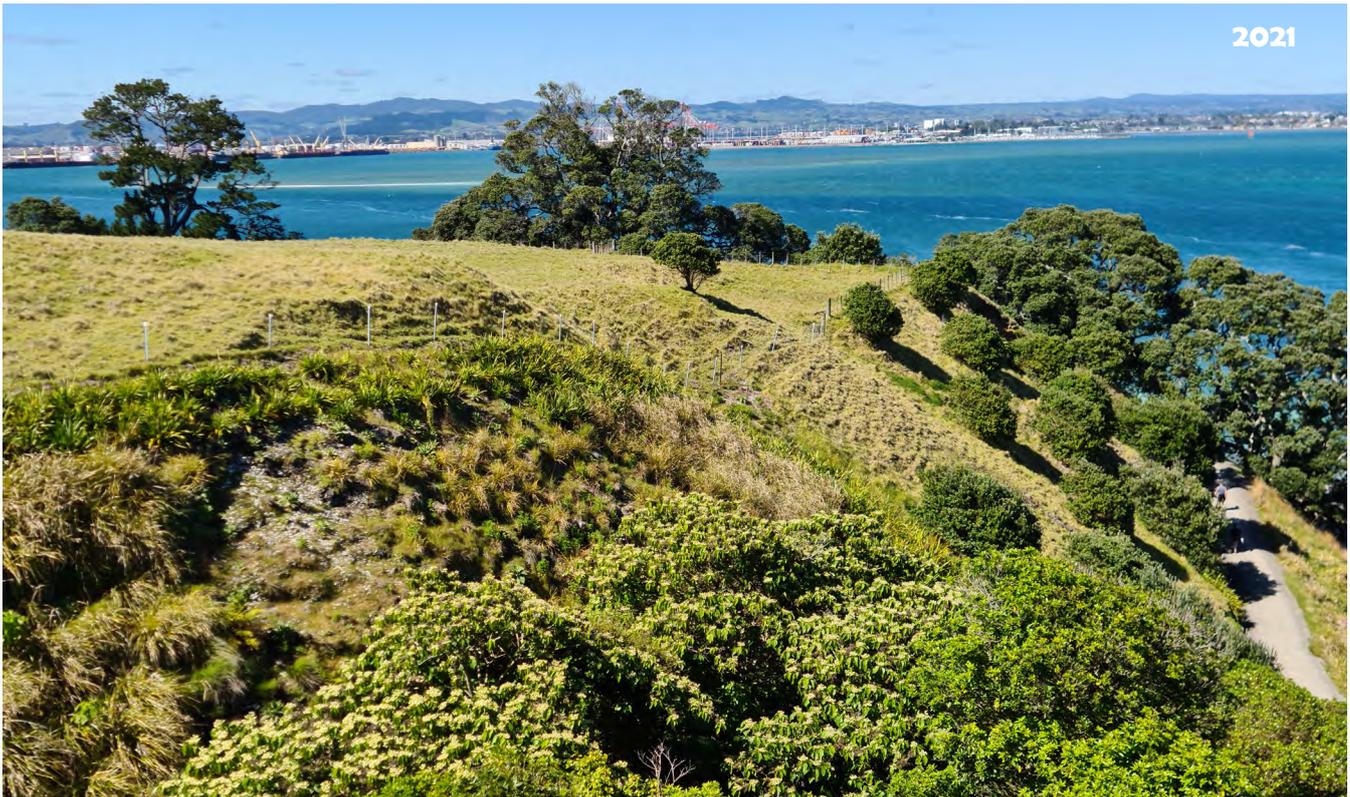
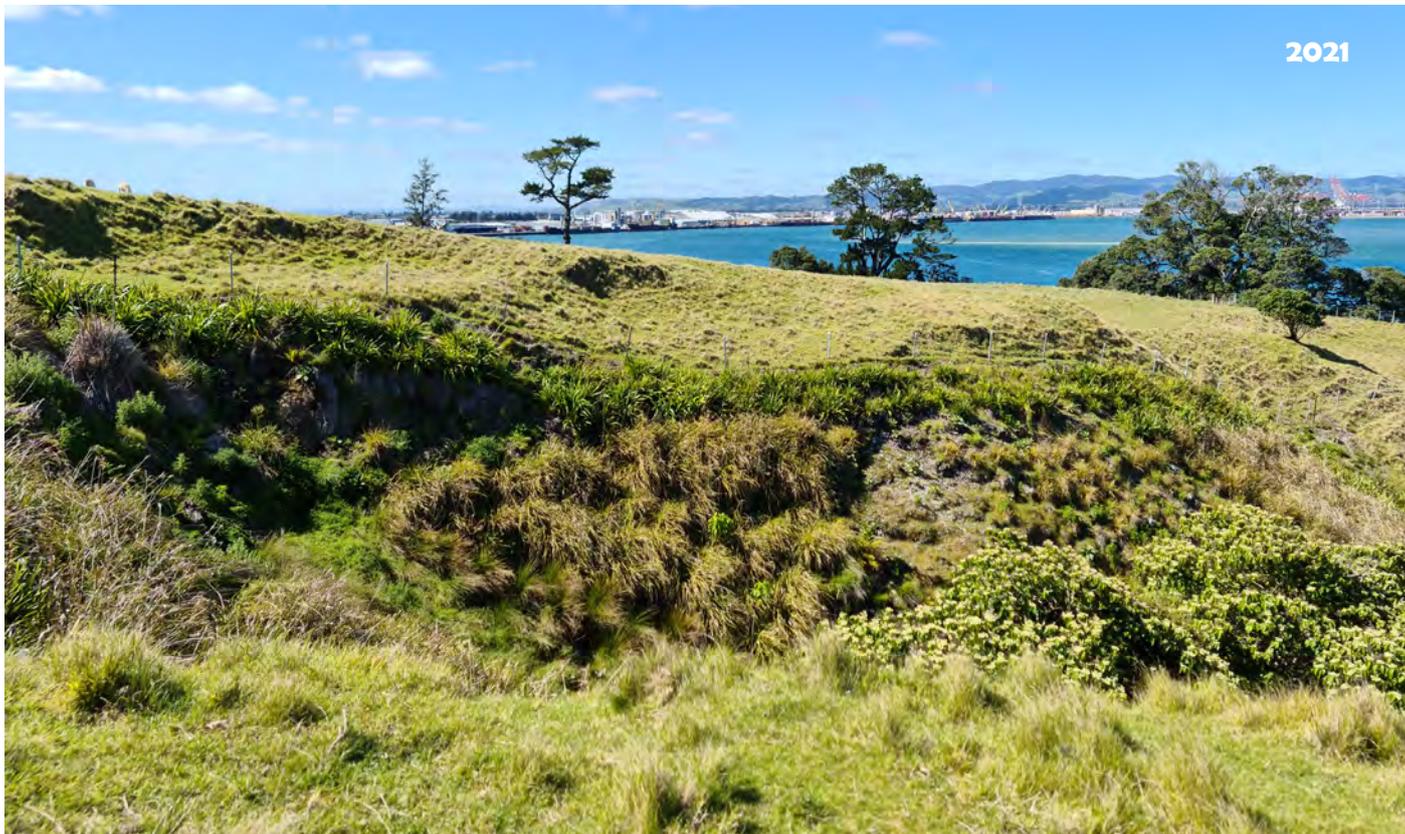
Monitoring Site 4

Fence placement, rabbit browse and slope stability

Notes: Vegetation cover on eroding archaeological features is now well established. There is no significant evidence of rabbit browse in the areas where grazing has ceased. There has been considerable improvement in vegetation cover and slope stability over the monitoring period.

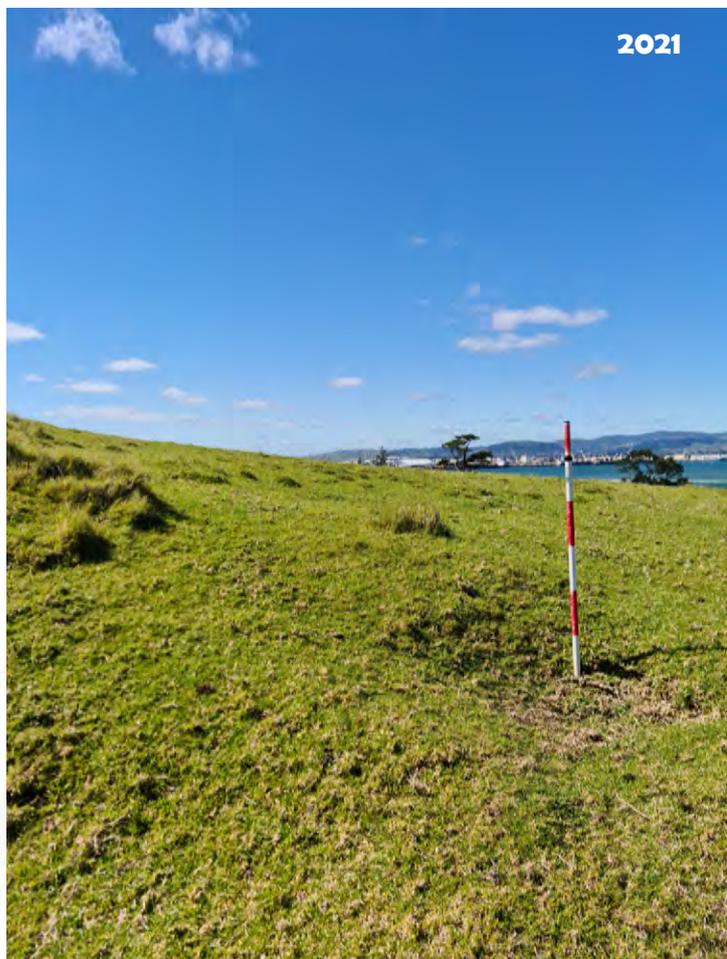
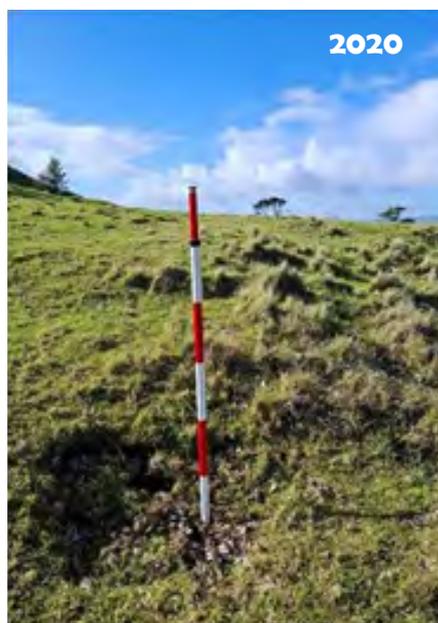
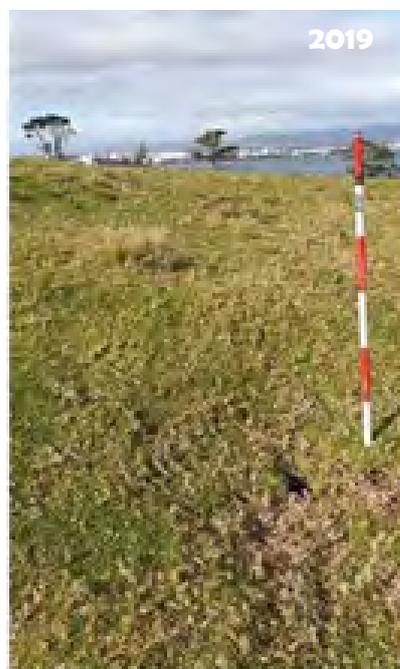
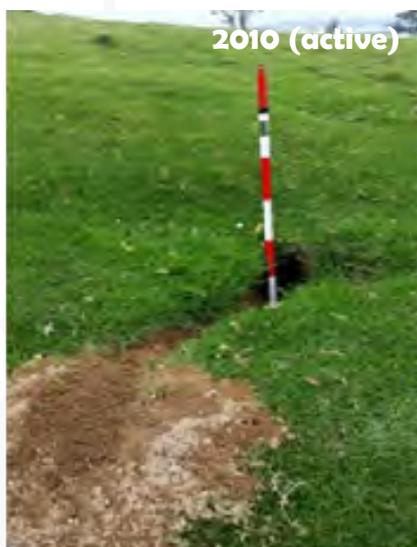
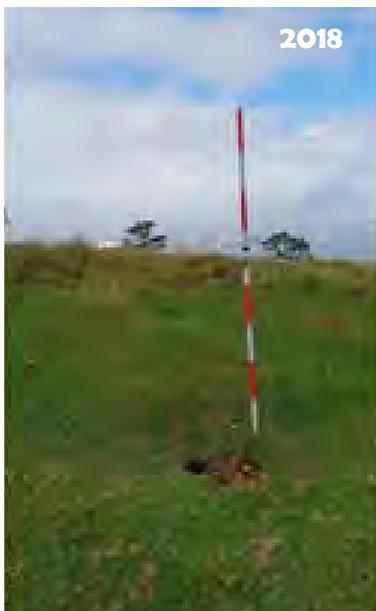
Monitoring Site 5

Rabbit damage (inactive)

Notes: Old rabbit damage, visibility decreasing. Note danger that such features start to look like archaeological depressions over time. Area around burrow entrance has deflated over time
