ARCHAEOLOGICAL SITE CONDITION MONITORING
REPORT - MAUAO HISTORIC RESERVE, TAURANGA

InSitu Heritage Ltd

29 October 2021

Tauranga City Council
Private Bag 12022
TAURANGA

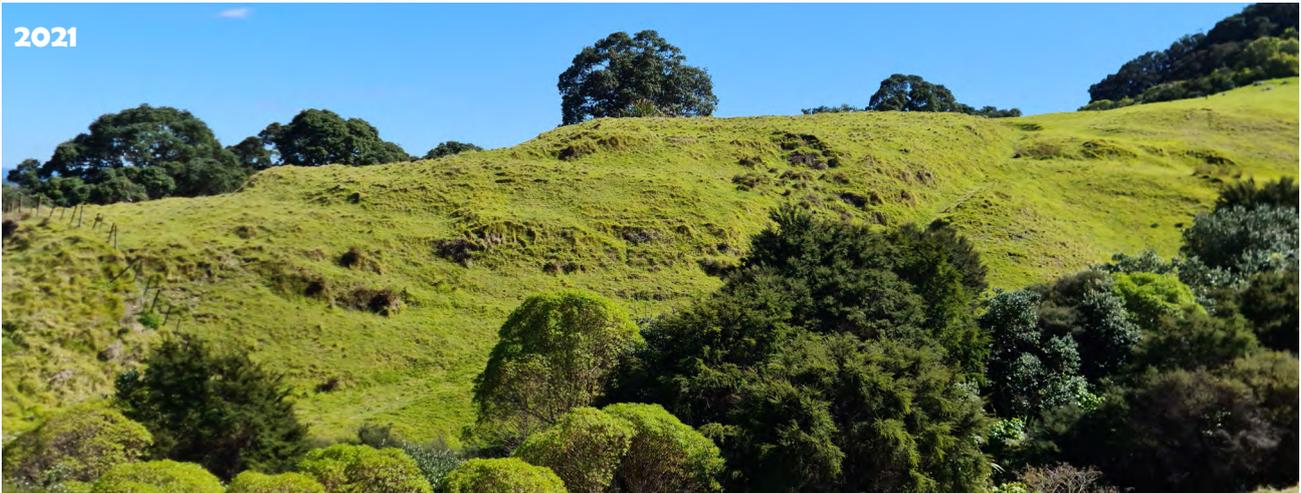
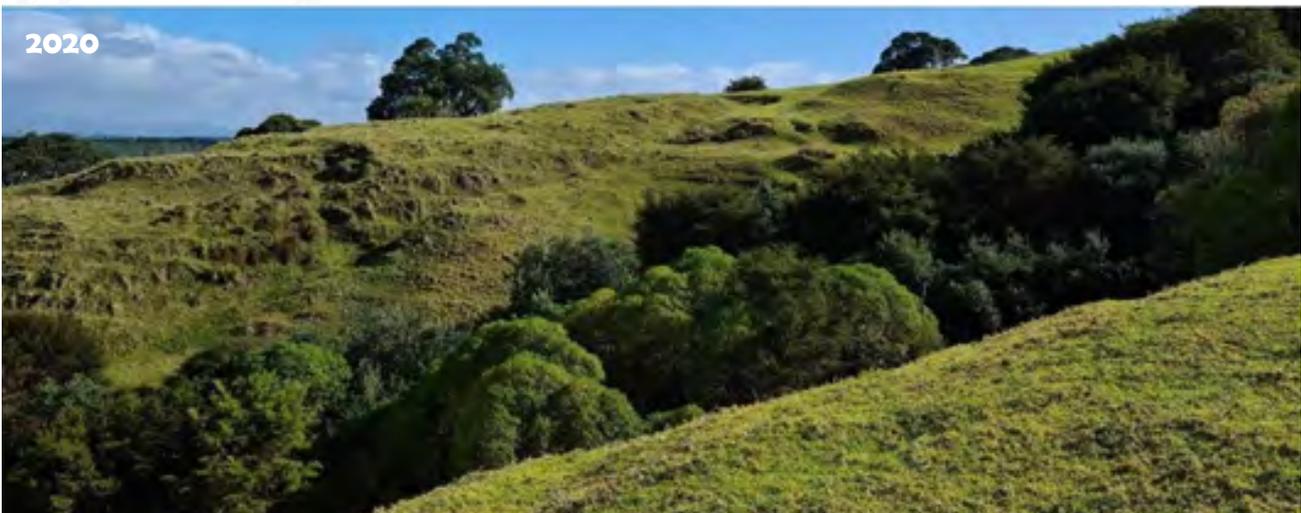
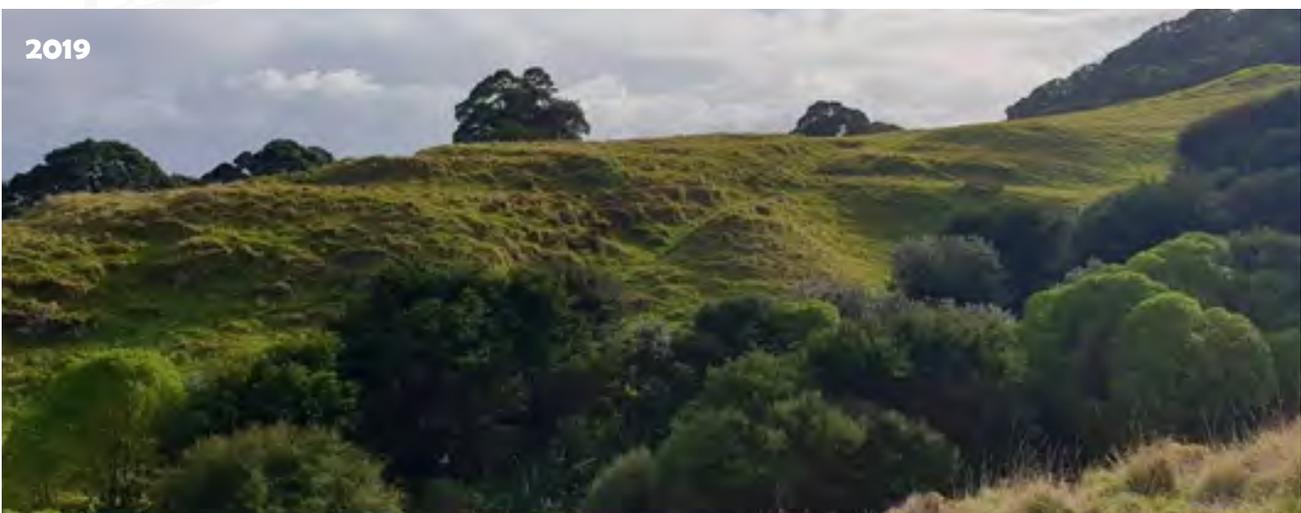
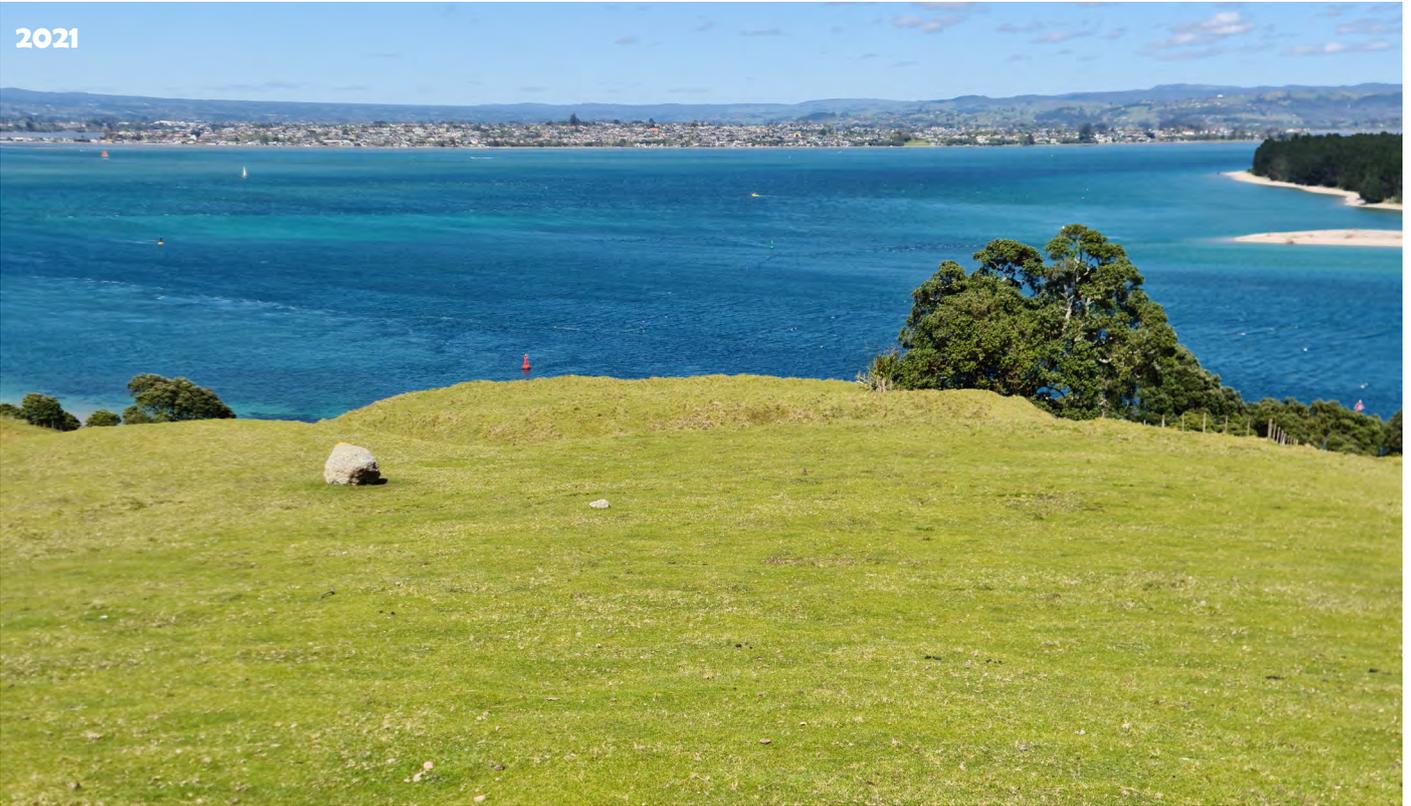
Monitoring Site 6

Pa U14/173 condition/grass cover

Notes: General views across pa to demonstrate grass cover. Site is stable with good ground cover being maintained. Very little evidence of recent rabbit browse but rabbits are present in low numbers and should be closely monitored.

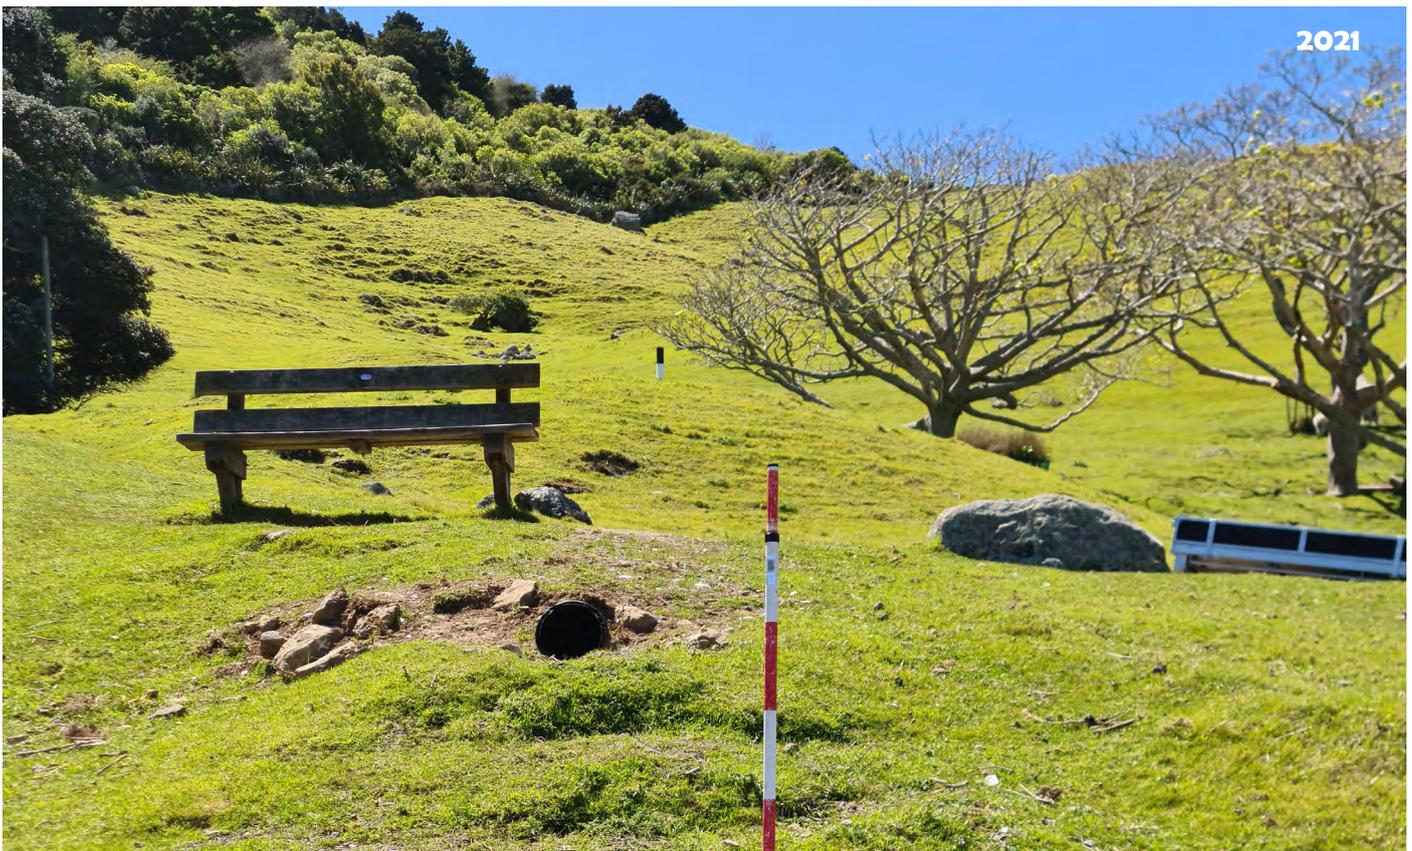
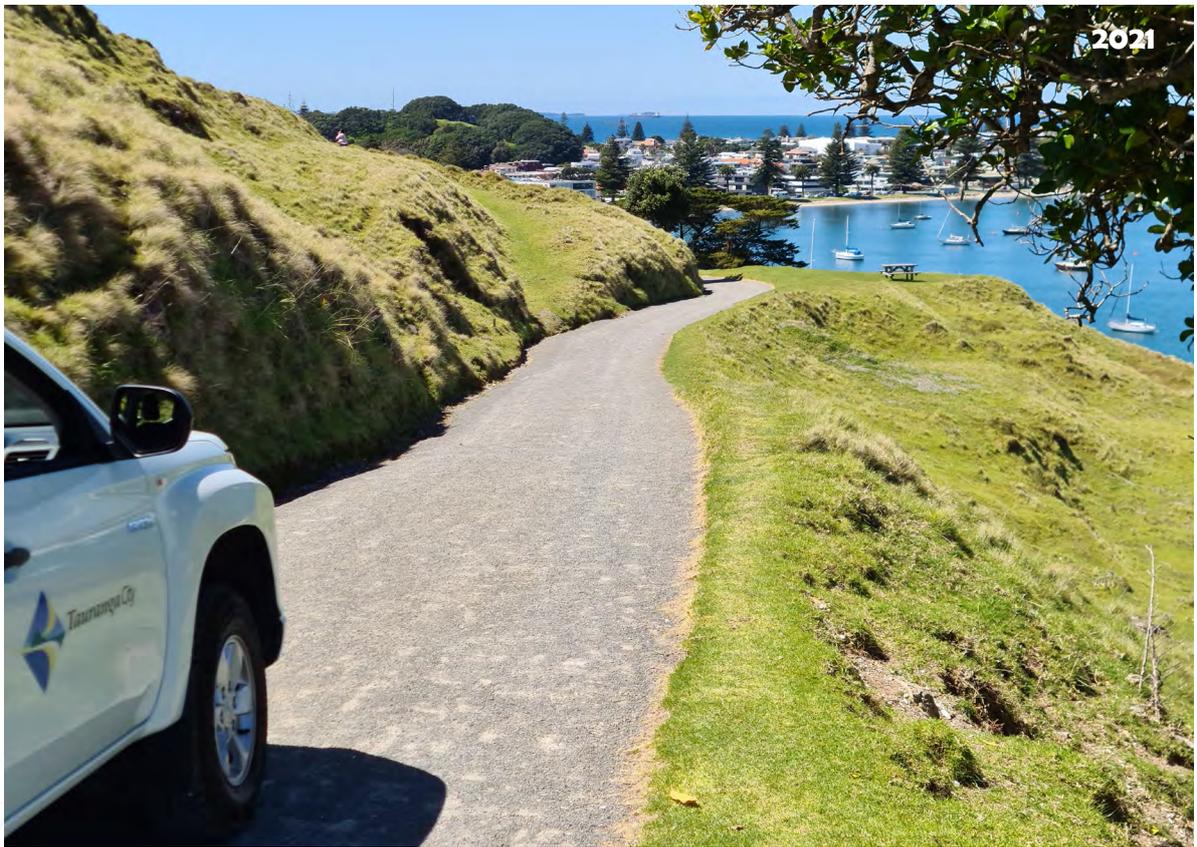
Monitoring Site 7

4WD track maintenance issues - tailings management

Notes: There is no recent evidence of tailings being dumped on archaeological features above the track, as was the issue in the past. However, the artificial build-up of material continues to 'create' features adjacent to the track. There is still a significant issue with metal being distributed onto terraces below the track. The distance between culverts, their function and the treatment of tailings needs further management attention. Consideration should be given to removal of artificial build-up with archaeological supervision.

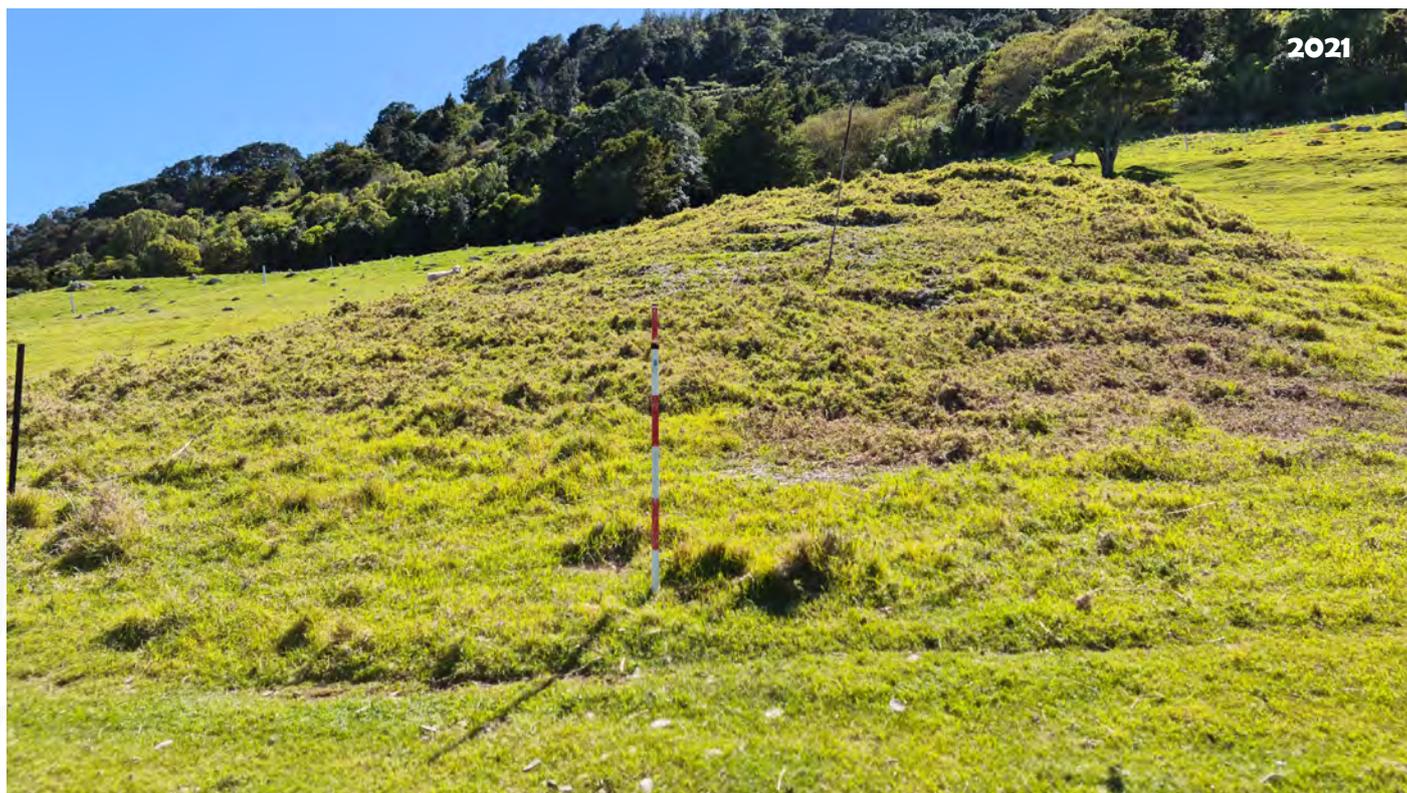
Monitoring Site 9

Erosion on shell mound - stock and vegetation management

Notes: Grass sward is kikuyu; stock have had access to the mound since December 2019. Stock numbers in Spring 2021 are higher than the previous year and this has impacted on the grass cover on the southern side of the mound. Stock numbers should be closely monitored and reduced if necessary to maintain sward height.

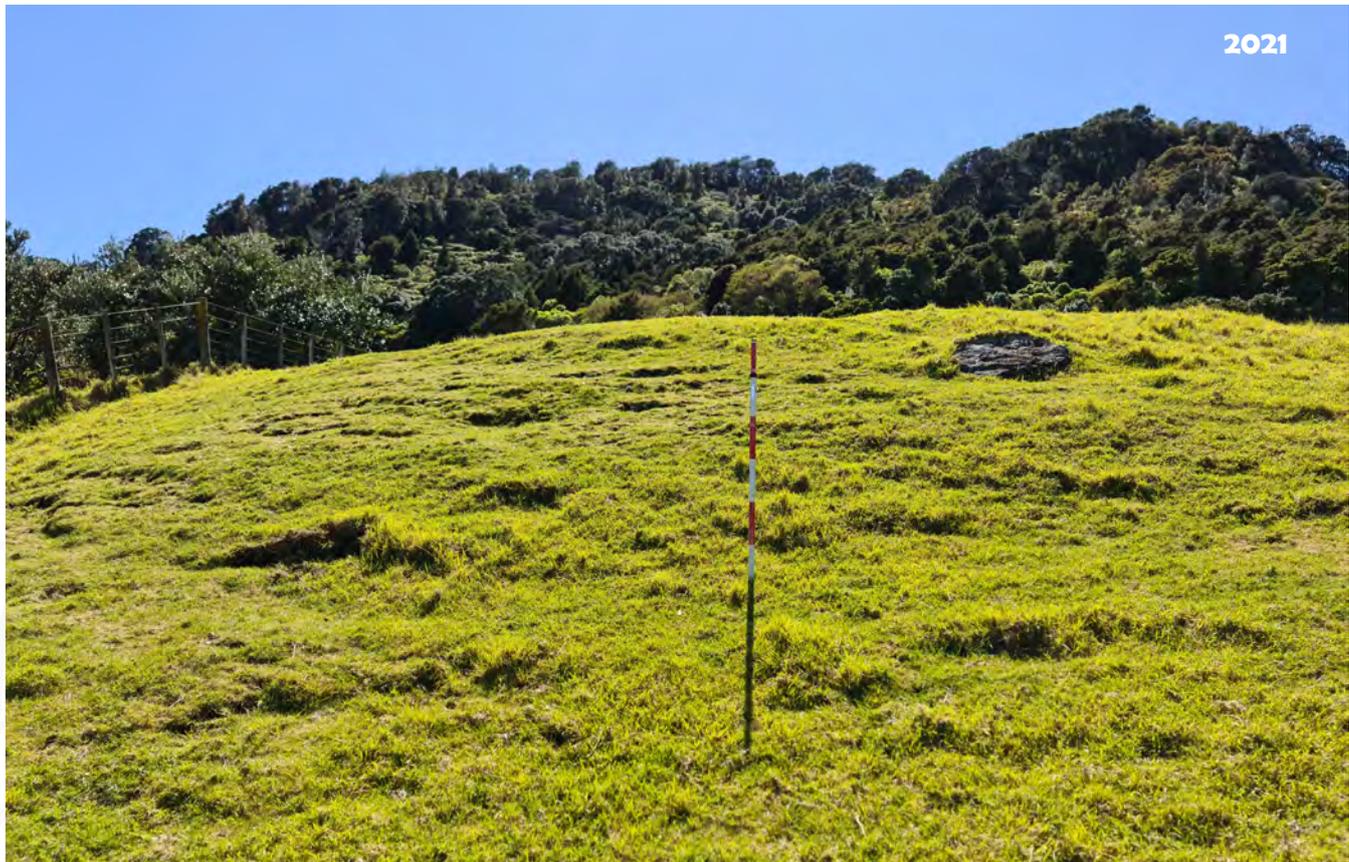
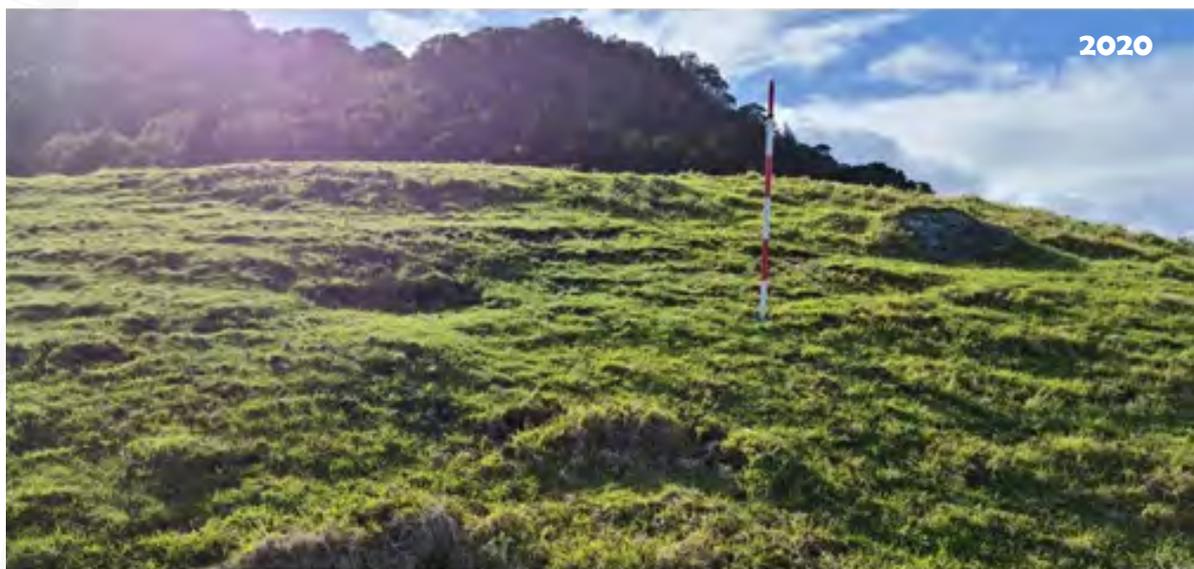
Monitoring Site 10

Rabbit damage (active)

Notes: Vegetation cover has significantly improved as greater rabbit control measures are in place, but this should be closely monitored. No recent rabbit browse at this location, but rabbits were seen in the area during the monitoring visit.

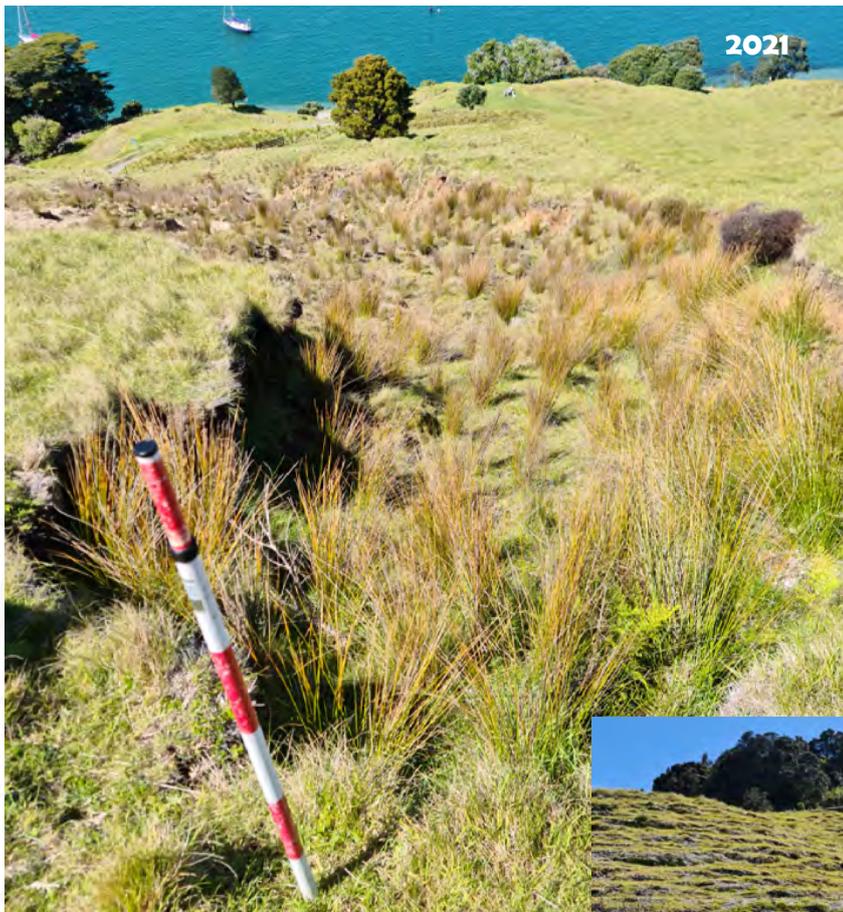
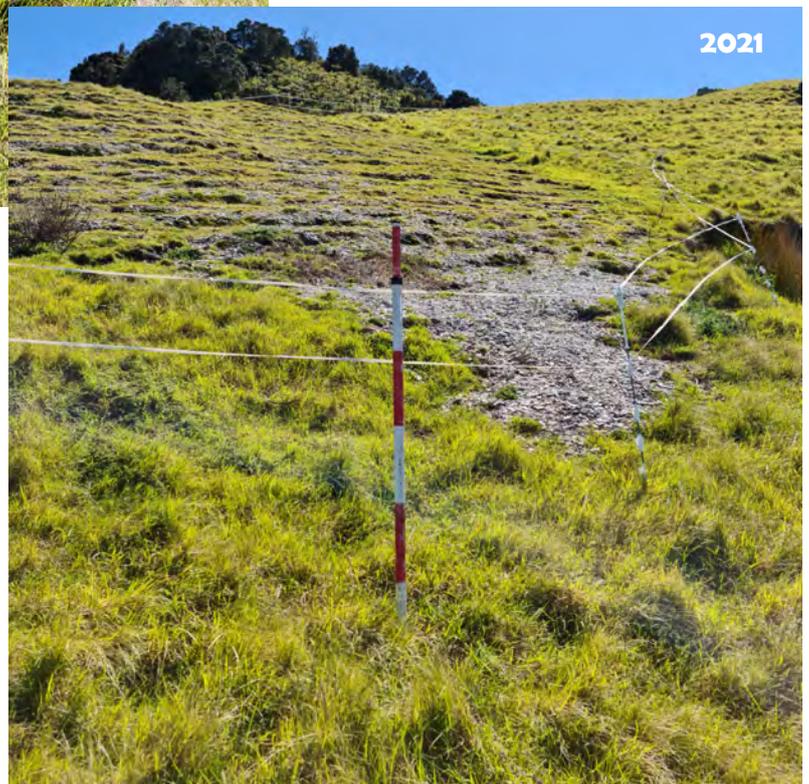
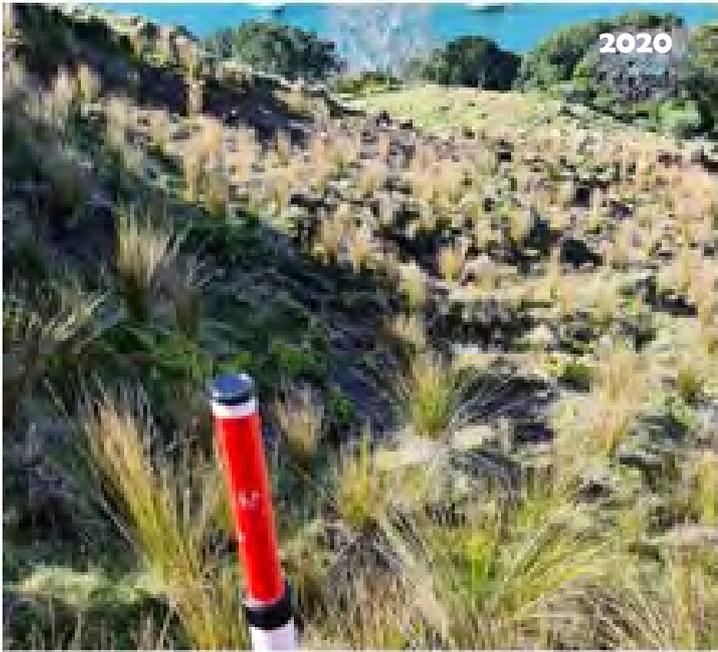
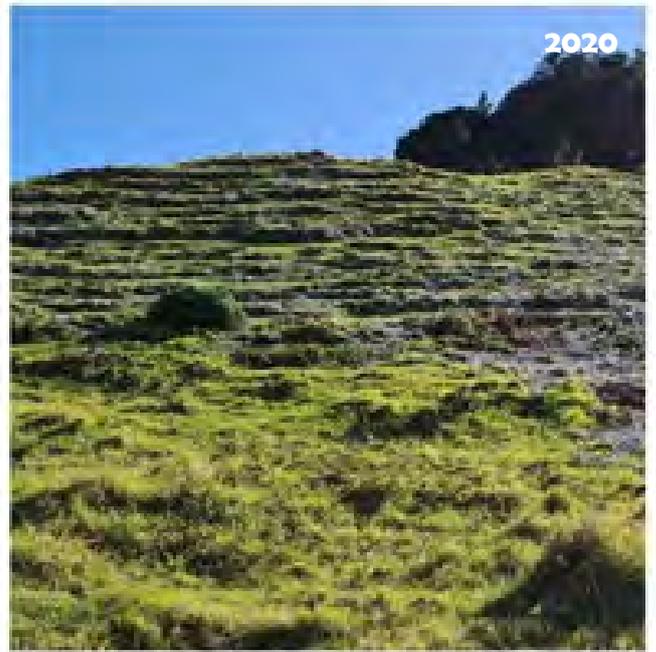
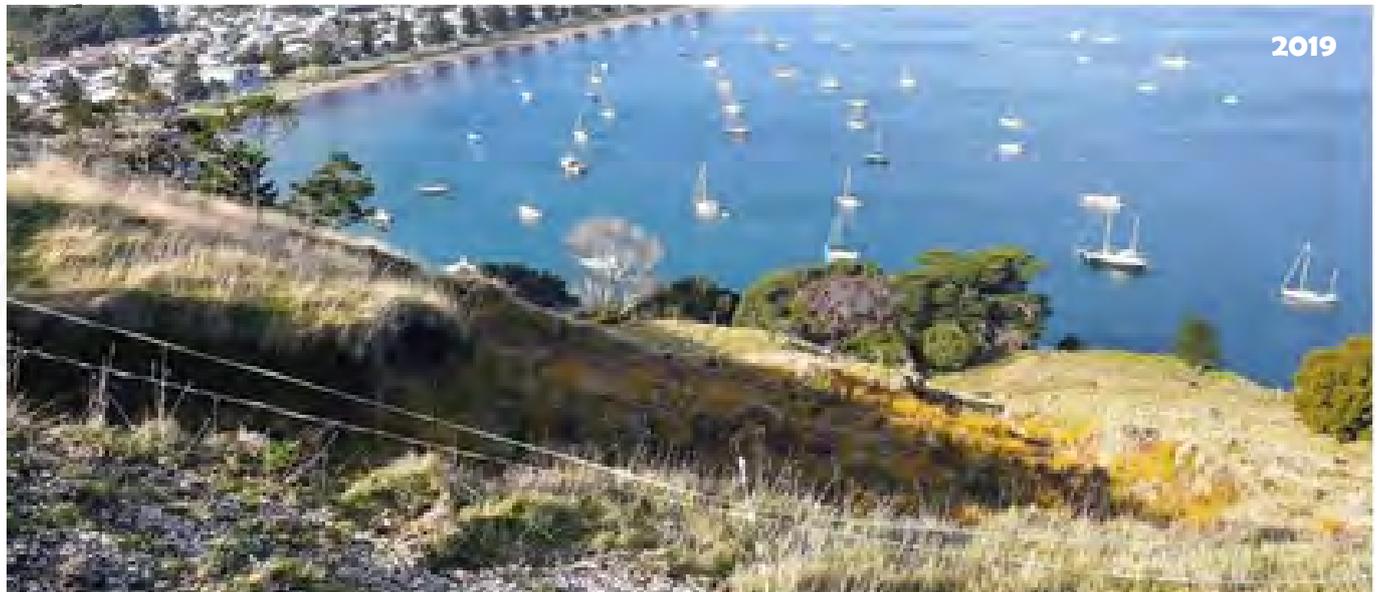
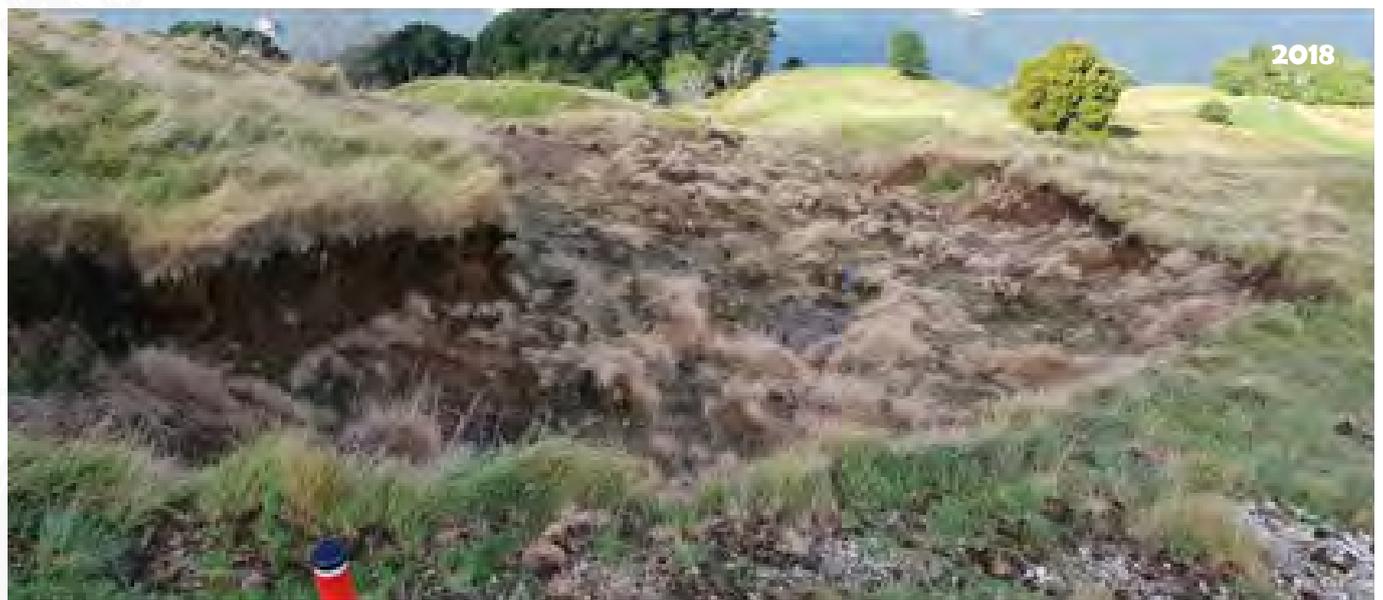
Monitoring Site 11

Land slip on southern slope

Notes: 2018 planting of slip scar is well established. Still a lot of visible shell midden at the top of the slip scar and some limited new exposure since 2020 inspection. Stock exclusion on shell mound not successful so far due to location, it may need a temporary netting fence instead. Recommend archaeological investigation followed by planting and livestock exclusion.

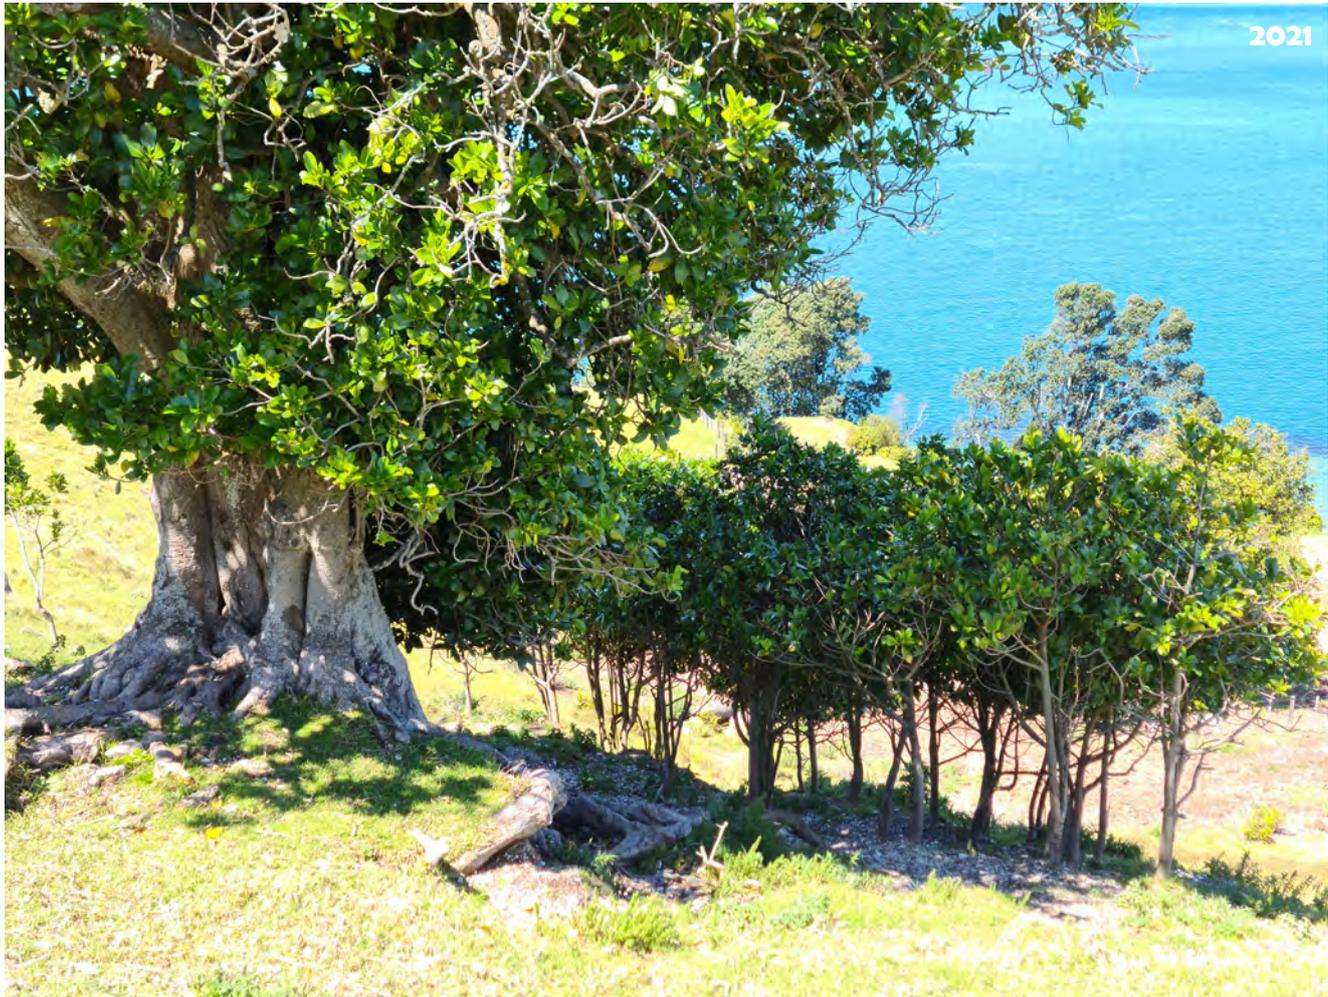
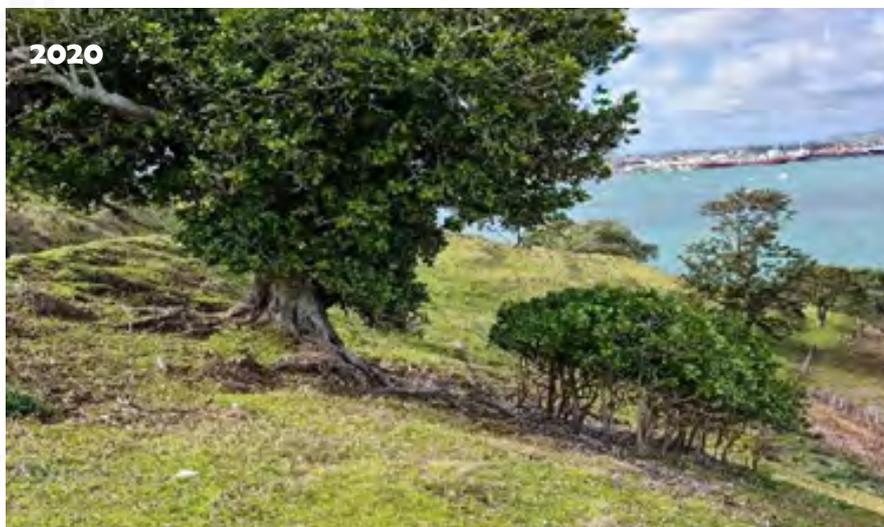
Monitoring Site 12

Fence around middens on southern slope

Notes: Fence around middens that was installed in 2003 was removed in 2018. Some browse of young karaka initially, but grove now well established and no new erosion of midden in evidence. Continue to monitor condition.

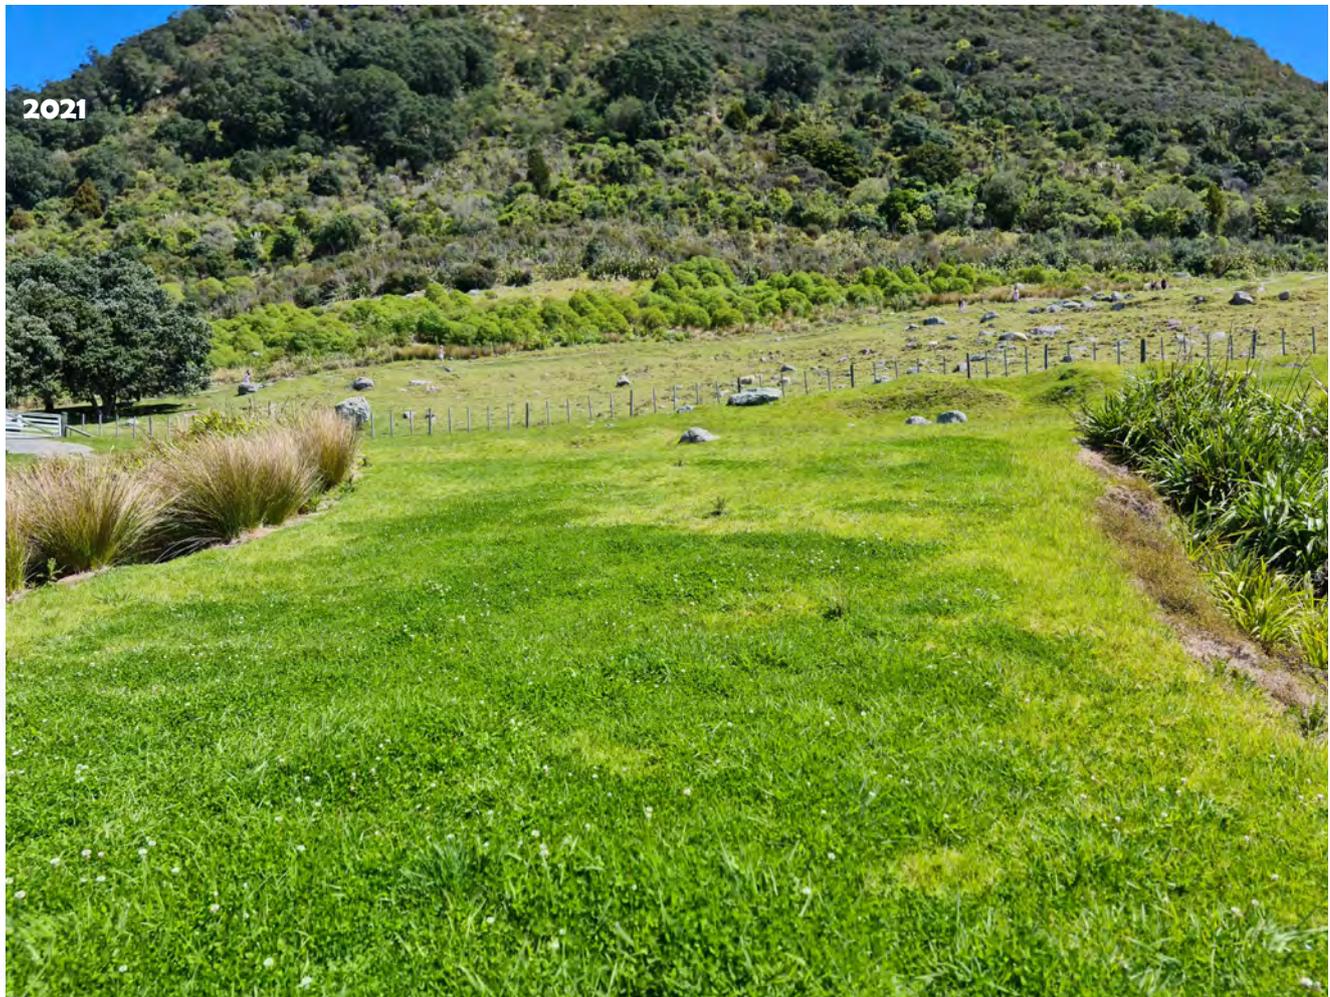
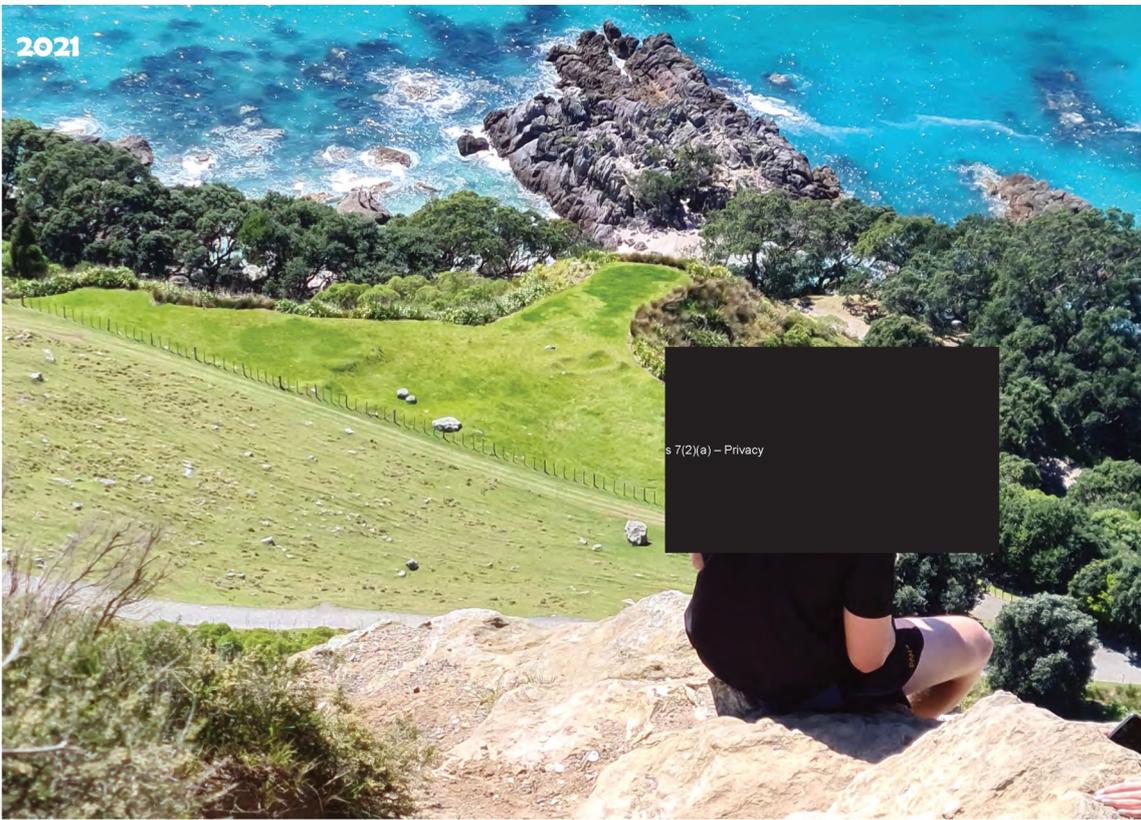
Monitoring Site 13

Area of military camp, helicopter pad, pits and terraces retired from grazing in 2018

Notes: Management of vegetation and site visibility has significantly improved following cessation of grazing. Features stable.

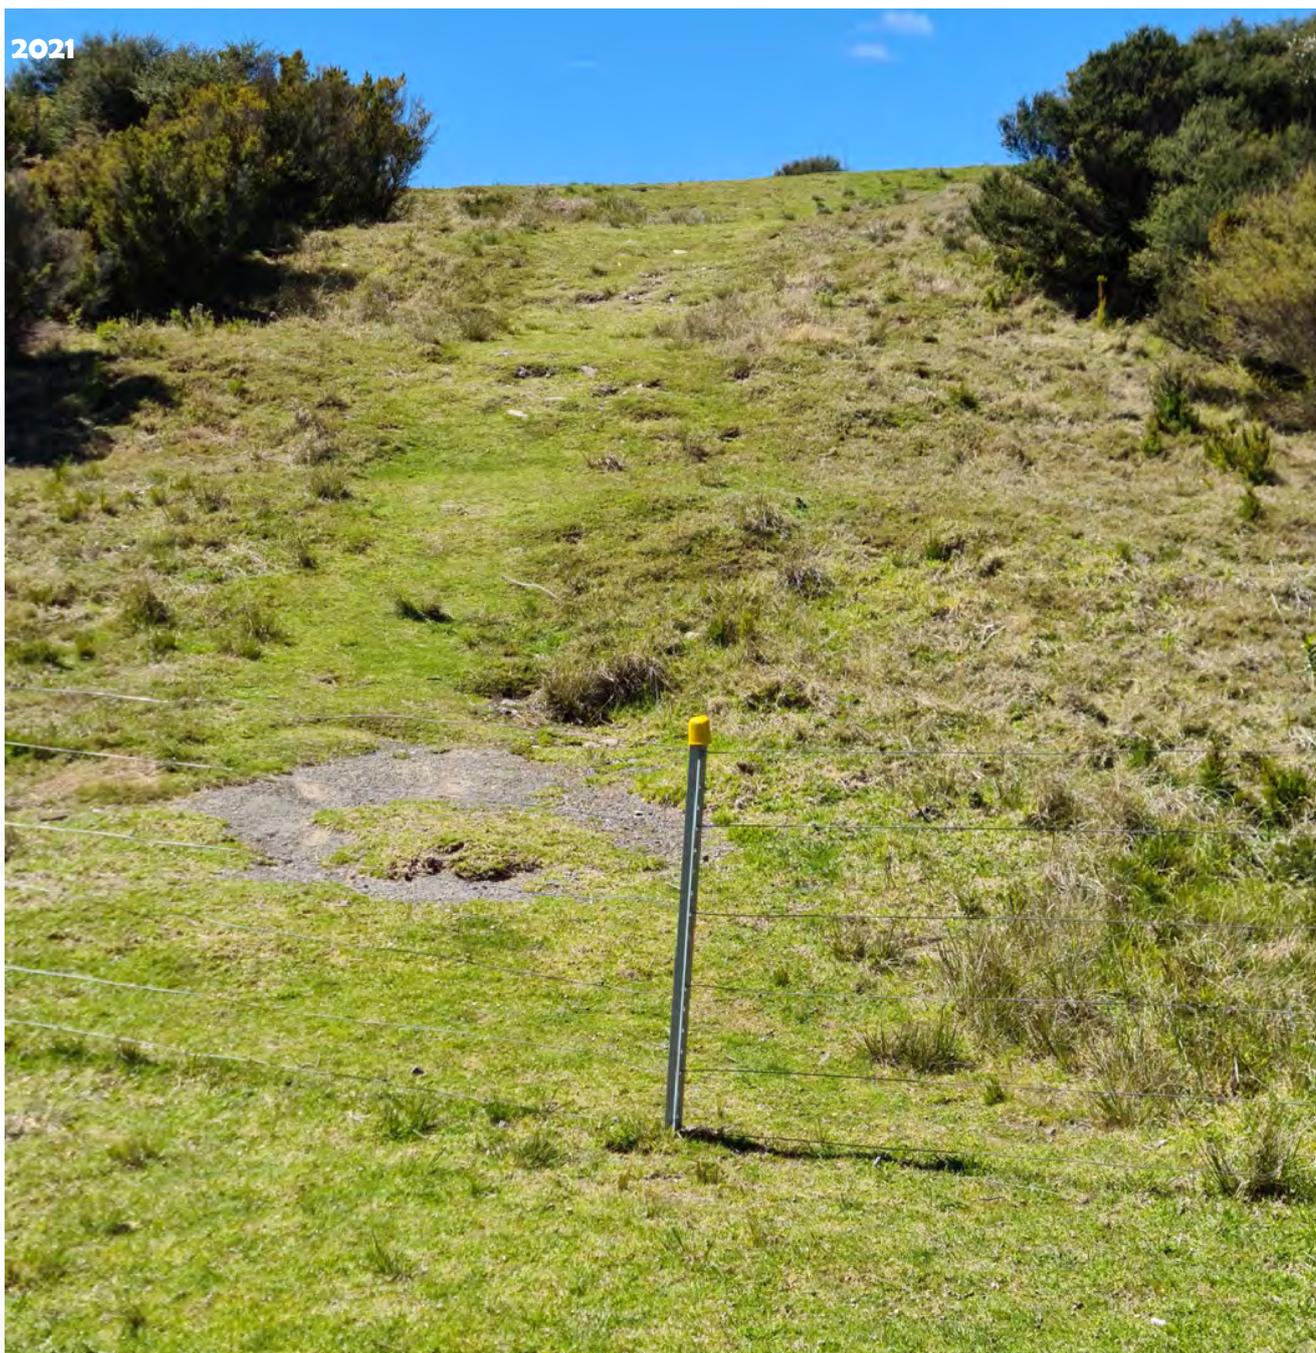
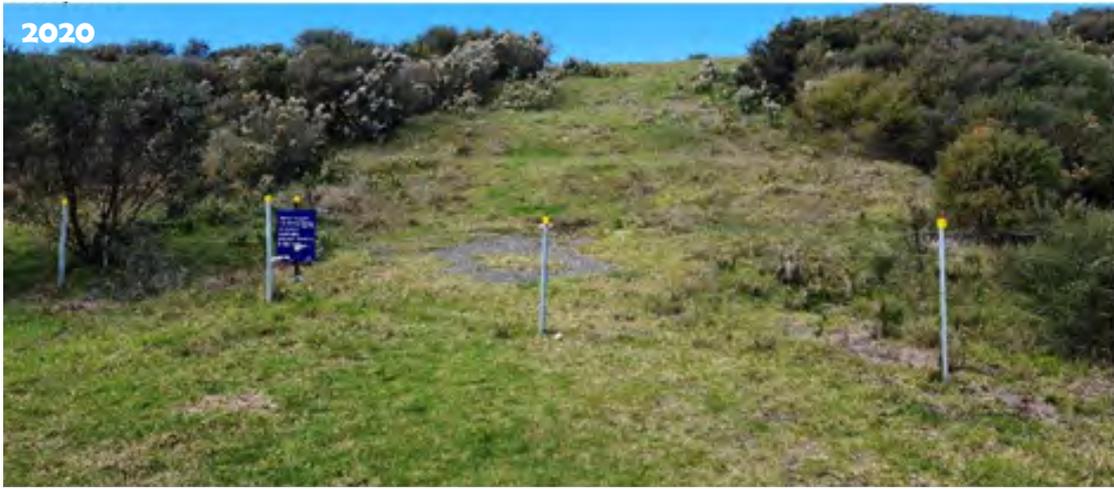
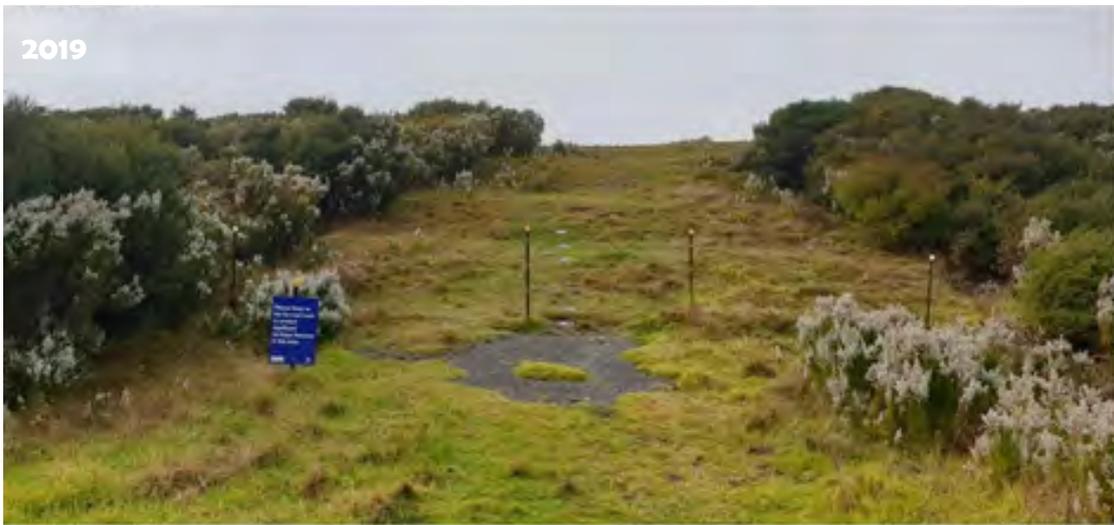
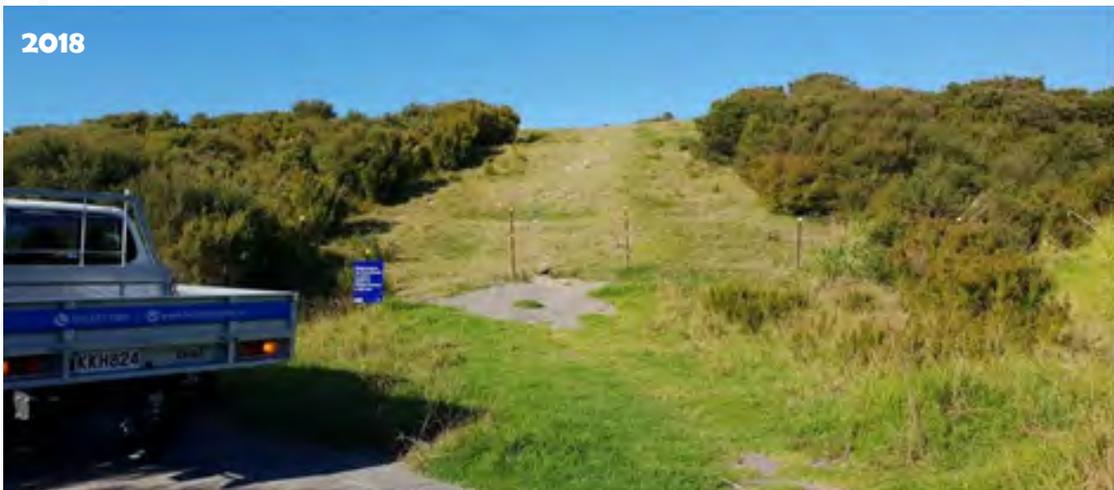
Monitoring Site 14

Repairs to summit terrace

Notes: Repair to terraces completed in 2013. The aggregate at the base of the slope was not moved as recommended as in 2019, but now less visible. Encroaching vegetation has been managed to keep terraces visible.

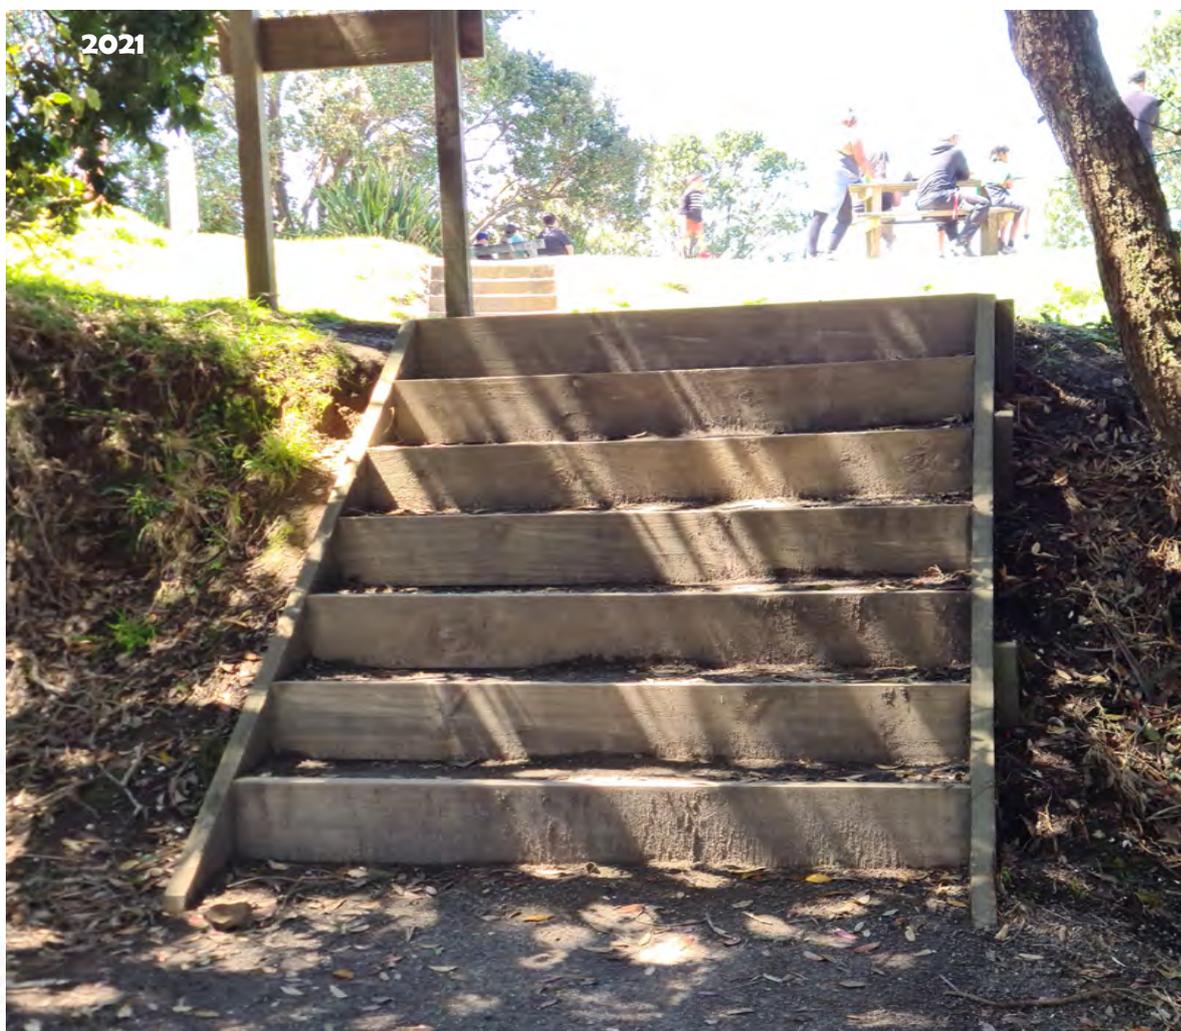
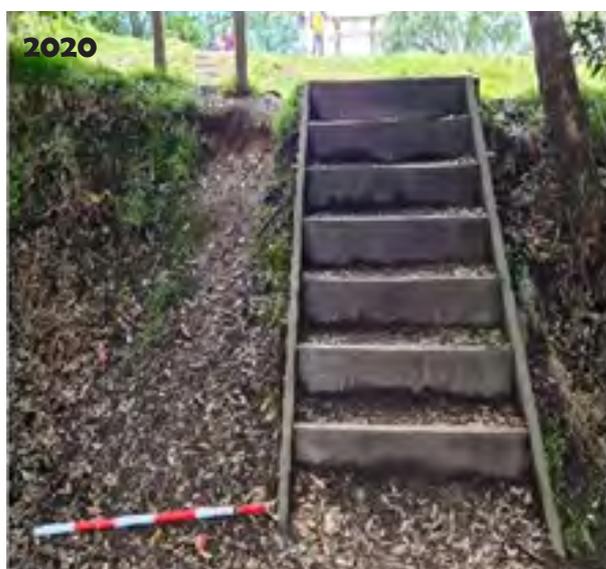
Monitoring Site 15

Repair to bank on summit and steps intallation

Notes: Width of steps has been increased to cover desire line. Continue to monitor use.
