ARCHAEOLOGICAL SITE CONDITION MONITORING
REPORT - MAUAO HISTORIC RESERVE, TAURANGA

InSitu Heritage Ltd

29 October 2021

Tauranga City Council
Private Bag 12022
TAURANGA

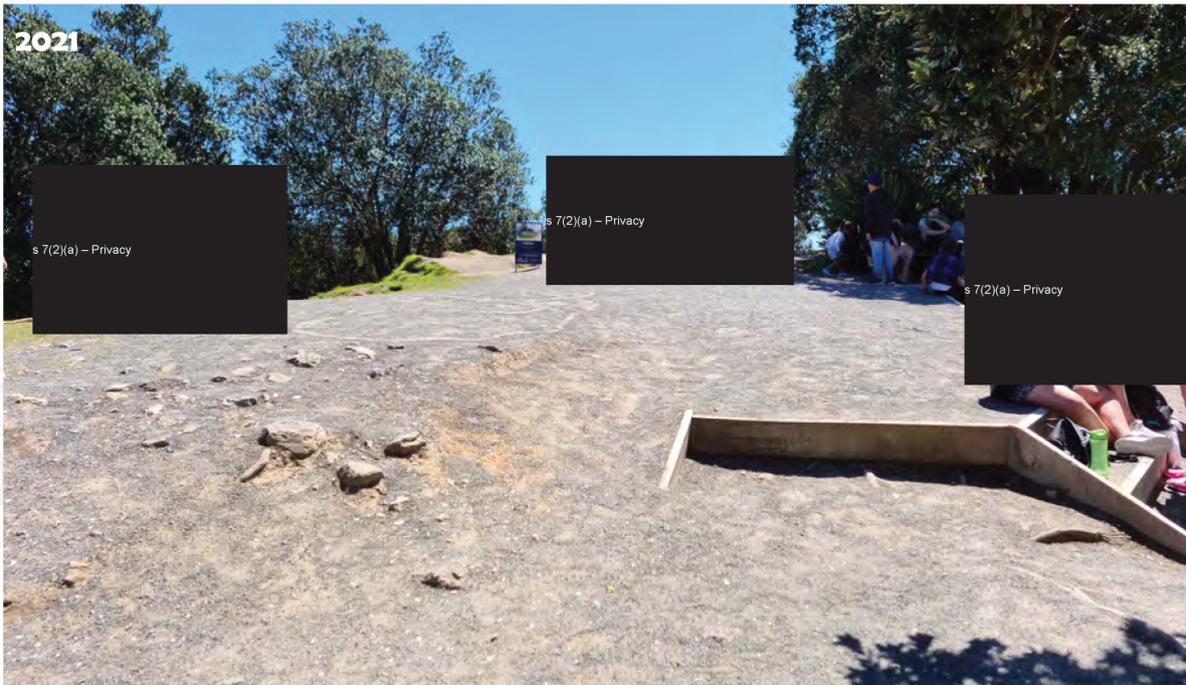
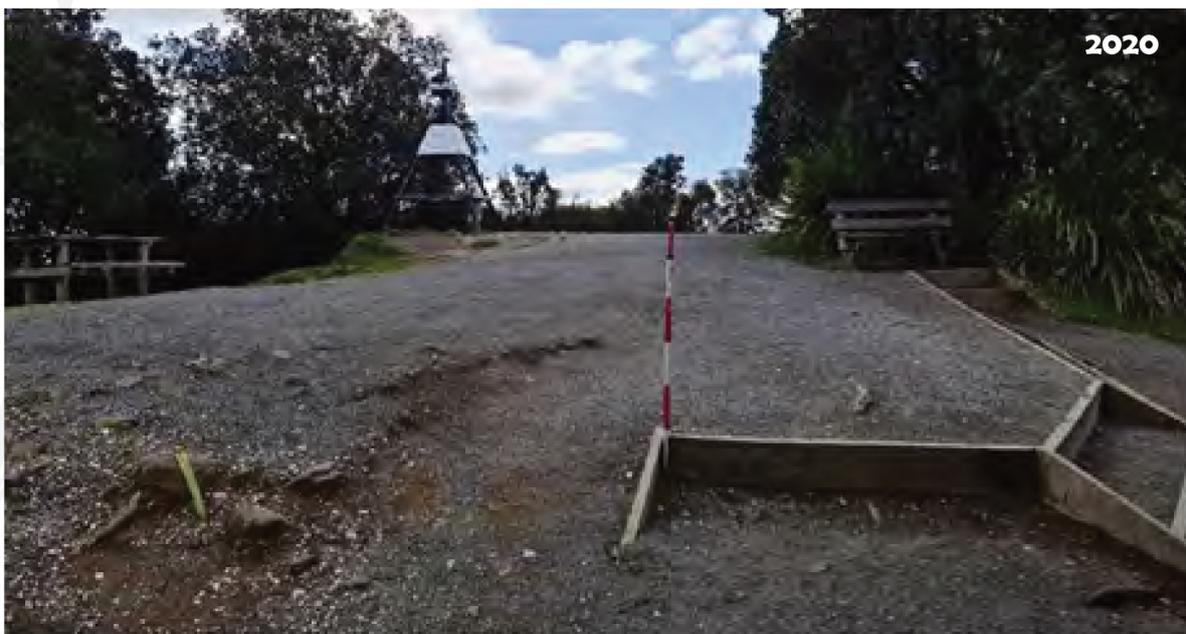
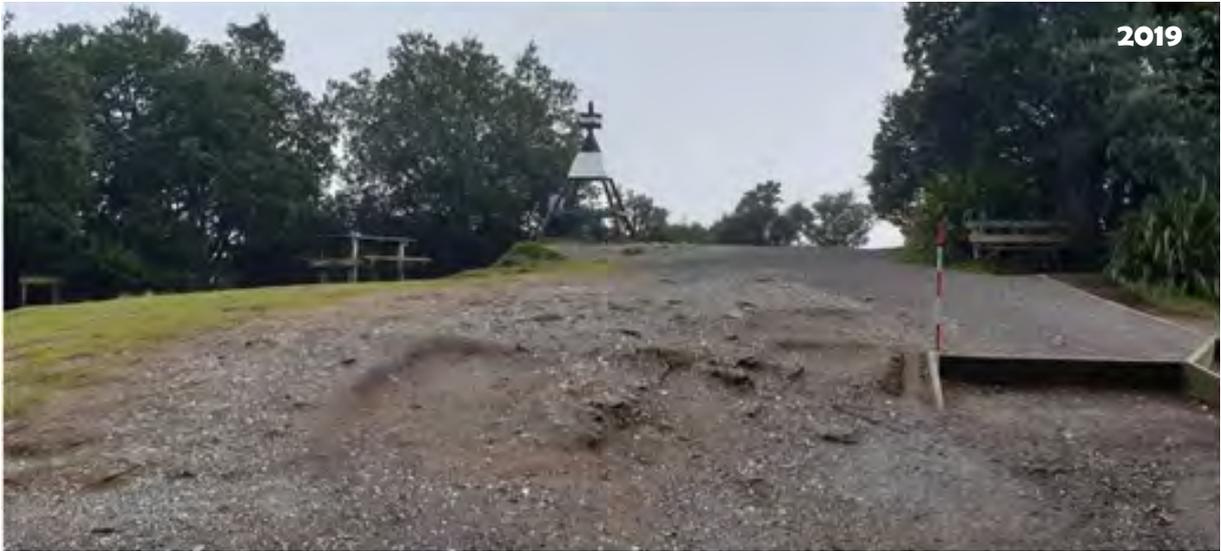
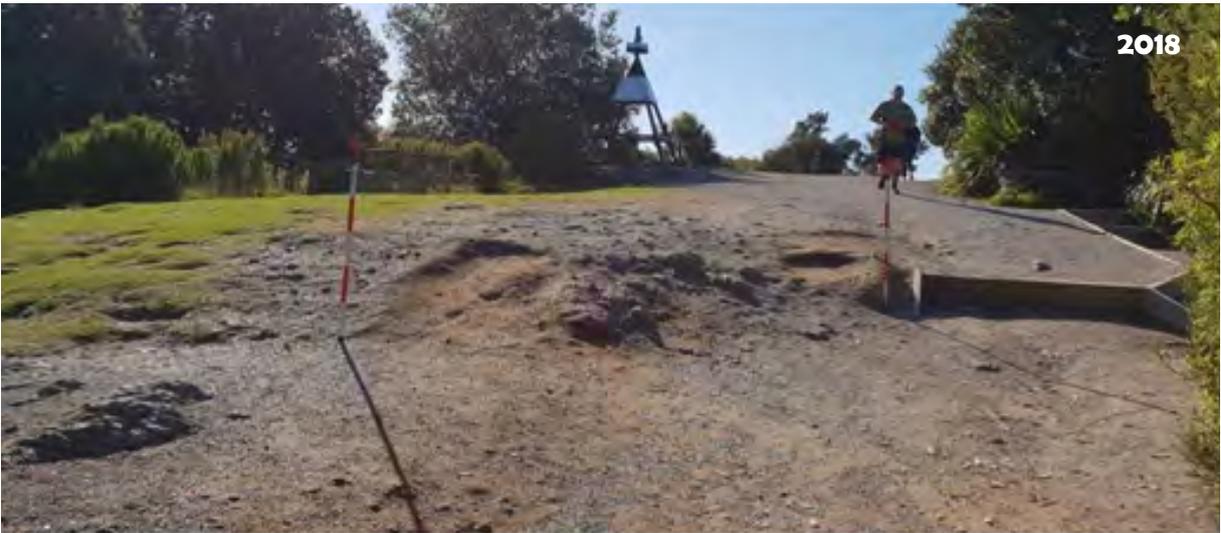
Monitoring Site 16

General monitoring of summit wear

Notes: There is on-going wear of imported armouring material on summit; on-going recapping is required by bringing in additional material from stockpile. Trig removed June 2021.

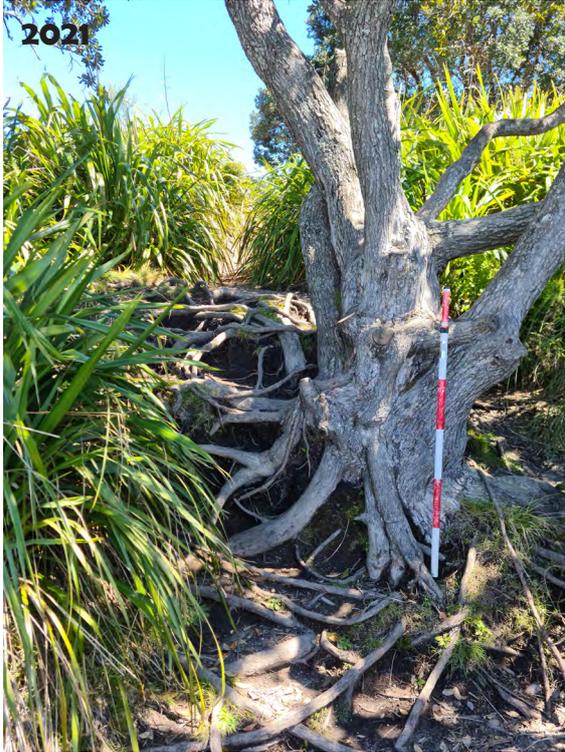
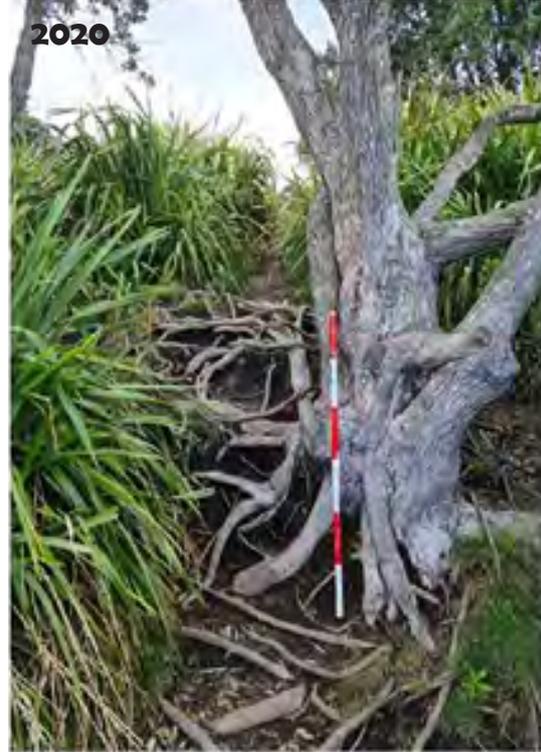
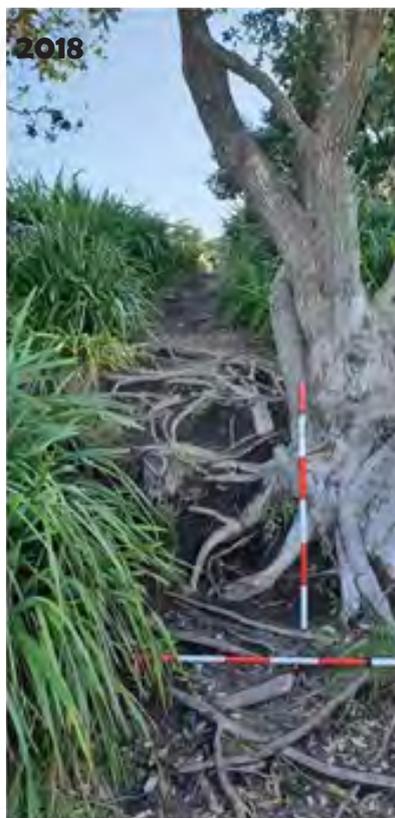
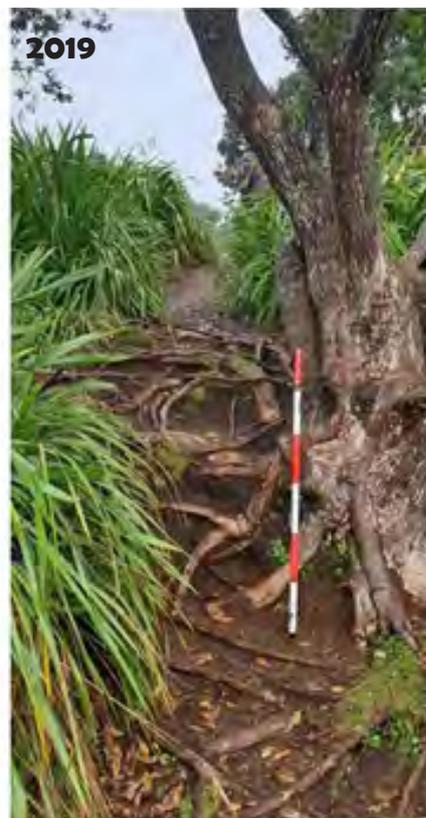
Monitoring Site 17

Desire line track on summit

Notes: Desire line is continuing to cause wear to intact archaeological deposit, and soil loss is readily apparent. Action to block access to prevent further wear was recommended in 2018 and needs to be implemented. Continue monitoring. Additional fill material may be required around the tree.

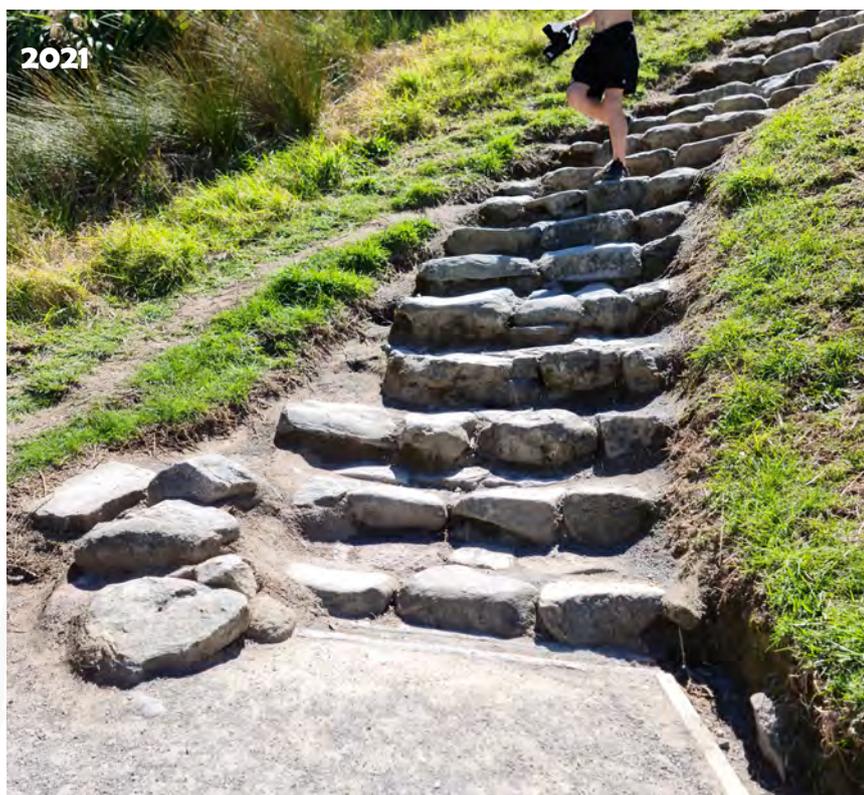
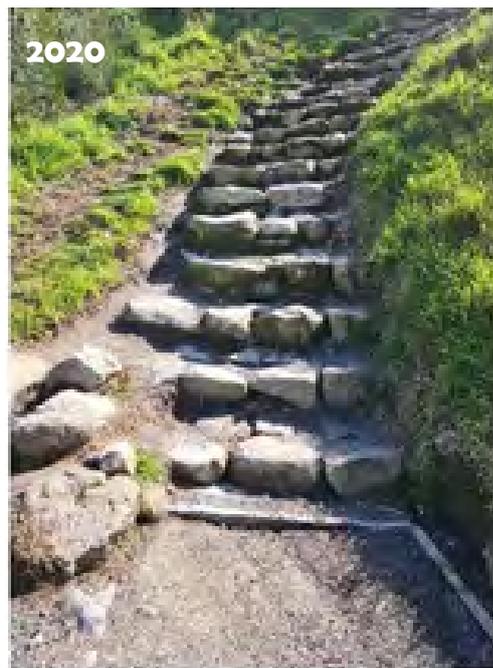
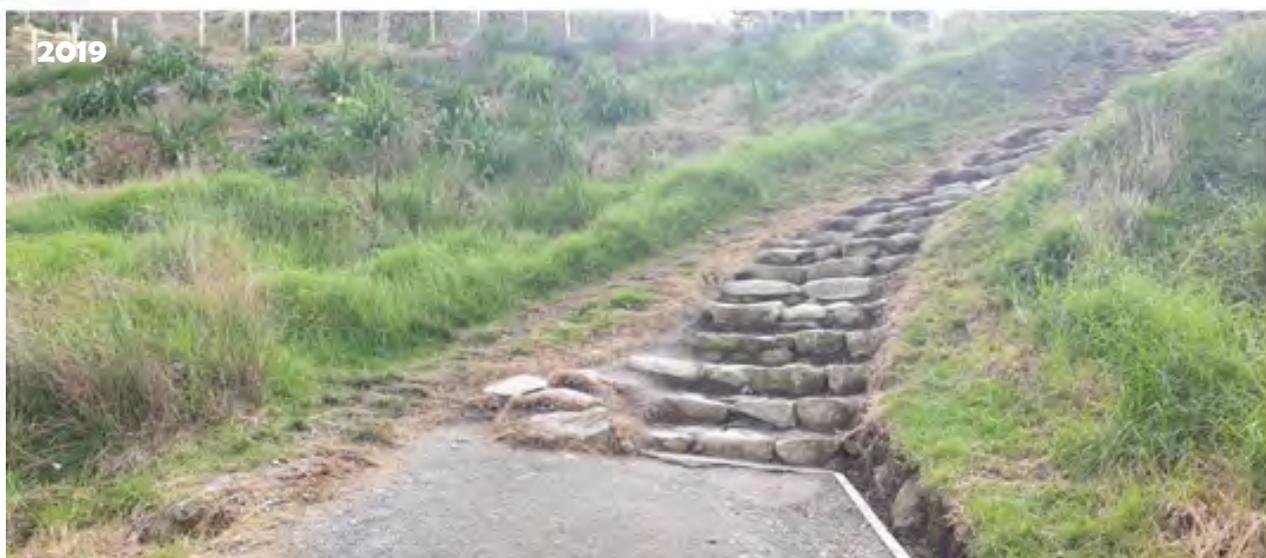
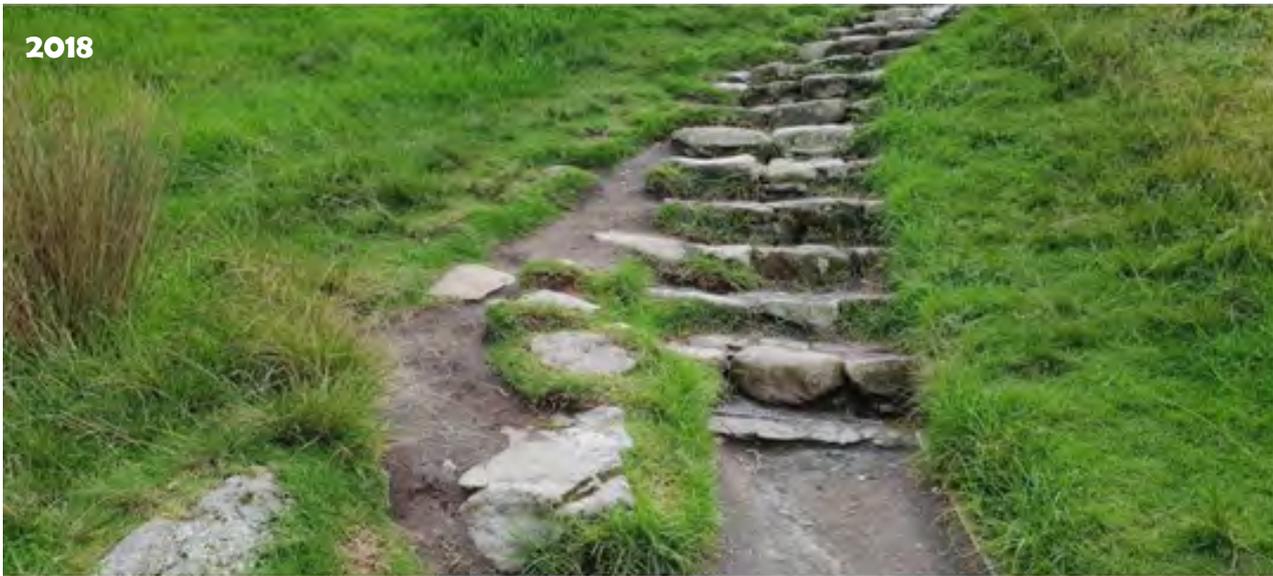
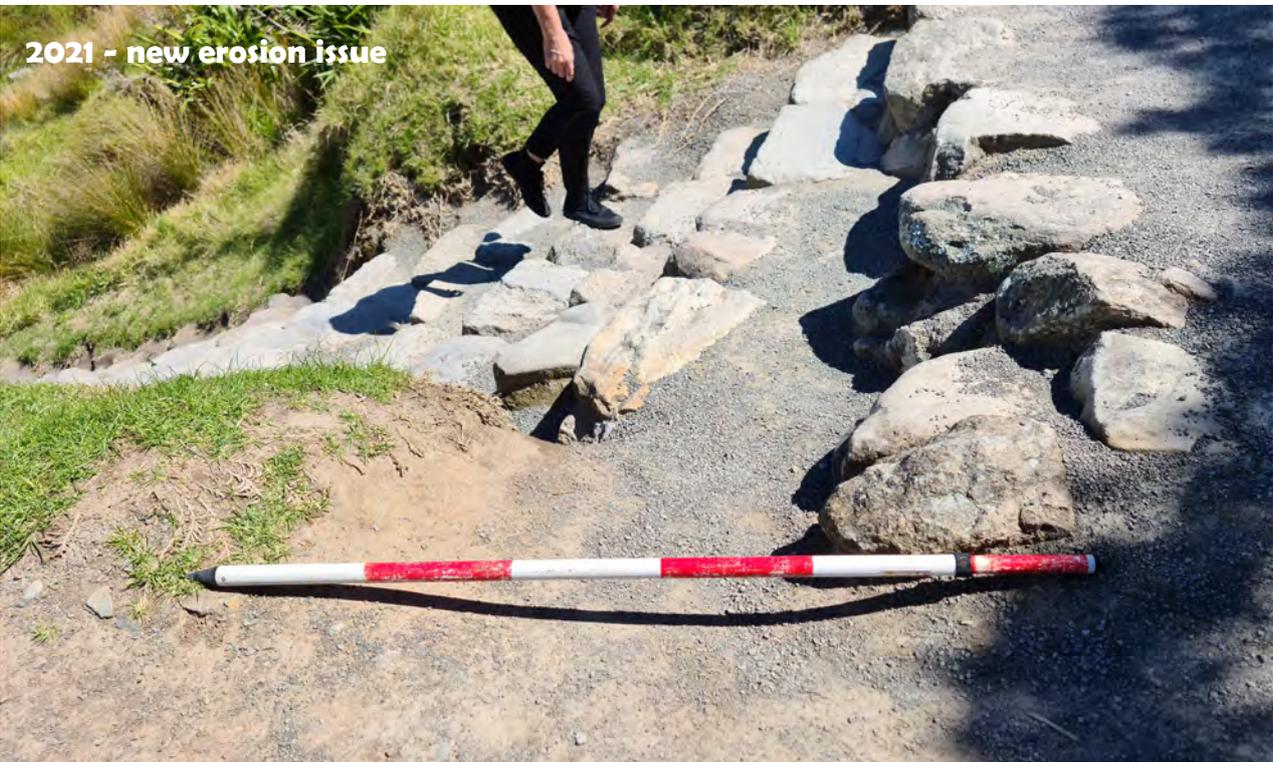
Monitoring Site 18

Stone steps condition and erosion

Notes: Stonework stable at present, but erosion from desire line more visible than in 2020. Weed spraying corridor needs to be reduced as this is encouraging desire lines. **Action needed at the top of the stairs to reduce water flow and erosion.**
