TAURANGA STORM EVENT OF 18 MAY, 2005: LANDSLIP ISSUES

**TAURANGA LANDSLIDES: 18 MAY 2005
SITE VISIT & REVIEW NOTES**

Version: 10005.2.1
Date: 13 July 2005

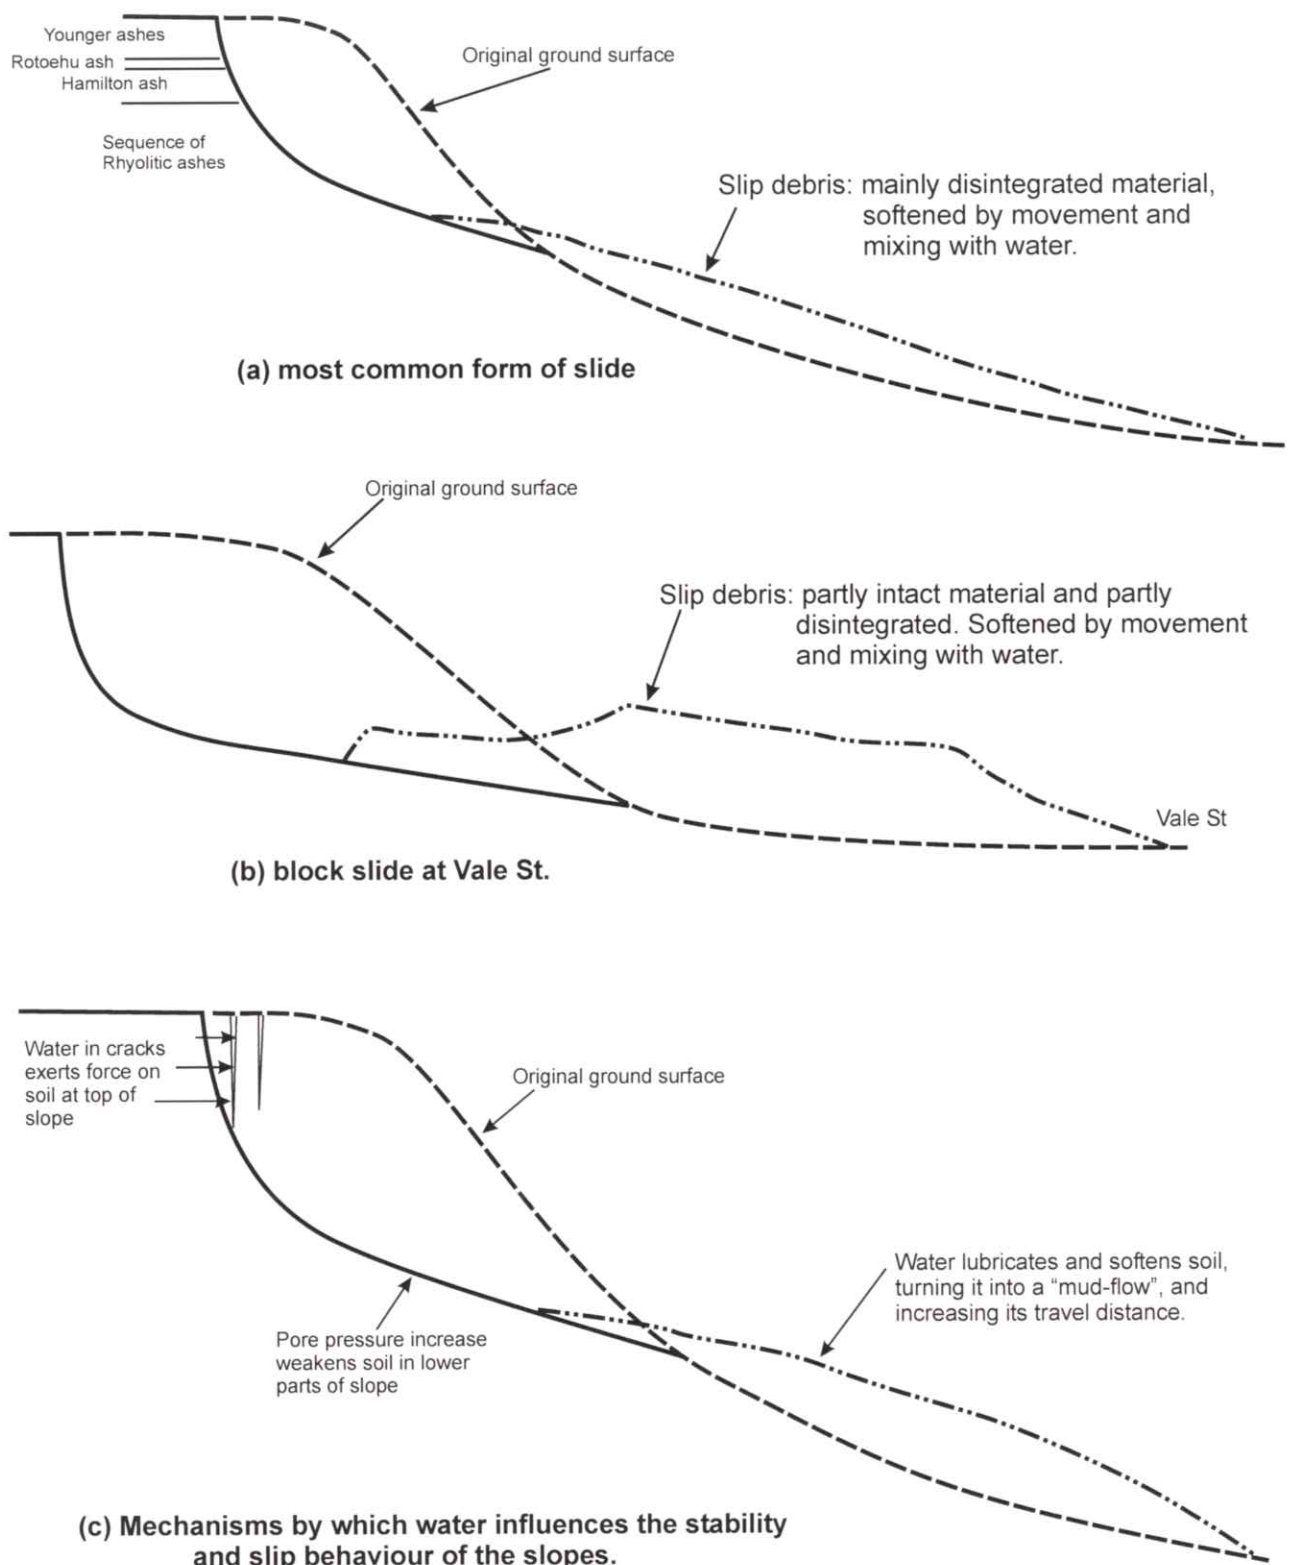
Figure 1 Diagramatic representation of slip cross sections

There was, however, at least one slip that was rather different from most of the slips. This was the large slip in Vale St. which pushed the house below it a considerable distance towards the road. This slip extended over almost the full height of the slope and had the form of what is known as a “block” slide. In this case a large block of the slope moved semi-horizontally towards the front of the section. As with the other slips, it partly disintegrated as it moved, and became softened by any water that was available to it. This form of this slide is shown in Figure 1(b).

Figure 1(c) attempts to illustrate diagrammatically the way in which water induces slips in slopes. The mechanism is not one whereby previously dry sloped become wet. All soils, especially those in Tauranga consisting of fine-grained clayey materials, contain large quantities of water all year round. The influence of periods of intense rainfall is to “pressurise” this water, and consequently to weaken the soil. The longer the time over which the site is subjected to abundant supplies of surface water, the greater will be the increase in pressure and consequent weakening effect.

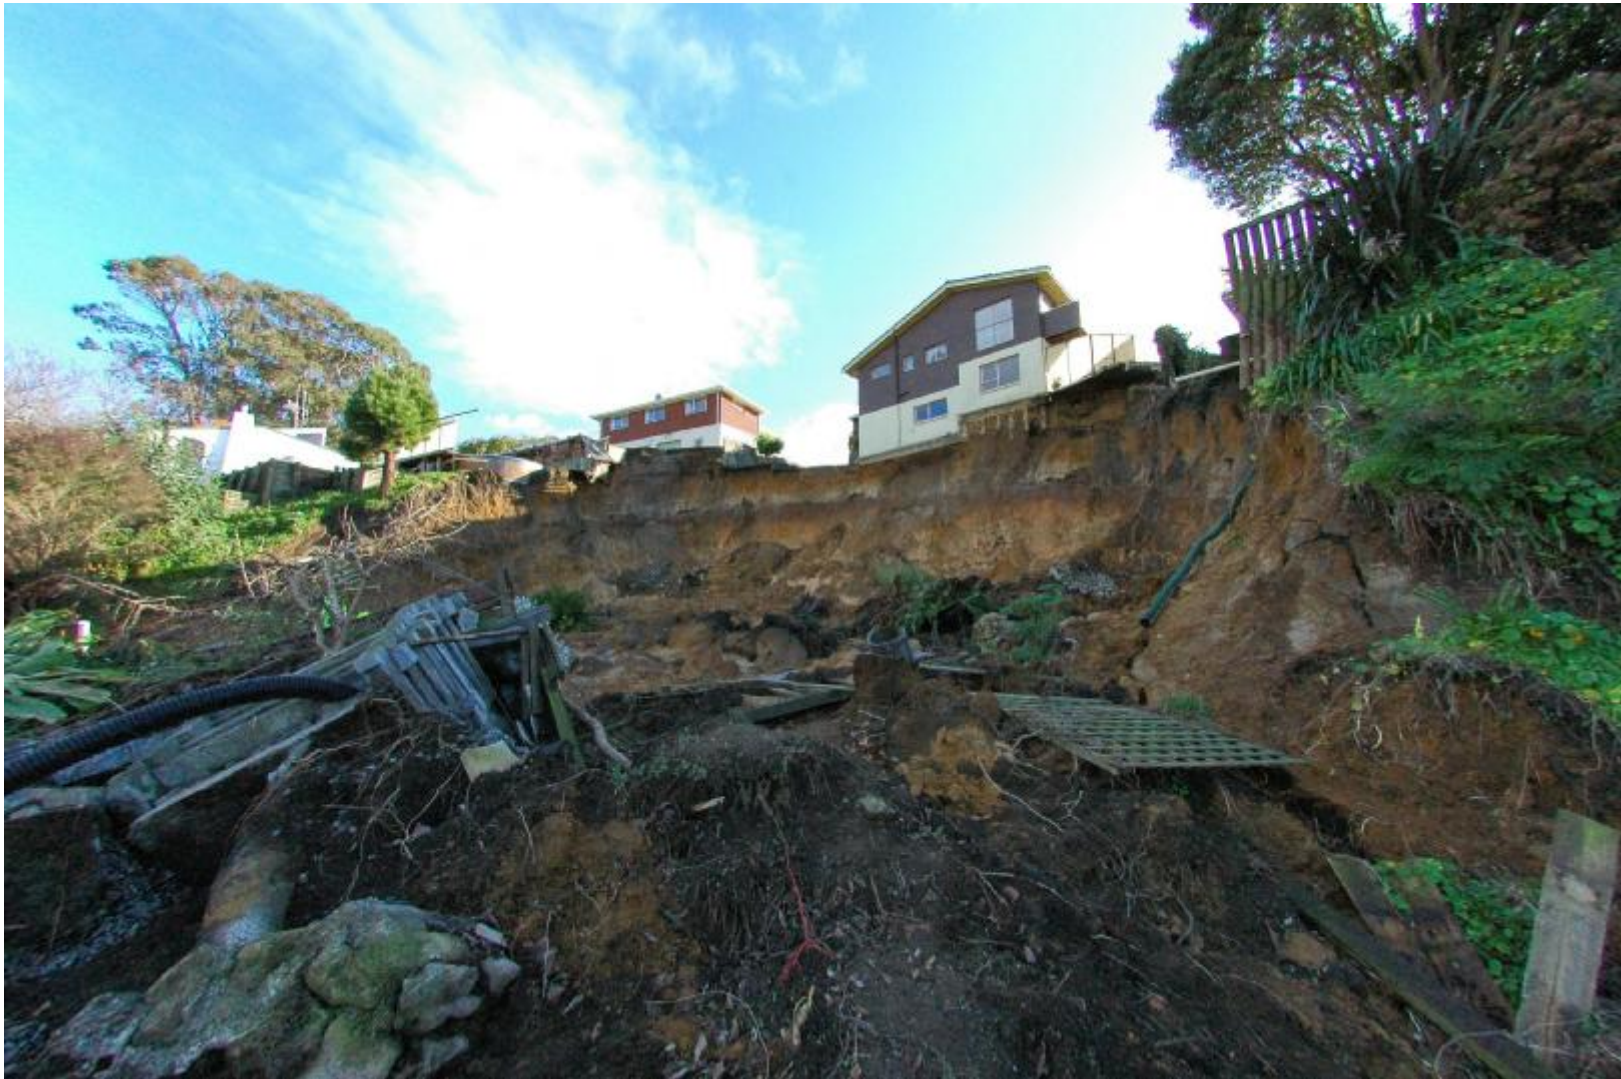
Figure 2: Example of landslide geometry at Vale Street
TAURANGA MAY 2005 LANDSLIDES

- Landslide runout was generally within a 4H:1V line projected from the headscarp. Most of the damage to houses was caused by runout rather than subsidence effects.

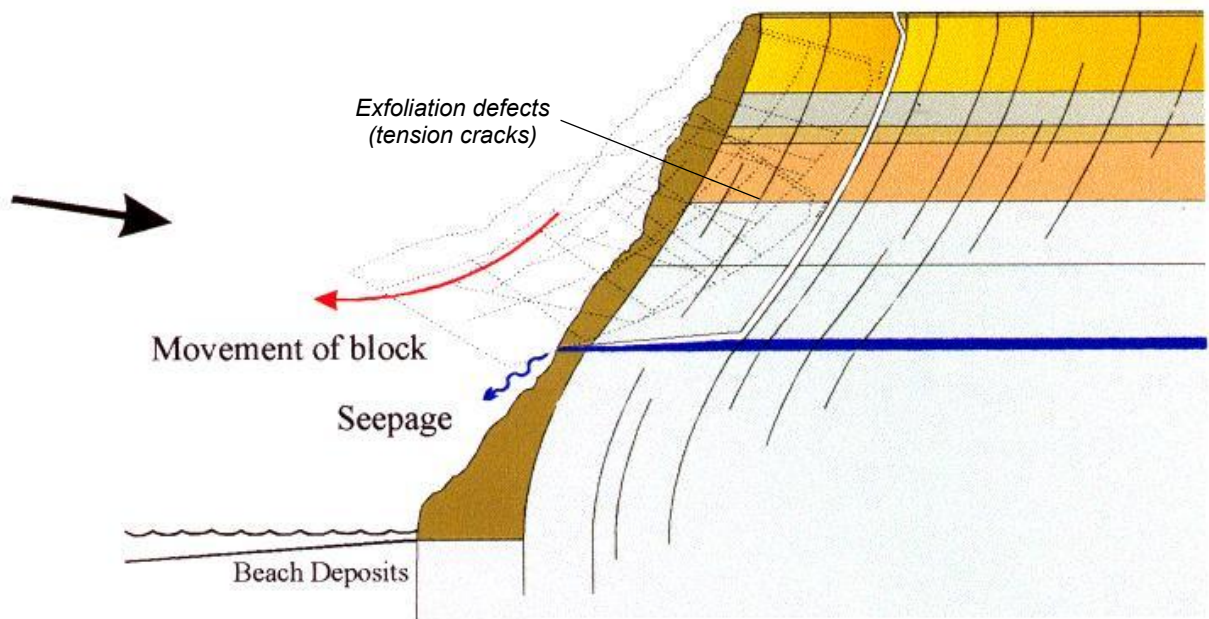
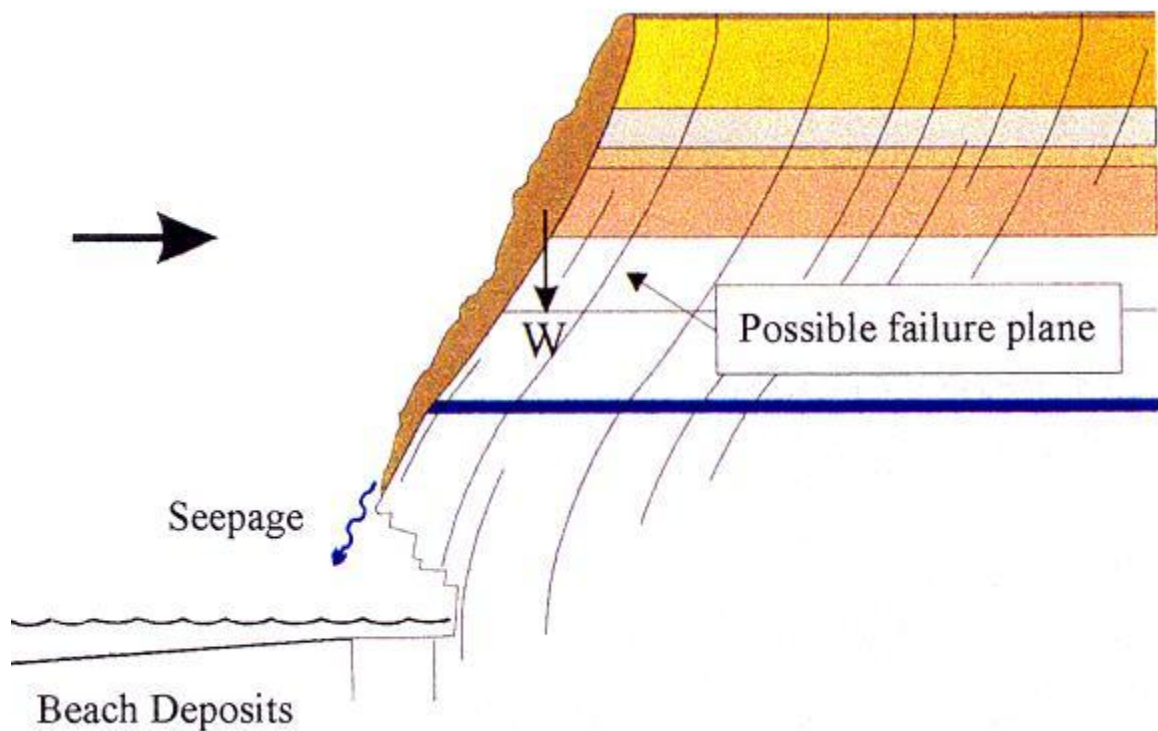
Figure 3: Slide morphology described by Oliver 1997

The presence of tension cracks is critically important to these slides. Such features have previously been identified by Oliver⁵ (*Figure 3*) who referred to these as *exfoliation defects* rather than the more appropriate terminology of *tension crack* or *stress-relief defect*. These features have a significant effect on slope failures since their orientation precludes any significant frictional resistance along the features, and the water pressure in the open joints can exert high horizontal pressures on the slide mass.

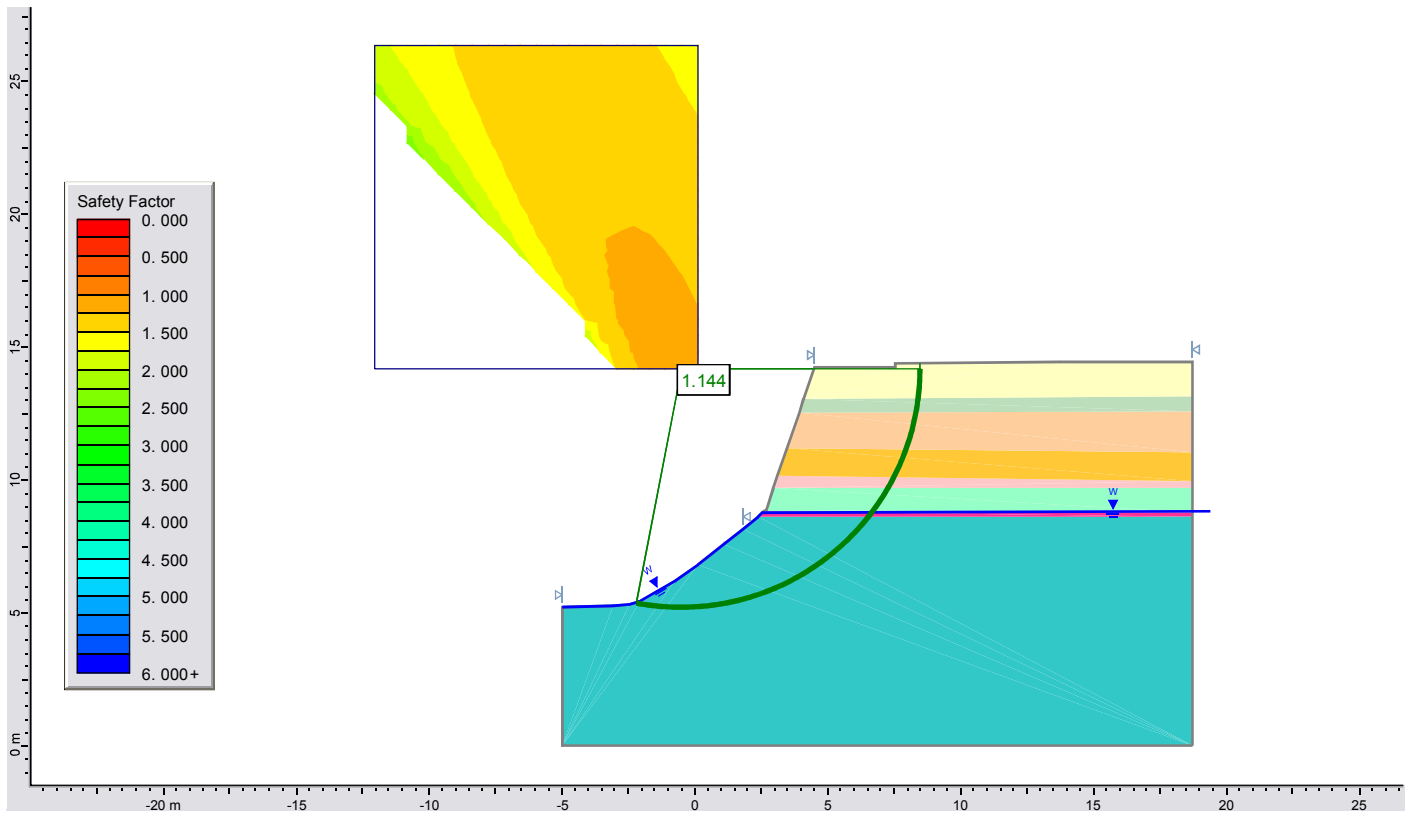
Figure 4: Slide with low groundwater level on ash layer

5. Without tension cracks or other structural controls present, the critical failure mode in these types of materials would be fairly deep-seated circular failures (see *Figures 4* and *5*) regardless of the level of the groundwater table. With water-filled tension cracks (*Figures 6* and *7*), the Factor of Safety (FOS) of the slope is significantly reduced and the critical failure surface moves closer to the slope crest for all groundwater conditions. Note that the above analyses are fairly simplistic since the toe of most failures is generally at the ash horizon.

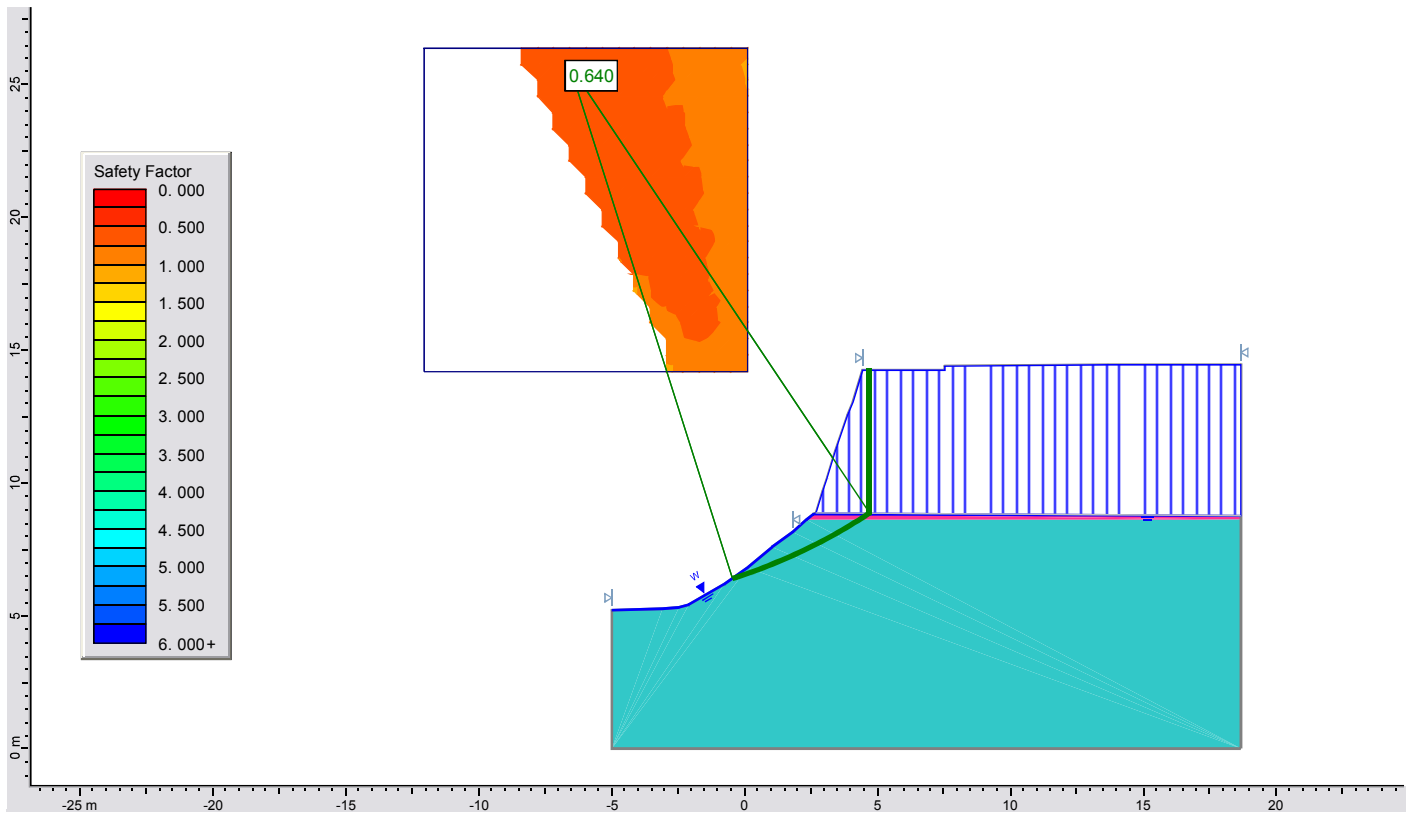
Figure 6: Slide with low groundwater level on ash layer plus tension cracks

- The back faces of the slides are often controlled by near vertical discontinuities or tension cracks
 - High water pressures in these tension cracks have the effect of causing slide "blowouts" which would have initiated regardless of the inherent soil or rock mass strength
