Rock Engineering Consultant

**TAURANGA LANDSLIDES: 18 MAY 2005
SITE VISIT & REVIEW NOTES**

Tauranga District Council
Private Bag 12022
Tauranga

Version: 10005.2.1
Date: 13 July 2005

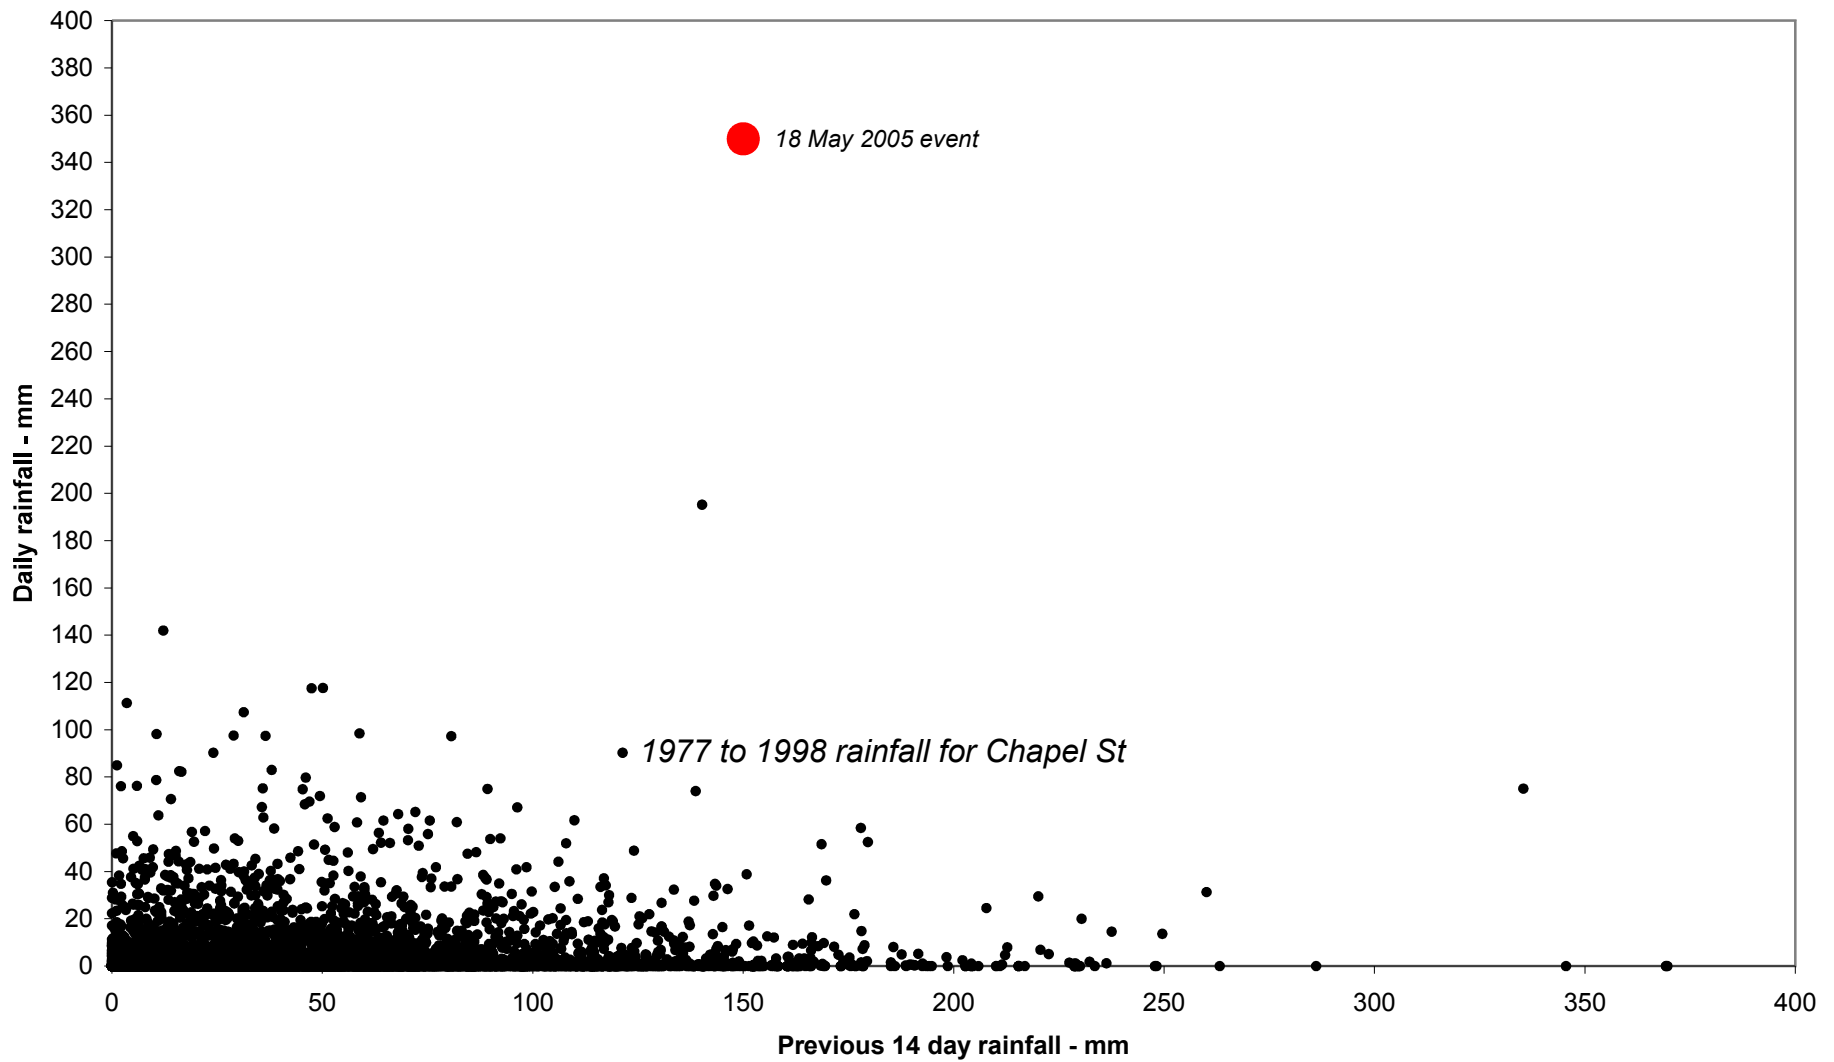
Figure 1: 18 May 2005 rainfall compared with 1977 to 1998 at Chapel St

3. Local residents report considerable variation in rainfall and flooding over the city area during the 18 May event. The rainfall has been assessed as a 1 in 150 year event or greater. The effect of rainfall on the stability of slopes can be quantified by considering the total rainfall on the day of the event together with the cumulative rainfall over a previous number of days³. *Figure 1* shows the 18 May 2005 rainfall in comparison with the rainfall data at Chapel St from 1977 to 1998 (as used for the 1999 Mauao stability assessment⁴). The combination of daily and precedent rainfall exceeds any for the period from 1977 to 1998 and probably for the entire period of record in Tauranga.

8. The 18 May 2005 rainfall event was the highest 24 hour rainfall recorded in Tauranga. Because of the failure of the stormwater drainage system, slope failures would have been significant even if the previous few months had been drier than normal.

15. Rainfall records should be reviewed to assess the severity of the daily and precedent rainfall for the 18 May 2005 event.
16. Geological cross sections should be established for all failure areas to identify failure mechanisms, allow back analyses and determine runout characteristics of the slides. If slide areas are assessed by different individuals, an overview report to bring all data together would be helpful.
17. Representative areas near the ridge crests should be investigated in detail to provide information on the characteristics of tension cracks near slope crest.

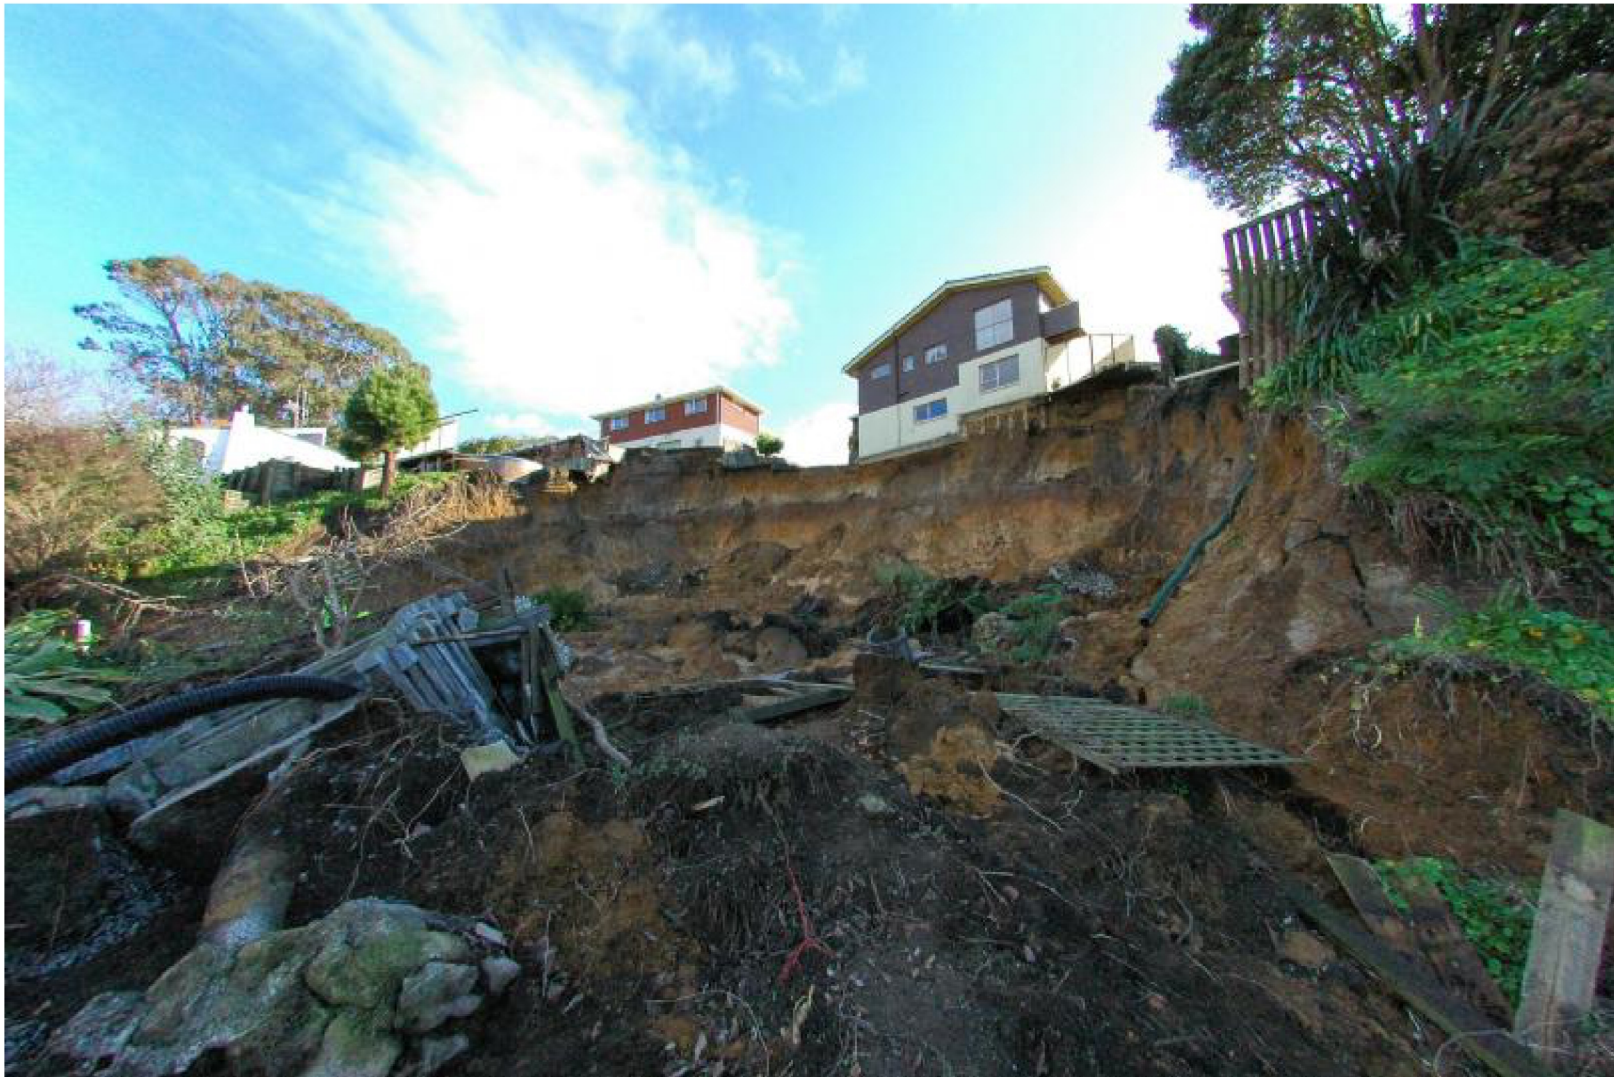
Figure 2: Example of landslide geometry at § 7(2)(a) - Privacy
TAURANGA MAY 2005 LANDSLIDES

4. The slides inspected were notable for a number of features as follows (see *Figure 2*):
 - The heads of the slides are generally close to the slope crest and often controlled by changes in slope cover such as buildings or sealed areas

- The back faces of the slides are often controlled by near vertical discontinuities or tension cracks
 - High water pressures in these tension cracks have the effect of causing slide "blowouts" which would have initiated regardless of the inherent soil or rock mass strength

- The slide bases are controlled by less-permeable, low-strength ash horizons. The orientation of these layers (horizontal or dipping out of the slope) affects the size and geometry of the slide

- Water pressures in the slopes would likely have been high because of the wet autumn but the high joint pressures developed from surface infiltration would have resulted in significant failures even with low groundwater pressures

- Landslide runout was generally within a 4H:1V line projected from the headscarp. Most of the damage to houses was caused by runout rather than subsidence effects.

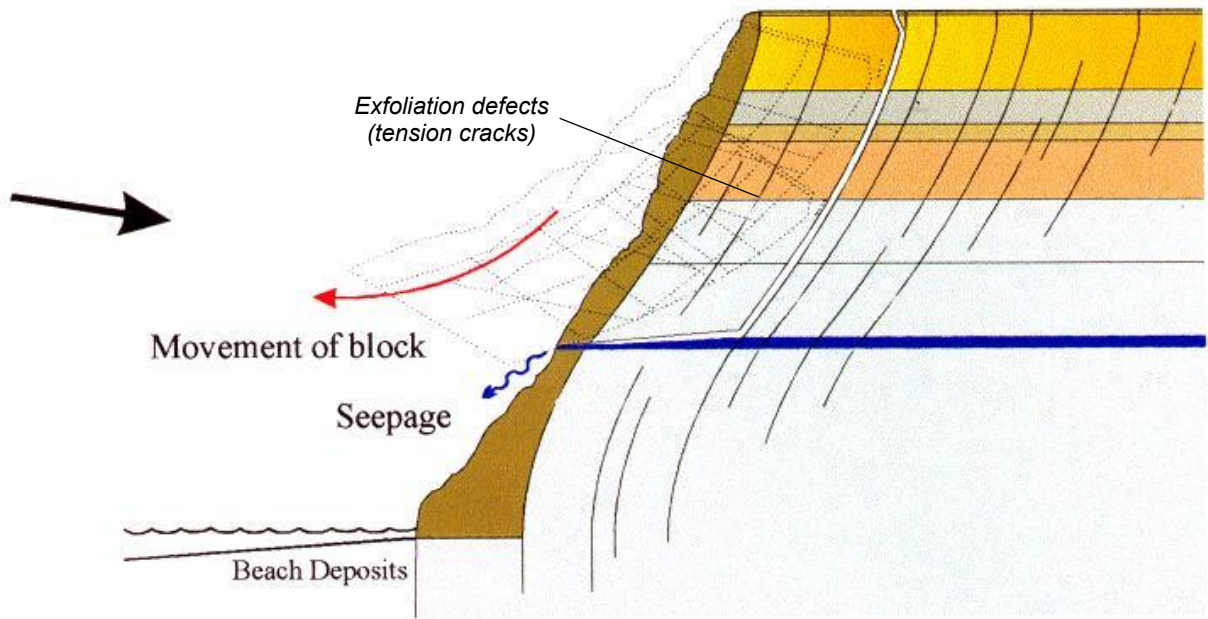
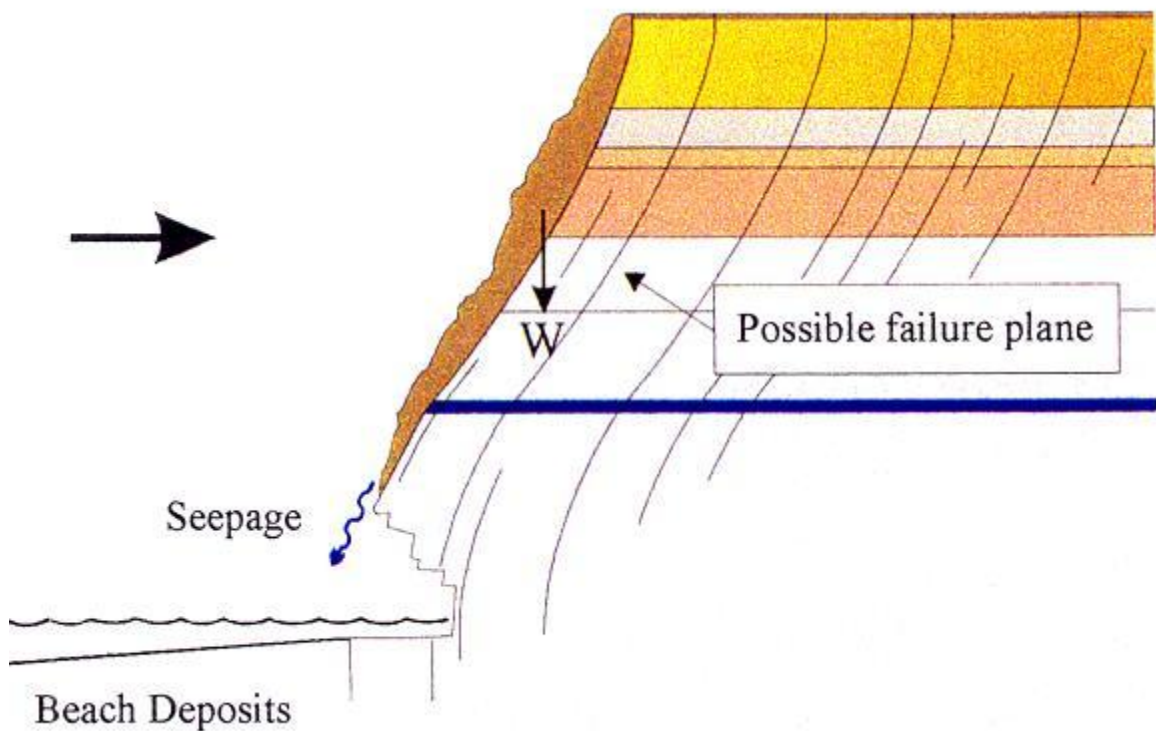
Figure 3: Slide morphology described by Oliver 1997

The presence of tension cracks is critically important to these slides. Such features have previously been identified by Oliver⁵ (*Figure 3*) who referred to these as *exfoliation defects* rather than the more appropriate terminology of *tension crack* or *stress-relief defect*. These features have a significant effect on slope failures since their orientation precludes any significant frictional resistance along the features, and the water pressure in the open joints can exert high horizontal pressures on the slide mass.

(a) Piping triggered block failure

(b) Wave erosion triggered block failure

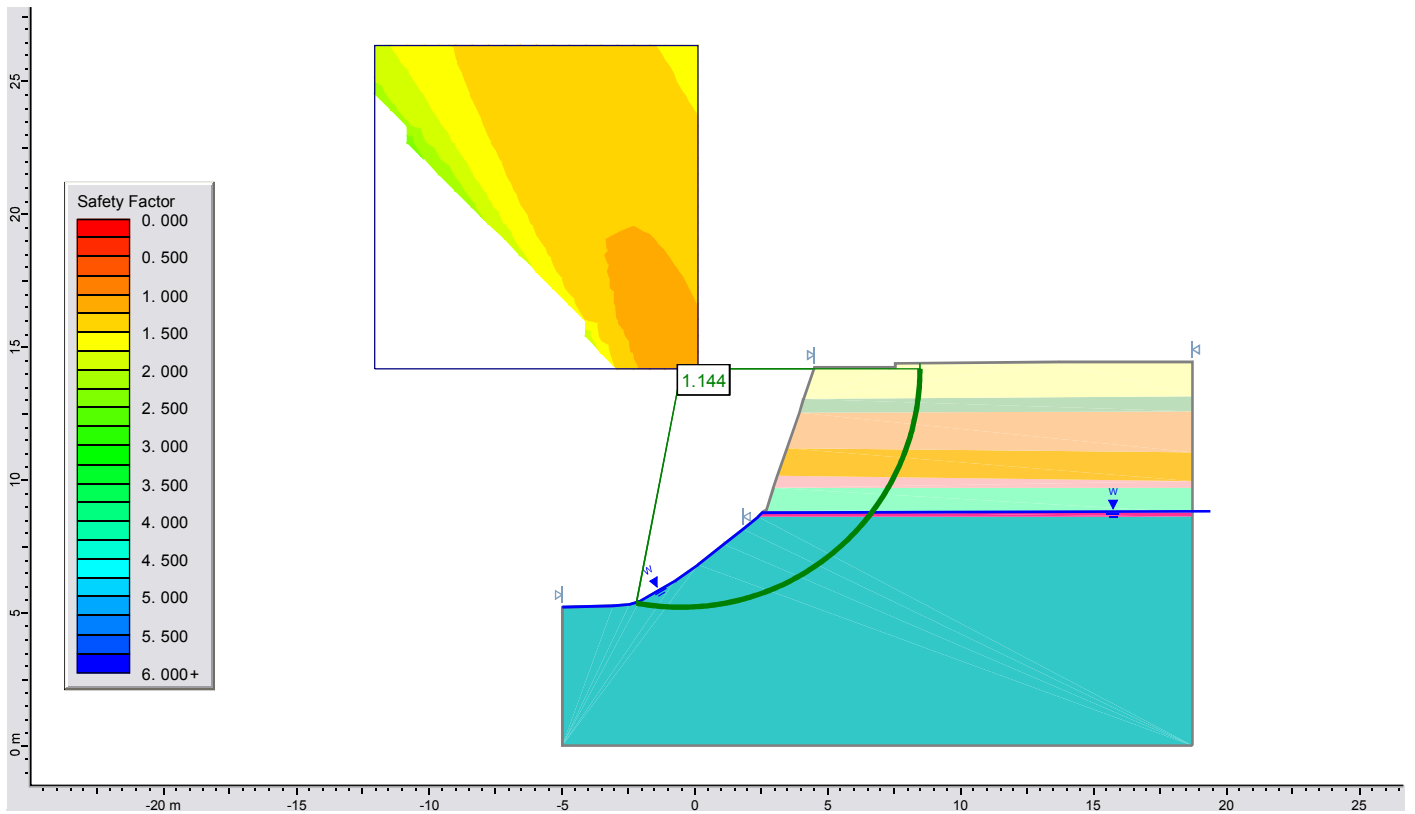
Figure 4: Slide with low groundwater level on ash layer

5. Without tension cracks or other structural controls present, the critical failure mode in these types of materials would be fairly deep-seated circular failures (see *Figures 4* and *5*) regardless of the level of the groundwater table. With water-filled tension cracks (*Figures 6* and *7*), the Factor of Safety (FOS) of the slope is significantly reduced and the critical failure surface moves closer to the slope crest for all groundwater conditions. Note that the above analyses are fairly simplistic since the toe of most failures is generally at the ash horizon.

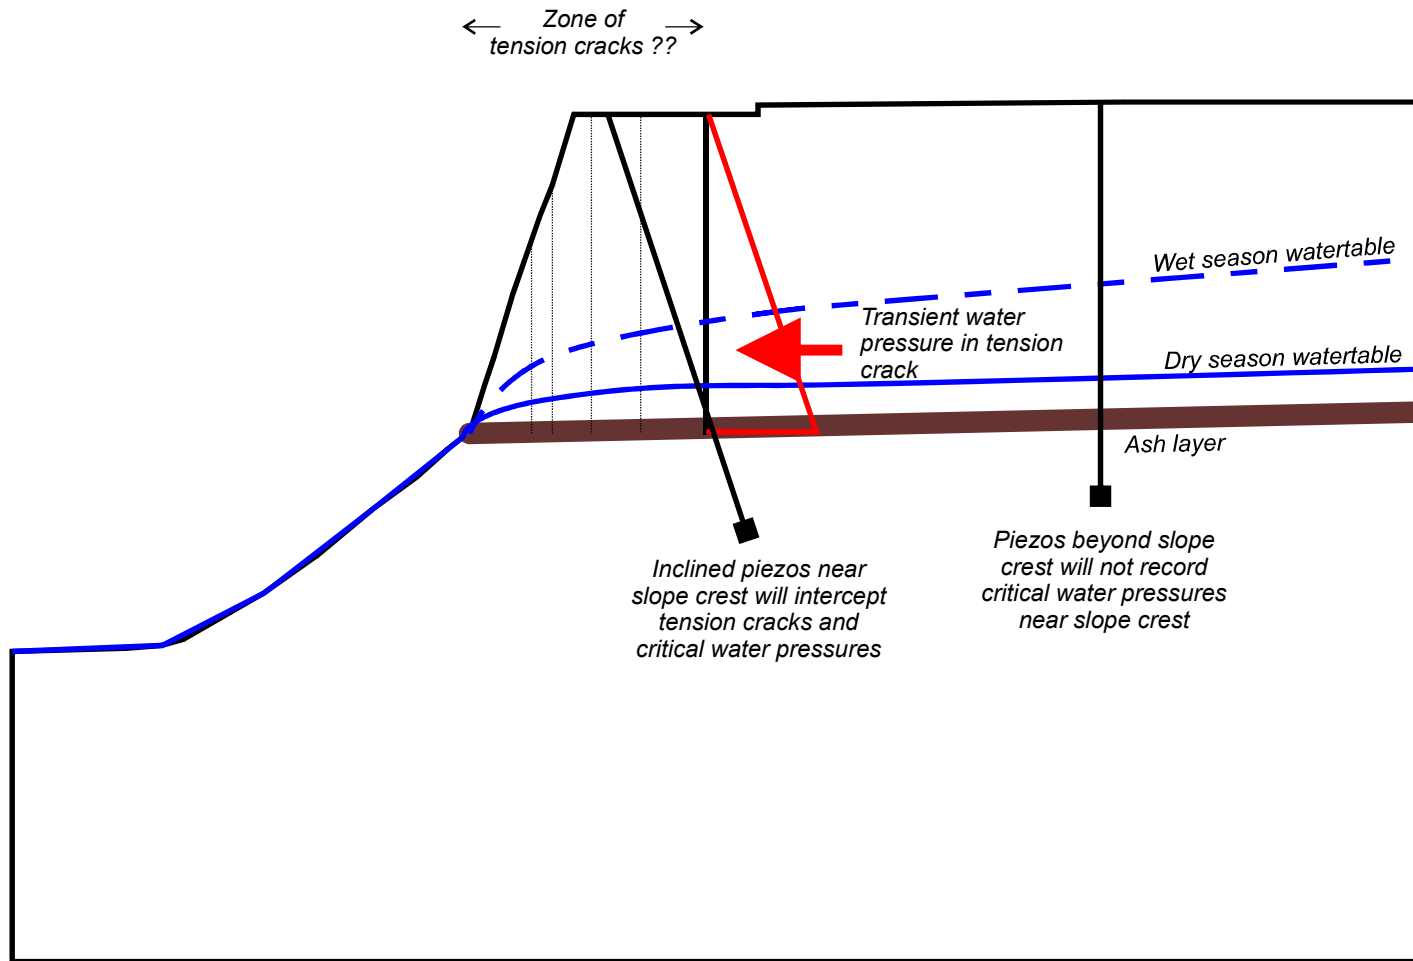
Figure 8: Piezo locations and slope water pressures
TAURANGA MAY 2005 LANDSLIDES

10. Very little is known about the response of these tension cracks to rainfall events (i.e. crack water pressure versus rainfall relationships). These features are most critical nearest the slope crests. Piezometers placed at some distance from the slope crest (measuring pore pressures within the slope) may give little indication of critical water pressures near the crest. Piezometric monitoring needs to take account of the tension cracks – this is likely to result in piezometers being placed in inclined drillholes to ensure interception of the tension cracks (*Figure 8*). Given the aerial variation of rainfall, automatic rainfall gauges should be located close to all automatic piezometer locations.

18. Piezometric monitoring should be established to identify critical water pressures near the slope crests. Automatic rainfall gauges will be required in the general area of the piezometers.
19. Any further proposals for slope monitoring should be reviewed in relation to the slope failure mechanisms and the instrument capabilities.
20. Conclusions arising from the review of these slides should be used to review TDC land development criteria and made available to all those concerned with development in this area.
