Rock Engineering Consultant

Draft: 22 June 2003
Project: 9902

MAUAO SLOPES: ROCKFALL RISK ASSESSMENT**INTRODUCTION**

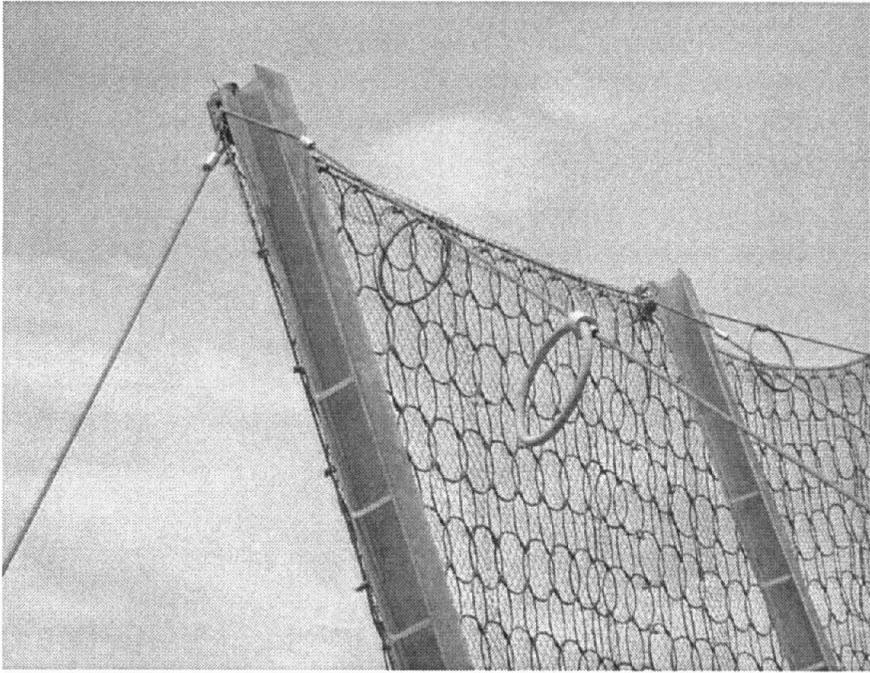
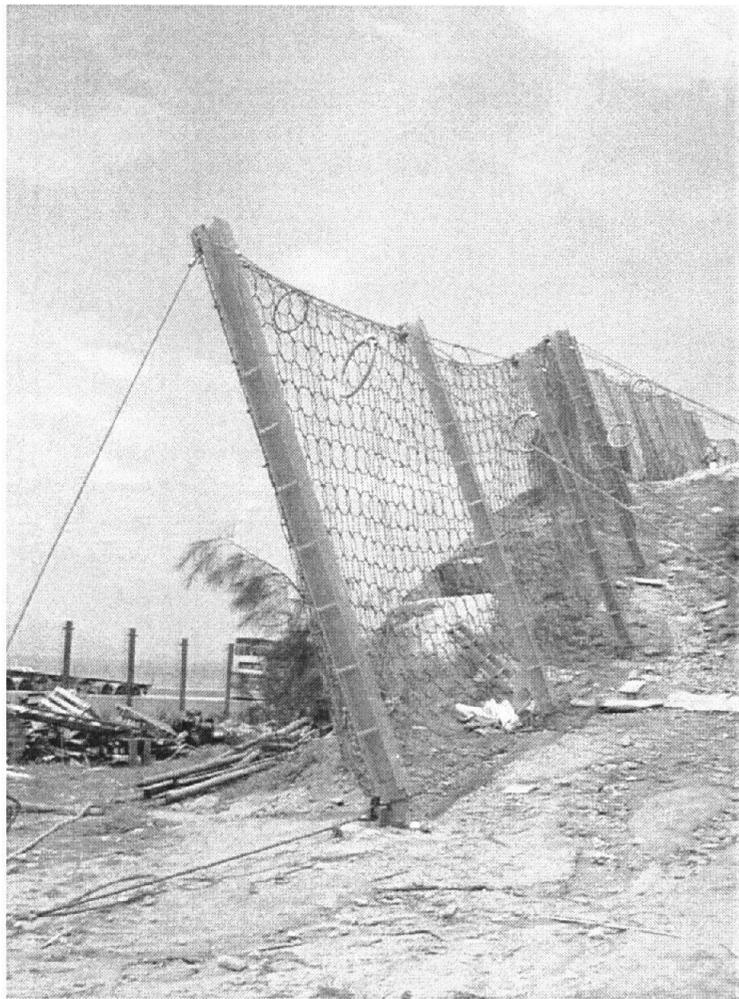
MAUAO RISK ASSESSMENT 2003
Figure 2: High capacity rockfall fence

4. Provision of high capacity rock catch fence at junction between bush and paddock (unlikely to be viable option because high kinetic energy of large blocks will probably exceed practicable fence capacity). See Figure 2 for example of high capacity rockfall fence

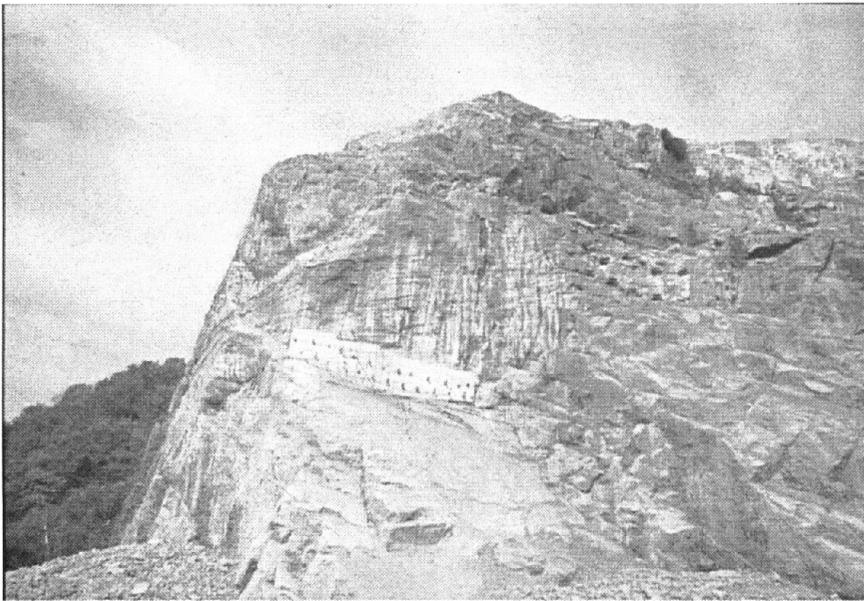
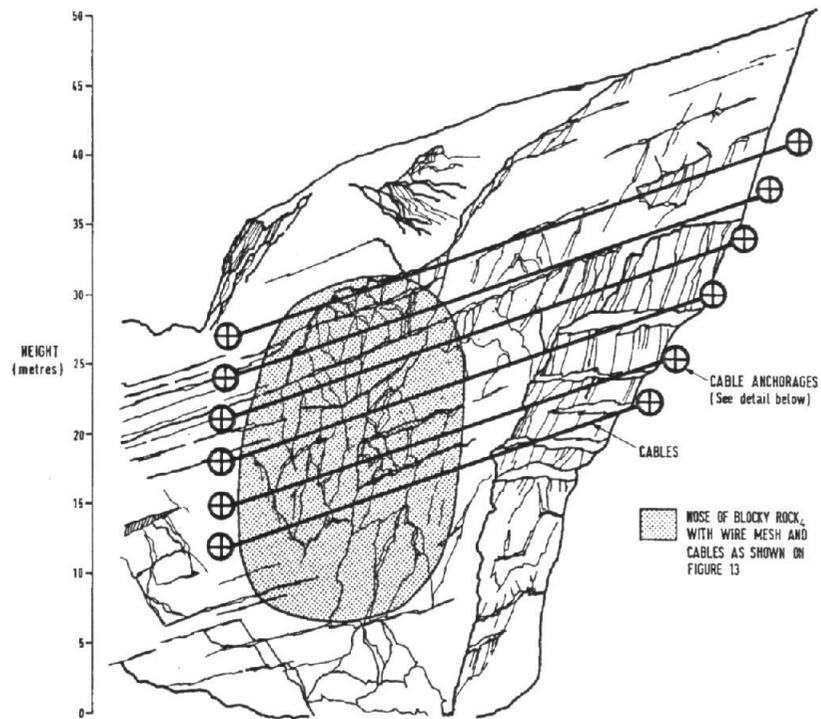
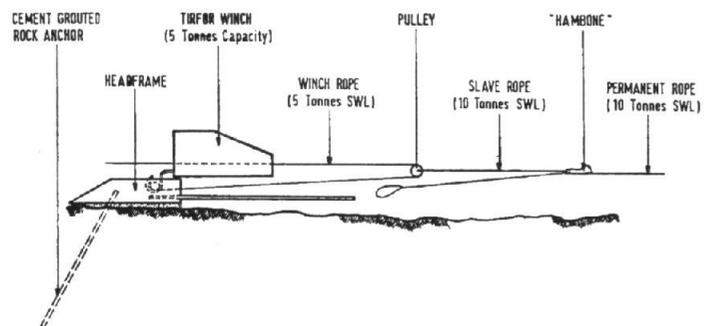
MAUAO RISK ASSESSMENT 2003
Figure 1: Example of cable lashing of 30,000T block

1. Do nothing – but continue to inspect and monitor for potential distress or accelerating movements
 2. Provide restraint with cable lashing (tensioned cables stretched around blocks and tied back to rockbolts). See example on Figure 1

6. LR/Avalon will produce an options report outlining the possible remedial measures. Avalon will provide an estimate of the cost of each option. Cable lashing may provide a reasonably priced and unobtrusive

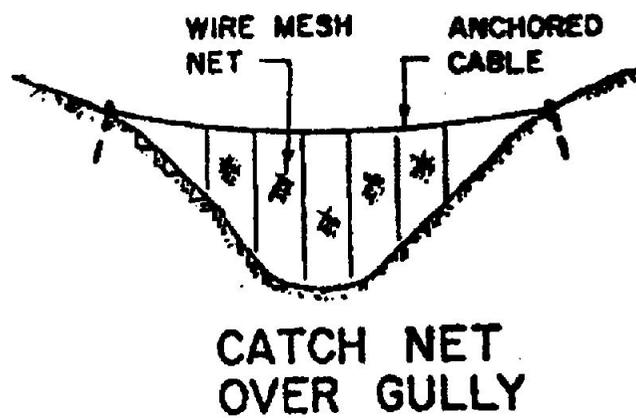
7. Avalon's report indicates that walkers on the Oruahine Path are at risk from small stones dislodged by rock climbers on the steep faces and gullies above the track. These rock fragments are generally small but with high velocity. Apart from signage and education as noted in the Avalon report, protection of the track could be effected at reasonable cost by providing catch nets in the gullies subject to this problem (see Figure 3). An outline design and costing will be produced for TDC's consideration.

*Wire mesh net = doubled layer of Maccaferri gabion mesh
Net hung from anchored cable and allowed to drape freely on to slope
Net requires periodic clearing away of trapped debris*
