136750 Redacted
Tree Asset Owner Approval – Application Form

A summary to date, including findings and recommendations as follows. You are welcome to discuss these within your wider team and let us know if there are any questions or thoughts before we finalise our report.

Tree Protection Plan
Excavation at Beachside Holiday Park,
Mount Maunganui, Tauranga
31st October 2023

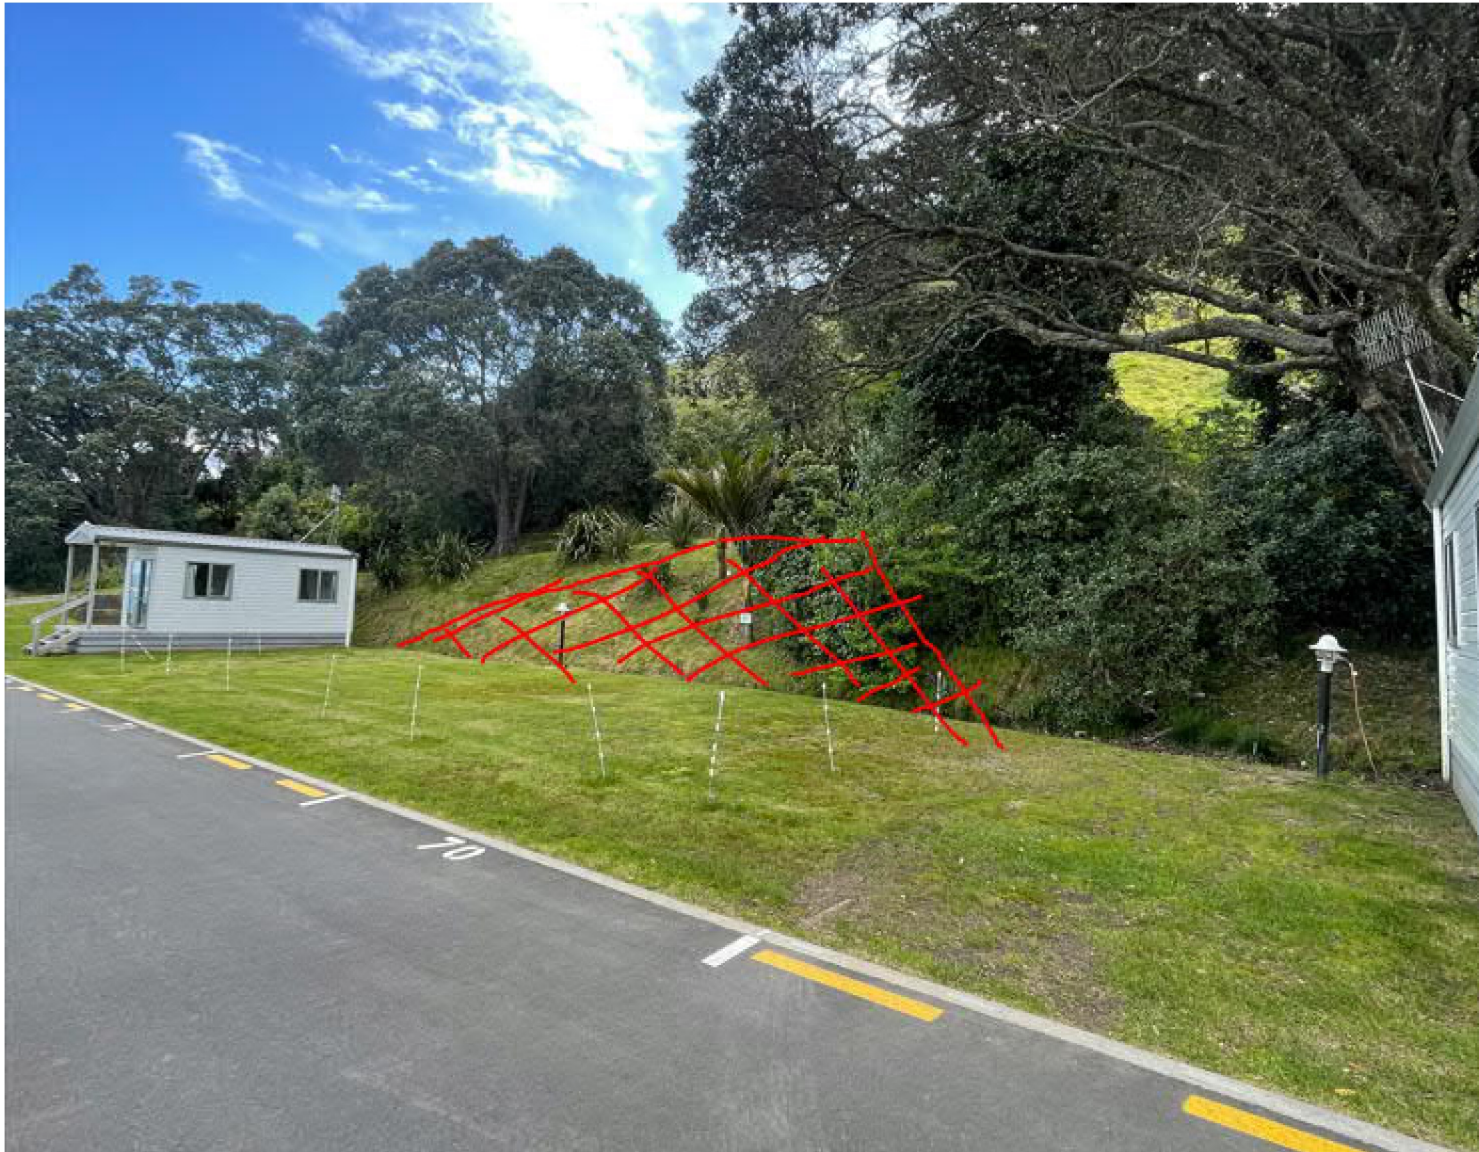
popped up there yesterday to review rough extend of the works. The slip does encompass the two nikau, so they would be affected if the slope was to be regraded. The extent of excavation also goes under the dripline of the large pohutukawa.

Can these works take place in the proximity of the large pohutukawa as shown below. Would an arborist stand over suffice?

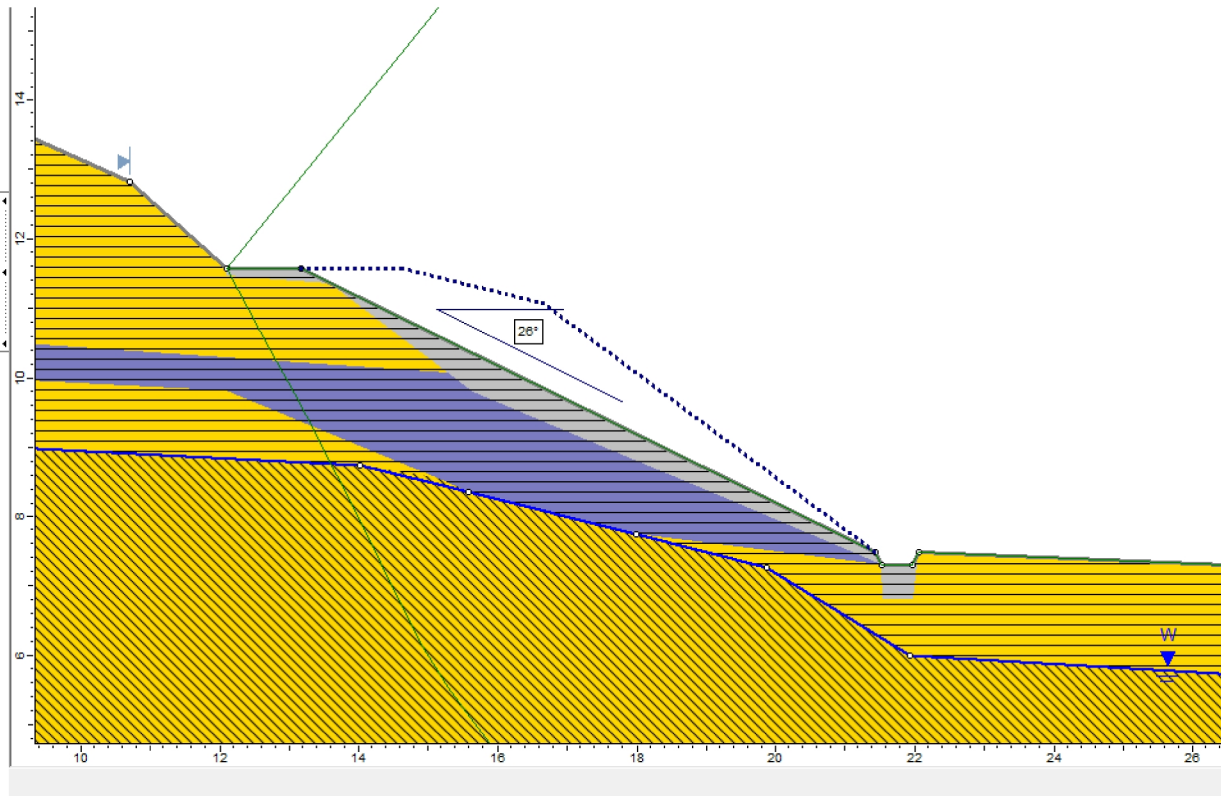
- Long-term, to allow a habitable structure below the slope, the fill should be regraded to not be steeper than 1:2 (vertical to horizontal) or 26 degrees. See screenshot below, cutting from the dotted profile to the profile shown. By achieving this new profile, the requisite factors for prevailing, elevated groundwater and seismic scenarios are achieved.

- The newly formed cut would need to be topsoiled and/or hydroseeded, and a cutoff drain installed above to help shed water away from the slope.
- This would mean decommissioning of the track, though it would appear the track is only used for access to the skip anyway.

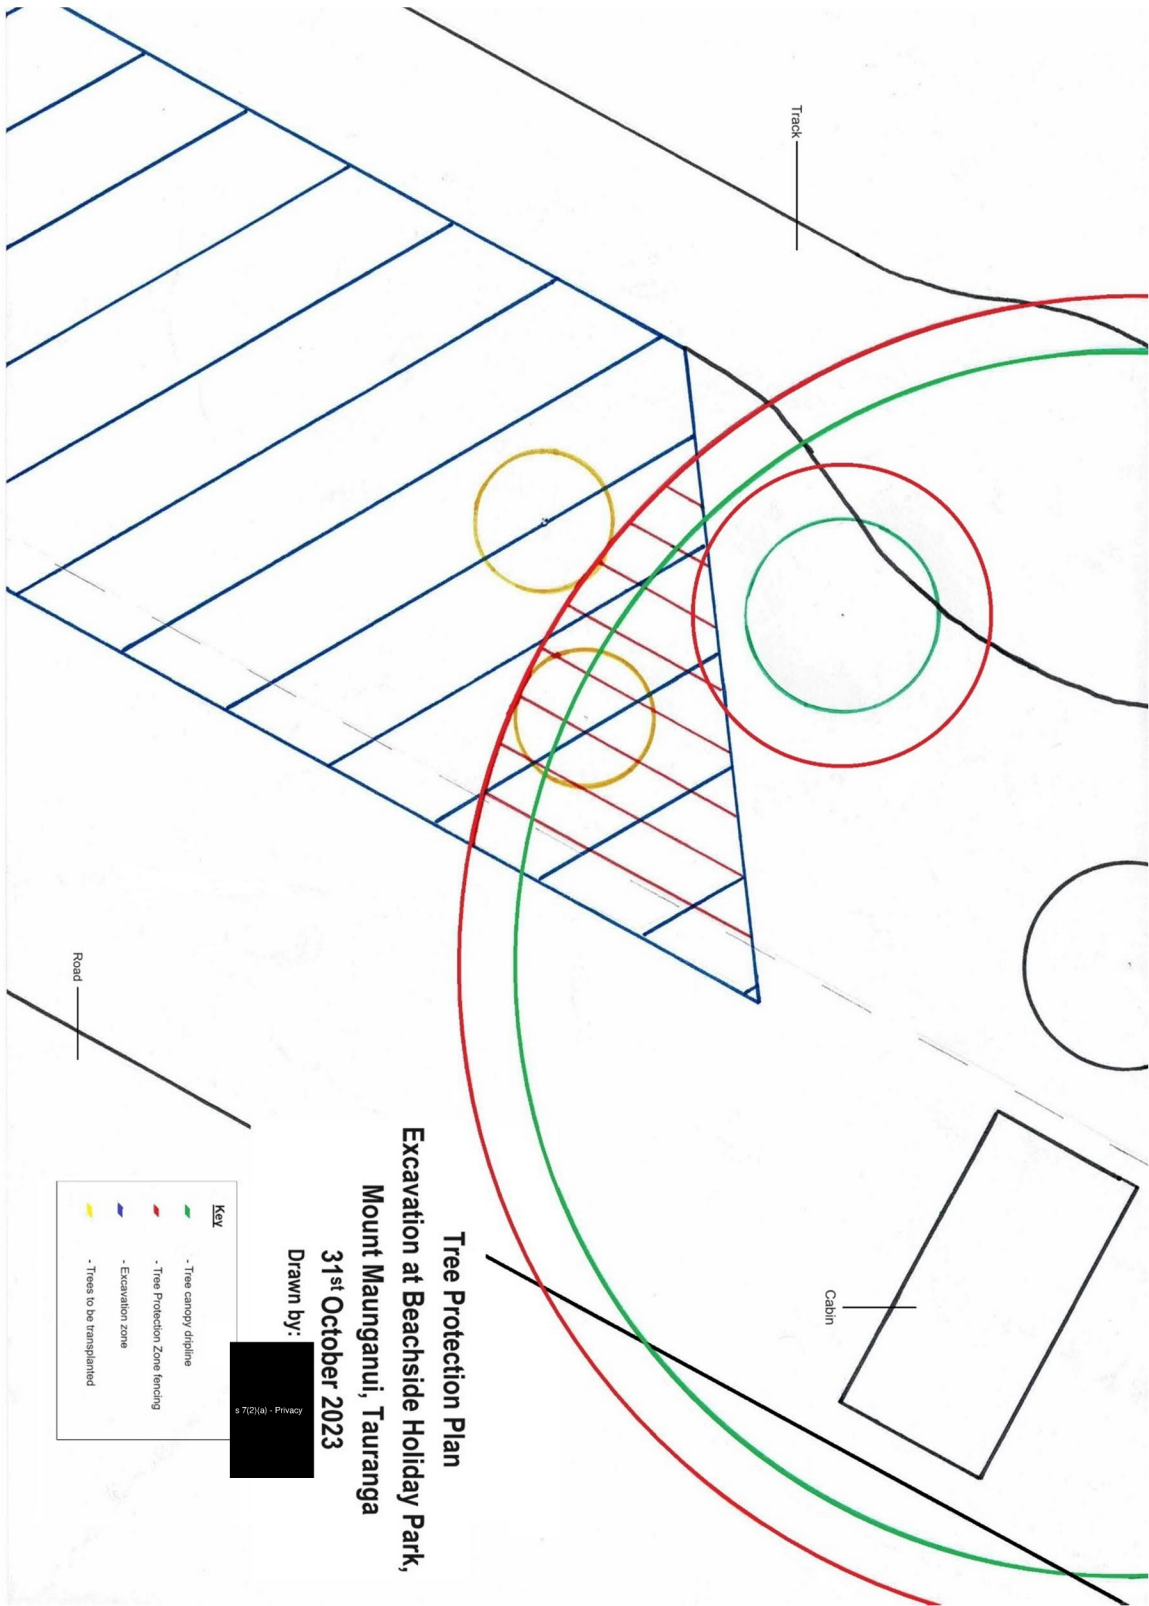
6.2 Tree Protection Plan - Map

The proposed excavation is approximately 7.2m South from the closet stem of the Pohutukawa, which is approximately 6m within the tree dripline. The excavation is also approximately 1m from a medium sized Karaka which sits beneath the Pohutukawa canopy. This Karaka is likely to be affected by the excavation. I anticipate the excavation encroaching on 10-15% of the Pohutukawa TPZ.

Tree protection fencing shall be put in place marking the TPZ prior to commencement. The TPZ shall be 1m outside the extremities of the tree's drip-line¹ unless otherwise approved by the monitoring arborist. Please see the Tree Protection Plan Map found in Appendix 6.2 of this report for clarification.
