Heritage Management Specifications for Mauao Historic Reserve, Tauranga

20 May 2016

Prepared for: Tauranga City Council
P O Box
TAURANGA

Prepared by: InSitu Heritage Ltd.
P O Box 710
WHAKATANE 3158

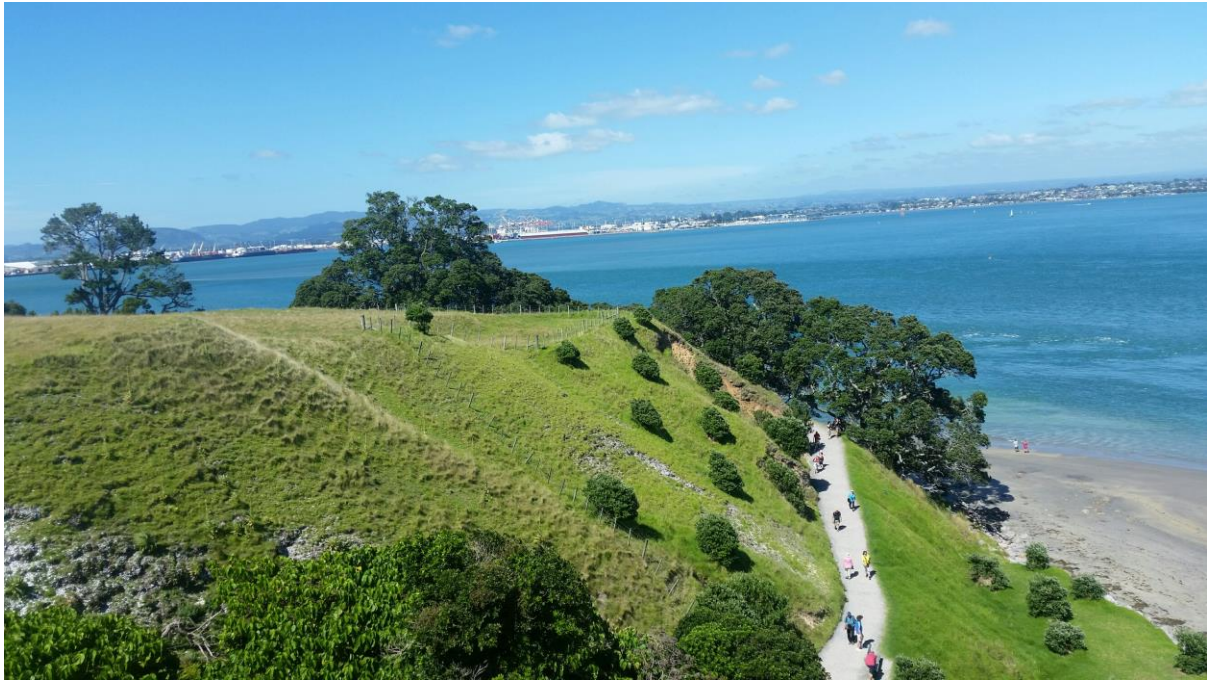
In addition the base track cut, coupled with over-grazing, resulted in the destabilisation of middens on the lower slopes, and these have been subject to on-going loss through erosion. This was partially addressed by retiring the areas from grazing in 2005, however the high rabbit numbers in the Reserve since that time means that vegetation growth on the slopes is not as dense as would be expected after ten years of no grazing. As a result midden continues to erode out onto the base track in several areas (Figure 3).

Figure 3: Eroding slopes with exposed midden.

- Large tree removal (Specification in Section 4.1)
- Remove smaller trees by felling at ground level, followed by herbicide application to stumps if necessary.
- Land-slip assessment and response (Section 4.2).

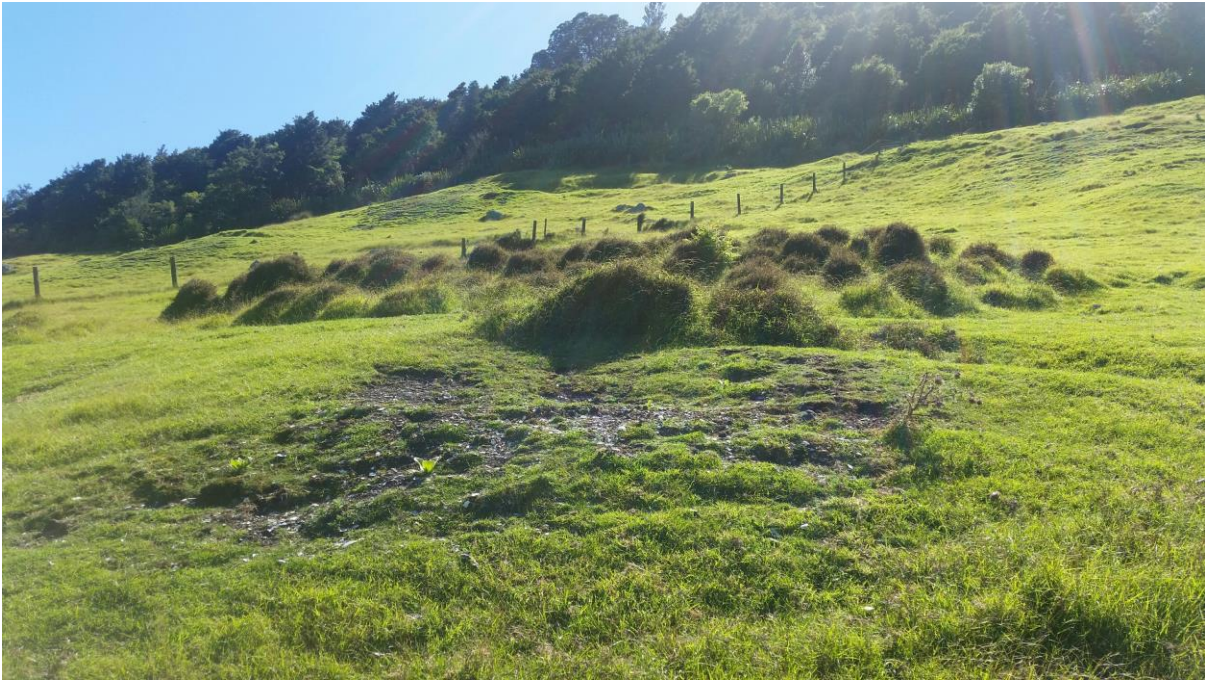
Figure 4: Vegetation established on midden above eroding mound.

- Establishment of pohuehue on shell mounds, this may involve excluding livestock by temporary fencing or protective netting, if required.

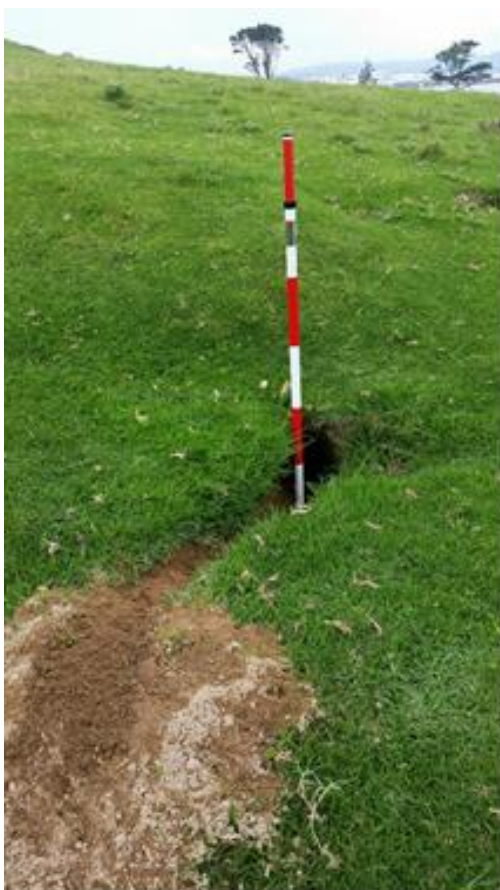
Feral rabbits are currently present in the Reserve in very high numbers. The rabbits are having significant detrimental impact on archaeological features both due to their burrowing activity (Figure 5), and browsing of vegetation which is exposing the ground surface and exacerbating erosion issues. This limits the opportunity to use vegetation as a method to protect and conserve archaeological features. Rabbits need to be reduced to either very low numbers, and maintained at those levels, or eradicated from the Reserve entirely.

Figure 5: Example of damage caused by rabbit burrowing.

- Implement rabbit control programme, with archaeological input to ensure no adverse effects on archaeological features.

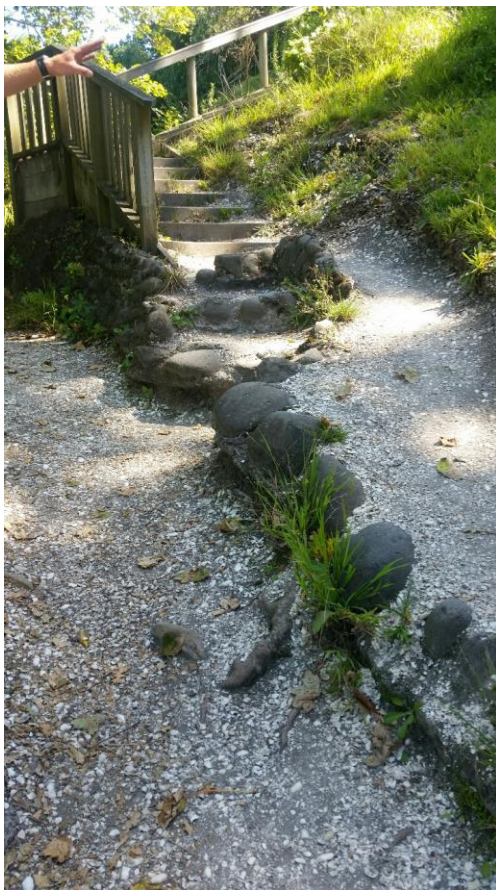
There are stone retaining walls and steps in the vicinity of the wharf but it is unclear whether they were constructed at the same time as the wharf or are later additions. Repairs are needed due to erosion and loss of stone work in these adjacent areas (Figure 6).

Figure 6: Eroding stone work in the vicinity of the stone jetty, note underlying midden deposit.

- A formal assessment by a suitably qualified conservator should be completed to determine what elements relate to the construction and use of the jetty up to the 1930s.
- A repair programme for the area of stone walls adjacent to the stone jetty needs to be separately developed, taking into account the underlying archaeological features as well.

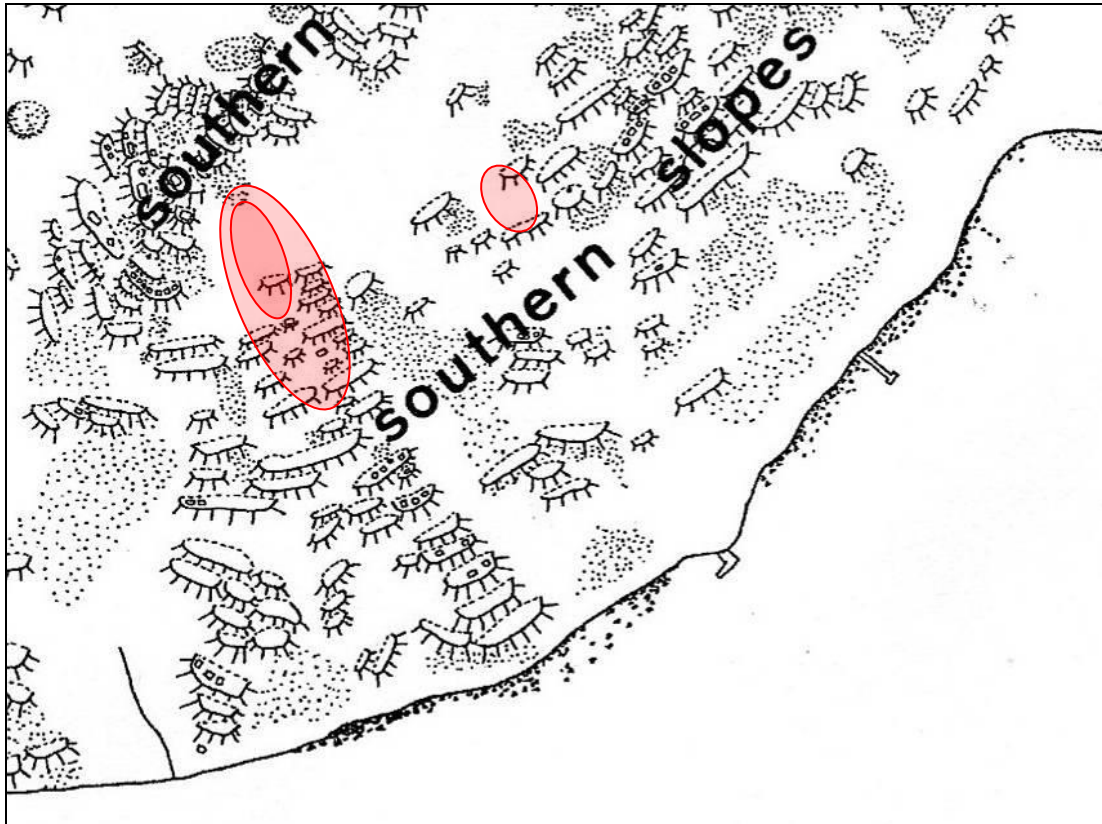
Loss or damage to archaeological features caused by land slips is a significant threat at Mauao. Since 2004 there have been three slips that have resulted in loss of features that were recorded in 2003 (figure 5). These areas are currently awaiting management action to stabilise the erosion faces and minimise the possibility of further loss of heritage fabric.

Figure 5: Recorded archaeological features on the southern slopes of Mauao, areas damaged by significant erosion scars indicated in red (from Phillips 2014, Figure 3).

- Immediately following land slip events check the archaeological features map (Figure 2) to determine if visible features are present in the affected areas and complete a field visit to confirm.
- Advise Heritage New Zealand and the Mauao Trust of the event; and as soon as practical arrange an archaeological inspection by a qualified, appropriately experienced archaeologist. Additional specialist advice on slope stability may also be required.
- In consultation with Heritage New Zealand, the Mauao Trust and the archaeologist develop a remediation plan for the slip area. This may involve fencing and planting of the affected area.
