13 April 2023

BC330131 Request for Further Information #3 - Category 1 Geo-Professional Review

30 September 2022

Awaiti Project Geotechnical Investigation and Desktop Summary Report

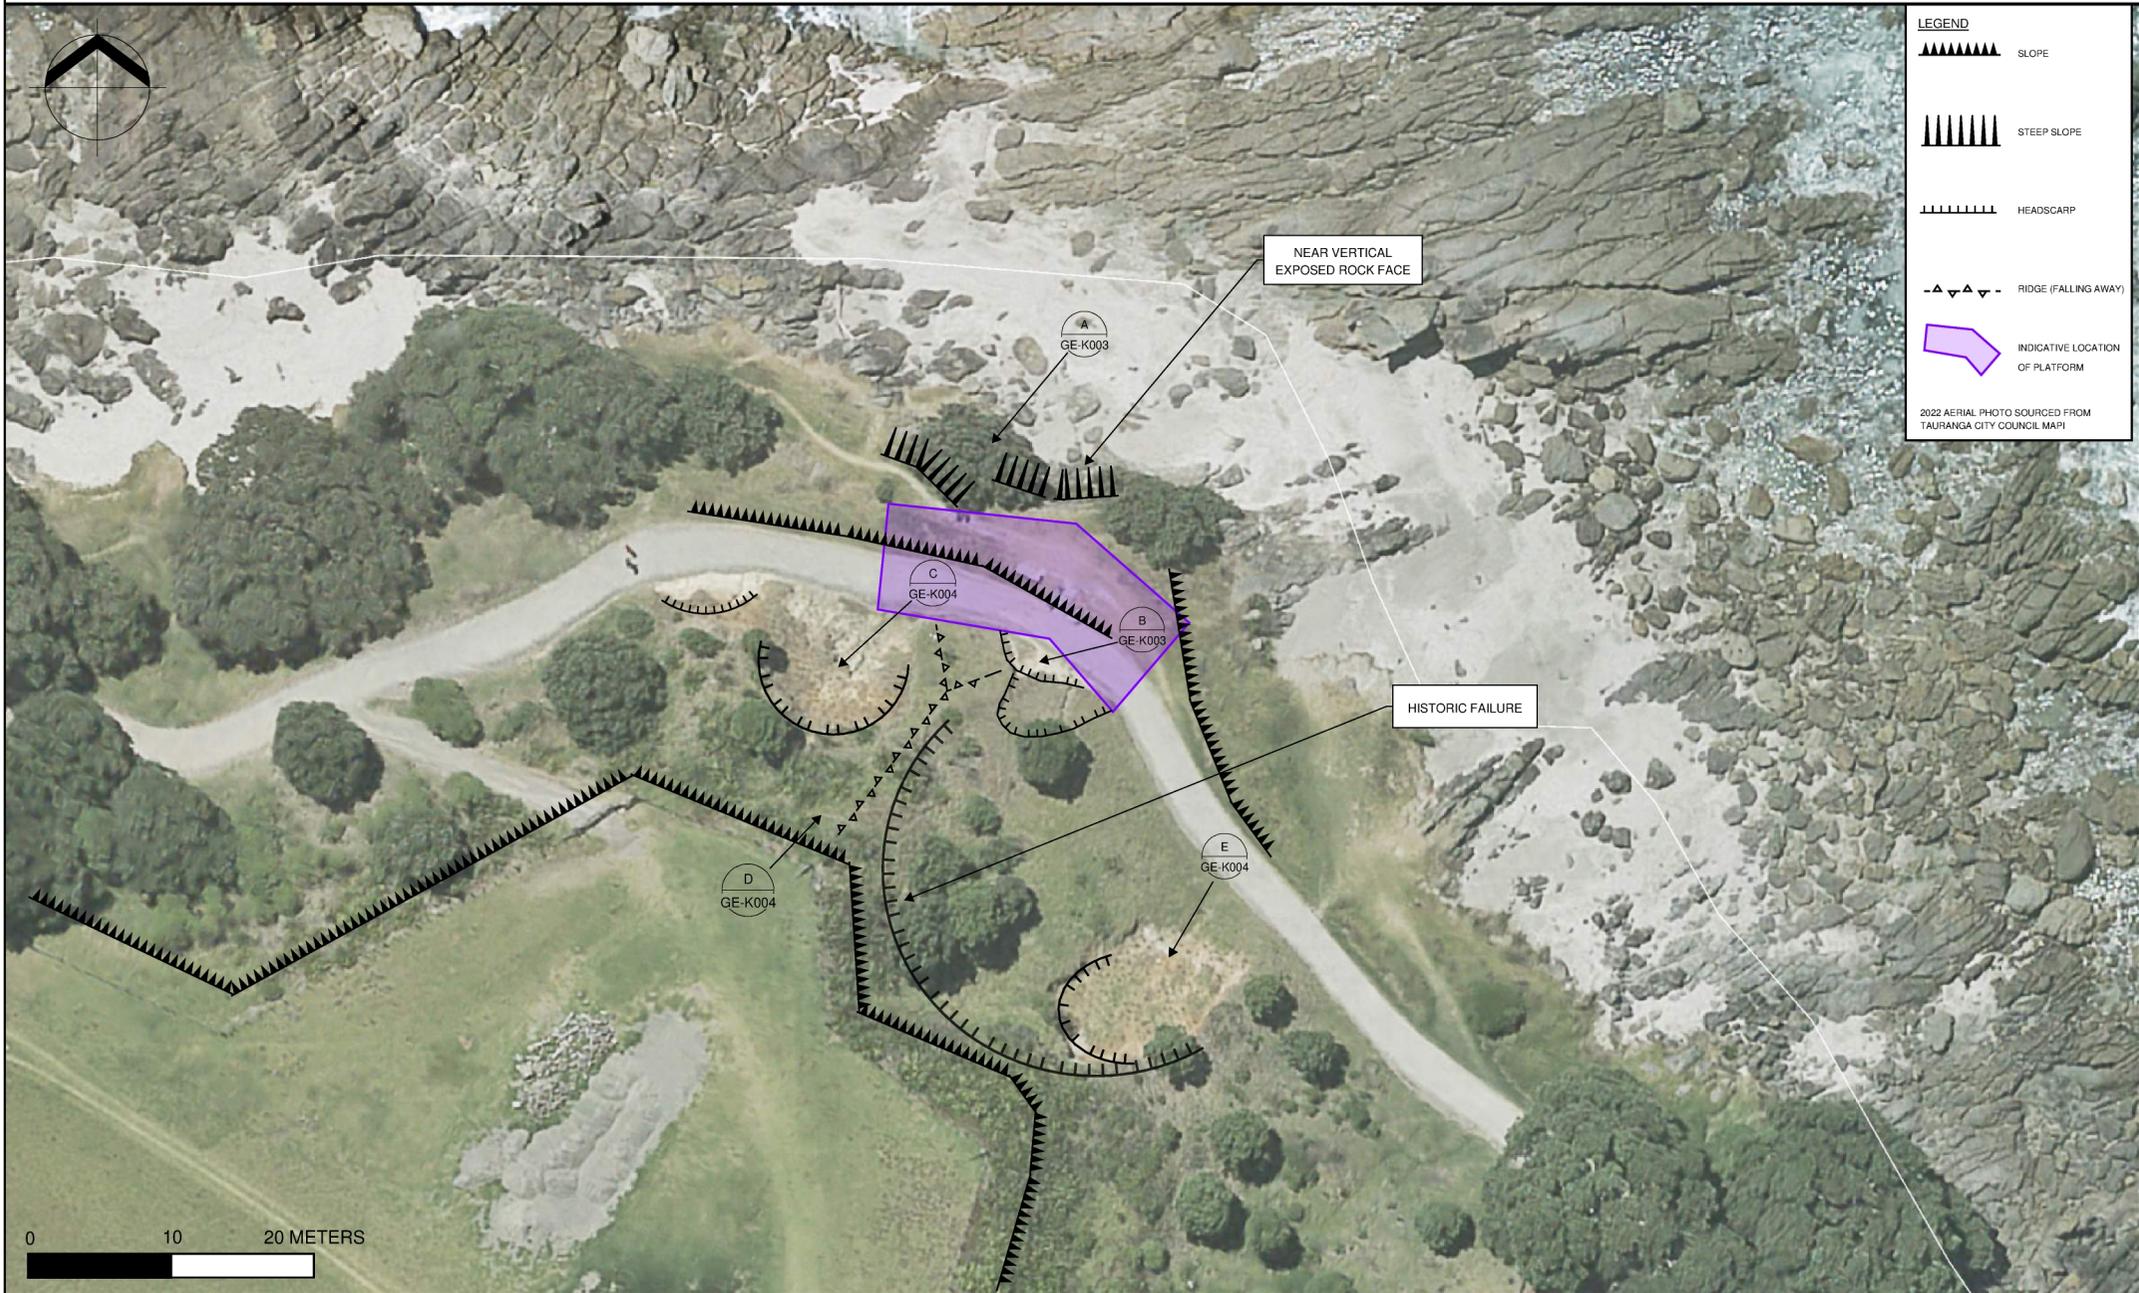
Discipline: GEOTECHNICAL
Drawing No: 4280807-GE-K002
Rev: A

Our aerial photo review identified that two shallow landslides started to develop from 2007. Our subsequent site inspection confirmed that two failures have occurred upslope of the proposed Awaiti location, to the west and east. The location and details of these failures are illustrated in sketches 4280807-GE-K002 to GE-K004 Rev A, included in Appendix A

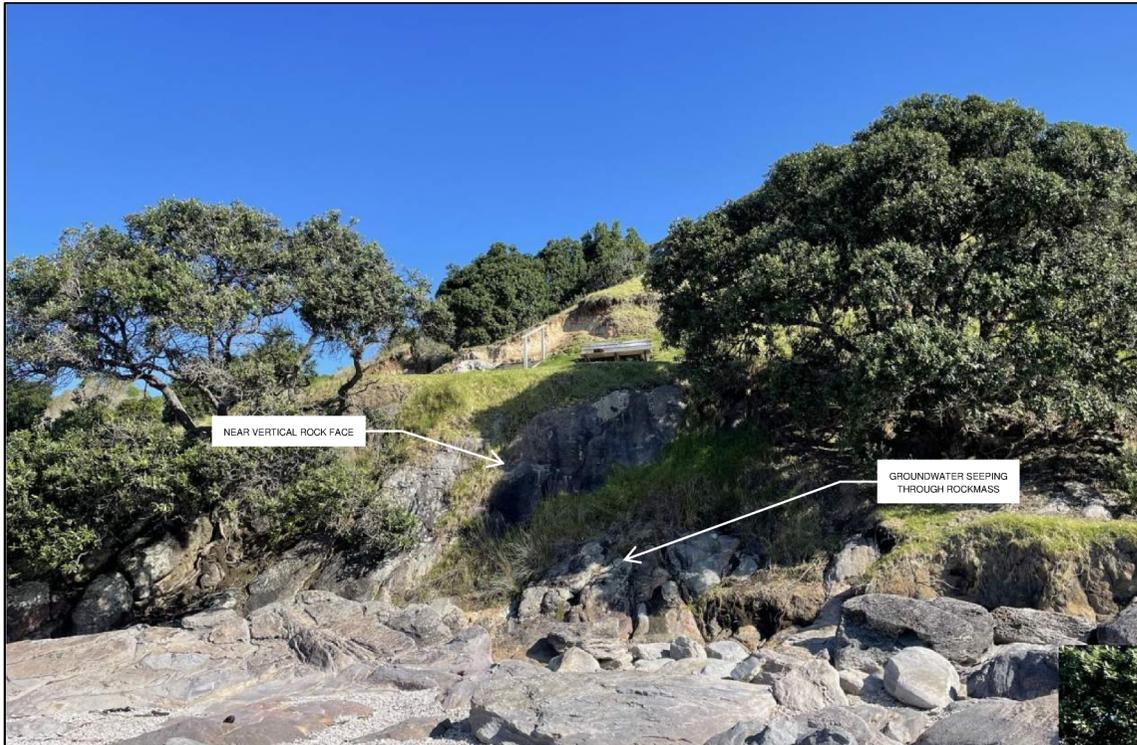
B DETAIL
GE-K002 N.T.S

NEAR VERTICAL ROCK FACE

GROUNDWATER SEEPING THROUGH ROCKMASS

1. IMAGE A: VIEW FROM BEACH TOWARDS PROPOSED VIEWING PLATFORM. ROCK FACE IS APPROXIMATELY 5m HIGH. ROCK OUTCROP IS VERY STEEPLY INCLINED. VERTICAL. ROCK APPEARS TO BE IN-SITU. NO SIGNS OF INSTABILITY OF THE ROCK FACE. GROUNDWATER SEEPING THROUGH THE BOTTOM OF THE SLOPE.
2. IMAGE B: VIEW TOWARDS SLOPE FROM PATH. ABOVE PROPOSED VIEWING PLATFORM. EXPOSED CUT APPROXIMATELY 3m HIGH. SOILS APPEAR TO BE COLLUVIUM AND ASHES OVERLYING RESIDUAL ROCK MASS. HEAD SCARP WITH MINOR DOWNTHROWN FEATURES TRACK SOUTH TOWARDS TREE. WATER SEEPING THROUGH RESIDUAL ROCK. NO IMMEDIATE RISK OF SLOPE FAILURE AFFECTING VIEWING PLATFORM.

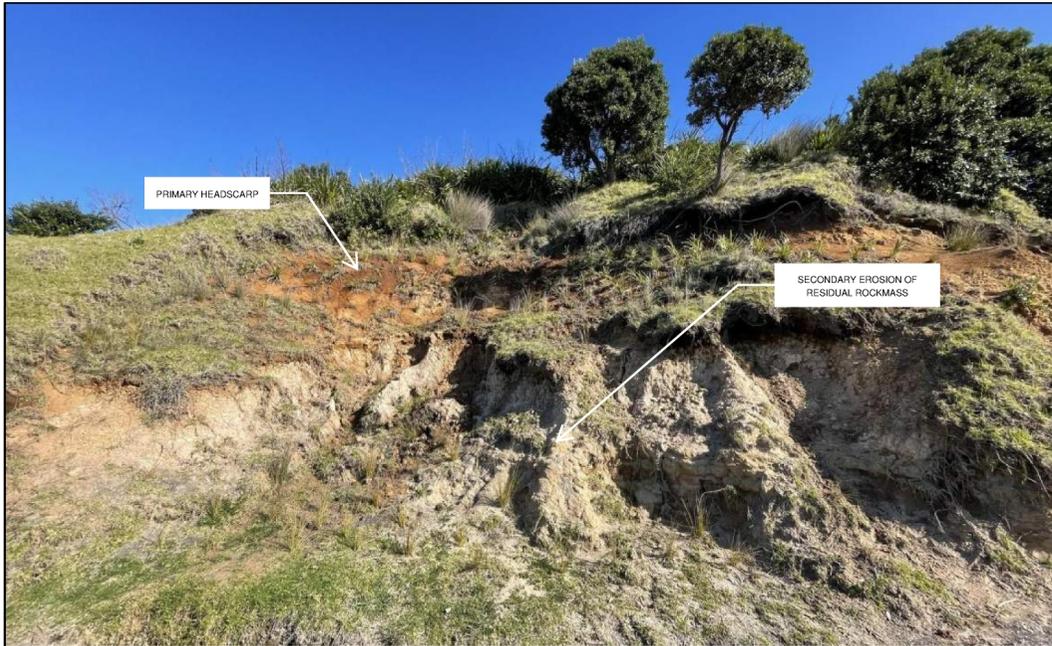
C DETAIL
GE-K002 N.T.S

The western failure is approximately 10m in diameter. The failure appears to have occurred on the interface of the residual rock and overlying soils. Groundwater appears to be permeating along the contact of the residual rock and overlying soils. The slope has been replanted with young vegetation, however there is continued surface erosion of the sandy residual rock material by rainfall. No evidence of recent instability was observed.

1. IMAGE C: VIEW LOOKING SOUTH FROM PROPOSED VIEWING PLATFORM. SLOPE APPROXIMATELY 10m HIGH. PREVIOUS SLOPE FAILURE APPROXIMATELY 7m HIGH AND 10m WIDE. FAILURE APPEARS TO HAVE OCCURRED ALONG CONTACT OF ASHES AND RESIDUAL ROCK MASS. SECONDARY EROSION PRESENT ON SANDY RESIDUAL ROCK CREATING STEEP FACES. PLANTING ALONG. NO SIGNS OF CONTINUED FAILURE.
2. IMAGE D: VIEW FROM TOP OF SLOPE LOOKING NORTH, TOWARDS VIEWING PLATFORM. SLOPE FALLS TO THE WEST AND EAST WHERE SLOPE FAILURES HAVE OCCURRED. NO SIGNS OF FURTHER INSTABILITY AT THE TOP OF SLOPE.
3. IMAGE E: VIEW FROM BEACH LOOKING SOUTH, TOWARDS MAUAO. SLOPE APPROXIMATELY 10m HIGH ABOVE BASE TRACK. PREVIOUS SLOPE FAILURE APPROXIMATELY 10m HIGH AND 9m WIDE. FAILURE APPEARS TO HAVE OCCURRED ALONG CONTACT OF ASHES AND RESIDUAL ROCK MASS. PLANTING ALONG FACE. OVERSTEEPENED HEADSCARP WITH SOME DEBRIS PRESENT

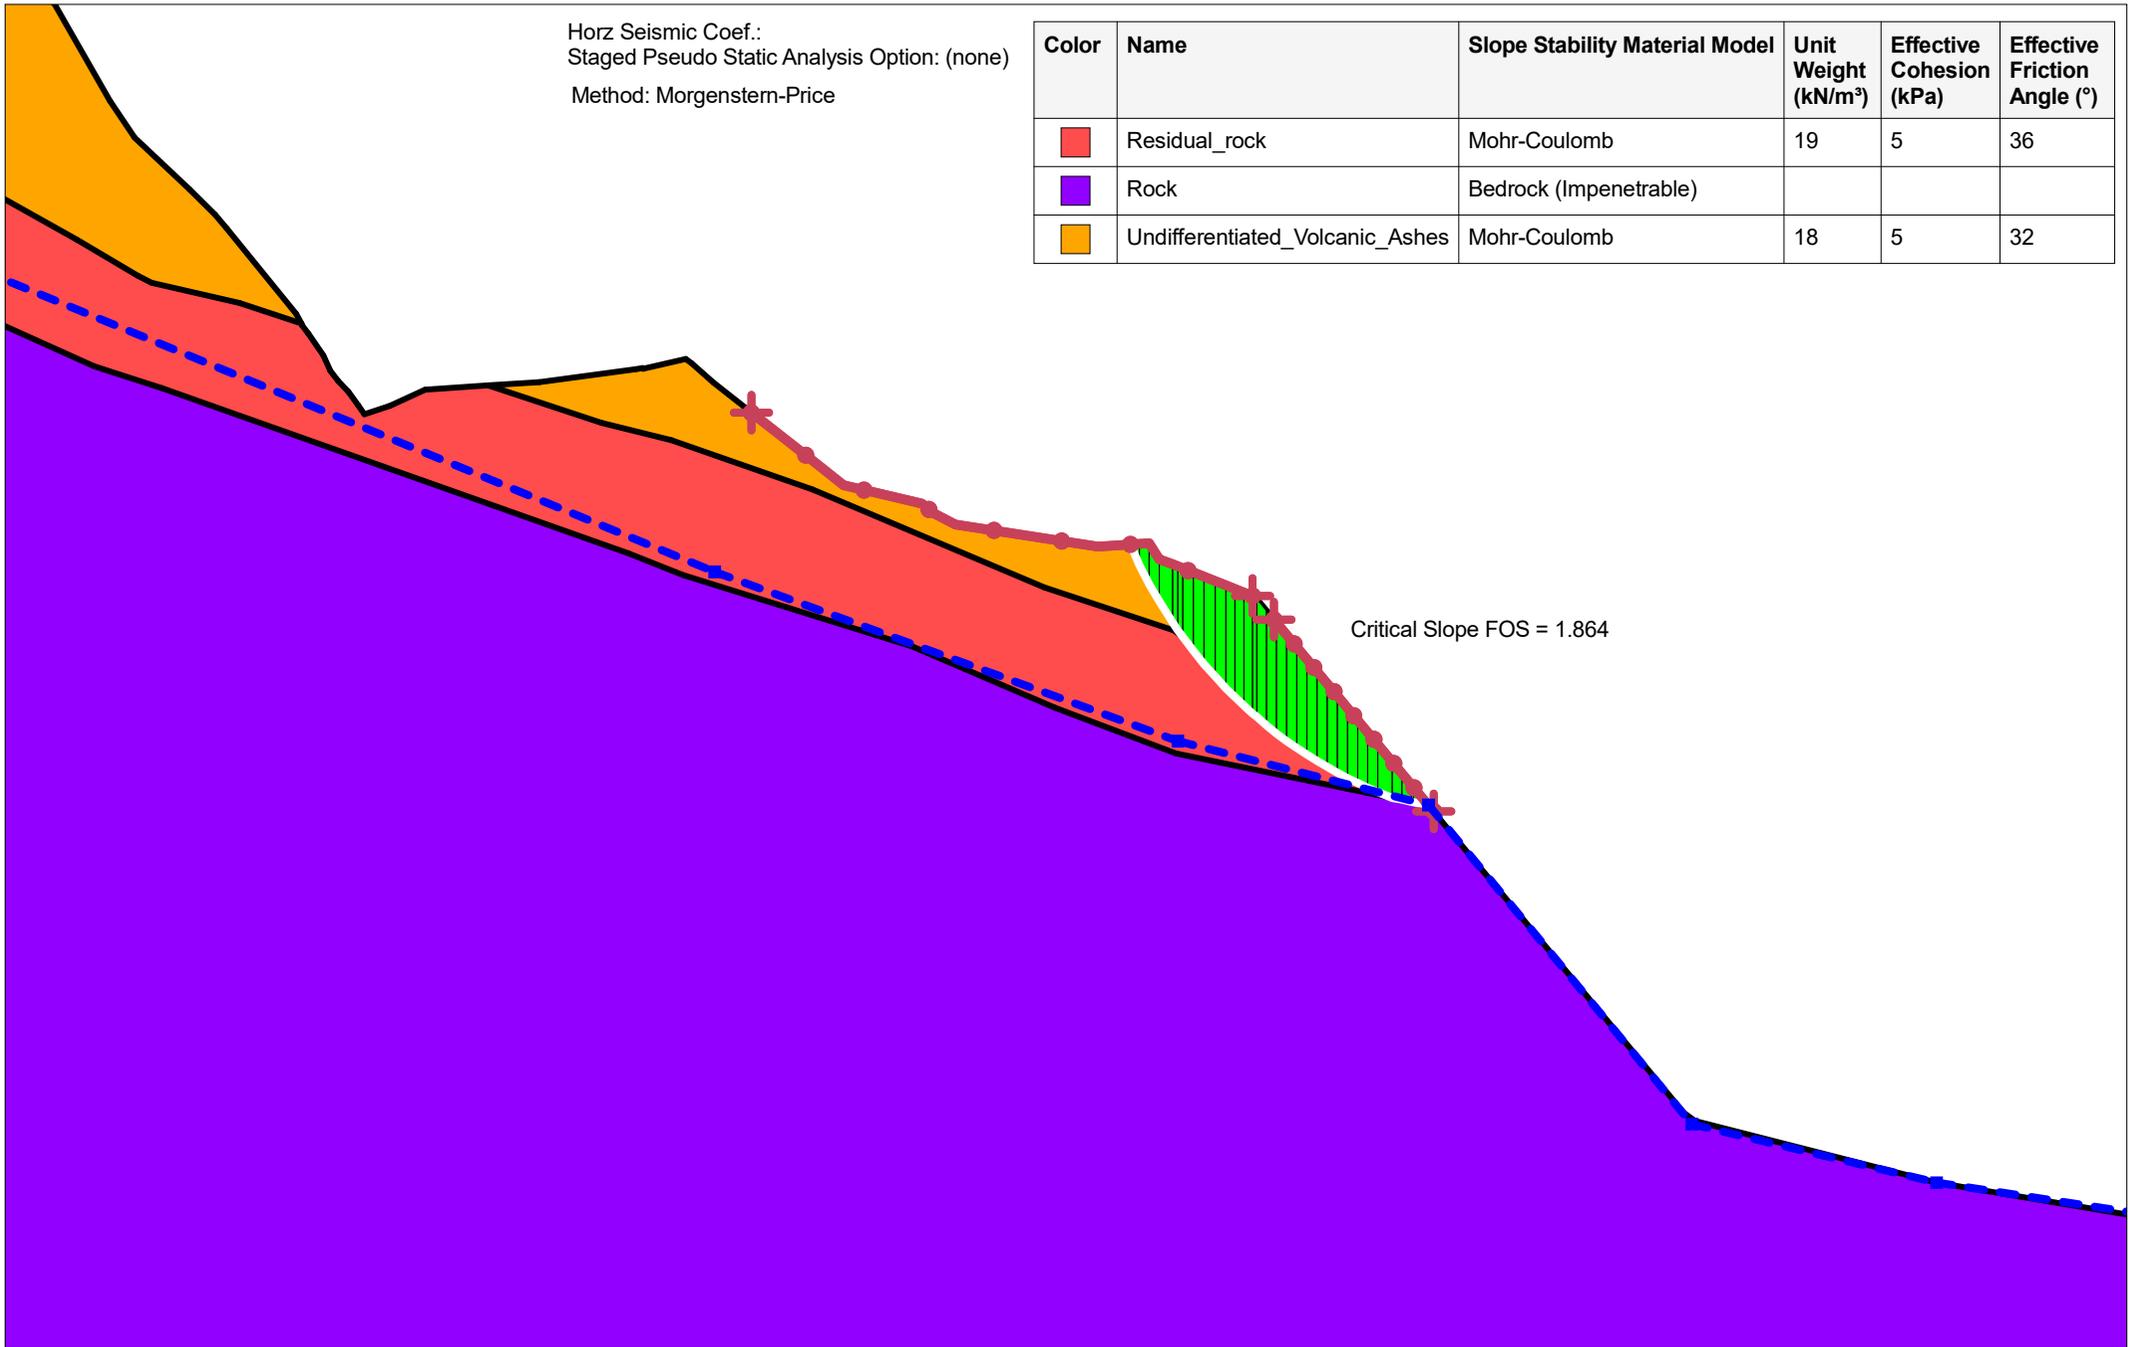
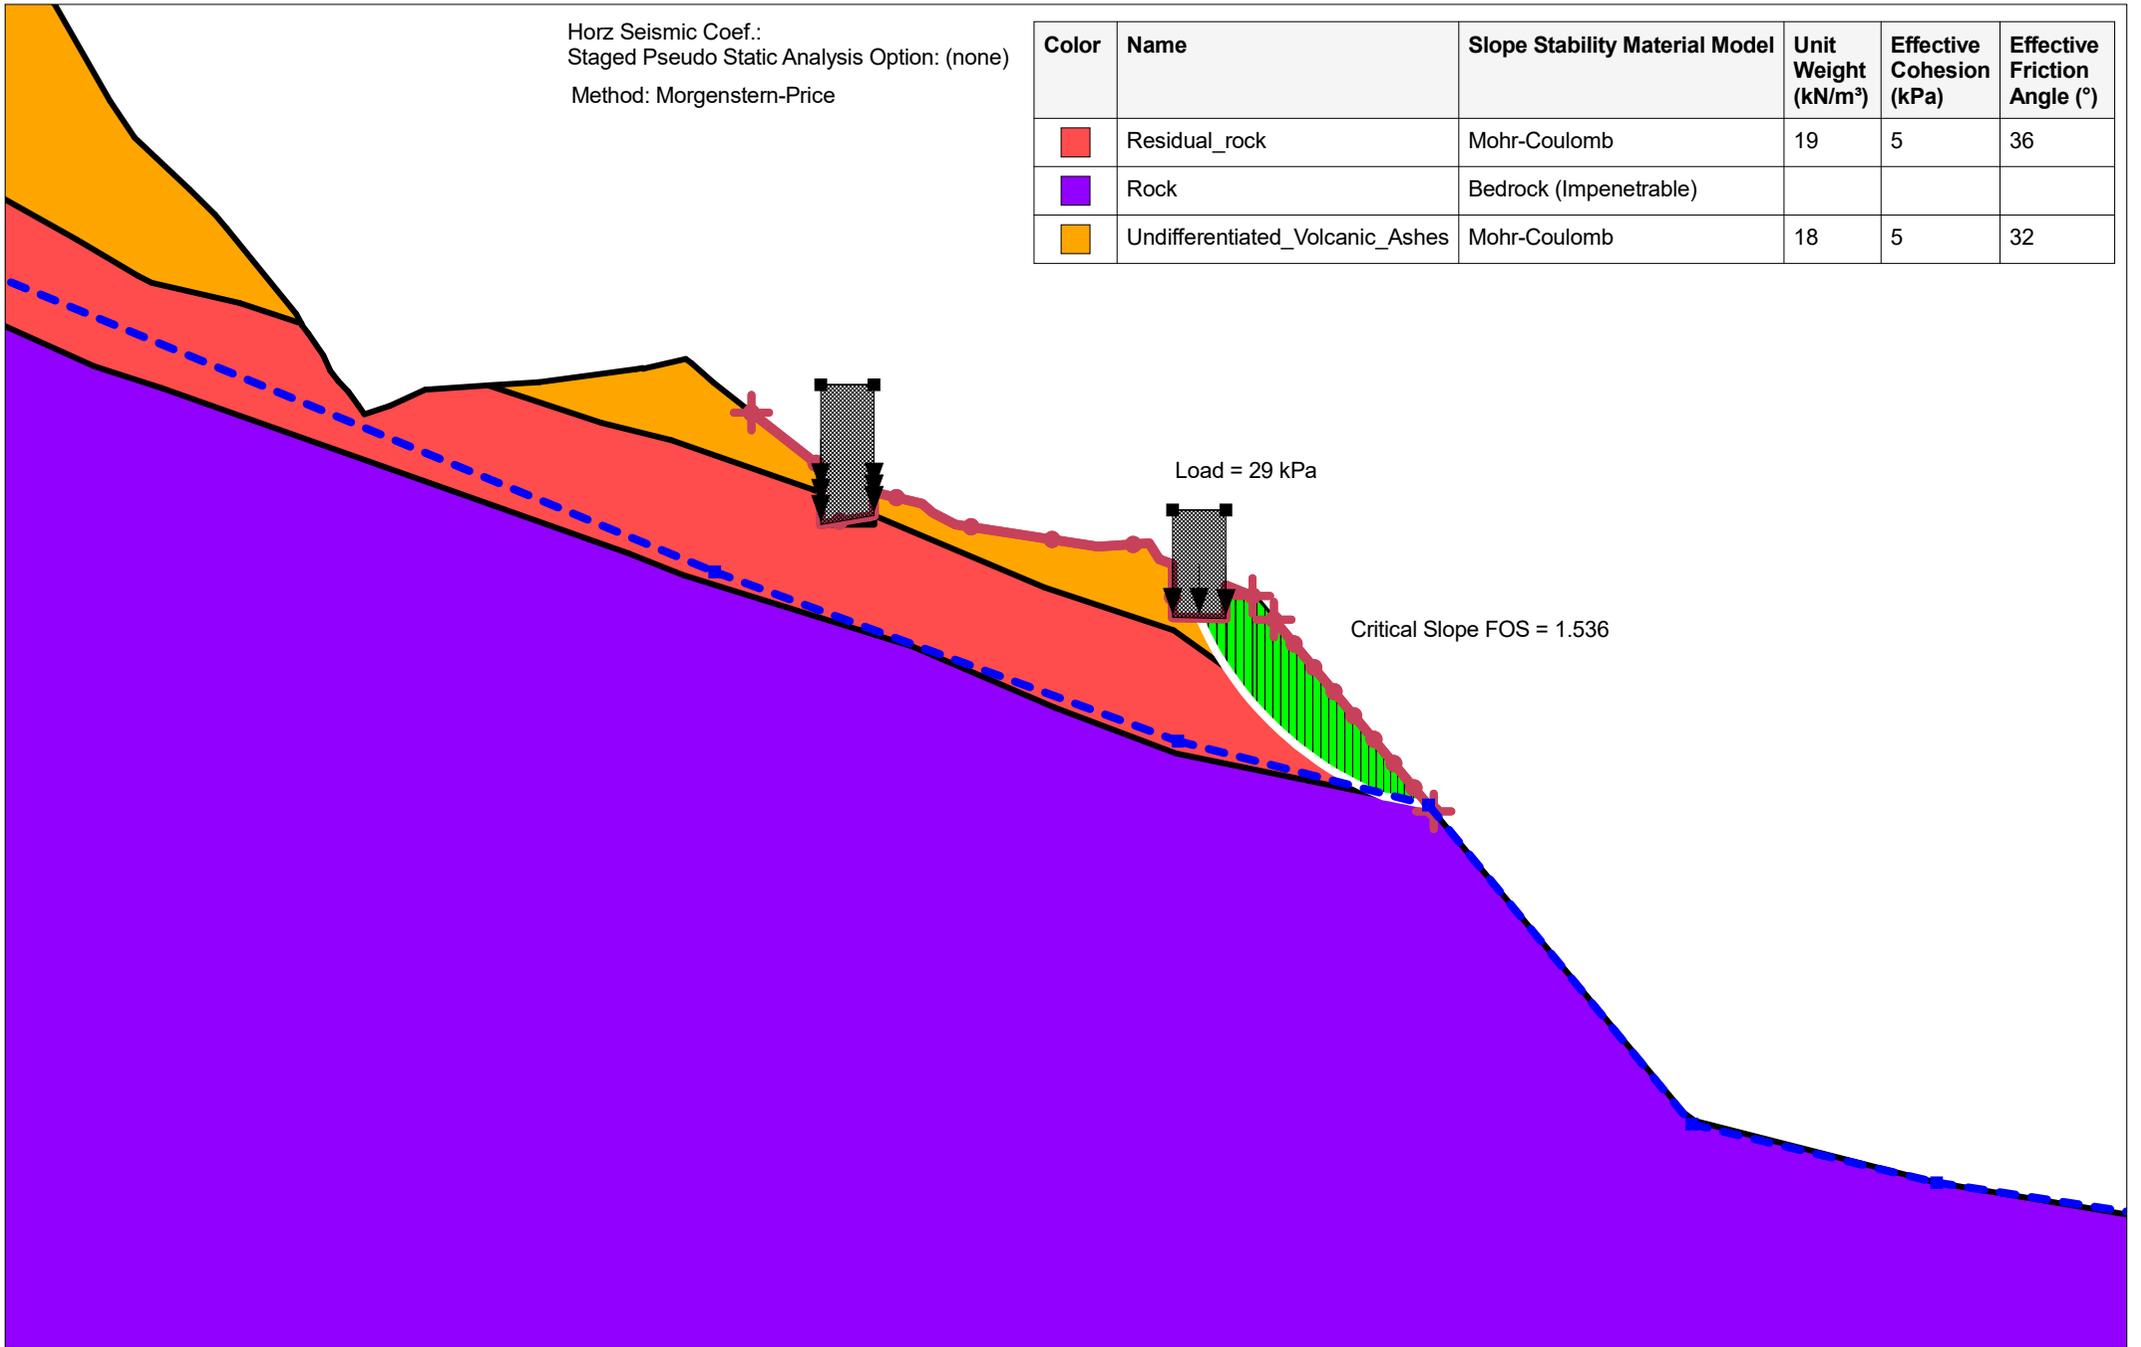
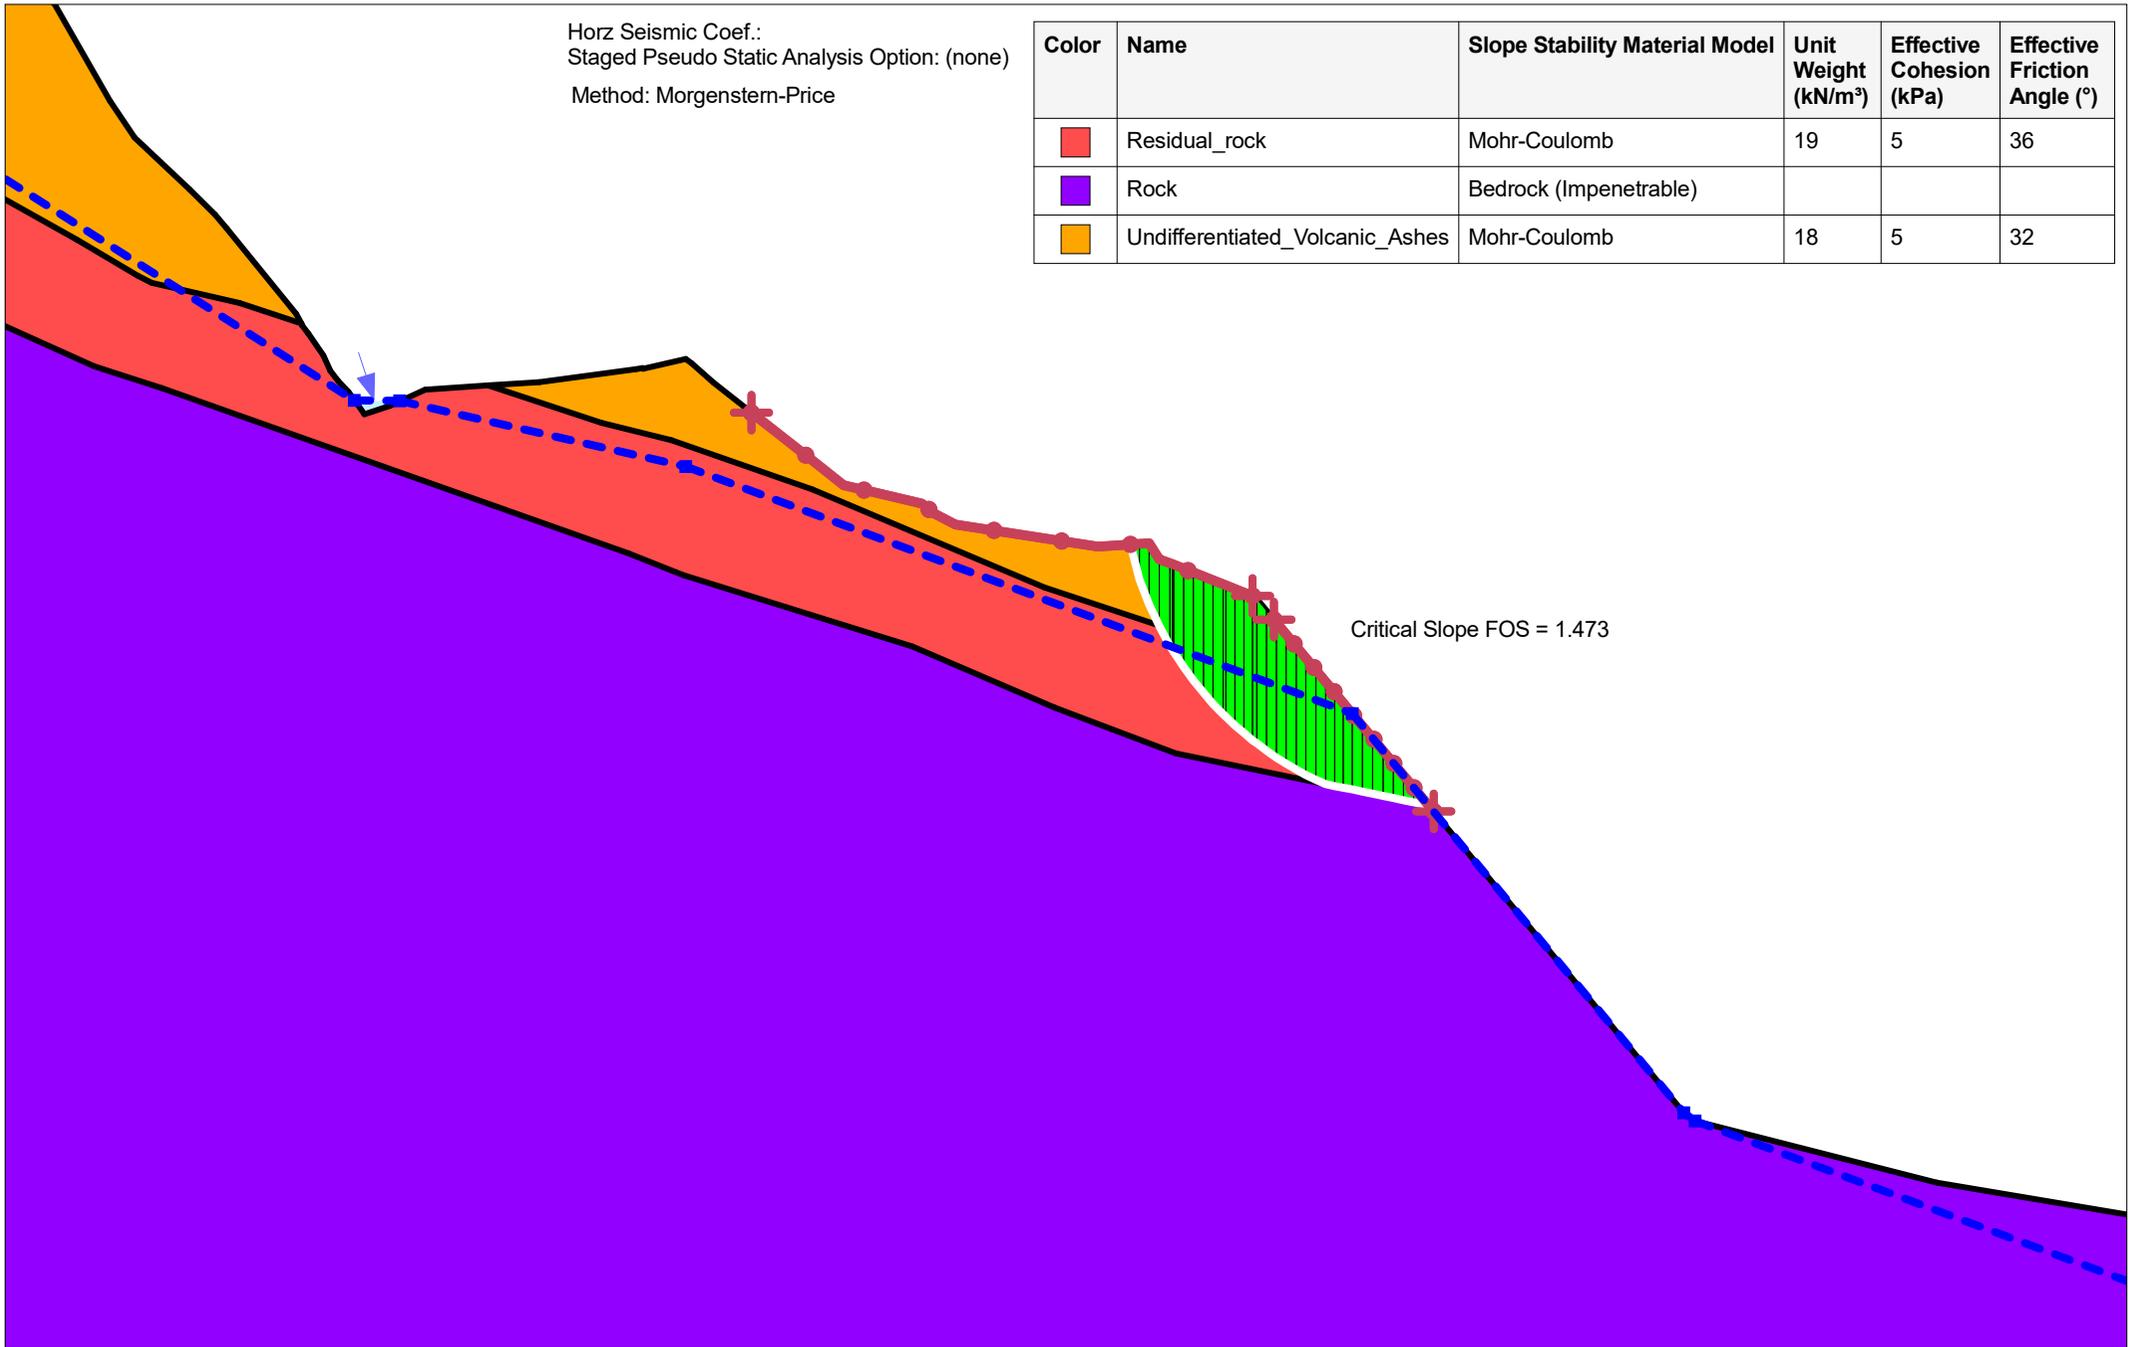
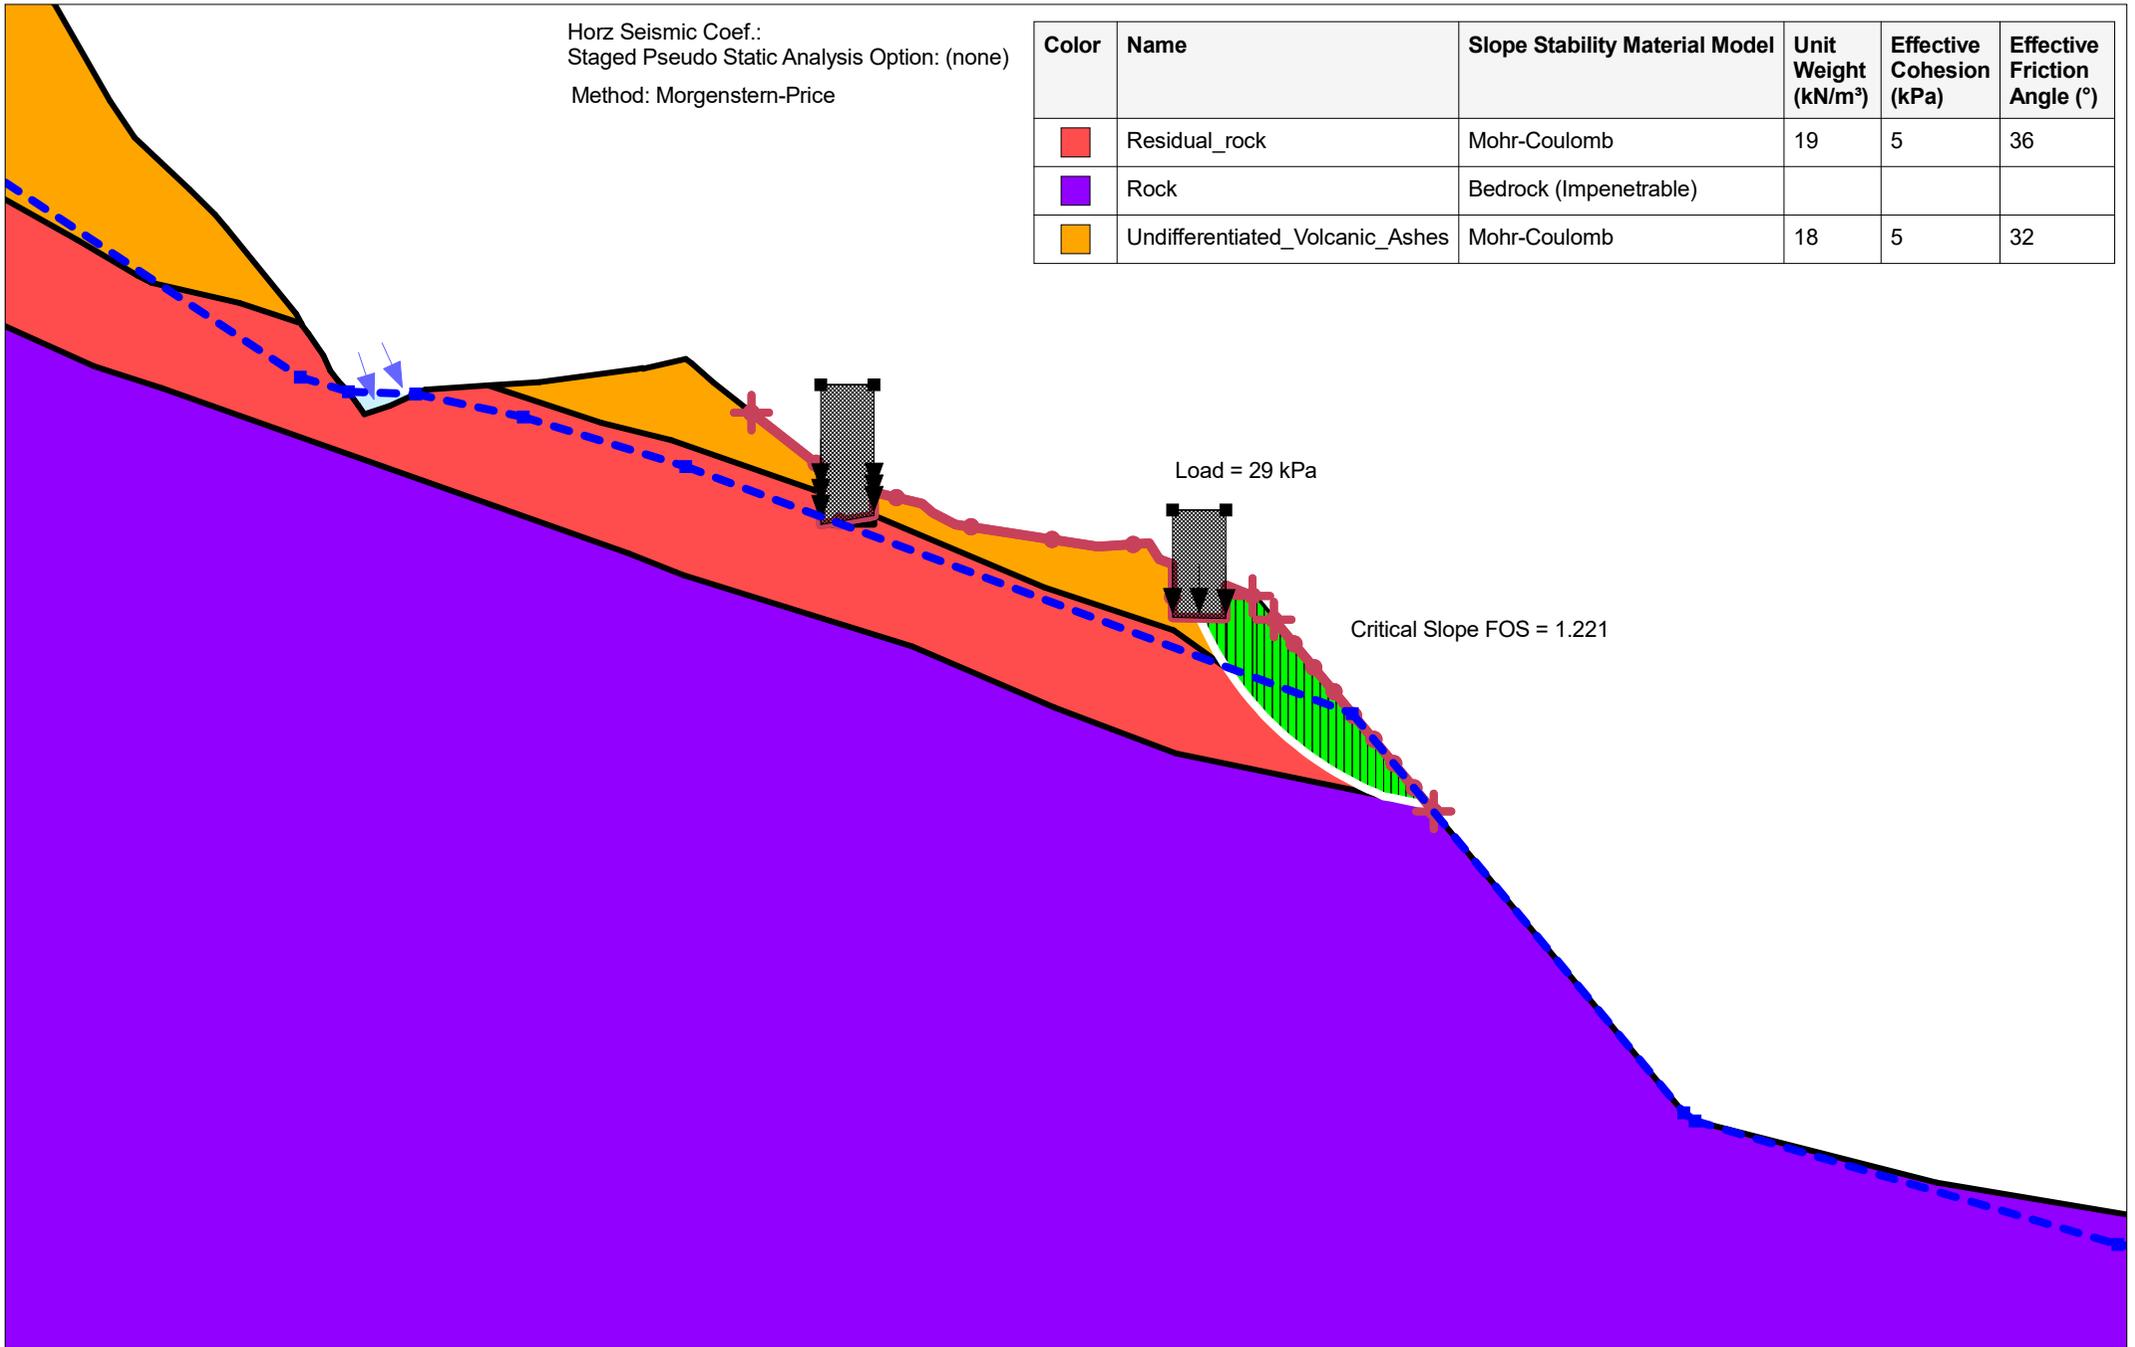
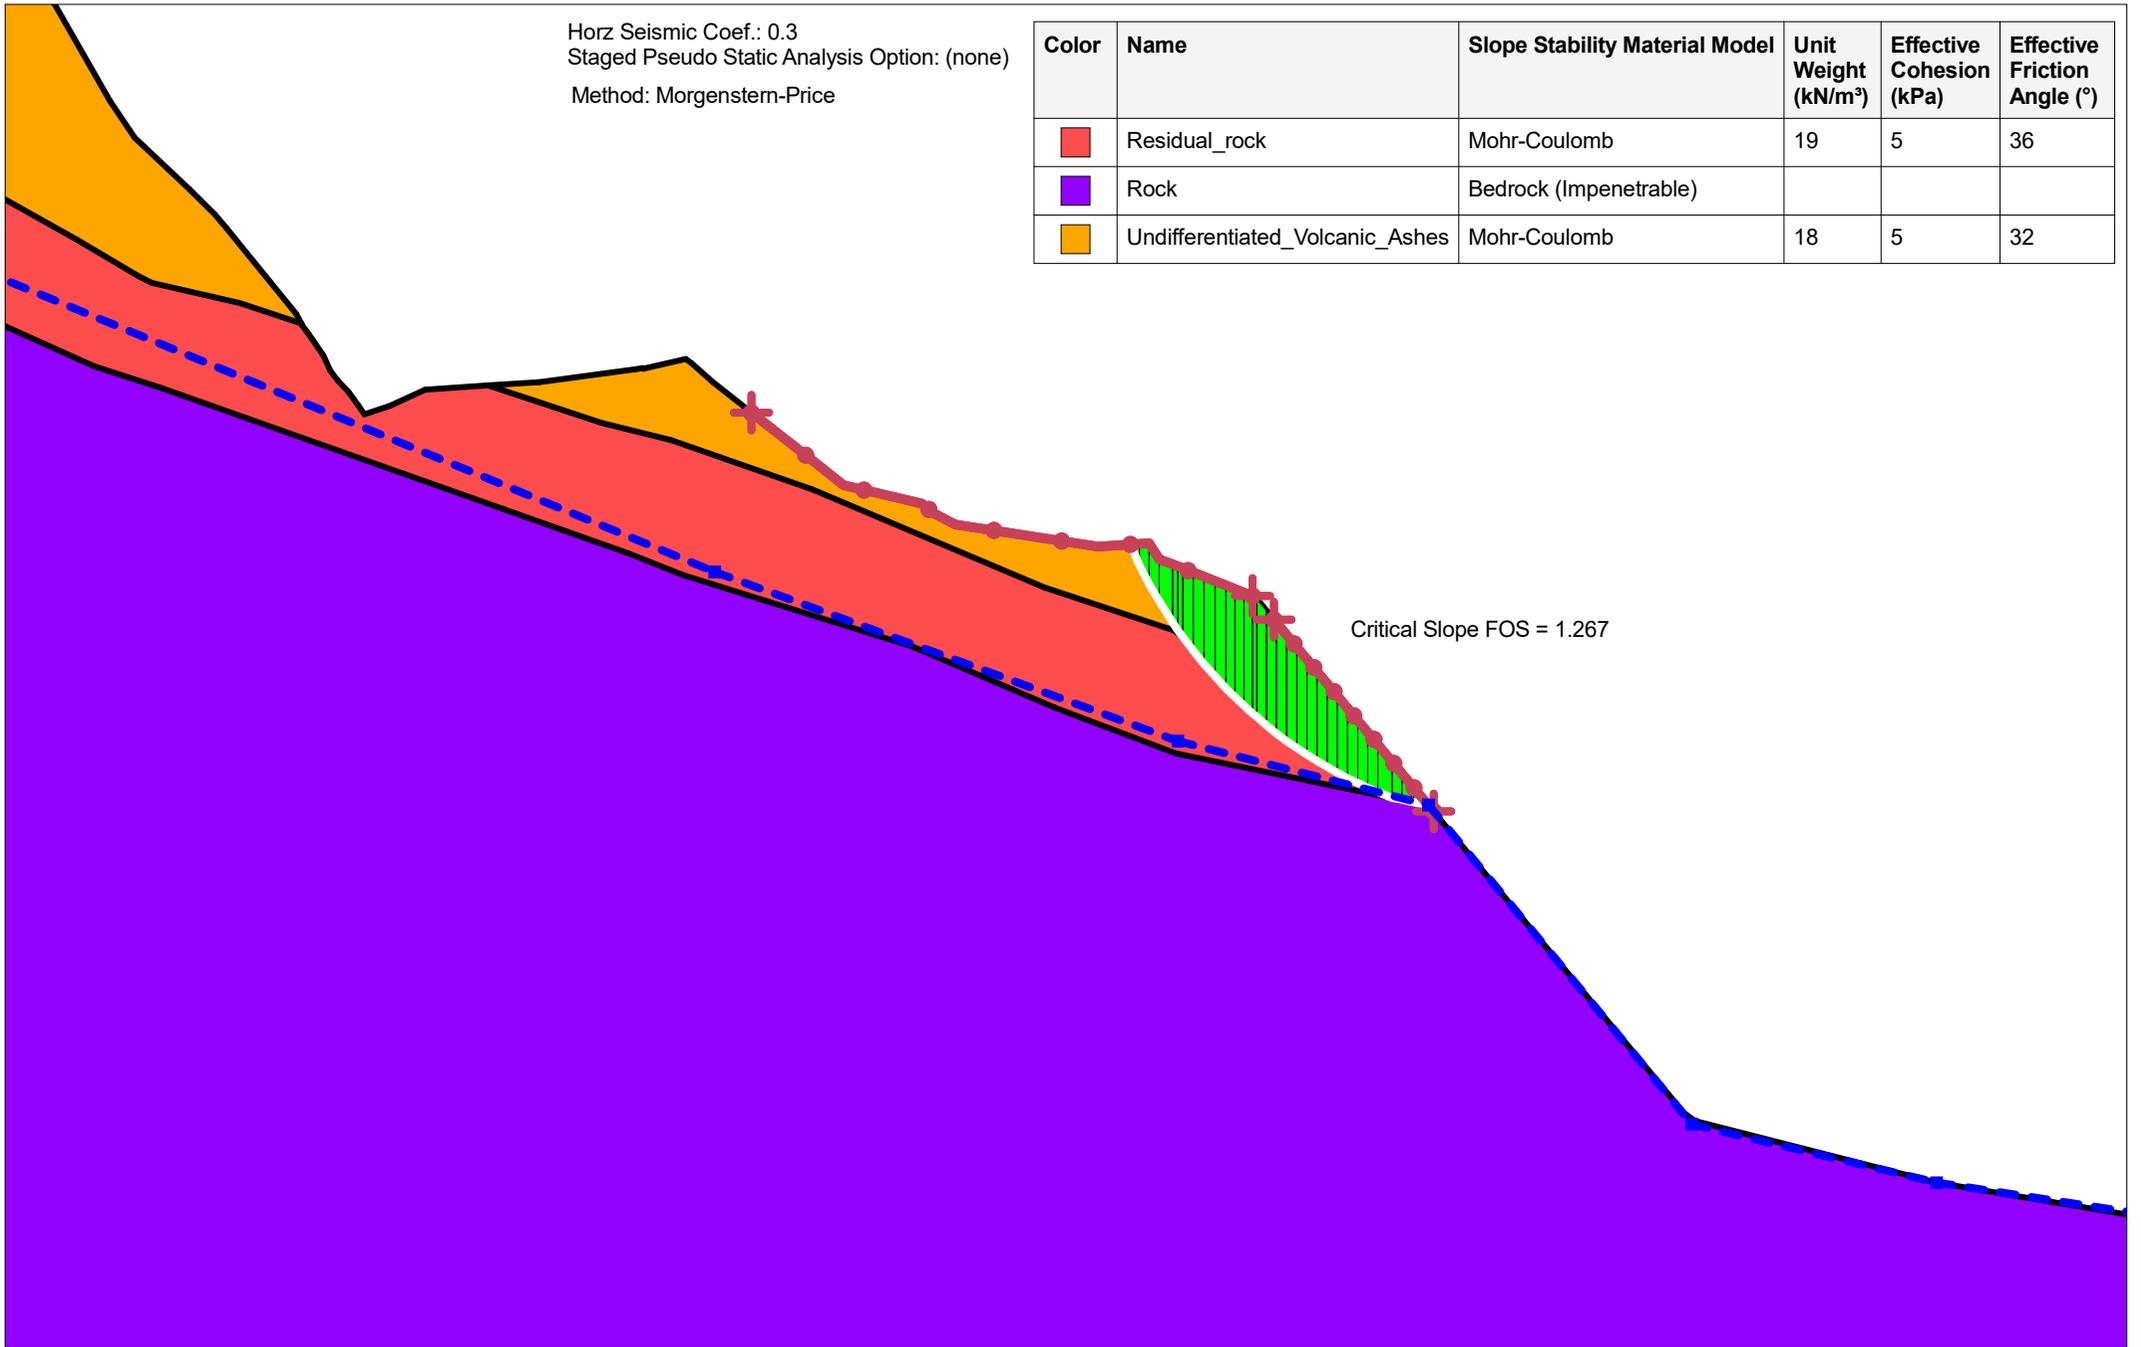
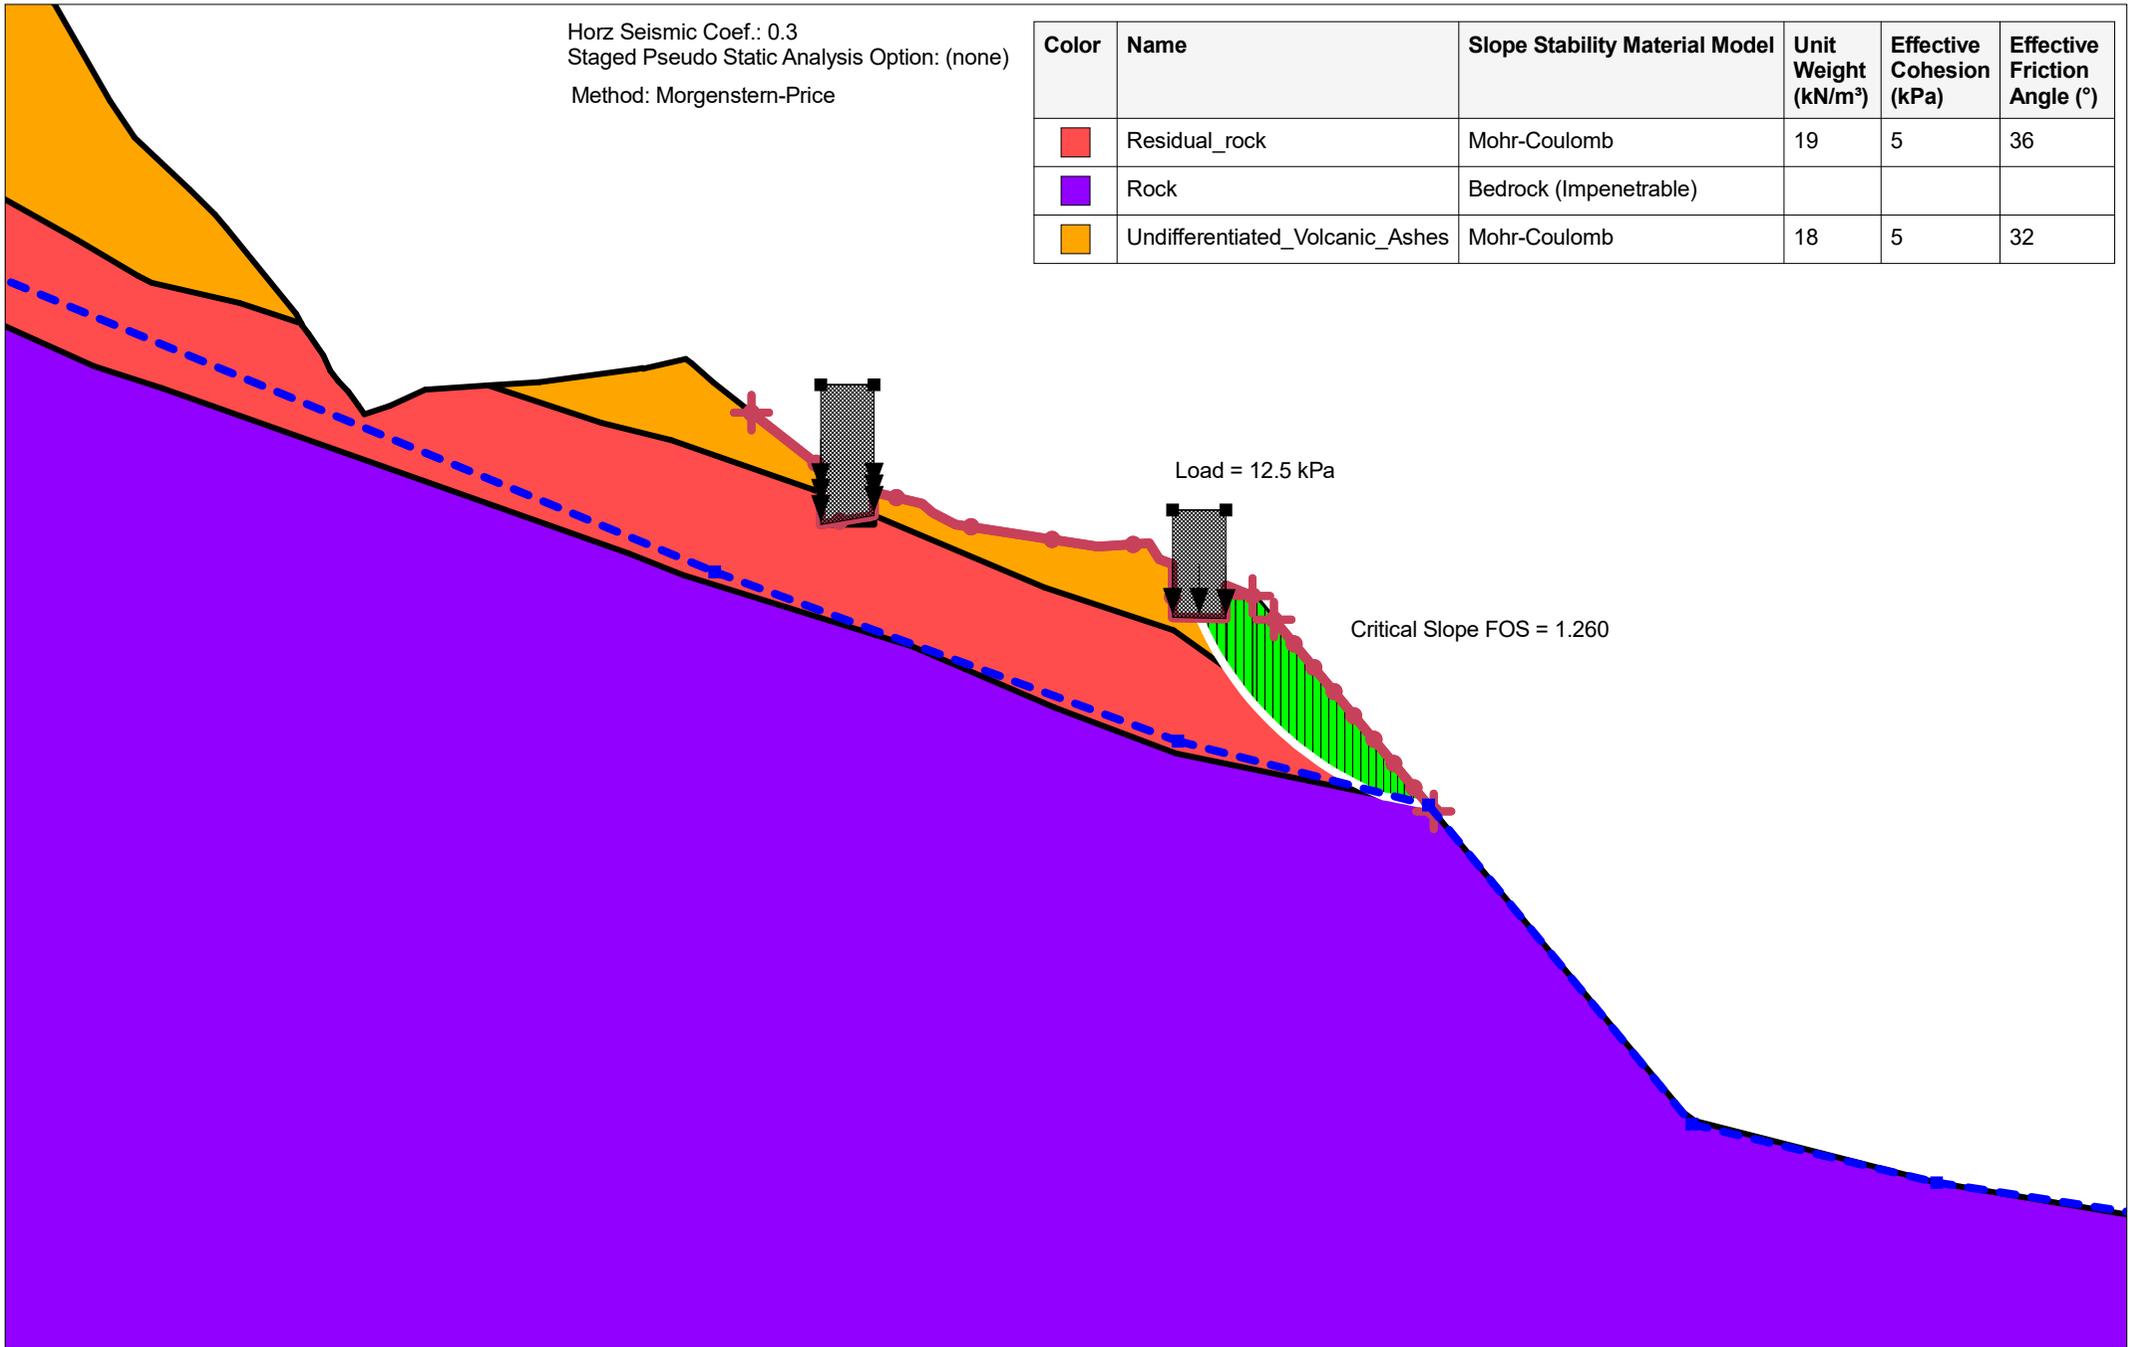
We carried out analyses for the existing conditions and with the proposed structure. The results of the analyses are summarised in Table 1 below. In all cases the slope stability meets the minimum requirements of TCC IDC DS-10.

Case	Minimum Factor of Safety required	Existing	Proposed	Requirements met?
Static	1.5	1.87	1.54	Y
Extreme groundwater level	1.2	1.47	1.22	Y
Seismic	1.0	1.27	1.26	Y
