## **Ngā Poutiriao ō Mauao Meeting Friday, 3 December 2021**

ARCHAEOLOGICAL SITE CONDITION MONITORING  
REPORT - MAUAO HISTORIC RESERVE, TAURANGA

ARCHAEOLOGICAL SITE CONDITION  
MONITORING REPORT  
MAUAO HISTORIC RESERVE, TAURANGA

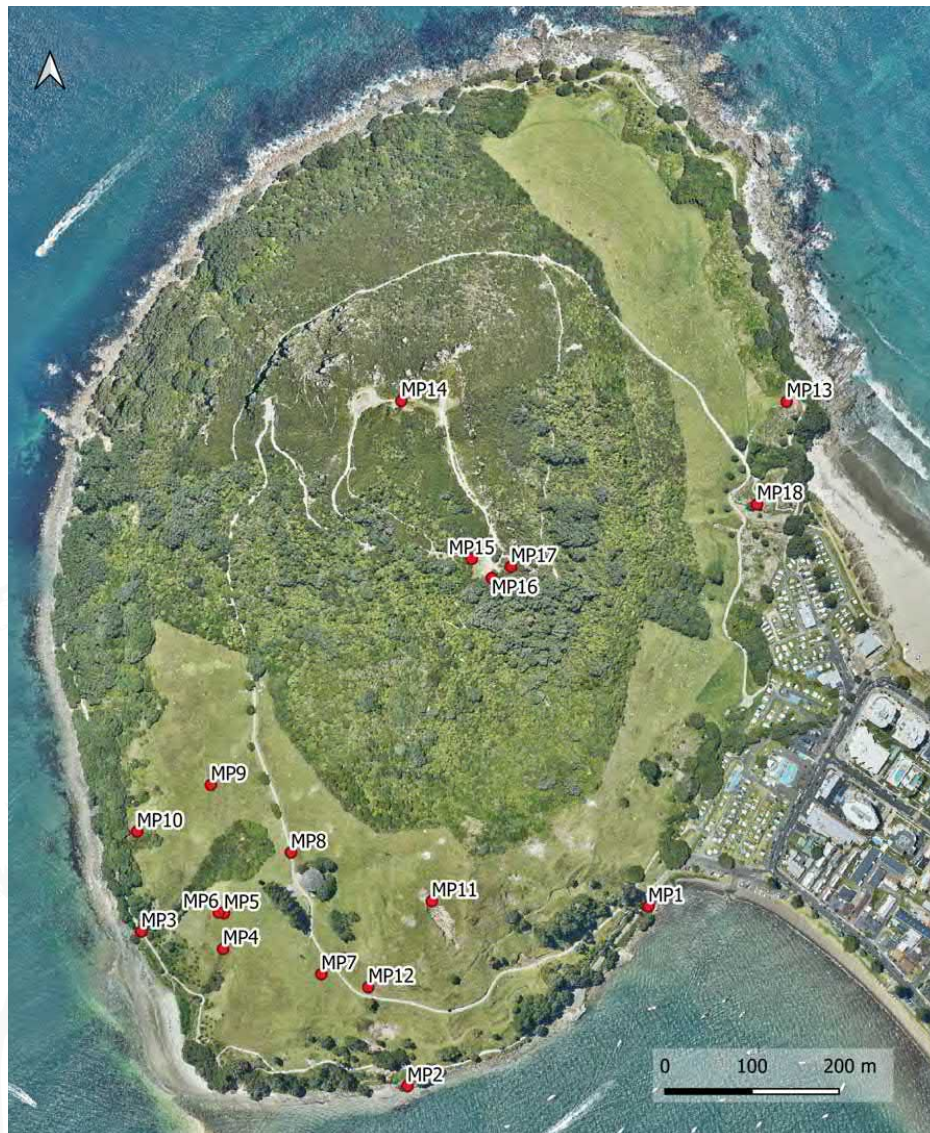
Figure 3 – Location of monitoring points within the Mauao Historic Reserve.

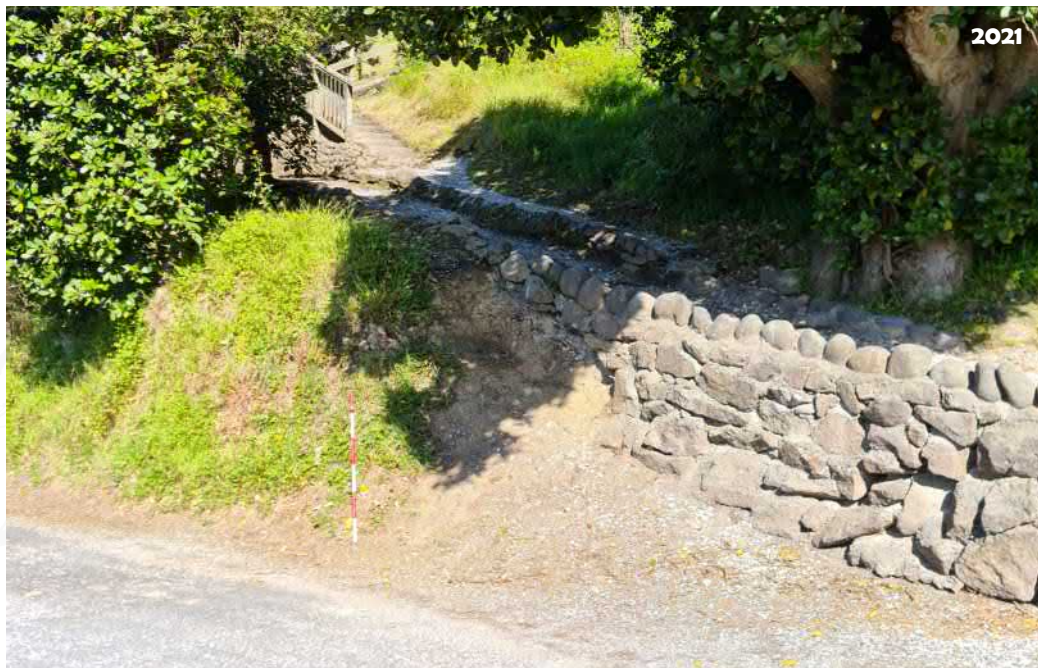
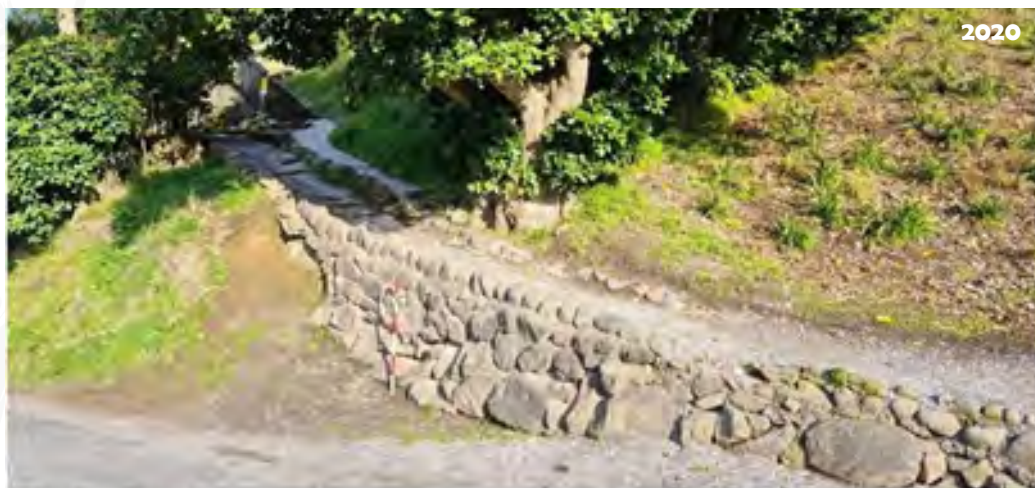
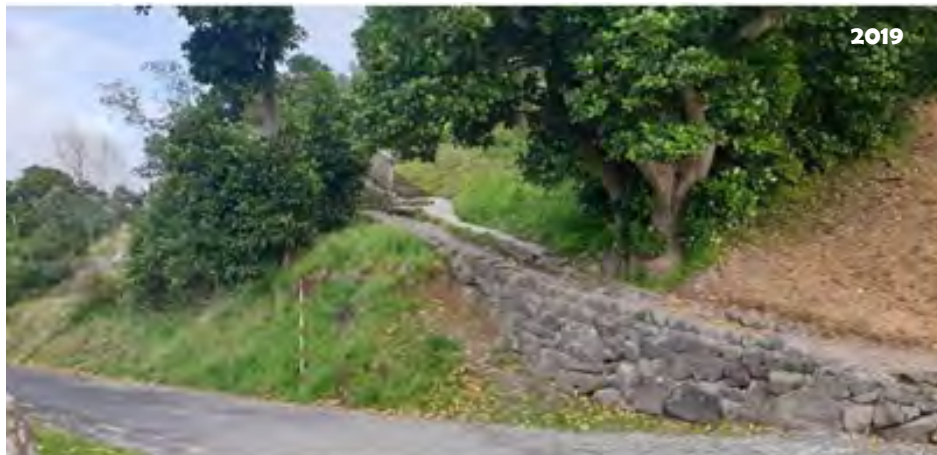
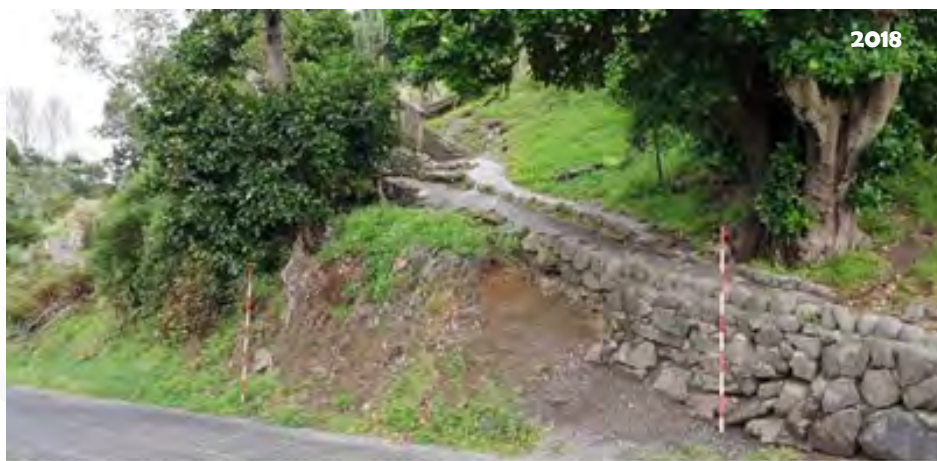
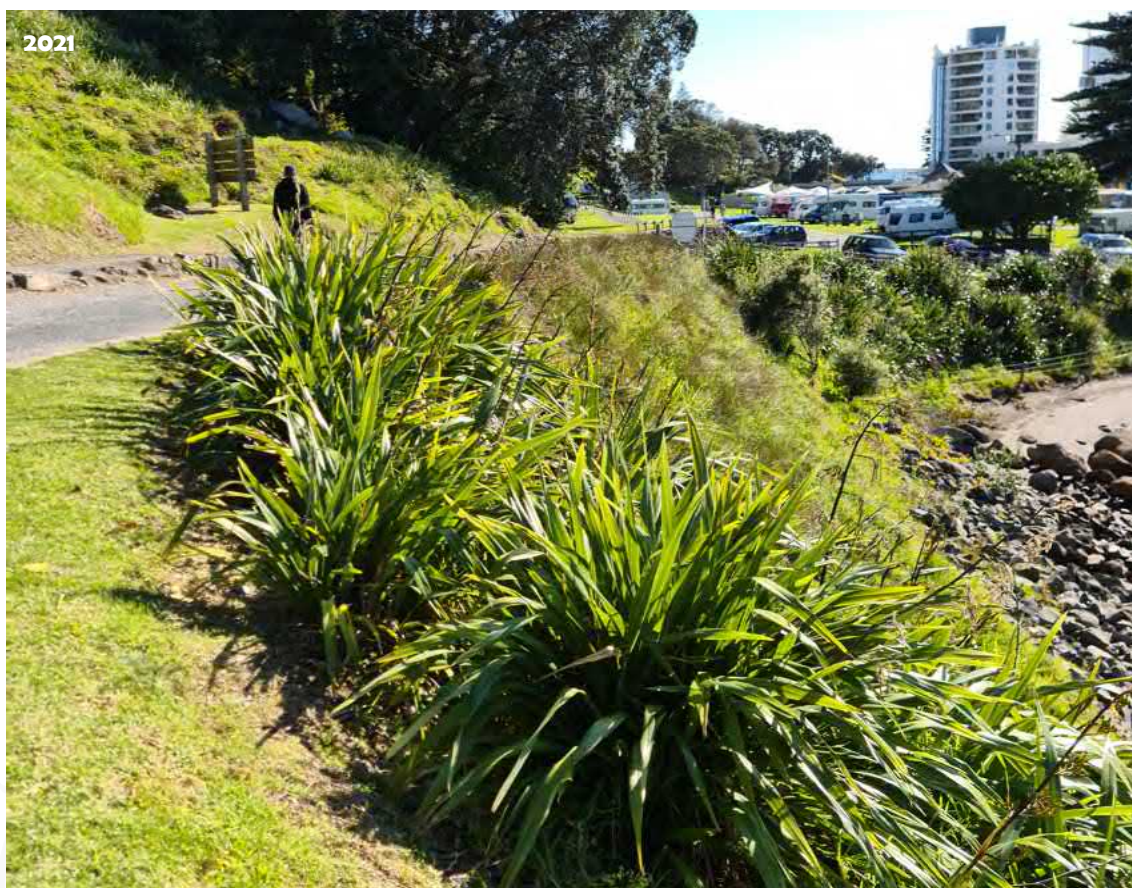
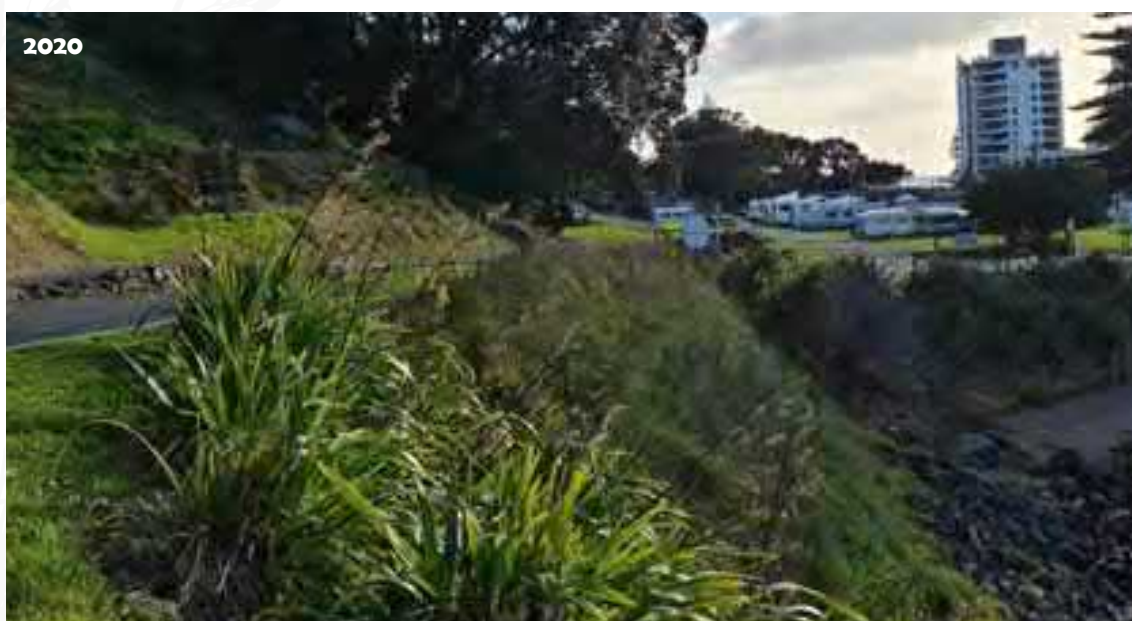
Stone Jetty surrounds - stone walls

Notes: Erosion is unchanged from 2020, grass cover advancing, but this could be primarily due to seasonal variability. Plants on terraces now well established, but some minor infill planting is required. Introduction of soil and planting along the track margin would assist to restrict visitor access to the formed track.

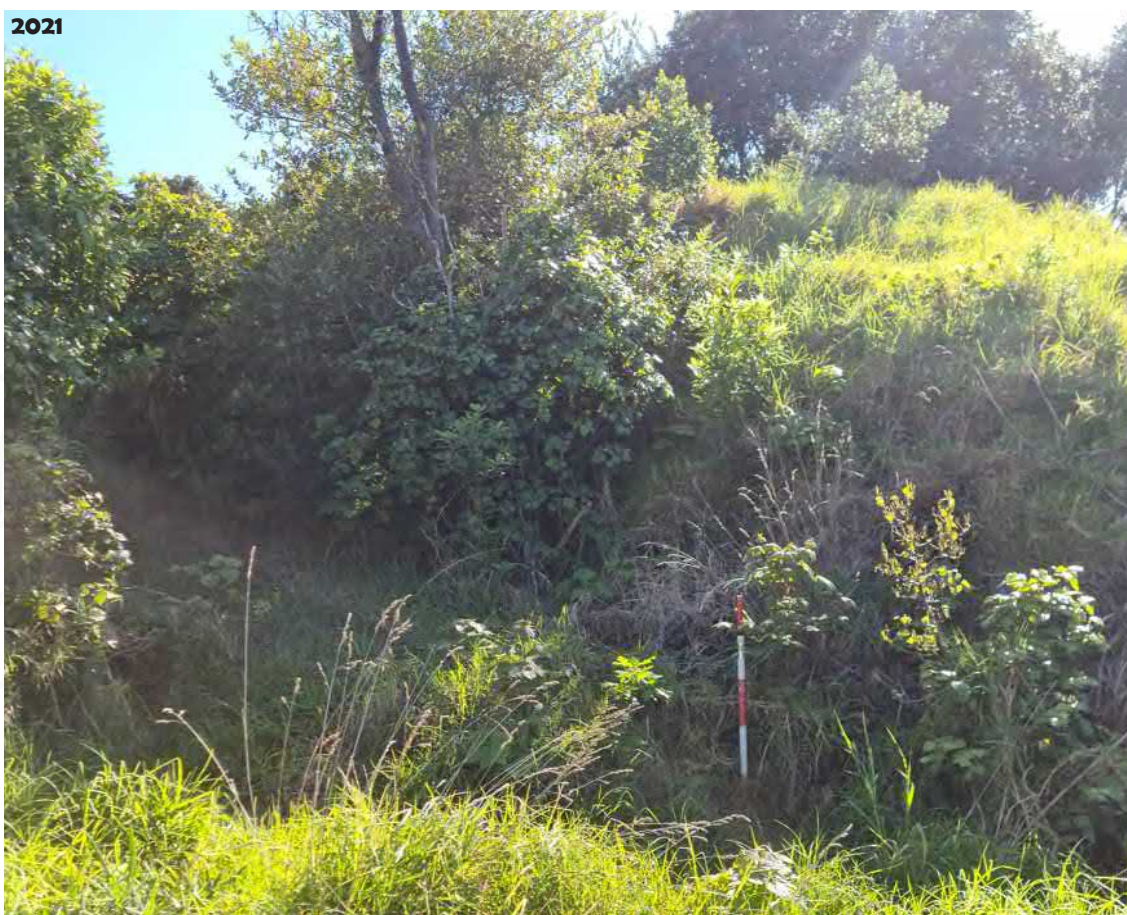
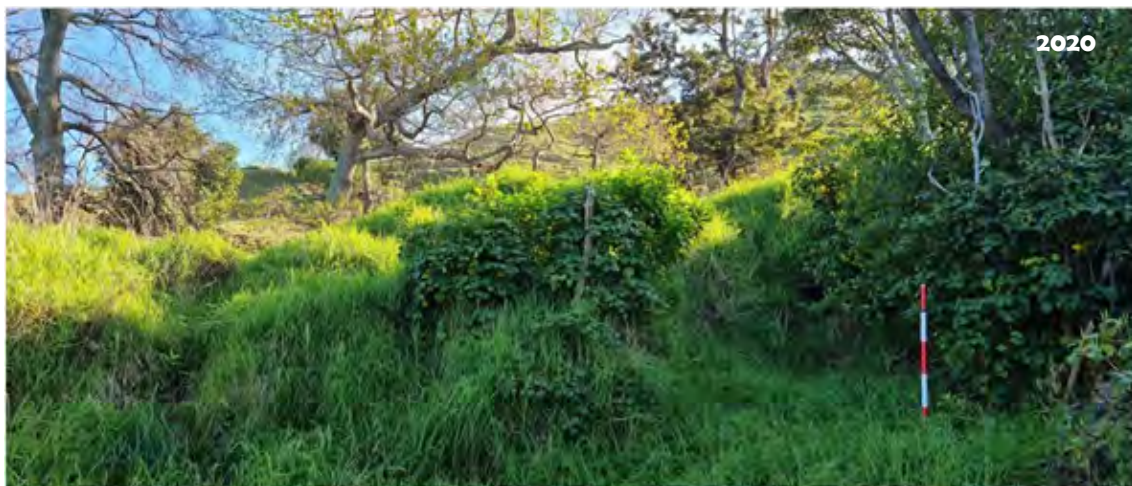
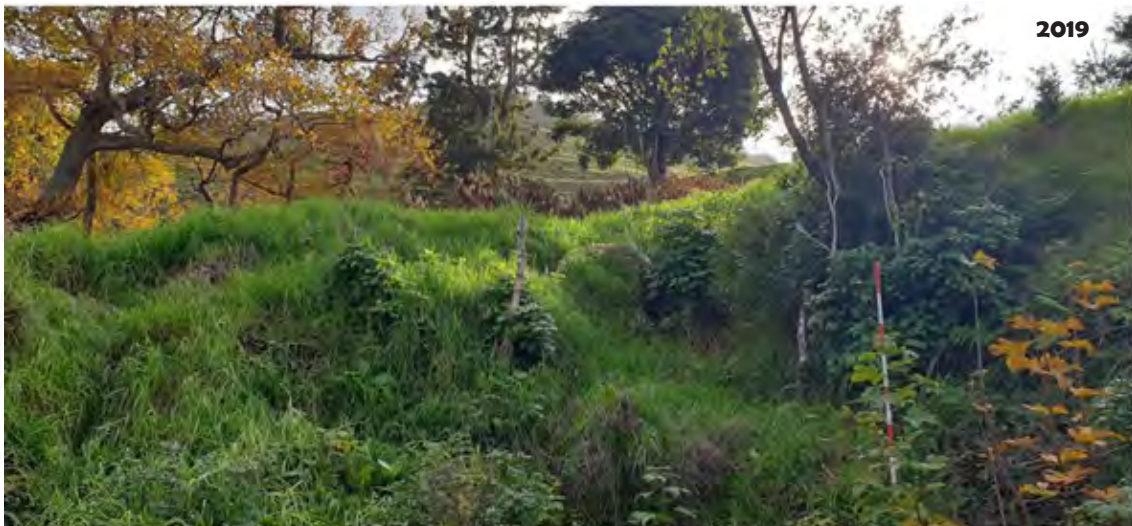
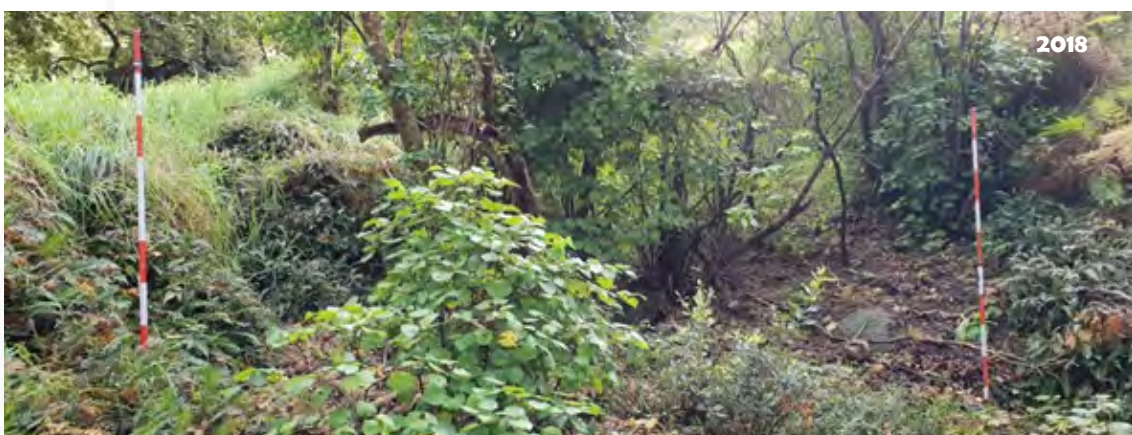
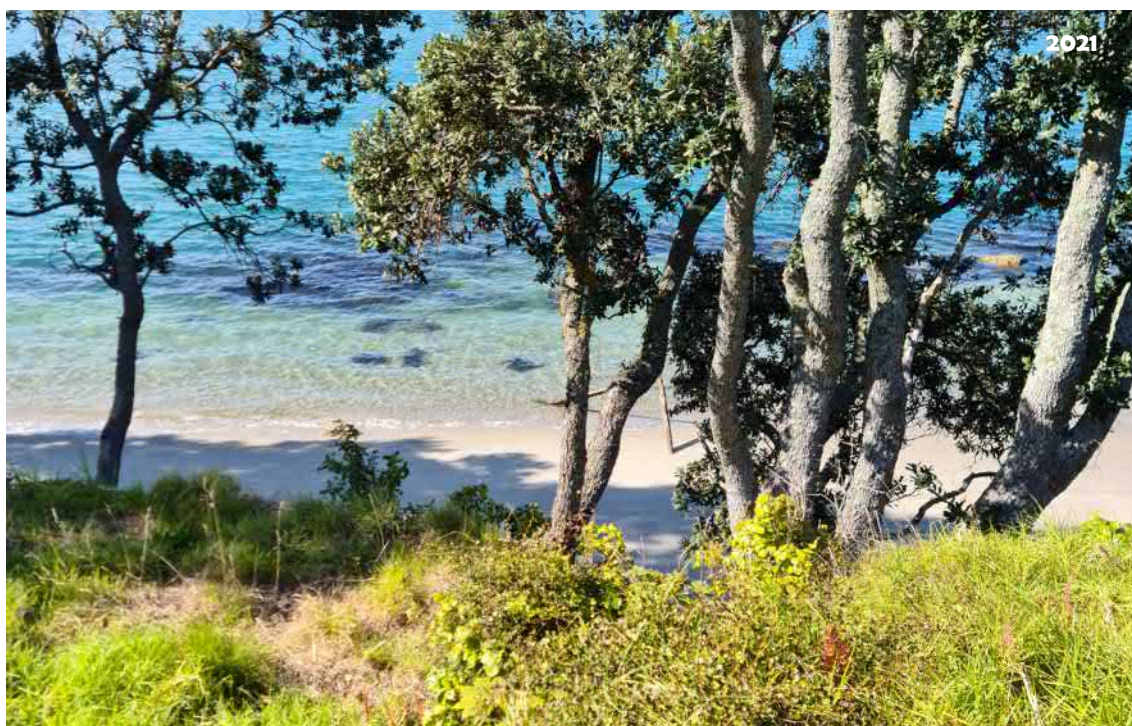
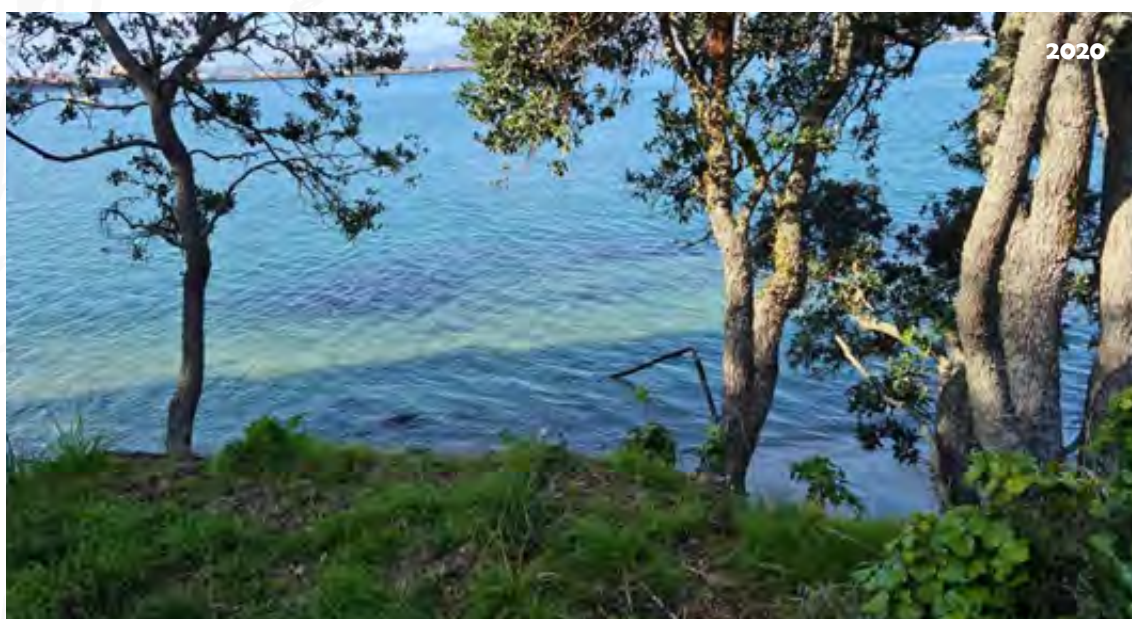
Iron jetty and surrounds

Notes: Vegetation clearance to reduce pōhutukawa and sycamore growing on the stonework face of the jetty that was done in 2020 needs to be maintained. There is on-going invasion by sycamore and other tree species. Interpretation should be developed at the jetty as part of the current project and the site should continue to be maintained in low vegetation/ferns/rank grass, with periodic weed

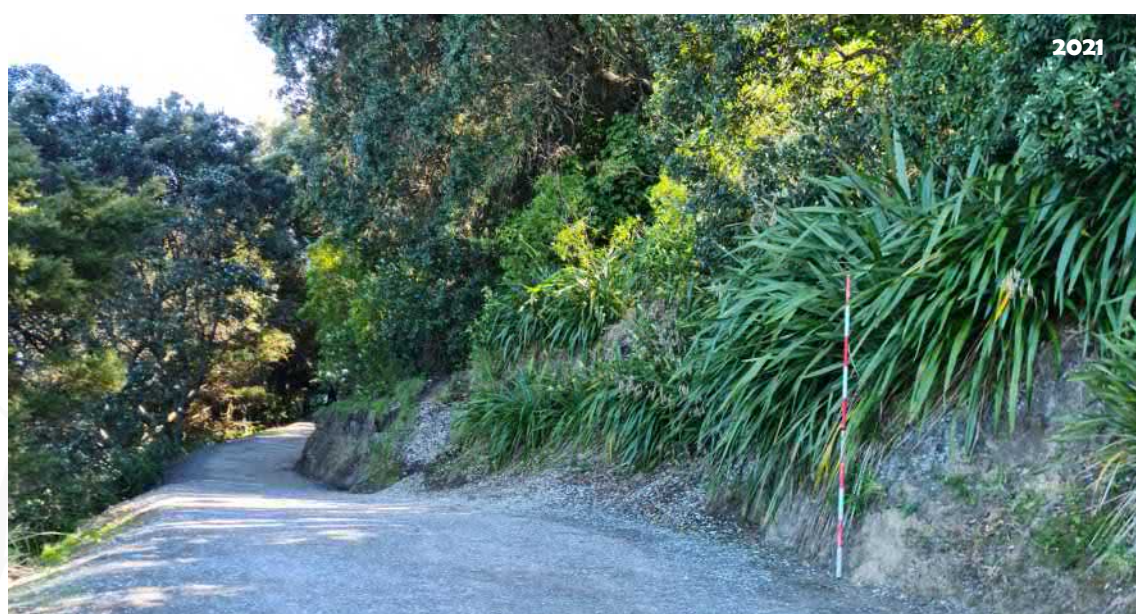
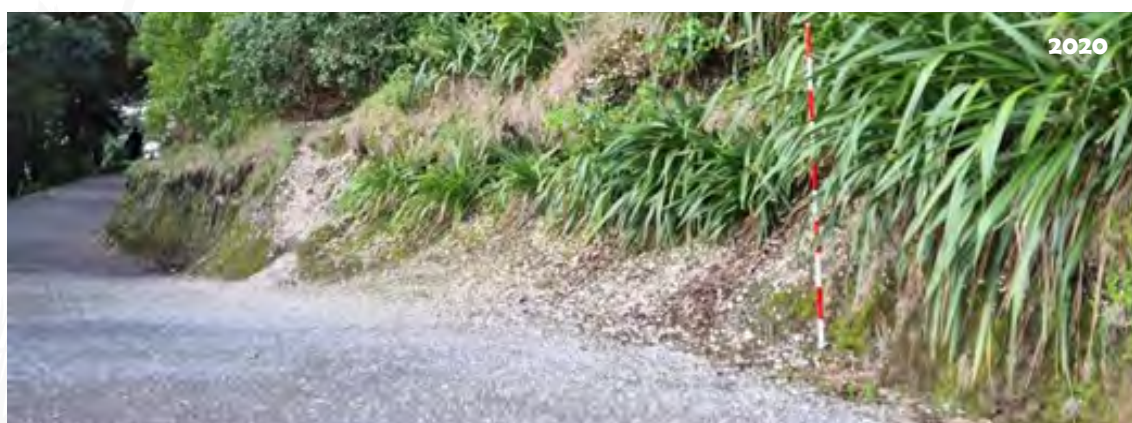
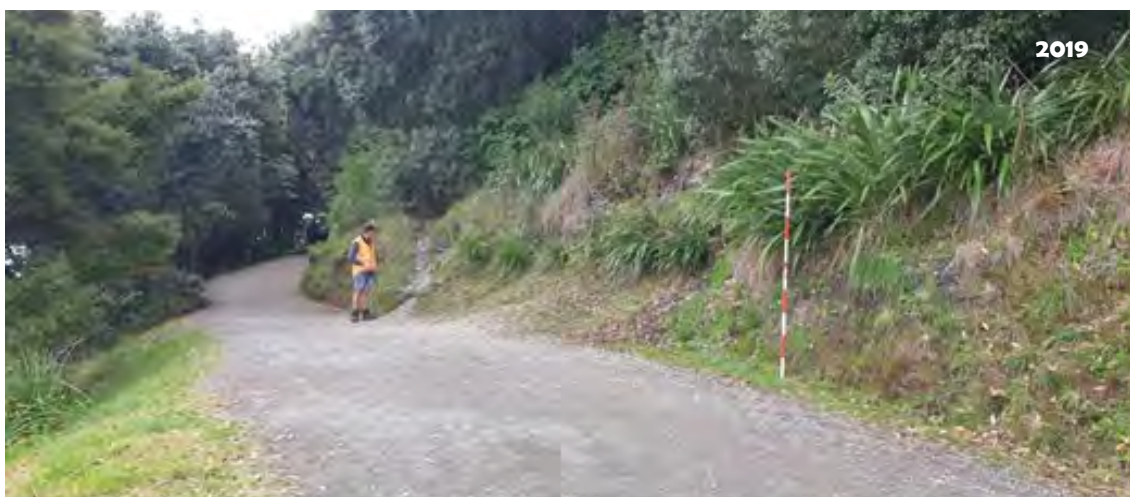
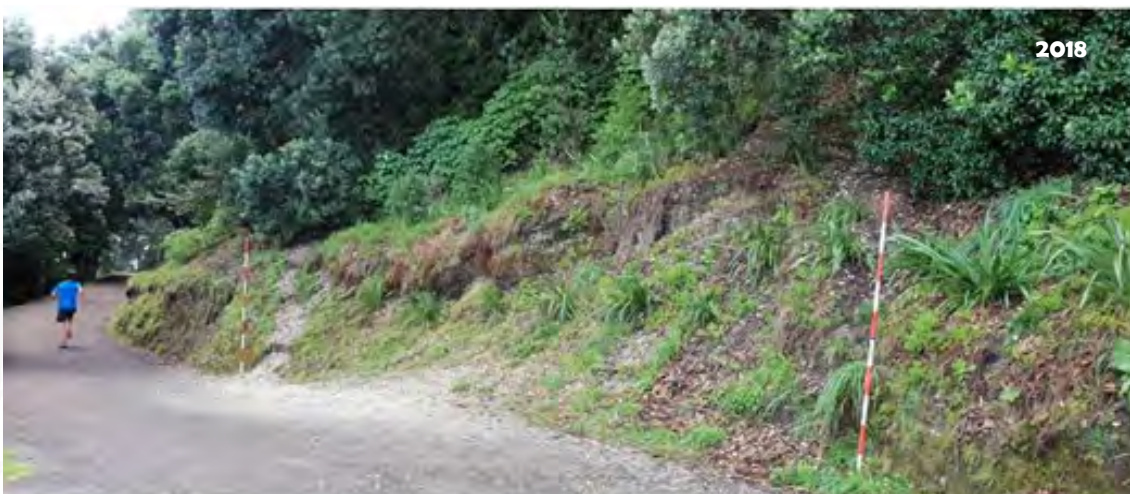
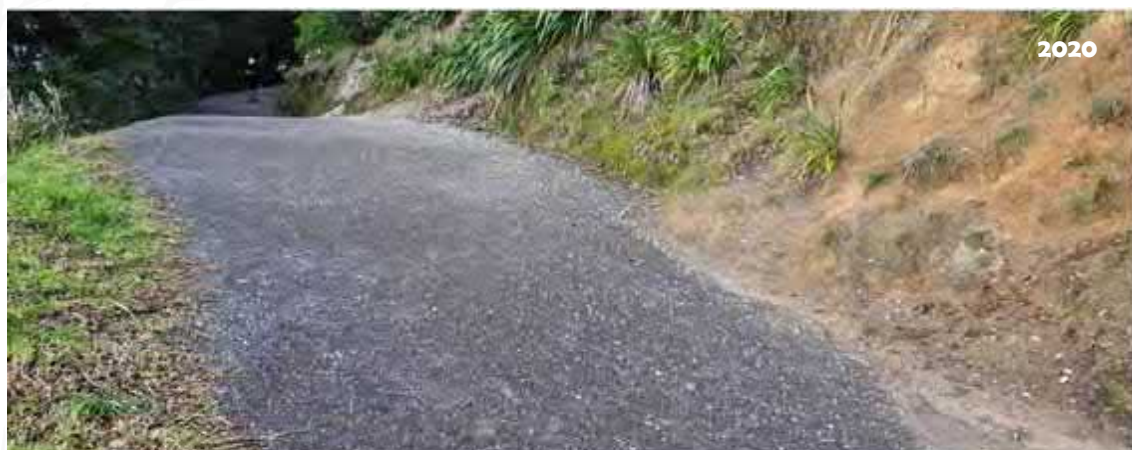
Base track midden erosion

Notes: There has been no significant advance or improvement in vegetation cover over the monitoring period and the eroded face is still highly visible. Shell is still accumulating at the base of the slope. Introduction of fill material may be required to get plant cover better established.

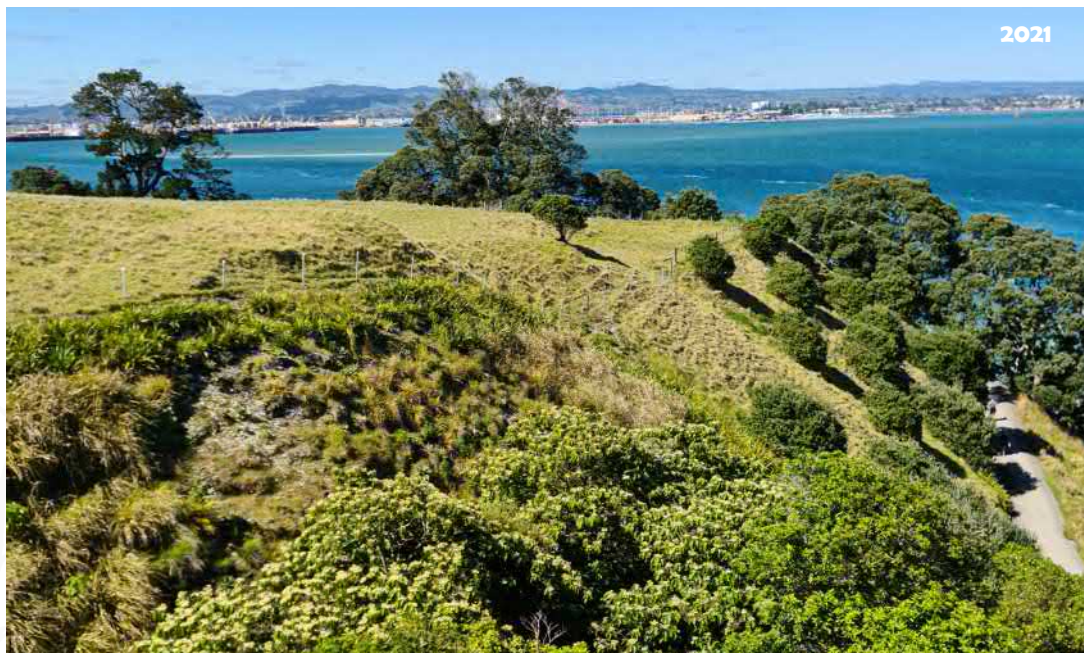
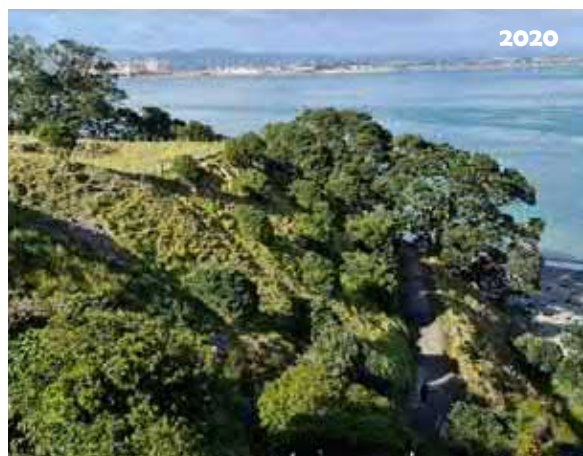
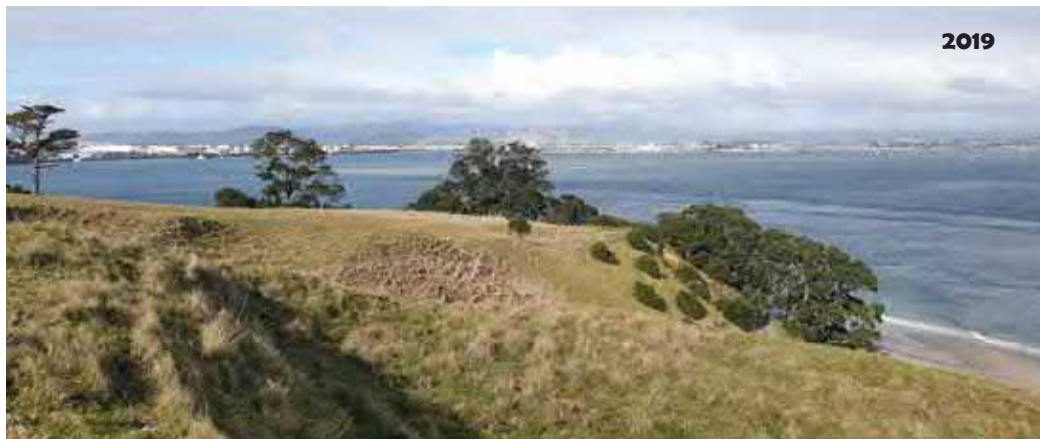
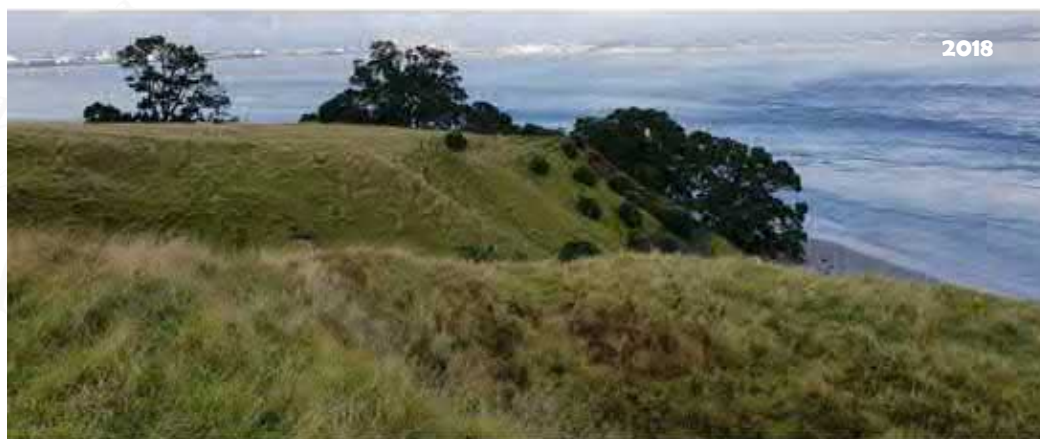
## Monitoring Site 4

Fence placement, rabbit browse and slope stability

Notes: Vegetation cover on eroding archaeological features is now well established. There is no significant evidence of rabbit browse in the areas where grazing has ceased. There has been considerable improvement in vegetation cover and slope stability over the monitoring period.

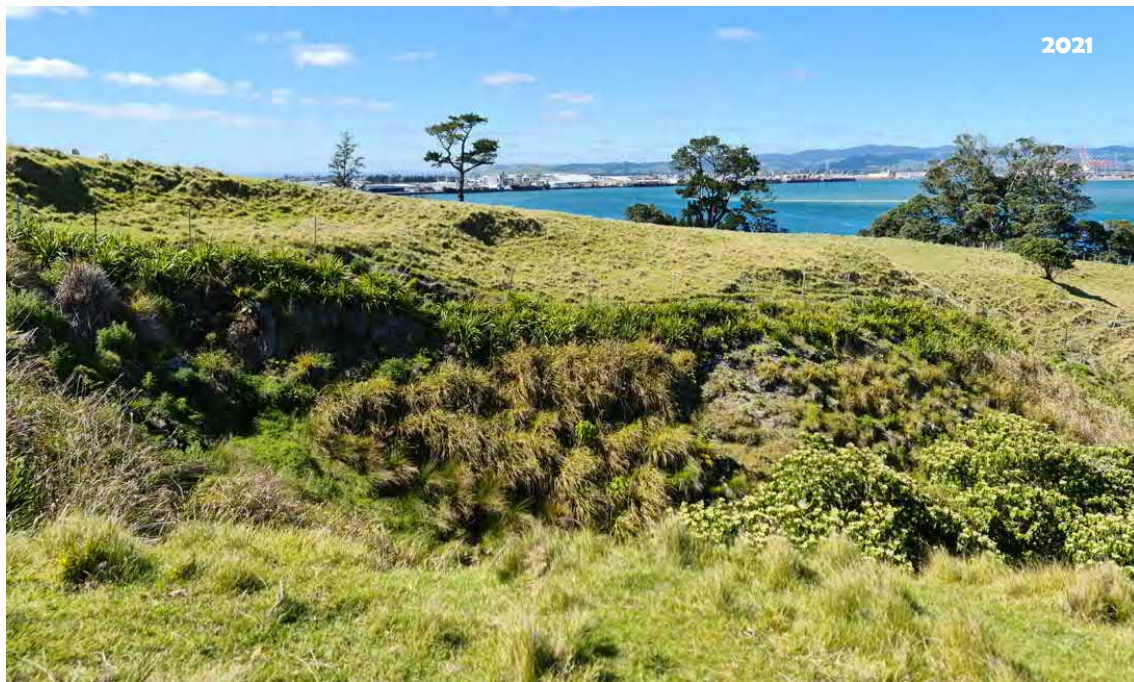
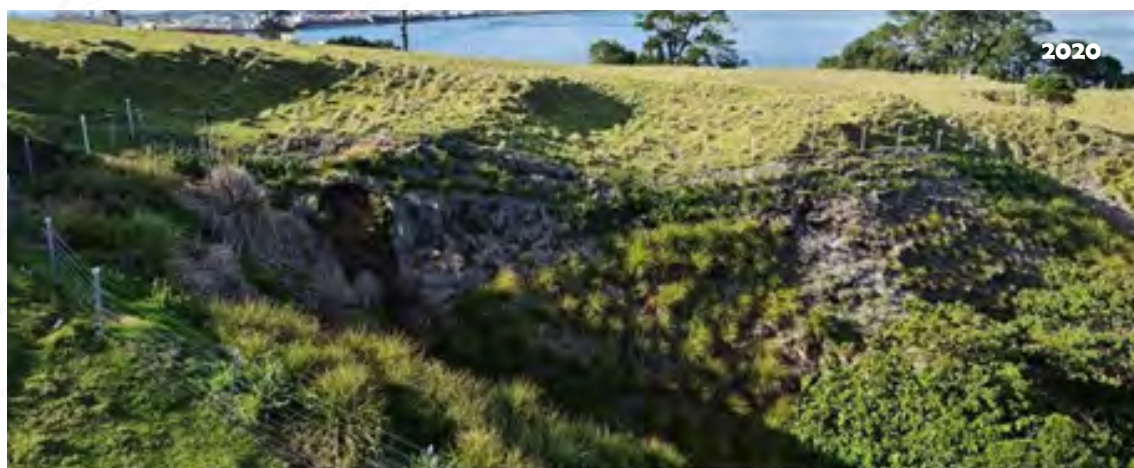
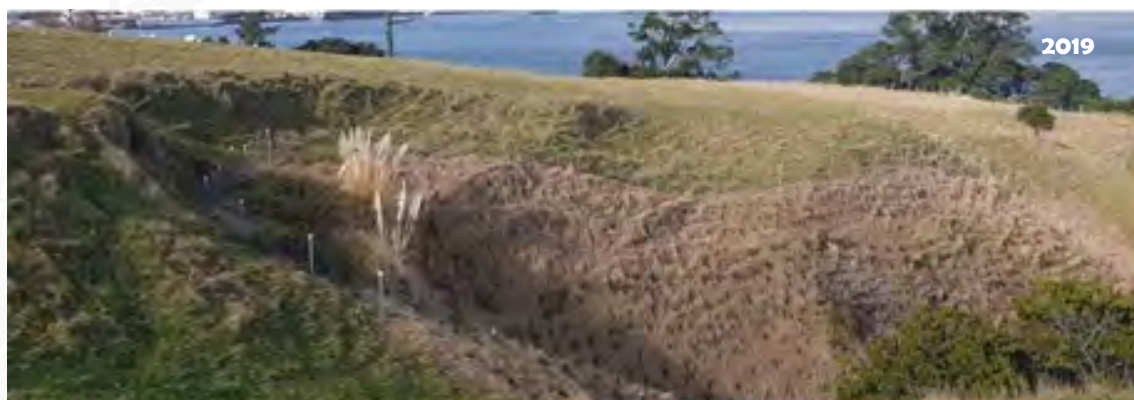
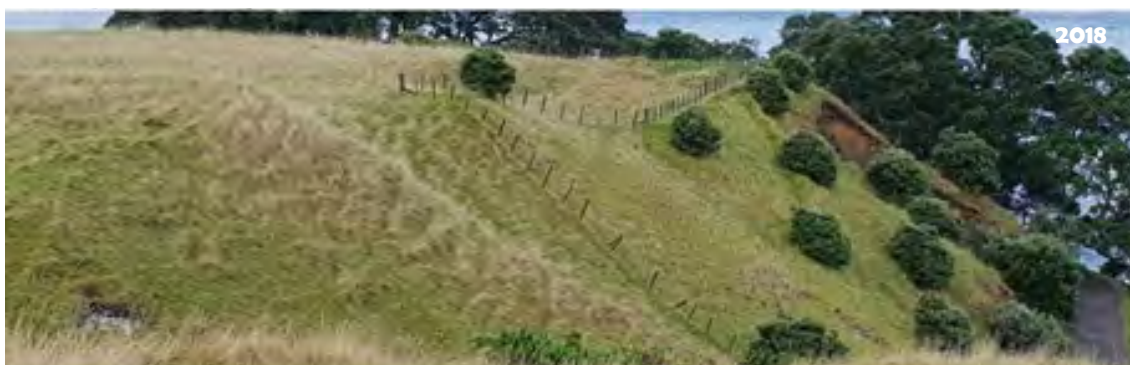
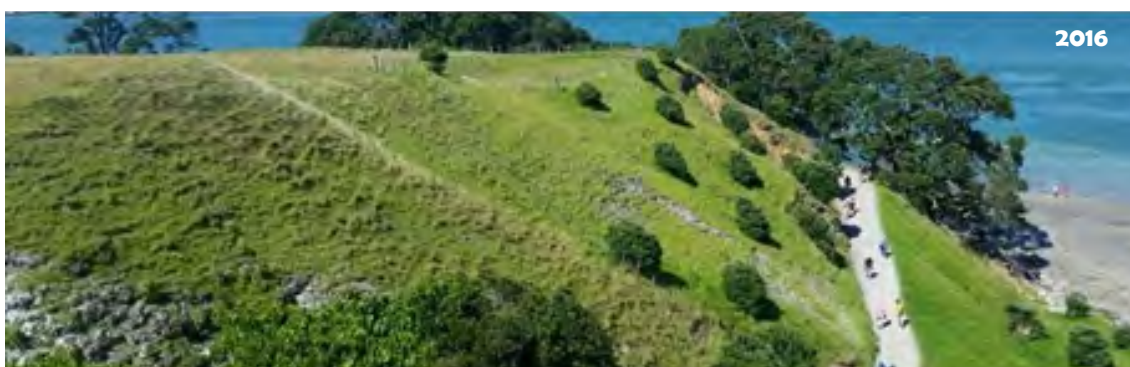
## Monitoring Site 5

Rabbit damage (inactive)

Notes: Old rabbit damage, visibility decreasing. Note danger that such features start to look like archaeological depressions over time. Area around burrow entrance has deflated over time

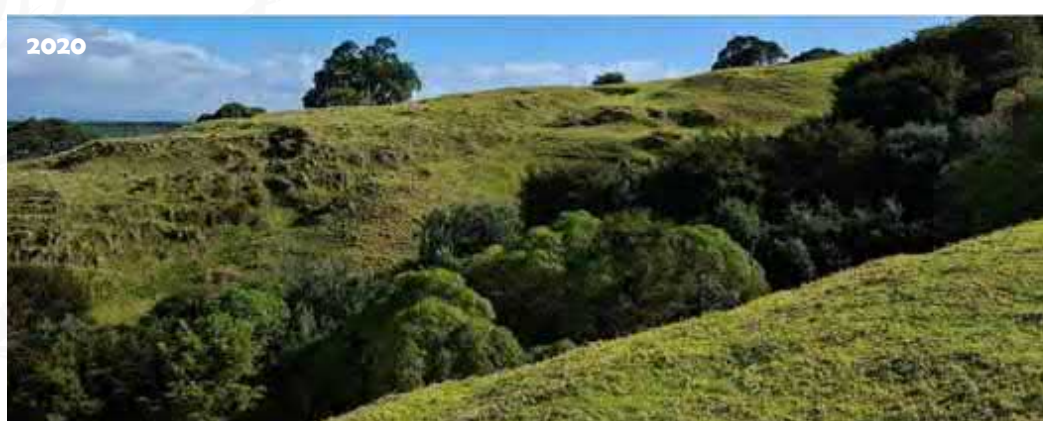
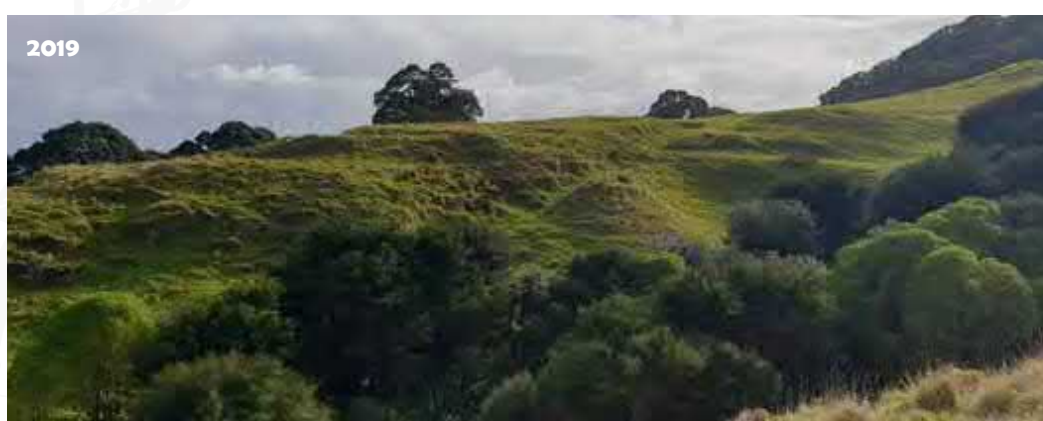
Pa U14/173 condition/grass cover

Notes: General views across pa to demonstrate grass cover. Site is stable with good ground cover being maintained. Very little evidence of recent rabbit browse but rabbits are present in low numbers and should be closely monitored.

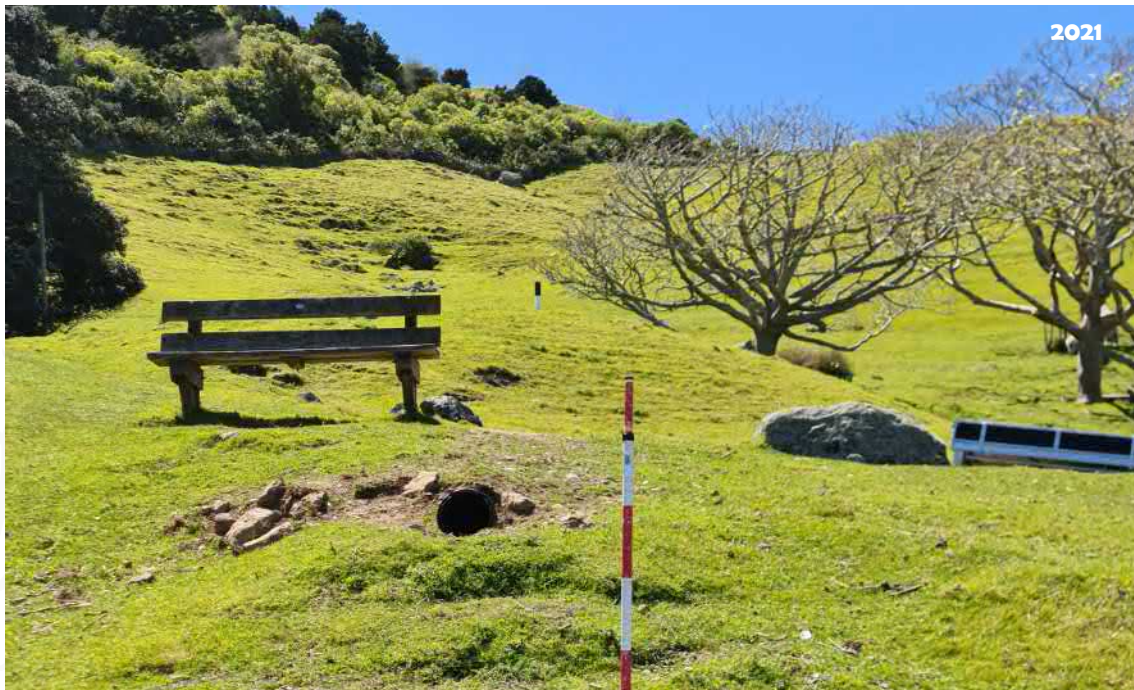
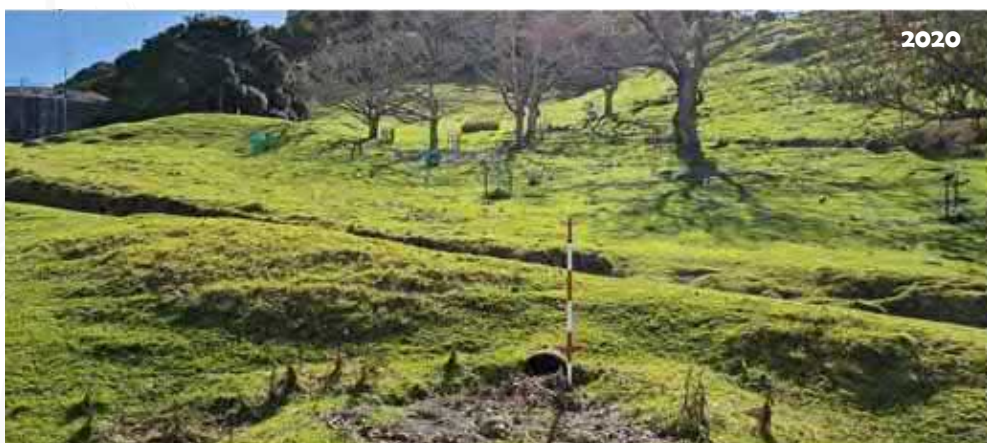
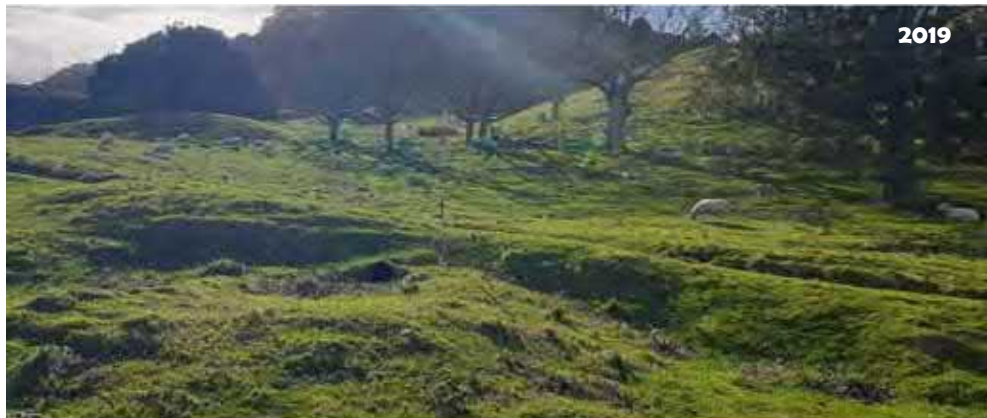
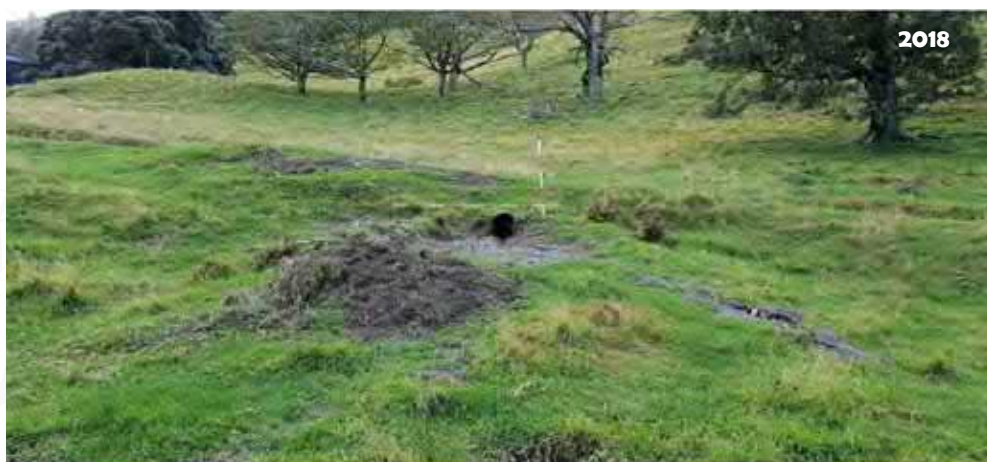
## Monitoring Site 7

4WD track maintenance issues - tailings management

Notes: There is no recent evidence of tailings being dumped on archaeological features above the track, as was the issue in the past. However, the artificial build-up of material continues to 'create' features adjacent to the track. There is still a significant issue with metal being distributed onto terraces below the track. The distance between culverts, their function and the treatment of tailings needs further management attention. Consideration should be given to removal of artificial build-up with archaeological supervision.

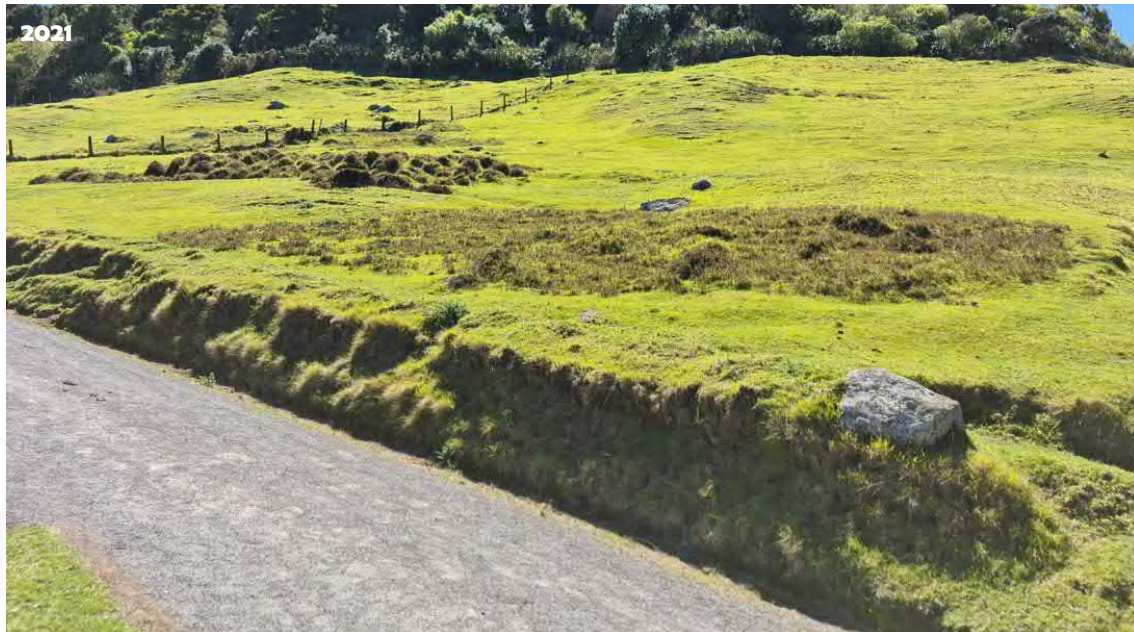
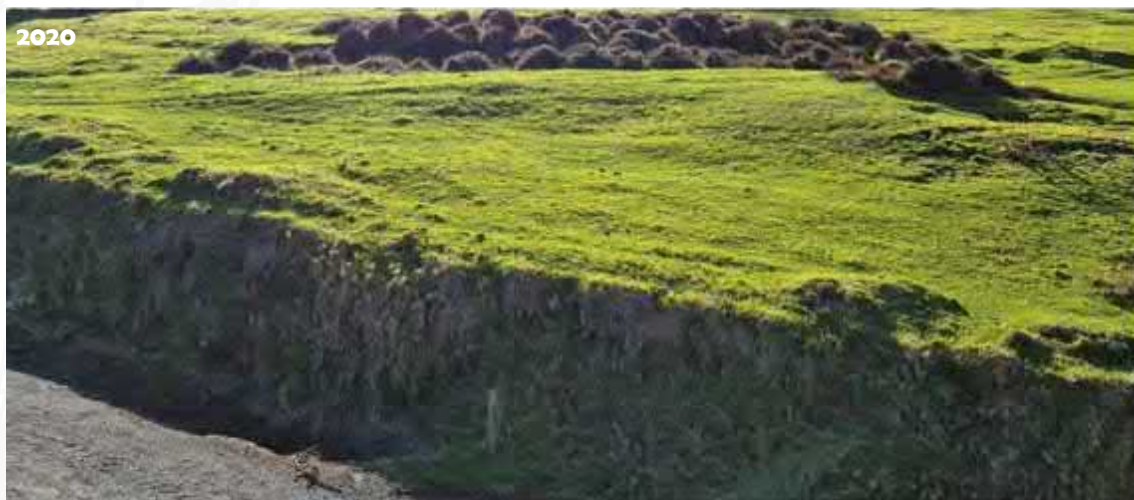
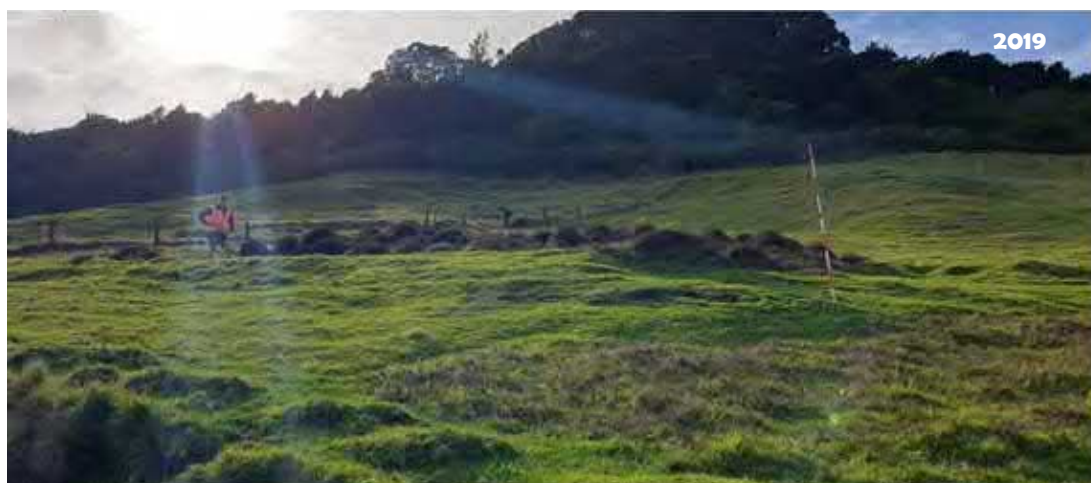
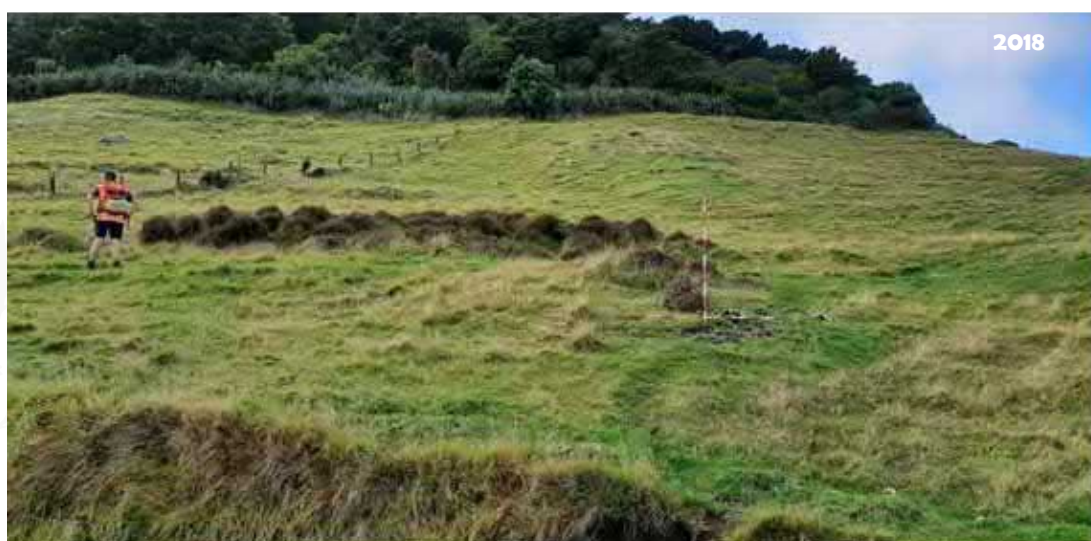
## Monitoring Site 8

Midden and vegetation management - pōhuehue growth

Notes: Grass sward is kikuyu; stock have had access to the mound since December 2019. Stock numbers in Spring 2021 are higher than the previous year and this has impacted on the grass cover on the southern side of the mound. Stock numbers should be closely monitored and reduced if necessary to
