## **Ngā Poutiriao ō Mauao Meeting Friday, 3 December 2021**

ARCHAEOLOGICAL SITE CONDITION MONITORING  
REPORT - MAUAO HISTORIC RESERVE, TAURANGA

ARCHAEOLOGICAL SITE CONDITION  
MONITORING REPORT  
MAUAO HISTORIC RESERVE, TAURANGA

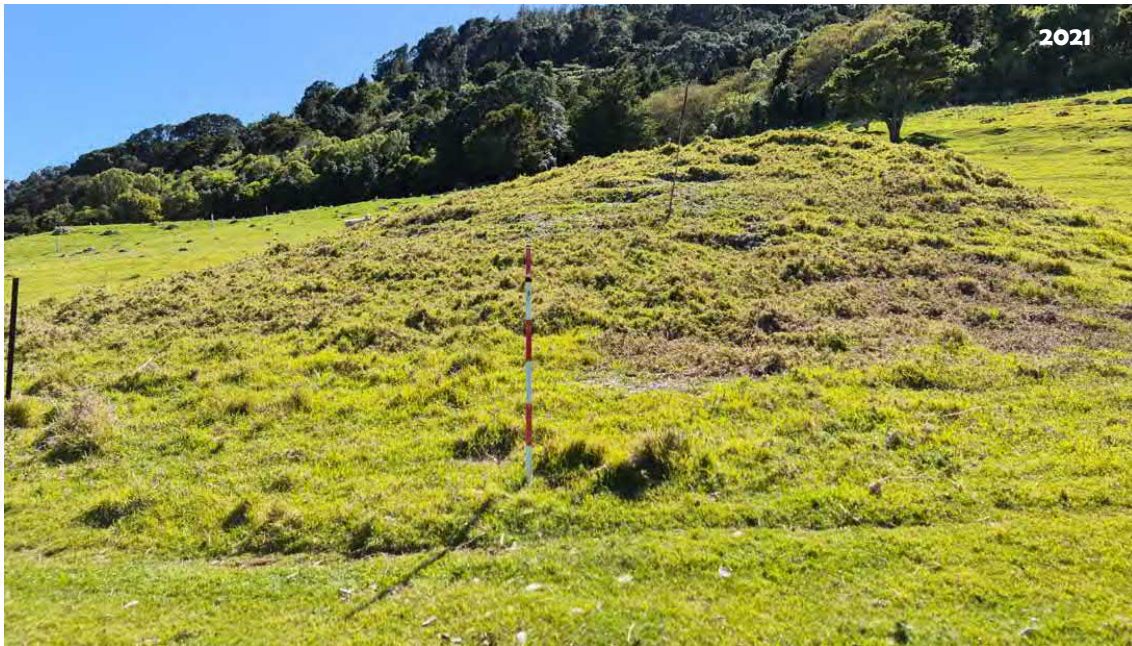
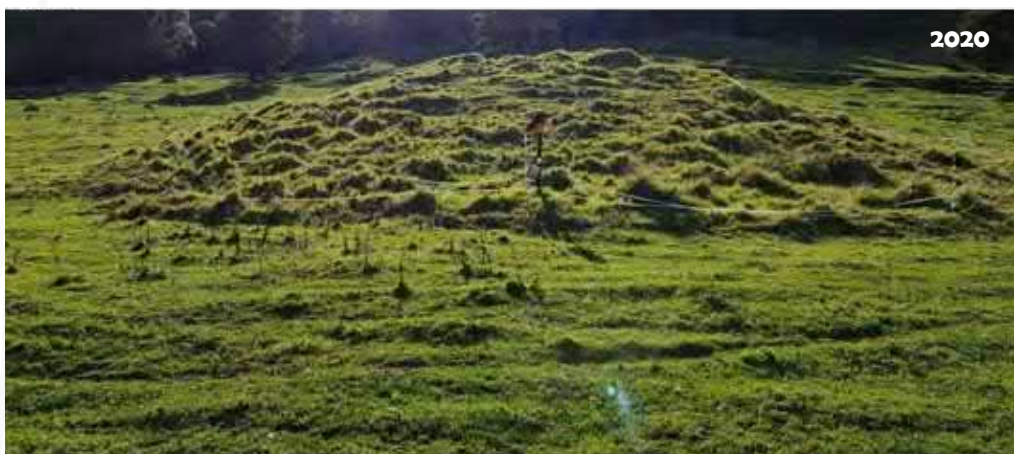
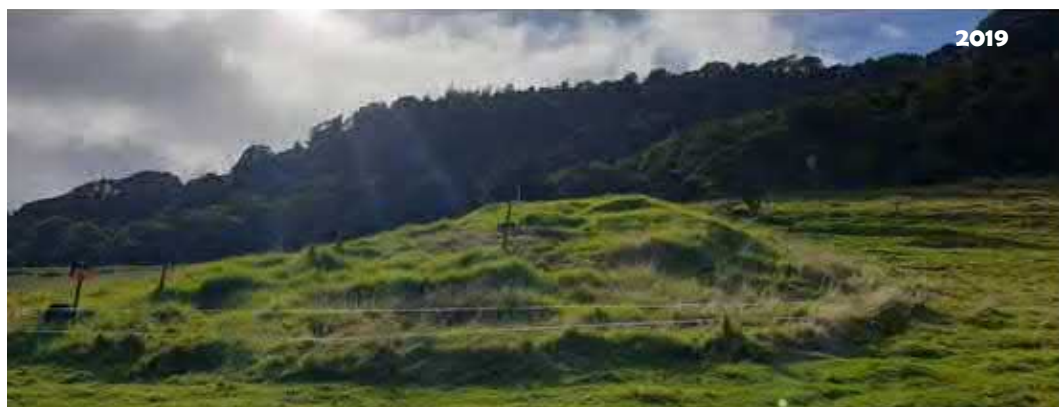
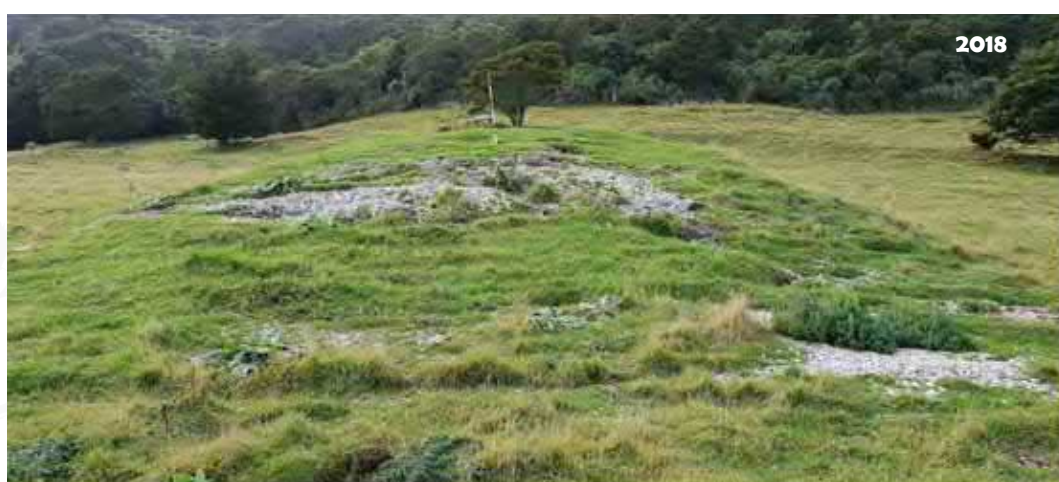
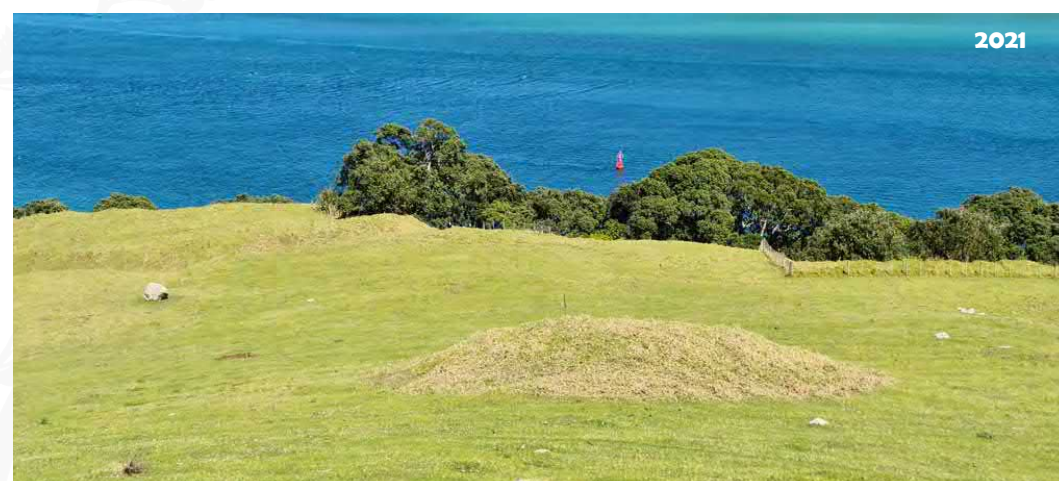
## Monitoring Site 9

Erosion on shell mound - stock and vegetation management

Notes: Grass sward is kikuyu; stock have had access to the mound since December 2019. Stock numbers in Spring 2021 are higher than the previous year and this has impacted on the grass cover on the southern side of the mound. Stock numbers should be closely monitored and reduced if necessary to maintain sward height.

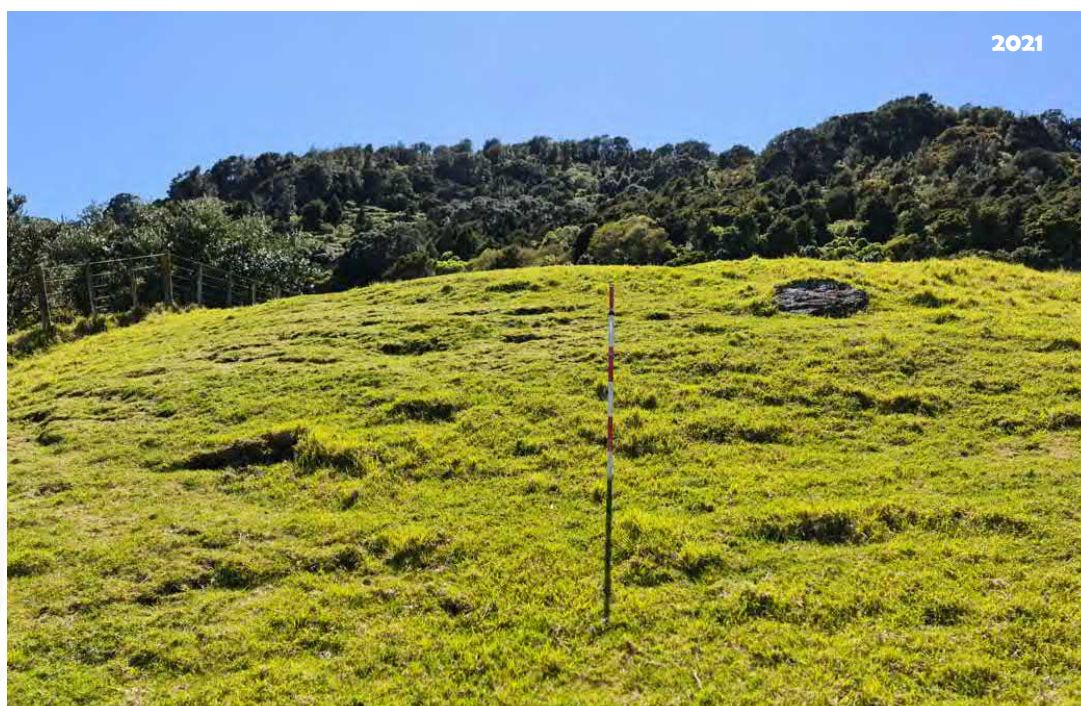
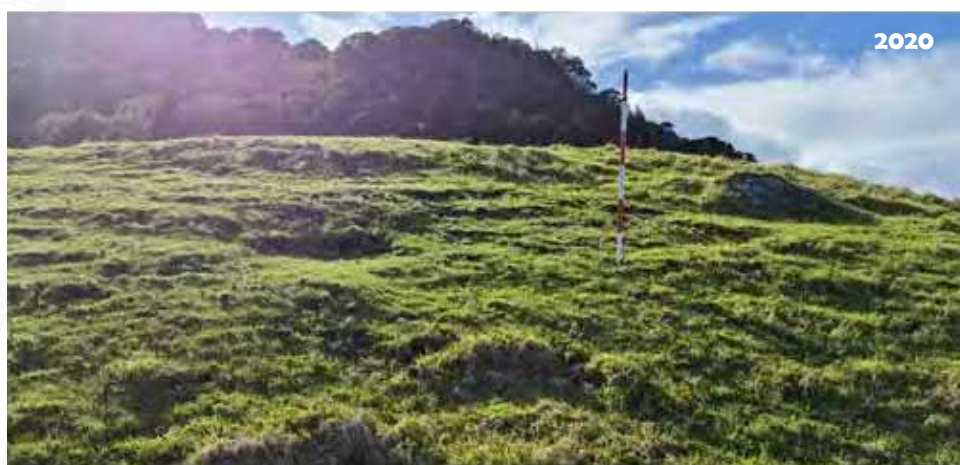
Rabbit damage (active)

Notes: Vegetation cover has significantly improved as greater rabbit control measures are in place, but this should be closely monitored. No recent rabbit browse at this location, but rabbits were seen in the area during the monitoring visit.

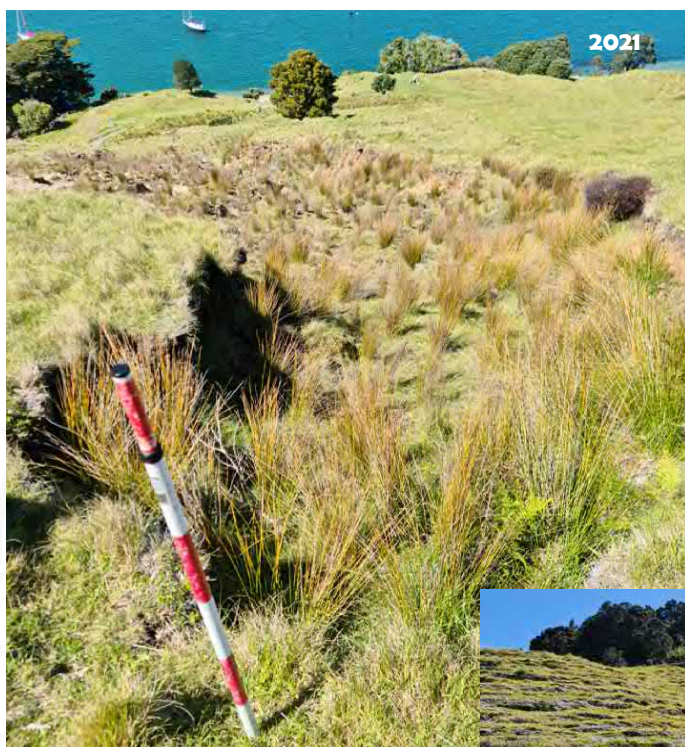
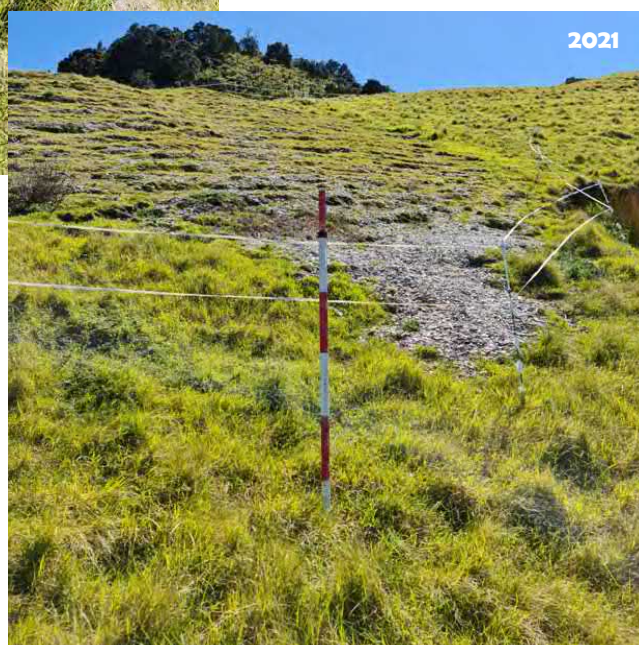
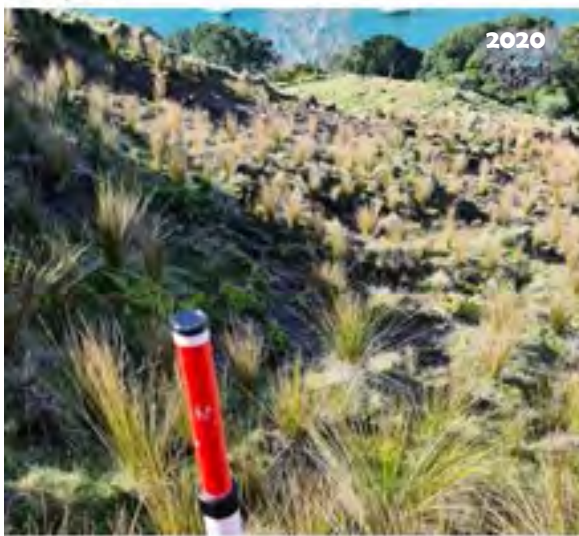
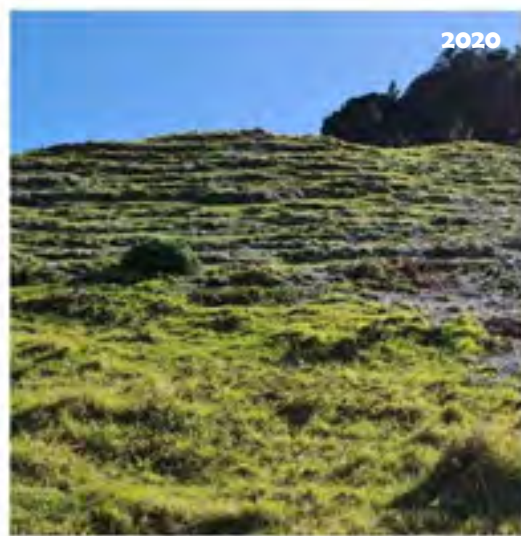
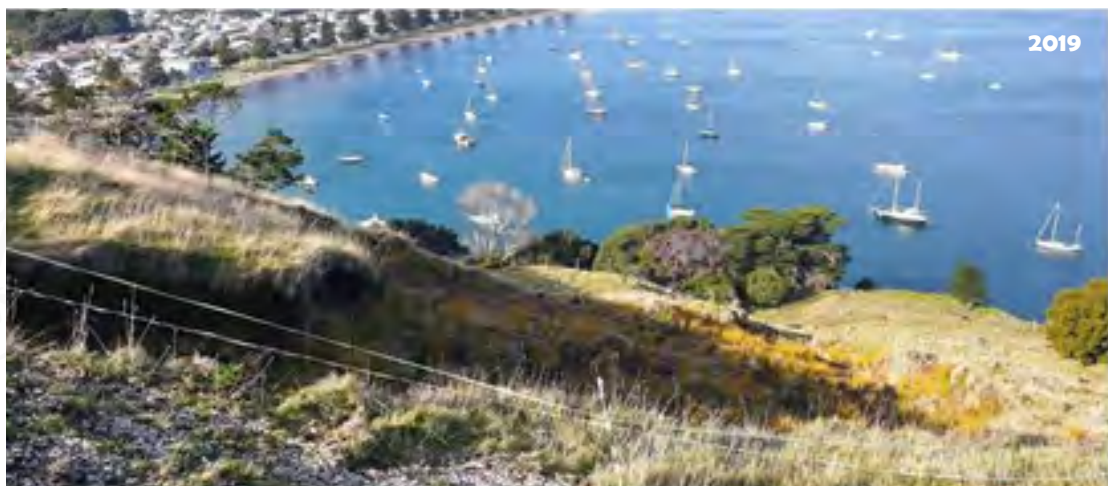
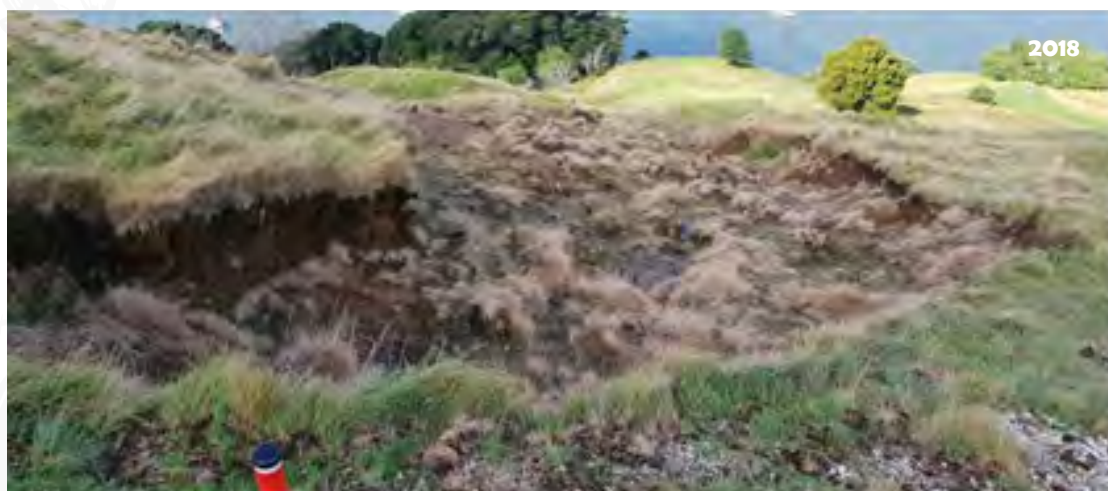
Land slip on southern slope

Notes: 2018 planting of slip scar is well established. Still a lot of visible shell midden at the top of the slip scar and some limited new exposure since 2020 inspection. Stock exclusion on shell mound not successful so far due to location, it may need a temporary netting fence instead. Recommend archaeological investigation followed by planting and livestock exclusion.

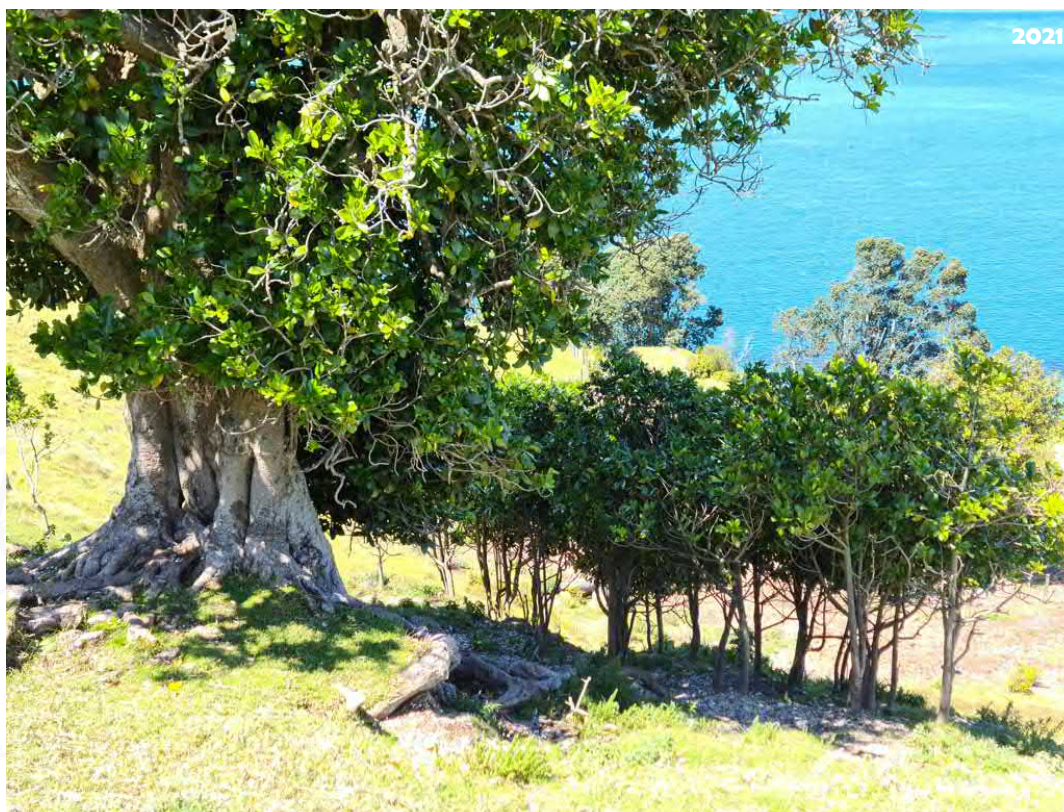
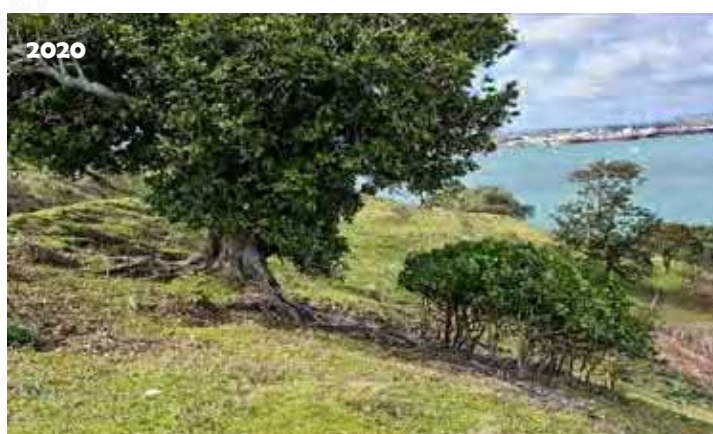
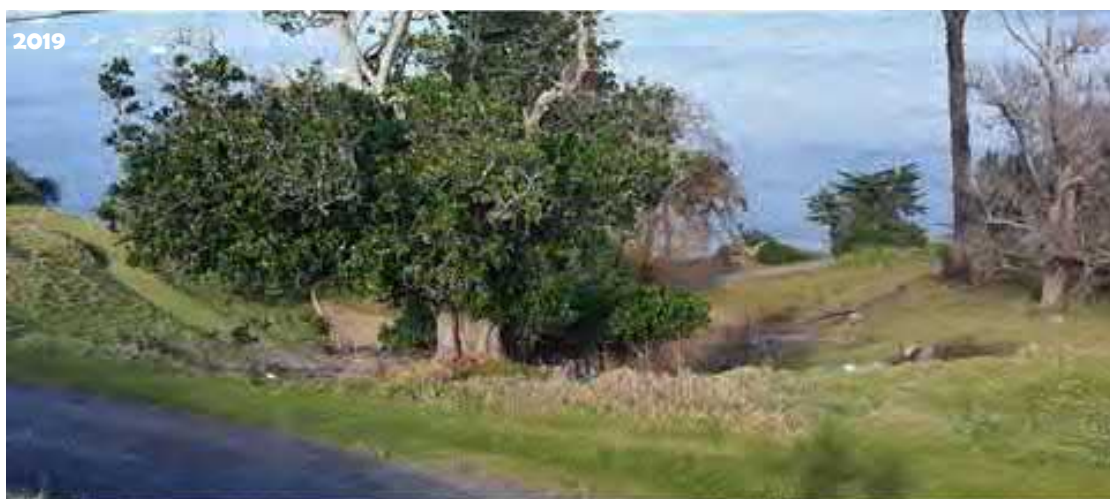
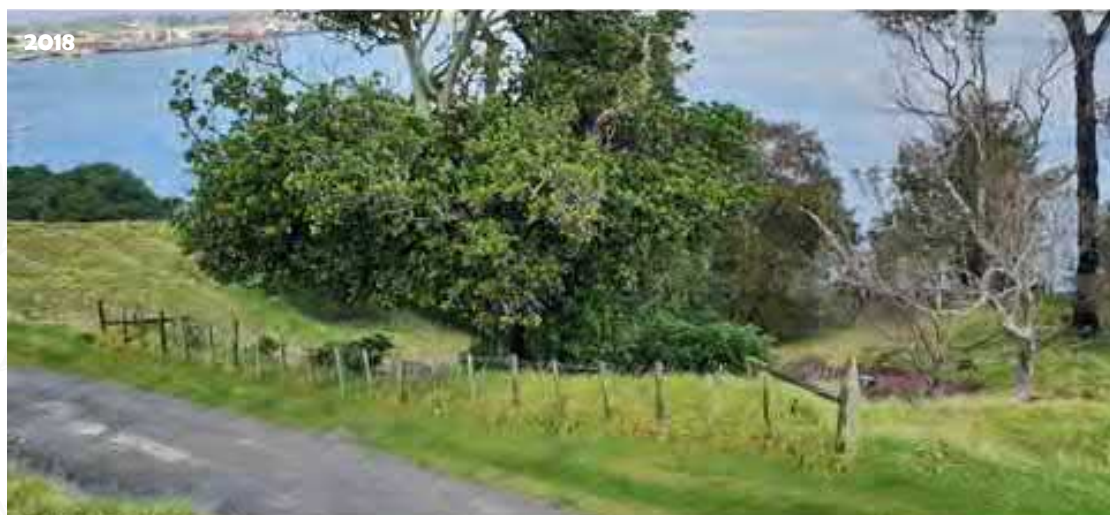
## Monitoring Site 12

Fence around middens on southern slope

Notes: Fence around middens that was installed in 2003 was removed in 2018. Some browse of young karaka initially, but grove now well established and no new erosion of midden in evidence. Continue to monitor condition.

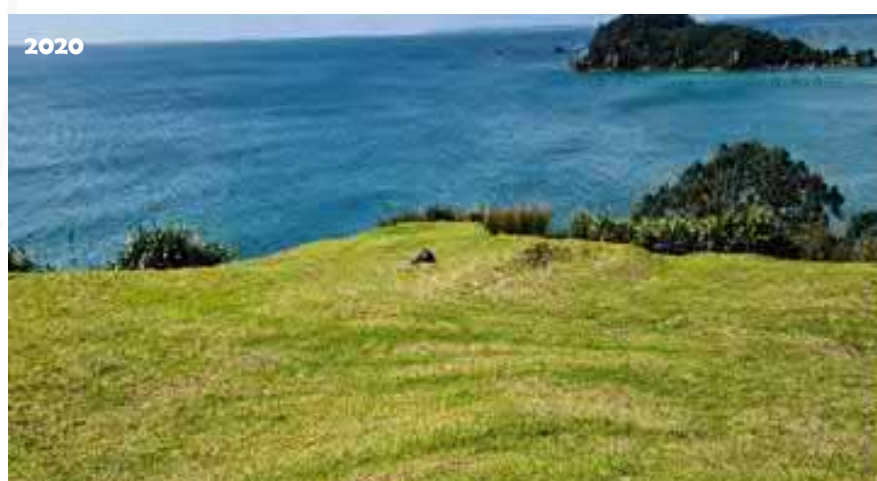
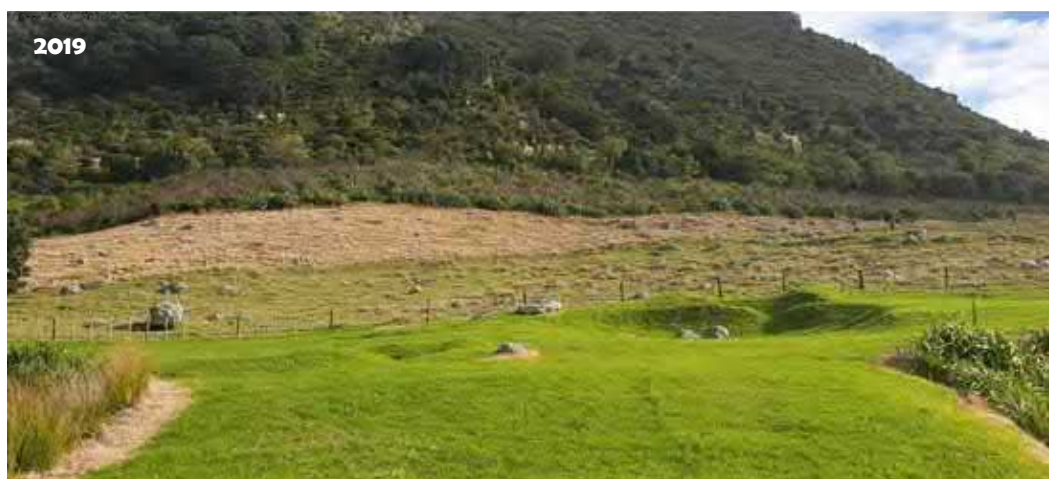
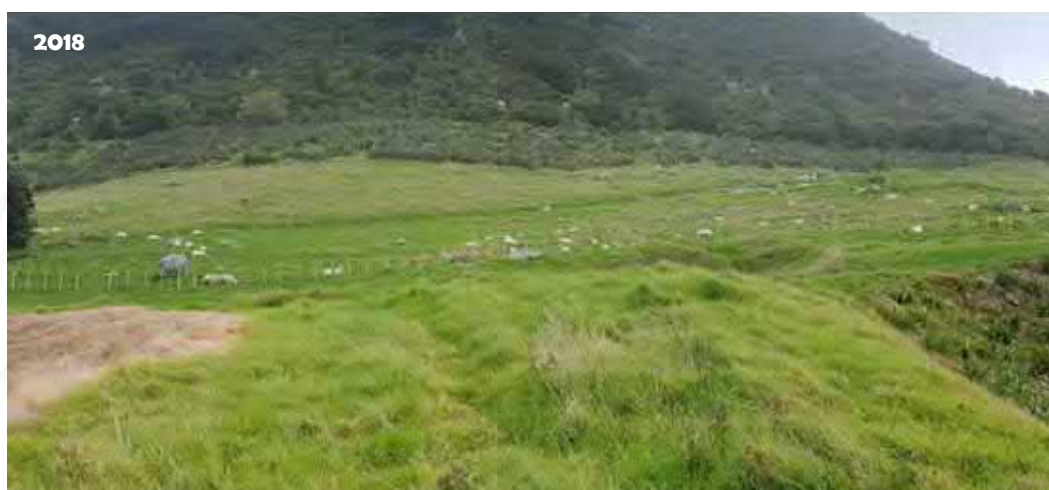
## Monitoring Site 13

Area of military camp, helicopter pad, pits and terraces retired from grazing in 2018

Notes: Management of vegetation and site visibility has significantly improved following cessation of grazing. Features stable.

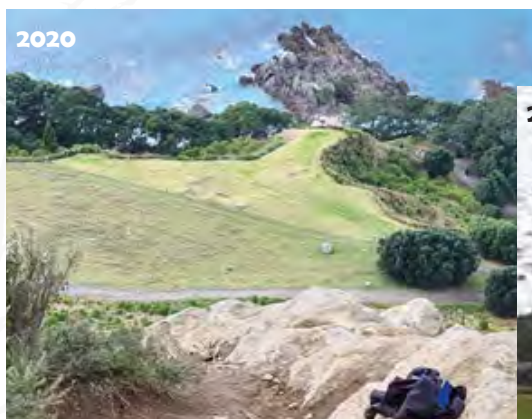
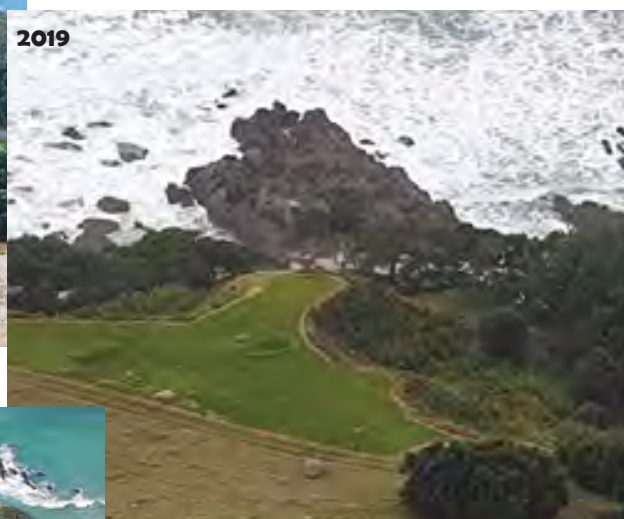
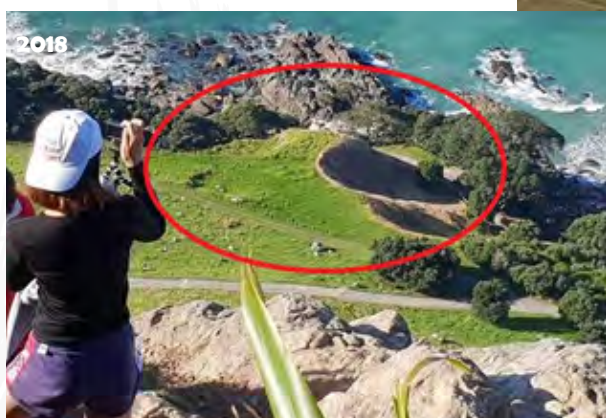
## Monitoring Site 14

Repairs to summit terrace

Notes: Repair to terraces completed in 2013. The aggregate at the base of the slope was not moved as recommended as in 2019, but now less visible. Encroaching vegetation has been managed to keep terraces visible.

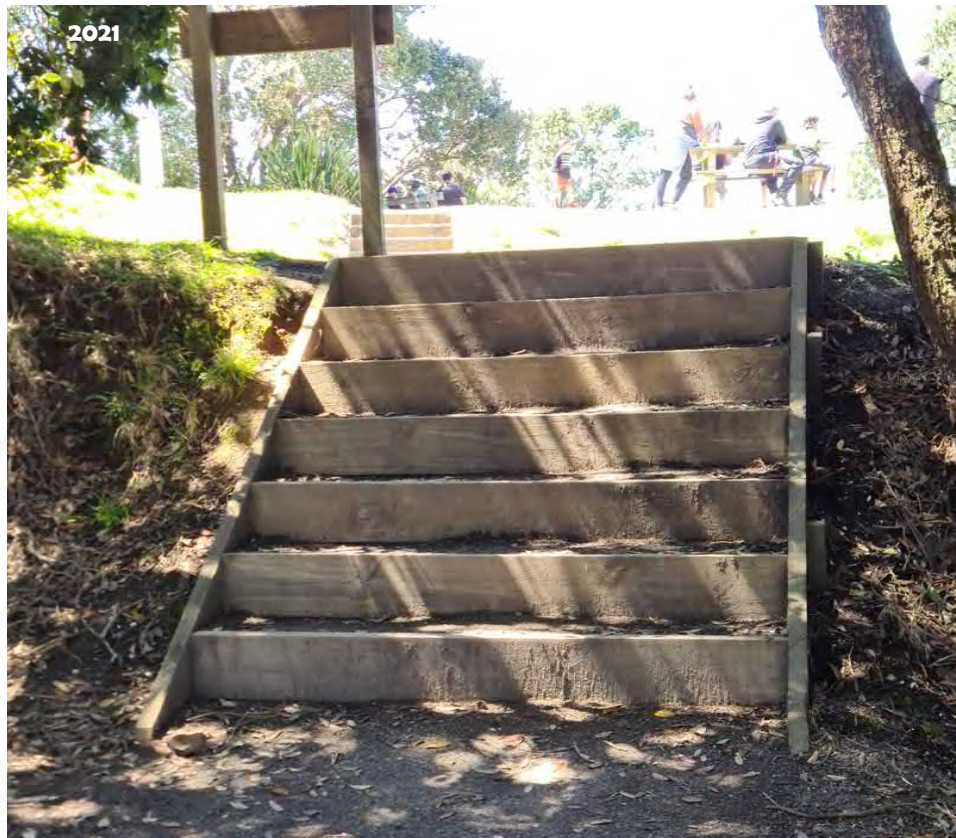
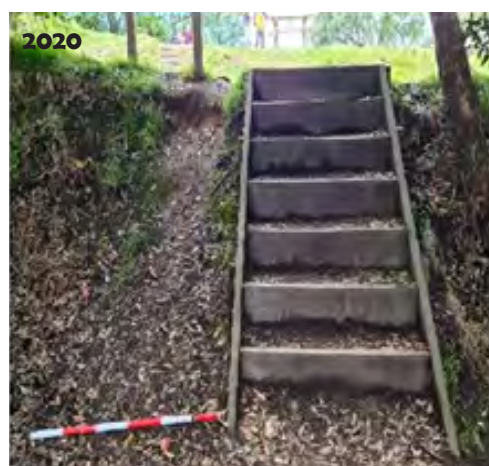
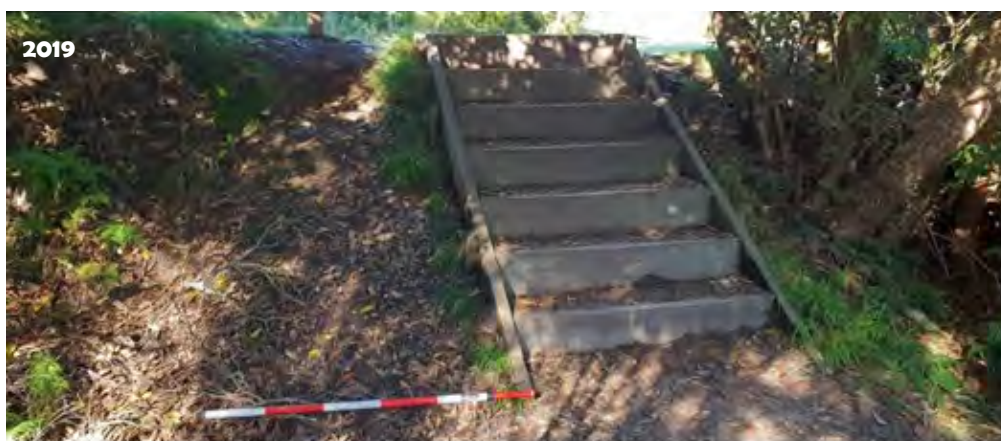
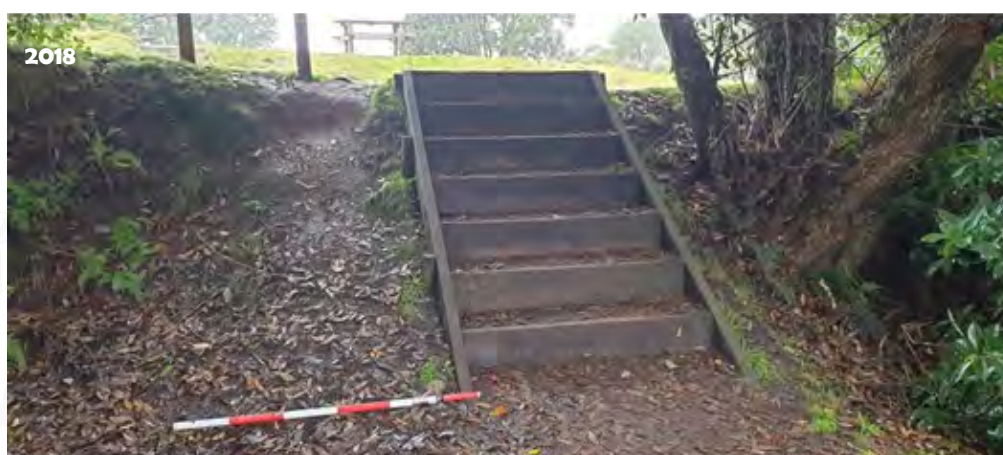
## Monitoring Site 15

Repair to bank on summit and steps intallation

Notes: Width of steps has been increased to cover desire line. Continue to monitor use.

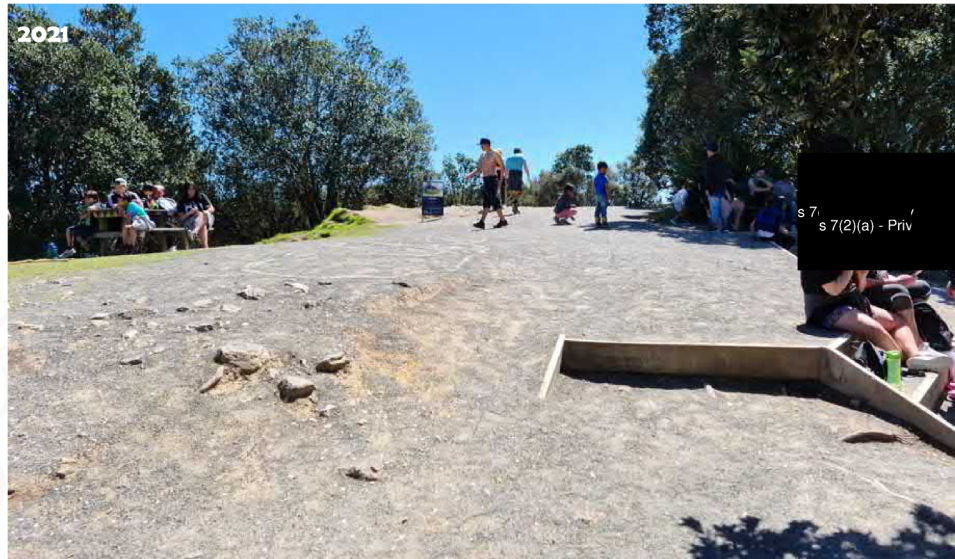
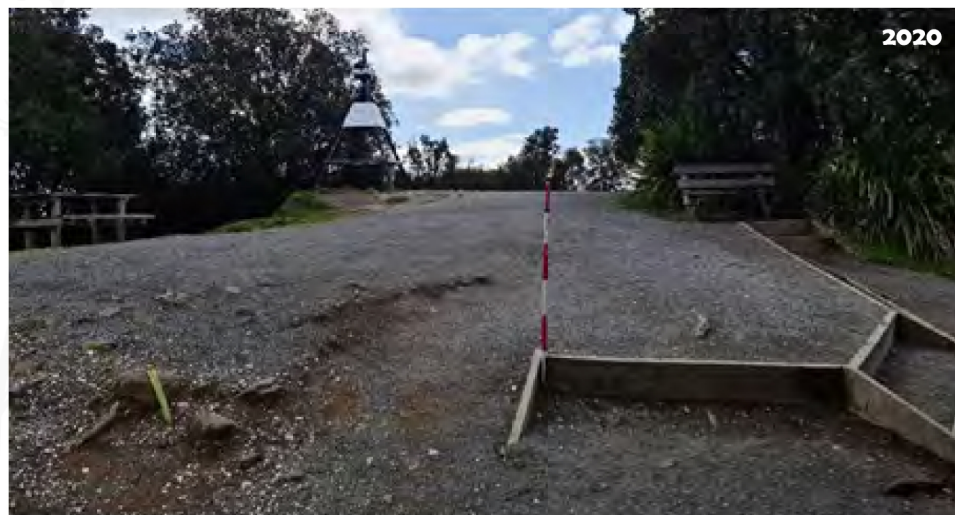
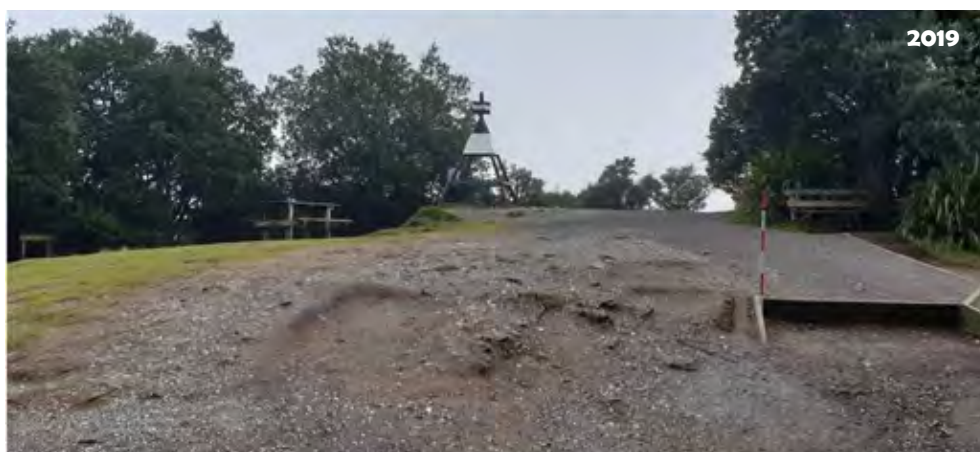
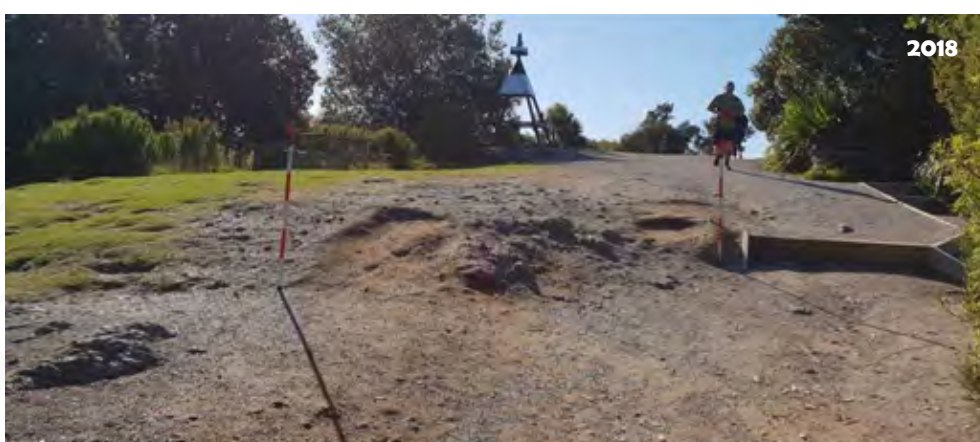
## Monitoring Site 16

General monitoring of summit wear

Notes: There is on-going wear of imported armouring material on summit; on-going recapping is required by bringing in additional material from stockpile. Trig removed June 2021.

| No. | Action | Timeframe | Comment on progress |
|---|---|---|---|
| 1 | Condition monitoring of capping and informal desire lines | On-going | Further recapping with fill material required. |

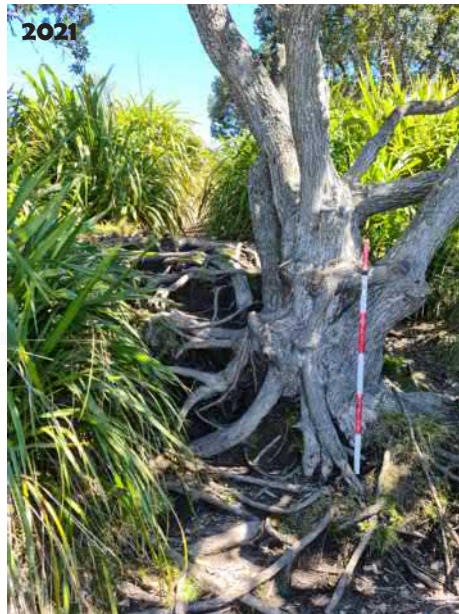
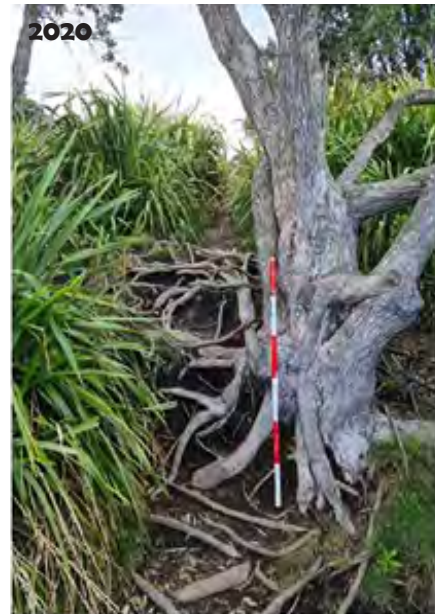
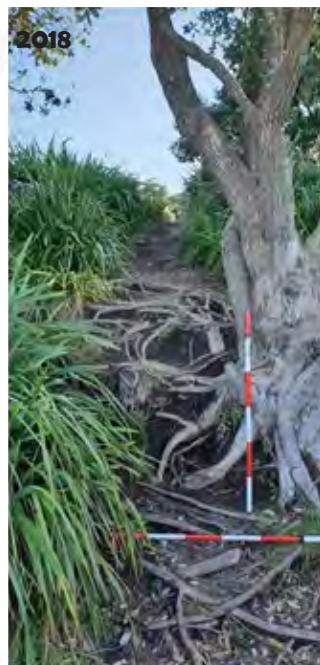
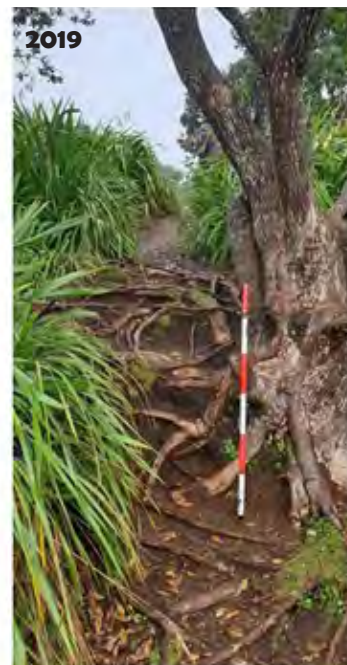
## Monitoring Site 17

Desire line track on summit

Notes: Desire line is continuing to cause wear to intact archaeological deposit, and soil loss is readily apparent. Action to block access to prevent further wear was recommended in 2018 and needs to be implemented. Continue monitoring. Additional fill material may be required around the tree.

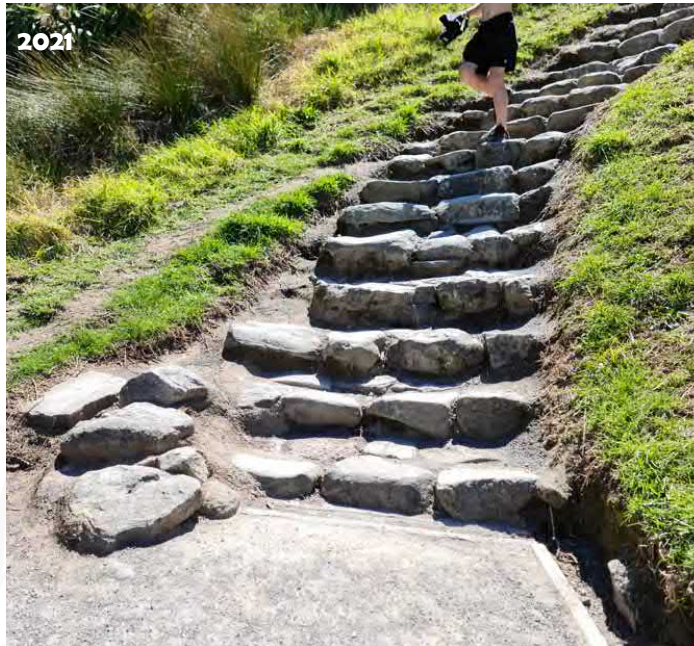
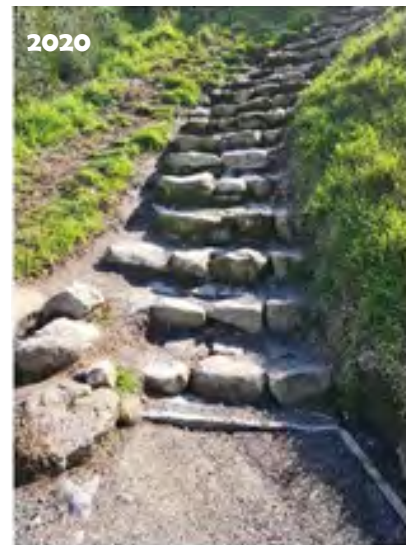
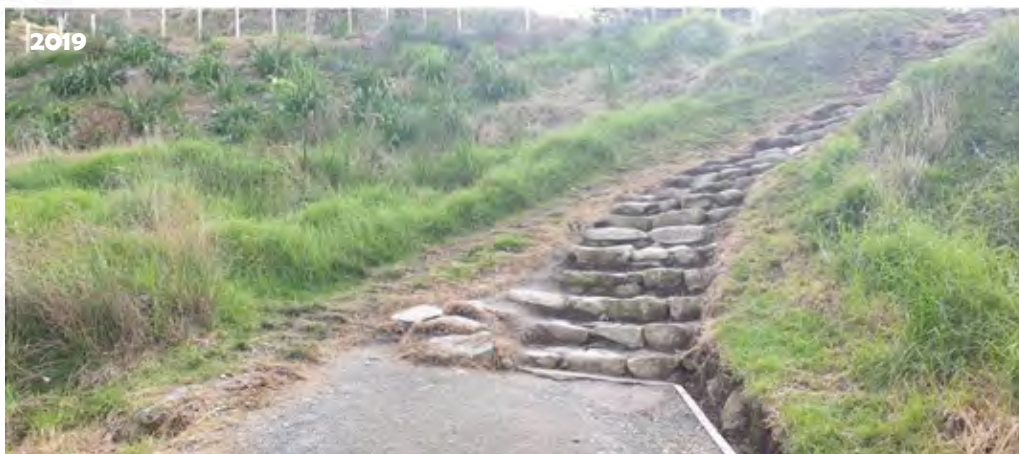
Stone steps condition and erosion

Notes: Stonework stable at present, but erosion from desire line more visible than in 2020. Weed spraying corridor needs to be reduced as this is encouraging desire lines. **Action needed at the top of the stairs to reduce water flow and erosion.**

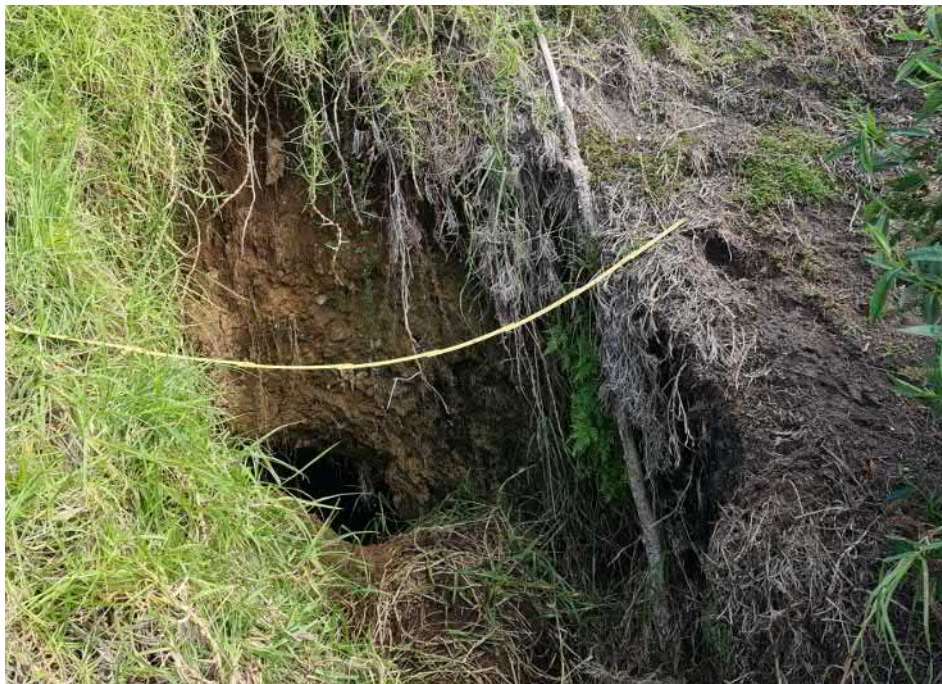
This feature looks likely to be a 1m<sup>3</sup> or so void collapse above a small underground watercourse in a natural "pipe", scoured out by flowing water.

*Photo 2; The sinkhole at the surface (2m scale).*

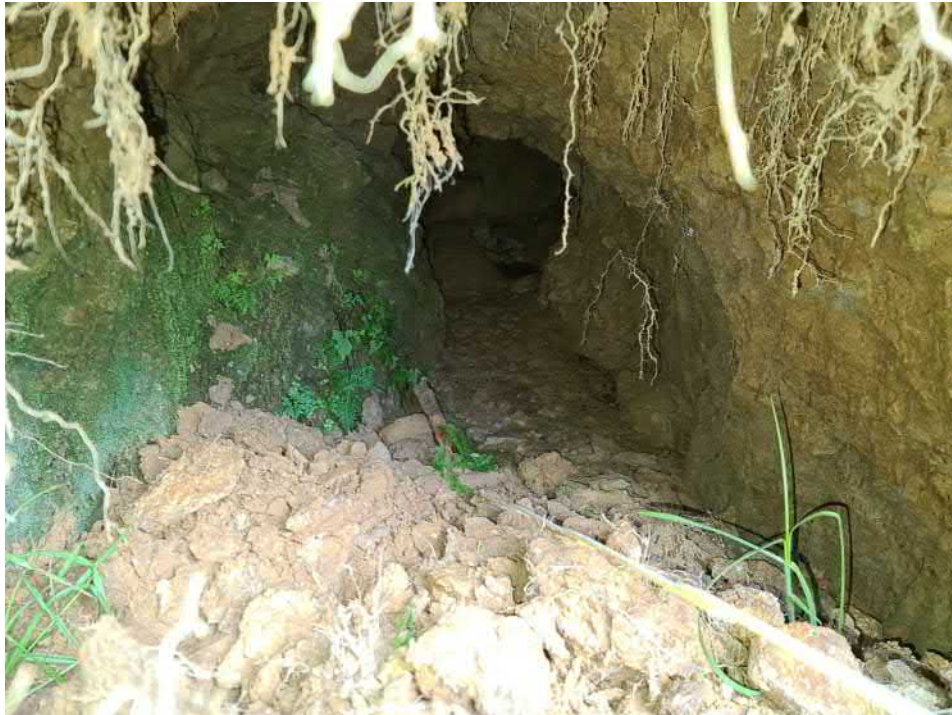
*Photo 3; The sinkhole entrance.*

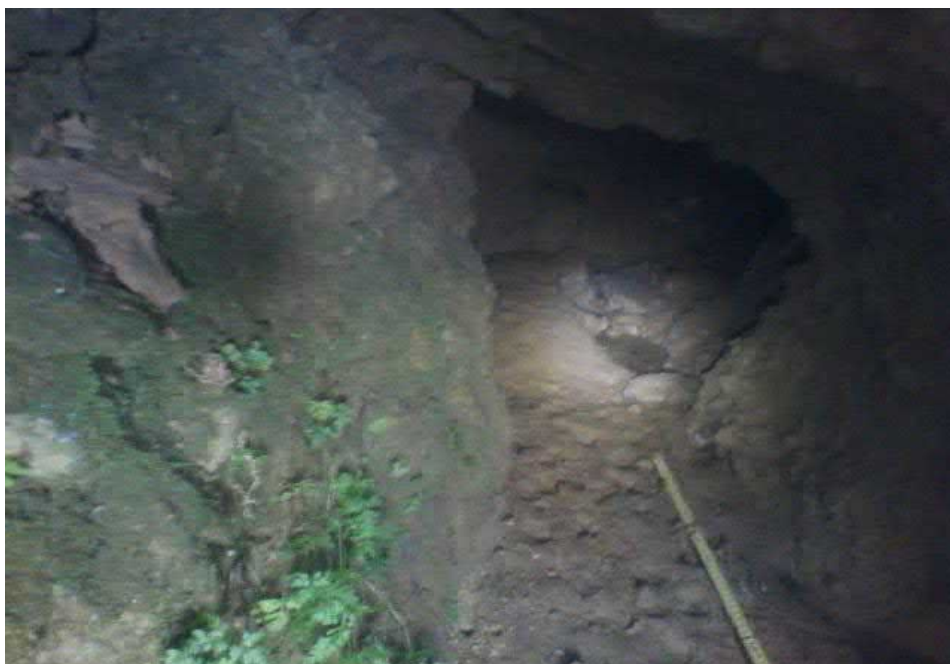
*Photo 4; Looking further in the 'tunnel' appears to continue to the right. A small pool of water can be seen on the floor.*

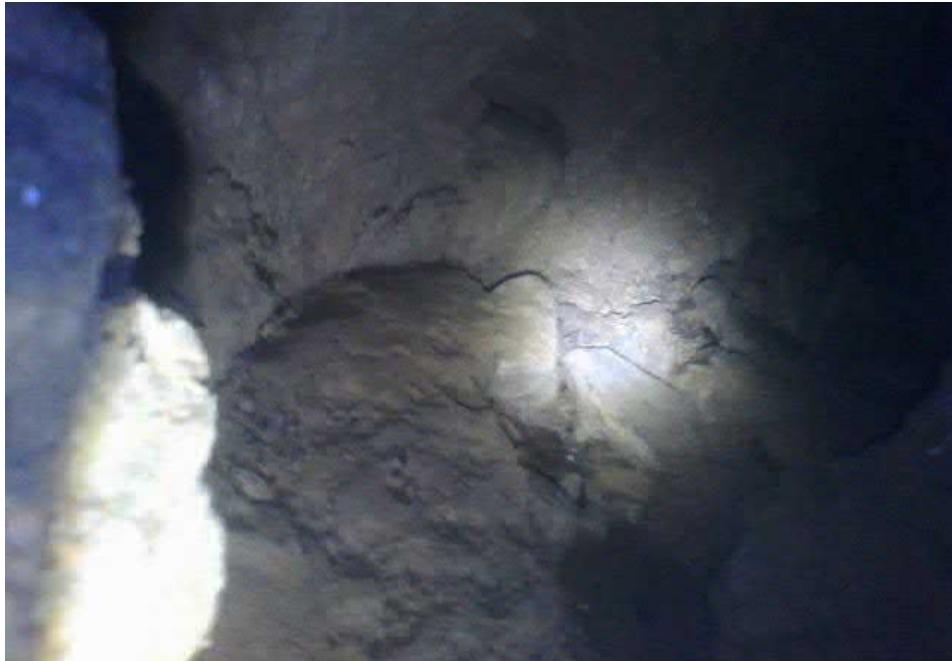
*Photo 5; The tunnel continues to the right. Furthest view in photo is around 5m from the entrance. The diameter of the tunnel here is around 0.5m.*

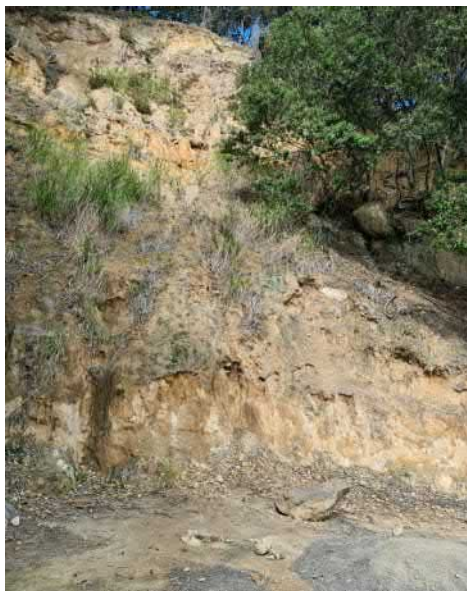
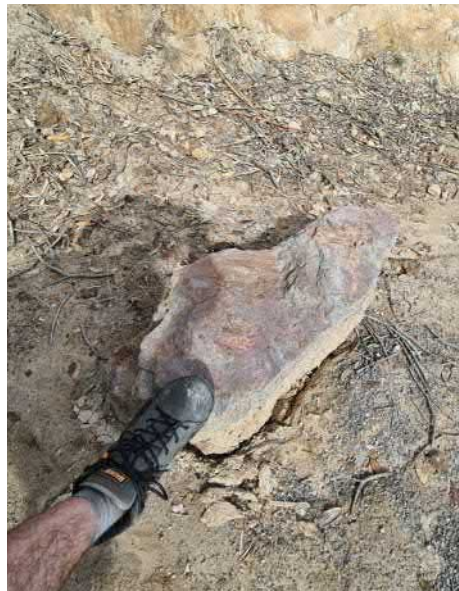
#### **6. Rockfall onto Base Track**

*Photo 6 & 7; A recent rockfall from the actively eroding slope above the Western Base track.*

As has been the case for many years, this slope continues to actively erode and generate occasional falling rock.

We recommend that this particular slope should continue to be scaled regularly as required, as new surface rocks are exposed.

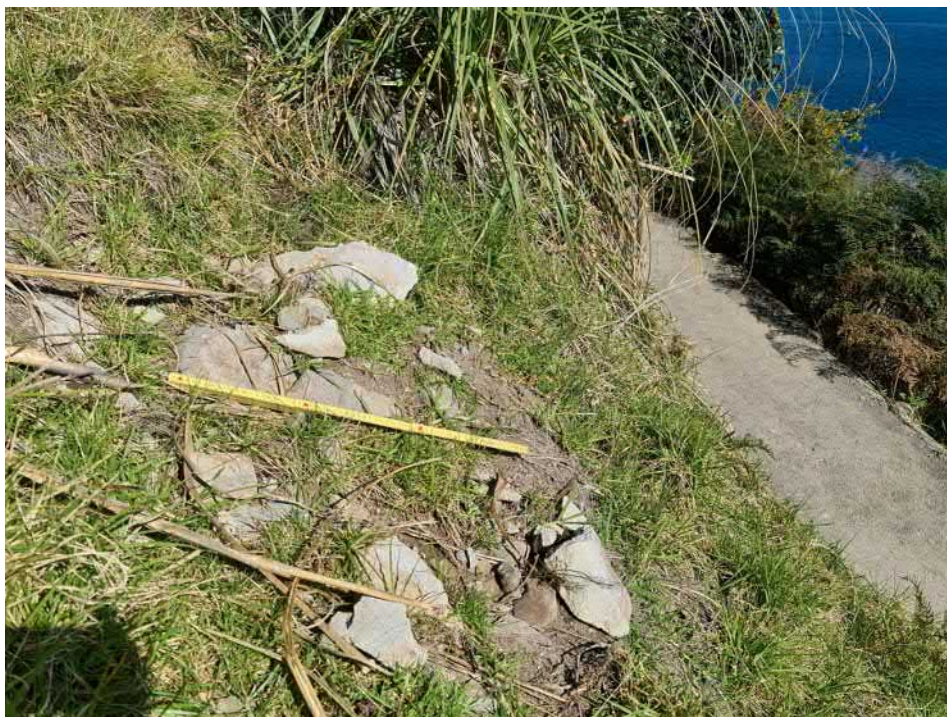
#### **7. Loose surface rock above the Oruahine track**

*Photo 8; Rock resulting from a small soil slip above the Oruahine track.*

In this case the rock is only 2m above the track so does not present a hazard but it illustrates how small soil slips and erosion continue to bring new rock to the surface.

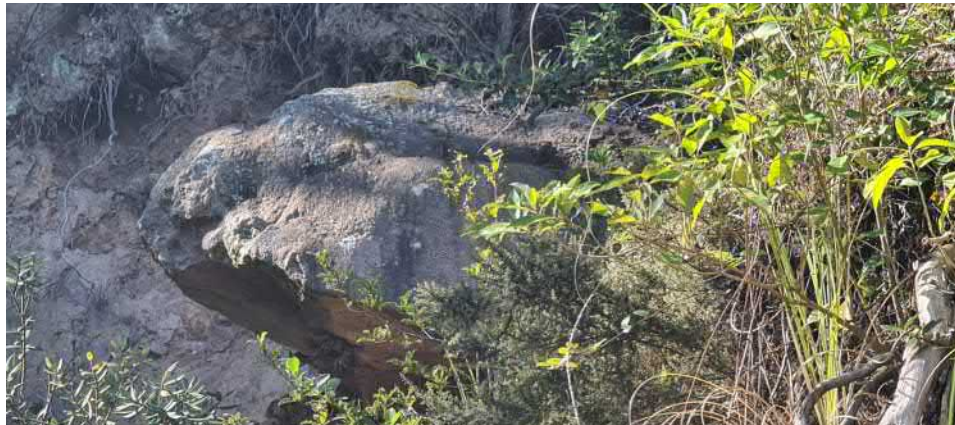
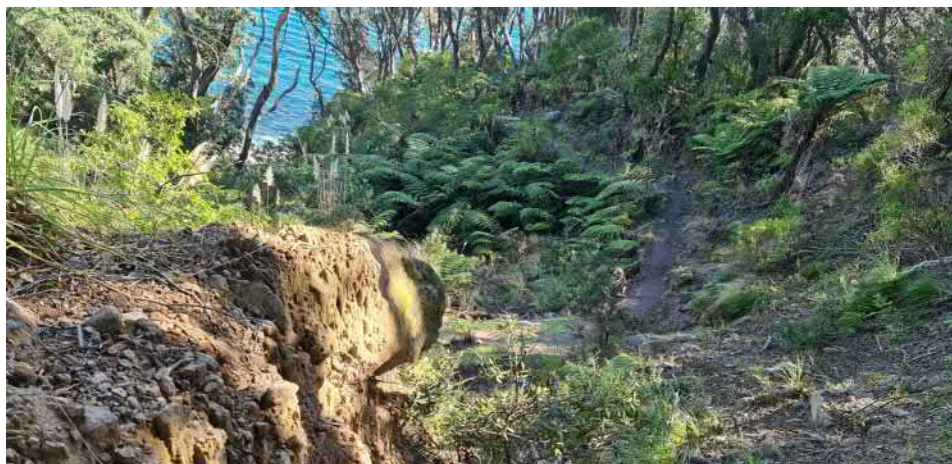
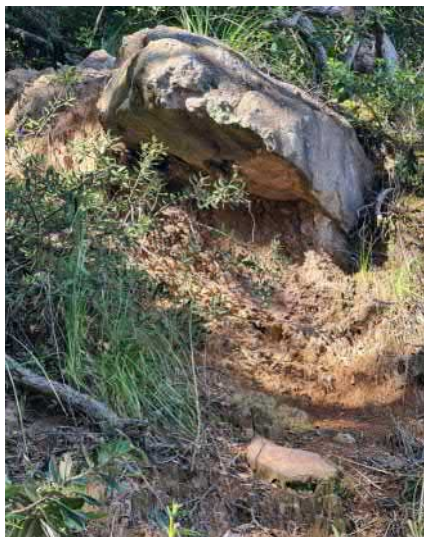
The location is at the crest of an exposed slip face around 10m above the mid Goat track. The boulder does pose a hazard to persons using the track below.

This boulder appears likely be able to be scaled relatively easily. Although it is unlikely to pick up enough speed to reach the Base track, there is a small possibility that it may therefore a temporary Base track closure would be required.

*Photo 9, 10, 11; Overhanging boulder above Goat track.*
