## **Ngā Poutiriao ō Mauao Meeting Friday, 3 December 2021**

ARCHAEOLOGICAL SITE CONDITION MONITORING  
REPORT - MAUAO HISTORIC RESERVE, TAURANGA

ARCHAEOLOGICAL SITE CONDITION  
MONITORING REPORT  
MAUAO HISTORIC RESERVE, TAURANGA

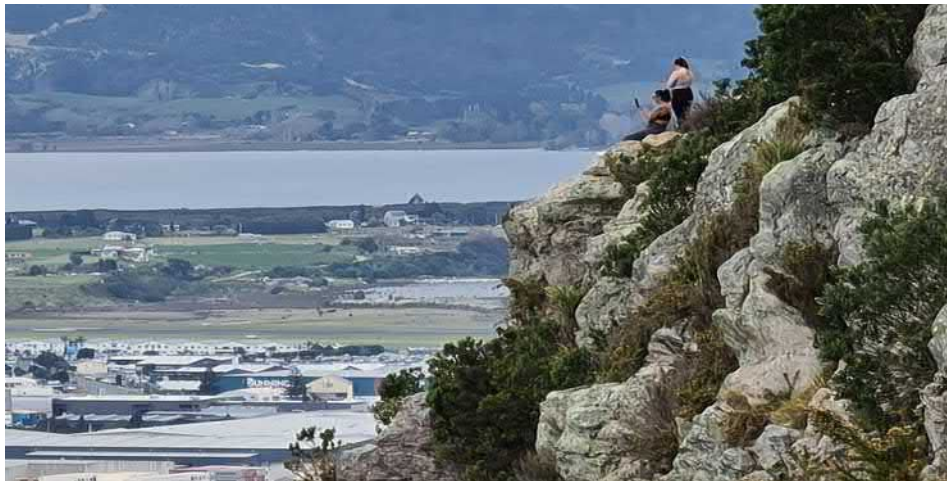
Photo 12; Off track persons on bluff crest above Waikorere track.

We have no reason to believe such persons triggered the 2 August rockfall, although it is possible.

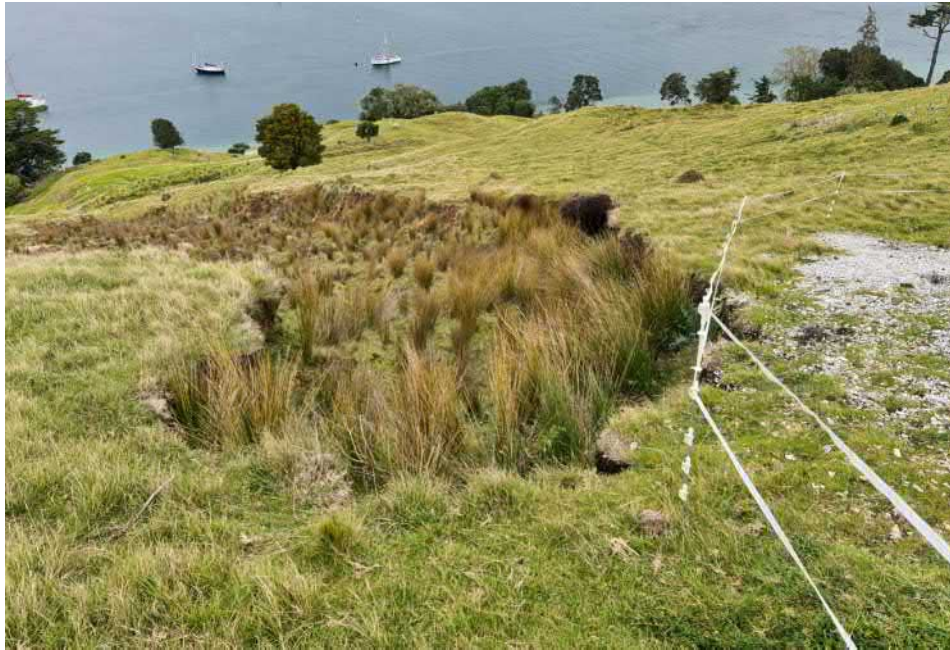
This slip was triggered by a large storm event in May 2005. 350mm of rain fell in 24 hours. It was initially two smaller slips, designated #7 and #8 out of a total of 52 slips generated by that rainfall event. *Extract from Avalon Report 0534B*

These separate slips eventually joined together and continued to expand, resulting in the picture today. Planting efforts have helped slow the erosion rate.

*Photo 13; Slip from above. Note midden on right.*

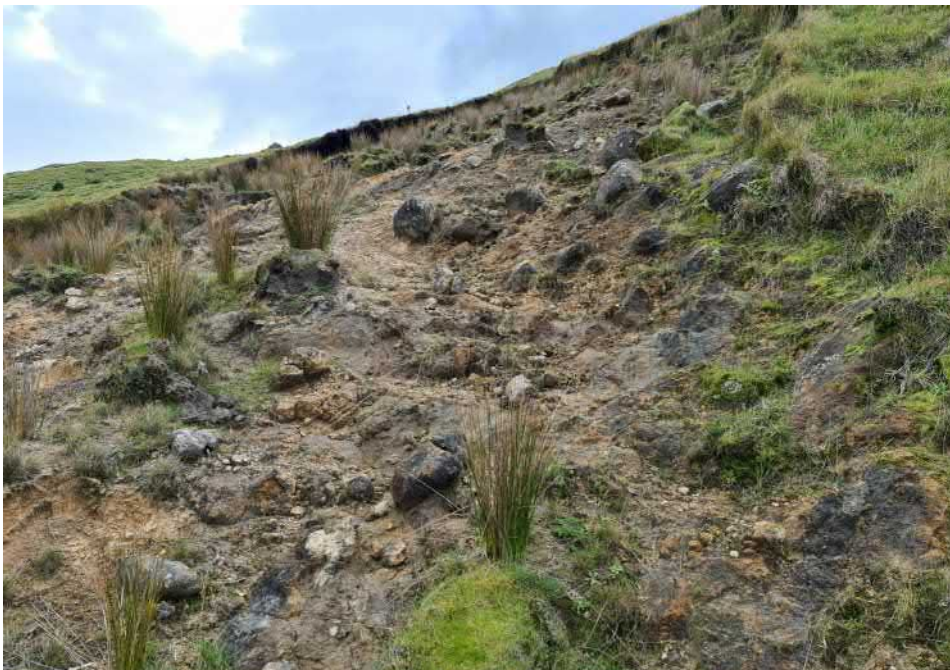
*Photo 14; Slip from below. Very rocky, difficult for vegetation to establish.*

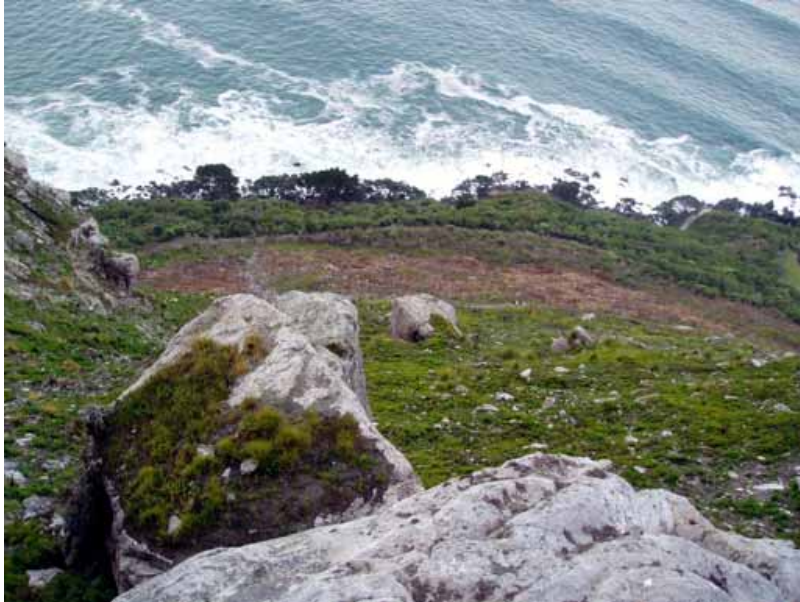
Photograph No 22; Unstable column at 3d.

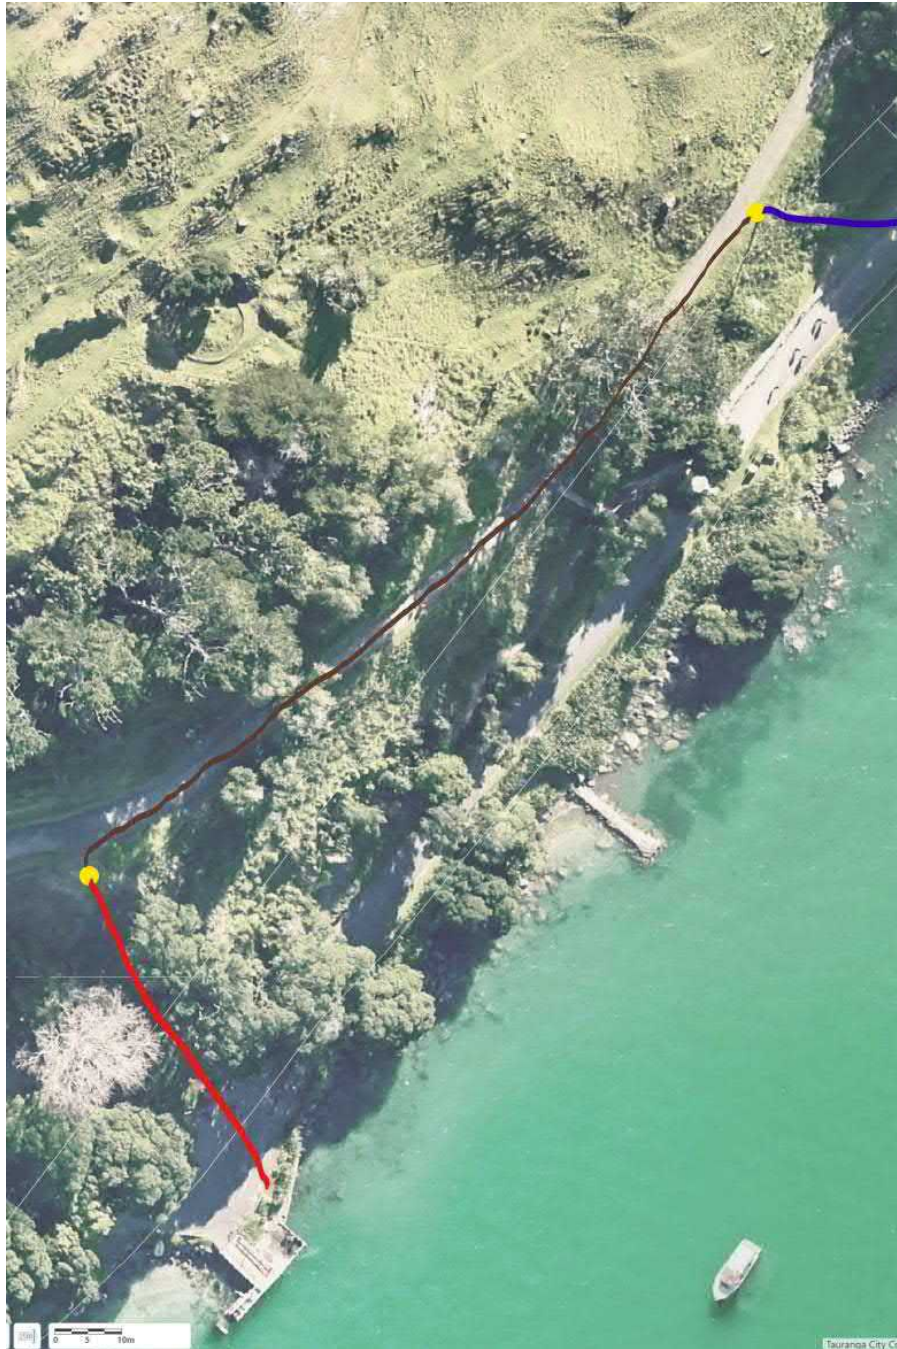
Mauao power poles.

Key: Yellow dots represent current power poles.

Blue line represents the current powerline which provides the power.

Brown line represent underground cable connecting the power poles.
