Tauranga City Council

Storm Recovery
Public Information Meeting
4 October 2005

Tauranga Storm Event of 18 May 2005 :
Landslip Issues

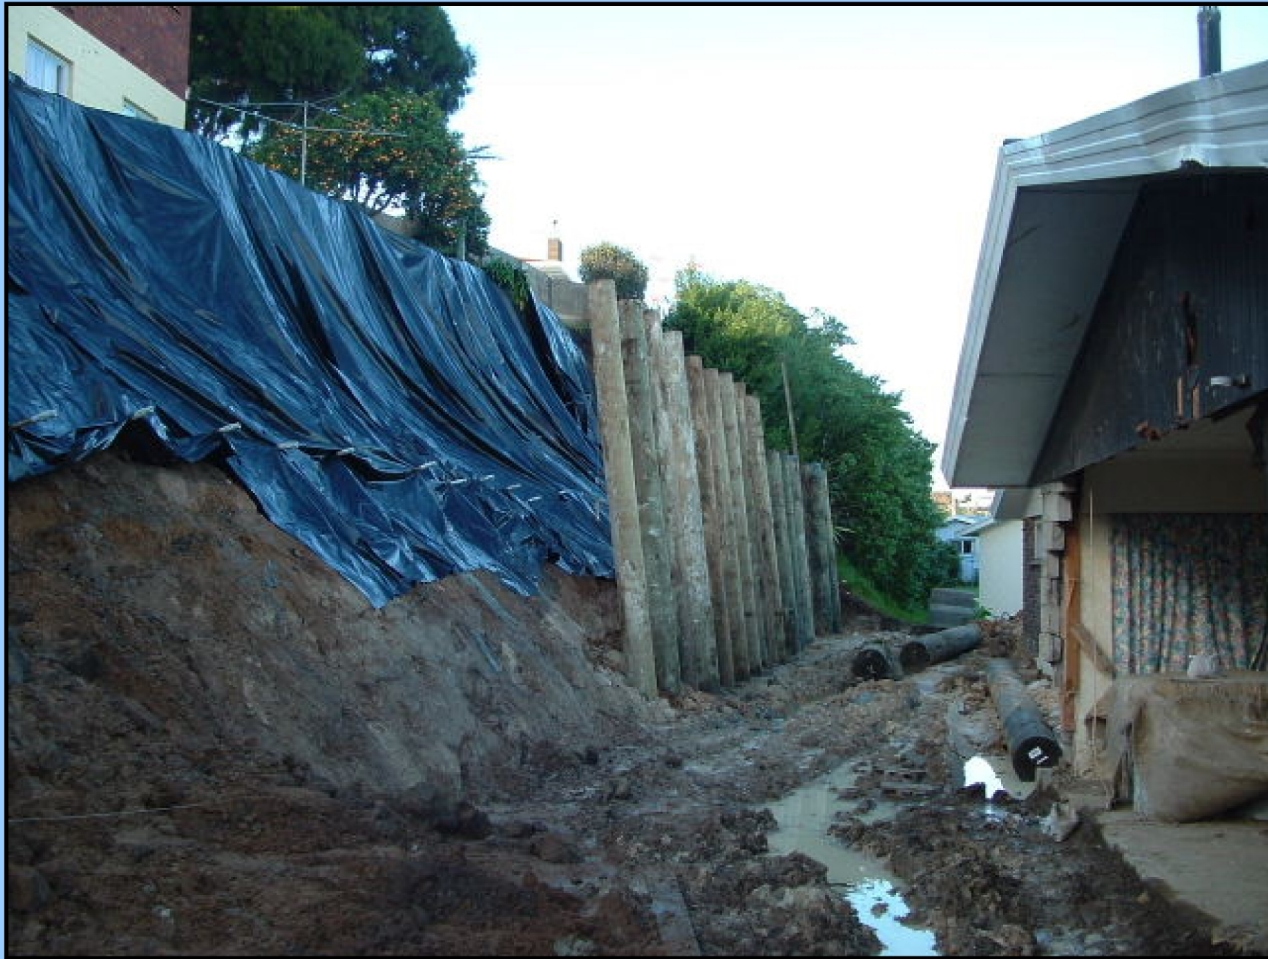
Retaining Wall

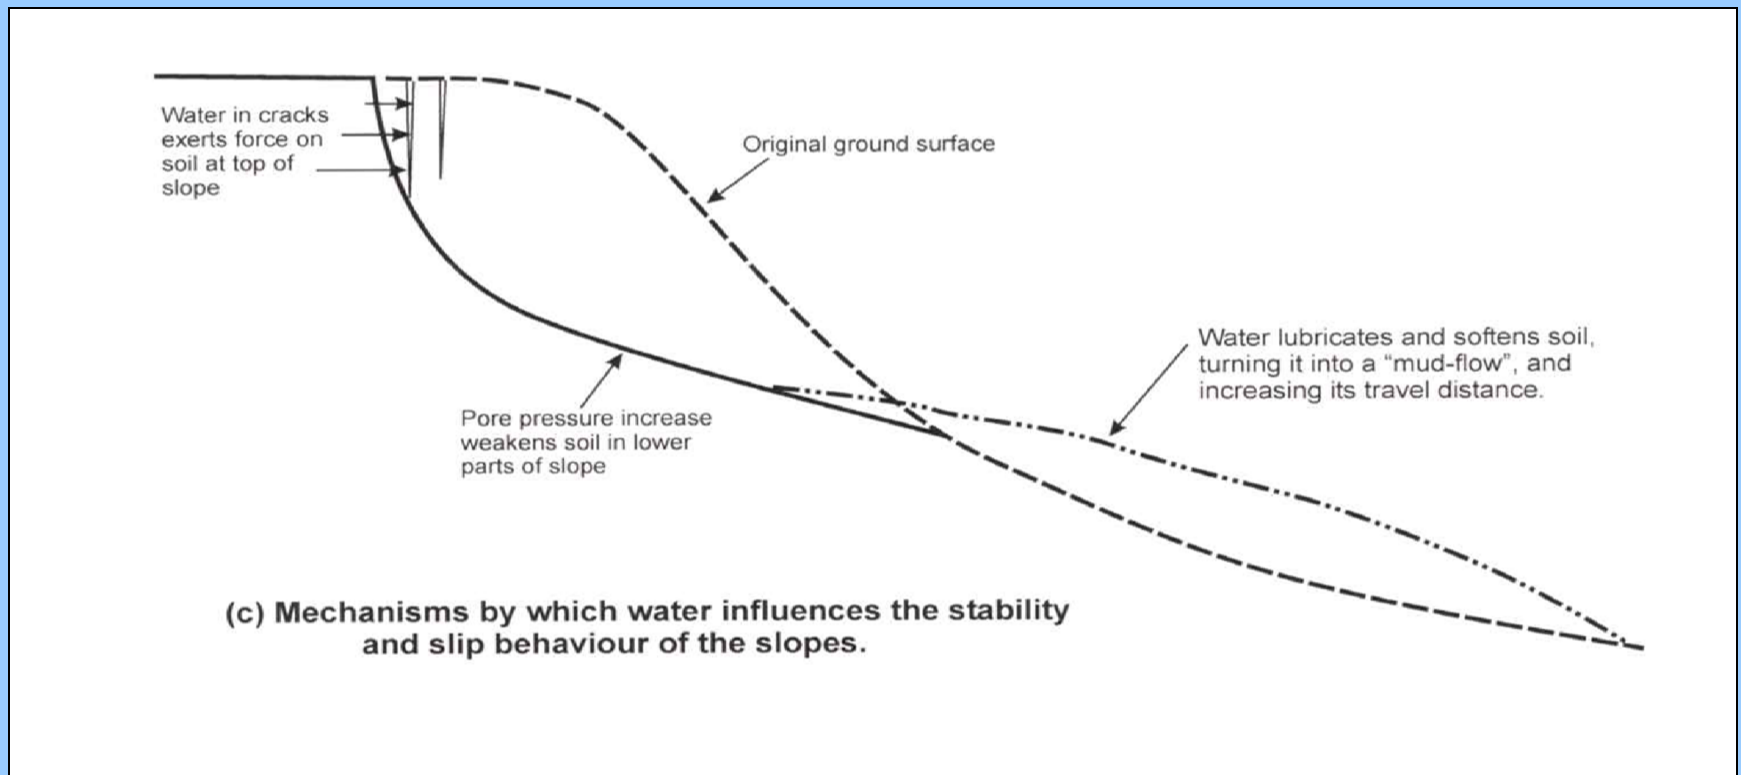
Diagrammatic representation of slip cross section

- Primary cause of the slips was 'overland flow due to the extreme rain event on 18 May' following heavy rain two weeks earlier
- Steep slopes – volcanic ashes – random vertical fissures
- Remains of sea cliffs formed by erosion
- Slopes facing east suffered more slips than those facing west
- Relic (old) valleys are masked by subsequent volcanic ash fall
- Soil types like those in Tauranga already contain large quantities of water
