# Fixing Mauao

## Mauao track repair and rehabilitation timeline

### What did we do, when did we do it, and why?

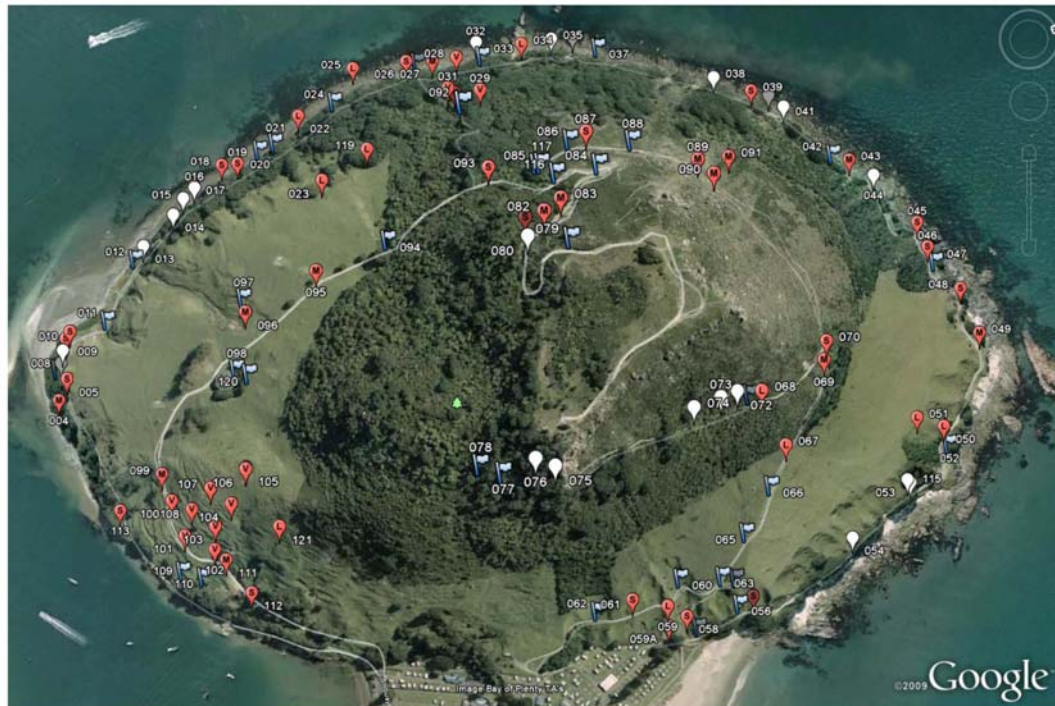
Map showing all of the slips that were identified after the January storm event.
