Avalon consulting

Mauao Camp Bluff; Zone 4 Boulder Scaling Works 15 January 2004

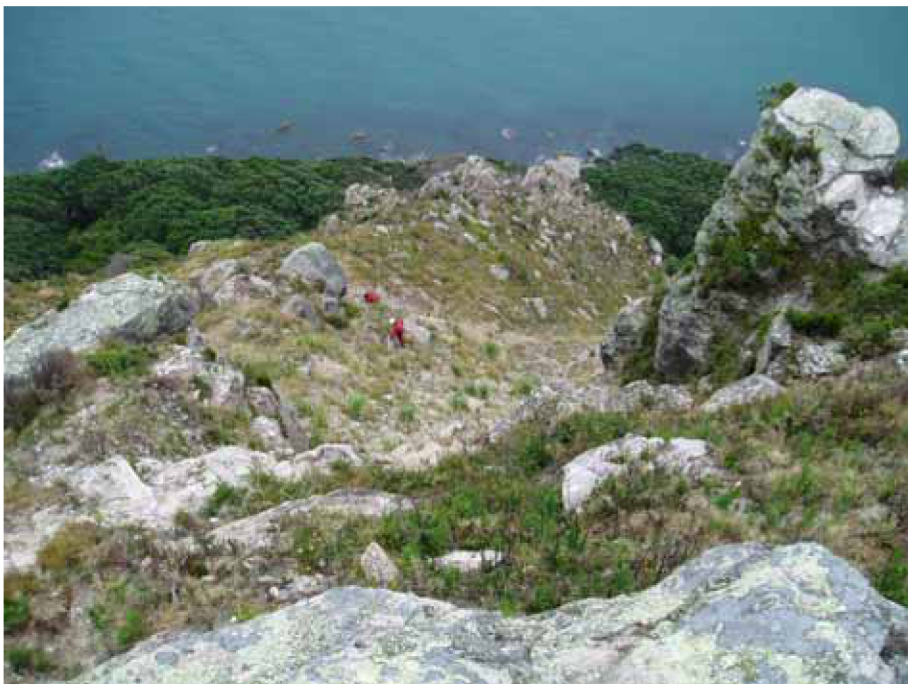
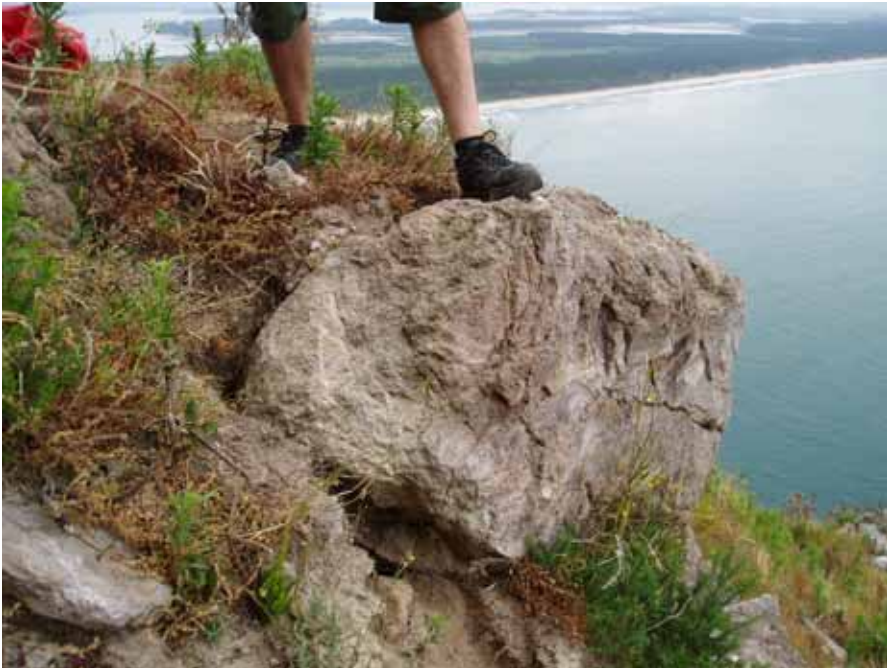
The boulder was approximately 1.5 x 1.0 x 0.75m in size and as such was a weight of approximately 3t. The boulder was partly supported by a smaller boulder (approx 0.5 x 0.5 x 1.0m) below, which also required removal.

The boulder was located in Zone 4 (see Avalon's 12/7/03 Report*) approximately 15m down from the head of gully 4d.

The following photographs show the location and general appearance.

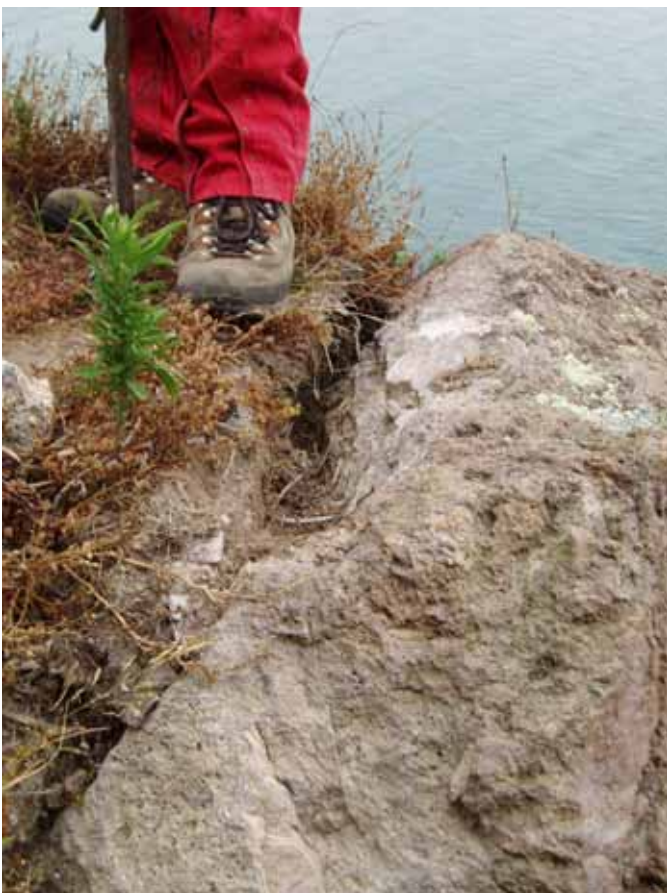
The boulder has moved forward recently by 150 to 200mm, as can be seen in the following photograph.

The boulder and surrounding areas showed signs of impacts indicating it may have been struck by a rock falling (pushed?) from above. The boulder was in a marginal position and may have already moved forward due to the supporting loose sand having been eroded by wind and rain.

The position was marginally stable and the boulder certainly presented a very real hazard to track users.

It is recommended that all slopes should be lightly scaled after this summer season. Once the vegetation becomes re-established the scouring should reduce significantly.
