ARCHAEOLOGICAL MAPPING OF STONE WALLS,
MAUAO HISTORIC RESERVE, MOUNT MAUNGANUI

June 2020

Prepared for: Tauranga City Council
Private Bag 12022
TAURANGA 3143

Prepared by:  
InSitu Heritage Ltd.
P O Box 710
WHAKATANE 3158

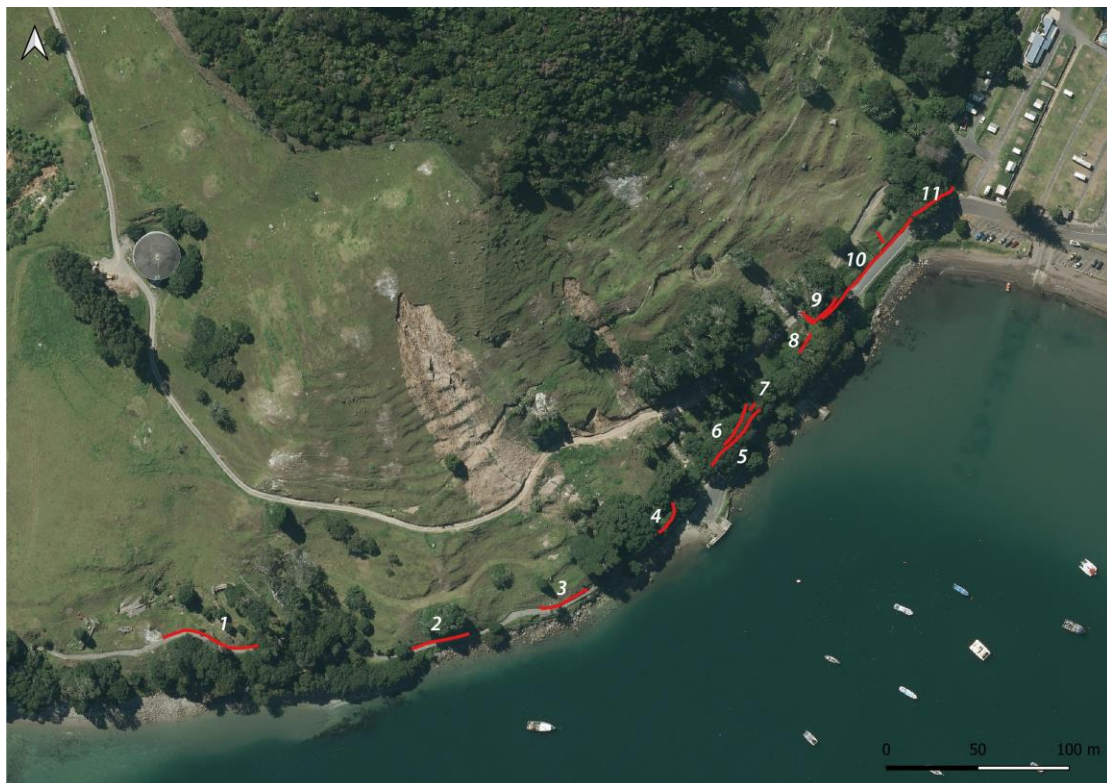
The archaeological field survey involved locating, mapping and photographing the stone walls, noting any changes in masonry style. Figure 2 shows the extent and location of the eleven stone walls identified as part of the fieldwork.

Figure 2 – Modern aerial photograph with the stone walls identified as red lines.

The entirety of the mapped walls in this report are located in the south-eastern quarter of Mauao, Figure 2. Historic aerial photographs show that the pathway lined by the current walls was in place by 1943 but it is not clear enough to depict the presence or absence of any stone walls.

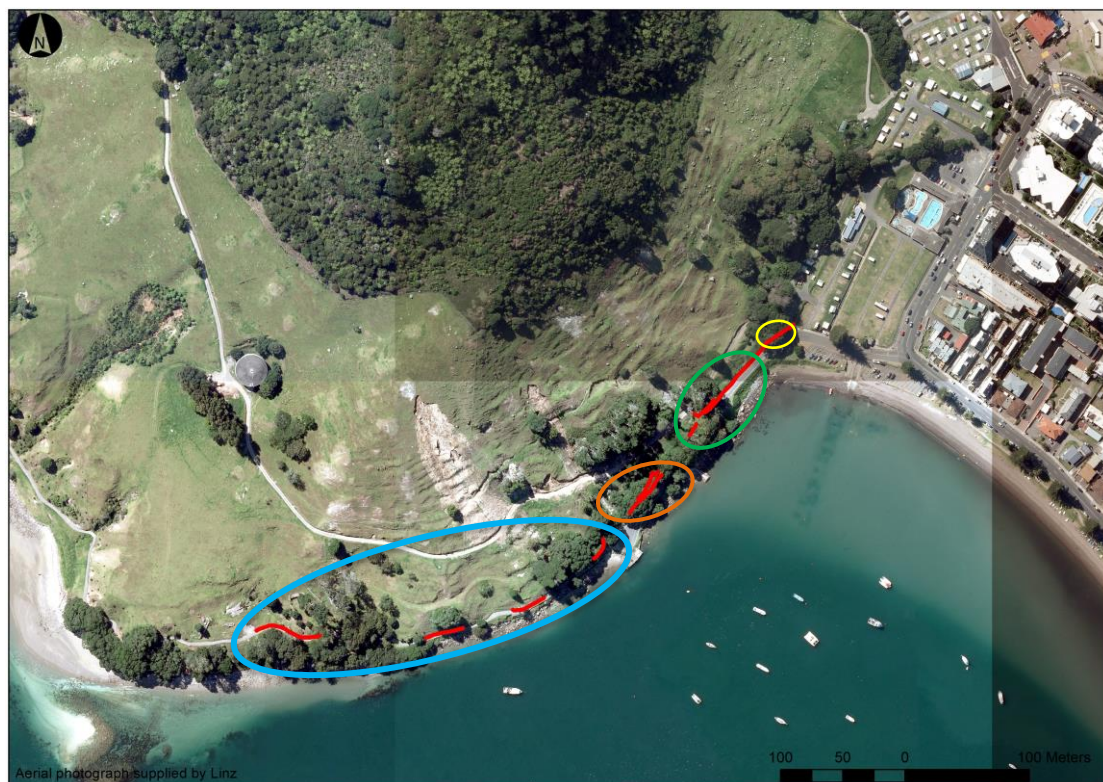
Group 1: Walls 1, 2, 3 & 4 located in the south of the Reserve (Figure 3; blue oval) consisted of sub-angular stacked rocks, approximately 300 x 100mm in size, with a rough

concrete layer on top of the wall and very sporadic mortar between the masonry. The walls were constructed by cutting back the hillside on the uphill side of the base track by ~300 mm, building a single-stone depth wall and then backfilling the area between the back of the wall and the cut. This area of backfill may contain evidence of the age of construction.

Group 2: Walls 5, 6 & 7 (Figure 3; orange oval) were constructed using larger sub-angular rocks, approximately 400 x 150mm, with a concrete layer on top of the wall and mortar used in between the rocks, both in construction and repair. The position of these walls going up a steep hill section with significant water runoff may have required the adaptation of methods used in the Group 1 to strengthen the walls in this group.

Group 3: Wall 8, 9 & 10 (Figure 3; green oval) uses rounded river cobbles, ranging from 70 x 100mm – 100 x 300mm, held together with mortar and a top layer of rough cement. Walls 9 and 10 both have smaller rounded rocks in the top layer of cement,

Group 4: Wall 11 (Figure 3; yellow oval) appears much more modern in construction, using uniformly sized and shaped rounded stones suspended in cement, with a layer of smooth cement on top the walls.

Figure 3 – Modern aerial photograph with differing styles of wall highlighted.

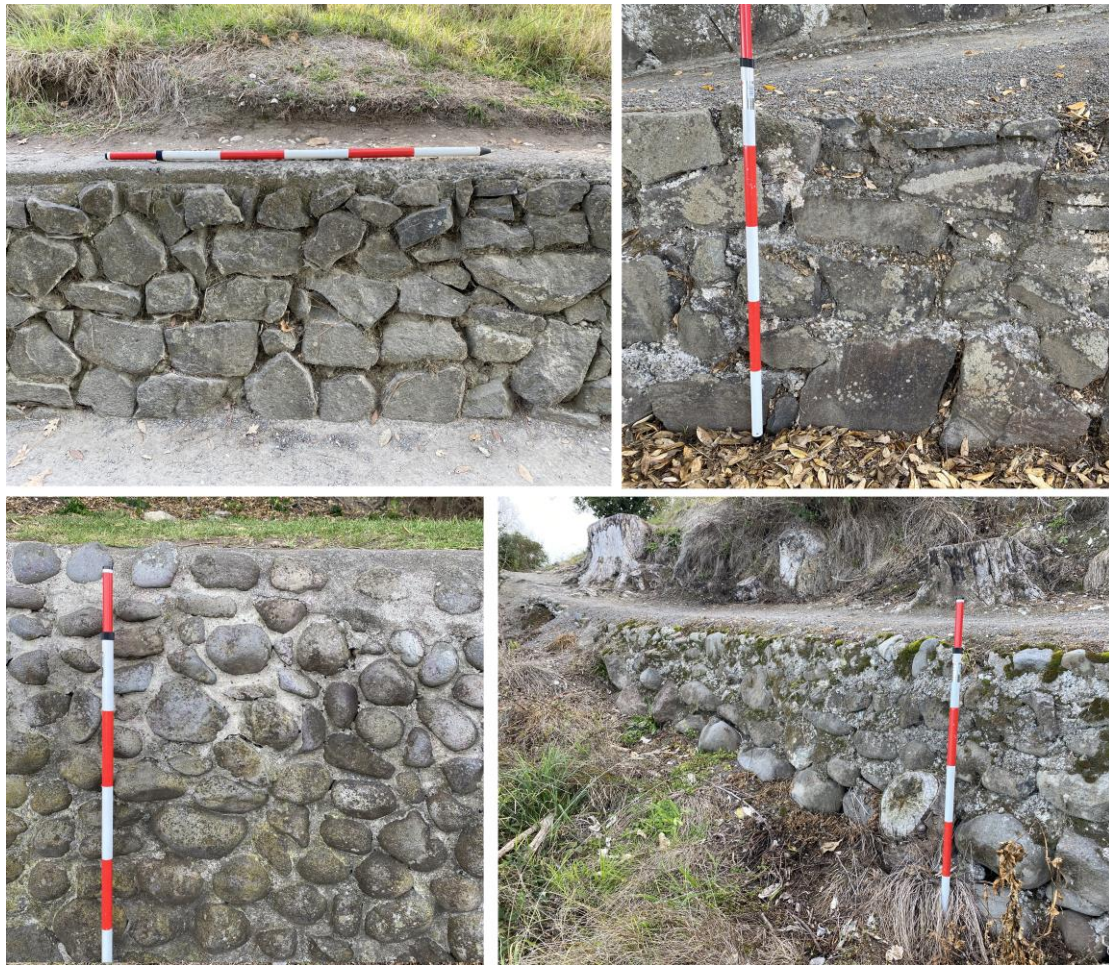
Four separate styles of wall masonry each using a different type of stone were identified (Figures 3 and 4).

Figure 4 – Comparison of wall masonry styles. Clockwise from top left: Wall 1, Wall 5, Wall 8 and Wall 11.

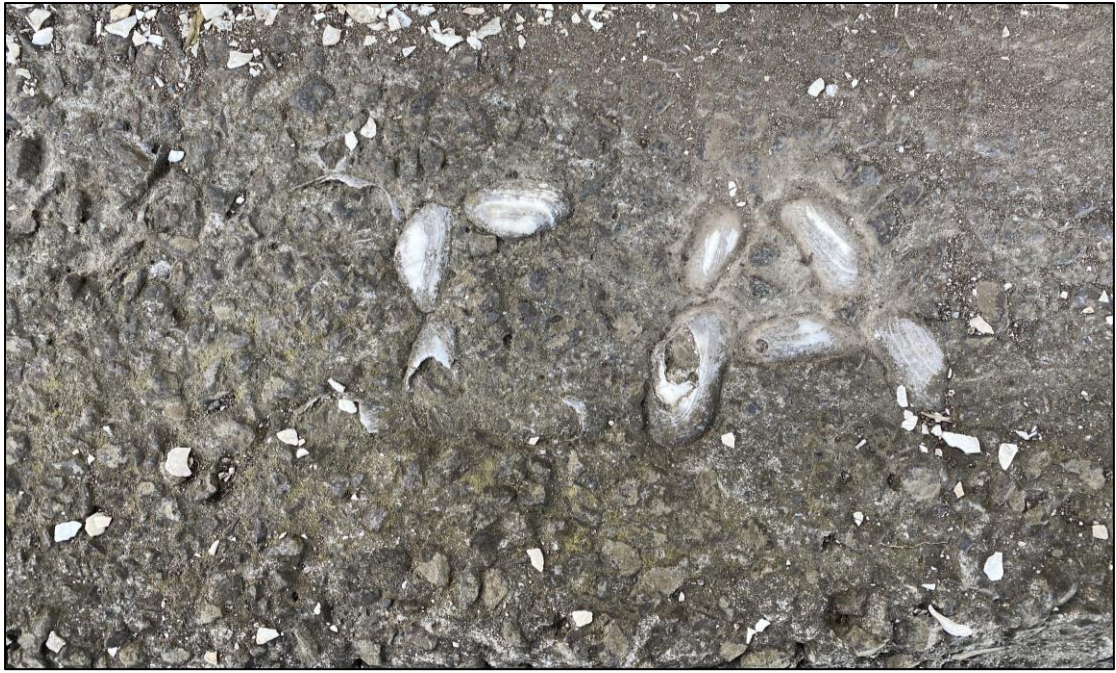
Graffiti was present along the top of some walls, either carved into the rough cement layer or created by shells being pushed into the cement, see Figure 5. While this was presumably done by some of the individuals involved in the construction of the walls, no dates or definitive names were able to be identified. The shell used in this graffiti is likely taken from one of the many middens created during Maori occupation, which are often retained by the Stone Walls.

Figure 5 – Some of the shell graffiti featured in the stone walls at Mauao, this appears to be the letters “JA”.

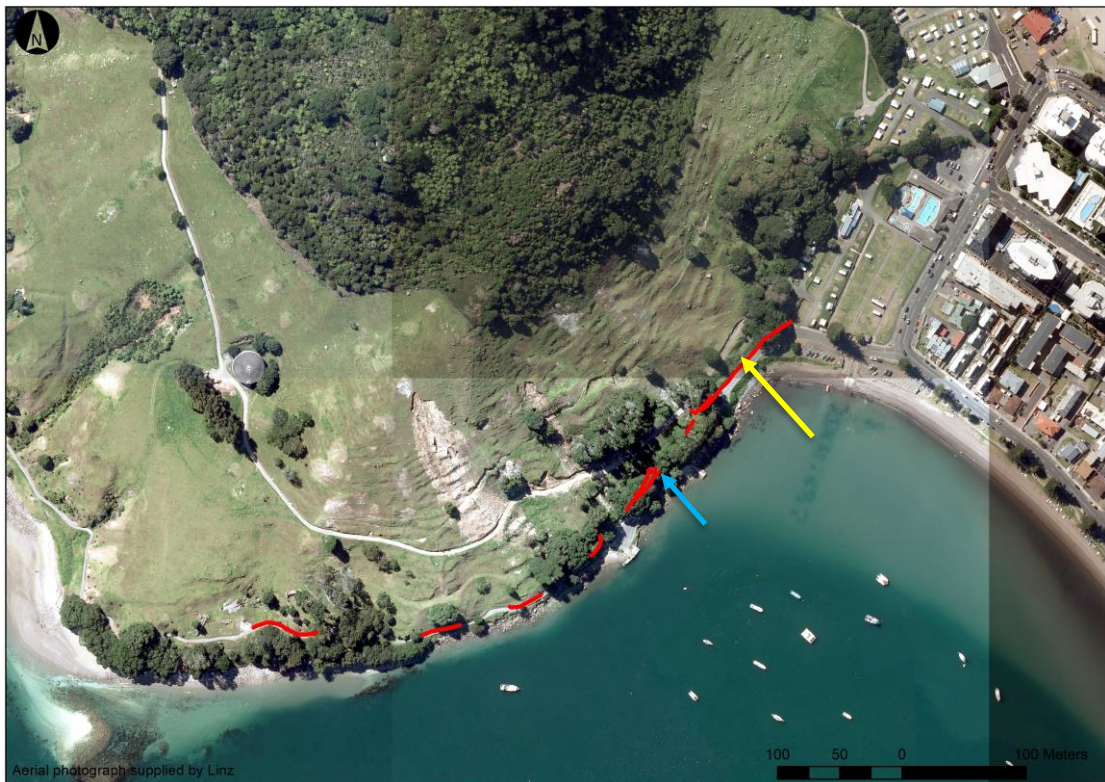
There were also stone steps recorded in two separate locations along the stone walls, see Figure 6. One of these (further to the east, marked by yellow arrow) was mostly grassed over, but appeared to lead to a small platform. The second (indicated by blue arrow) is now covered over with a wooden staircase, but is still just visible underneath, see Figure 7. This second staircase is positioned between the stone jetty and probable location of the last Pilot House in the Reserve, which may suggest an early construction date for this feature, although this cannot be confirmed. Note: these stairs are **separate** from the stone steps recorded as (U14/250).

Figure 6 – The location of two sets of stone steps identified as part of Stone Wall mapping exercise.

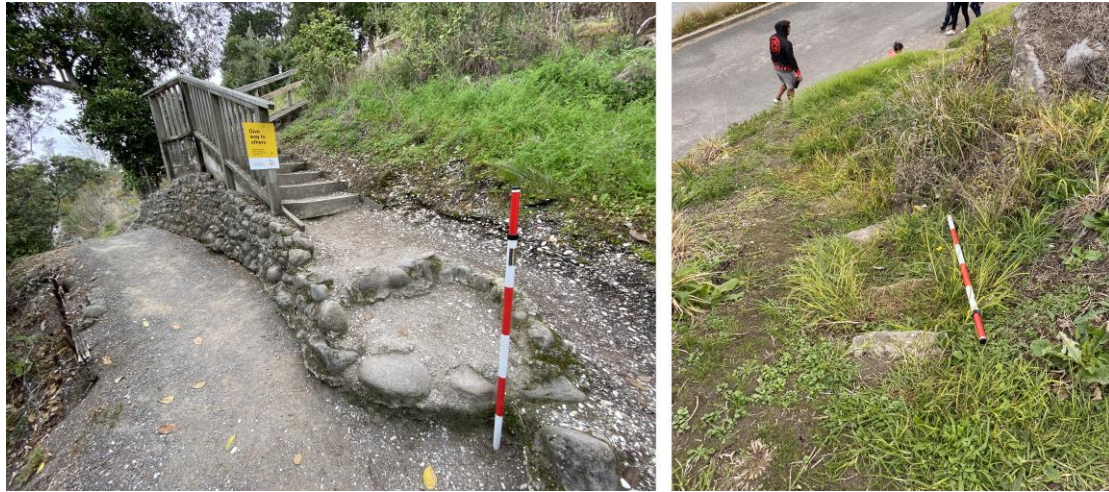
Figure 7 – Southern set of stone steps covered by wooden staircase (left). Grassed over set of stone steps located further east (right).

For Walls 5 – 10 surmising a construction date is less clear. The set of stone steps now covered by a wooden staircase appears contemporary with the Stone Walls, but again, a date from these cannot be properly determined. Given the location, it seems possible that these stone steps could have been put in place to give access between the Boulder Pier and the Pilots House, putting a date from 1889 onwards, but this is purely speculation. The grassed over set of stone steps appear much older, due to their rough and overgrown nature, but unfortunately a date cannot be determined.

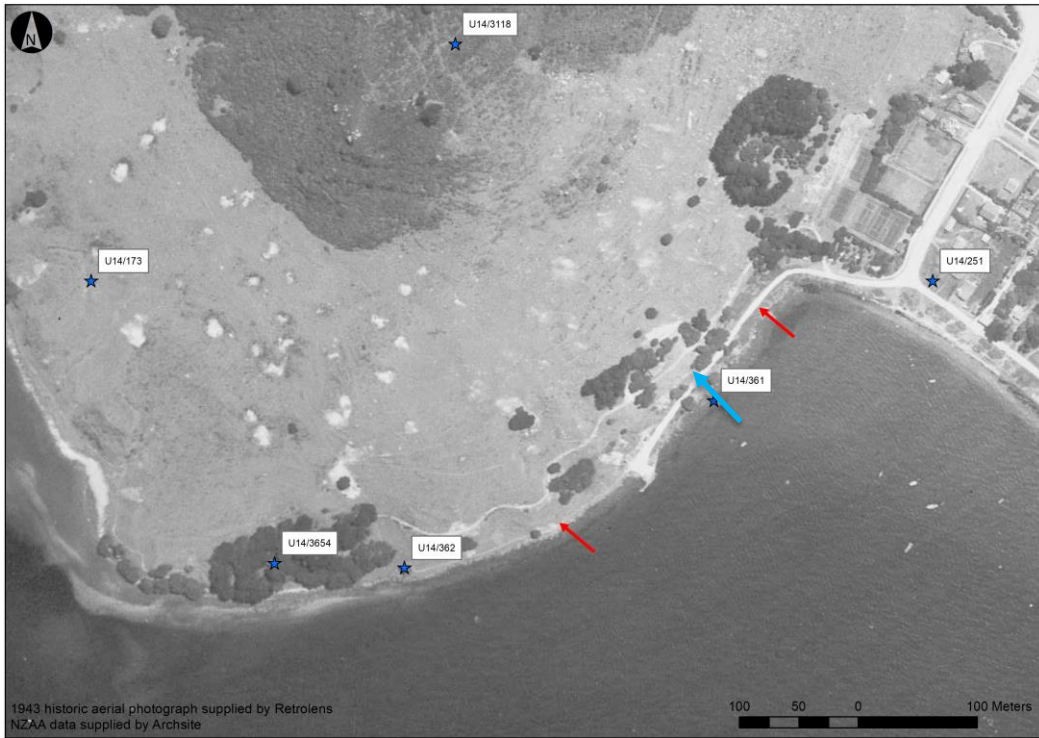
Earliest aerial photographs of the Reserve held on Retrolens date to 1943. The 1943 image (Figure 8) shows a series of tracks running toward the jetties, which historical photographs suggest were established in the late 19th century. The Pilot House site is also potentially visible, indicated by a blue arrow. The image is not clear enough to be able to detect any stone walls.

Figure 8 – 1943 historic aerial photograph with track and footpath location marked by red arrows.

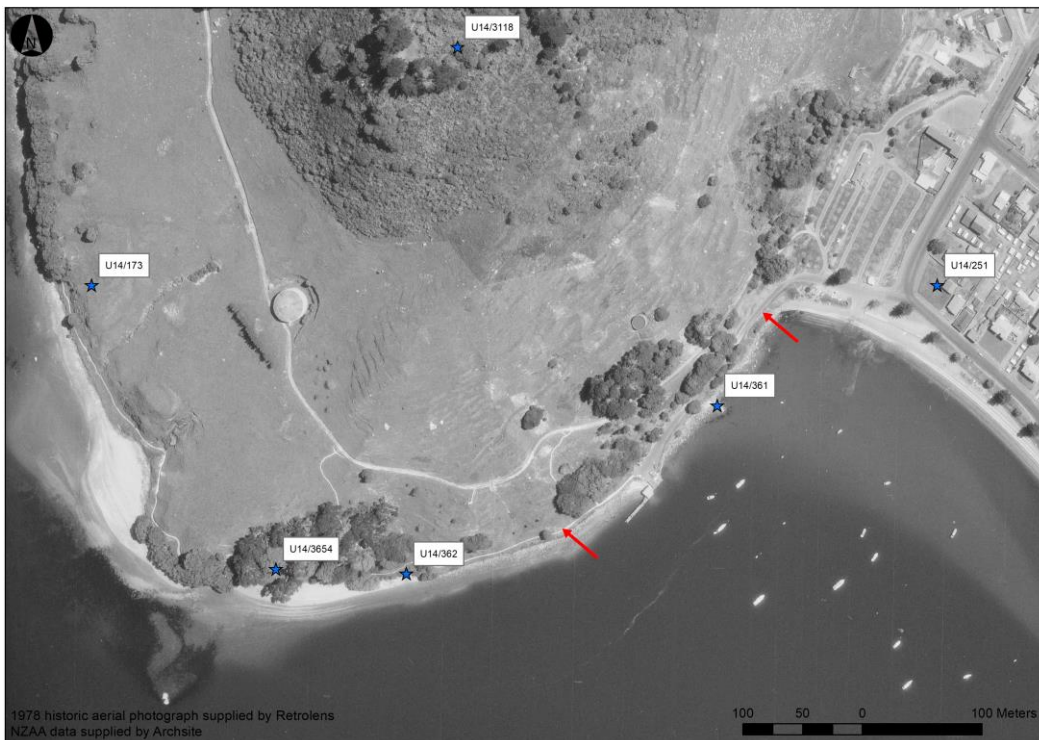
The 1978 historic aerial photograph (Figure 9) shows the establishment of the 4WD track, the sealed road to jetty, and the formalisation of the base track. The stone walls appear to be present where the sealed road has been established, further northeast from the jetties, but are not visible along the unsealed footpath base track.

Figure 9 – 1978 historic aerial photograph with track and footpath location marked by red arrows.

By 1978 Walls 5 – 10 are present, but Walls 1 – 4 & 11 are not yet constructed. Which dates Walls 1, 2, 3, 4 & 11 to after 1978, and therefore not requiring any archaeological management or recording. In the case of Wall 11, the recent dating of the wall is reflected in the masonry style employed, but it is surprising Walls 1 – 4 are not older, purely based on the aesthetic of the construction.
