**ARCHAEOLOGICAL SURVEY  
AND ASSESSMENT OF EFFECTS**

**PROPOSED  
MOUNT MAUNGANUI  
CAMPGROUND UPGRADE**

**KEN PHILLIPS (MA HONS)**

**MARCH 2009**

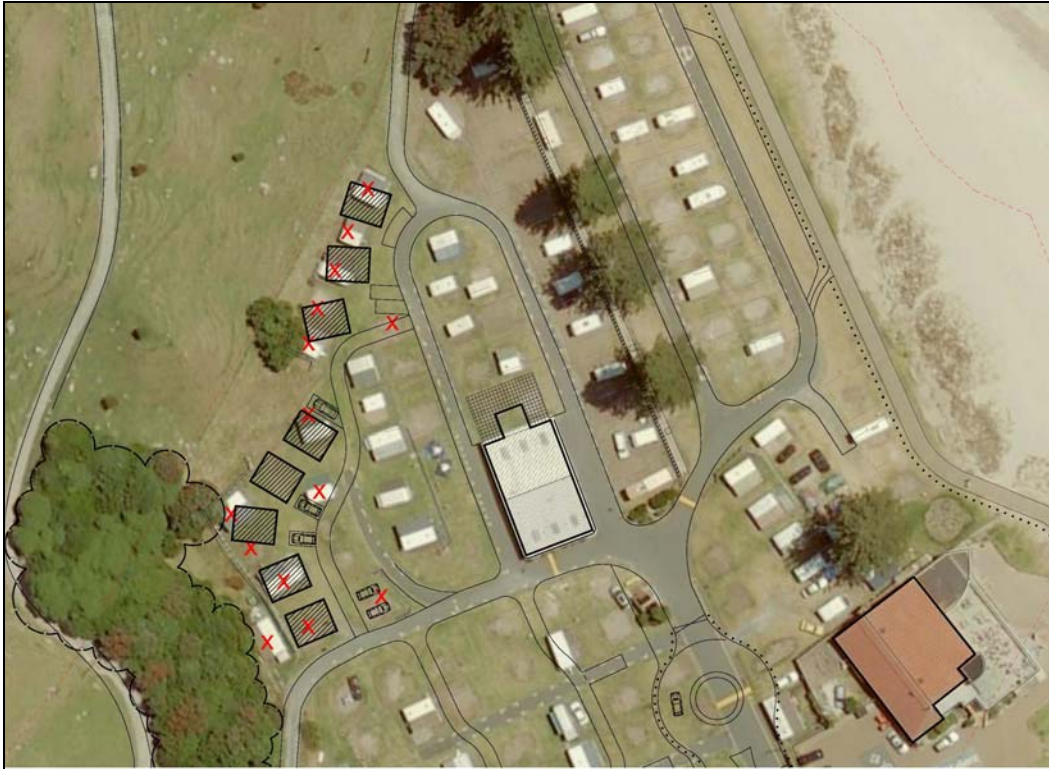
**Figure 5. Aerial photo showing proposed location of cabins and service roads.**

It is proposed to located prefabricated cabins below and on the northern side of the eastern spur. Ground disturbance associated with the cabin development will include excavation of pile foundations to support the cabins and associated trenching for utility installation. Ground disturbance associated with this work may disturb archaeology relating to the prehistoric occupation of this area.

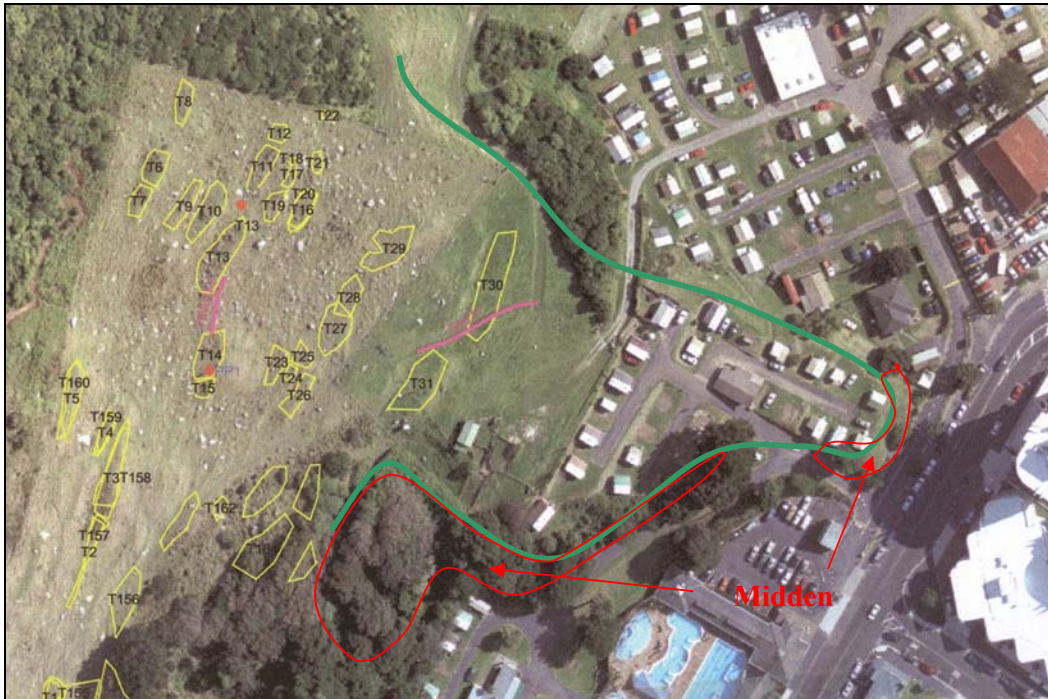
**Figure 6.** Aerial photo showing the location of recorded midden and terraces above the camp grounds and midden extending around the perimeter of the eastern spur indicated by the green line.

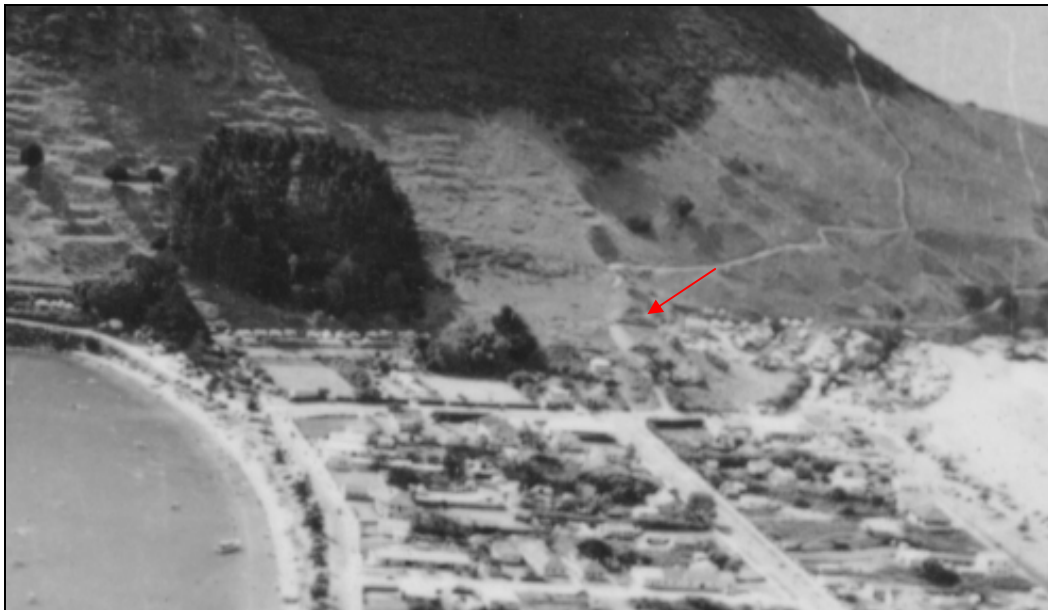
**Figure 7.** Early oblique aerial photo showing the eastern face of Mauao and possible early contouring of the eastern spur (arrowed)

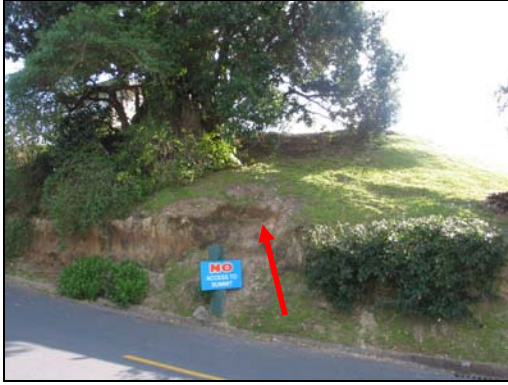
**Figure 8.** Midden eroding down a southern scarp at the eastern end of the spur immediately below camp site 18.

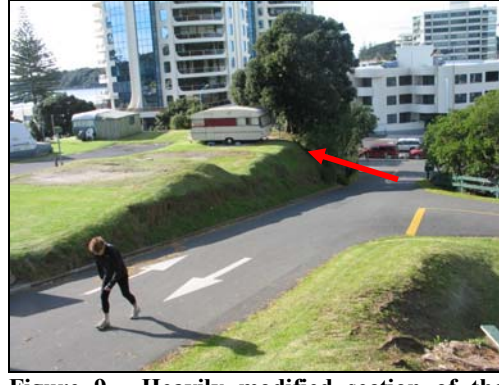
**Figure 9.** Heavily modified section of the eastern spur showing road cutting and terracing for camp site 18 - 21 and location of eroding midden (arrowed).

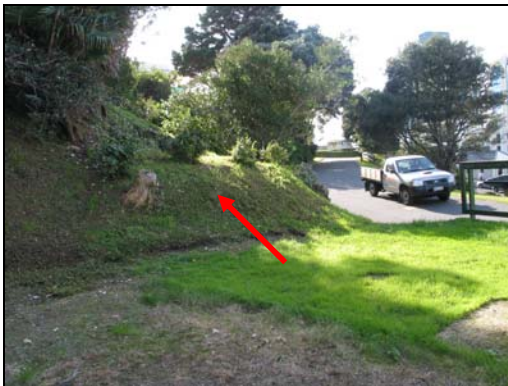
**Figure 10.** View looking north showing location of large midden eroding down the south western face of the eastern spur in the vicinity of camp site 61.

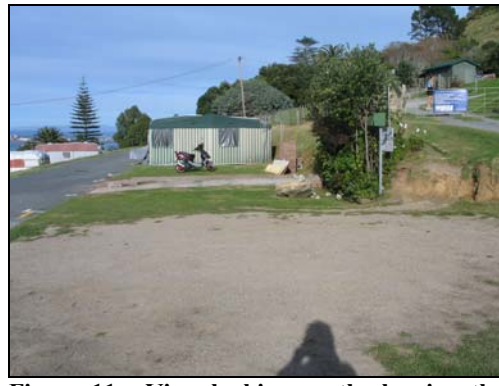
**Figure 11.** View looking south showing the upper cut and fill terrace forming camp sites 2, 3, 4, 5, & 6.

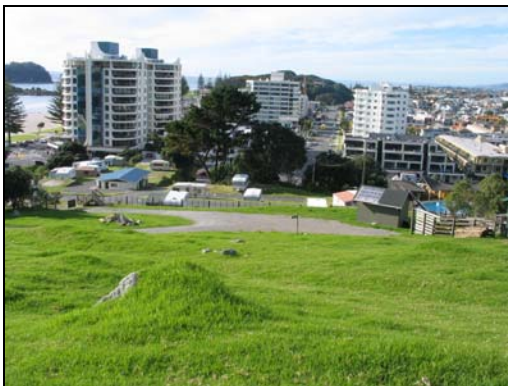
**Figure 12.** View looking east down the eastern spur from the occupation terraces within the stock yards.

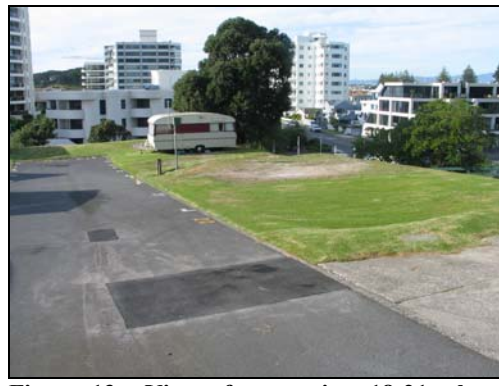
**Figure 13.** View of camp sites 18-21 where the first and second Pilot houses were probably located.

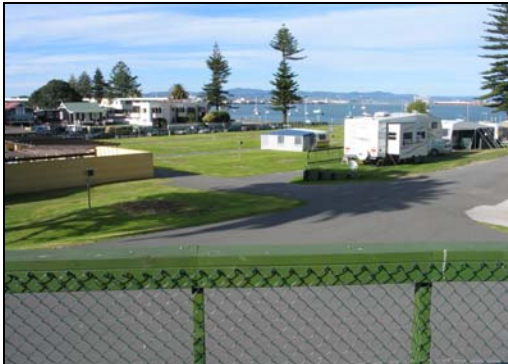
**Figure 16.** Terraced camp sites at the southern end of the camping ground.

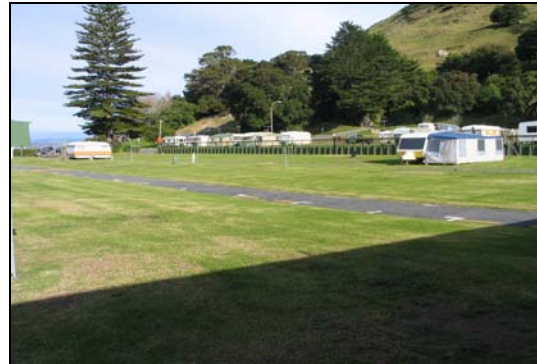
**Figure 17.** Level ground where the bowling green and tennis courts were located in the early 20<sup>th</sup> Century.

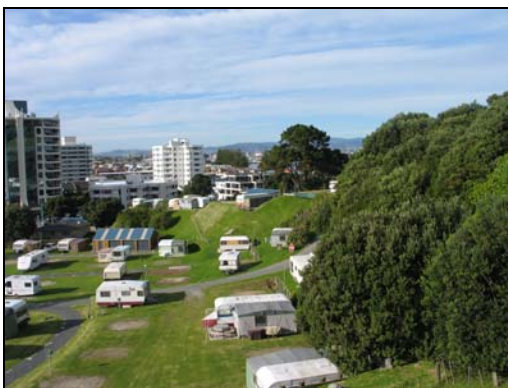
**Figure 18.** Camp sites on the northern side of the eastern spur showing limited contouring.

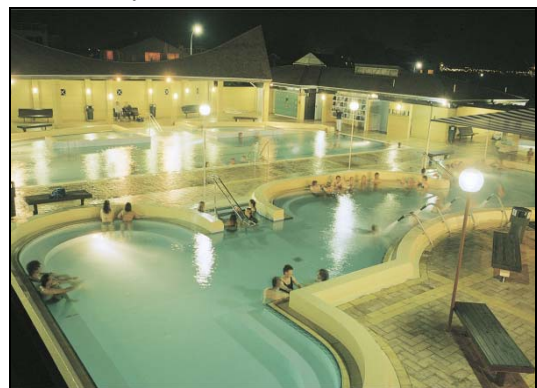
More recent developments such as the excavation of the hot water pools carried out in the mid 1960s and cut and fill terracing carried out to form level camp sites has had a greater impact on the subsurface archaeological resource.

**Figure 19.** Excavation of hot pools has probably destroyed subsurface archaeology.

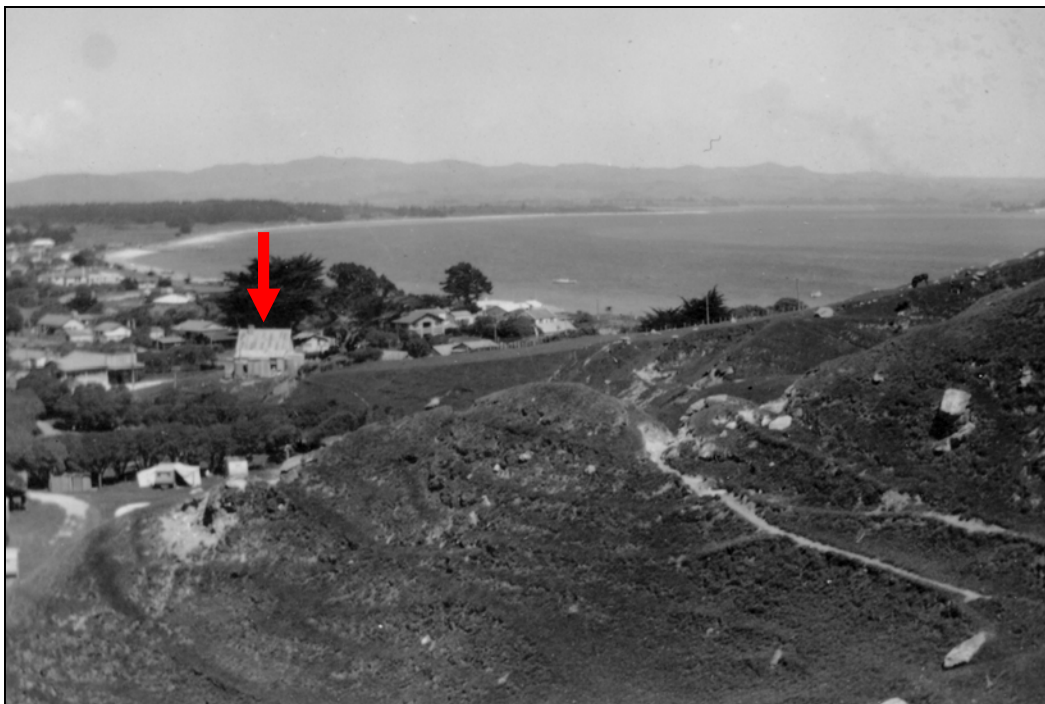
Figure 21. Early 20<sup>th</sup> Century photo (c.1920s) showing the location of the second Pilot House built in the 1870s viewed from the north. Note the contour of the spur extending upslope to the north west.

The first cottage appears to have been replaced in the mid 1870s by Captain Marks. This second cottage survived up until the late 1960s and appears in a number of early photos taken of Mt Maunganui. The cottage was oriented to the south with views from the veranda along Pilots Bay towards Te Papa. Several photos taken in the 1920s show a large *Macrocarpa* tree growing on the south-western side of the cottage.

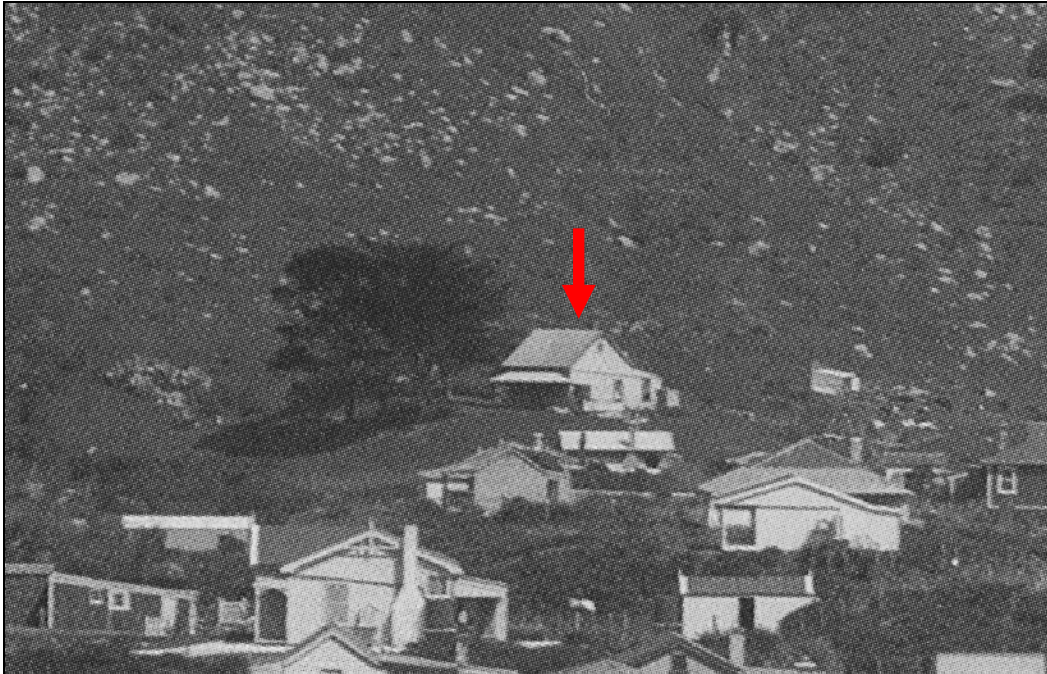
**Figure 22. Photo taken in the early 20<sup>th</sup> Century (c.1920s) showing the second Pilot House on the eastern spur viewed from the south east.**

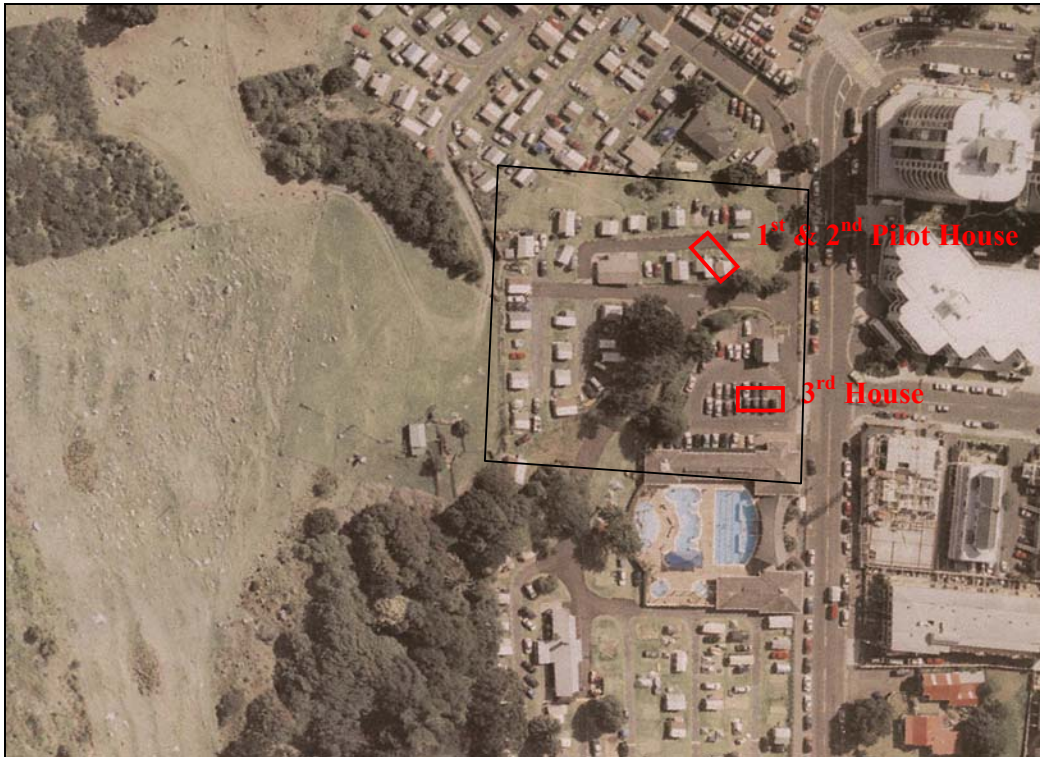
Figure 26. Aerial photo showing the approximate location of the pre 1900 cottages within the Pilot Reserve.

While there are no visible archaeological features identifying the location of the pre 1900 cottages, buried subsurface features may survive on the spur and within the Hot Pools car park. Archaeological features may include building foundations, rubbish pits and evidence of out buildings. Such features can provide significant archaeological information relating to living conditions of the first European residents at Mount Maunganui.

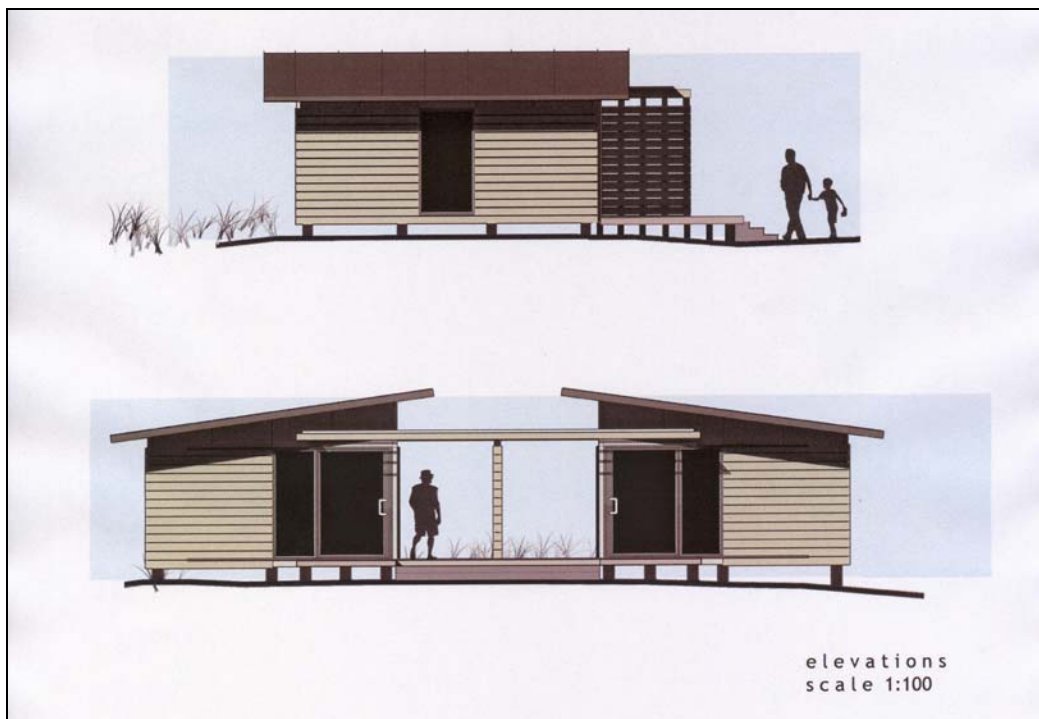
**Figure 27. Mount Maunganui camping Ground cabins design proposal prepared by Ross Maguire Architects Ltd.**
