Title *Mauao Slope Stability Study*

Subject: MAUAO STABILITY TOUR

CONTROL SURVEY

TITLE
 MAUAO
 DEFORMATION SURVEY

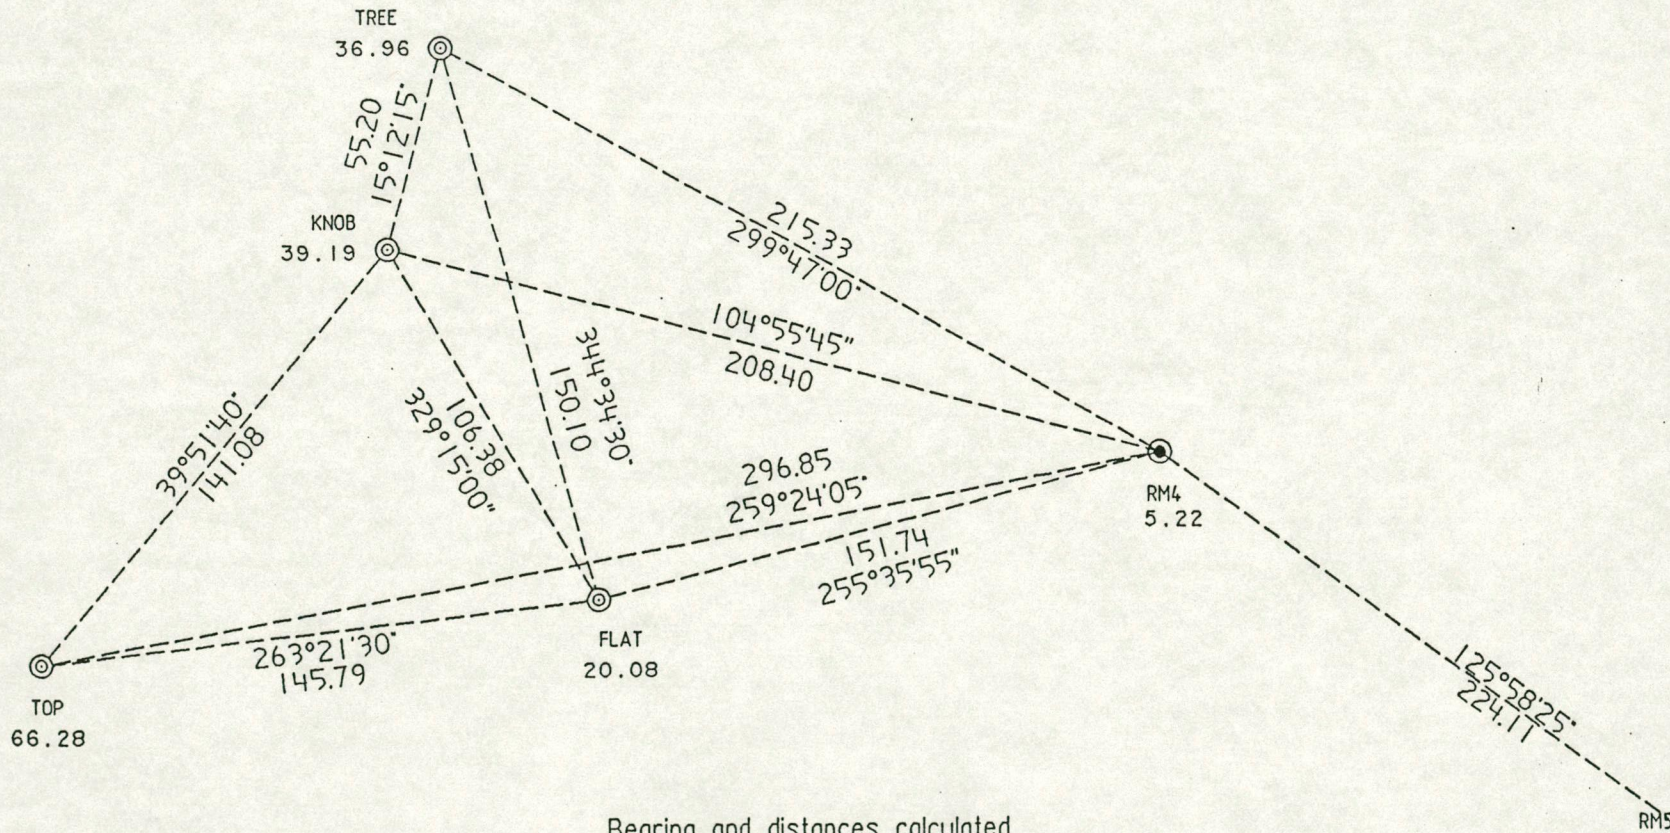
-X-	-Y-	-Z-	Code
274470.97	714172.29	5.224	RM4
274324.00	714134.55	20.080	FLAT
274269.60	714225.98	39.187	KNOB
274179.18	714117.69	66.281	TOP
274284.08	714279.25	36.959	TREE

Bearing and distances calculated from final coordinates and rounded to 5' for direction, 0.01 for distance and 0.01 for height

RM4 SO 59650 has been held as fixed with its coordinate and heights taken from SO 59650.

Orientation was fixed on the line RM4 SO 59650 to RM5 SO 59650.

A traverse was run from RM4 to FLAT to KNOB and back to RM4. This traverse closed 0.002 in the horizontal plan and 0.001 in the vertical plane.

From each of the traverse stations RM4, FLAT and KNOB the other 2 marks were observed (TOP and TREE).

The final coordinates and heights of TOP and TREE were calculated by meaning the adjusted observations from the traverse stations. TOP coordinates had a spread of 0.006 m in the horizontal plane and 0.011 m in the vertical pane.

TREE coordinates had a spread of 0.009 m in the horizontal plane and 0.014 m in the vertical plane.

Marks

RM4 and RM5 are brass plaques set into the channel.

All other marks are 750 mm long iron bars 12 mm in diameter set flush into the ground with a concrete collar poored insitu.

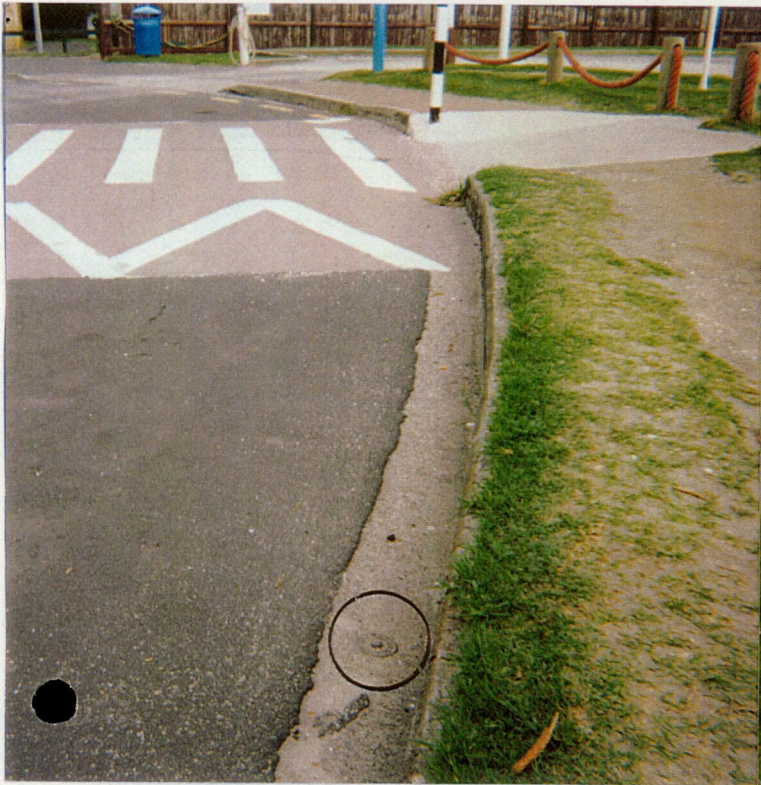
LOCATON OF MARKS AS
SEEN FROM RM4
