Mauao Base Track Remediation Project

Update Includes:

1. Signing the Heritage NZ application by Mauao Trustees
2. The removal of Pōhutukawa trees
two Pōhutukawa trees at the base of the Te Kawa split site for the new coastal track and one tree from the existing track above the slip site.
3. Update on the quality of the rock from Poplar Land and Oropi Quarries.
4. Te Kawa stormwater system;
5. Progress on the Mauao Base Track resource consent application with Toi Moana (BOPRC);

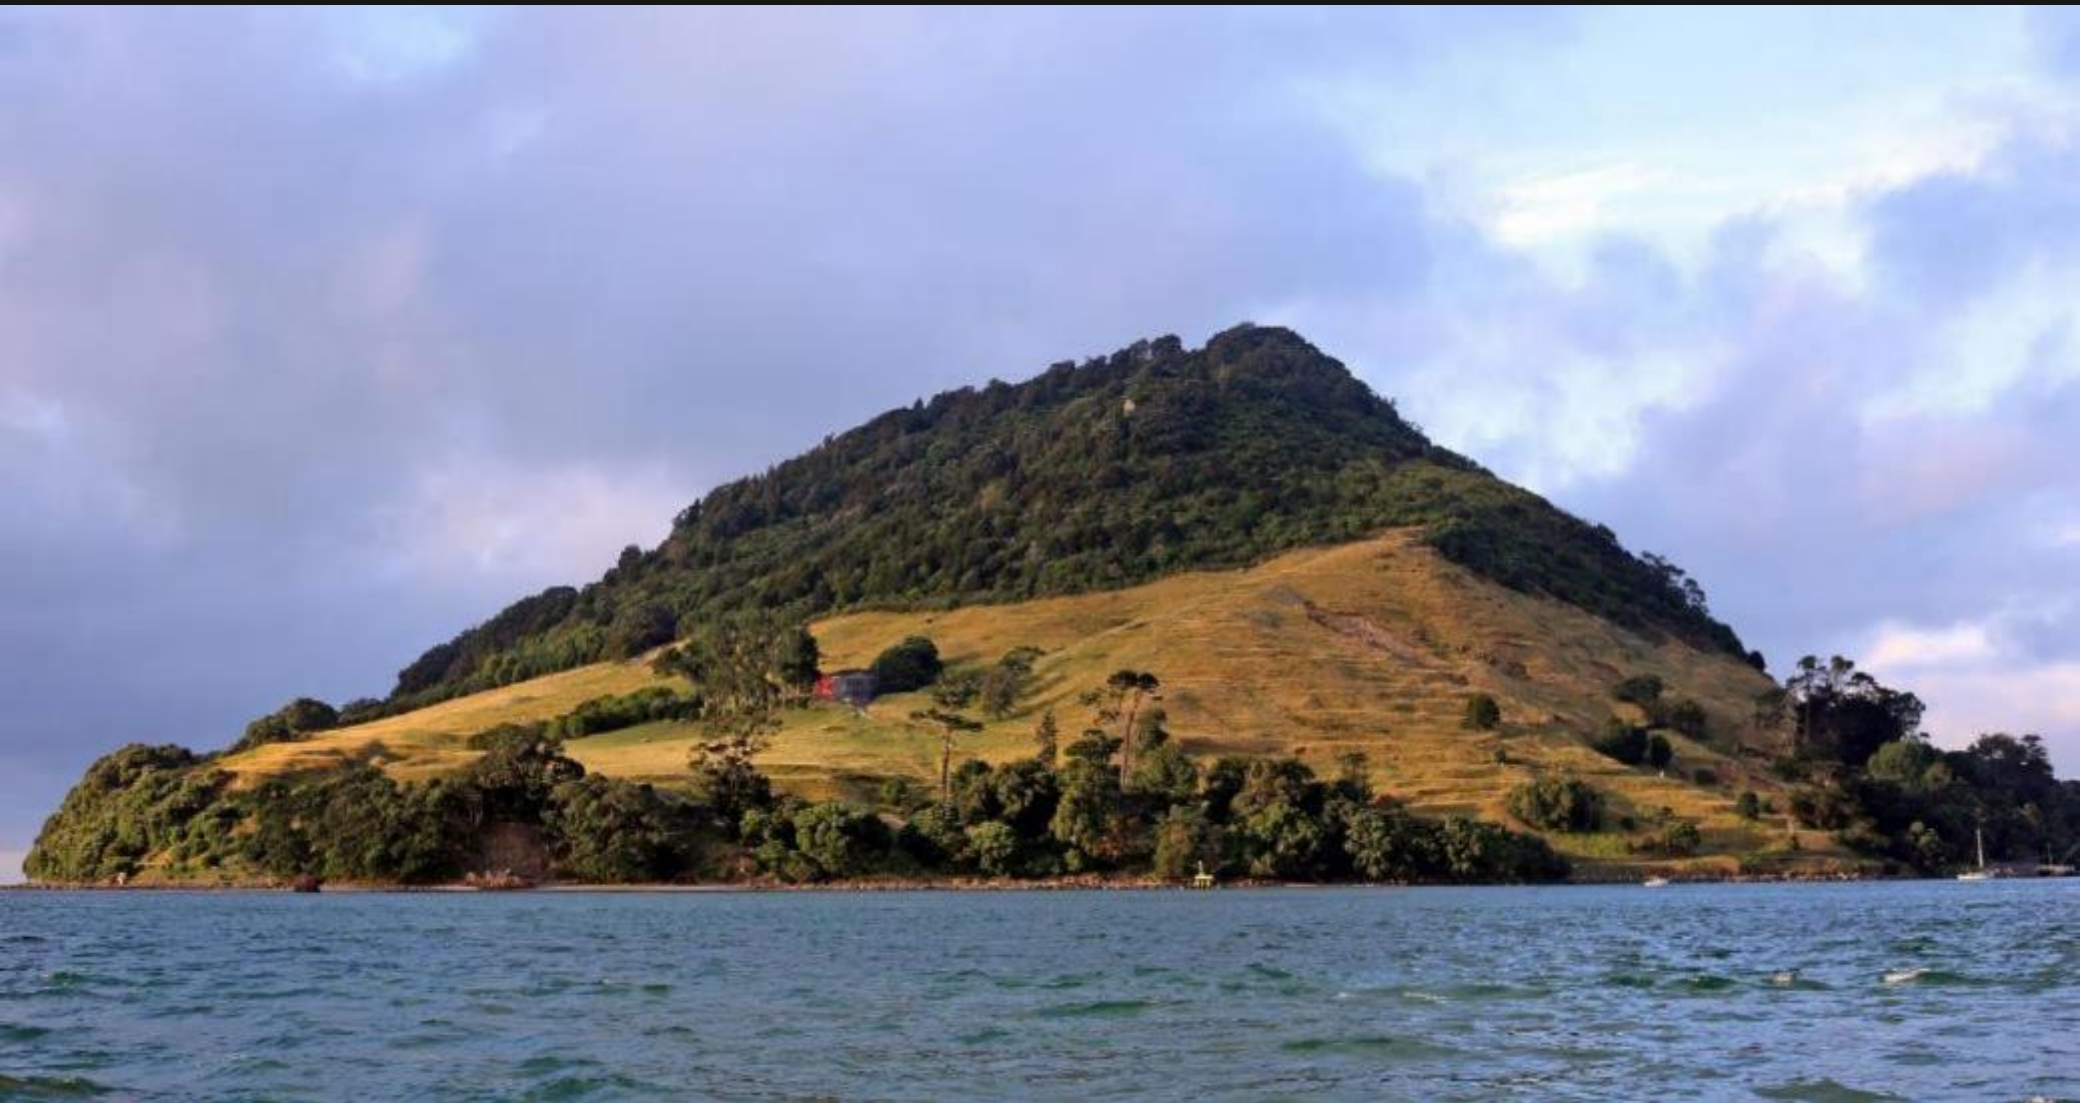
Significant slip at Te Kawa Point, Mauao - Cyclone Debbie (April 2017).

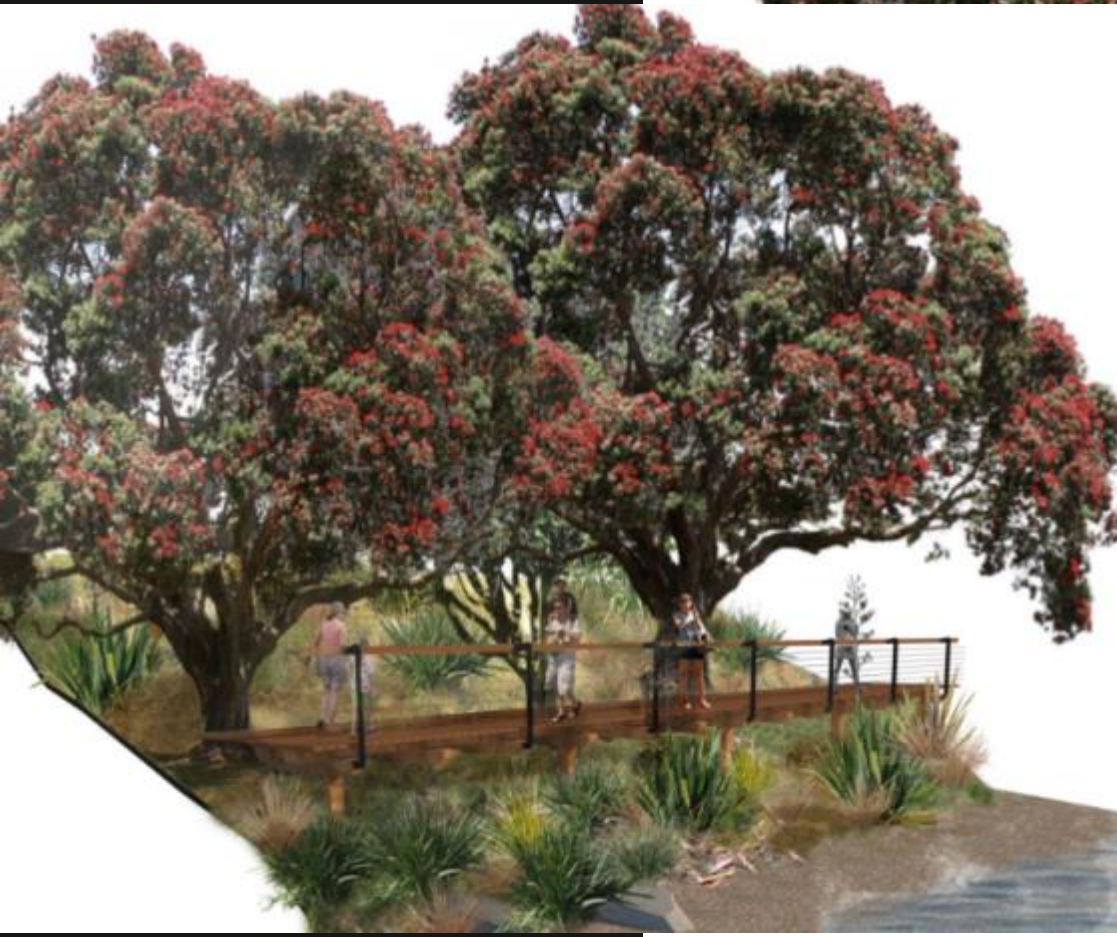
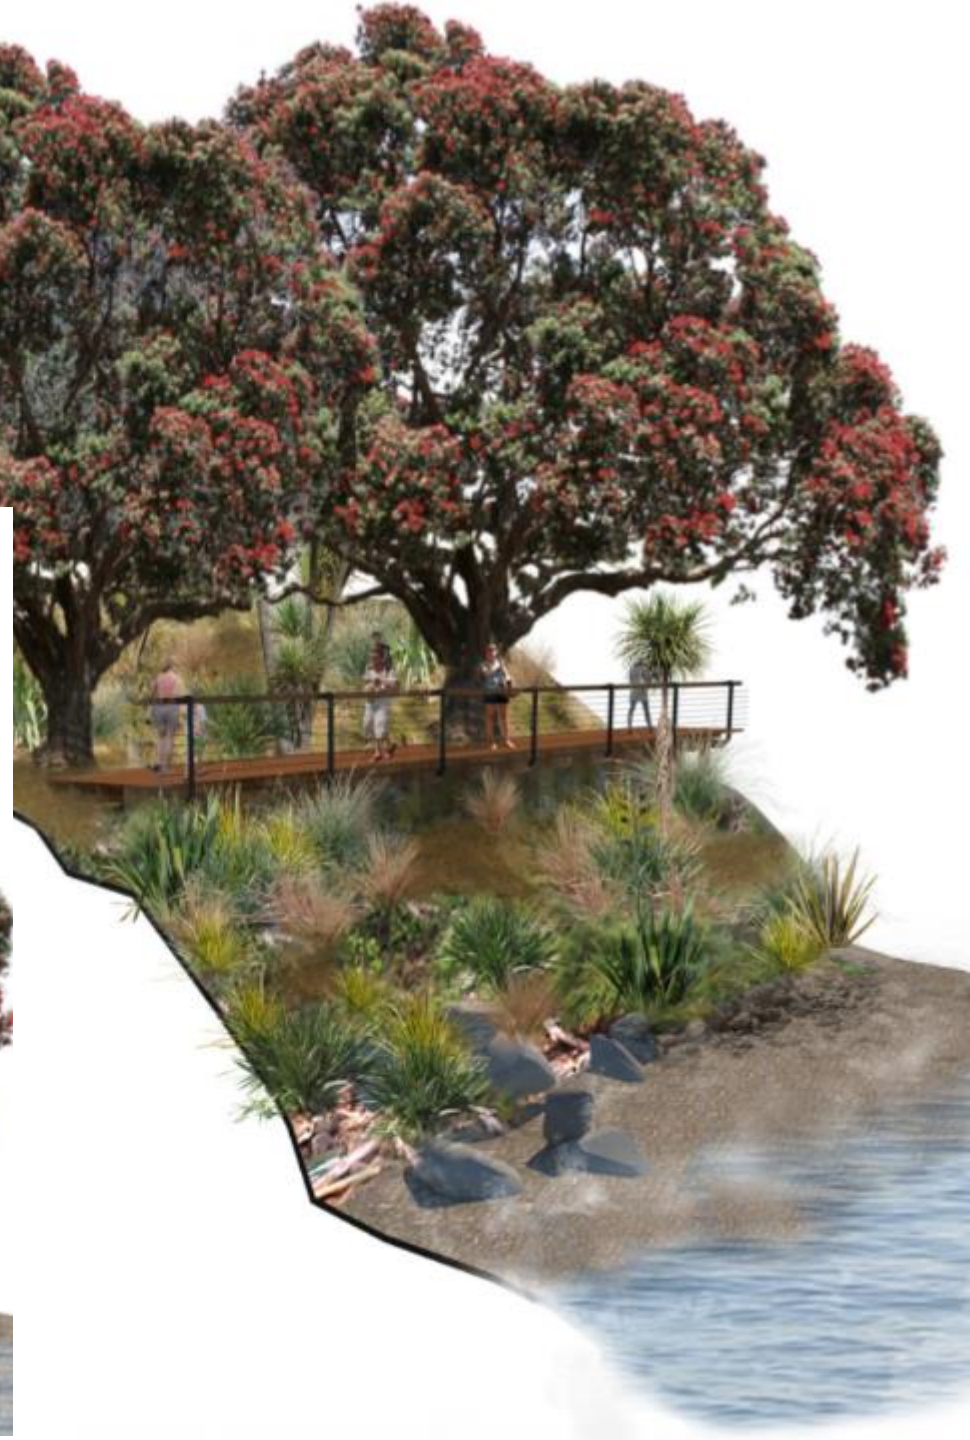
Proposed Boardwalk Options

The proposed 110m boardwalk is 2m wide and links the existing eastern base track with the rock revetment along the coastal shoreline to the Te Kawa beach on the south western side of Mauao. The proposed boardwalk provides a more durable material with a longer design life than timber, reduces the long term archaeological impacts and composite material does not result in any leaching of treatment chemical into the ground like timber. It is recommended that the project:

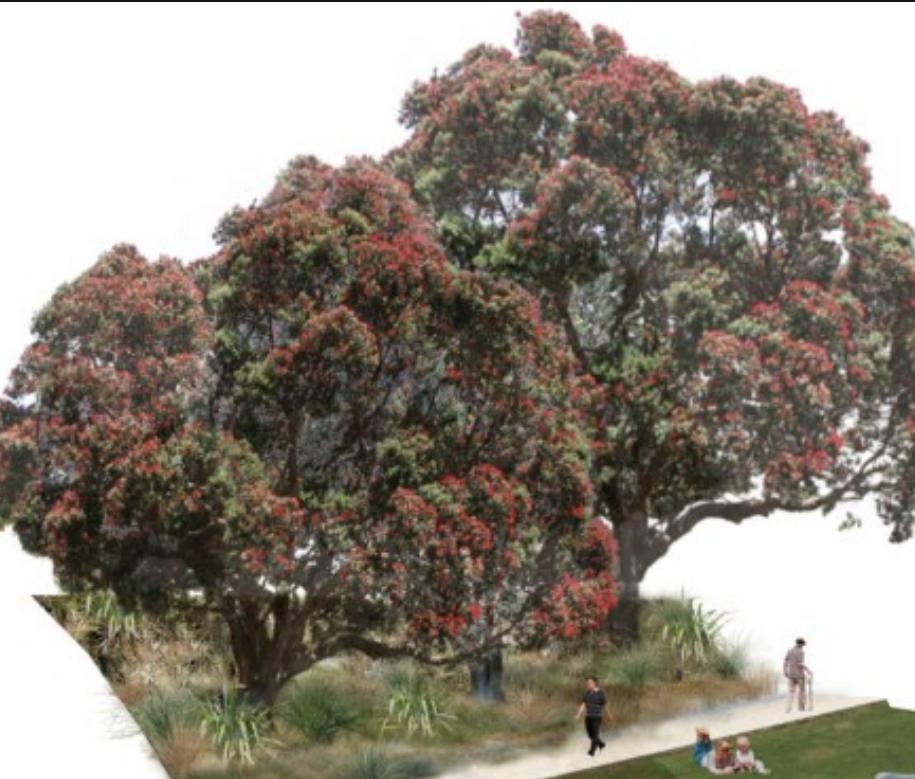
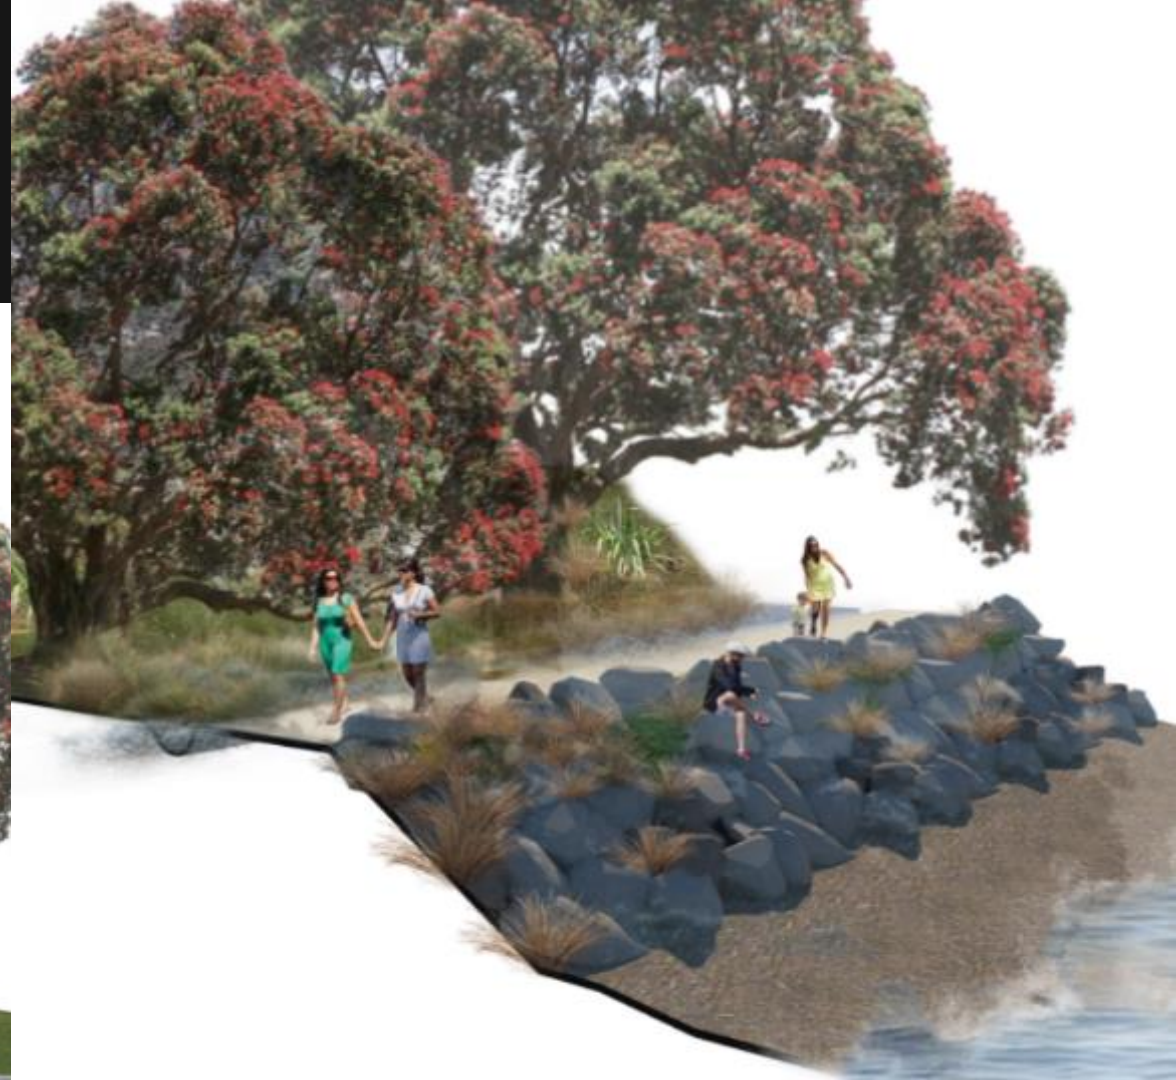
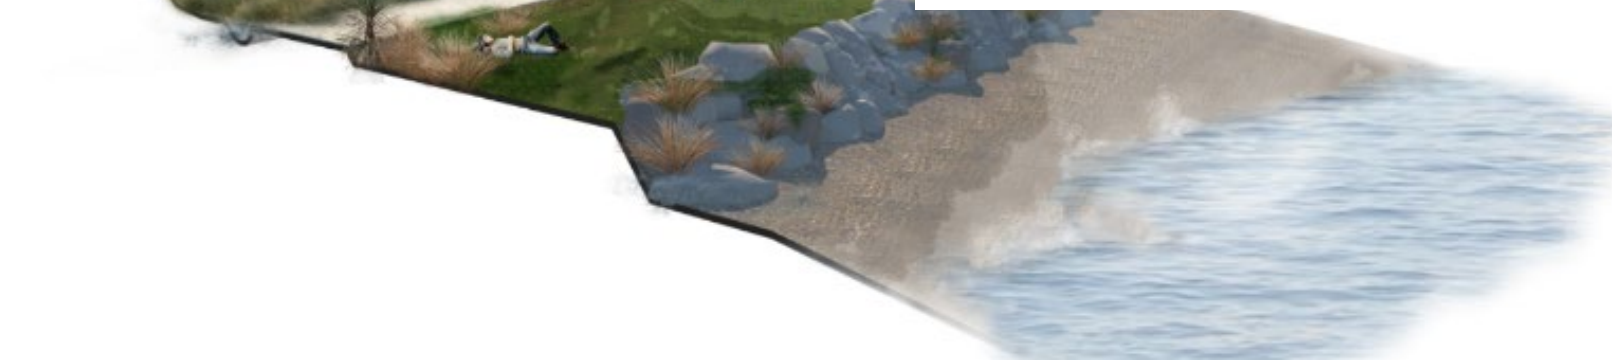
Rock Revetment Options

- **Landscape** – Revetment through the boulder field CH110-160, the removal of at least two low hanging mature Pōhutukawa trees, and the visual effects of the boardwalk with handrails align the escarpment.

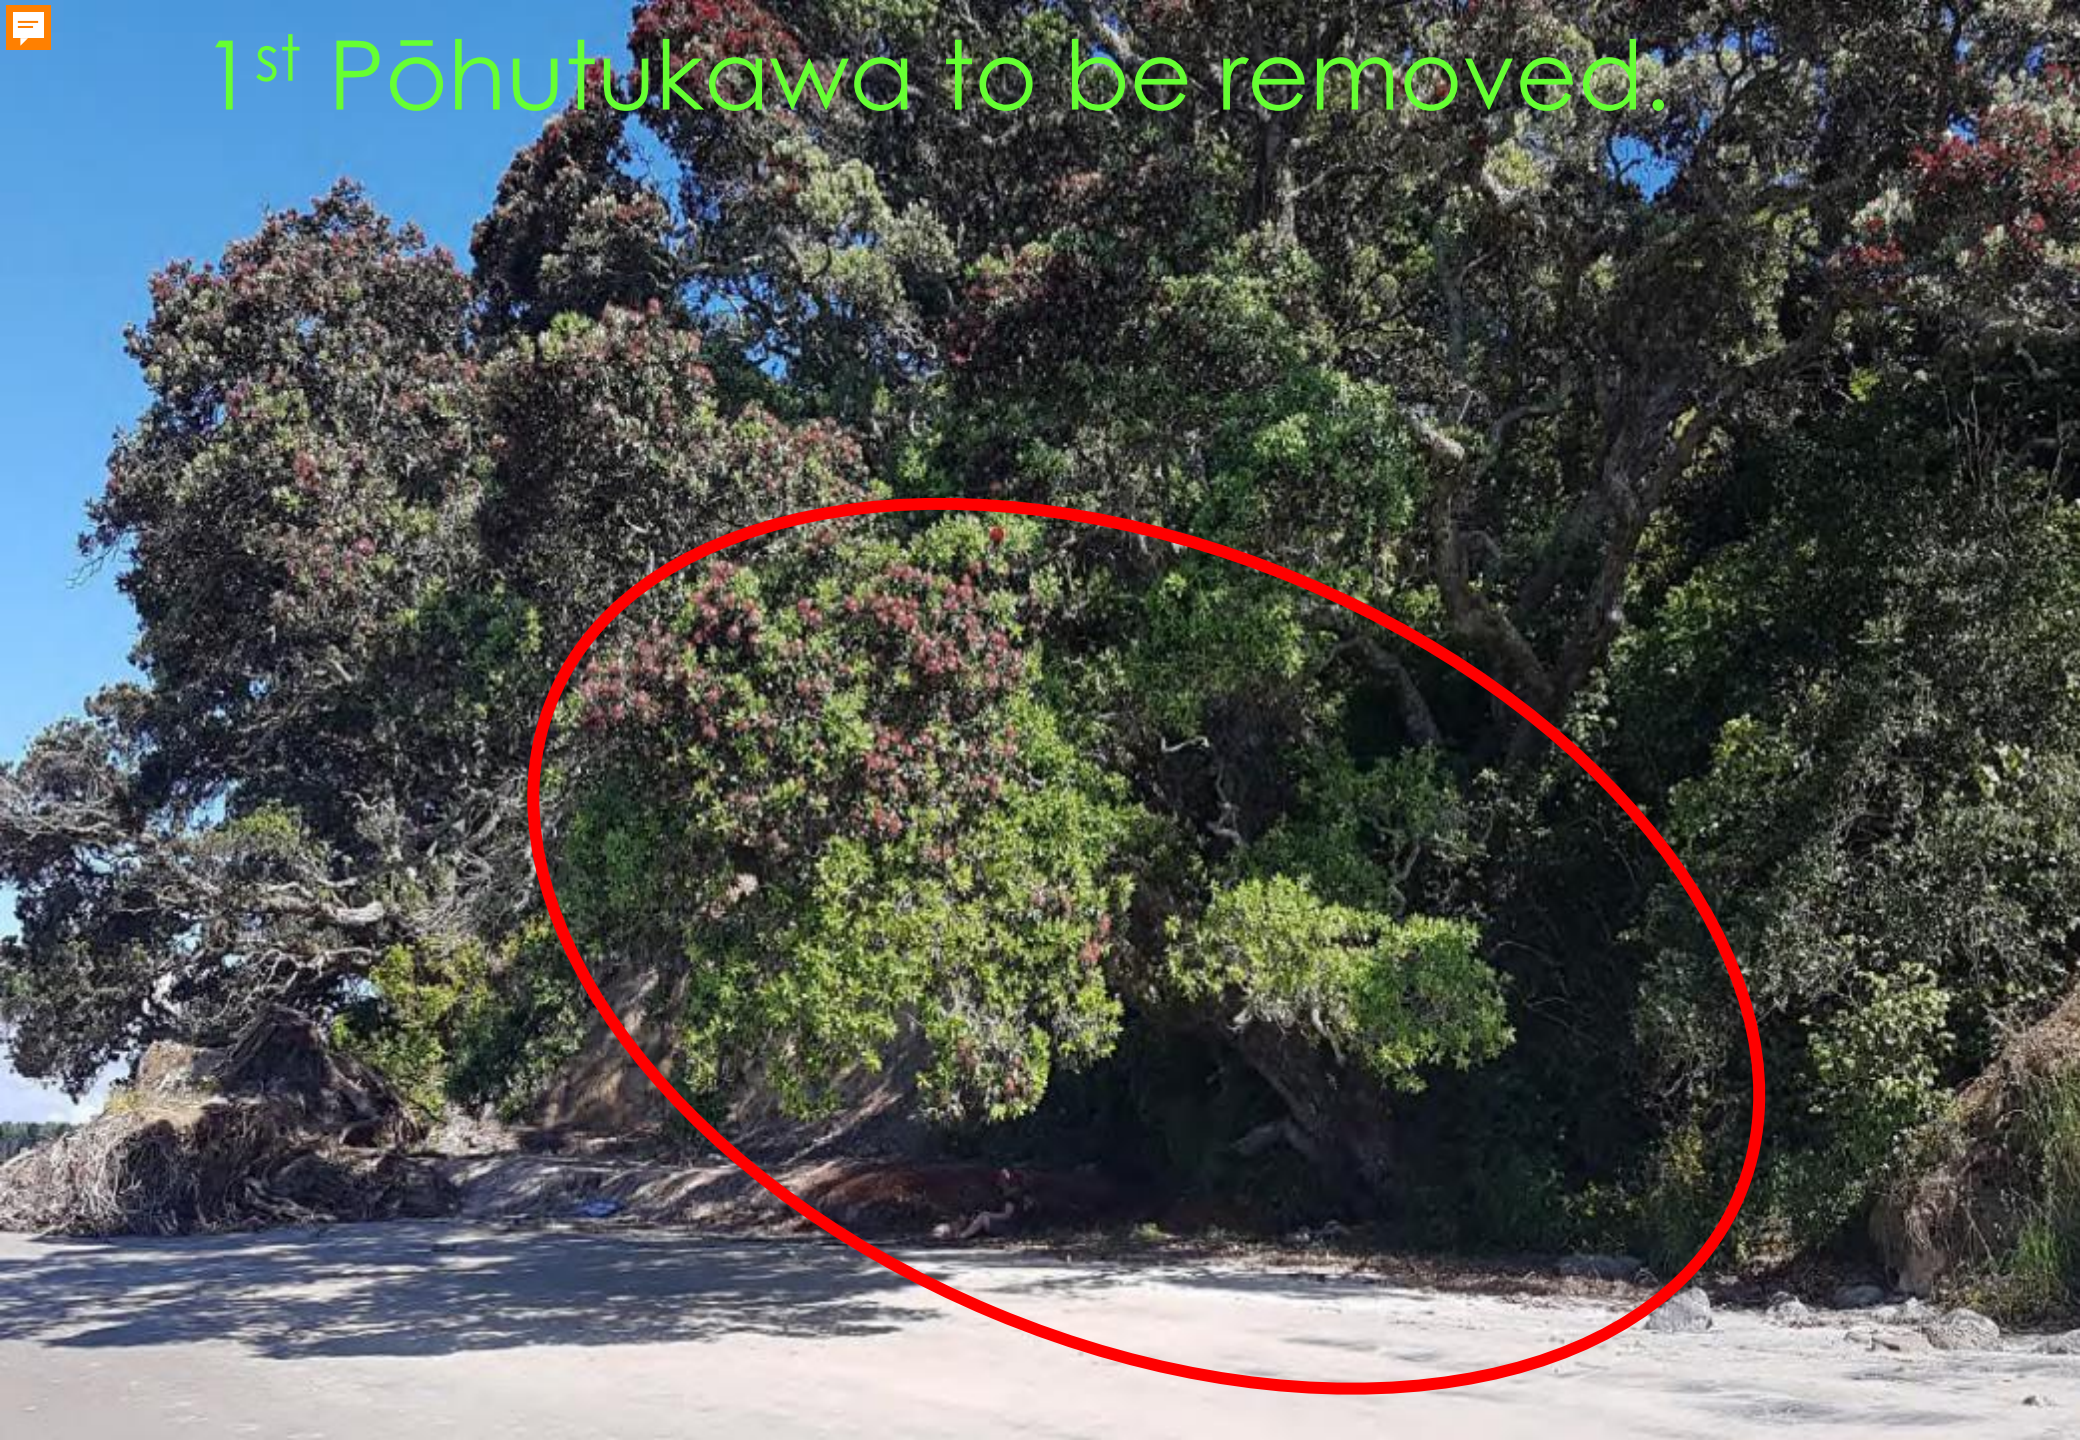
1st Pōhutukawa to be removed.

Arborist estimated the age of the Pōhutukawa Trees to be approximated **125 to 150** years old.

- Determined by counting the growth rings from the trees.
- The trees were probably sown in 1868 to 1893.

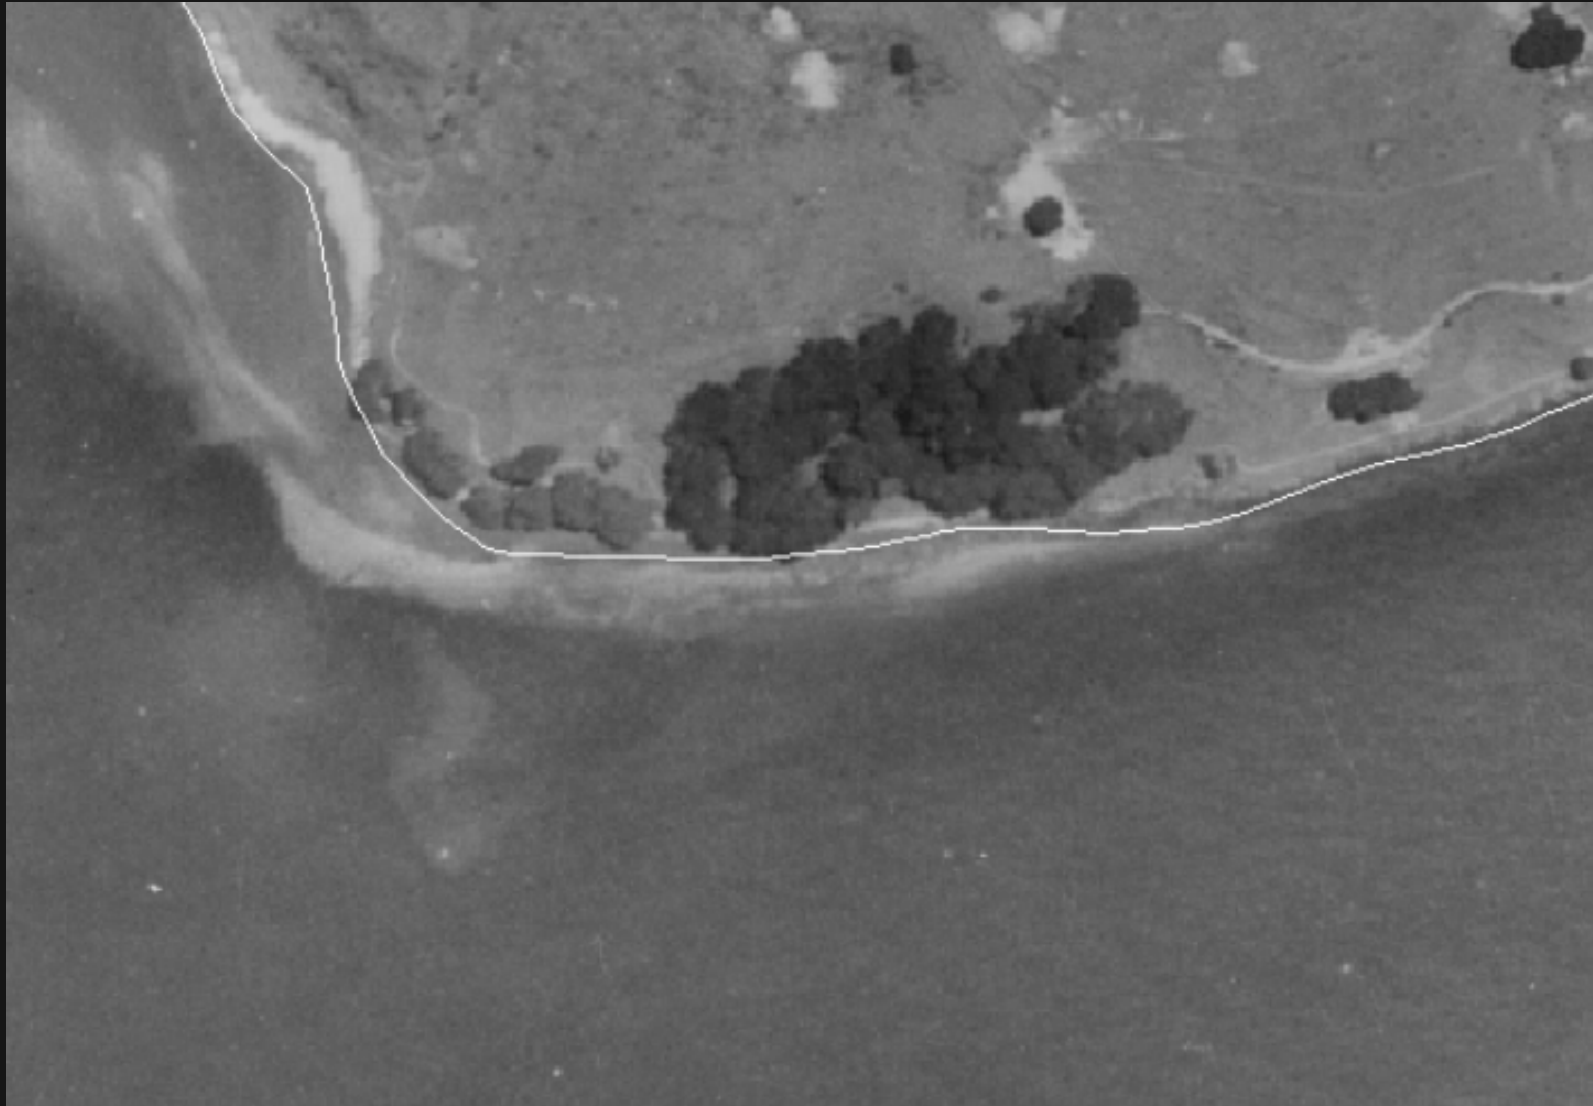
Project site 1943

- The **1943** - there are two clear groves of trees, the first being around the Te Kawa slip site and the second grove further east and extends to Waipatukakahu.
- Differences: size of the tree canopy and the density of the trees.
- The **1977** - shows the maturity of the Pōhutukawa trees at the Te Kawa slip site and the thinning of the canopy of the eastern grove of mixed trees.
- **2017** - shows the dense pōhutukawa canopy prior to the April slip event.

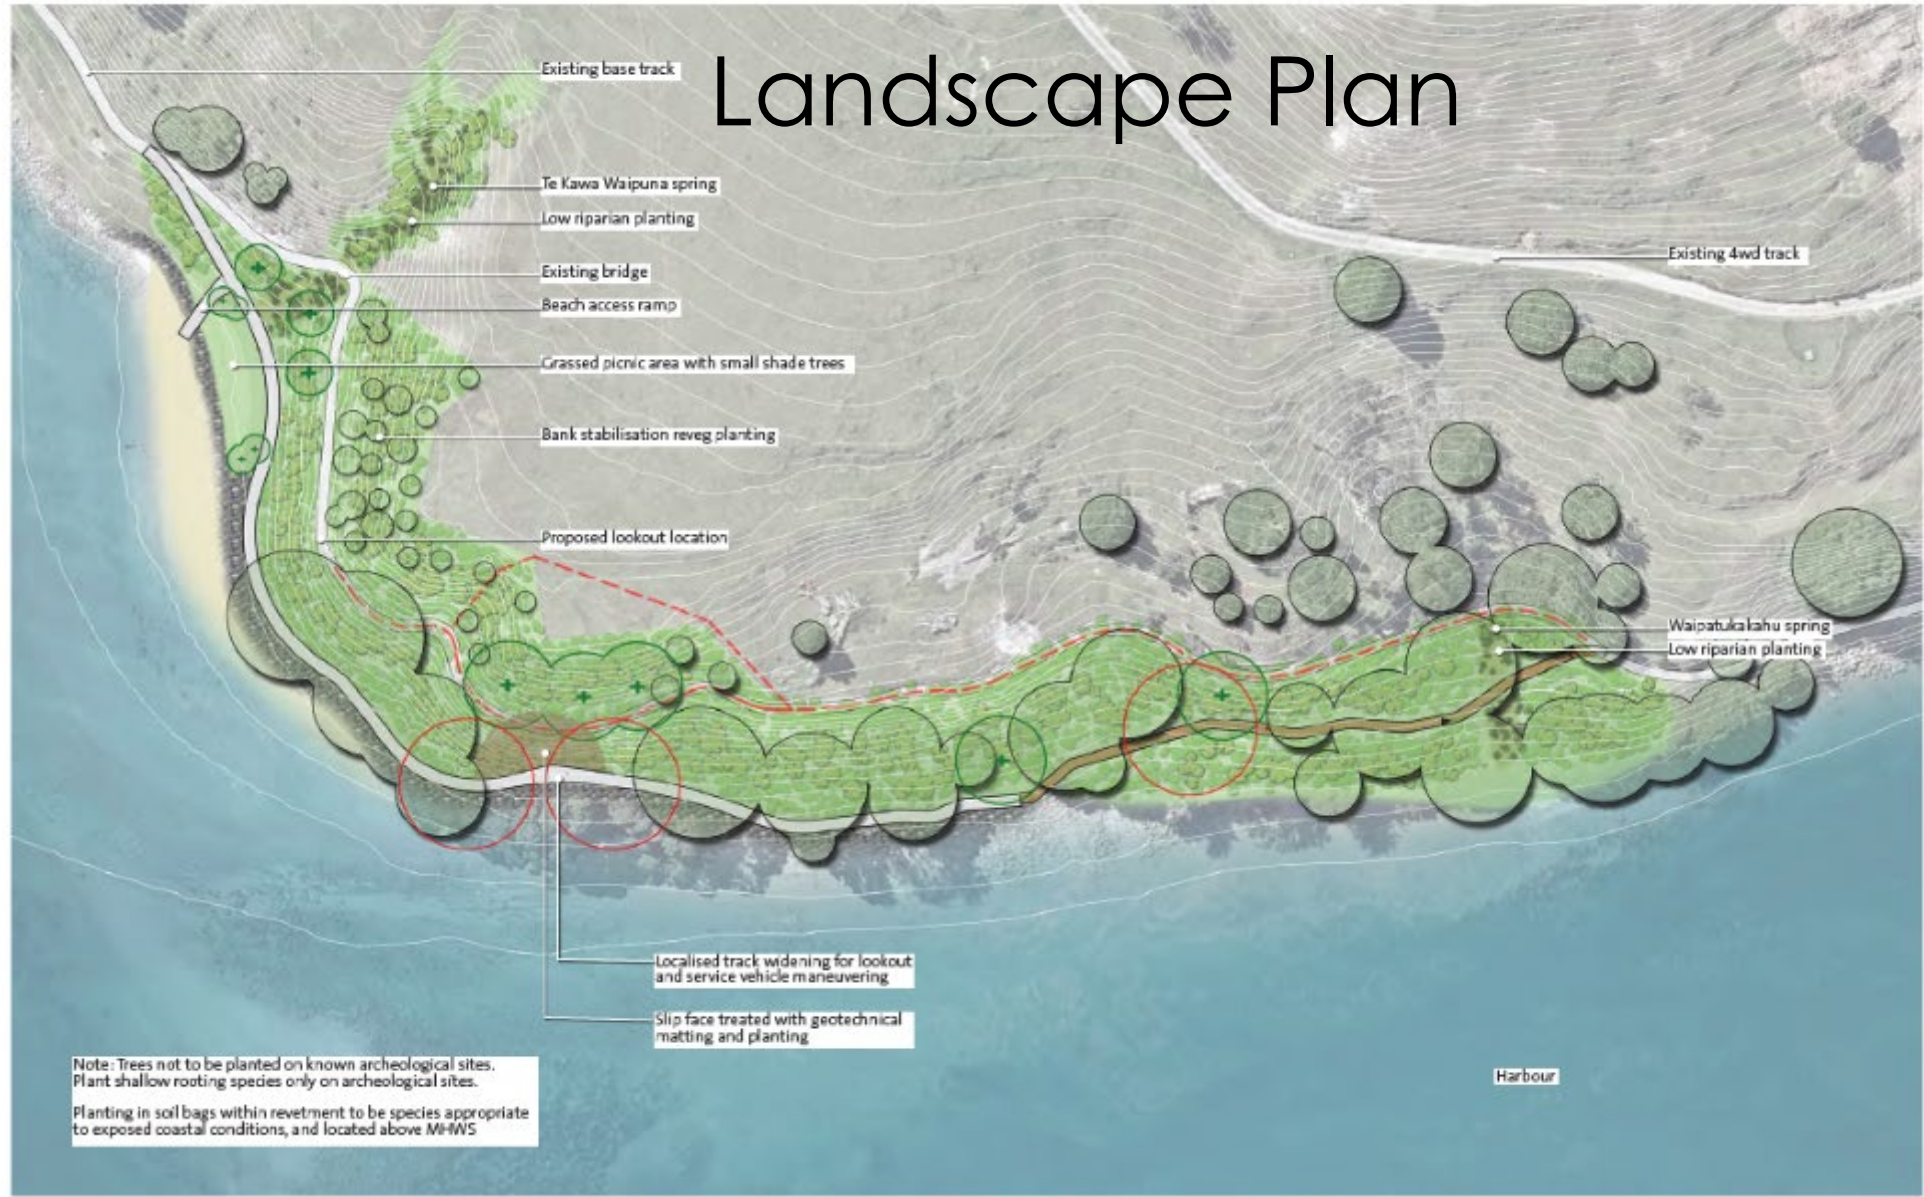
Landscape Plan

Note: Trees not to be planted on known archeological sites.
Plant shallow rooting species only on archeological sites.
Planting in soil bags within revegetation to be species appropriate to exposed coastal conditions, and located above MHWS

Managing the potential adverse effects of the proposal through the adherence of current design principles / values in the construction, completion and maintenance of the track by:

- a) Maintain the current design RL (height & width) of the revetment.
- b) Remediation of the sandy shoreline following construction.
- c) Alignment of the revetment follows the natural coastal edge and avoids linear patterns (straight lines).

- d) Use of local natural stone that visually integrates, in a weathered condition, with existing stone materials present and used on Mauao.
- e) Landscape vegetation measures (8):

- Avoid any further removal of native vegetation cover, i.e. Pōhutukawa trees.
 - Include dominant native tree cover along the coastal margin / edge.
 - Include the planting of Pohuehue, Oi Oi etc along the top 1/3 of the revetment.

- Additional coastal marginal planting along the Te Kawa beach revetment edge.
 - Native plants includes Pōhutukawa, Pūriri, Karaka, and other native shrubs that wont effect known archaeological sites.

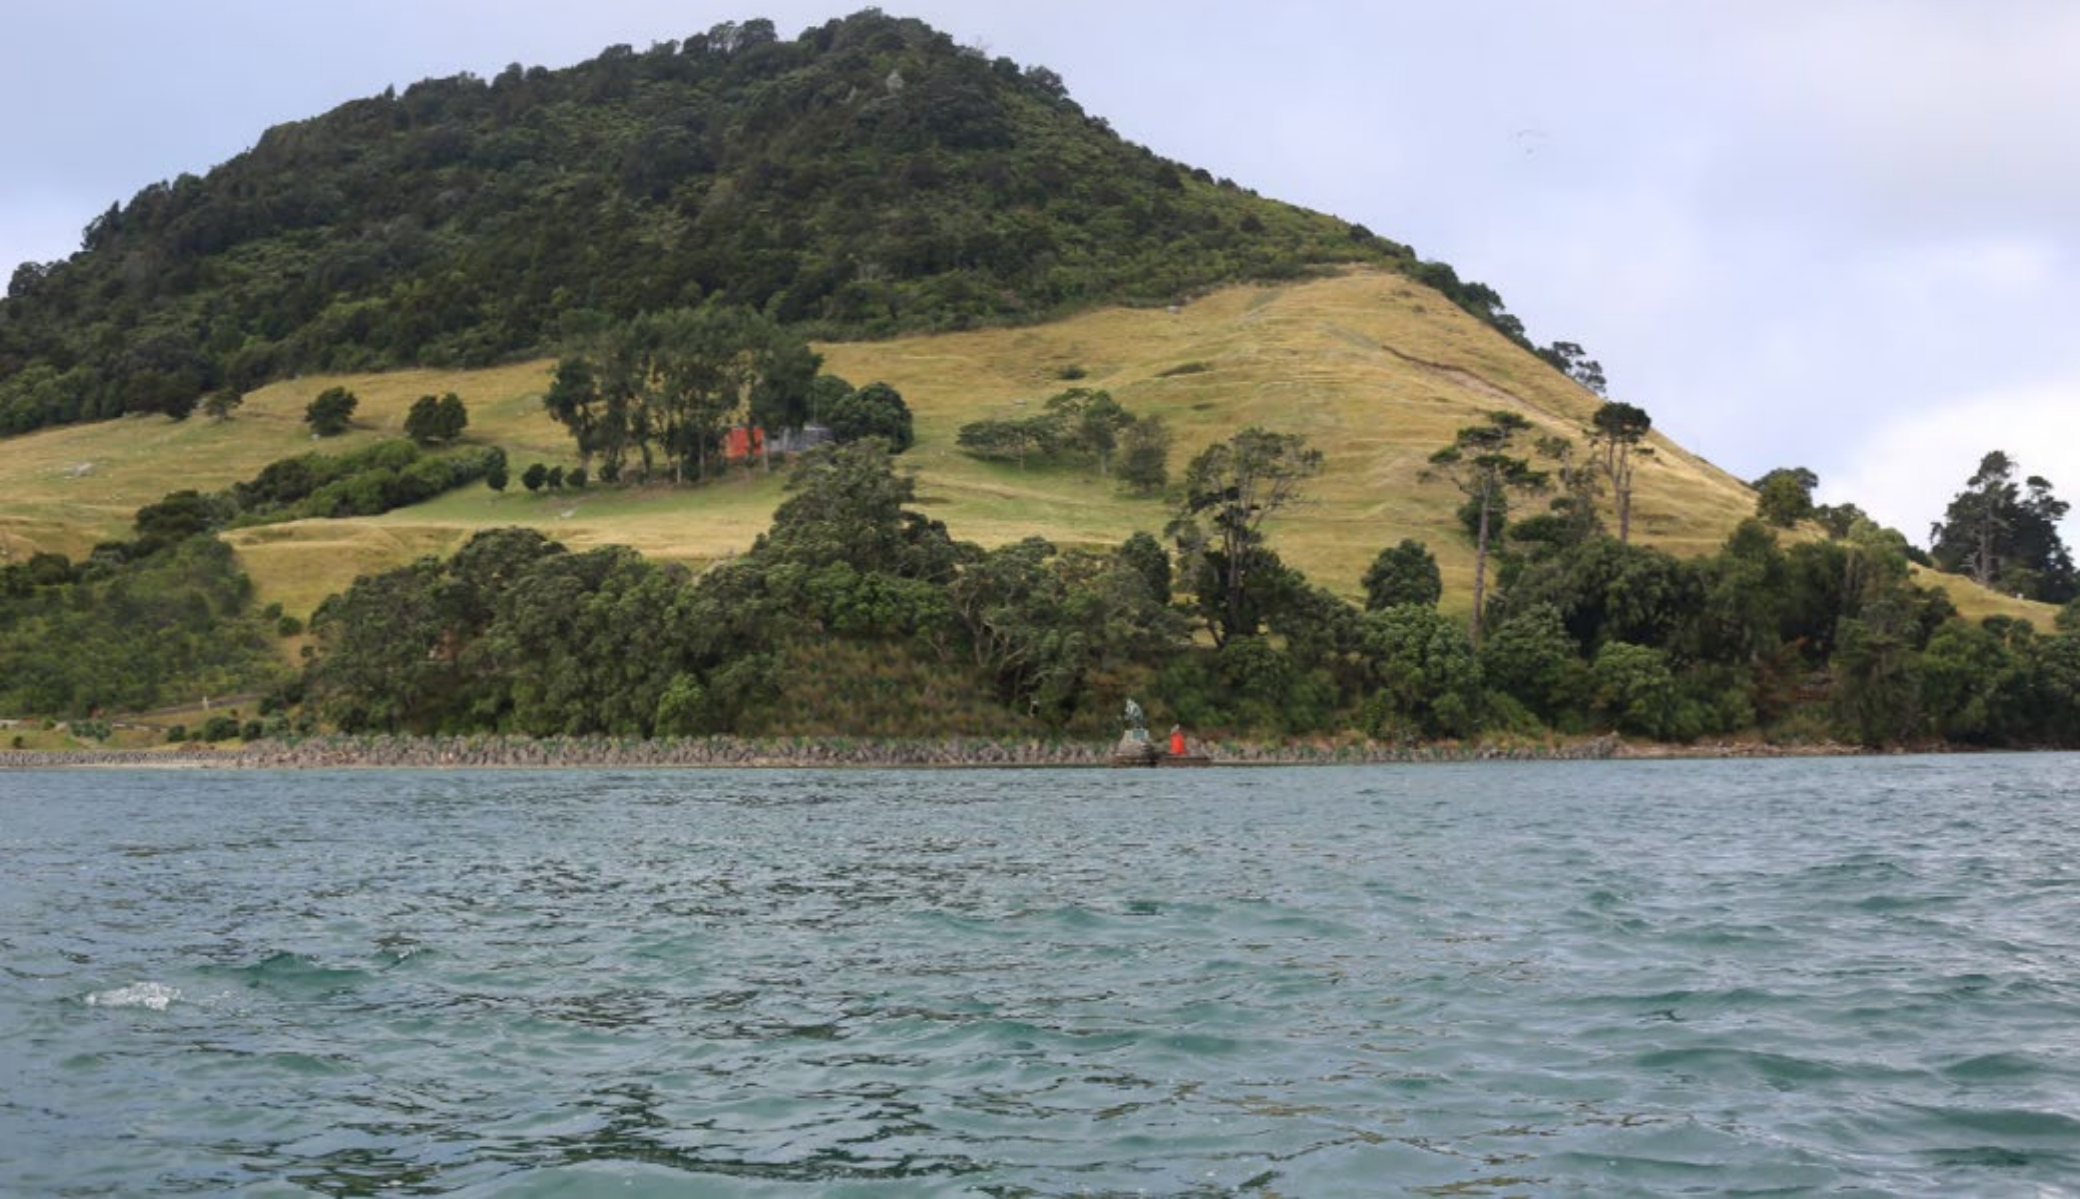
Mauao Simulation – 5 years

“11.3 The overall landscape and visual effects of the proposal, on the site’s immediate landscape values and its viewing audience, will be moderate to high. At a broader scale the adverse effects will be low to moderate in nature. Management and mitigation of these effects can be achieved through the application of the proposed recommendations in Section 10 to ensure the effects identified are limited to the immediate landscape and visual effects, avoiding adverse effects on the broader Outstanding Natural Features and Landscape of Mauao.”

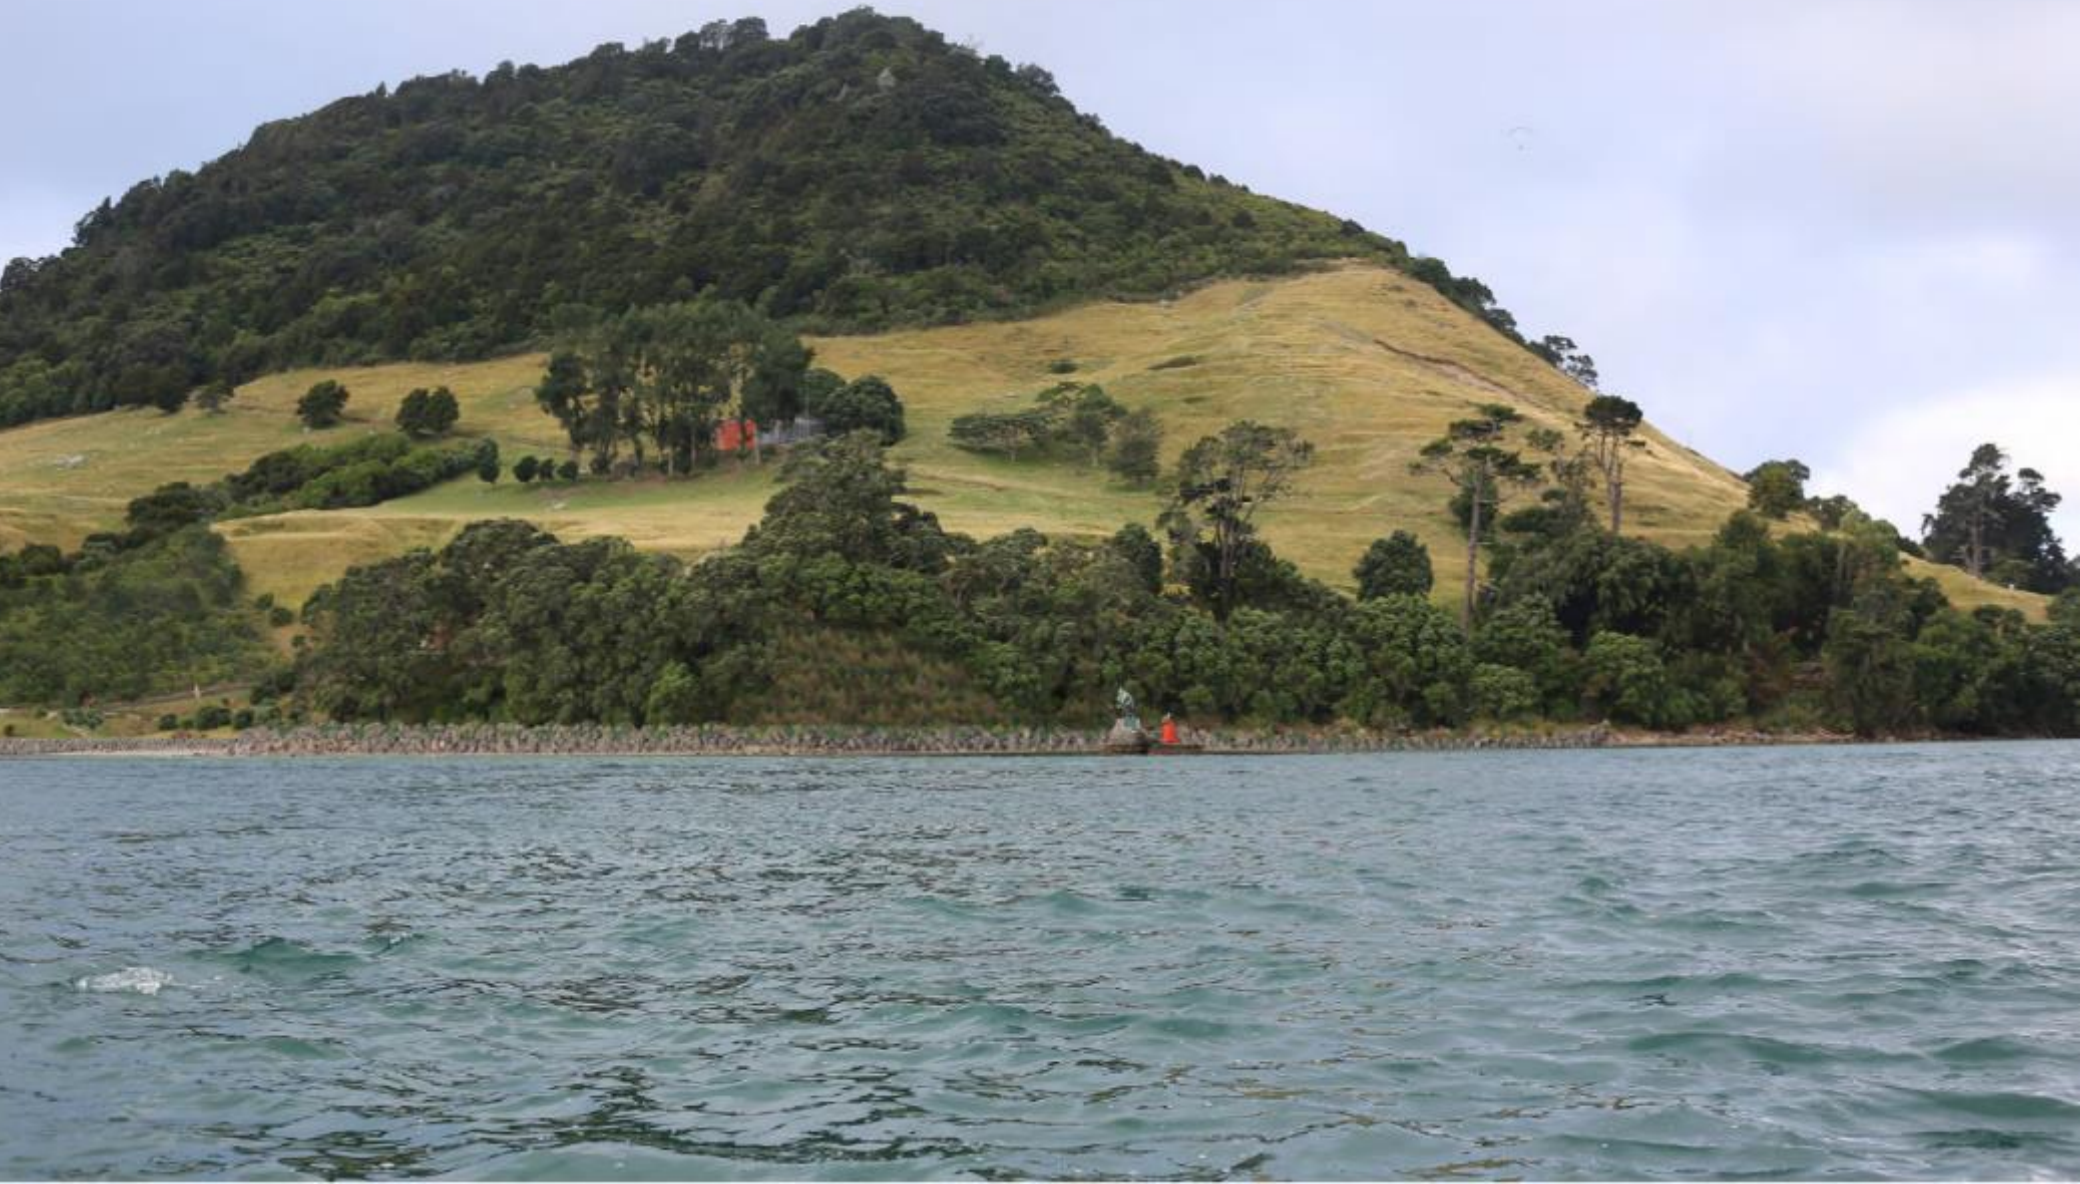
Mauao Simulation – 20 years
