**Contract: TC1/14**  
**Reserves Walkways Maintenance**  
**Tauranga City Council**

**Monthly Report**  
**April 2018**

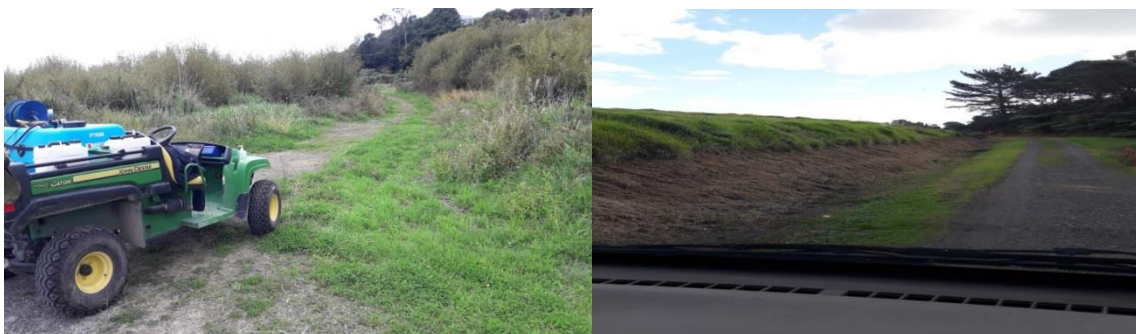
An area that will need spraying in May is through K Valley and in particular the service tracks (see photo below) which were only recently reach mown and sprayed. One job completed at the end of the month by a reach mower was at Cambridge Park which cut back the top of the drain line and also areas away from the track that the ride on mower is unable to access. (see second photo below).

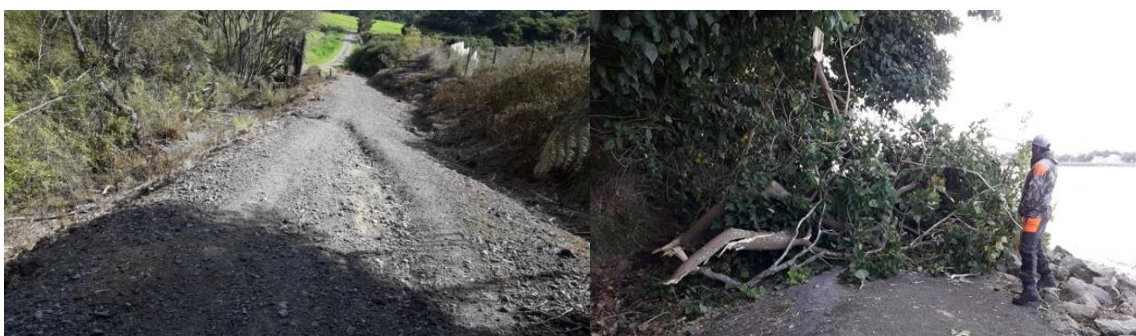
The first photo below shows an area of wash out at Marshall Street in K Valley which has been filled in roughly but may require a proper repair and possible drain install to fix the problem. Other weather related issues from earlier in the month can be seen in the second photo, these were ongoing tree issues that started in late March where arborists were required for tree removal work at Faulkner and Novella Place, where work carried on into early April. This photo shows the Daisy Hardwick side of Waikareao West having a tree come down and needing urgent work to tidy it up for the track network to get its access back.

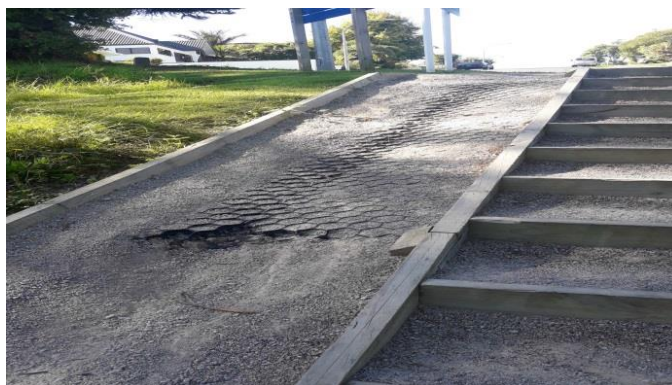
One area that has been getting ongoing top up work but is now deteriorating a lot is at York Park on the bike ramp. The photo below shows wash out made worse by bike riders skidding through it. The surface now sits much lower than the edging. Concreting the bike ramp would help prevent it further eroding but due to its steep incline may make it quite dangerous to ride down when trying to brake. The degree of slope could be altered slightly if the start of the ramp at the top end was lowered so it sat below the steps rather than in line with them. Recreational Services will discuss this further with Council.

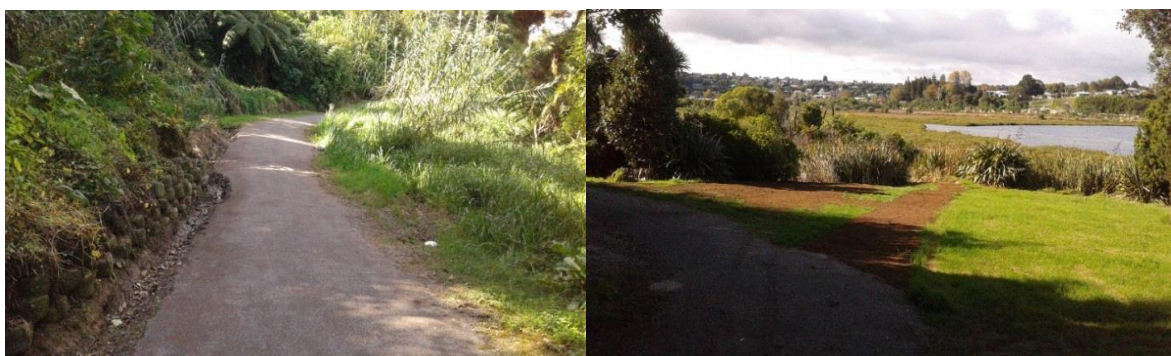
Unscheduled work has gone well this month with Judea Reserve nearing the end of its renewal work. The photo below shows the inside drain dug out with a digger through the top sloping section to allow water flow. Because this area fills up with gunky soil and vegetation it will require an annual trip to the site with the digger to keep the water flowing properly and avoid damage to the surface. With new drains installed and linked up to the side drains it should be more effective in diverting water to the waterway next to the track. The second photo shows the finishing touches to Elmes where top soil and old cricket clay was used (free of charge) to fill in the old track now not required since the work done to the main trunk line track. Grass seed has also been applied.

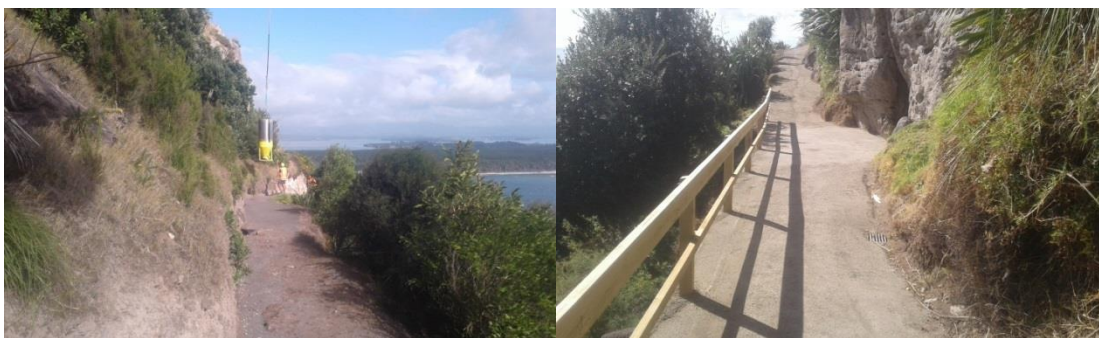
The exciting job this month was working with the helicopter to resurface the Orauhine track (see photo overpage). This year's helicopter was much more user friendly for the team in spreading the aggregate where it was needed. This meant less hard labour time to spread piles out as was the case last year on the Waikorere track. The only difficulty for Recreational Services was trying to keep up with the helicopter where it was dropping the aggregate to spread and with the digger trying to load up the buckets with aggregate quickly enough. With the buckets also being too small for the digger bucket it is hoped next time a helicopter is used bigger buckets will be available to help speed up the process of filling them. The second photo shows a new hand rail installed on top of the retainer wall with a great finish achieved.

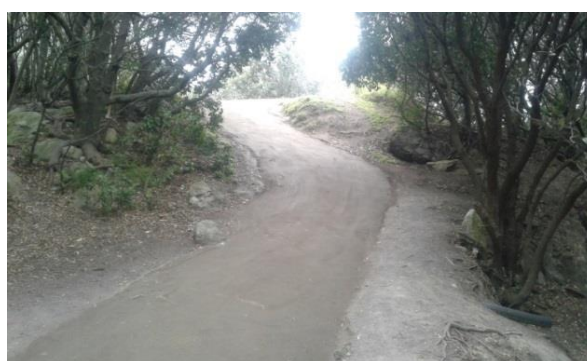
The end of Moturiki had the helicopter utilised to drop aggregate on site so that resurfacing could be done from the end of the track back to the sets of steps (see photo below). This was an opportunity to correct scouring and get the correct slopes for water to flow away from the middle of the track and run down the sides of it.

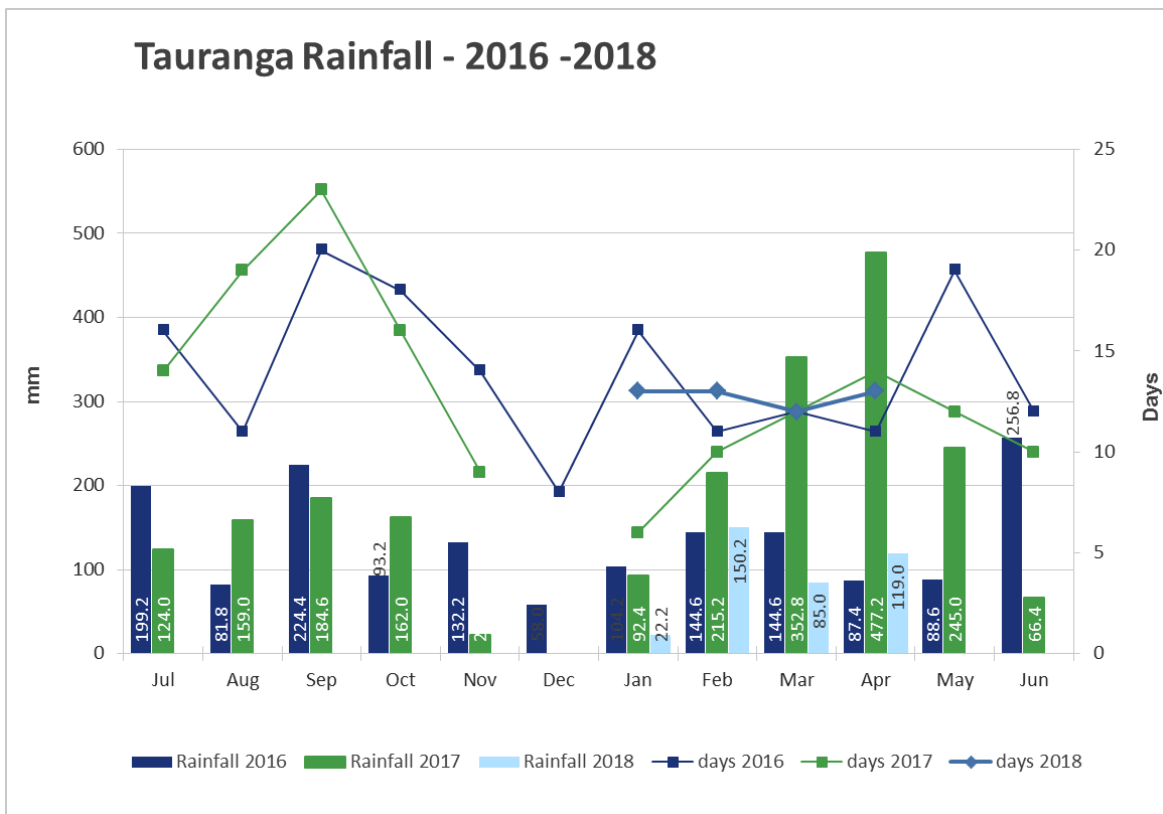
The rainfall figure for April 2018 was 119mm over 13 days, compared to 477.2mm over 14 days at the same time last year.

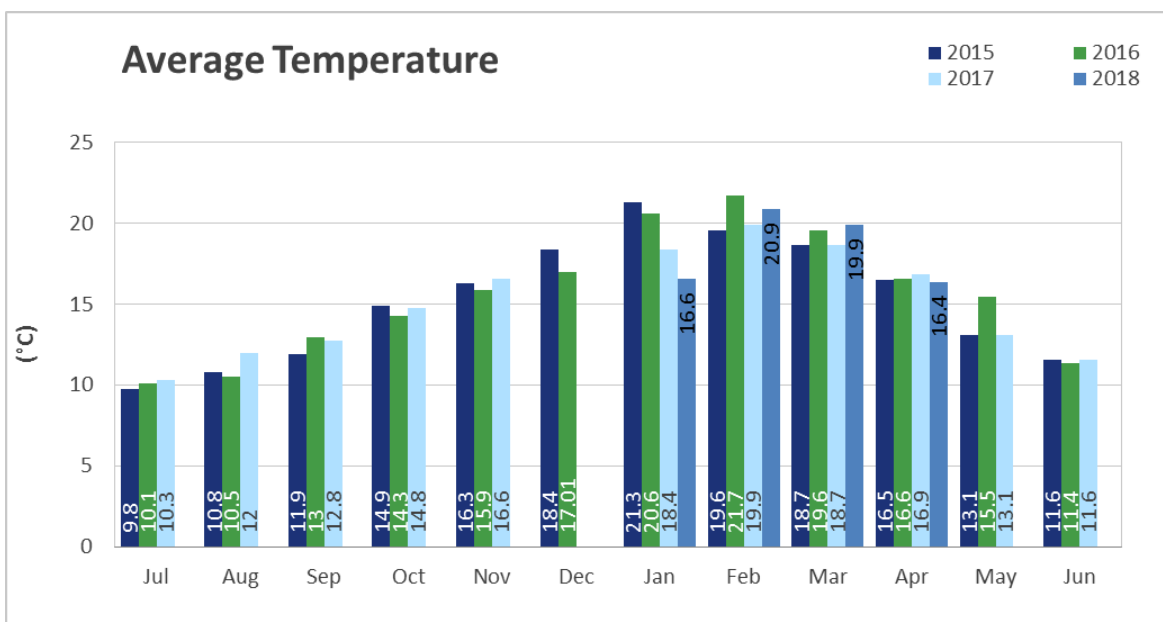
The average temperature recorded was 16.4°, compared to 16.9° at the same time last year.

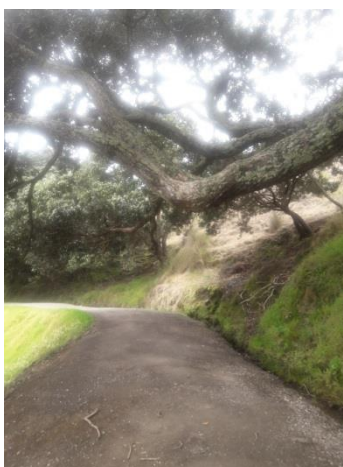
- Mauao's Waikorire track has a section at the Bluff which is very narrow and has a straight drop. This really needs attention and ultimately some kind of safety railing installed for everyone's safety. The Orauhine track has a number of trip hazards where large rock is showing through the surface which is now completely worn down and desperate for renewal work.
- Mauao Base track has a low hanging branch that is starting to sag into the envelope. Needs an arborist to look at removing it (see photo below).

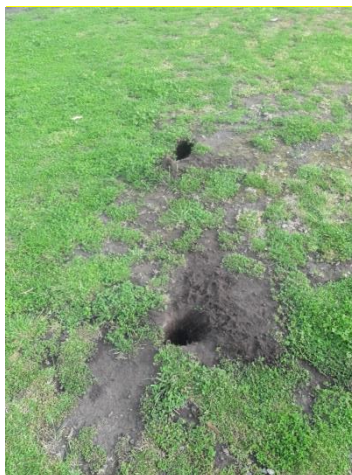
- Moturiki has rabbits which are digging holes in the surrounds (see photo below).
