CONTRACT OVERVIEW

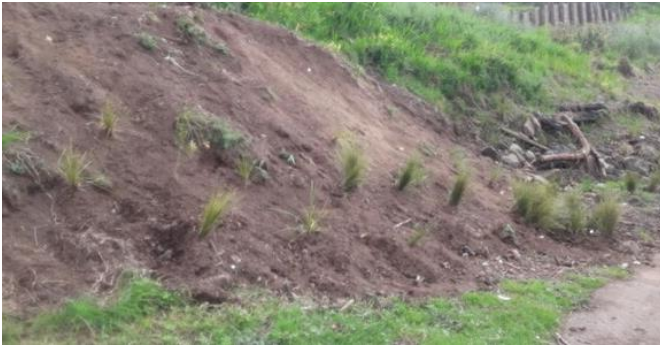
Unfortunately Esk street Reserve had approximately 30-50 recently planted grasses stolen from the new track realignment renovation work.

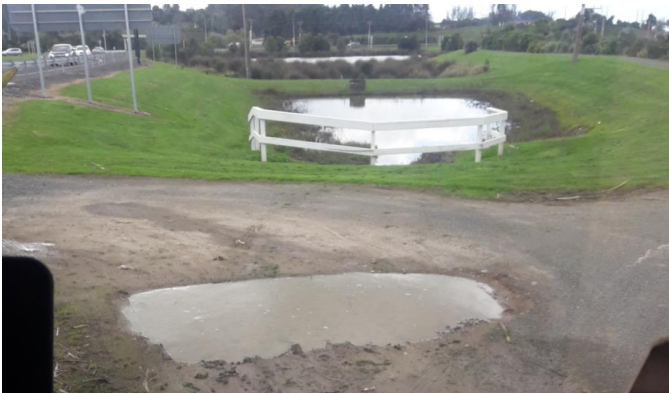
A popular track within the Lakes that links to Kopurerua Valley has a nasty scoured out hole that Recreational Services will fill with Gap 40 and fines. The team will try and shape this for water to run away off the track.

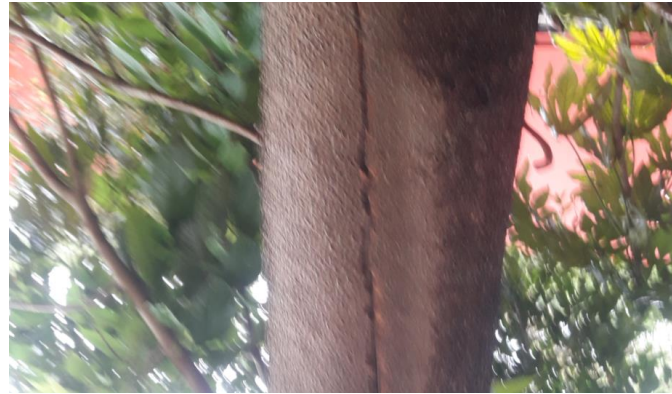
As expected with the Spring equinox, strong winds have produced a steady supply of tree falls throughout the tracks and walkways. Waikareao West was the worst and Recreational Services used Full Circle to help with the scale of this work. There were many others that were called through by the public around this time which Recreational Services managed to tidy up. Just after all these tree issues the team were undertaking a hazard assessment at Matua Salt Marsh and noticed a large tree with a split down the middle that posed a risk to public safety. The tree was situated on railways land however if the tree had of split it could have fallen either way onto the track or onto parkland. Recreational Services arranged to have the tree felled to ensure the hazard was removed.

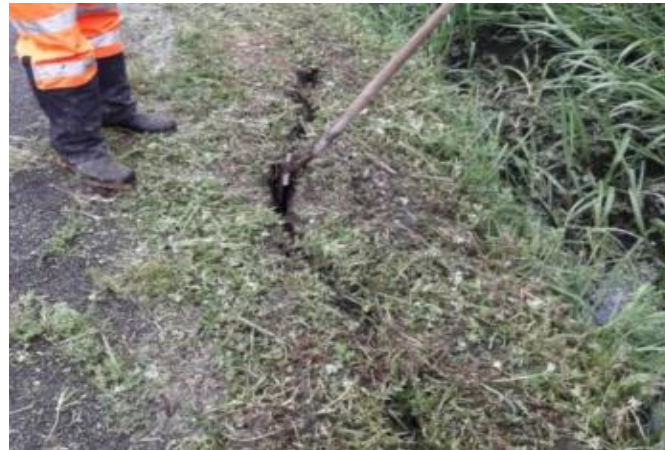
Erosion at Judea Reserve is an issue highlighted by large cracks appearing next to the track. Constant water flow beside the track has slowly eroded the bank. A combination of rainfall and general river flow along with a very wet August has ensured water levels are up.

- RED FLAGS**
- The Mt Drury hand rail is not strong enough on the set of steps. This along with the structure being old really needs replacing in the near future.
 - The Waikorire Track on Mauao has the Bluff section which has a very dangerous drop off on a blind corner. Ideally a structure with hand rail would be installed to make the public safe in this spot.
 - Kopurerua Valleys service tracks have holes that formed due to running water and unstable ground under the tracks. Holes have been filled in but are likely to come back.
 - Judea Reserve erosion as per comments and photo in September 2019 overview.

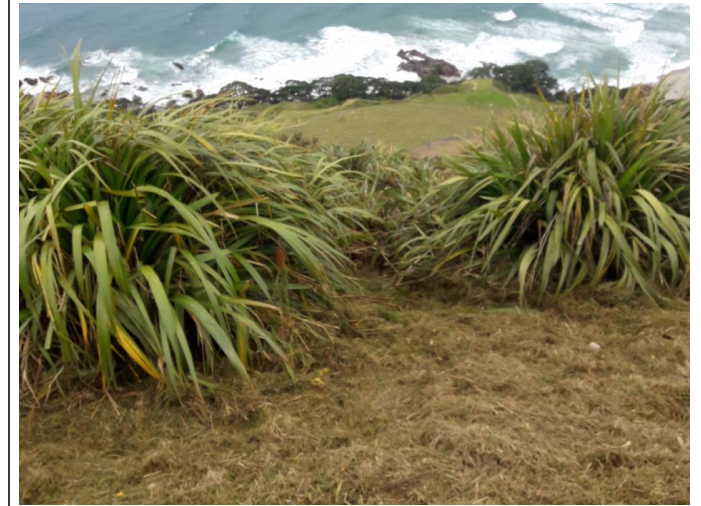
Recreational Services have concentrated on clearing Heather on Mauo this month after working on the Tutu earlier. The photo below shows the heather has been cleared from the false summit grass area down to the paragliding take off area.

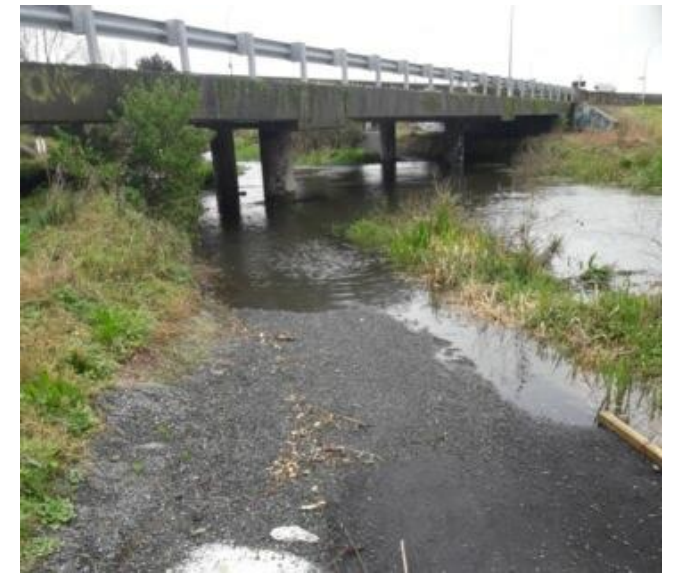
King tides have caused a problem this month both operationally and for park users at Kopurerua Valley. As seen in the photo below water levels have risen to mid calf height restricting access for daily users. Metal has washed off the track with each king tide leaving the surface as an ongoing issue. Unfortunately the track is unable to be lifted due to the height restrictions of the over bridge.
