Recreational Services
YOUR PARKS AND GREEN SPACES SPECIALISTS

Contract: TC1/14
Reserves Walkways Maintenance
Tauranga City Council

Monthly Report
August 2016

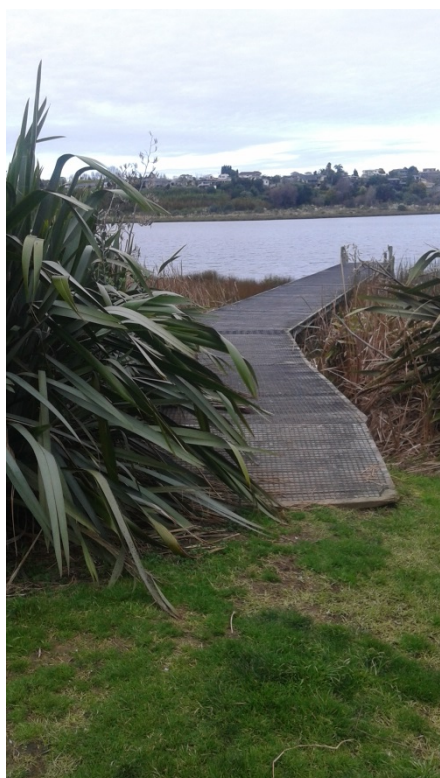
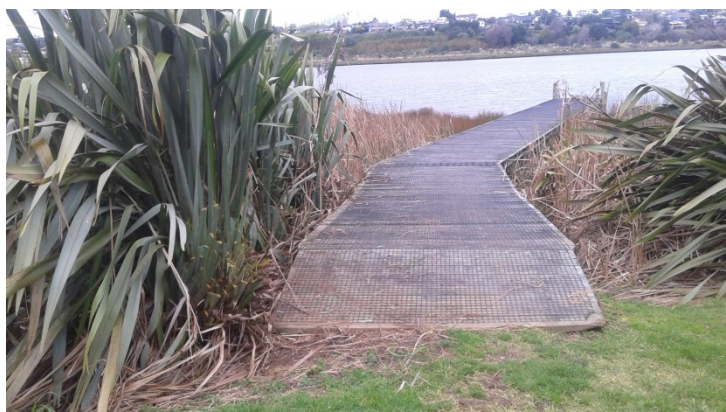
It's not only grass growth that has started up again with flax growing and requiring trimming through the better part of Winter. The before and after photos below show one of the boardwalks in Elmes Reserve needing a good tidy up to cut back overhanging vegetation. This is really another example of mature flaxes growing too closely to the track envelope and would be a good one for either removal or splitting in half and removing the closest side to the track. Hopefully other contractors can get onto the flax removal work that RS asked Council to be carried out before they become maintenance problems again through the upcoming growth period.

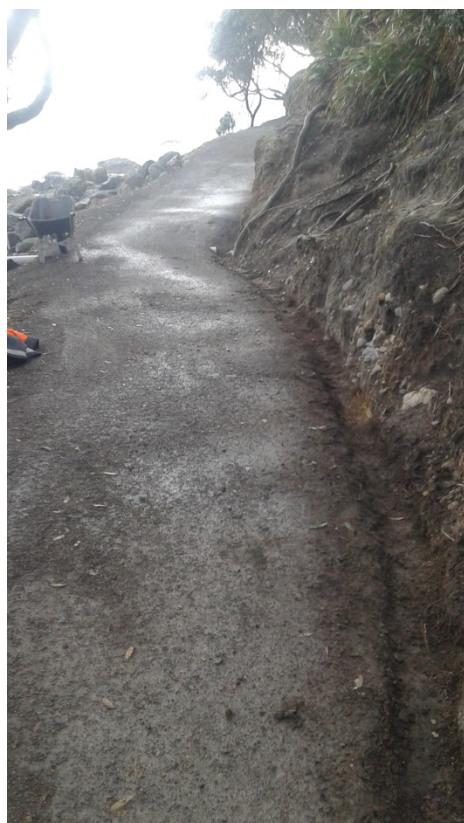
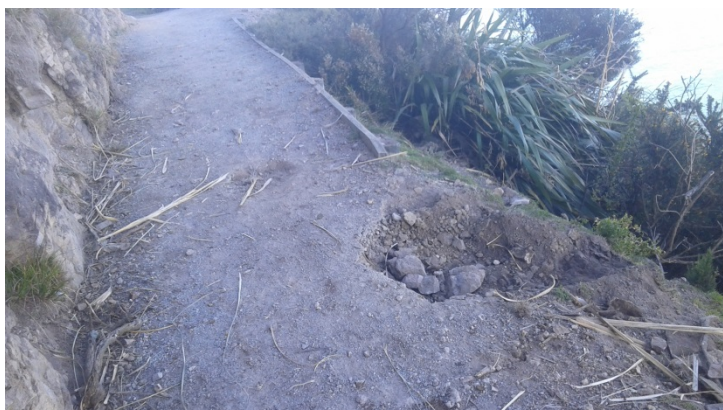
Plenty of work has been happening at Mauao with RS doing a comprehensive spray of the tracks which included trying to get to any noxious weeds like Pampas and Gorse growing within arms reach of the track envelope. The drain lines have also been cleared again on the majority of the base track (see photo on left below). It's a painstaking job but one that will hopefully not need as much attention as we change seasons. Leaf litter in general though will be an ongoing problem for now that will need ongoing maintenance. The photo on the right, shows another job that required attention on the Orauhine track from a rock falling recently. Further resurfacing work is ideally needed on this track so hopefully when the time comes to do the Waikerere track, the worst sections of the Orauhine could also be completed.

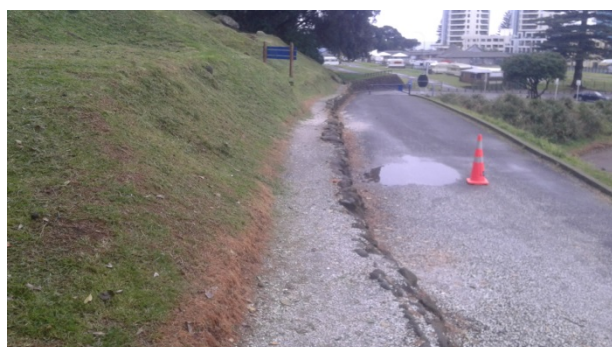
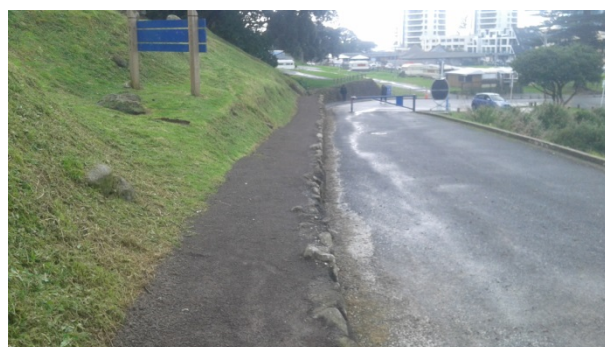
The unscheduled team have spent some time at Pilot Quay tidying up the tracks here. The before and after photos below show one section of track worked on and tidied up.

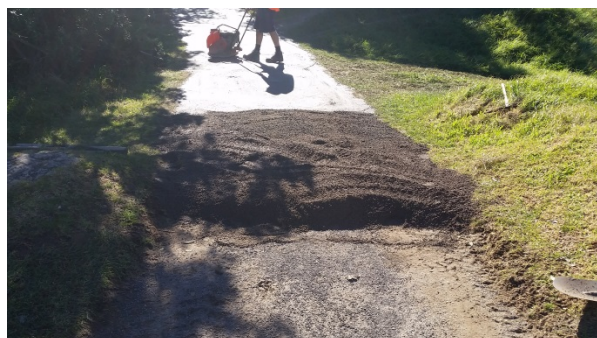
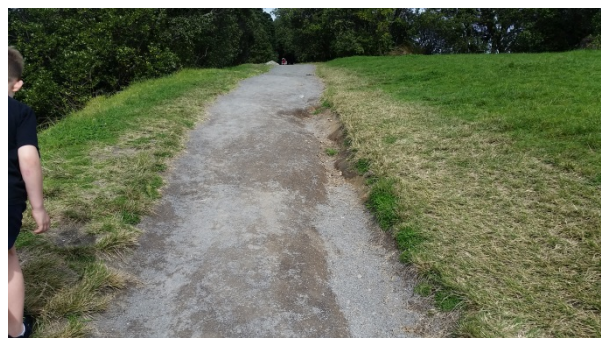
Moturiki was another big job to complete recently with the track having new edging installed and being resurfaced from the first lot of stairs to the start of the track. The left photo below shows the amount of aggregate applied to get the track sitting higher than its surroundings. The track now has water running off it rather than sitting on it and has come up very well, with a lot of compliments from the public. The end of the track at the lookout is in need of work though with the photo on the right showing a large gouge that has formed. If there was a possibility of potentially using the helicopter while it's at Mauao, this would be a huge efficiency to get this section tidied up. Penguins have been found inhabiting one of the large 200mm drains just as you enter the bush area of track on Moturiki, so RS has been leaving this drain to not disturb them.

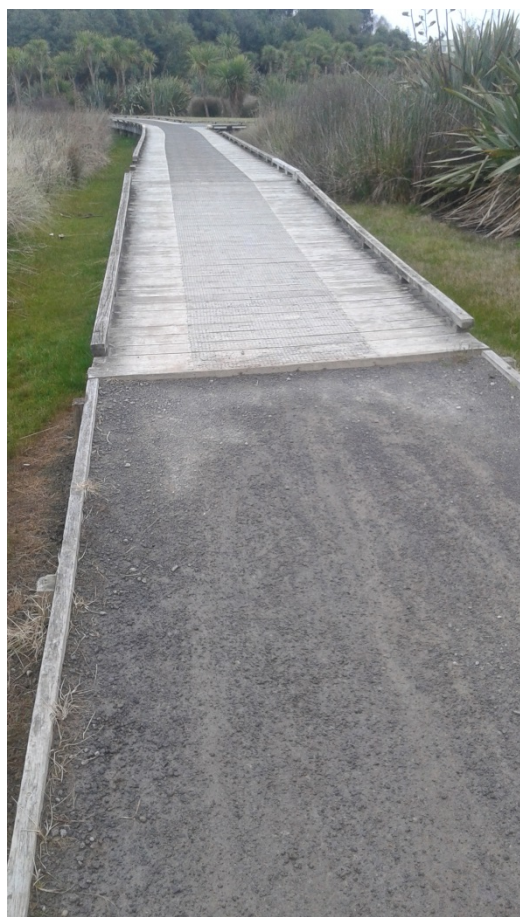
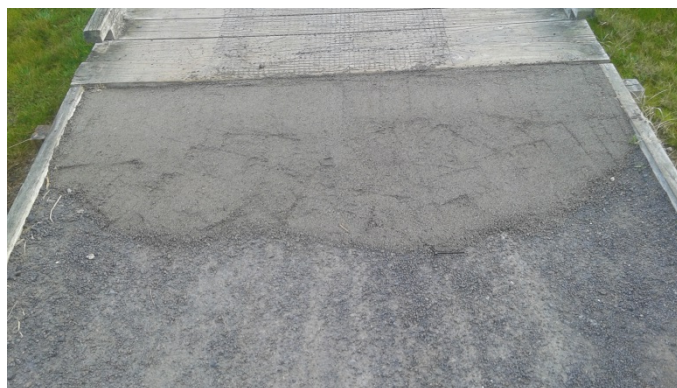
Many bridges have needed work where the edges are becoming exposed; this will be an ongoing job. The below before and after photos show one that was recently done at Matua Saltmarsh. There is still also the odd bridge that is losing aggregate down the edge. RS will continue to dig out any that have this problem and apply geo-cloth so the aggregate isn't falling through and the issue doesn't come back.

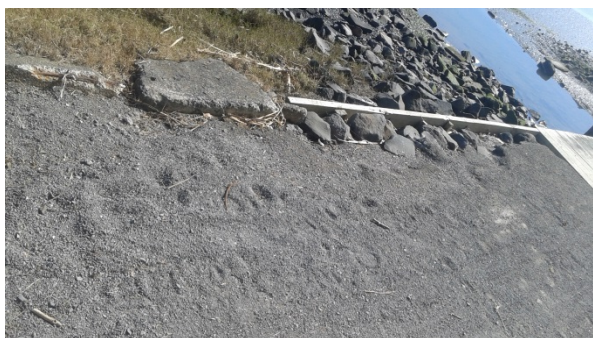
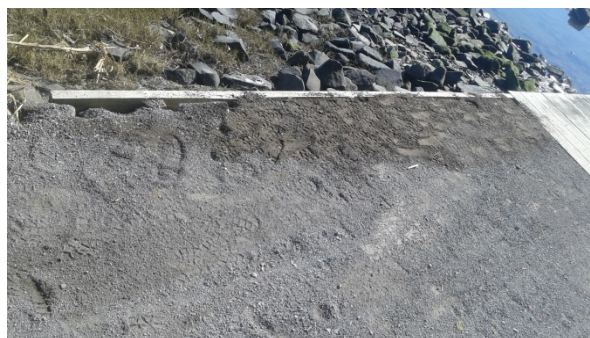
Waikareao Foreshore bridge was fixed again as king tides and rainfall scoured out one edge of it (see before and after photos). RS will continue to top up and compact as and when needed.

- Waikareao Foreshore Bridge is constantly having aggregate being washed out of the edge of it. The bridge needs extending and possible lifting to remove this issue
- Ohauti has a large puddle at the start of the entrance (see photo below) which needs aggregate to build it up but also a channel to be dug out so water can escape from here. The digger could do this while on site doing the track re-alignment

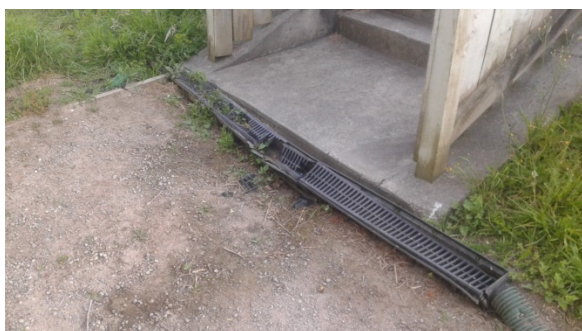
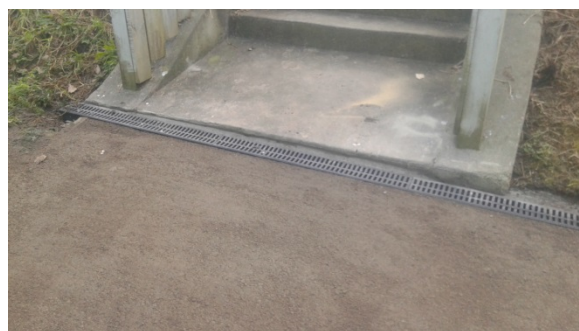
Gordon Carmichaels Graham Place section of track has had old and broken drains removed and resurfacing carried out. The before and after photos below show the great result that was achieved.

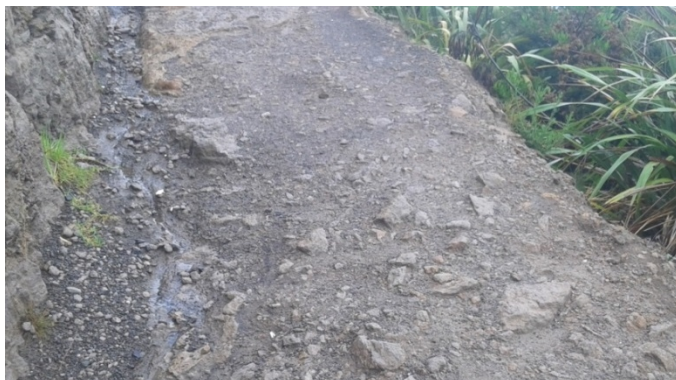
- Considering the worst sections of the Orauhine track to also resurface, as per the below photo, when doing the Waikerere work
