Contract: TC1/14
Reserves Walkways Maintenance
Tauranga City Council

Monthly Report
March 2017

Recreational Services
YOUR PARKS AND GREEN SPACES SPECIALISTS

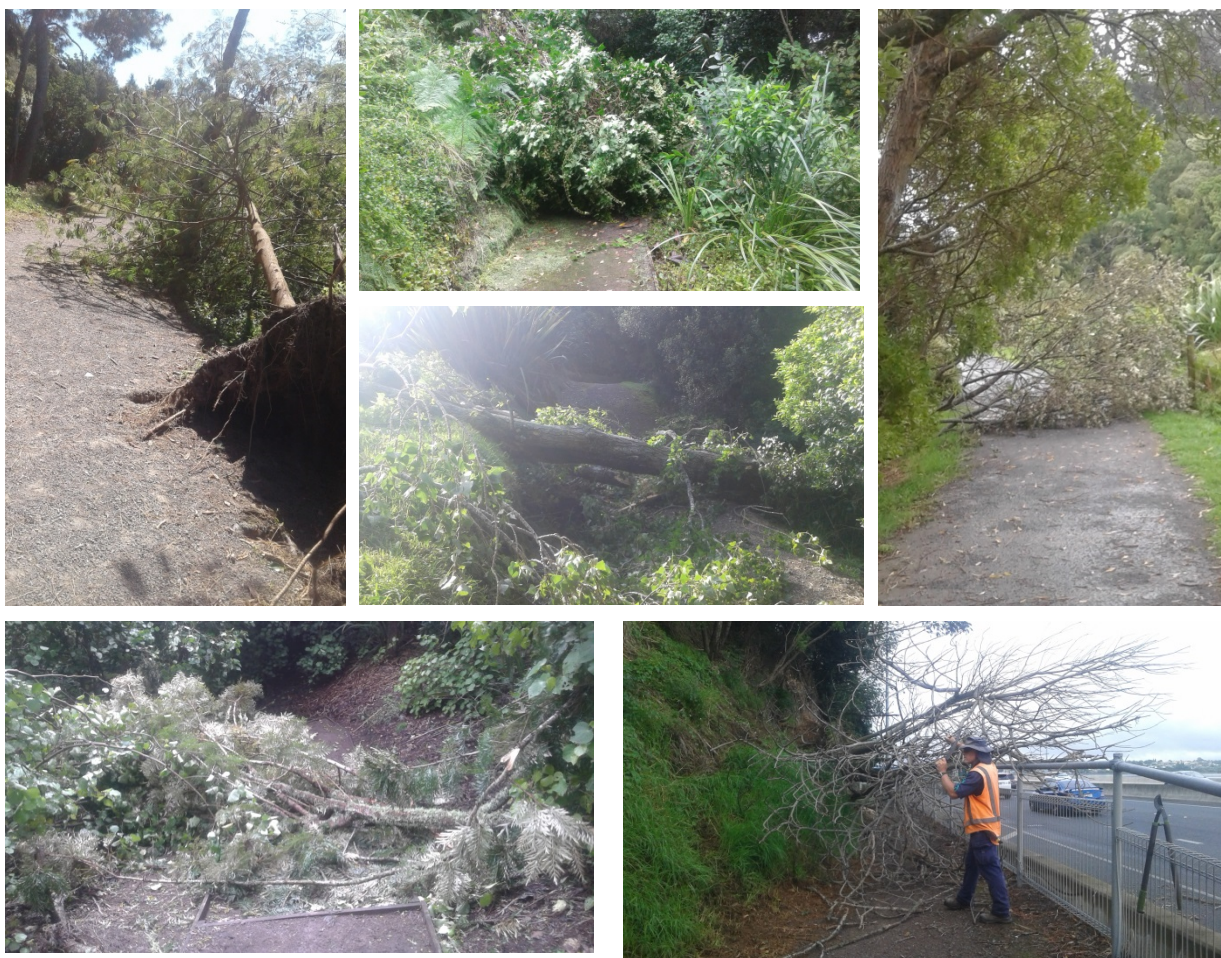
March has been a month heavily dictated by the weather as periods of fine and warm conditions have given way to spells of downpours and stormy weather. This has seen a lot of damage to the tracks network from falling trees and branches which has required RS to cut up and remove what we could. The many photos below show some of the damage that RS encountered. Some of the very big trees that were brought down, like at Johnson Reserve, needed the arborists so were called through to Council to action.

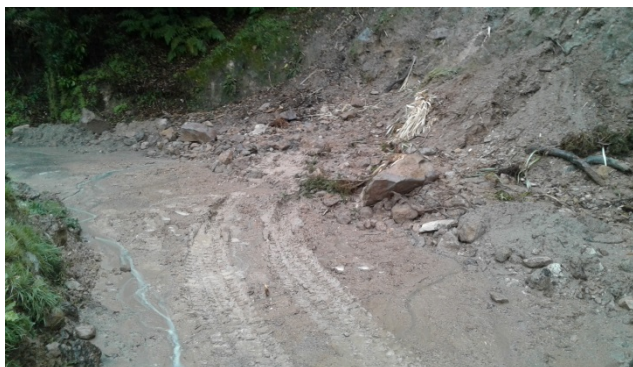
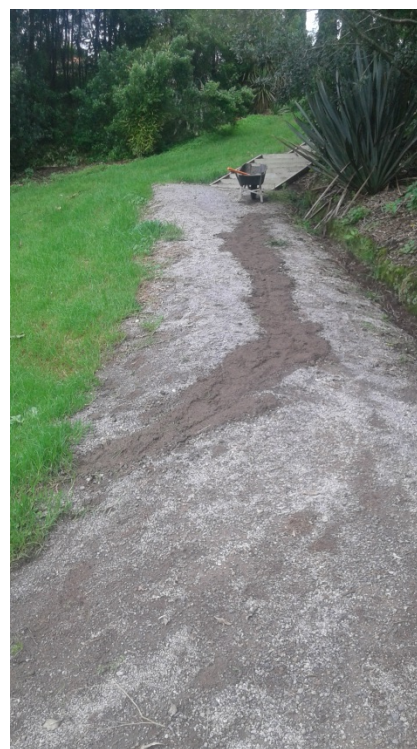
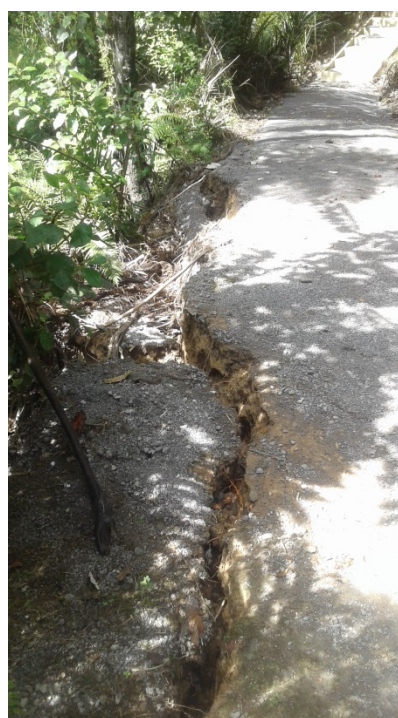
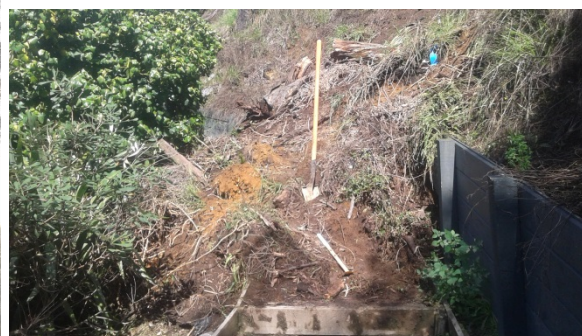
Another part of the damage that came with the stormy weather was a number of slips that required cleaning up. The photos below of Tom Muir, McLaren's Falls Totara/Rimu track and the Mauao base track were all examples of this with scouring also being evident in some places, with one of the photos below showing Ohauti being raked back level. This will be an ongoing maintenance job over the Winter with heavy spells of rainfall more likely. Where the same areas are having to be repaired from gouging RS will look to install drainage to remove the problem in the future.

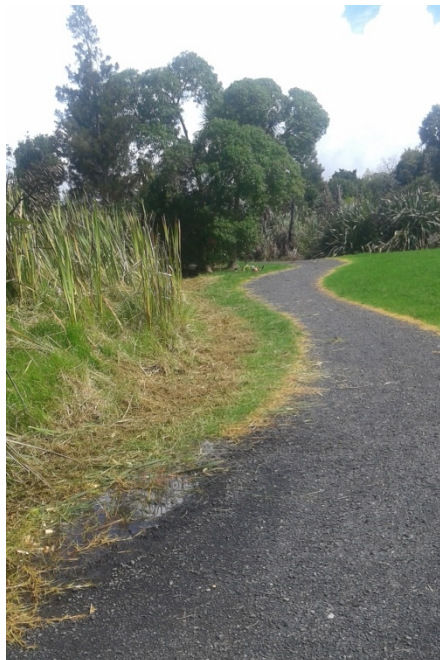
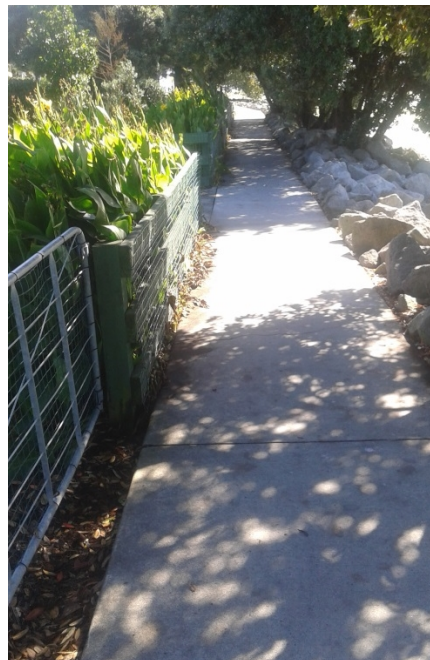
Despite the crazy weather and extensive damage, RS did find time to get stuck into spraying with many areas having rapid grass and weed establishment along with weedeating and shrub pruning within the passage. The metal blade has been getting good use of late over nylon as it has the ability to cut through thicker woody weeds and in doing so give an even cut (see photo below of Elmes). The second photo shows the boundary line at Beach Road being cut back to regain the width of the track.

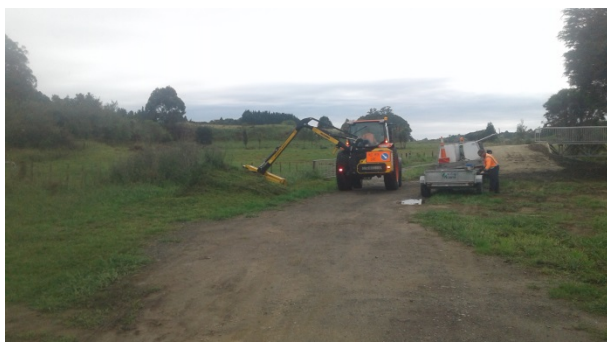
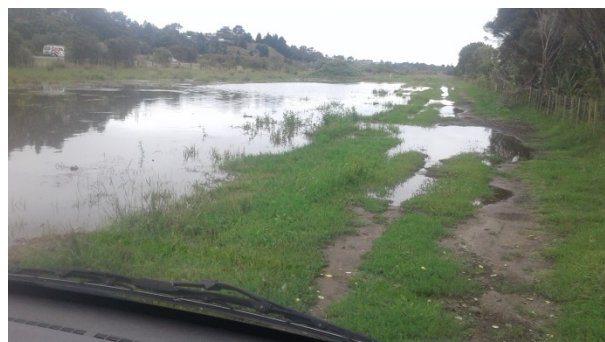
With K Valley having some very big variations coming on contract in April, RS has been spending time bringing them up to specification with spraying and reach mowing carried out (see photo below). The reach mower has worked really well in being able to see whats in the ground and allow our ride on mowers to get in and start maintaining. The reach mower did have problems with old fencing wire and timber being hidden within the long grass which did slow the job down to avoid damage to the reach arm head. Further work is required with the reach mower on the Marshall Ave side of K Valley where the flat section of track needs the sides cut down. Unfortunately when it was booked in to do this, the whole section was under water. This is one of the problems with the Valley, as can be seen in the second photo, where the track is flooded on the Toll road side. Ideally any tracks that are going to be resurfaced really need building up by a good 500mm to keep them high enough from flooding issues and allow them to stay in use particularly through Winter. RS has also had issues completing all of the K Valley variation work as some of the dead end/service tracks are very overgrown and hard to follow where the track should be. A site meeting will be organised with Council to define exactly where maintenance is required.

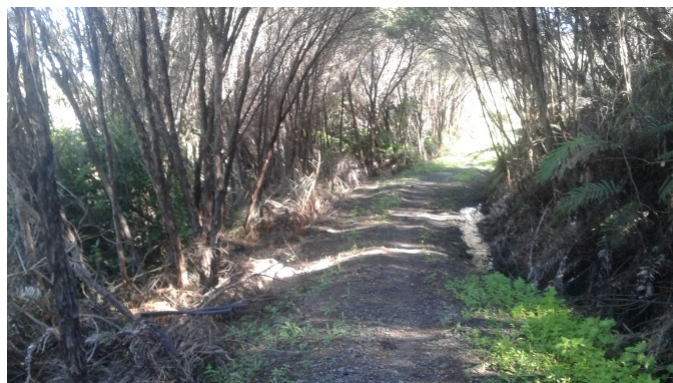
On the opposite side of K Valley and the Toll road, another variation has been the Cambridge Park to Westridge section. It's a challenging section to maintain with a very rough track that has weeds growing through it (see photo below). The track has been sprayed and the envelope cleared but with all the rainfall it will need another spray in the near future to tidy up. Ultimately a major surface renewal needs considering as the track is not up to specification and needs significant drainage work also to allow water to escape and not further damage the track. One small section needs urgent work however as it doesn't have width to get a gator or mower through and is also incredibly rough and needs filling in with Gap 40. RS will hire a digger, purchase some drainage pipe and order aggregate to make this section accessible.

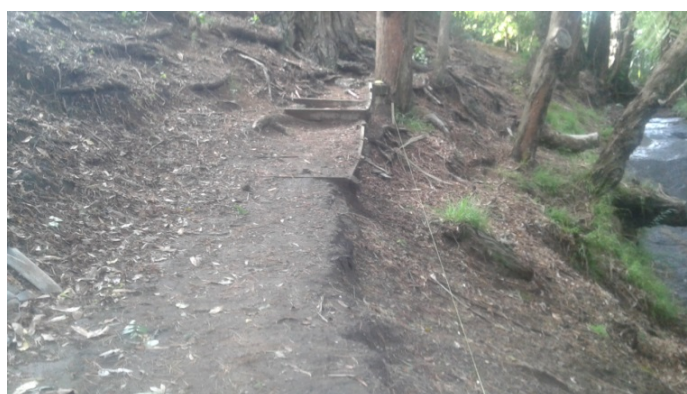
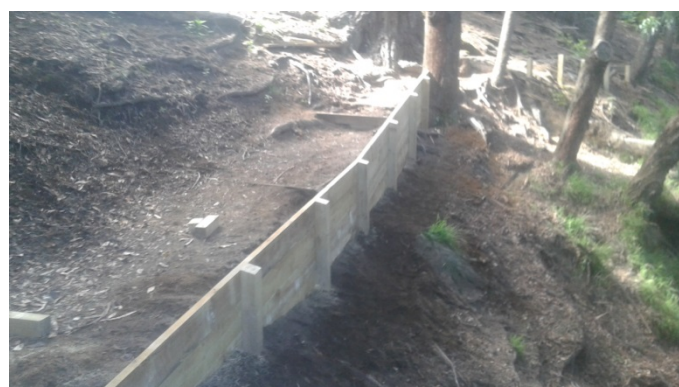
The team also started renewals work at Endeavour Heights on the Northern side of the loop track. This is a very tricky site with limited access and very little to work with as a starting point. RS managed to get some retaining started (pictures below) before being directed to a higher priority job but we look forward to getting back in to complete this work in the coming weeks.

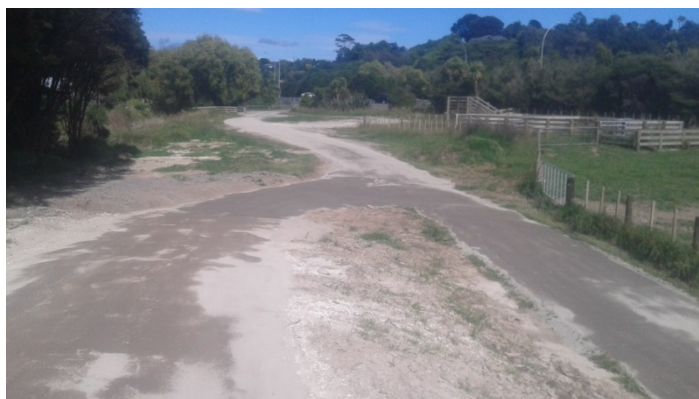
With a short lead time and a sense of urgency, our unscheduled team was asked to quote on the approach ramps to the new pedestrian bridges installed on the Koperurua Valley track network. RS were asked to go ahead with this job as a priority and have made great progress (photo below of Southern bridge) before the wet weather caused delays in getting materials onsite. The job is now complete but the amount of rainfall has seen some damage to the surface as well as what looks to be a horse that's walked over one side of the bridge and made it very uneven.

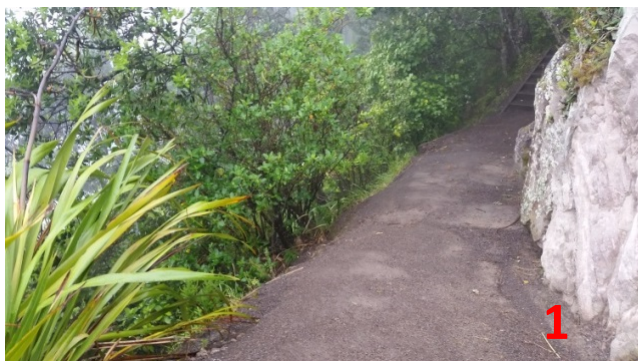
- Matua Saltmarsh has a section of track that is now always under water on or near high tide.
- Mauao's Waikorere track has a section at the Bluff which is very narrow and has a straight drop. This really needs attention and ultimately some kind of safety railing installed for everyone's safety (see photo 1 on next page).

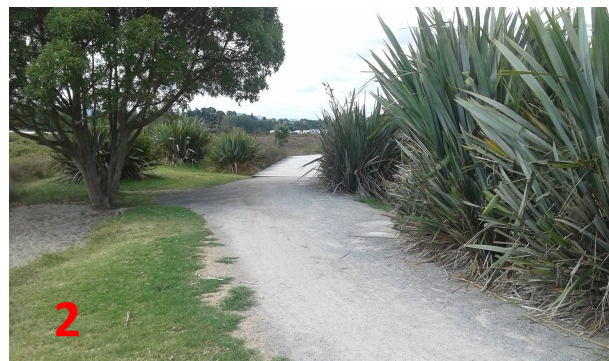
- The flaxes growing on the track at Gordon Carmichael and other tracks mentioned to Council have still not been removed as well as other areas now becoming an issue (see photo 2 on next page).

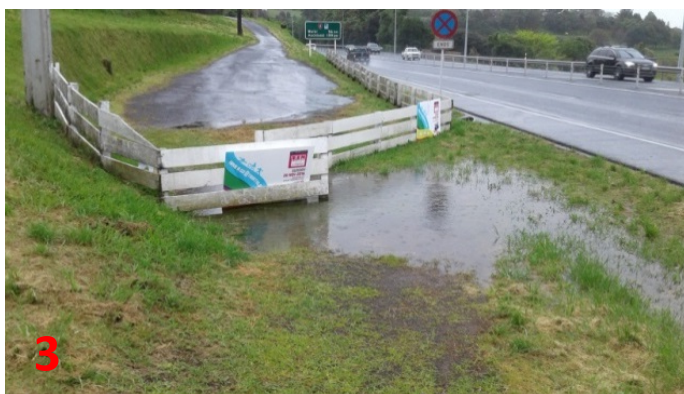
- Bethlehem Wetlands entrance into the track by the motorway is constantly under water after rain. It's a low spot and with the fence line running through there it makes it hard to lift the area and take away the problem. Need further discussion on how to fix (see photo 3 on next page).

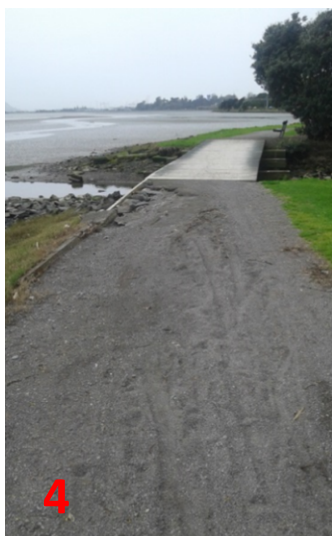
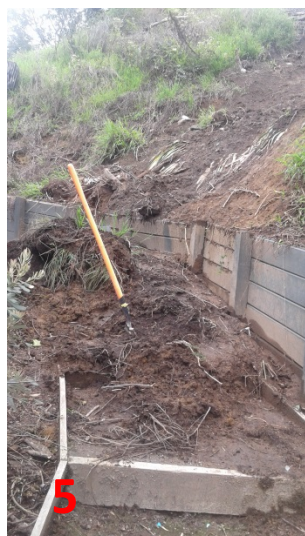
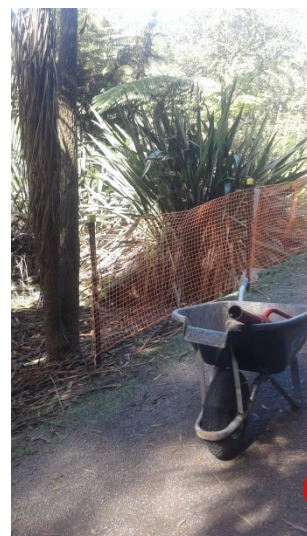
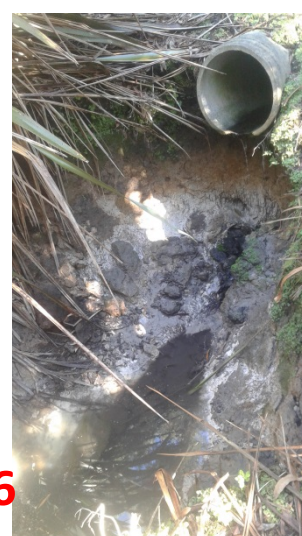
- Waikareao Foreshore Bridge is constantly having aggregate being washed out of the edge of it. The bridge needs extending and possible lifting to remove this issue (see photo 4 on next page).

- Tom Muir slip recently cleaned up looks like it will slip again onto the track and could be a health and safety issue (see photo 5 on next page).
- Millbrook stormwater has a large stormwater drain pipe that has created a chest deep cavity where the water pools before overflowing and running away (see photos 6 on next page). The track has been fenced off but the hole needs filling with large rock.
