Reserves Walkways Maintenance
Contract: TC1/14

Tauranga City Council

Monthly Report

November 2015

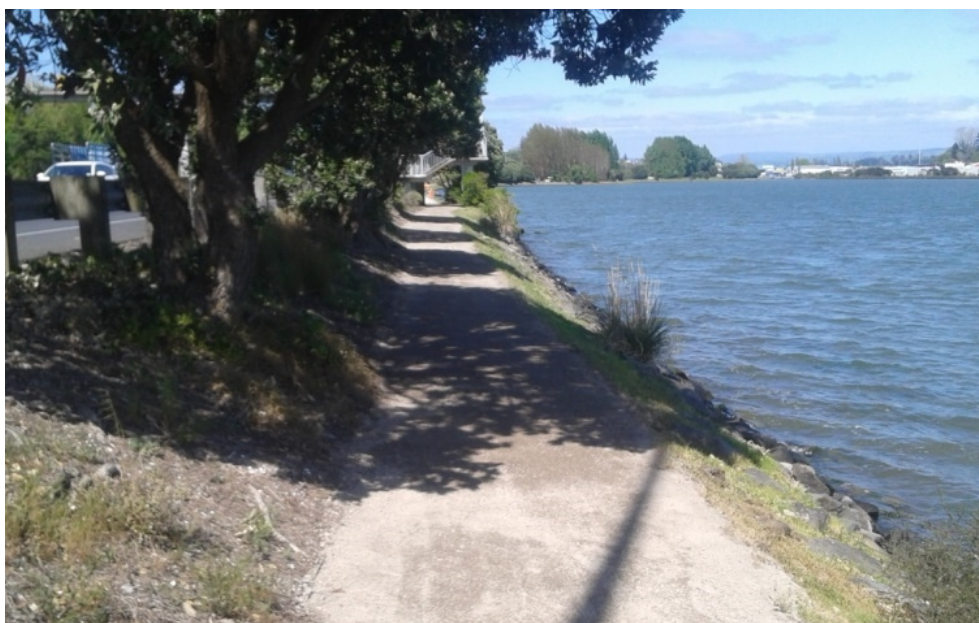
The Unscheduled team have continued to roll from one job to the next, with a variety of work being carried out. One last effort was made to finish off re-surfacing large sections of track around the Takitimu Drive area. A large section of track is now complete, from Elizabeth Street down towards Waihi Road with an average depth of 75mm being applied to bring the track up to at least level with its surroundings (see photo below). A new track has also been installed on the other side of Takitimu Drive, at Glasgow Street. This was a grass link through a reserve but now has an aggregate track in place to join the track going one way to Graham Park and the other way to Elizabeth Street. The section of track from Glasgow to Elizabeth Street had a major prune and some shrub removal due to the amount of vegetation overhanging and growth right next to the track surface. It is now looking much better and more open which meant rubbish build up within it could be removed, this included a couple of old bikes and random bits of scrap metal. The Graham Park section of track has also been completed and came up well, with rainfall after the job to settle the new surface.

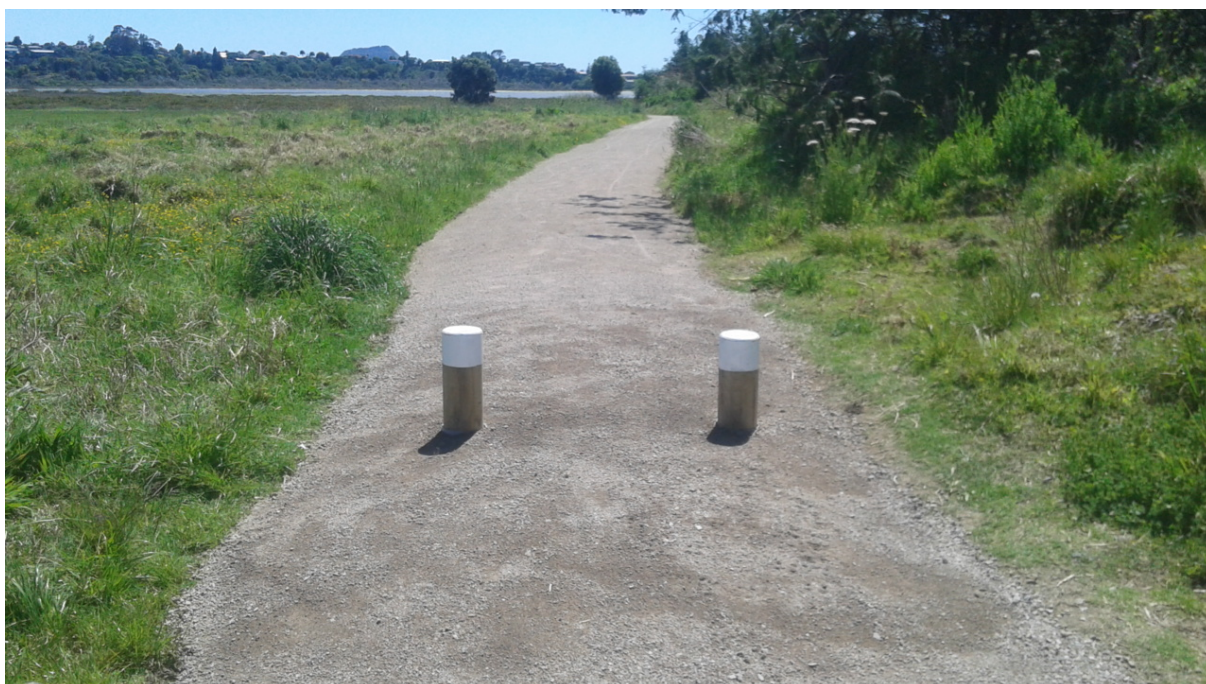
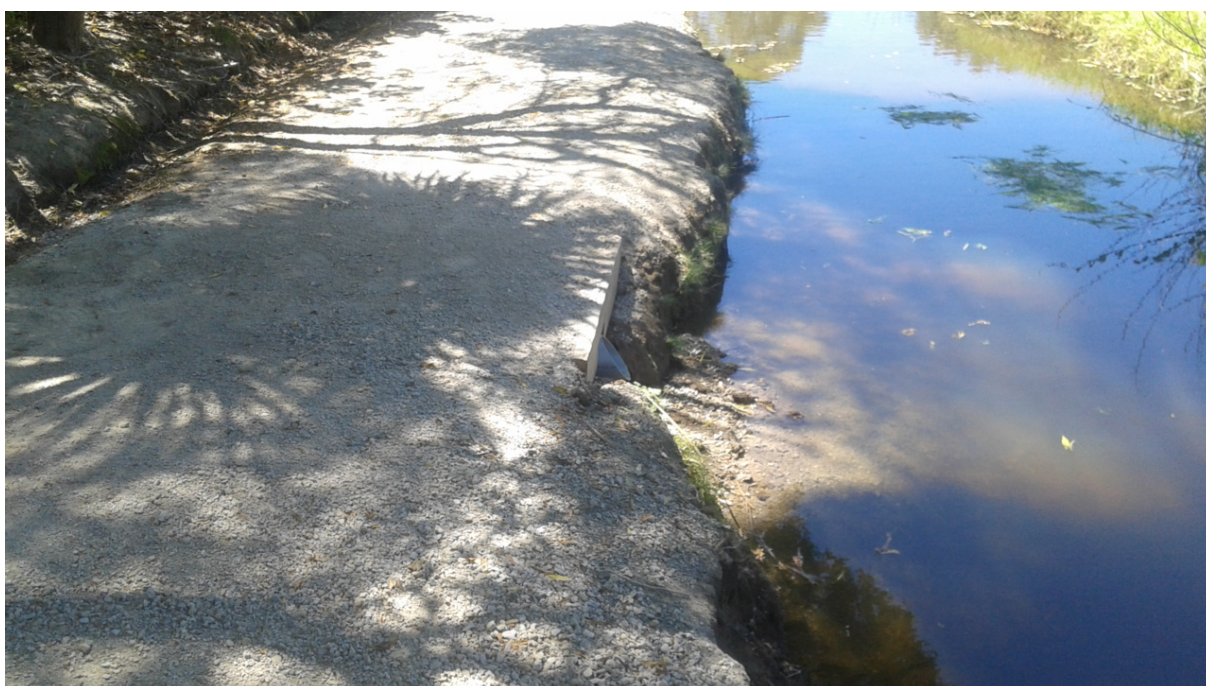
A new section of track and bollards has been installed from the Judea Rugby Club into the Waikarao West network (see photo below). This is an addition to the contract so will require a variation for ongoing maintenance. The second part of this job was working on the bottom section of track at Novella Place. Water run-off was creating a lot of scouring and also eating out the waterway embankment. The second photo below shows the worst area for erosion, now having a drain in place and a piece of edging to help stabilise it. There is also another drain back from this photo to catch water running down the Novella Place track which can then divert it straight into the waterway. This diversion will hopefully stop further surface scouring.

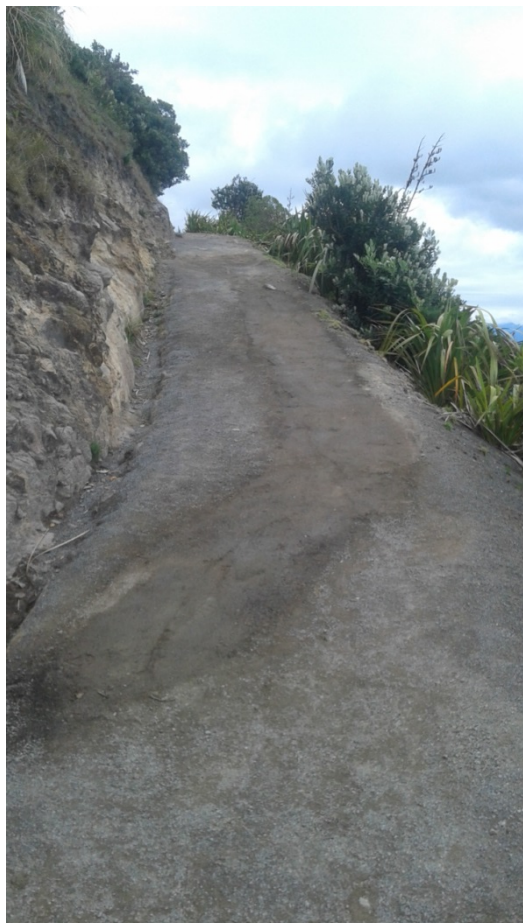
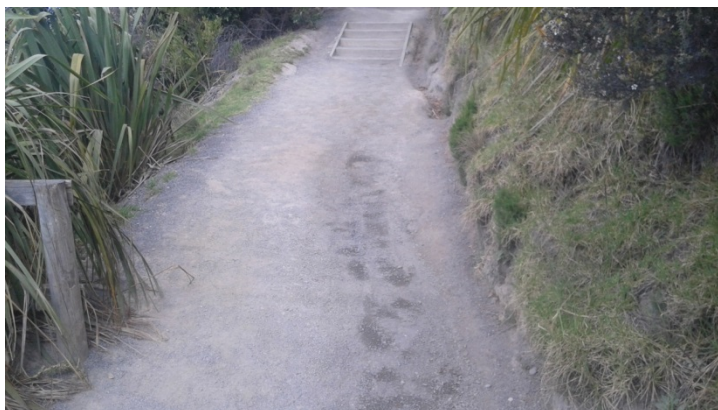
The start of the Orahuine and Waikerere tracks have had constant scouring issues in the surface so the RS team have filled them in with aggregate and cement dust to hopefully give more stability (see photos below). The Orahuine track also had a speed bump installed at the top of this steep area to divert water to the inside culvert channel. RS will monitor these areas to see if this removes the constant issues that have been had. The Waikerere track will also need a grated lid drain installed at the bottom of the steps above this issue just repaired, over the Summer to take some of the water run-off away from the track.

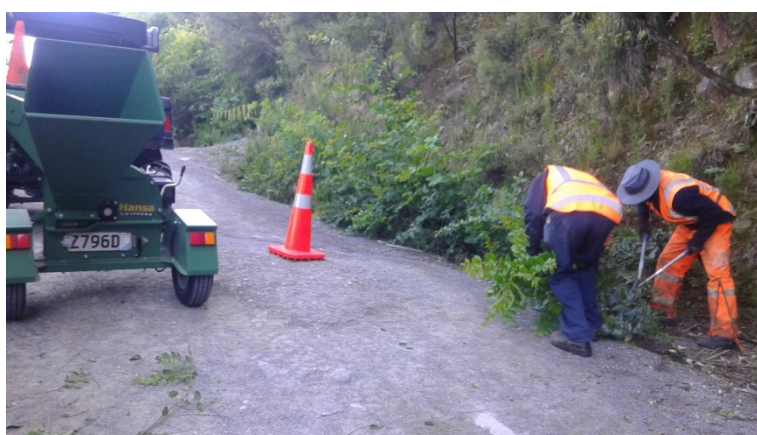
The Toot removal along the edges of the 4-wheel drive track is now complete. This took two days with three staff to cut, chip and swab the stumps (see photo below). The team also went into the bush to find more of this weed growing further back. Some large shrub sized plants were removed. Hopefully this thorough work will have taken out the majority of this weed problem but the way it has spread through such a large area, there will no doubt be small amounts to treat in the near future.

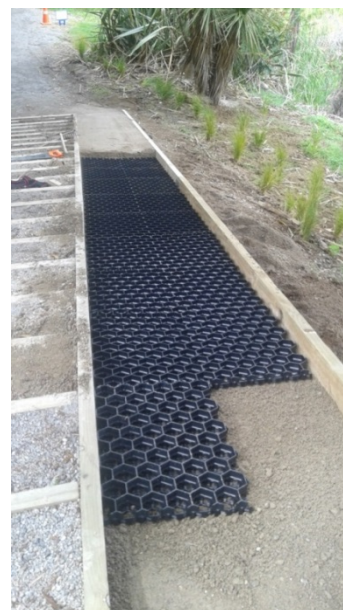
The Geo grid has been installed at York Park right next to the set of stairs at the start of the track (see photo of installation to the right). This will help with erosion and bike riders wanting to come down this piece of track. Just below this section is a little bridge which is unstable and losing material down the side of it. This needs to be looked at in the near future to strengthen and stabilise it.

- K Valley boardwalks need signage to warn the public of slippery conditions, particularly on frosty mornings. Grip tread potentially needs applying.
- Cambridge Park has large rocks now exposed from recent reach mowing.
- Darraghs Road, branches cut by neighbour have been thrown onto Council land.
- Judea Bamboo growth needing cutting back and pasting.
- Belvedere, start of track not on contract and causing water gouging issues.
- York Park bridge losing material down the edges and needing strengthening work in the near future.

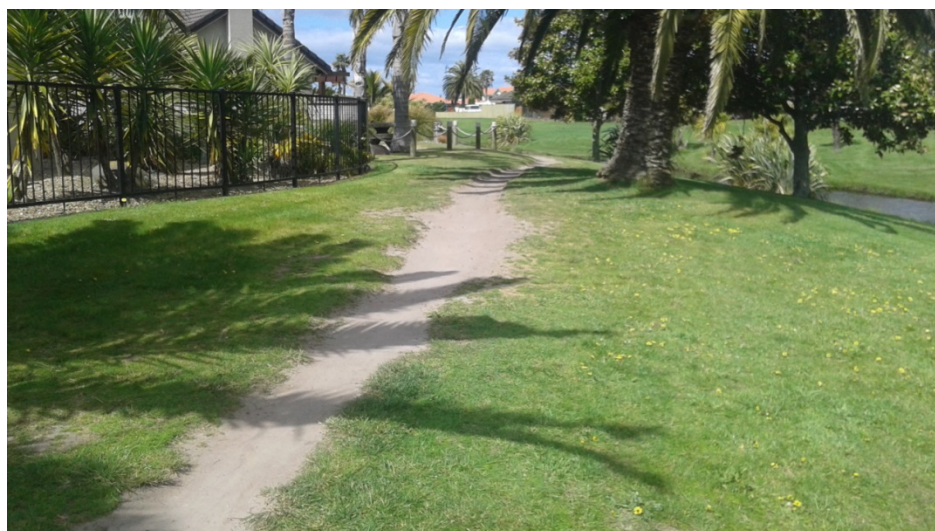
RS tracks maintenance staff continue to put through good ideas for improvements with recent ideas being a track extension at Yatton Park to join the concrete footpath to the start of the loop track stairs and also Royal Palm Beach needing tracks installed to replace the man made dirt tracks currently (see photo below)
