Crime Prevention through Environmental Design Audit & Injury Prevention
through Environmental Design & Universal Access Assessment
Prepared for Tauranga City Council

12 January 2015

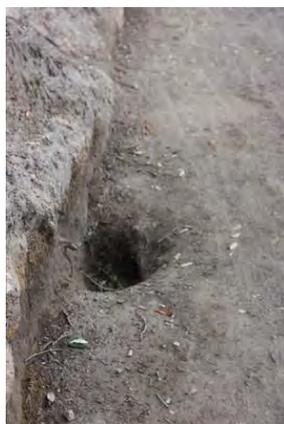
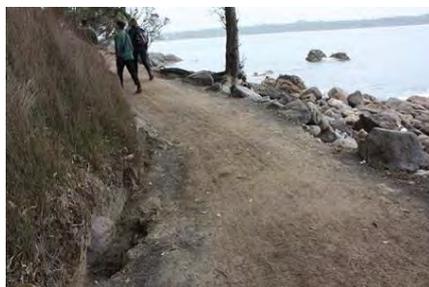
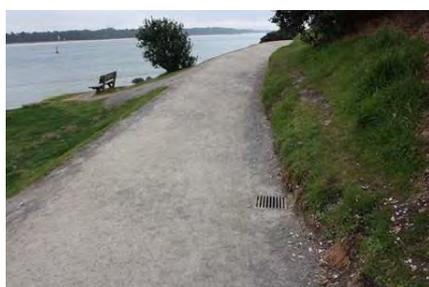
Figures 3, 4 and 5 Drainage holes on inward side of Base track and trial drainage cover

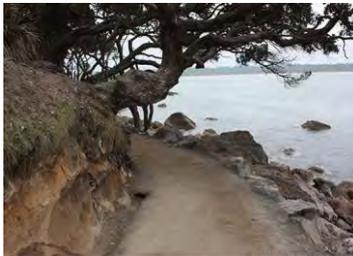
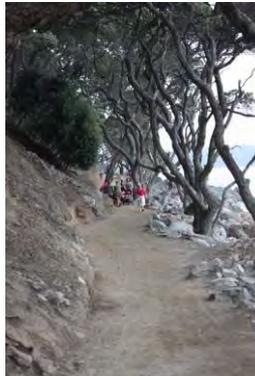
Figures 7 and 8 – Examples of pohutukawa branch projections over track

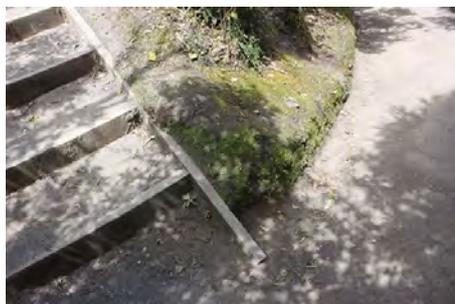
Figure 9 – Example of timber end of step protruding out into track corner

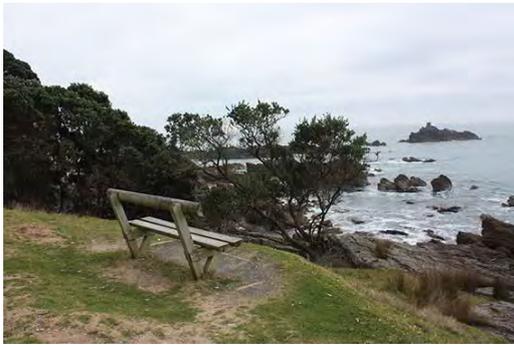
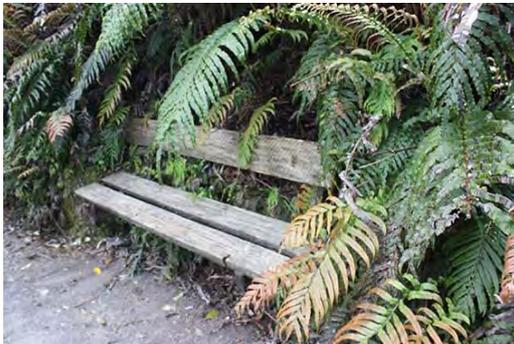
Figure 13 and 14 – Examples of timber seat at sides of track to allow for rest (Base track and Motu Kauri track)

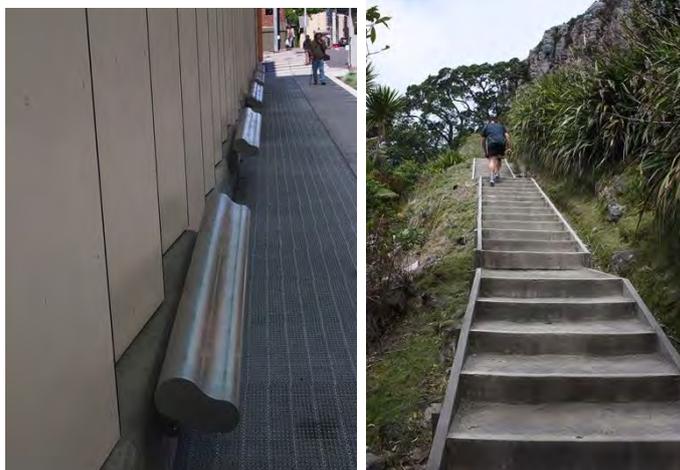
Figures 15 and 16 – Example of urban seat leaners (people remain slightly standing) and steps at Waikorire track

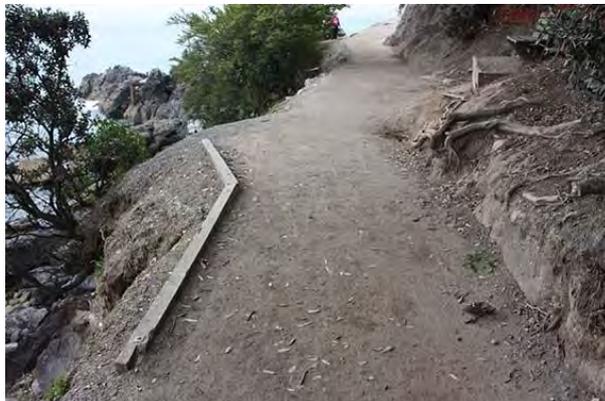
Figure 17 – Example of timber edge definition on Base track

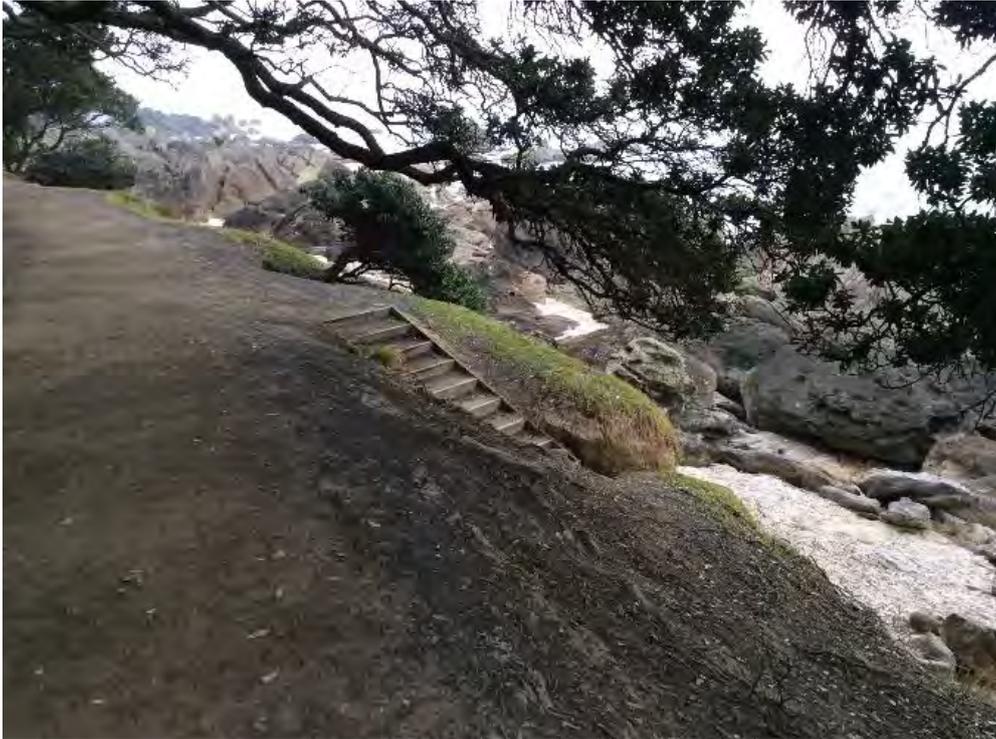
Figure 5: Formal access to Shelly beach lying beneath the base track. These steps are located in high visibility areas for safe access. Excess material can accumulate on the tread of the steps so it is recommended that this is maintained.

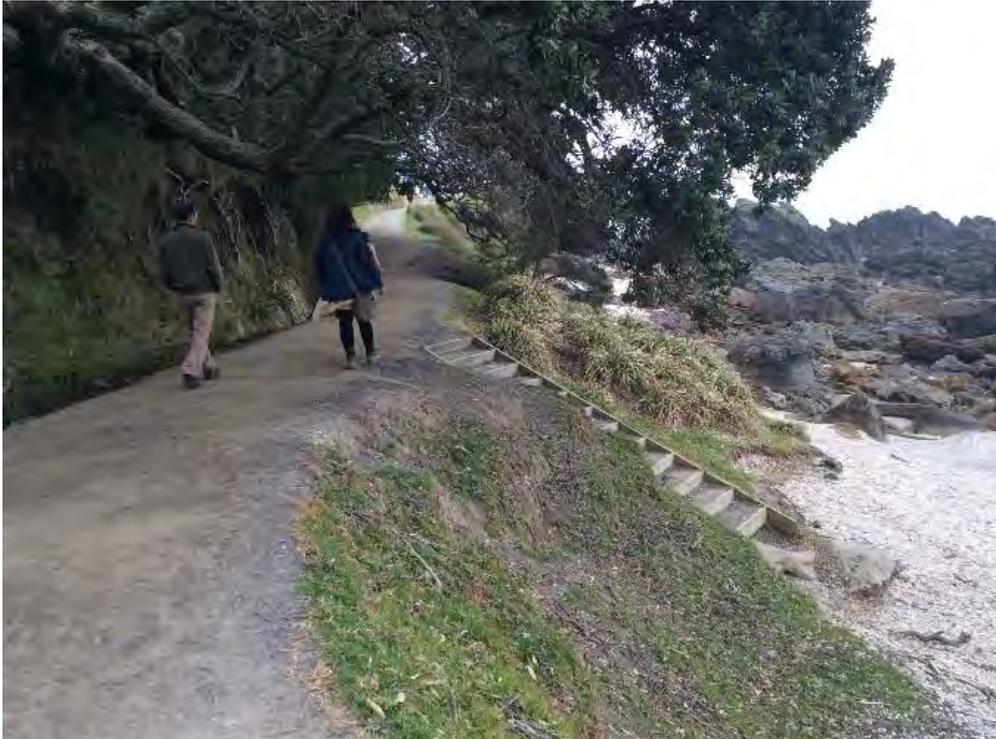
Figure 7: Formal access to Shelly beach lying beneath the base track. These steps are located in high visibility areas for safe access. Excess material can accumulate on the tread of the steps and gouging beneath the last step can occur so it is recommended that this is maintained.

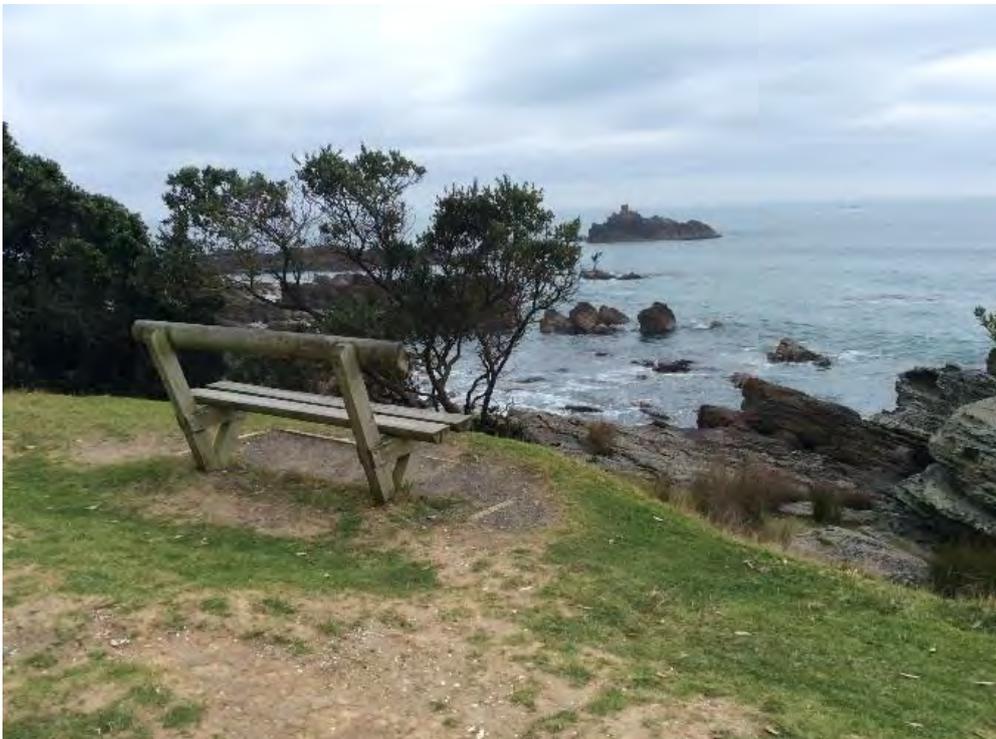
Figure 8: An older seat installed looking over the northern shore of Mauao. Seats of this age are to be removed in the near future and replaced with more modern seats.

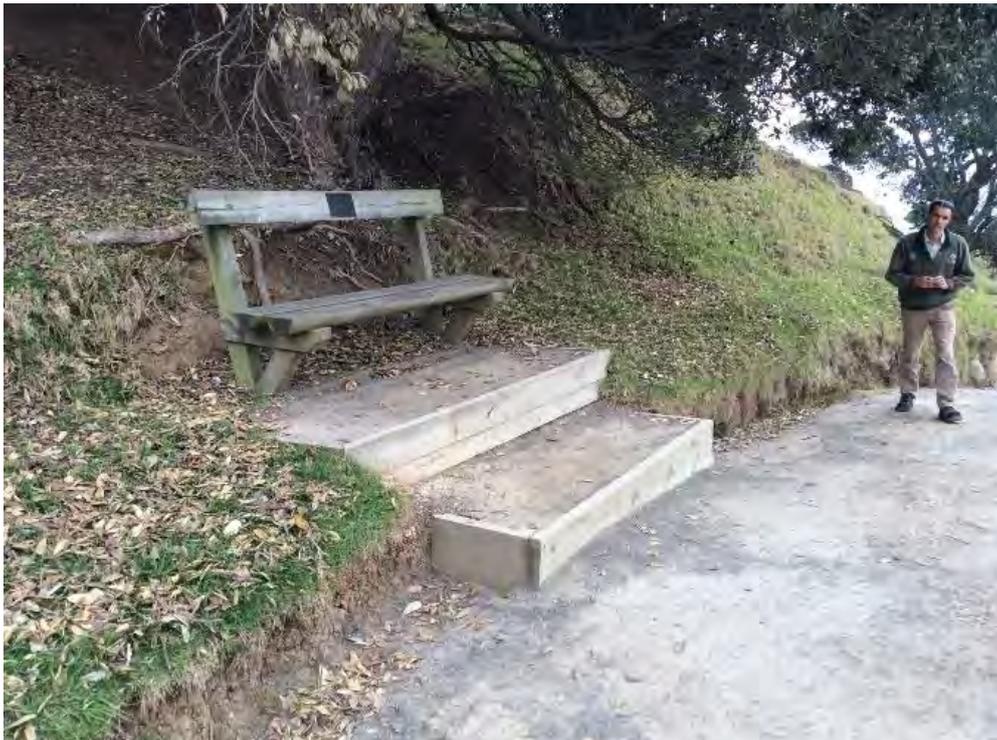
Figure 9: An older seat installed into the bank face looking over the northern shore of Mauao. Seats of this age are to be removed in the near future and replaced with more modern seats. The Park Ranger is looking to replace all memorial seats over time with wishes from iwi stating that Mauao is not a memorial site.

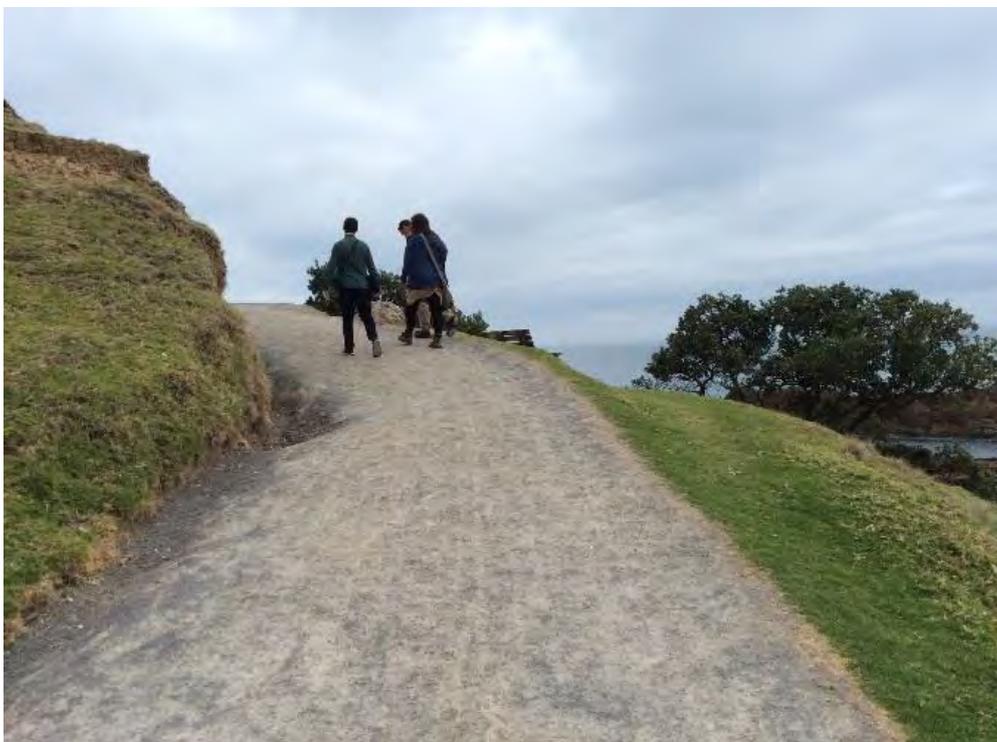
Figure 10: The grade along the base track is relatively easy, however at some points the grade is quite steep for a period of time, posing potential issues for wheelchair users in which Tauranga City Council states that the base track is suitable for.

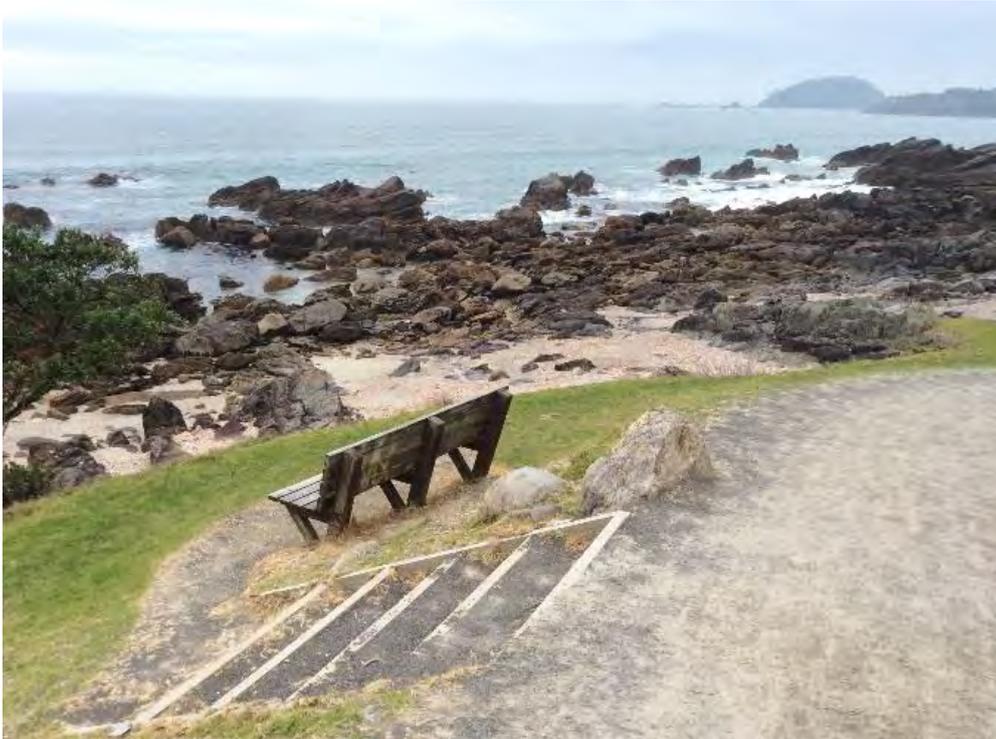
Figure 11: An older seat installed looking over the northern shore of Mauao. Seats of this age are to be removed in the near future and replaced with more modern seats.

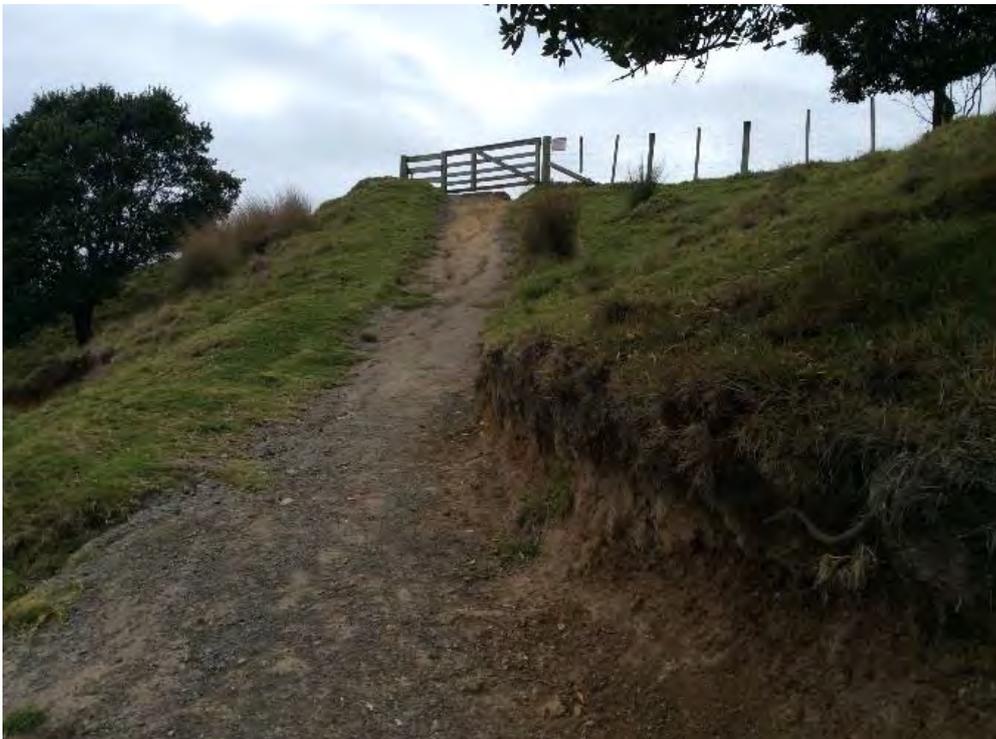
Figure 12: Users are accessing maintenance only tracks for alternative routes around and up Mauao. This can be dangerous with terrain and ground material not being suitable to traverse, however these areas, if upgraded have potential for more formalised alternative routes that create added escape routes.

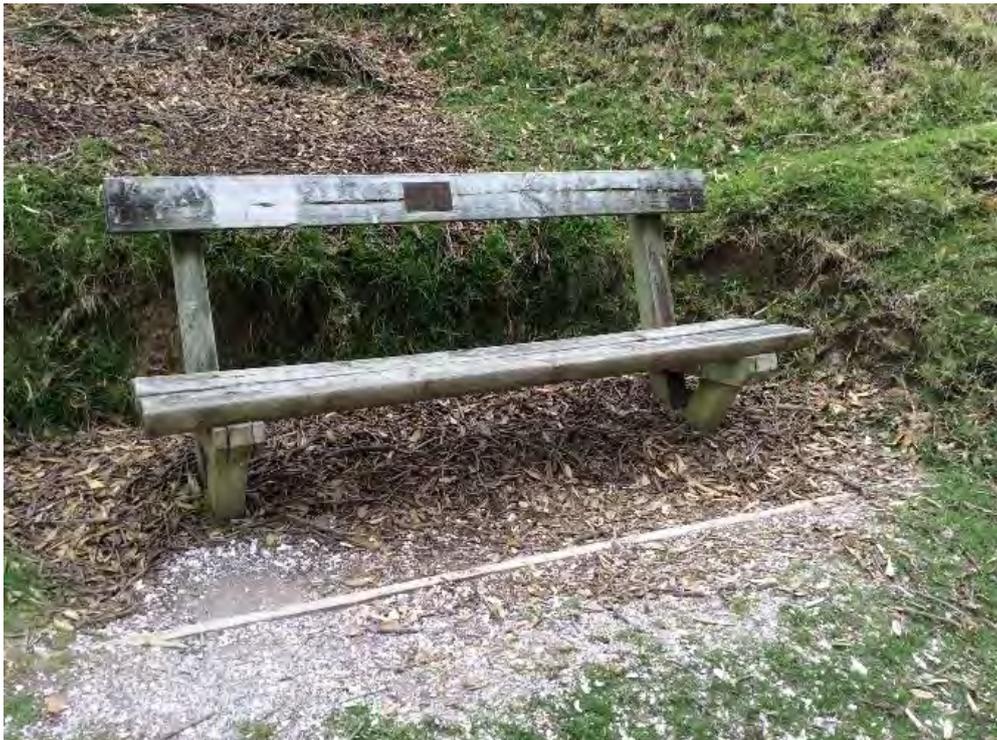
Figure 13: An older memorial seat installed looking over the northern shore of Mauao. Seats of this age are to be removed in the near future and replaced with more modern seats.

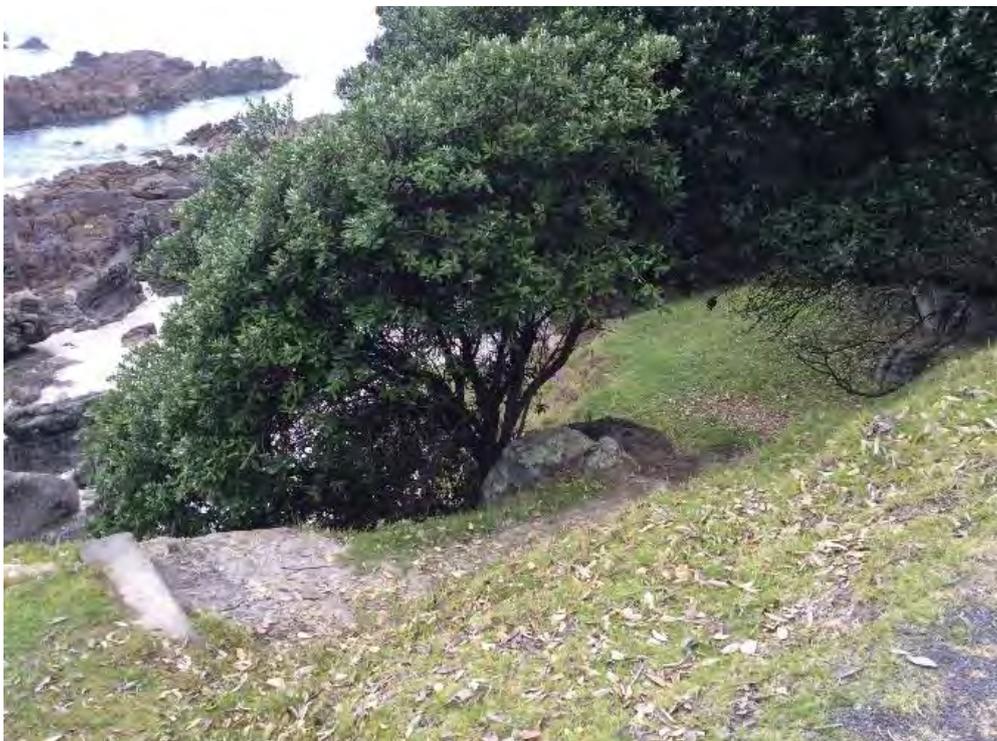
Figure 14: Historic access track to the beach at the northern tip of Mauao, beneath the base track.

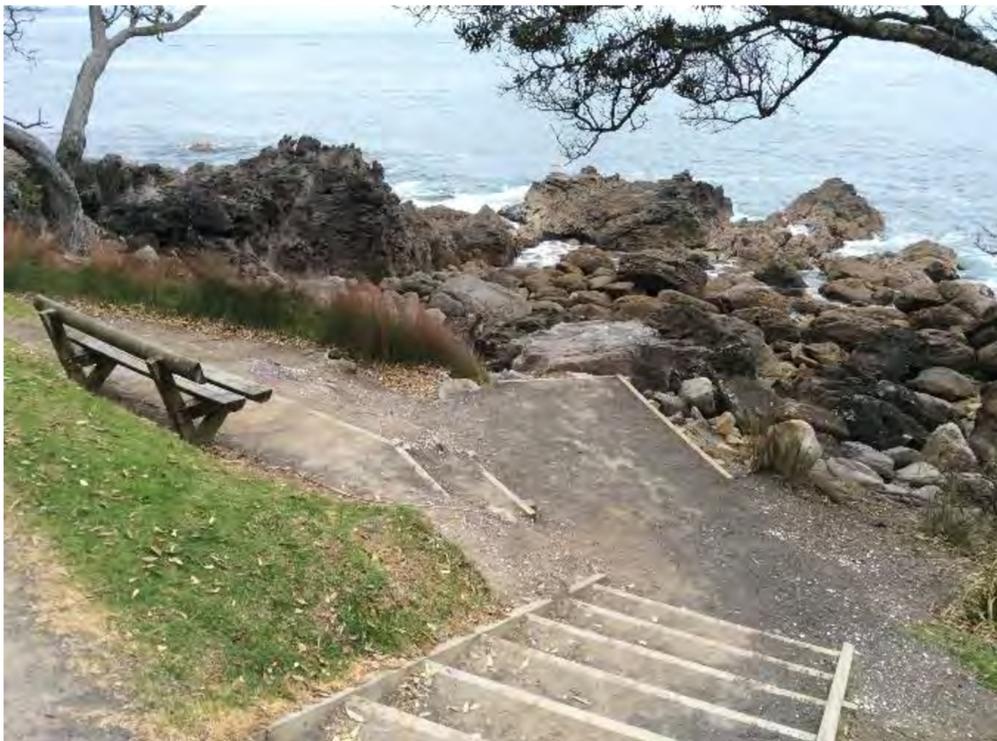
Figure 18: Seat at the base of steps which continue to the rocks on the shoreline. This seat overlooks the 'Ranui' wreckage site, in which the engine block still lies amongst the rocks and is visible at low tide. This seat will be replaced with a newer seat over time

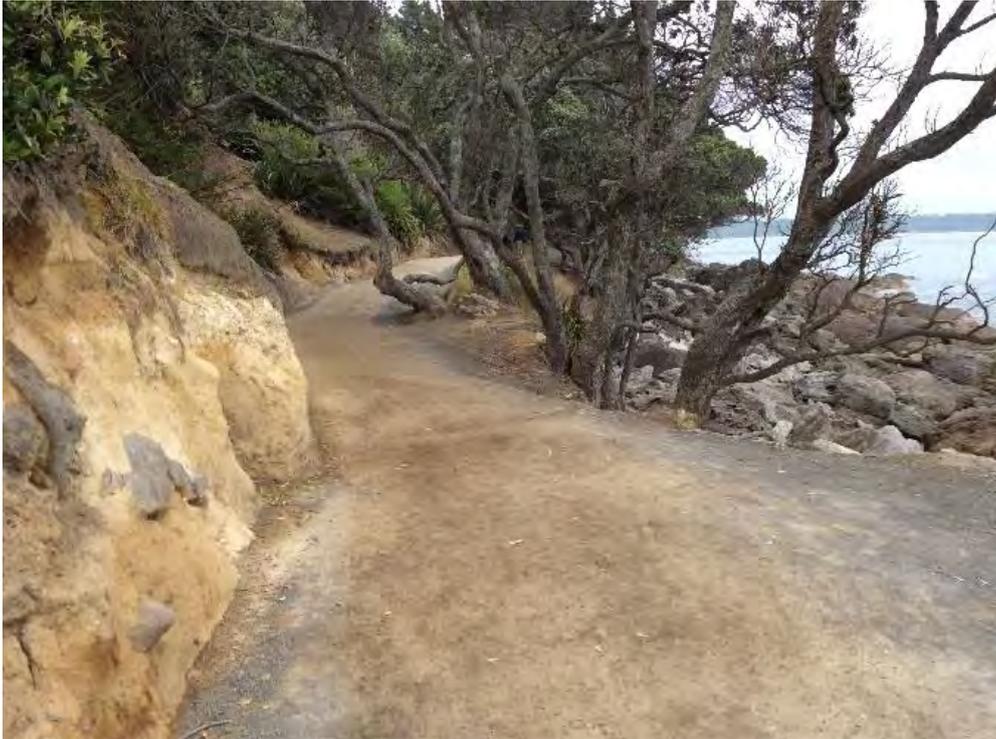
Figure 19: The low point on the base track has been elevated over time. In the worst of weather only there is minimal amounts of sea spray onto the track with can wash away some ground material.

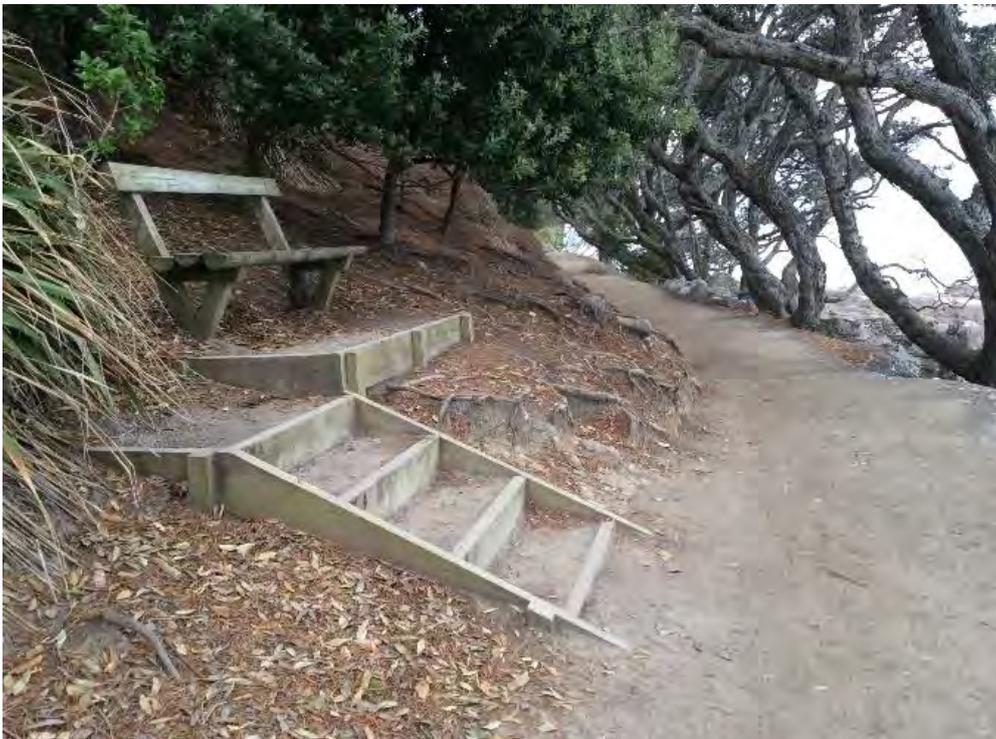
Figure 20: An older seat installed looking over the north-western shore of Mauao. Seats of this age are to be removed in the near future and replaced with more modern seats.

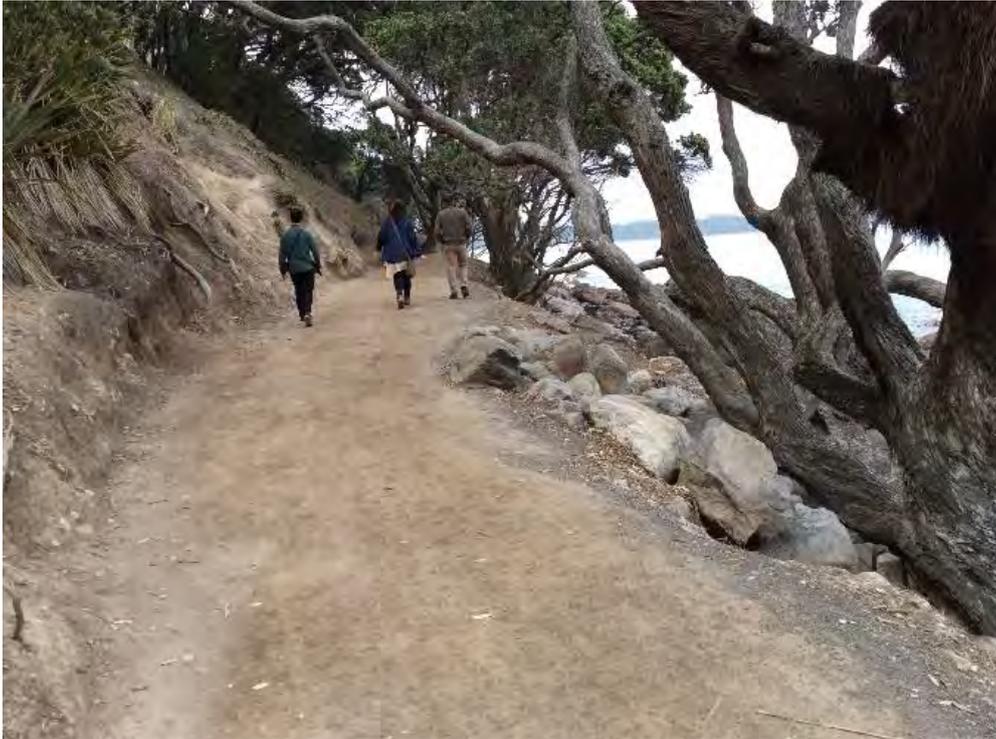
Figure 21: Along the track efforts have been made to remove any leaf litter and easily ignited vegetation within 1m either side of the track to reduce the risk of arson.

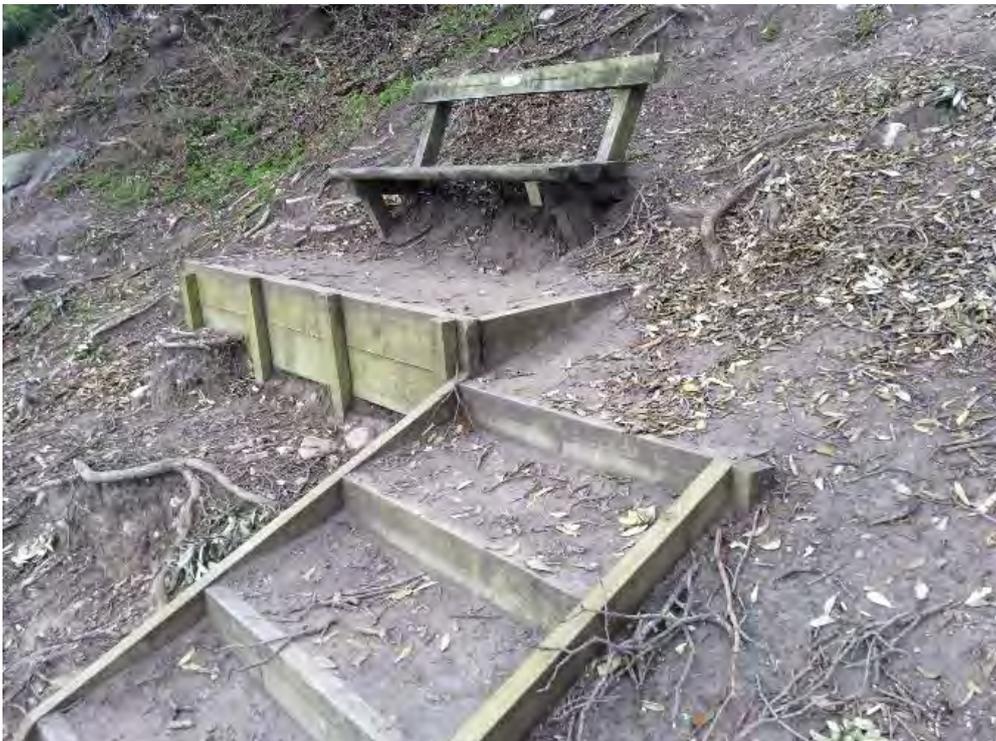
Figure 22: An older memorial seat installed looking over the western shore of Mauao. Seats of this age are to be removed in the near future and replaced with more modern seats.

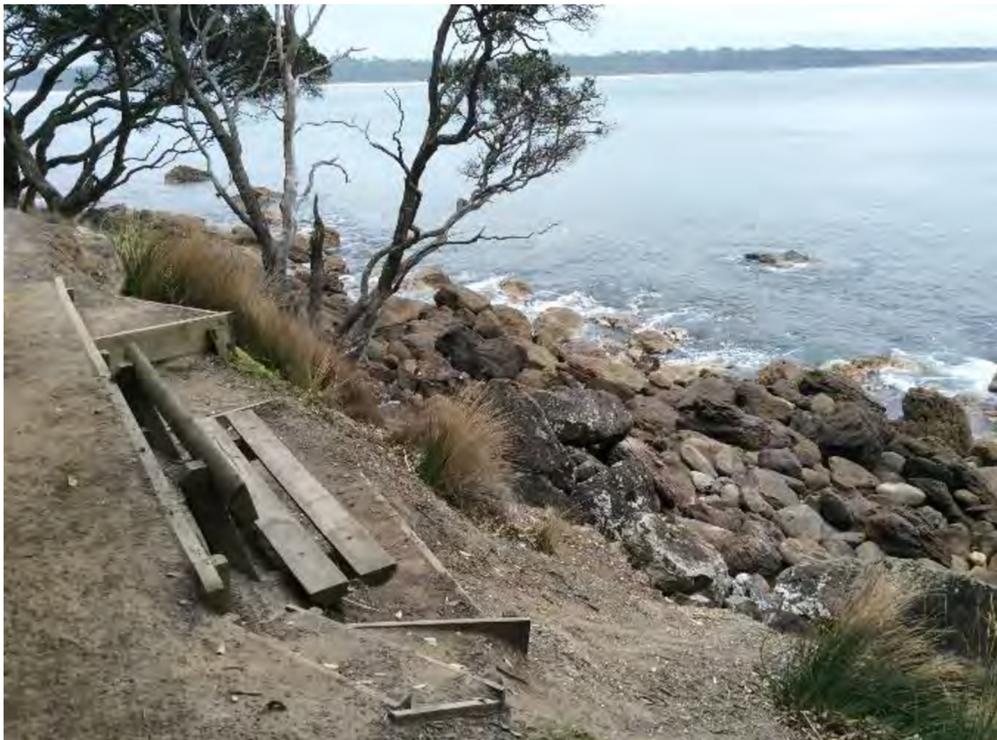
Figure 23: An older seat installed sunken down to track level looking over the western shore of Mauao. Seats of this age are to be removed in the near future and replaced with more modern seats.

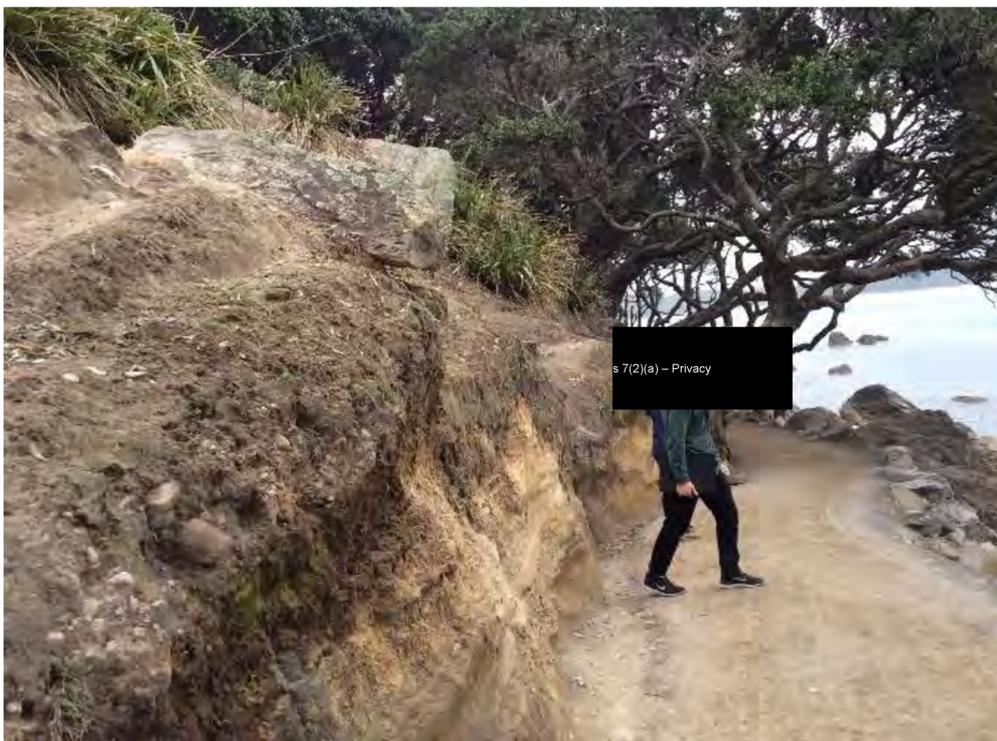
Figure 24: Along the track efforts have been made to remove any leaf litter and easily ignited vegetation within 1m either side of the track to reduce the risk of arson. This is the location where a fire was started in an arson attack on Mauao, burning through a large amount of bush cover.

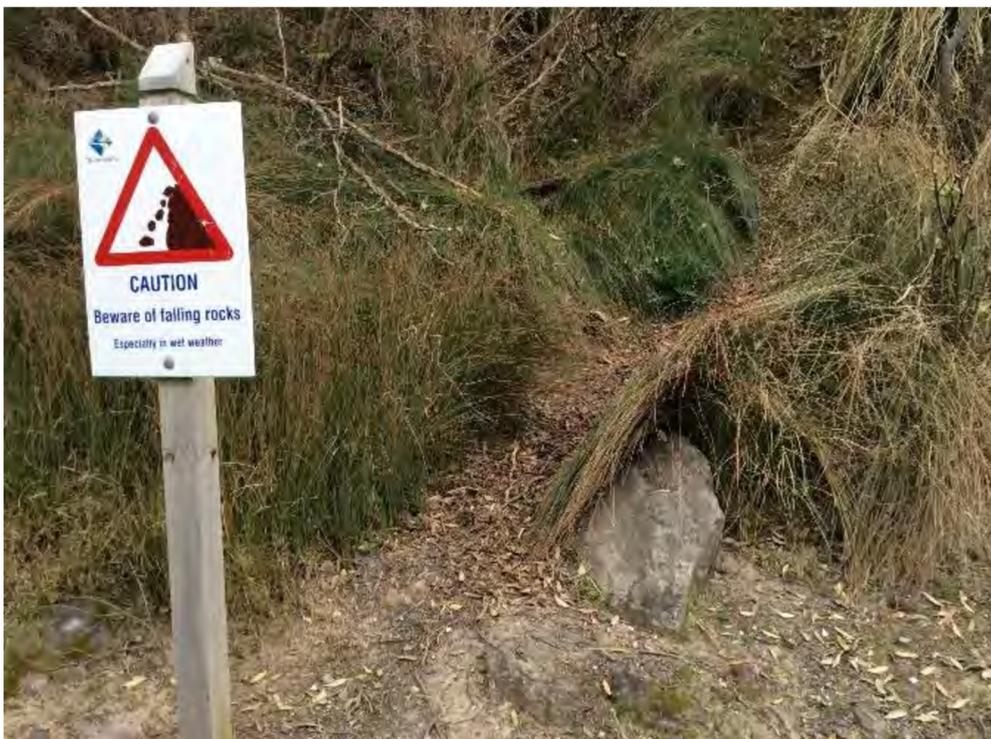
Figure 26: Sign notifying users of potential rock fall hazards in the higher risk areas. Similar signage could be used for other purposes, particularly indicating the safe use of the area as well as location of entries and exits as well as distances from these access points.

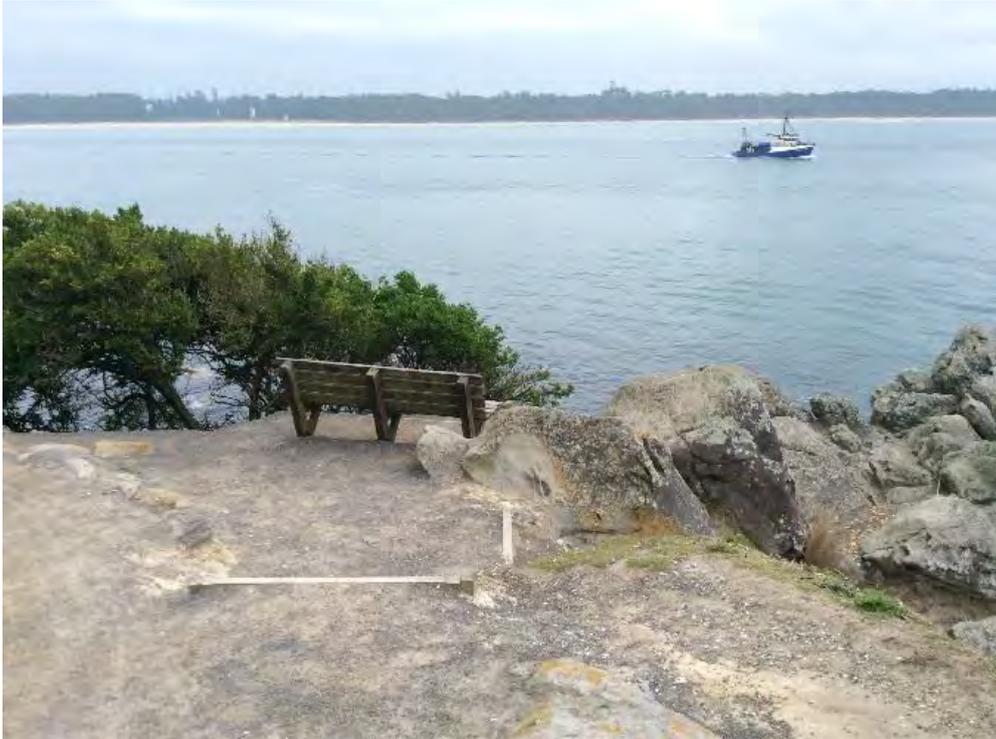
Figure 27: Seat looking over the western shore of Mauao out to Matakana island. Seats of this age are to be retained in the near future and replaced once older seats have been.

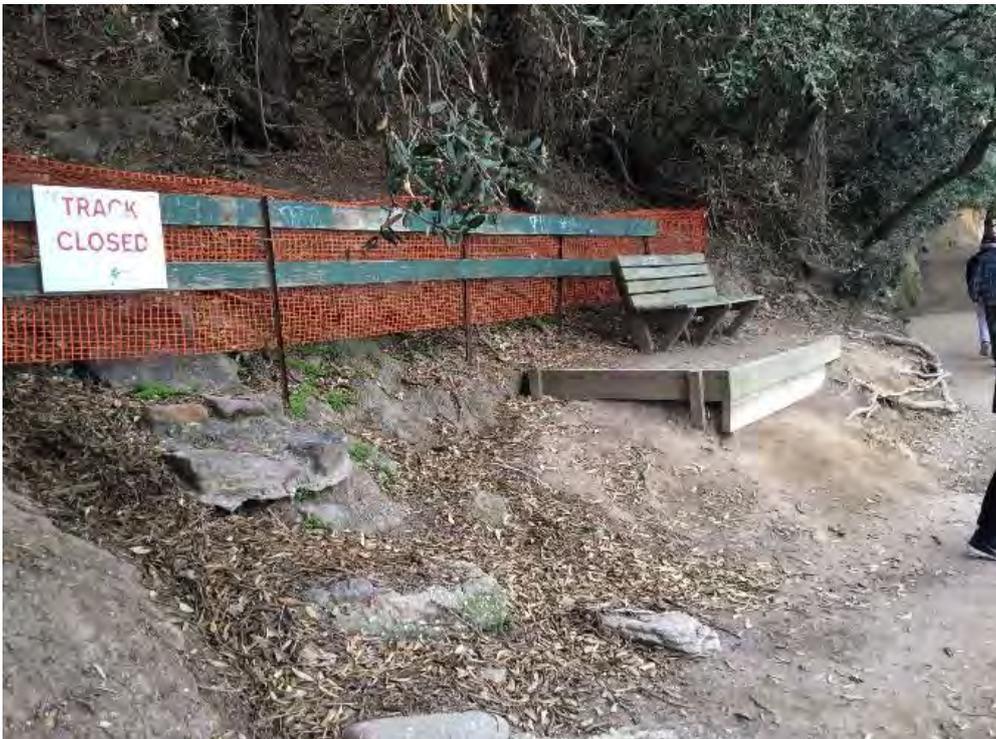
Figure 28: The use of fences and other blocking techniques to prevent users from entering closed tracks is not completely effective. It is recommended that alternatively informative signs on why the track is closed would be more effective of a deterrent from entering the track and is also less intrusive on the character of the walk.

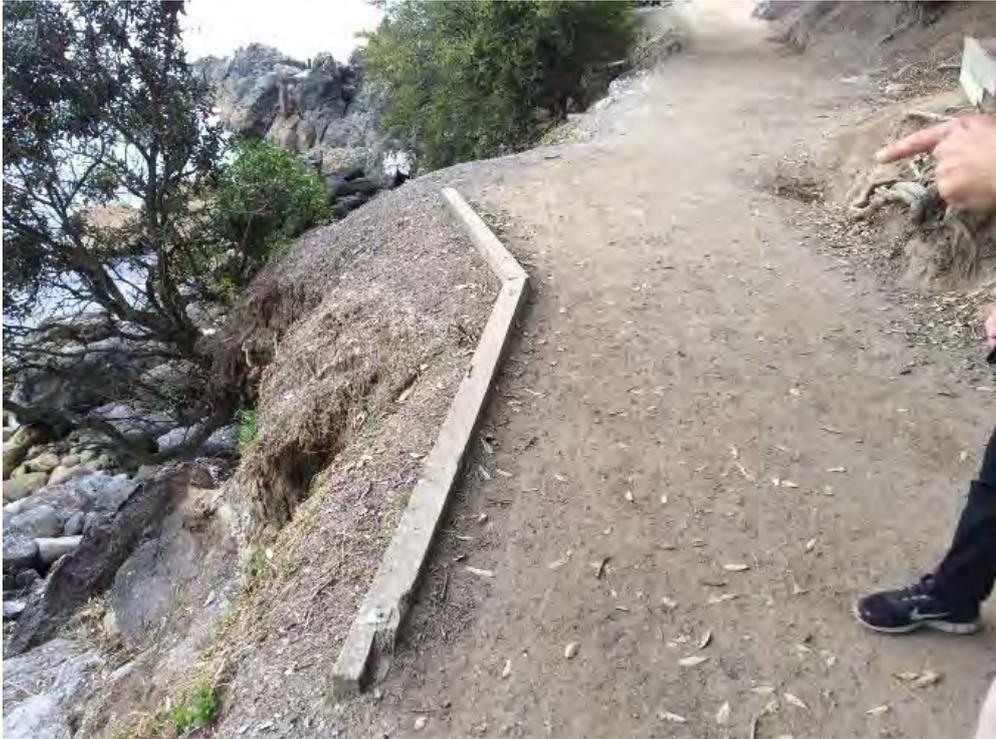
Figure 29: Edging boards are located along the edges of particularly narrow sections of the baser track or more high risk slip areas of the track to better define the edge of the track and reduce falls. It is recommended that other areas are assessed for possible installation of the edging boards to further improve safety.

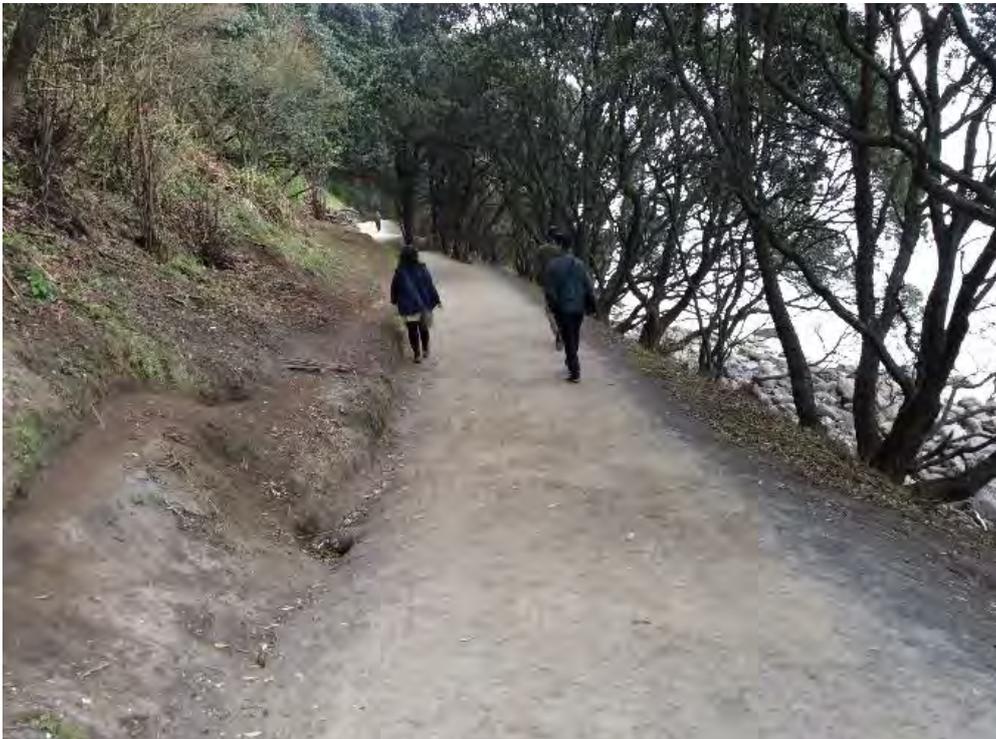
Figure 30: Informal tracks are formed along the edge of some sections of the track. This can become an issue if excessive damage upon the surface occurs, however currently it is not an issue and is hard to prevent when keeping vegetation away from the edge to reduce arson risk.

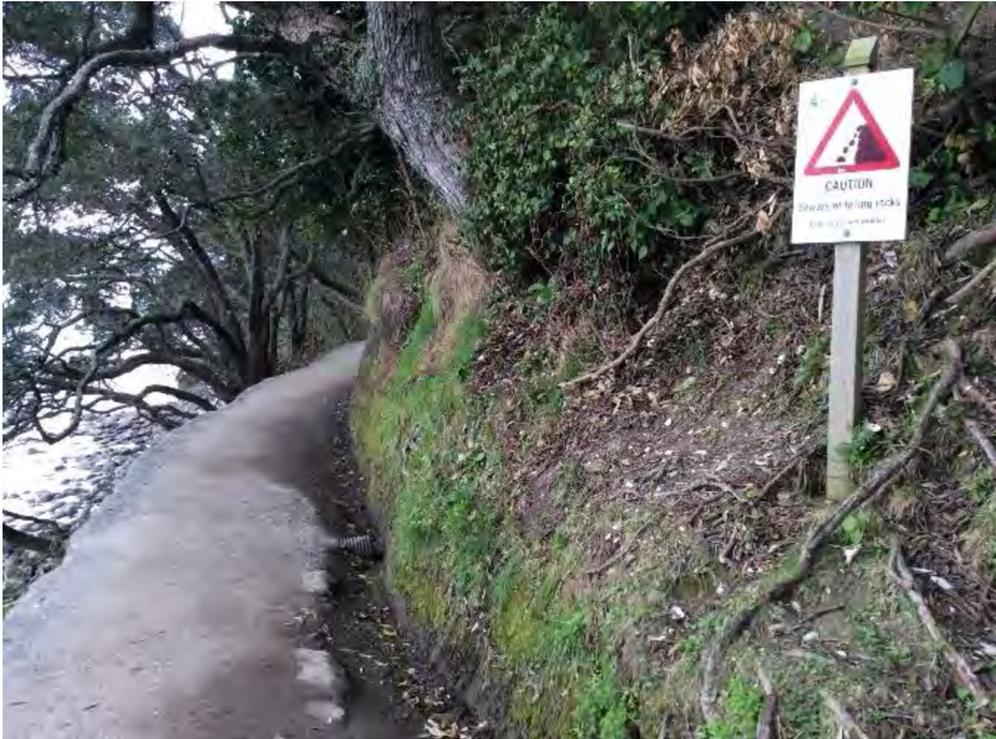
Figure 31: Some sections of the base track narrow considerably. It is recommended that potentials for widening is assessed to better accommodate users for greater safety and better views down the track for increased awareness of surroundings.

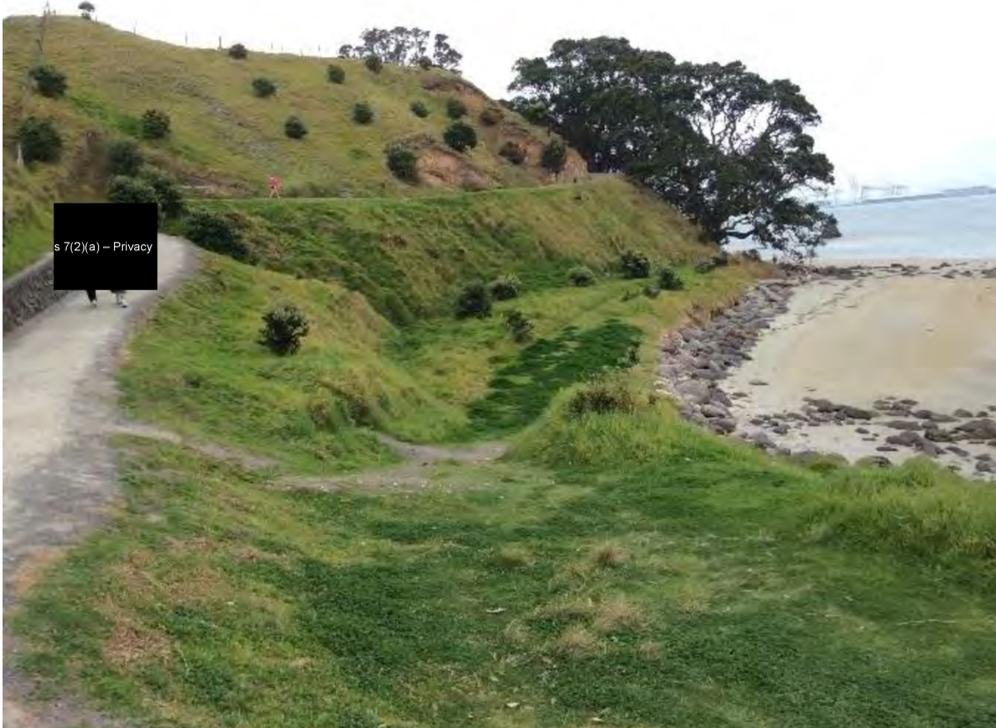
Figure 32: Access to the beach is informal but with clear sightlines, providing safe access whilst maintaining the natural feel of the walk.

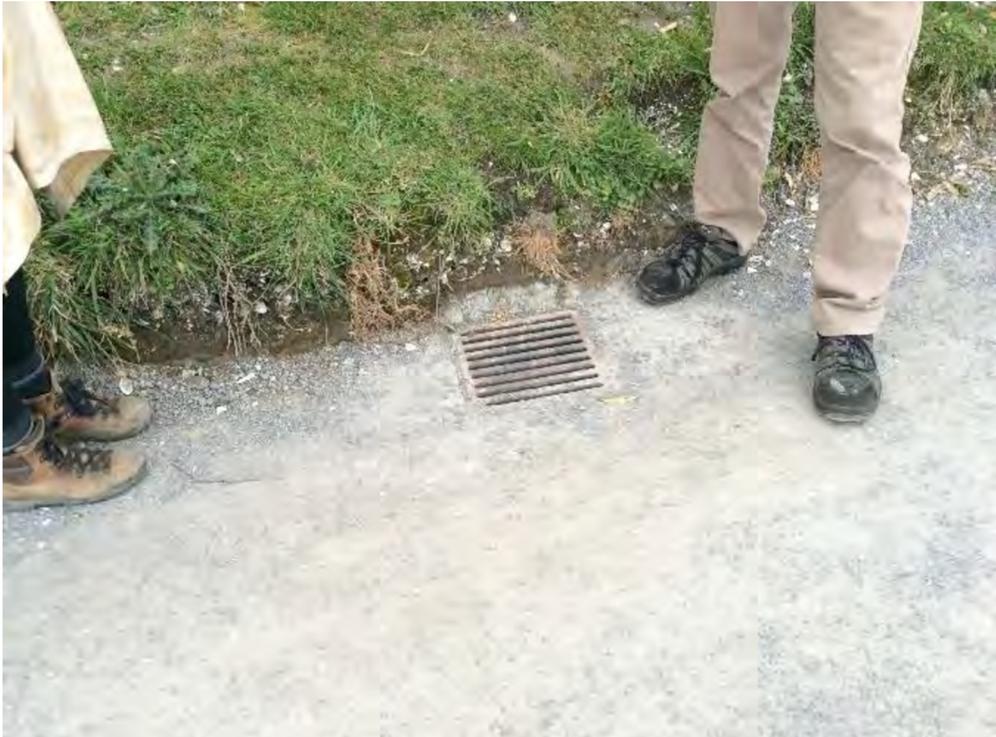
Figure 33: Drainage grate flush with the track is an effective, safe option for drainage as it eliminates any trip hazard as well as opportunity to intentionally damage drainage pipes.

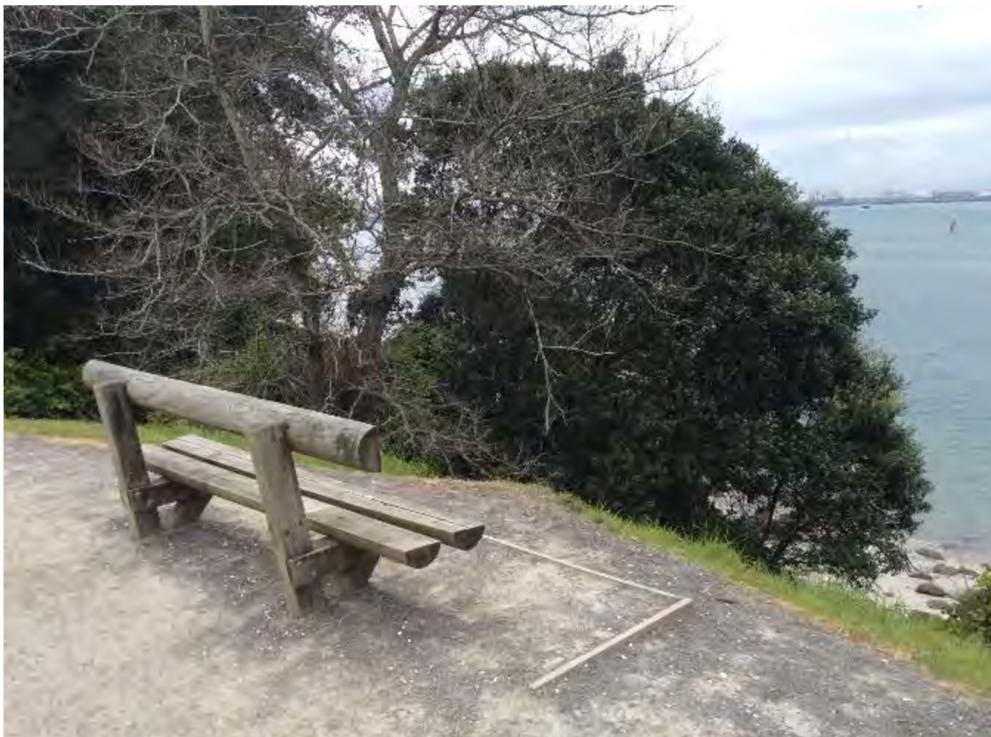
Figure 36: Seat looking over the southern shore of Mauao into Tauranga harbour. Seats of this age are to be retained in the near future and replaced once older seats have been.

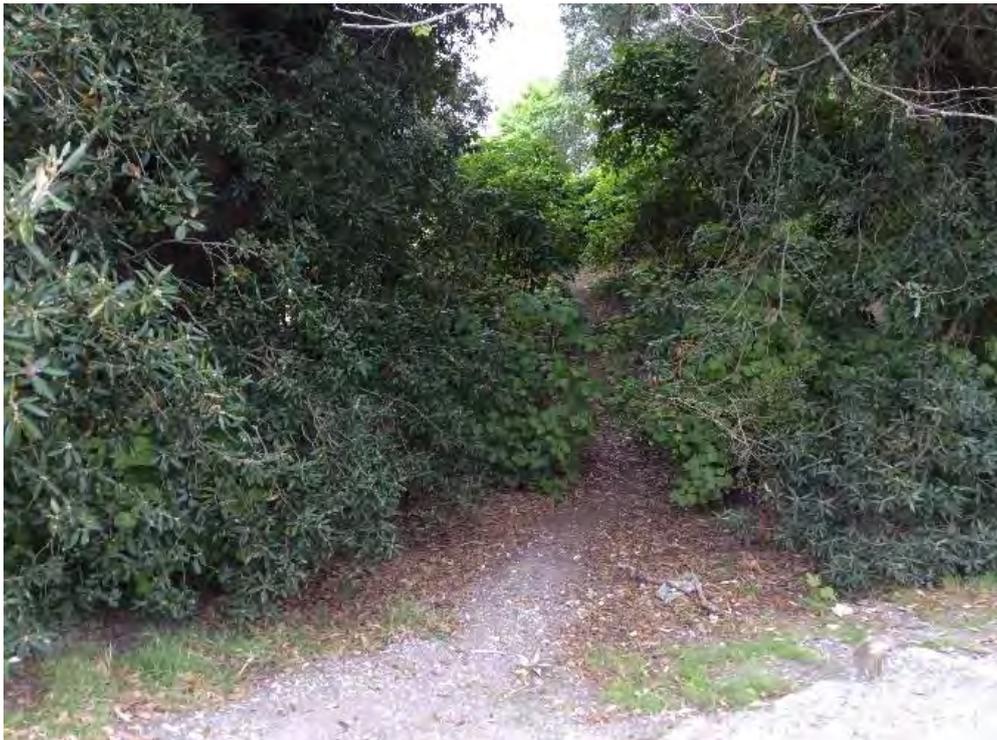
Figure 37: Informal beach access to the beach at the southern tip of Mauao. Due to the vegetation it provides an area for hiding so is recommended that vegetation be manicured in such a way that it opens sightlines and reduces opportunities for hiding.
