Crime Prevention through Environmental Design Audit & Injury Prevention
through Environmental Design & Universal Access Assessment
Prepared for Tauranga City Council

12 January 2015

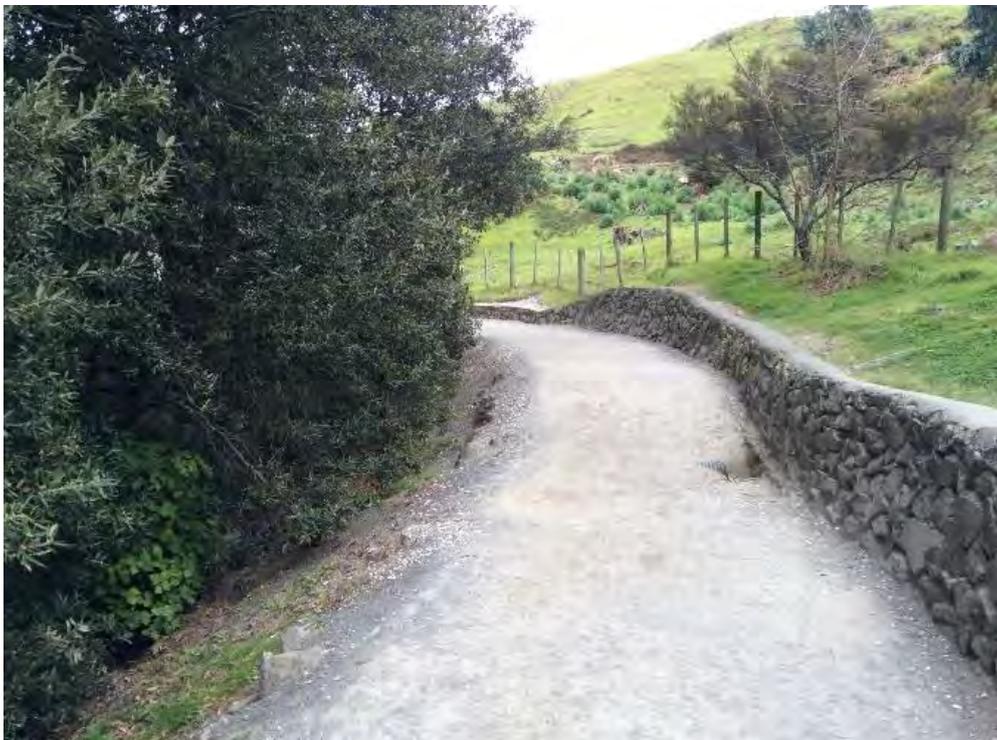
Figure 38: Vegetation obscuring sightlines along the base track. It is recommended that vegetation be manicured in such a way that it opens sightlines and reduces opportunities for hiding.

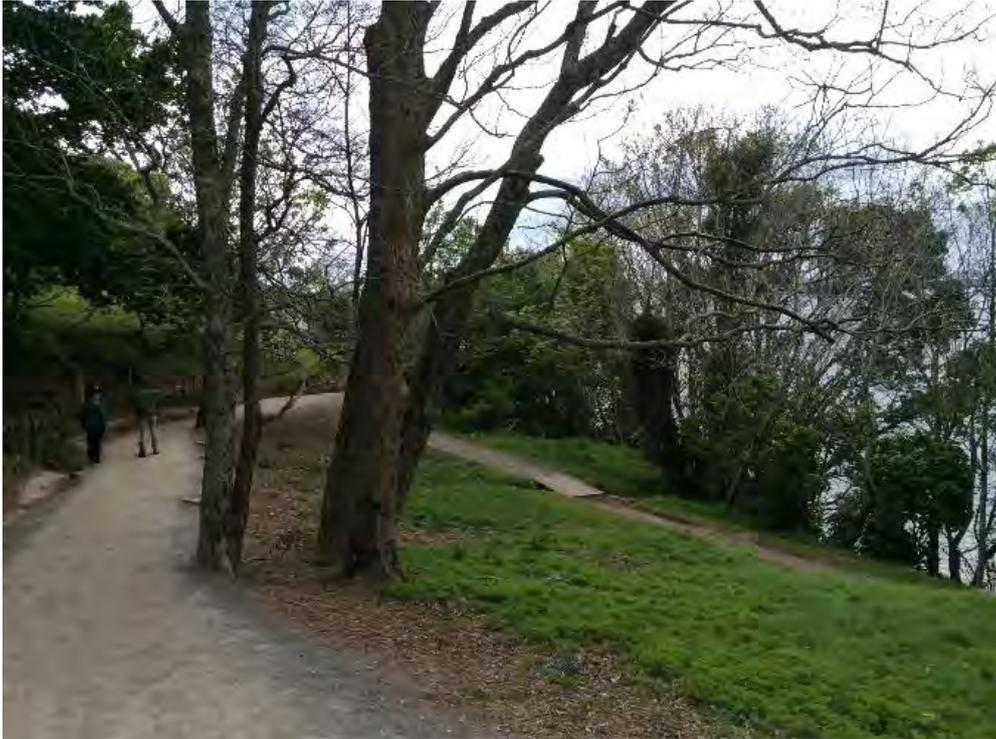
Figure 39: Base track and beach access path. The use of grass allows for clear sightlines, resulting in a good sense of safety for users of the base track as well as those using the beach access track.

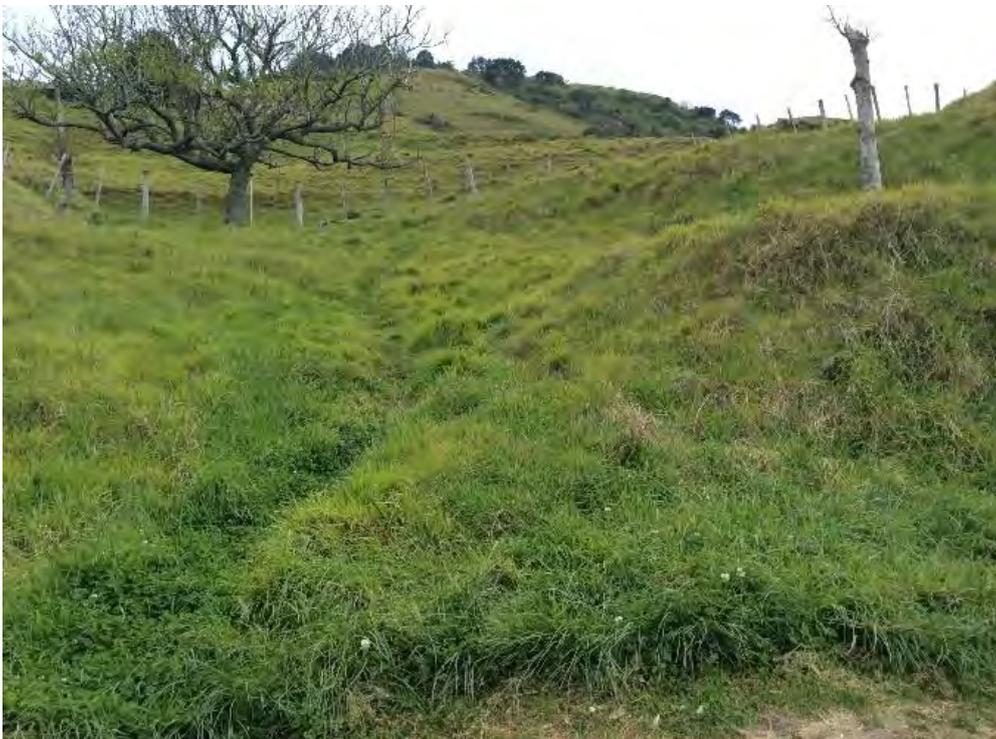
Figure 40: Informal access routes have been formed by users to link to other tracks on Mauao. These informal tracks have potential to act as alternative routes that increase safety and potential for escape in untoward situations. It is recommended that these routes are not shut off and possible formalisation of these tracks could be looked in to.

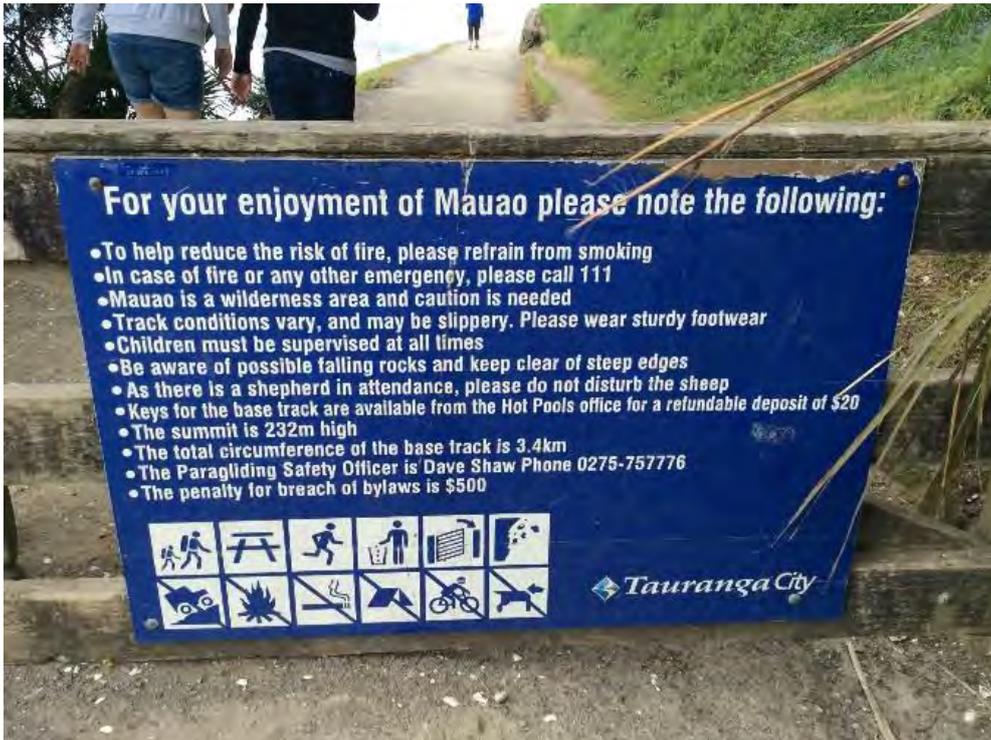
Figure 41: The signs contain a multitude of information, discouraging users to read all of the points. This can lead to improper use of the base track. It is recommended that these signs are reviewed with an aim to provide more concise and informative signs that are visually dominant resulting in a greater uptake of users abiding by the safety procedures.

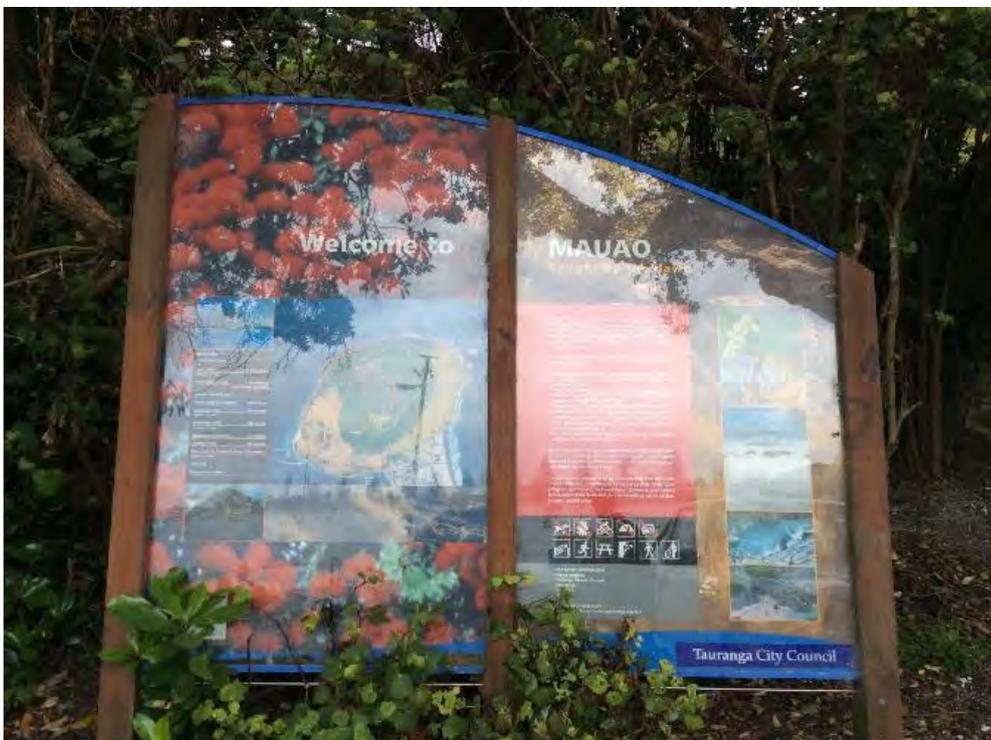
Figure 42: Information signs are located in relatively hidden areas, resulting in very few users reading the information. It is recommended that these signs are relocated into more visible areas, resulting in more users reading the information, This could bring about outcomes including reduced vandalism and encourages a sense of ownership

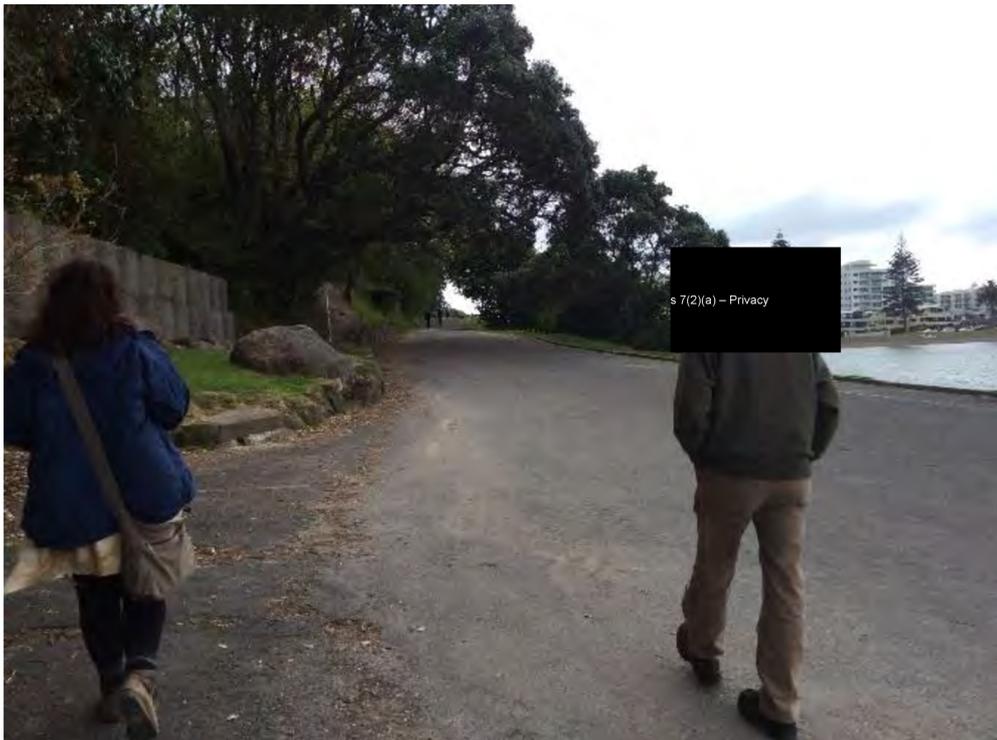
Figure 43: The road that links to the Pilot Bay entrance is not open to public vehicle use. It is wide with open sightlines, however does not provide any alternative routes for escape. The addition of lighting could improve the feeling of safety in this area at night.

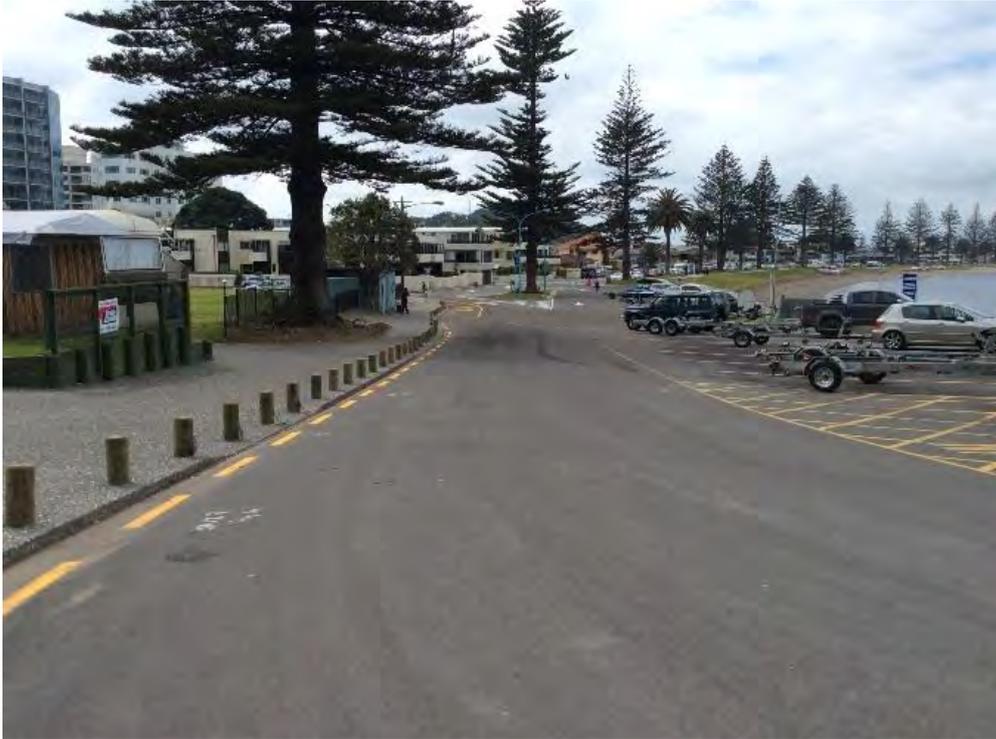
Figure 45: The road before the section closed off for public vehicular use leading to the base track is used for boat trailer parking. This allowance for boat trailer parking results in an extra wide road, providing extensive sightlines for a high sense of safety. CCTV is recommended to be mounted upon the toilet block at the edge of this road section.

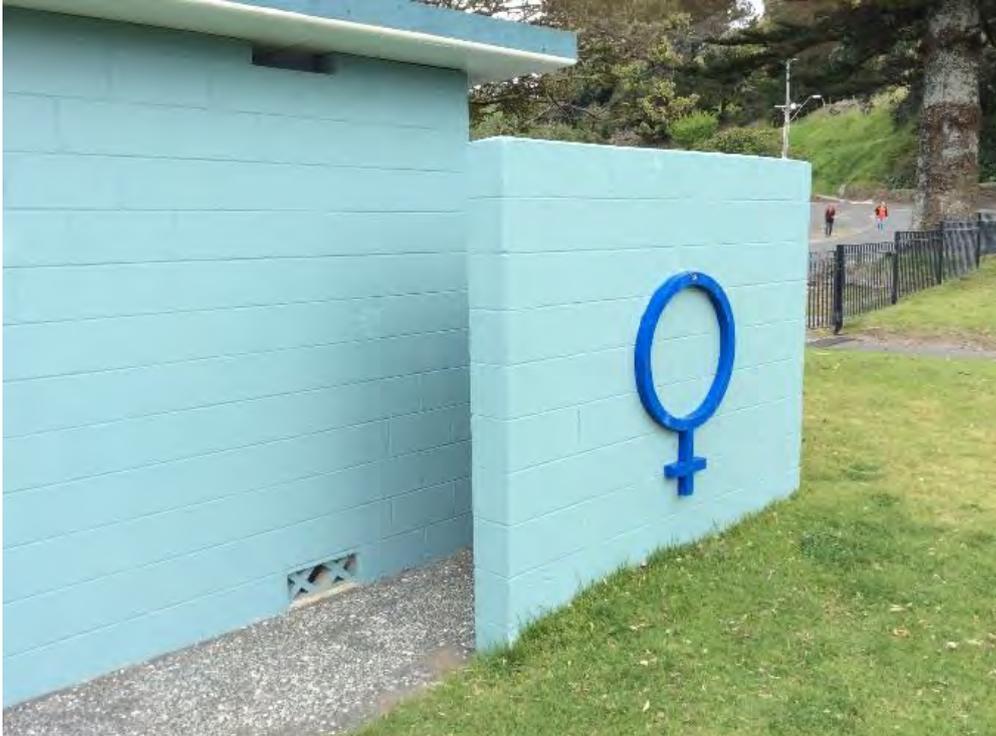
Figure 46: The toilet block that lies on the edge of the campground and the Pilot Bay entrance to the base track of Mauao. The return wall at the back of this toilet block provides a place to hide as well as vandalise. It is recommended that this return wall is removed to increase safety for users.

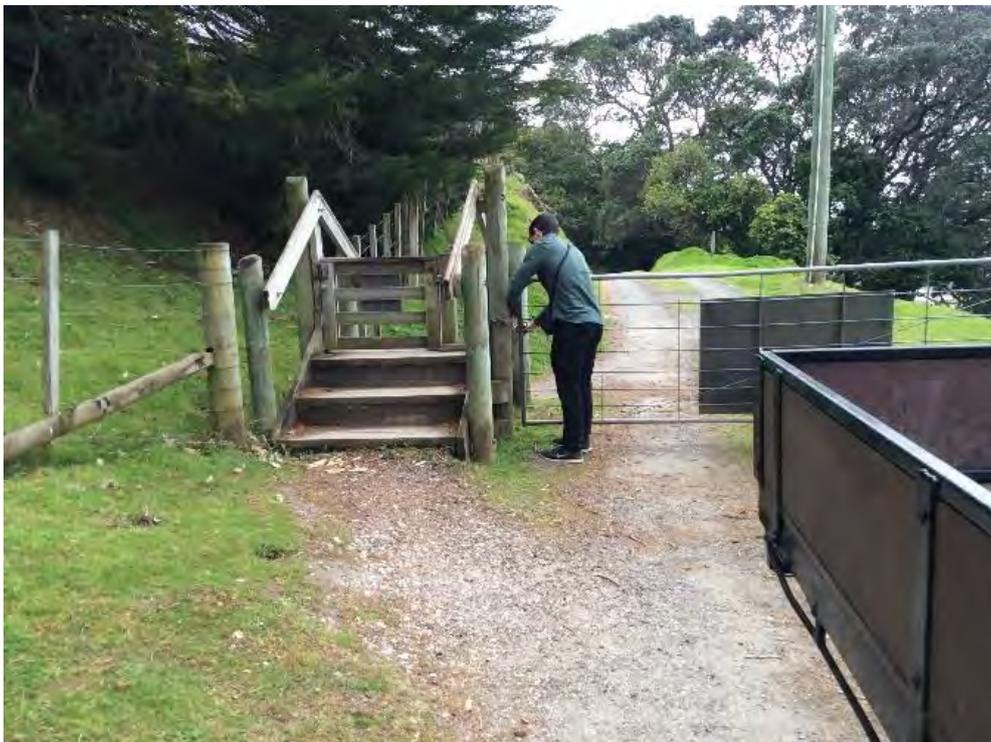
Figure 47: Access at the base of the 4WD track, located at the Pilot Bay side of Mauao includes both pedestrian and 4WD access. Pedestrian access is up steps and through a gate, located next to the 4WD access which is through a farm gate that is locked at all times. 4WD access is restricted to authorised persons only.

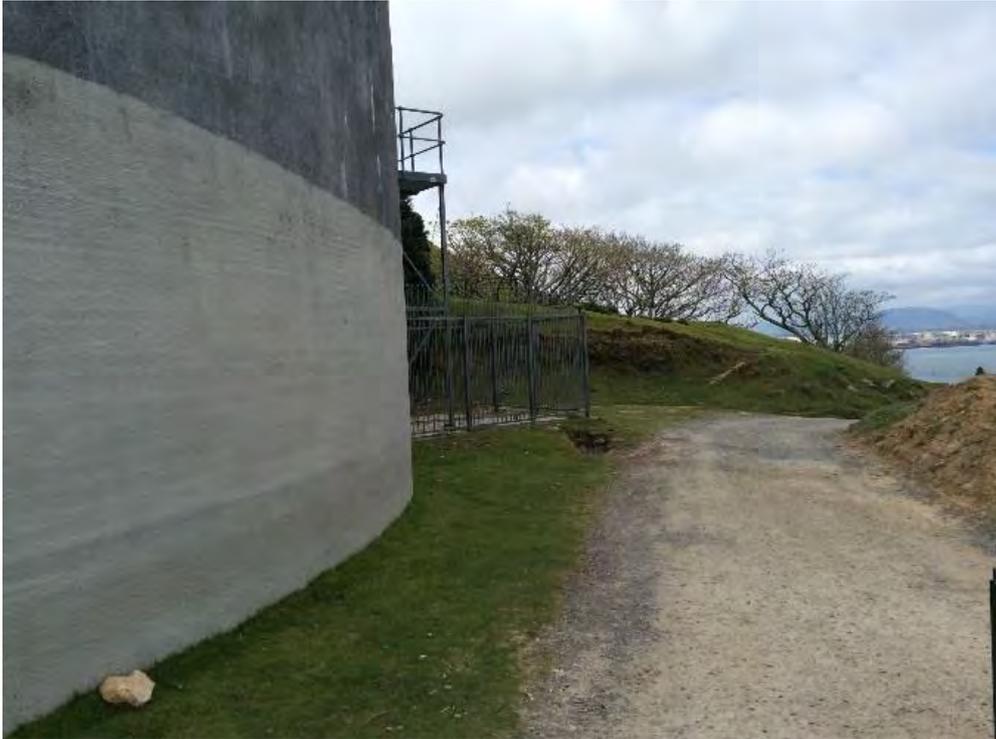
Figure 49: The water reservoir is subject to graffiti and vandalism on occasion. The current remedy is to paint over any graffiti at the first instance, this is not a more permanent and lasting solution. It is recommended to vegetate around the water reservoir to create a screen and barrier for anyone intending on vandalising it.

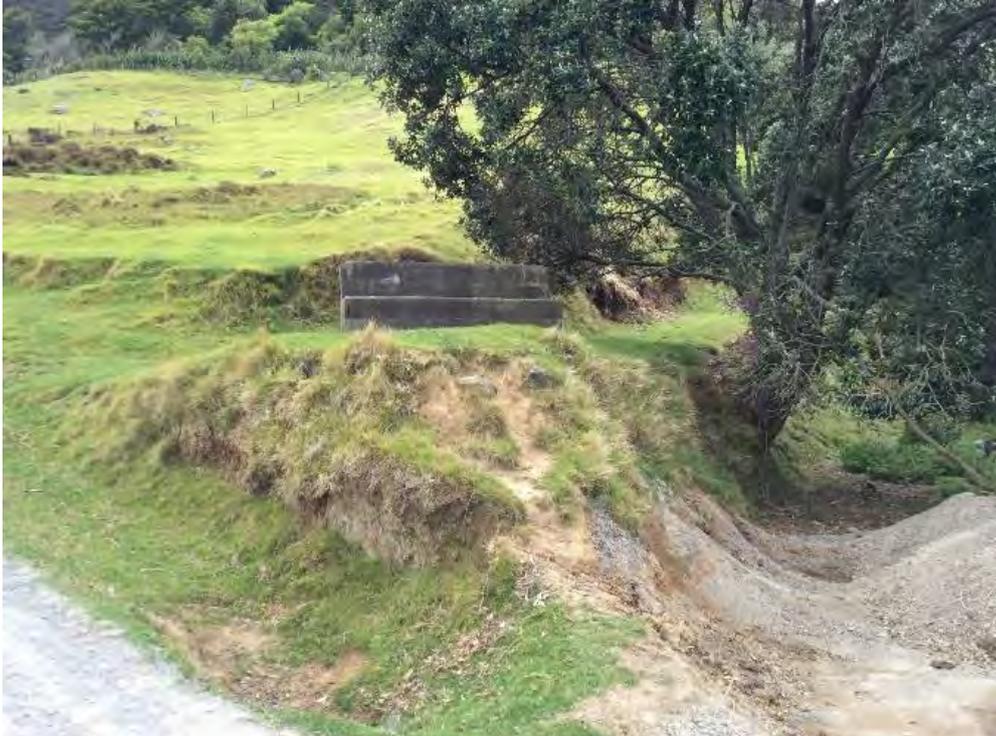
Figure 50: An old concrete seat has become a landmark and feature of the walk. It is recommended that this seat is maintained due to its significance and familiarity to users as well as its unique nature being made out of concrete.

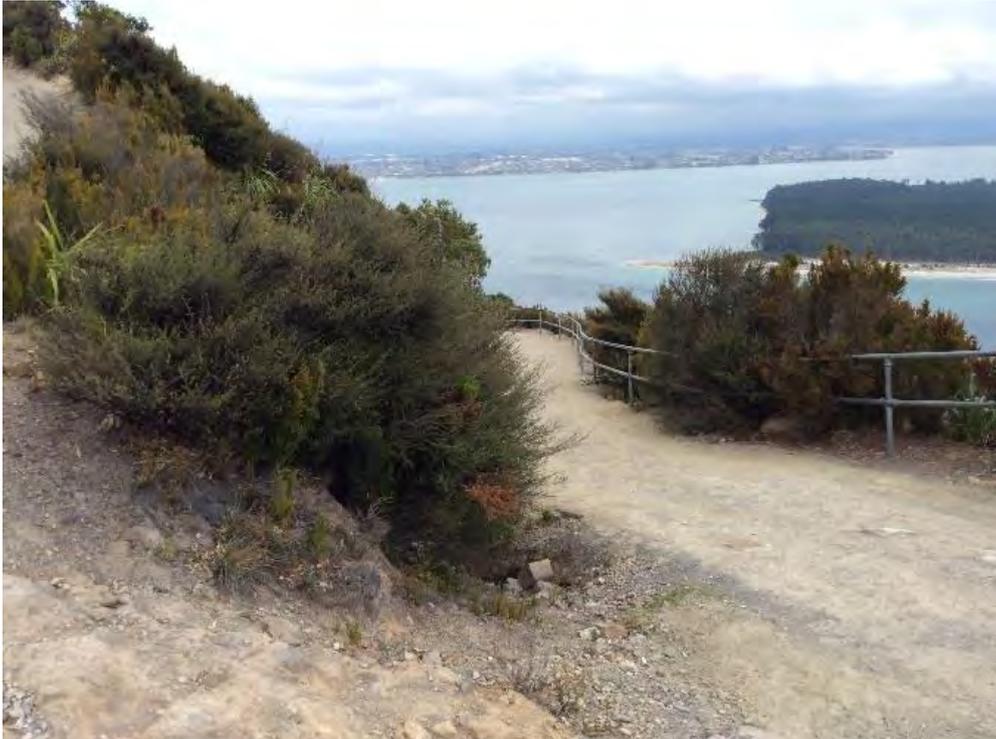
Figure 51: Leading up to the hairpin corner of the track access to the outside edge of the track has been stopped through the installation of hand railing. This was installed after a landslip revealed the steepness and instability of this edge.

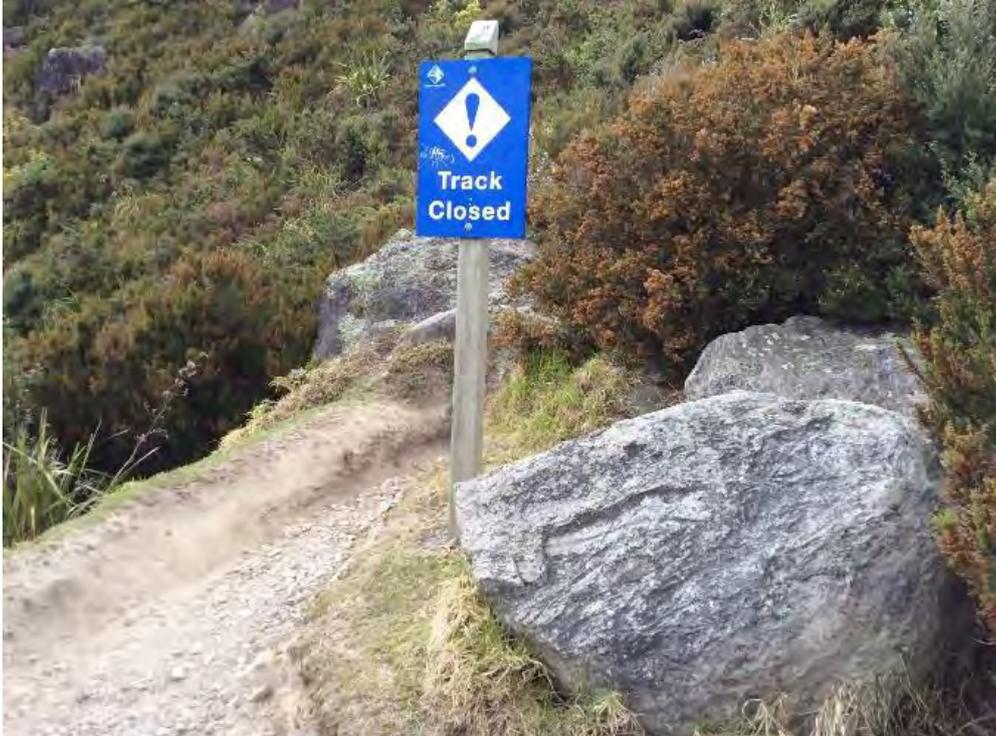
Figure 52: Highly visible sign notifies users that the track is closed. It is recommended that signage options be assessed with potential incorporation of more informative details incorporated into the sign e.g. 'track closed due to rock falls' to better inform and deter users from accessing the closed tracks.

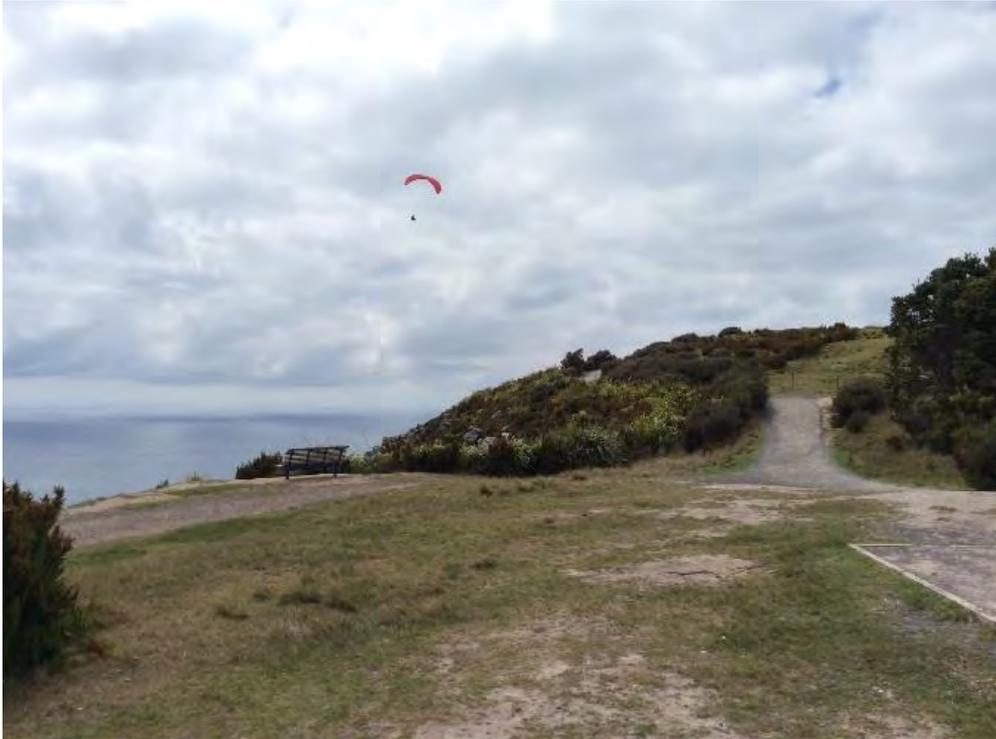
Figure 53: The clearing along the 4WD track leading up to the summit provides both good panoramic views as well as quality sightlines for a good sense of safety and knowledge of the surroundings.

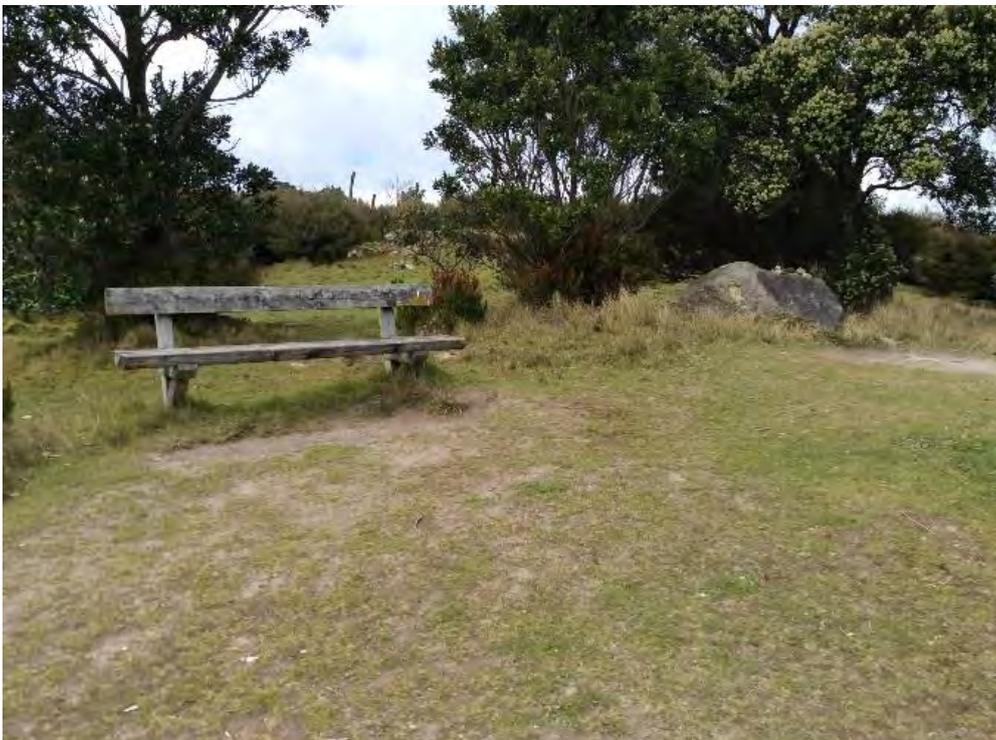
Figure 54: An older seat installed in the clearing along the 4WD track just beneath the summit of Mauao. Seats of this age are to be removed in the near future and replaced with more modern seats.

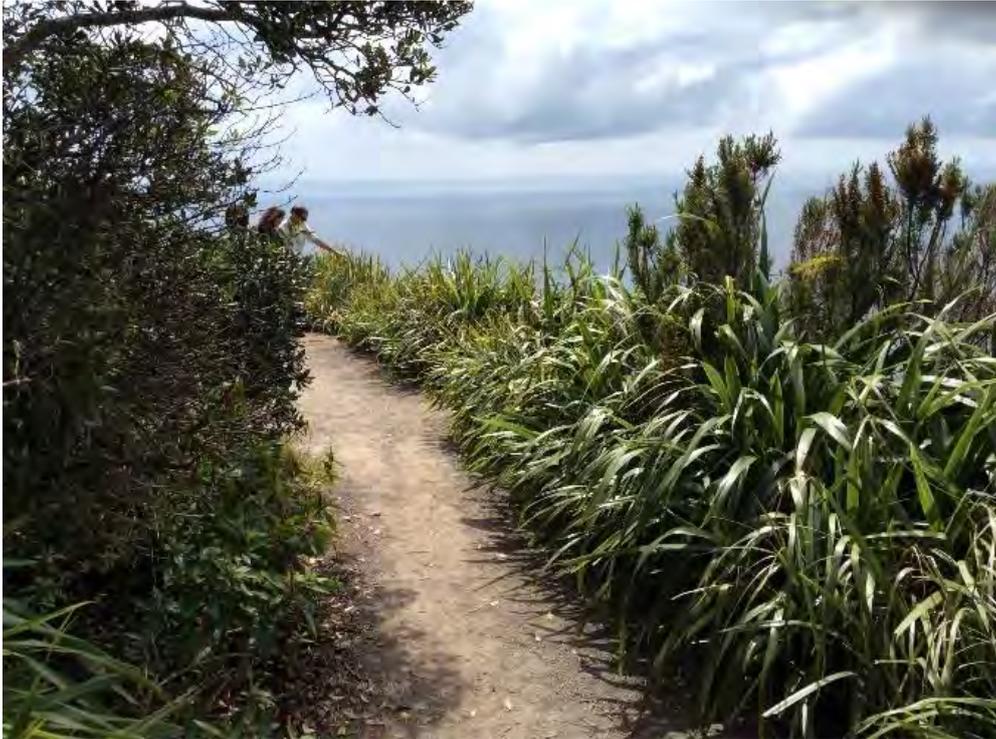
Figure 55: The viewing track at the summit of Mauao is lined with a soft border of mountain flax. This provides not only visual amenity but also added safety from slipping as well as hindering the ability to stray off the designated areas into hazardous areas.

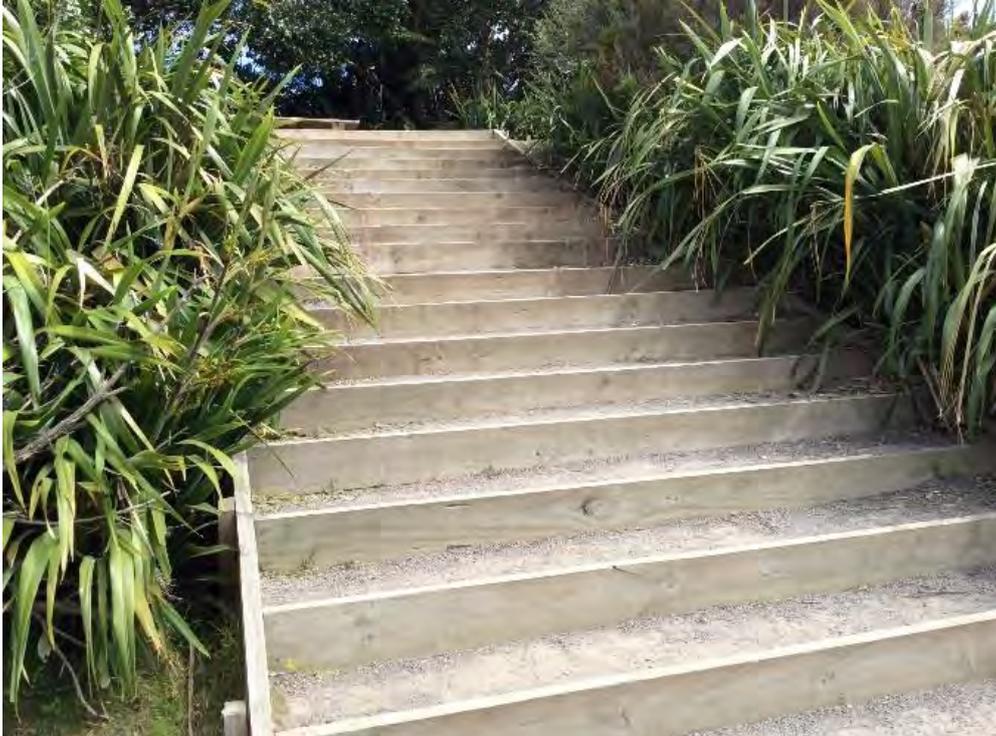
Figure 56: Stairs leading down to the viewing track at Mauao's summit are wide, well-constructed and maintained with mountain flax borders and quality ground material that reduces slipping. This promotes proper usage of the area by providing quality viewing spaces and access ways.

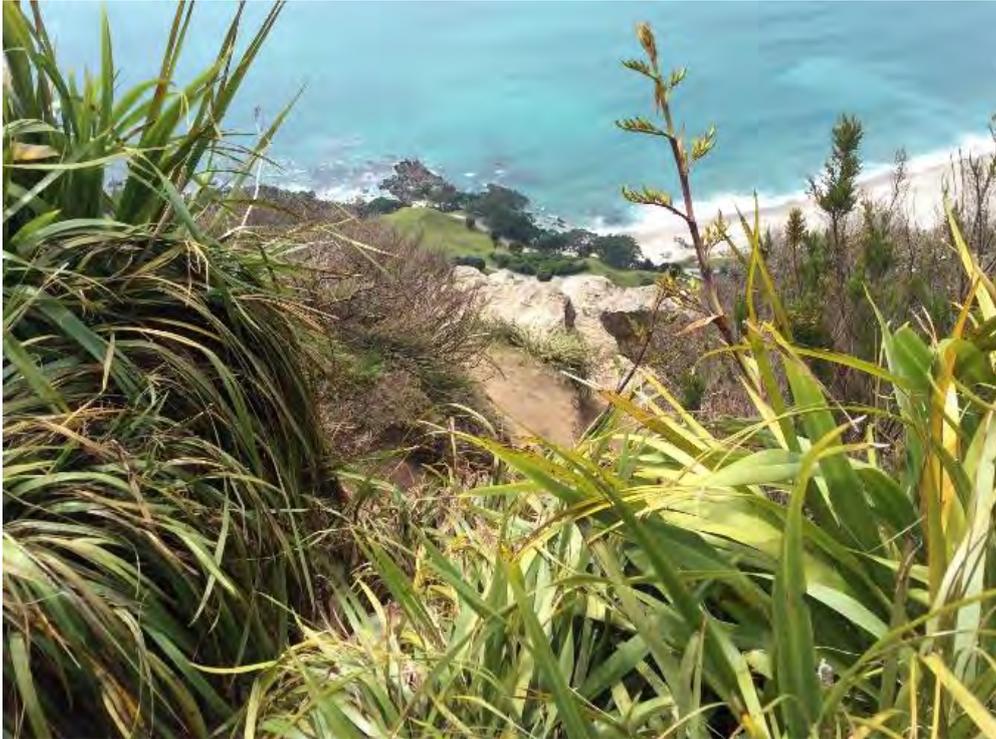
Figure 57: Some users have opened gaps in the mountain flax border to access dangerous viewing points along Mauao's cliff edges. It is recommended that these gaps in the mountain flax border are filled in to reduce opportunities to access these dangerous areas.

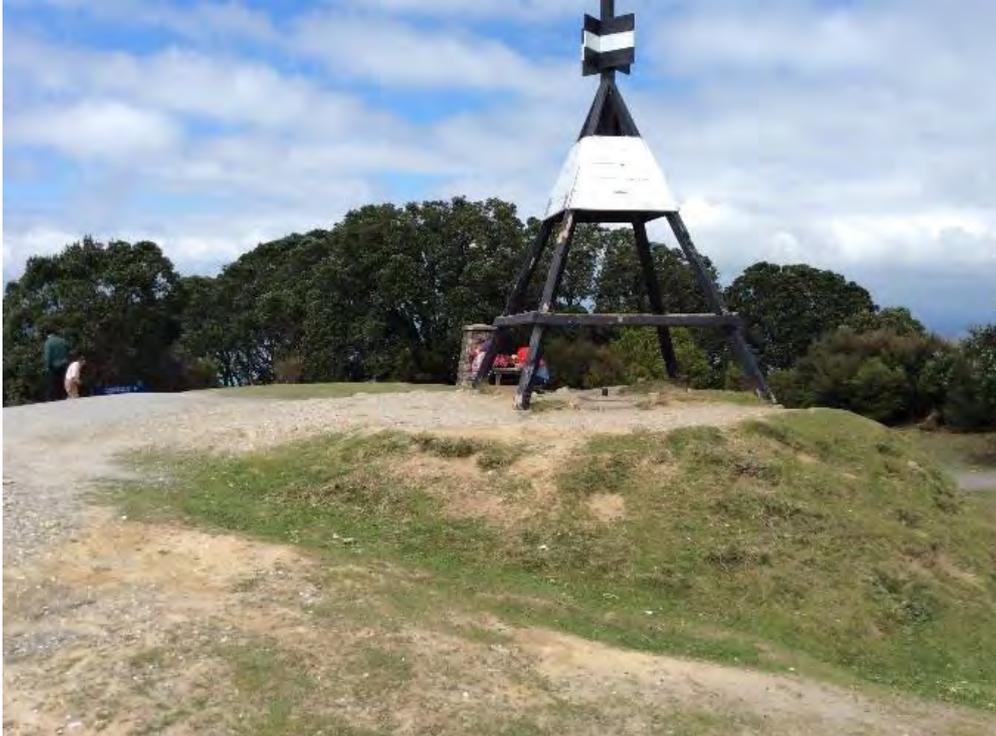
Figure 58: The summit of Mauao. The area is open and well maintained, providing a safe, highly visible area which deters any vandalism upon the summit marker.

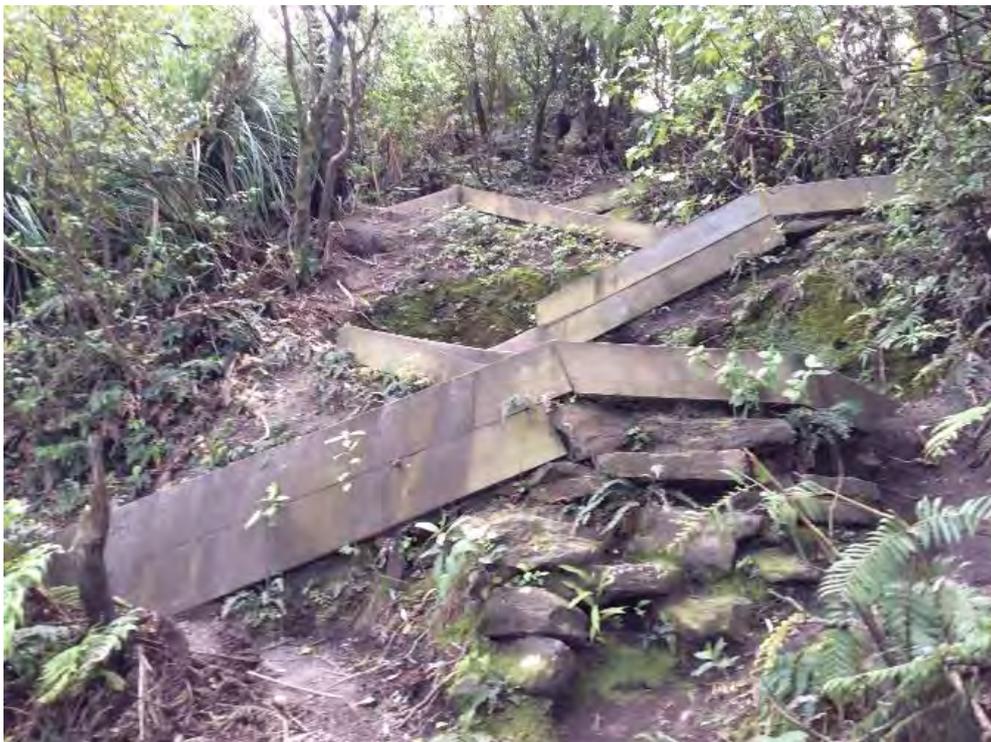
Figure 59: Connecting the Motu Kauri track to the Waikorire track there is a series of winding, steep steps through bush. It is recommended that the steps are maintained by removing any excess material and levelling the tread. Ensure that all wood is structurally sound and not rotting, if so, replace.

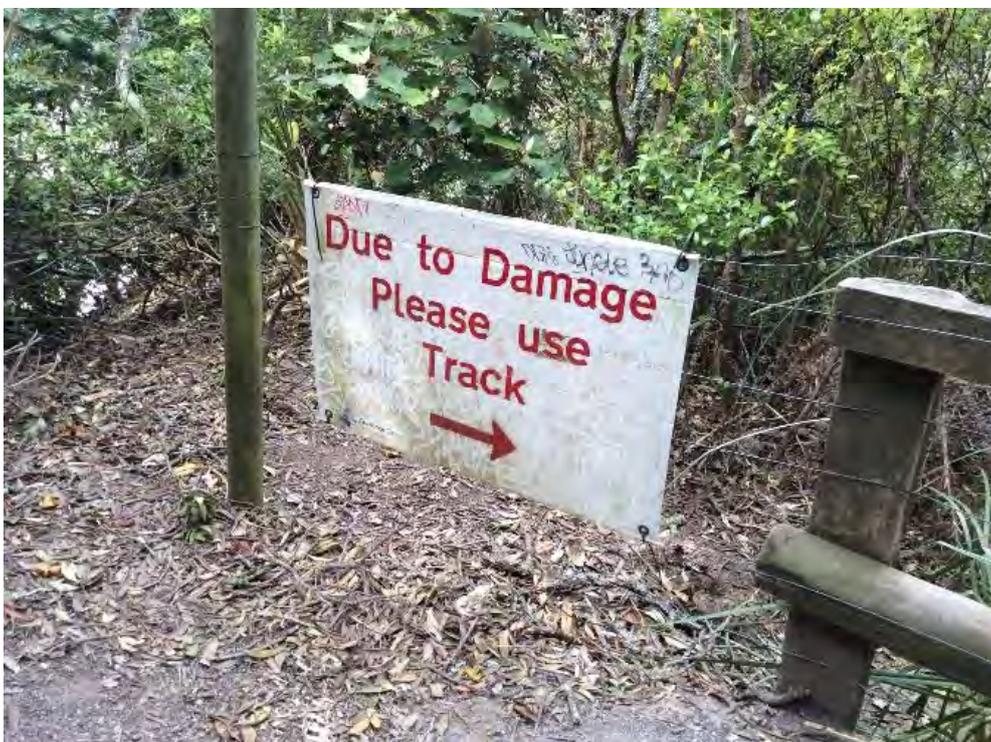
Figure 60: Signage and wire fencing used to prevent users from cutting through bush. This is quite unsightly and also relatively ineffective. It is recommended that border planting is installed to prevent cutting through the bush whilst providing amenity.

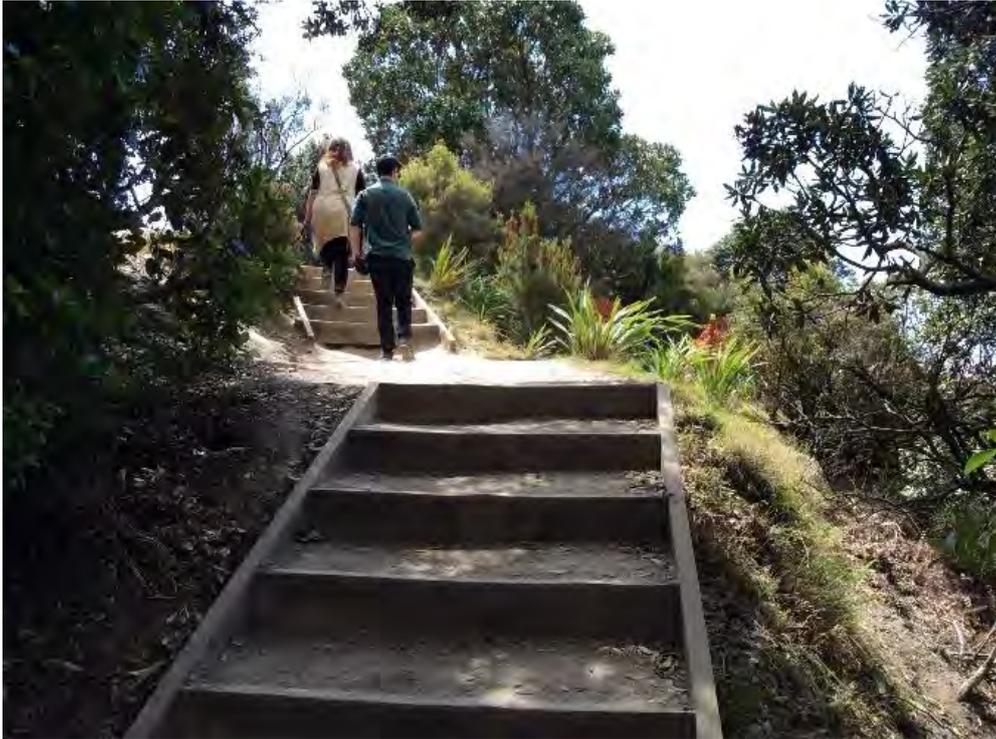
Figure 61: The final series of steps on the Motu Kauri track leading to the summit of Mauao. The steps are well constructed, with a good quality and well maintained ground surface. The absence of vegetation at the immediate border of the track provides greater sightlines for an increased sense of safety and less opportunities for hiding.

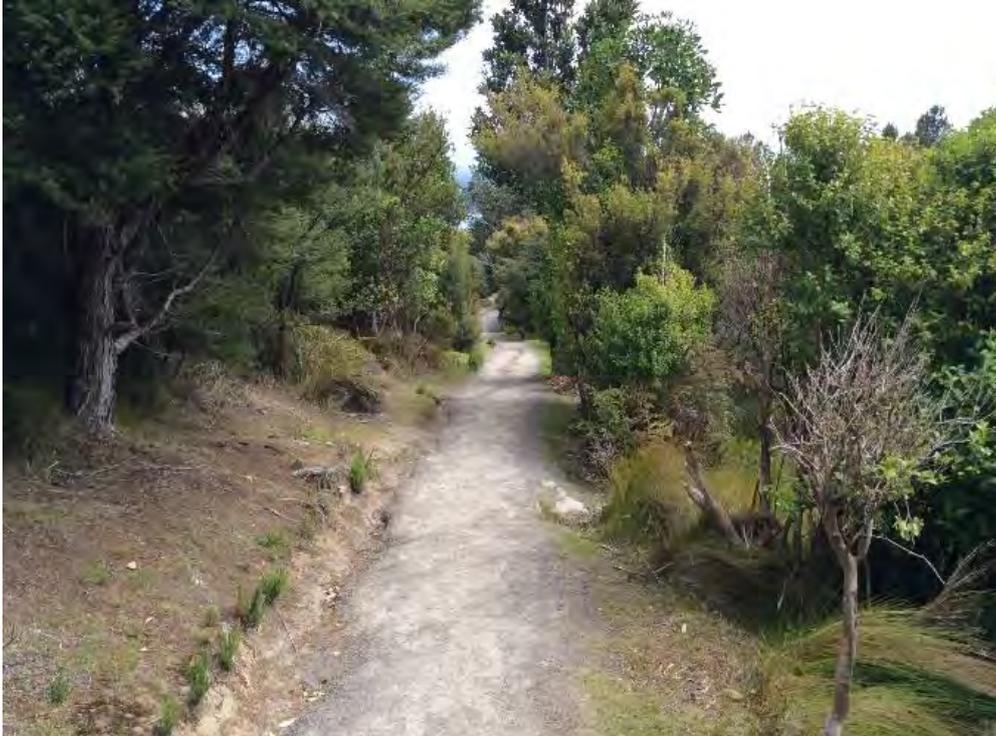
Figure 62: The track is rather narrow and runs through vegetation that is closely located to the track. There are some opportunities for hiding within this closely located, dense vegetation and it is recommended that vegetation is maintained close to the track to ensure best possible visibility while maintaining the bush track atmosphere.

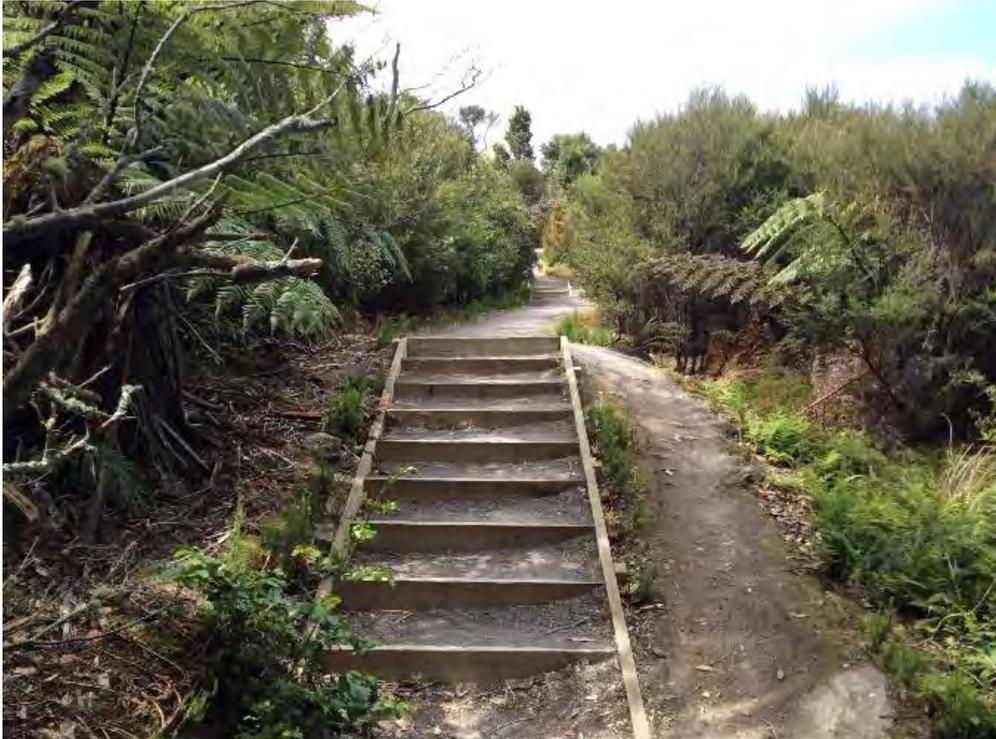
Figure 63: A short set of steps marks the access to the Motu Kauri track from the 4WD track, ascending to Mauao's summit. It is recommended that vegetation is maintained close to the track to ensure best possible visibility while maintaining the bush track atmosphere and excess build-up of material on the steps is removed.

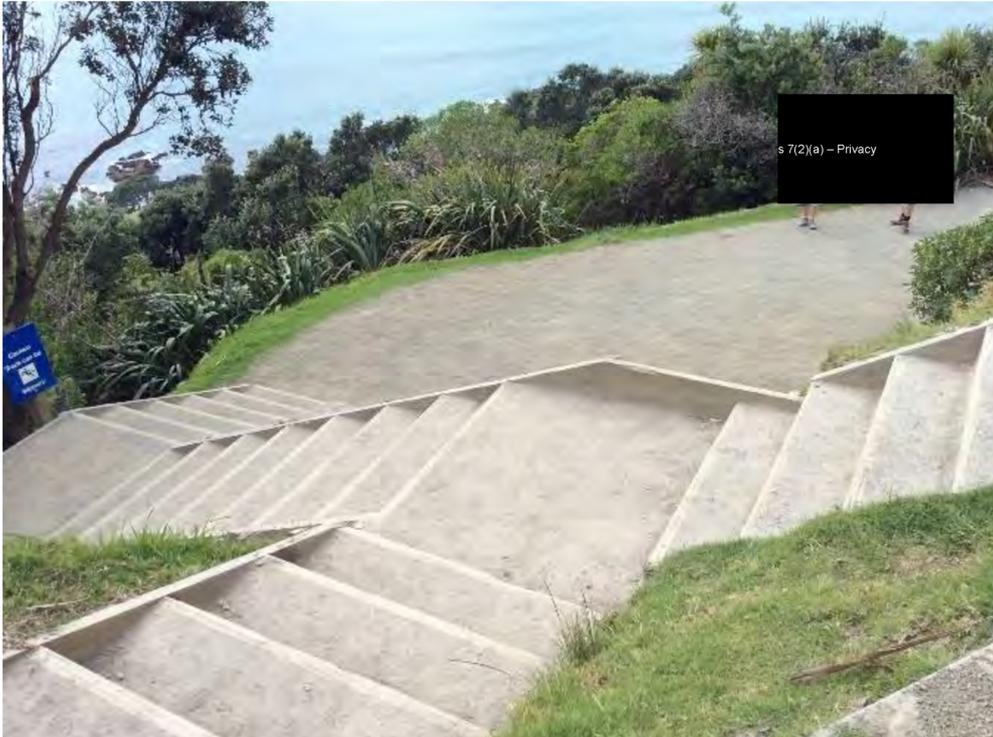
Figure 64: The Waikorire track links to both the 4WD track and the Oruahine track. The junction between the Waikorire track and the Oruahine track is marked with this wide set of steps which are well maintained and constructed.

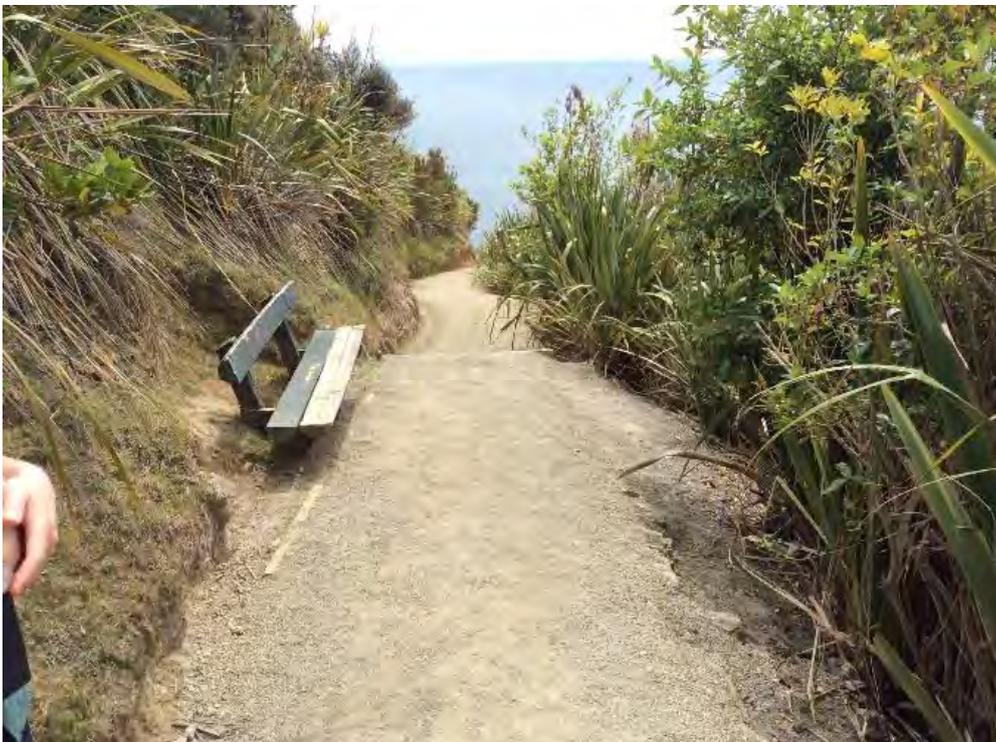
Figure 67: Rest areas, particularly seats are quite sparse in relation to the severity of steepness of the track which results in a greater need to rest at shorter intervals. Older seats like this are to be removed and replaced by newer seats in the near future.

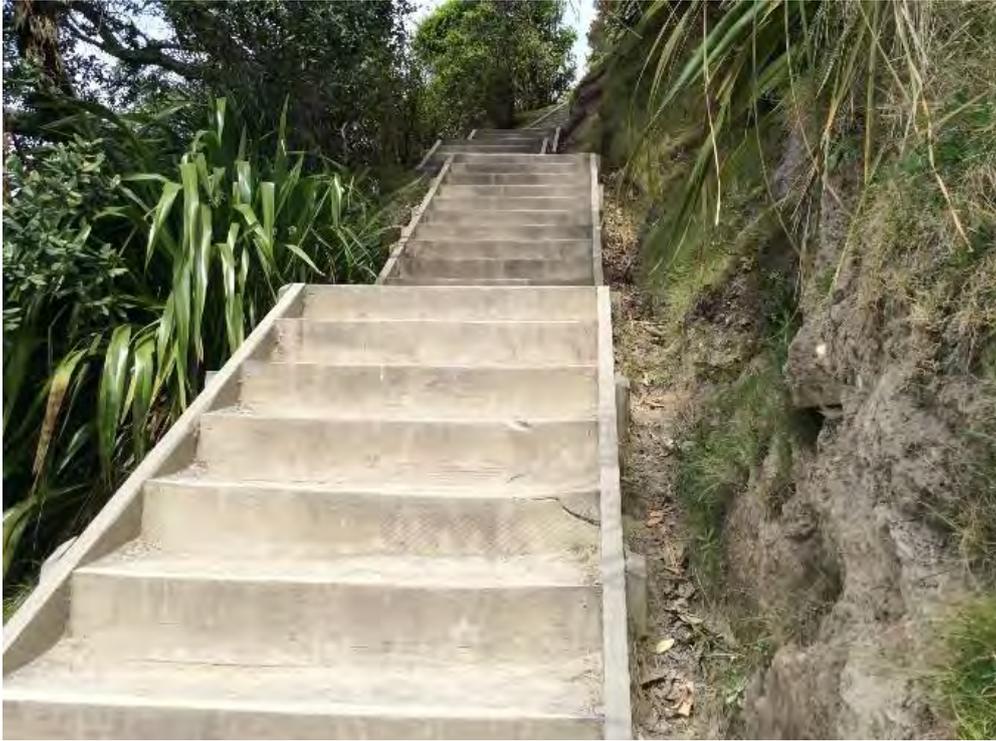
Figure 68: Access up Waikorire track from Oruahine track is via a constant combination of steps and landings, ascending steeply. The ground material is well maintained and the steps are well constructed. Sightlines along the track and out are clear, providing a sense of safety for users.

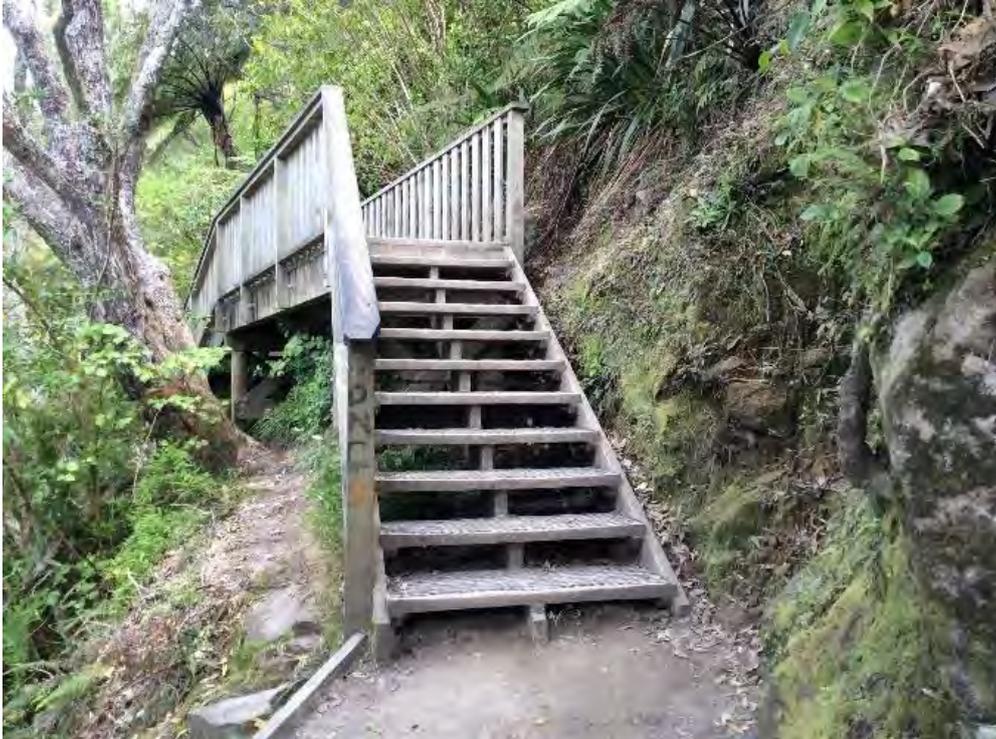
Figure 69: The bridge along the track is in good condition and is well constructed with good handrails and slip proofing. There is evidence of minor, old vandalism, however the design of the bridge is such that it provides very little areas for vandalism to occur or have a major effect.
