Crime Prevention through Environmental Design Audit & Injury Prevention
through Environmental Design & Universal Access Assessment
Prepared for Tauranga City Council

12 January 2015

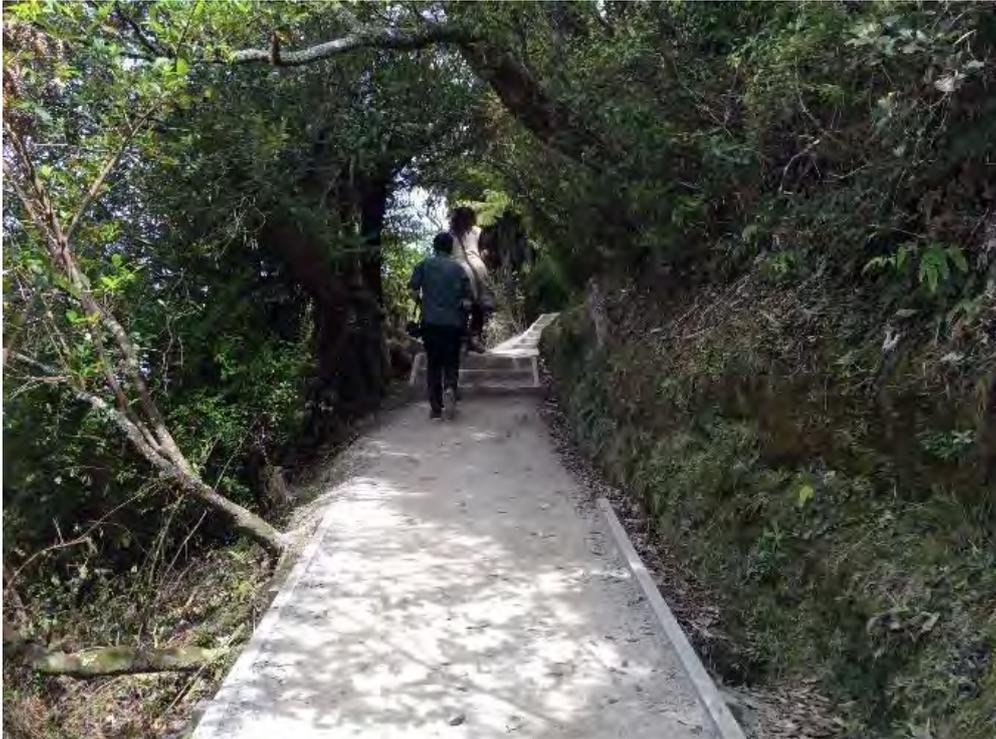
Figure 70: In sections of the track there is vegetation enclosing on both sides of the track, however sightlines along the track are good and the steepness of terrain off the track does not support opportunities for hiding so in this case the high sense of safety is still maintained.

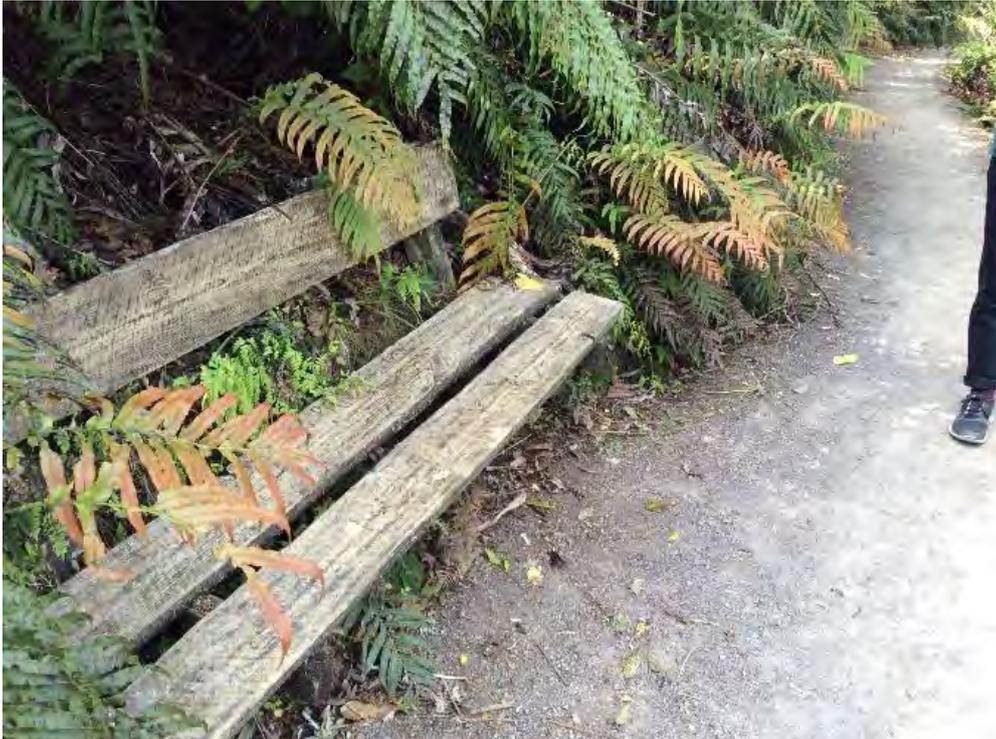
Figure 74: An older seat nestled into the vegetation along the narrow section of the Waikorire track between the connection to the 4WD track and the junction with the Motu Kauri track. Seats of this age are to be removed in the near future and replaced with more modern seats.

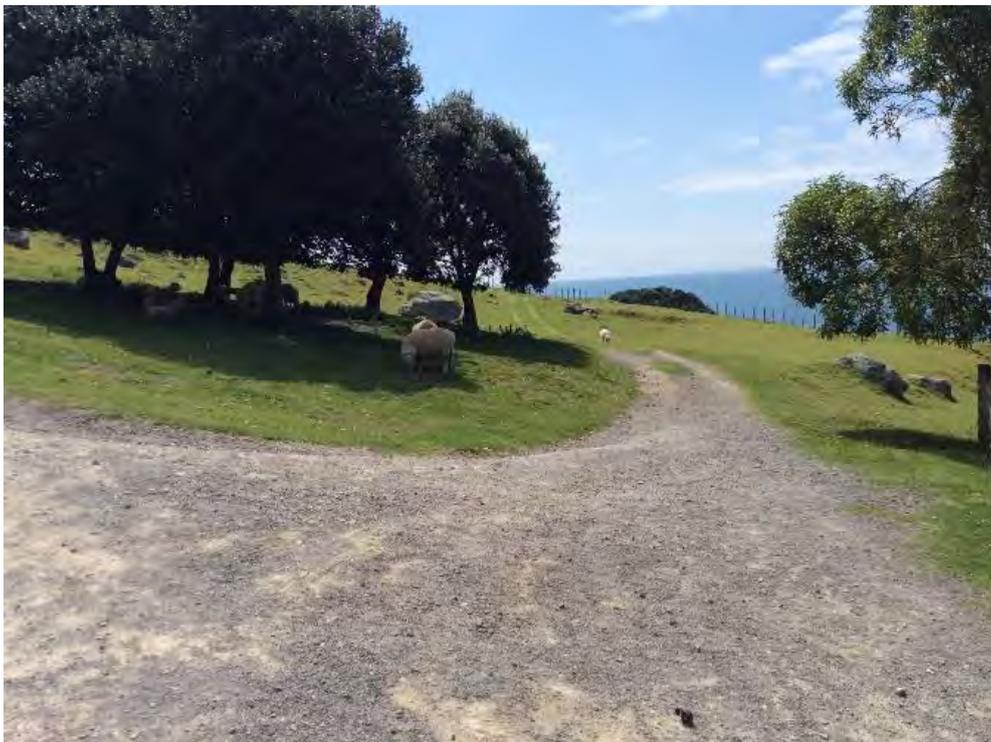
Figure 75: Access leading up to the junction with the Waikorire track is a gentle grade with a wide track, however, from the stone steps up to the junction the ground material is a GAP 40 chip. This results in a much higher frequency of slipping as the larger chip moves more freely. It is recommended that this chip is replaced with the finer gravel.

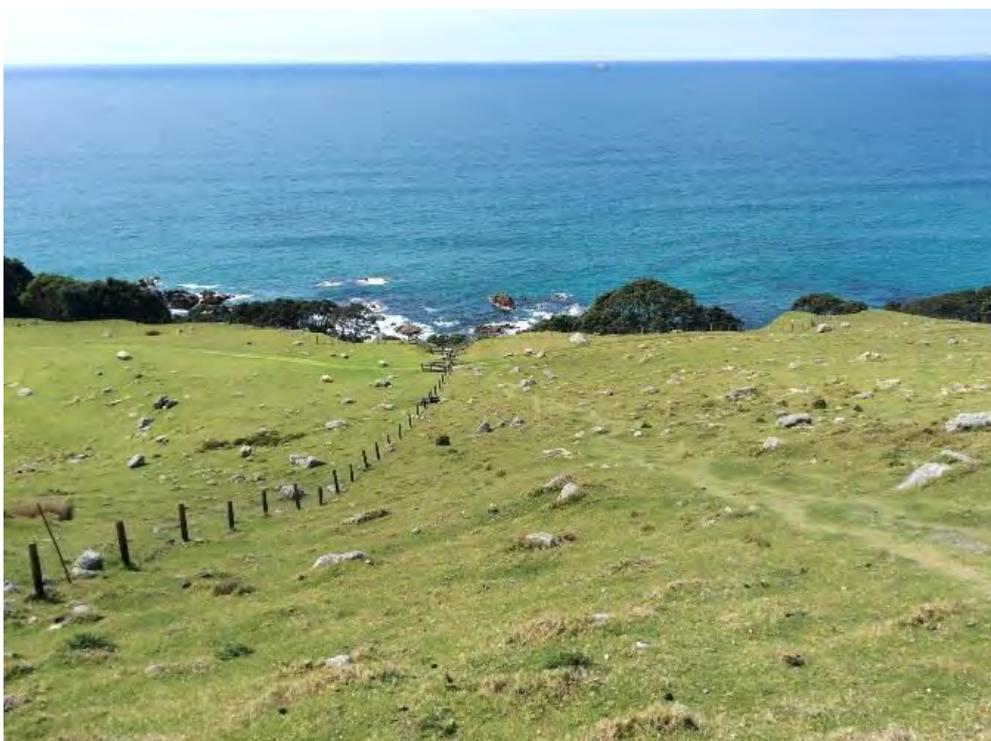
Figure 76: On the lower section of the track there are informal tracks that connect to the base track through farm land. These provide added escape routes and should be looked into for enhancement to add safety for those choosing to access informal tracks.

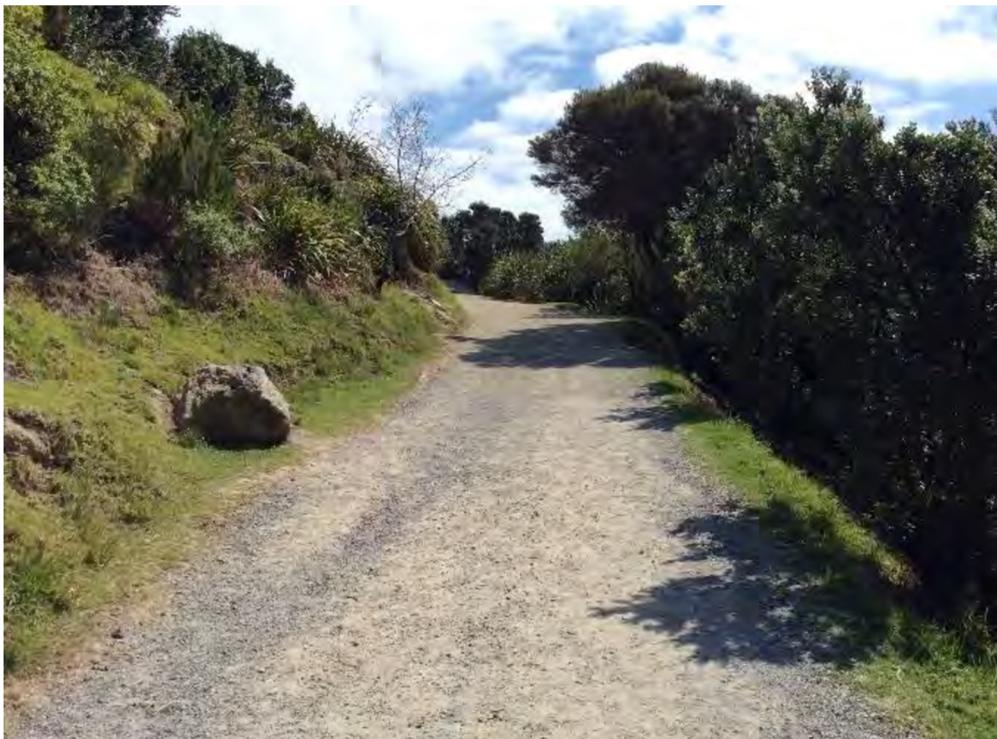
Figure 78: Access leading up to the junction with the Waikorire track is a gentle grade with a wide track, however, from the stone steps up to the junction the ground material is a GAP 40 chip. This results in a much higher frequency of slipping as the larger chip moves more freely. It is recommended that this chip is replaced with the finer gravel.

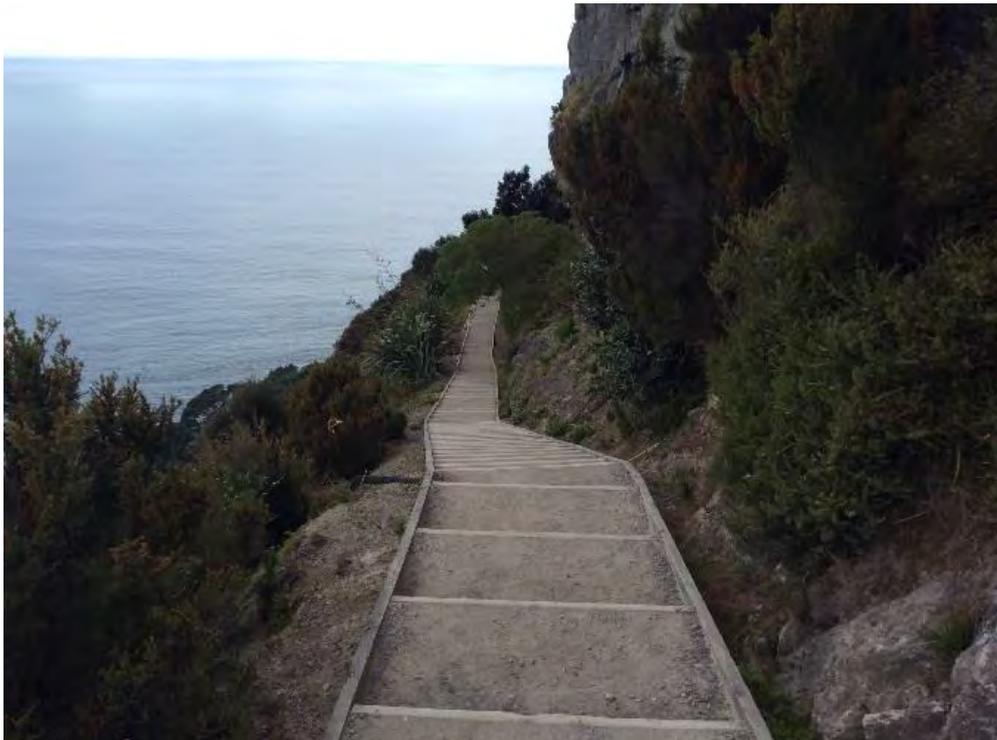
Figure 79: The upper section of the track consists of stairs that cascade down through a short section of bush and down an area on the cliff edge. The steps are well constructed with a good quality and well maintained ground material. Sightlines are clear for safety. Mountain flax is used as a soft border to define the steep cliff edge.
