Project Number: 2-9B441.00

Tauranga Landslide Susceptibility Study

Technical Report

22 September 2023

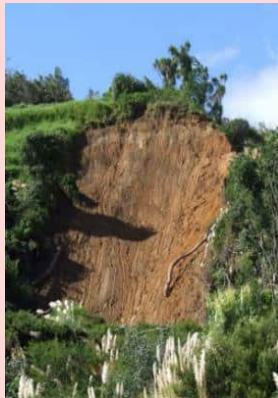
<p>Ōmokoroa (Moon et al. (2017), University of Waikato)</p>

Type of landslide	Description	Example(s) in Tauranga	Image
Shallow translational slide-flows	<p>Failure in shallow volcanic ash layers, with relatively planar failure surface.</p> <p>Relatively small amount of material.</p> <p>Often due to water infiltration into (and possible saturation of) permeable layers overlying a less permeable layer (e.g., a paleosol).</p> <p>Long runout distances, particularly if lots of water is present.</p> <p>Hamilton Ash deposits at the surface often exhibit tension cracking, allowing water ingress, and contain several lower permeability paleosols. This failure mechanism is therefore more likely within this unit.</p>	<p>Various locations where there is a shallow ash cover.</p> <p>Past examples:</p> <ul style="list-style-type: none"> - Pāpāmoa Hills - Welcome Bay - Coastal cliff areas in Maungatapu and Matua (and in nearby Ōmokoroa)

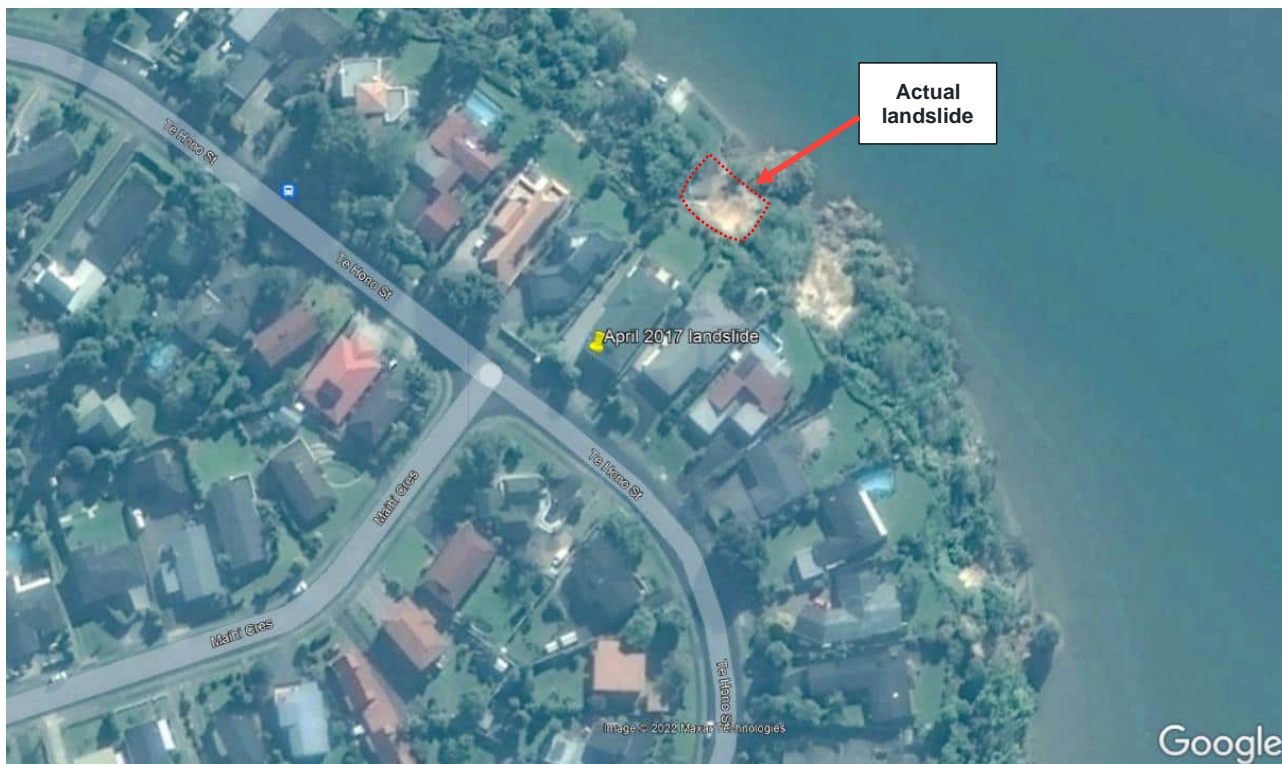
Figure 11: EQC data point (yellow pin) for an April 2017 landslide in Maungatapu. EQC data has only address information, so points are not located at the true landslide location.

Addresses where insurance claims had been lodged in relation to landsliding were provided by EQC. Of these claims, 210 entries were located within the study area in Tauranga. The locational accuracy of these landslides is poor because only the property address is available, as opposed to the actual landslide location. An example of this is shown in Figure 11. In addition, EQC landslide claims can relate to failure of retaining walls and other man-made structures, for which the correlation of landslide occurrence to landslide-influencing factors is likely to be different when compared to unsupported slopes.

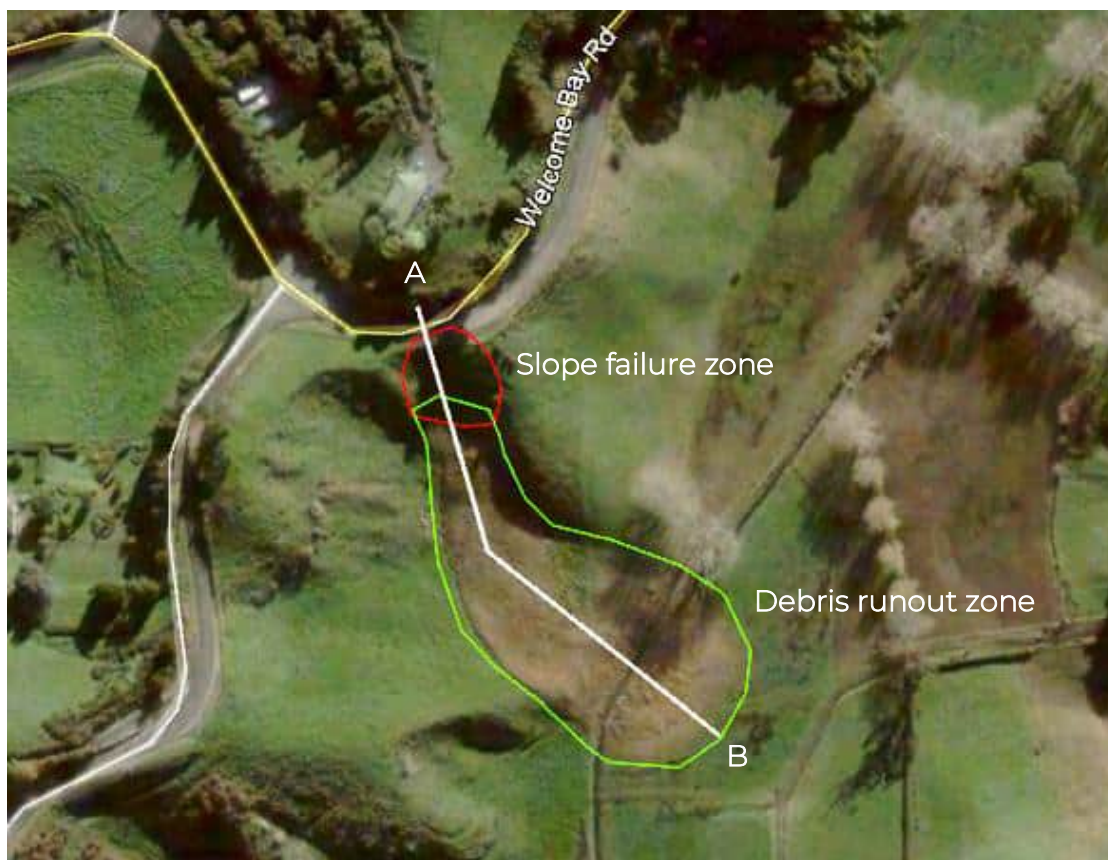
Figure 13: Map and cross section of a failure in the 2005 storm on Welcome Bay Road, showing the debris runout extending to a 4H:1V line projected from the head scarp, with a debris flow extending well beyond this line (approximately 6.5H:1V from the head scarp).

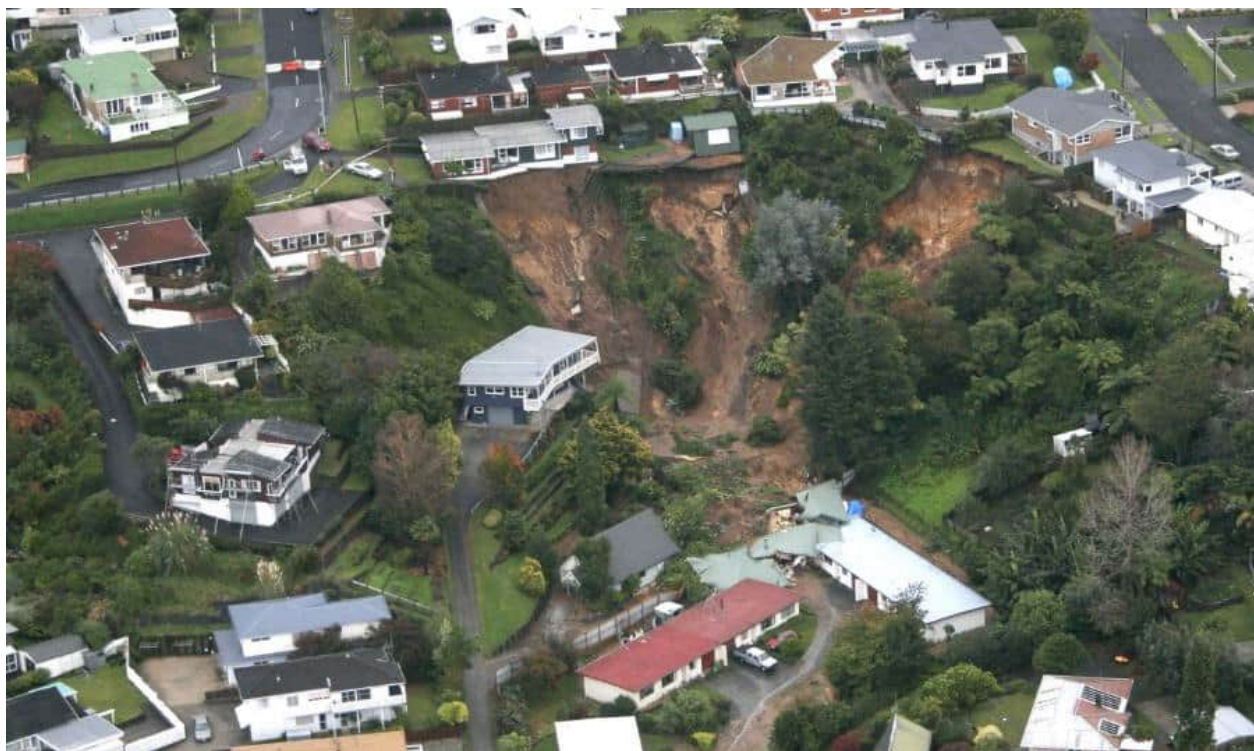
Figure 14: Landslide above Landscape Rd in Otūmoetai on 18 May 2005 (photo from BOPRC: <https://www.boprc.govt.nz/living-in-the-bay/emergencies/our-natural-hazards>).
