GEOTECHNICAL

Mauao Slopes; Monitoring Report for April 2018

This letter is to report the survey benchmark monitoring, site geotechnical walkover, rockfall and slip developments since the previous monitoring.

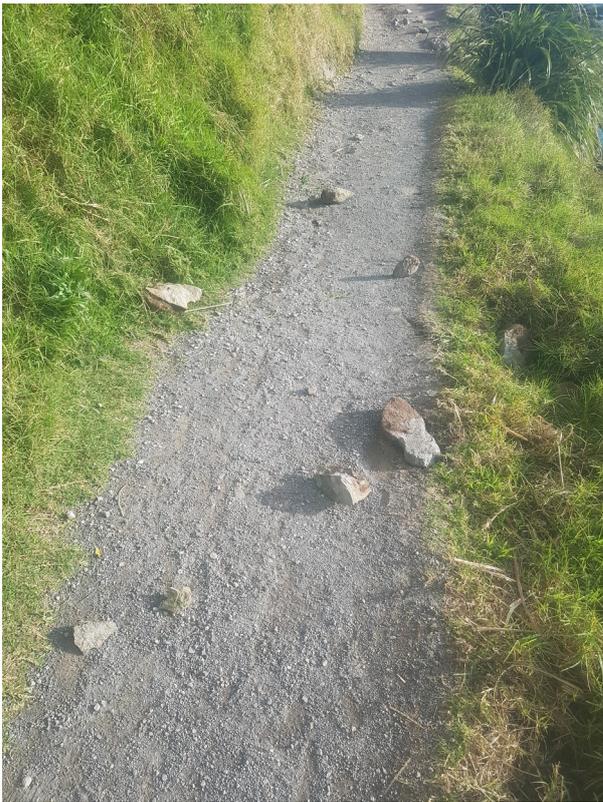
During the work the team found a number of unstable looking areas of rock face. Some of the smaller rocks were scaled in a controlled manner, landing on the Oruahine track below.

Photo 1. Rock found on Oruahine track.

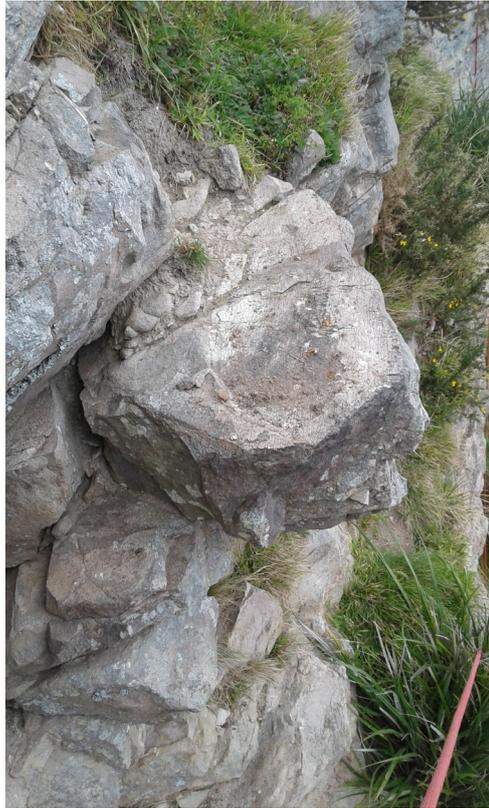
A significant amount of larger unstable boulders were also found. The team reported this to s 7(2)(f)(ii) by email of marked up photographs; see below.

Photo 2. Loose rock above the Oruahine

Avalon recommended a team a two technicians for minimum one day to scale this area.

This work has not yet been completed.

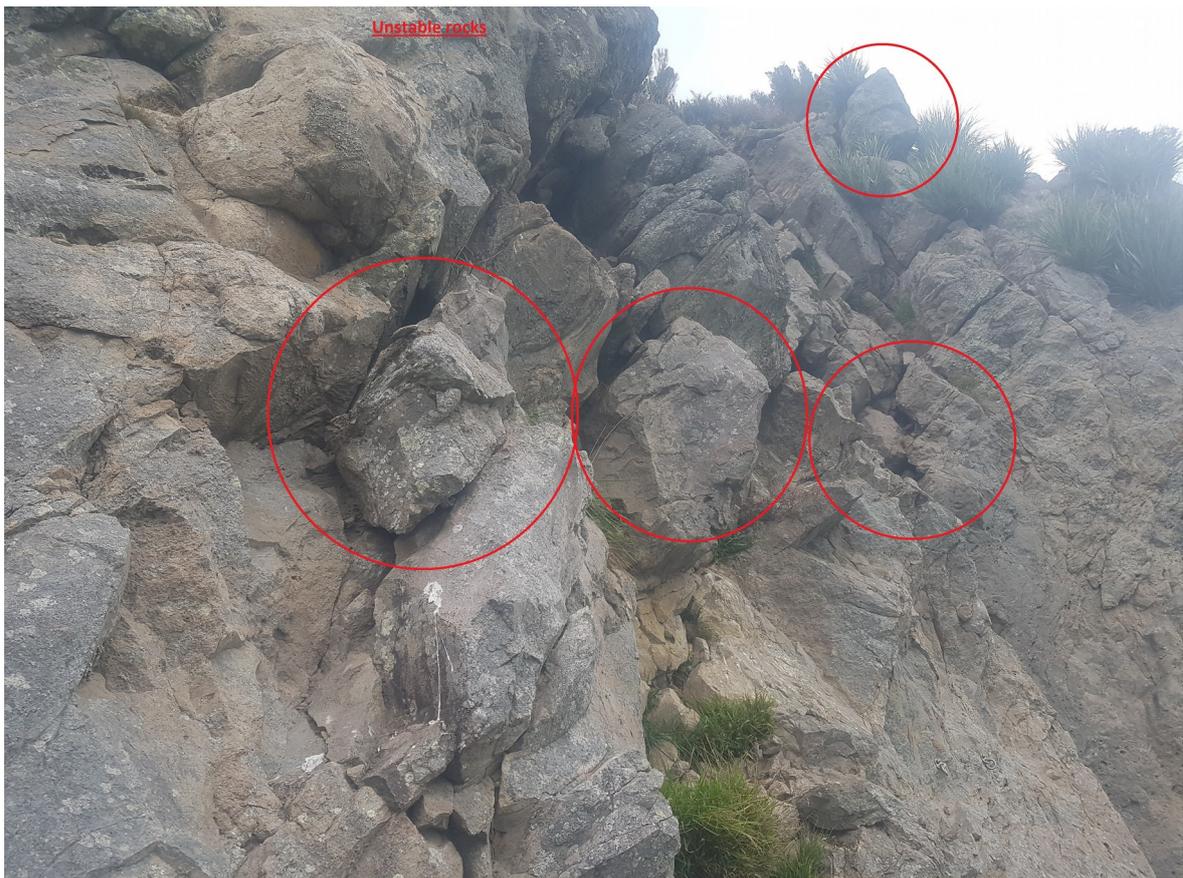
Photo 3. Loose rock above the Oruahine track.

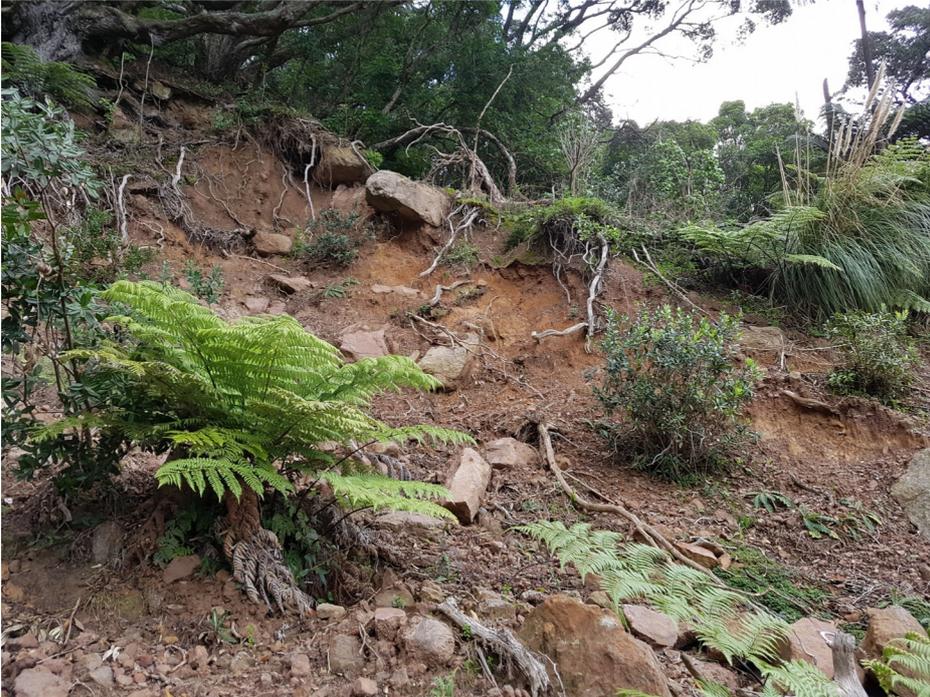
§ 7(2)(f)(iii) contacted Avalon regarding a few particularly hazardous and unstable looking boulders eroding out from the crest of a recent soil slip above the western Base track.

Photo 4. Slip above Base track.

Avalon mobilised a three person team, Aegis Security closed the Base track and the marginal rock was scaled or moved in stable areas of slope.

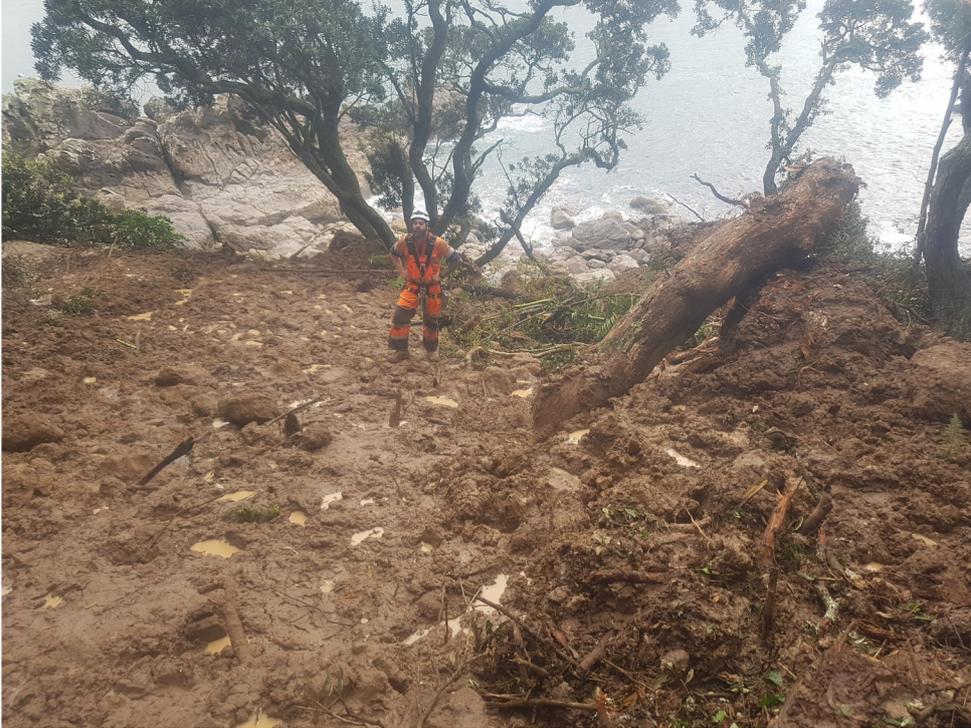
A soil slip event above the north west Base track.

Photo 6. Slip above Base track

s 7(2)(f)(ii) called Avalon to inspect the slip and scale as required. This work was carried out in one day under Avalon's Project Reference # 17054.

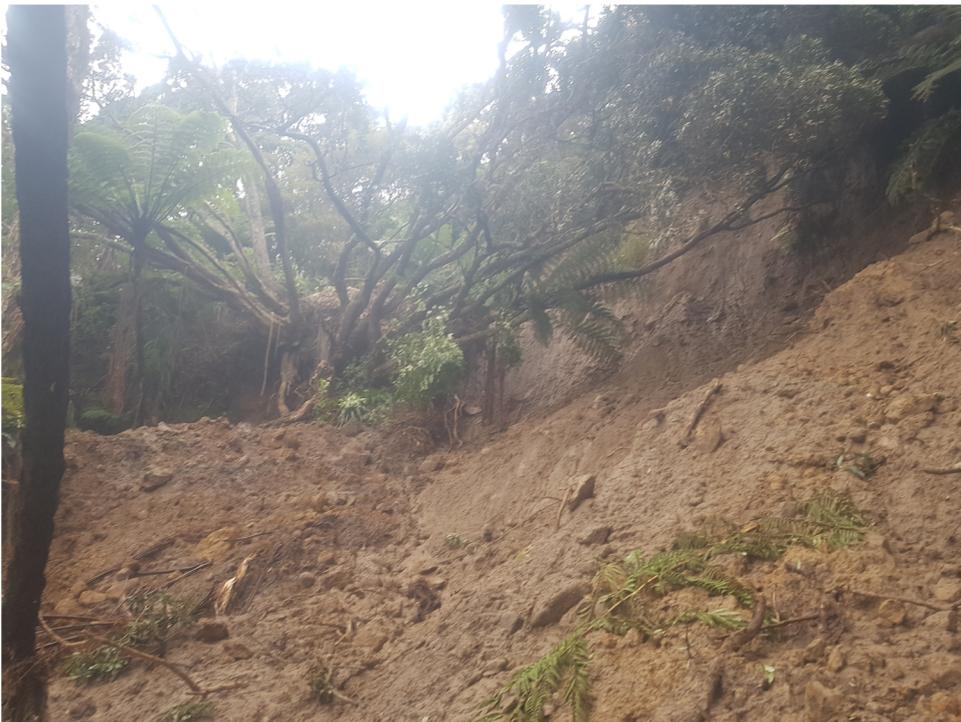
Photo 7. Slip above Base track

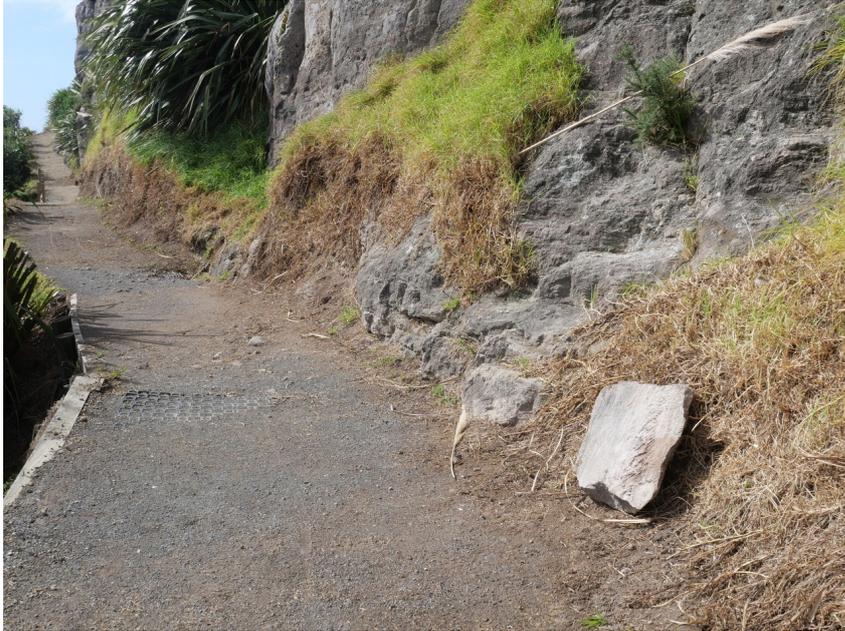
The inspection walkover found two rocks on the tracks which likely were rockfall. One was on the Oruahine track:

Photo 8. Rock found on Oruahine track.

The exact source locations of these rocks could not be located. Obviously both these rockfalls would have been extremely hazardous to anyone in the vicinity at the time and they are a reminder that the rockfall risk to public is very real.

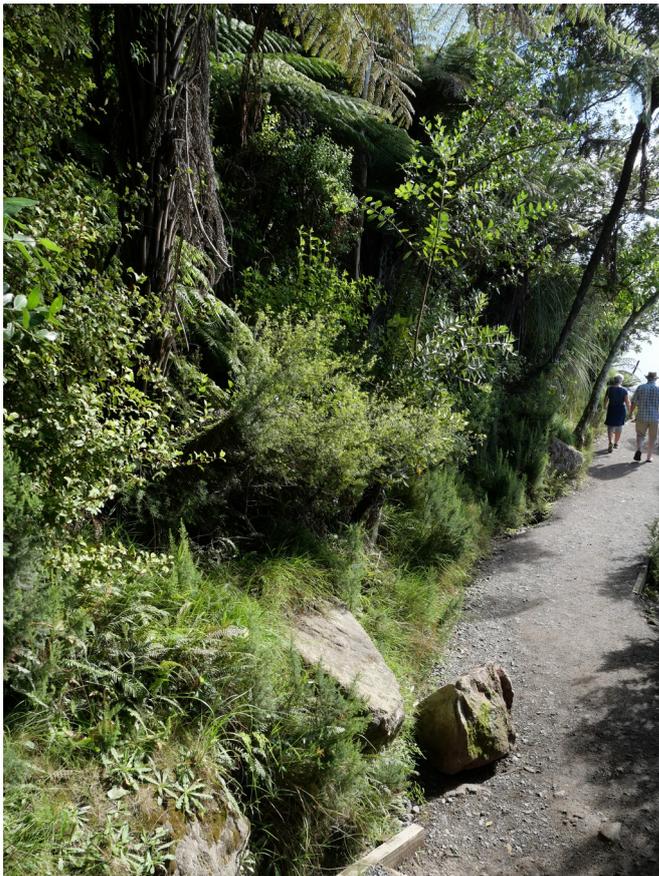
Photo 9. Rock found on Waikorere track.

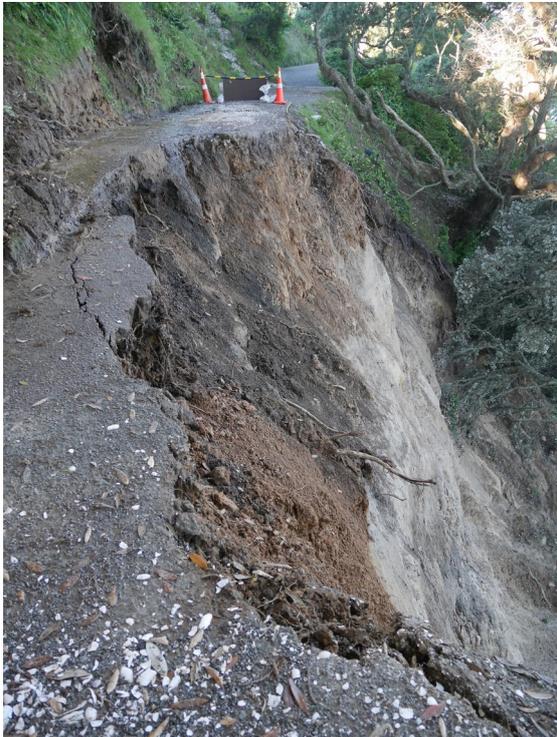
The major underslip on the base track northwestern side had not changed much in comparison with 12 months previously.

Photo 10. April 2017

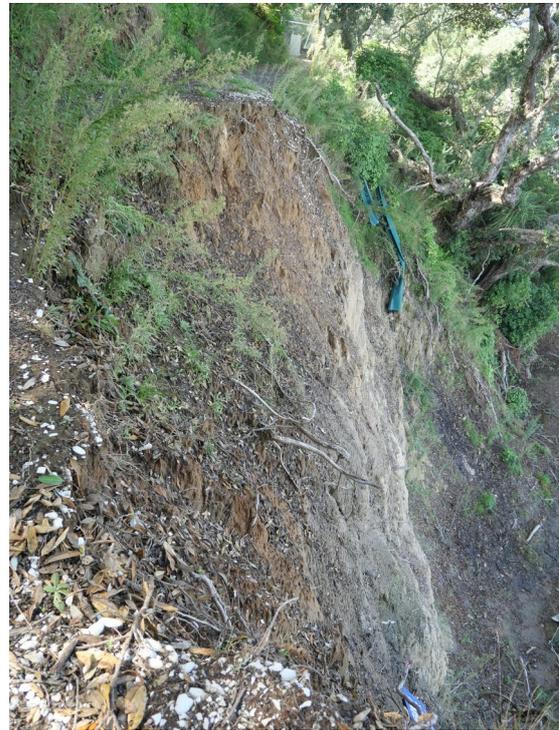
Photo 11. April 2018.

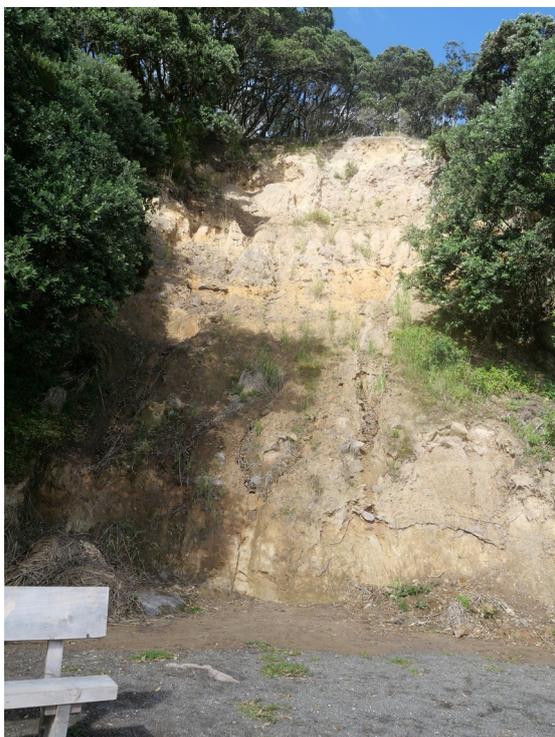
Photo 12. New bench seat below base track slip.

The slip and rockfall source immediately above the northern base track in photo 5 appears to have become more stable subsequent to the scaling work done in 2017. Ongoing erosion at this location will eventually result in exposed rocks and increased rockfall risk. Due to this the siting of the two new bench seats below may not have been the best choice of location even though there is a good verge behind the seats.
