Mauao Slopes; Monitoring Report for April 2018

This letter is to report the survey benchmark monitoring, site geotechnical walkover, rockfall and slip developments since the previous monitoring.

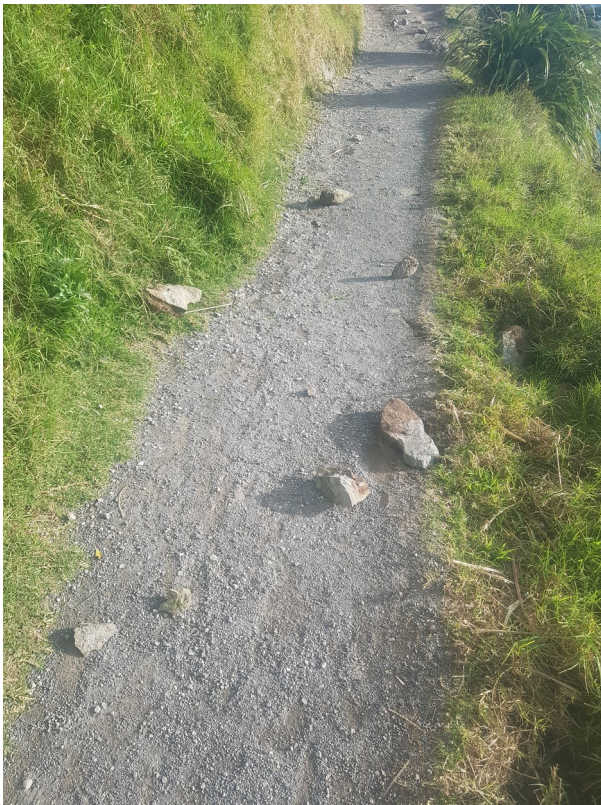
Photo 1. Rock found on Oruahine track.

During the work the team found a number of unstable looking areas of rock face. Some of the smaller rocks were scaled in a controlled manner, landing on the Oruahine track below.

Avalon recommended a team a two technicians for minimum one day to scale this area.

This work has not yet been completed.

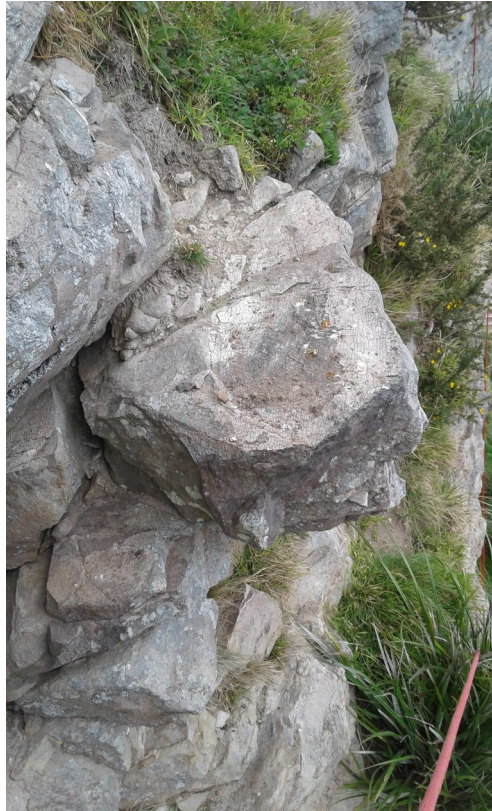
Photo 2. Loose rock above the Oruahine

A significant amount of larger unstable boulders were also found. The team reported this to s 7(2)(f)(ii) by email of marked up photographs; see below.

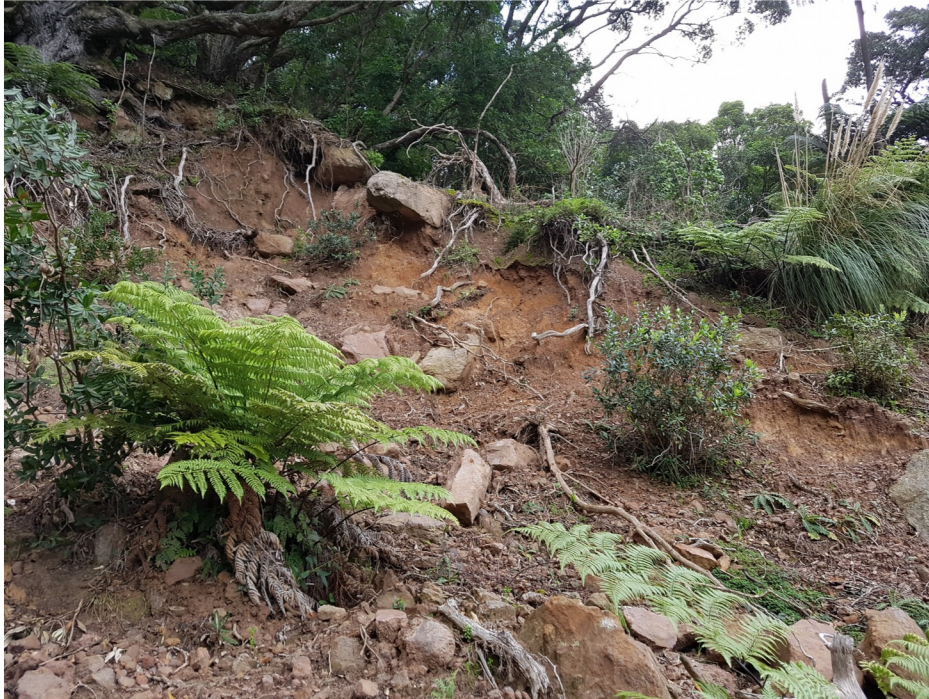
Photo 4. Slip above Base track.

§ 7(2)(f)(iii) contacted Avalon regarding a few particularly hazardous and unstable looking boulders eroding out from the crest of a recent soil slip above the western Base track.

Avalon mobilised a three person team, Aegis Security closed the Base track and the marginal rock was scaled or moved in stable areas of slope.

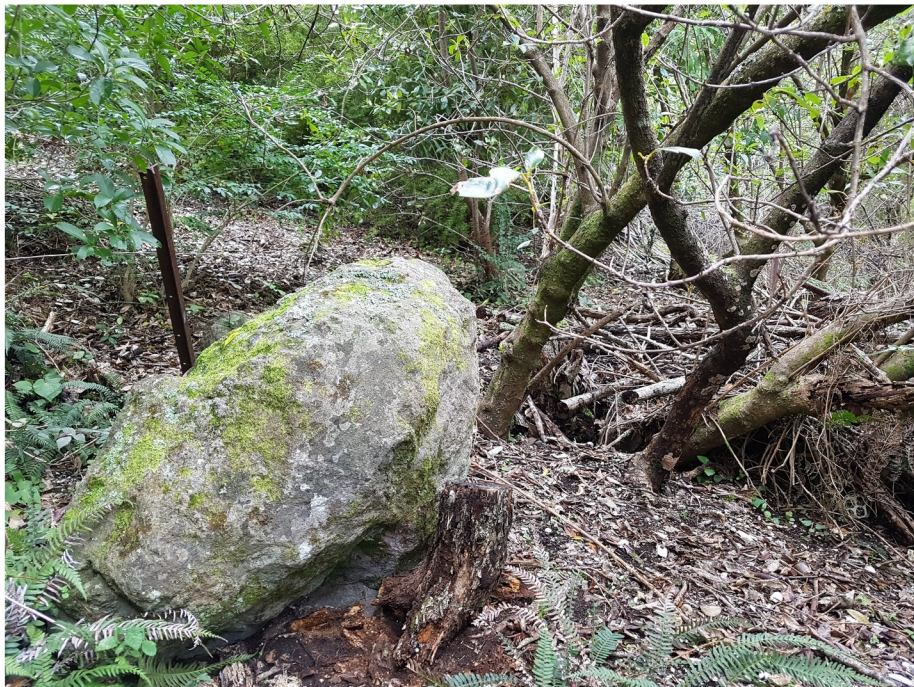
Photo 5. Boulder now moved to a safe location.

The slip and rockfall source immediately above the northern base track in photo 5 appears to have become more stable subsequent to the scaling work done in 2017. Ongoing erosion at this location will eventually result in exposed rocks and increased rockfall risk. Due to this the siting of the two new bench seats below may not have been the best choice of location even though there is a good verge behind the seats.

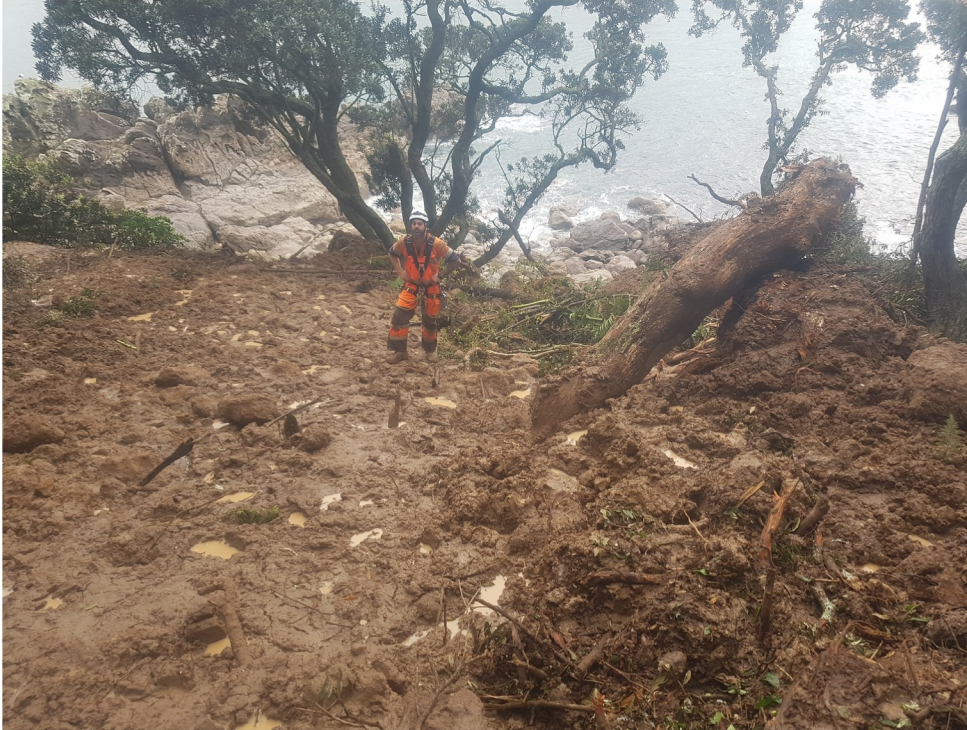
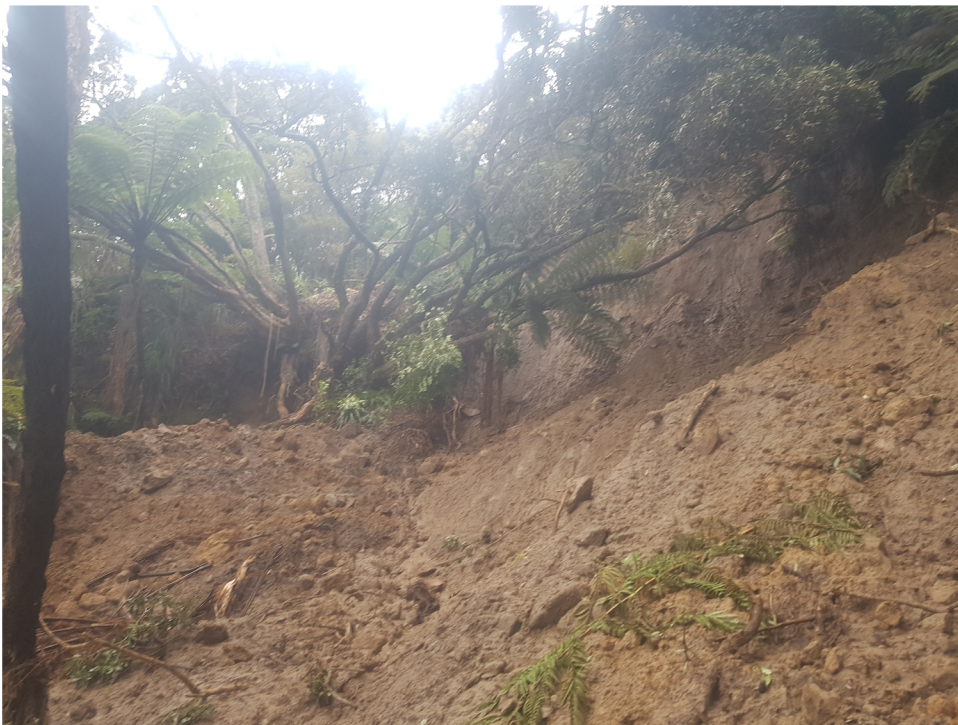
Photo 6. Slip above Base track

A soil slip event above the north west Base track.

s 7(2)(f)(ii) called Avalon to inspect the slip and scale as required. This work was carried out in one day under Avalon's Project Reference # 17054.

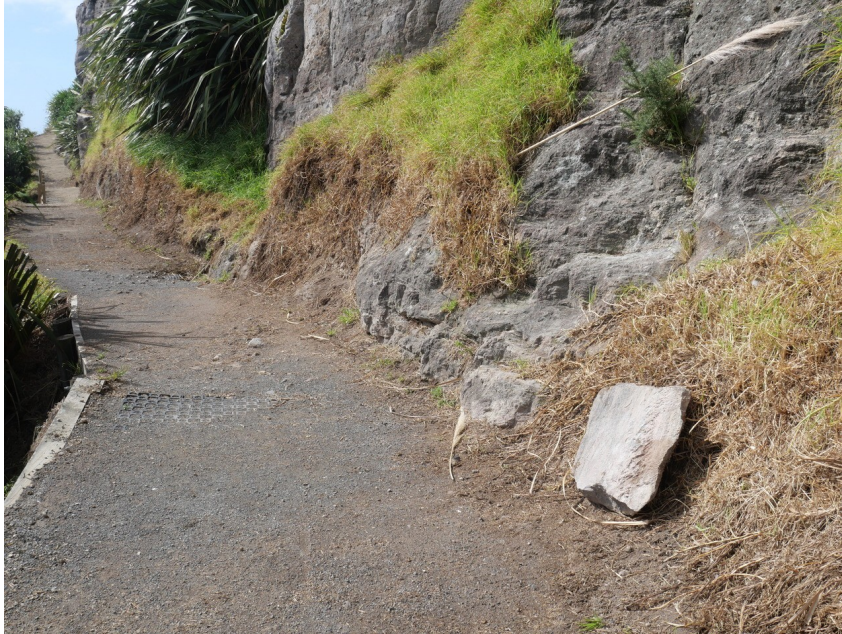
Photo 8. Rock found on Oruahine track.

The inspection walkover found two rocks on the tracks which likely were rockfall. One was on the Oruahine track:

The exact source locations of these rocks could not be located. Obviously both these rockfalls would have been extremely hazardous to anyone in the vicinity at the time and they are a reminder that the rockfall risk to public is very real.

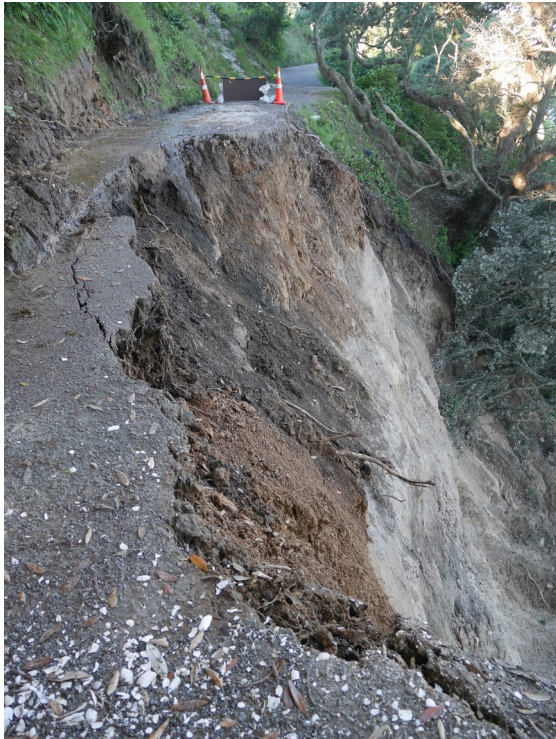
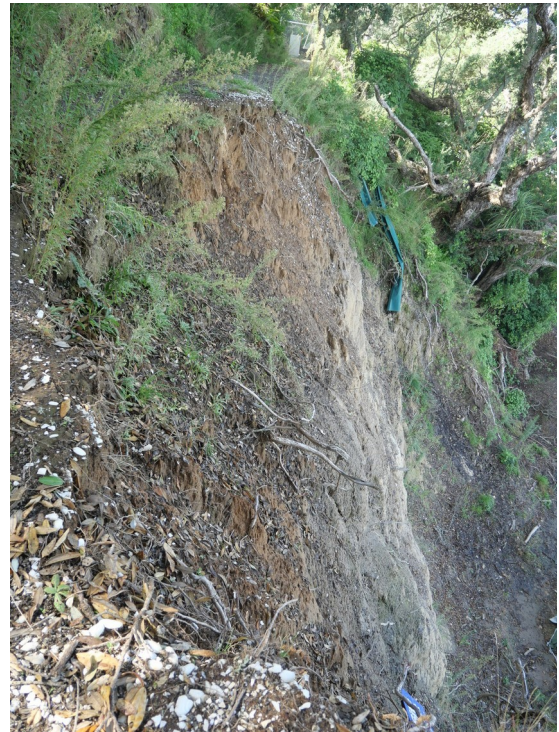
The major underslip on the base track northwestern side had not changed much in comparison with 12 months previously.

Photo 10. April 2017

Photo 11. April 2018.

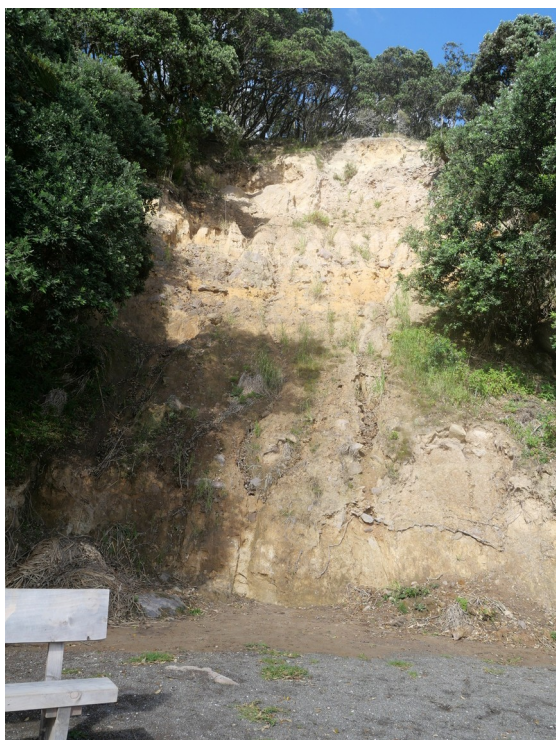
Photo 12. New bench seat below base track slip.
