Tauranga District Council  
Private bag 12022  
Tauranga

8 January 2010

### **Mauao Slopes; Monitoring Report for December 2009**

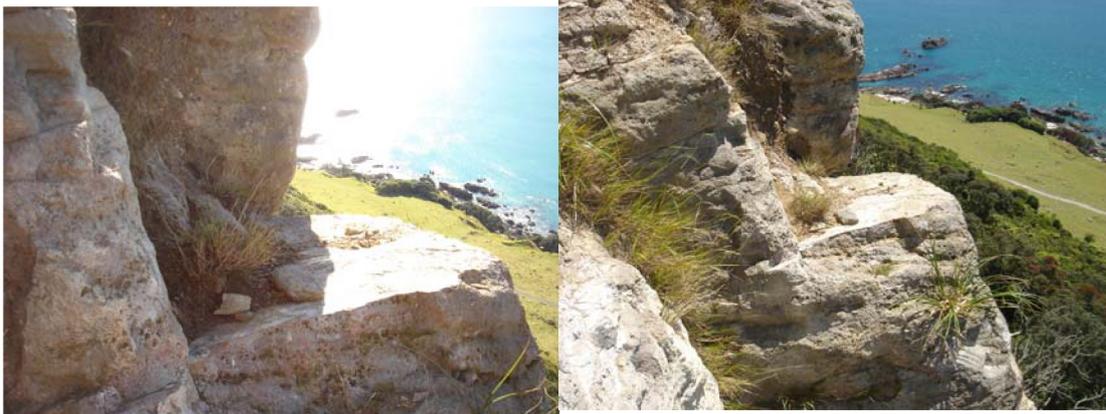
Photograph 1 & 2; The typical small ledge we monitor on the camp bluff.

The photographs above show how ongoing weathering continues to move around sand, gravel and small rocks on bluff ledges and how occasionally these will fall towards the tracks below.

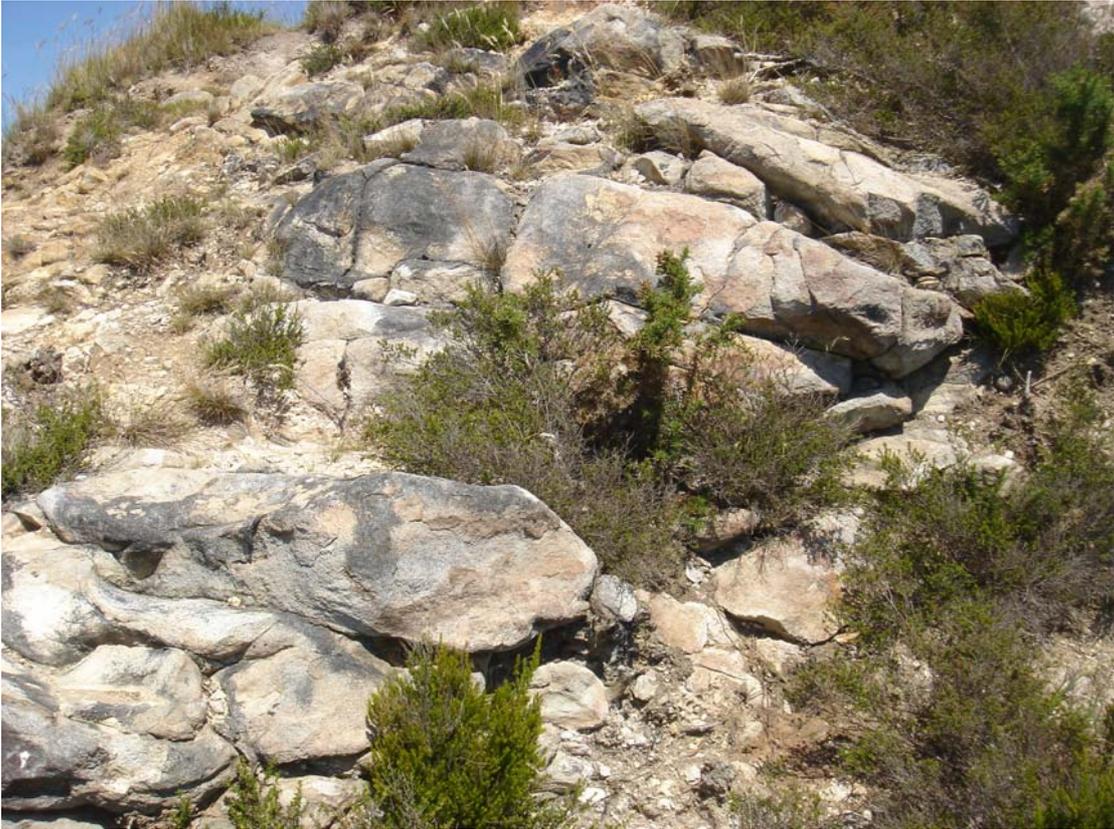
The photographs below show typical ongoing scour of steep areas of colluvium at the crests of the bluffs.

Such areas will undoubtedly be releasing occasional small rockfall. The risk to track users is mitigated by the fact that such rockfall will most often occur during stormy weather, when the tracks are not very frequented.

Photograph 3; Scoured area at crest of bluffs.

We recommend that weed spraying should continue to be well targeted to avoid development of loose sandy areas, which would be prone to scour.

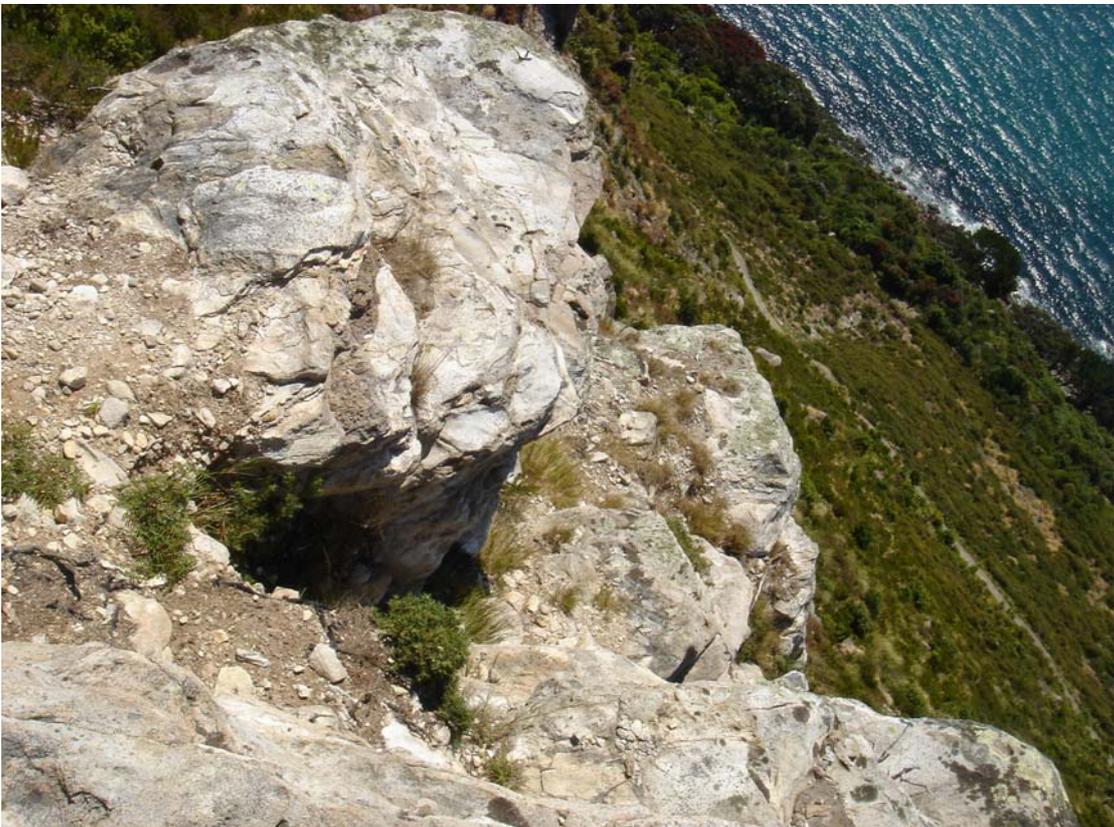
Photograph 4; Scoured area at crest of bluffs.

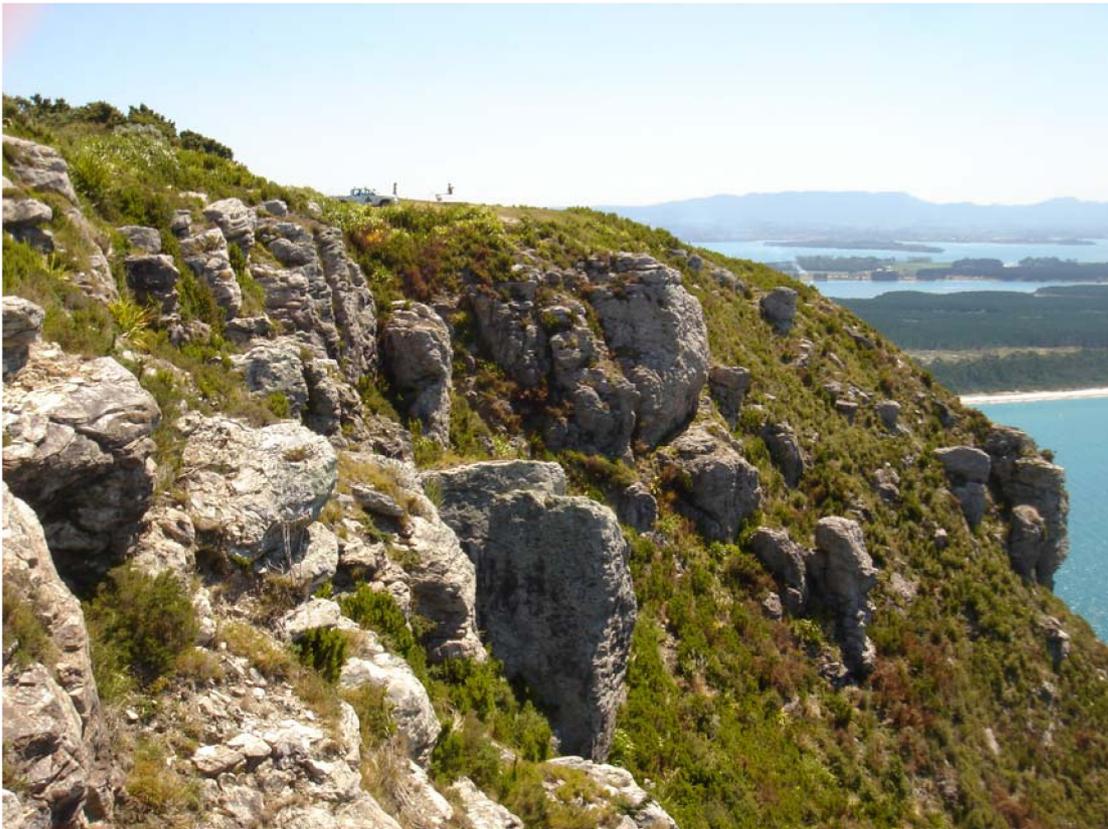
The growth of vegetation below the bluffs is favourable as it will tend to catch and trap some of the smaller rockfall before it reaches the tracks.

Photograph 5; Vegetation is re-establishing well on the upper slopes.
