Mauao Slopes; Monitoring Report for 10 June 2010

Please find set out below a brief report following the recent slope and rockfall monitoring.

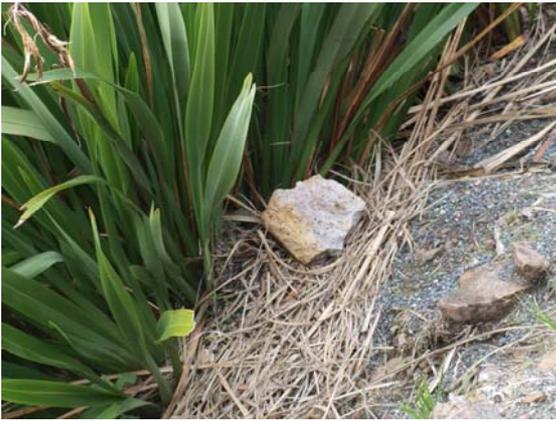
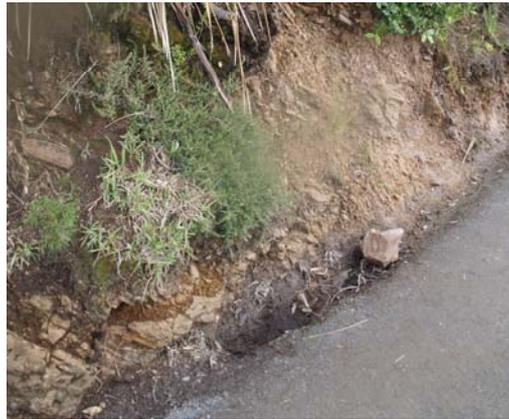
1. No significant rockfall or slip events have been reported to or observed by Ranger staff since the previous monitoring (December 2009).
2. This walkover found some evidence of recent minor rockfall, which is as would be expected and confirms that rockfall does occasional cross tracks – see photographs 1 & 2.

Photograph 1 & 2; Minor rockfall evidence alongside Waikorere track.

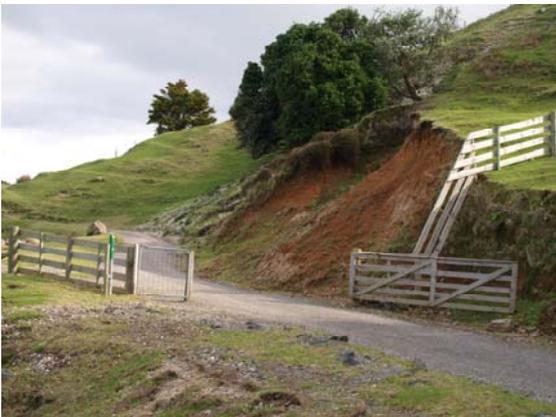
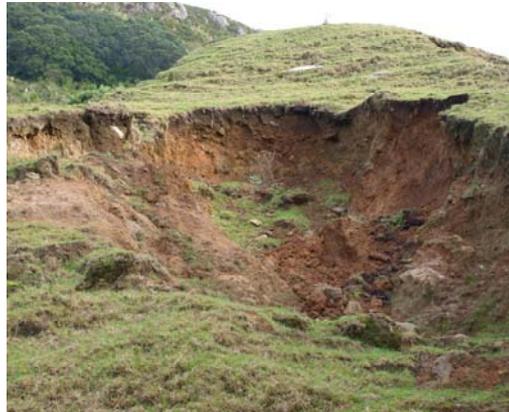
5. The May 2005 flood event slips now appear to have mostly locked up and in general are mostly re-vegetating well. There a few release scarps which are still actively eroding but these pose no risk, see photographs 3 & 4.

Photograph 3 & 4; Ongoing minor erosion at 2005 slip crests.

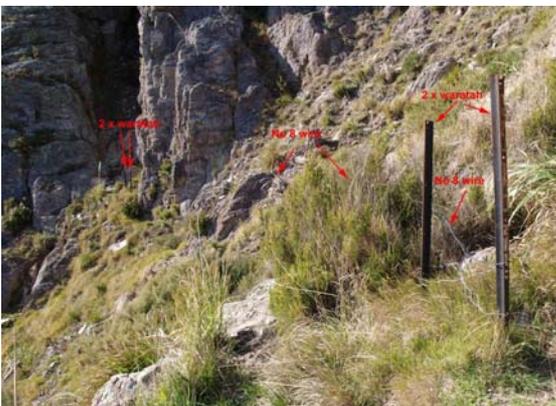
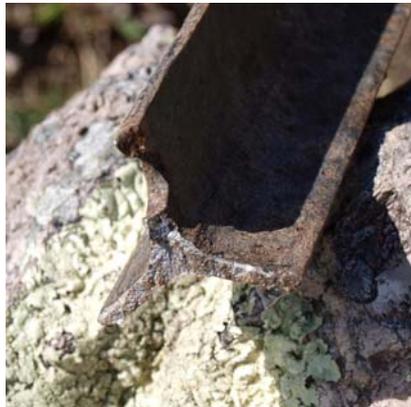
Photograph 5 & 6; Waratah posts (now removed)

Whilst carrying out the walkover inspection two sets of two 'waratah' posts were found in the 'bowl' area off the end of the 4WD track hairpin bend. The posts did not appear very well embedded or strong. We tried to pull one out to check depth and with very little effort it broke off with brittle failure just above ground level, see photographs 5&6.

Searching our previous monitoring photographs, we found the posts were installed in this location between December 07 and November 08. They appeared likely to have been used

for some height safety/abseiling purpose unknown to TDC or Avalon. At TDC's request Avalon removed them and searched for and removed a number of other posts.

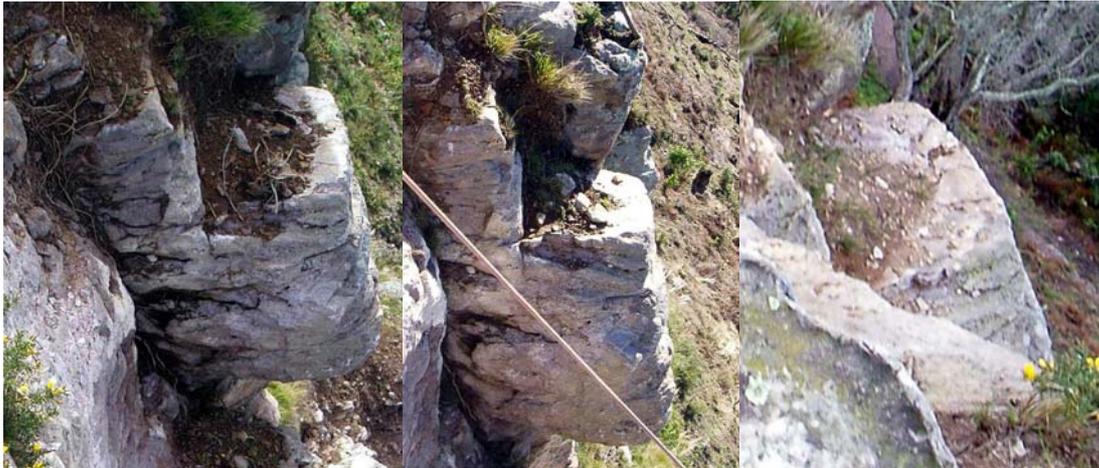
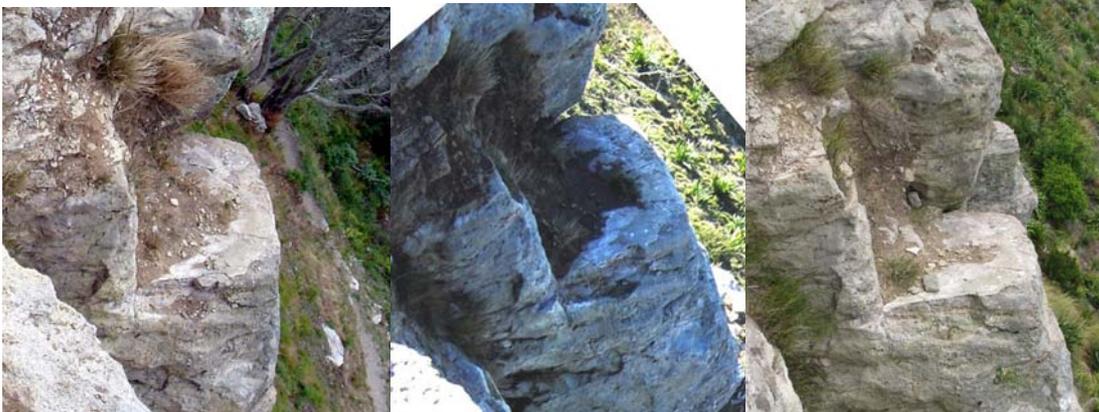
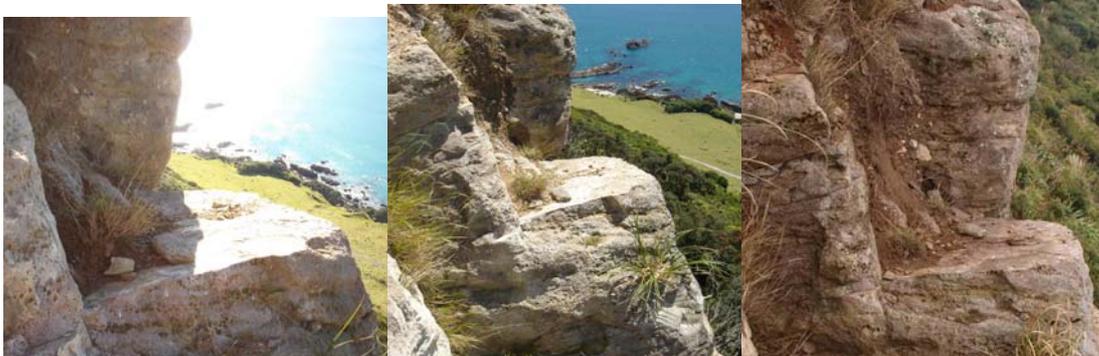
The small 'camp bluff ledge' we monitor as a typical example was inspected and again showed a rearrangement of the rock debris. The following photographs show the changes over the last 6 years, demonstrating how ongoing weathering continues to move around sand, gravel and small rocks on bluff ledges. Occasionally these processes will release rockfall towards the tracks below.

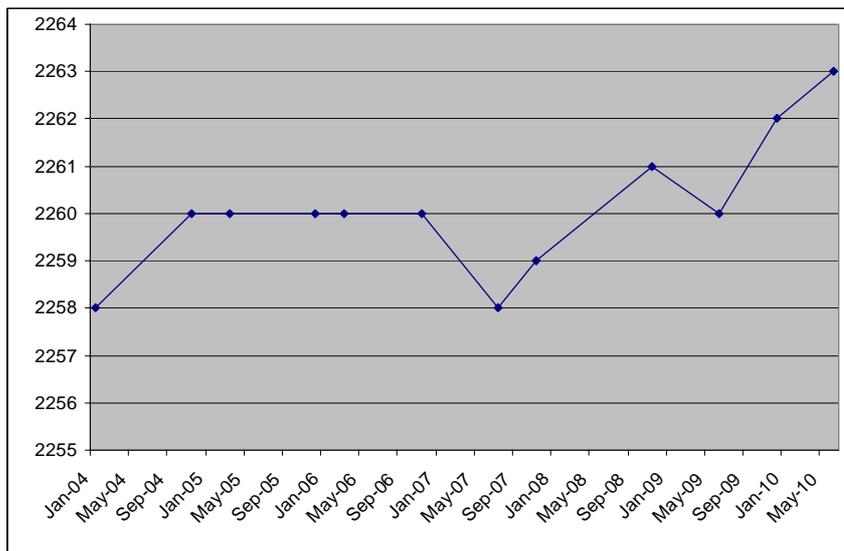
As would be expected, some of the areas show a slow creep movements as weathering opens joints in the rock mass. The following plots are indicative of the type of movement detected.

Camp bluff; Average 1mm/yr over the last few years.

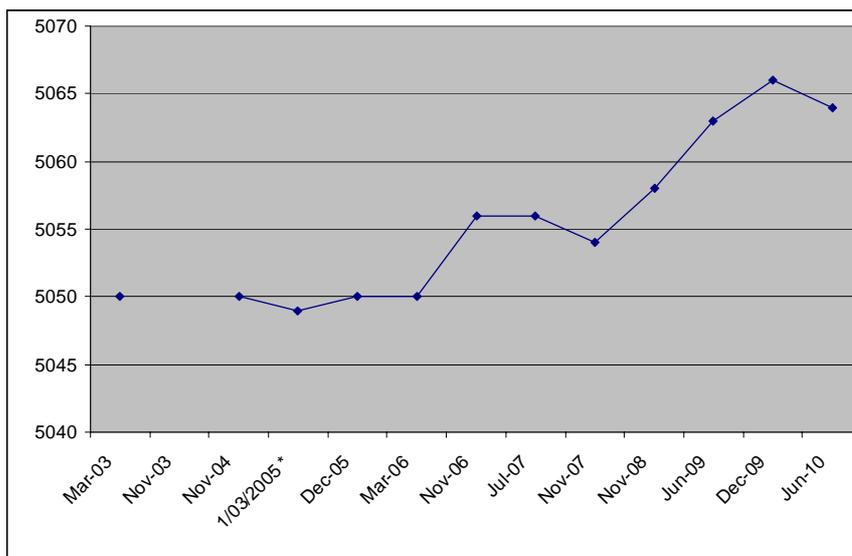
3A NE bluff up to a few mm/yr over the last 4 yrs.

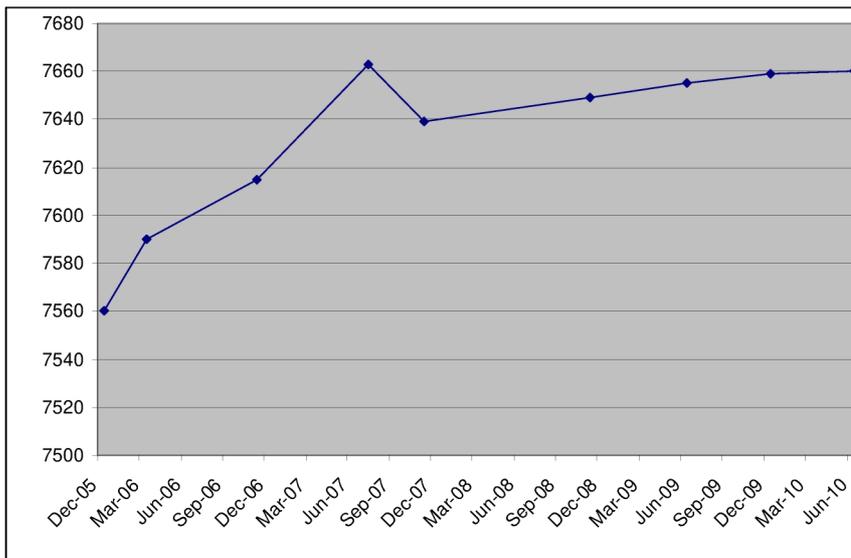
Zone 6B Scaled Boulder; 100mm in 5 yrs, slowing as it settles into the soil.

These movements are not cause for alarm but are another indicator of the fact that erosion is ongoing. Minor rockfall does occur relatively often and larger falls will occur occasionally.
