Mauao Slopes; Monitoring Report for December 2013

This letter is to report on survey benchmark monitoring and the site geotechnical walkover completed December 2013. Our previous monitoring was in May 2013.

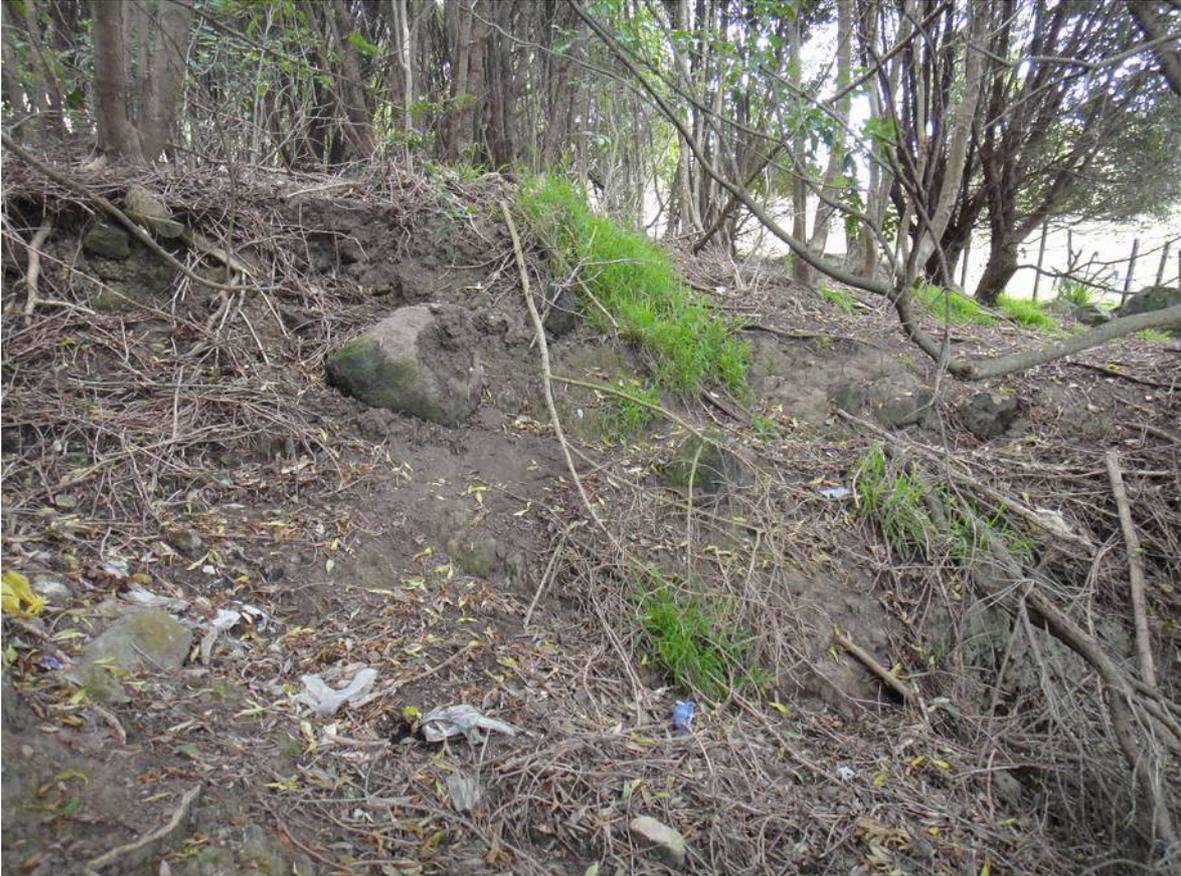
Photo 1; September 2012

Our first photographs are of a small eroding slope above and behind one of the camp ground cabin site's retaining walls. In 2012 a small boulder was noted as having very recently rolled out of the bank (Photo 1).

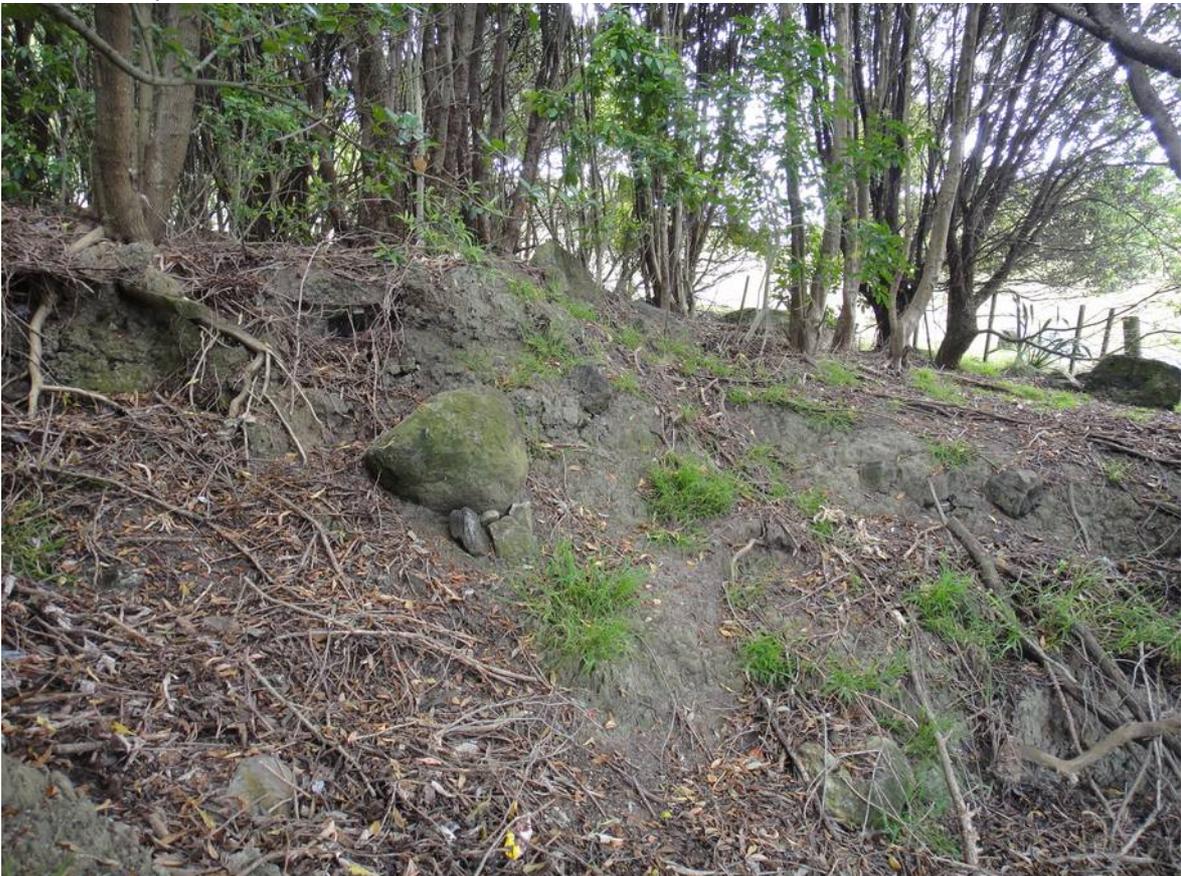
Photo 2; December 2013

On this visit we found the boulder had moved forward very slightly but appears to have had smaller rocks hand-placed beneath it to add support. Interesting and a good thing that this type of issue is being spotted, presumably by the camp maintenance staff?

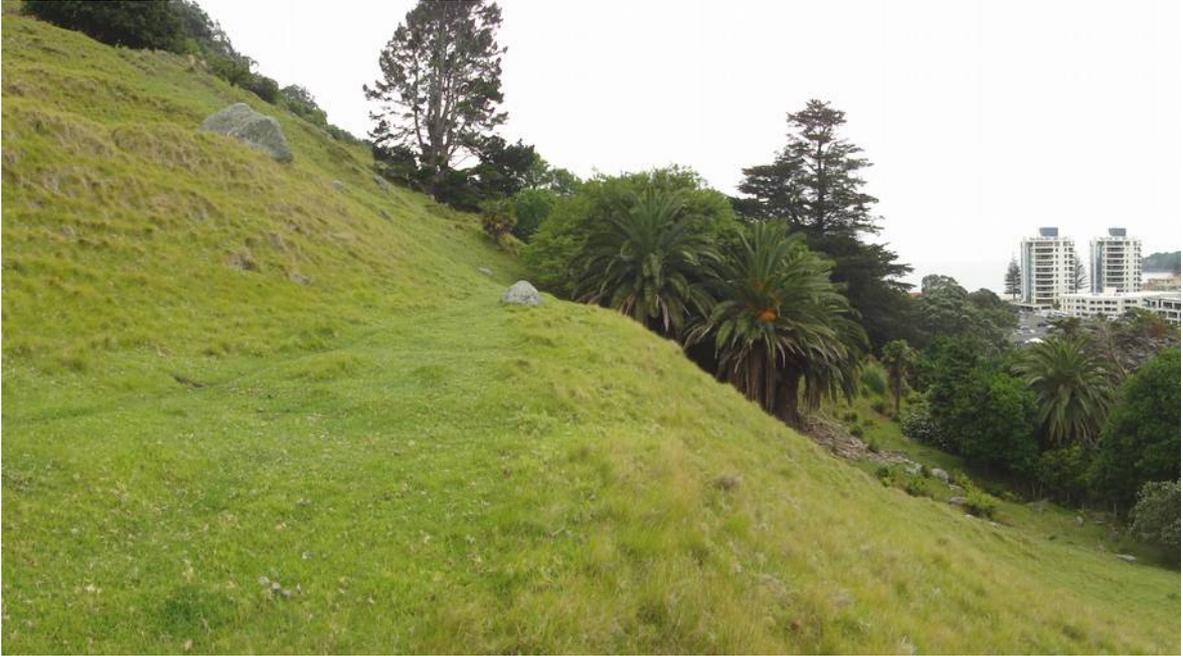
Photo 3; Area above camp ground on harbour side

A thorough walk through this area found no signs of recent instability but was a reminder of how steep these particular slopes are and the fact that they appear to be the scarp of a historic landslide which, if reactivated, could result in a significant debris flow into that area of the camp ground.

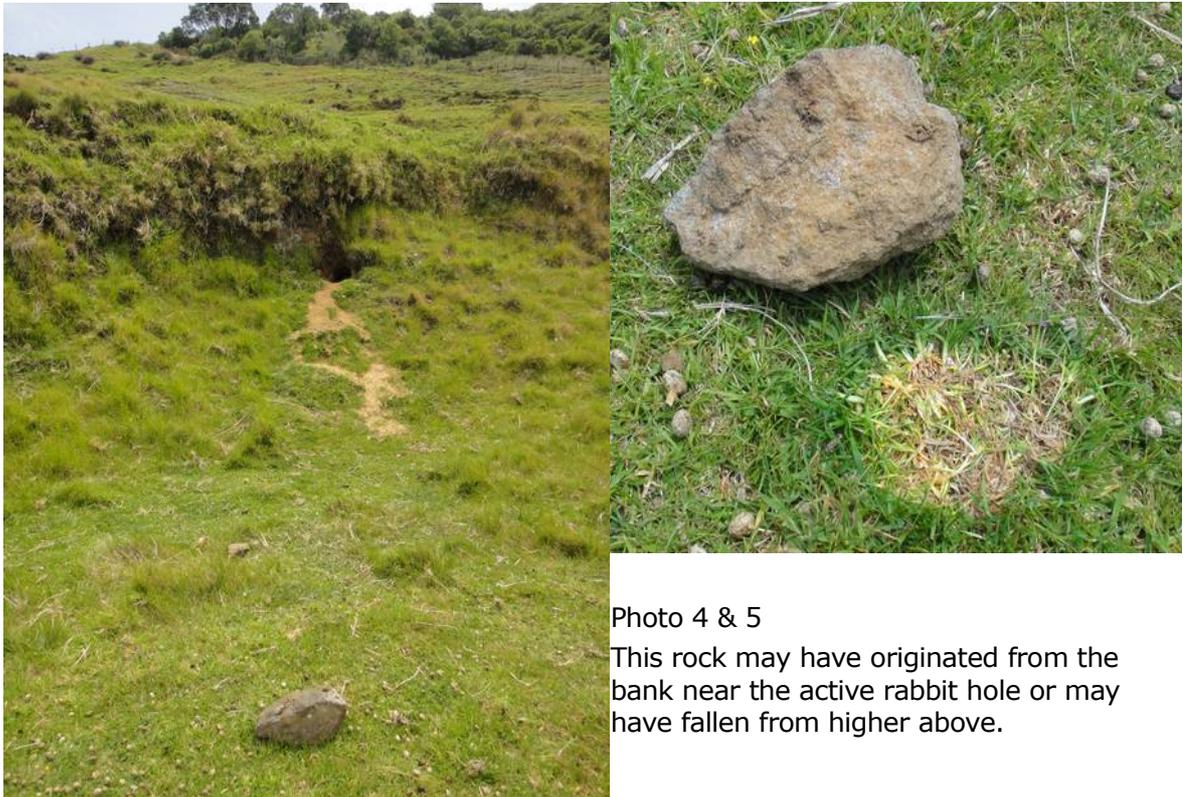
Photo 4 & 5

A hundred metres or so further west a small rock was found which when rolled had fresh grass below. See photo's 4 & 5, below:

This rock may have originated from the bank near the active rabbit hole or may have fallen from higher above.

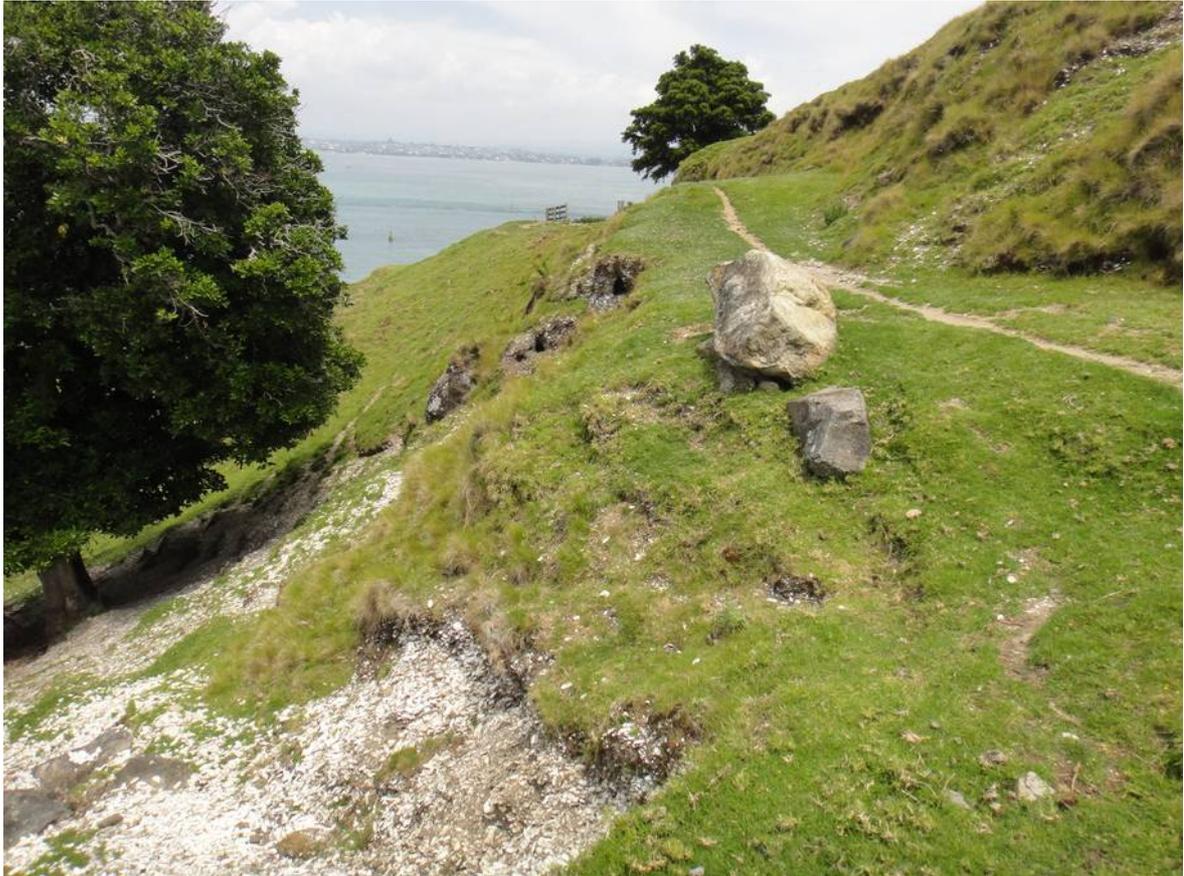
Photo 6. Boulders above the lower 4WD track.

These boulders have been static for some time but are a reminder of how easily some rockfall can be triggered by ongoing erosion or a soil slippage below.

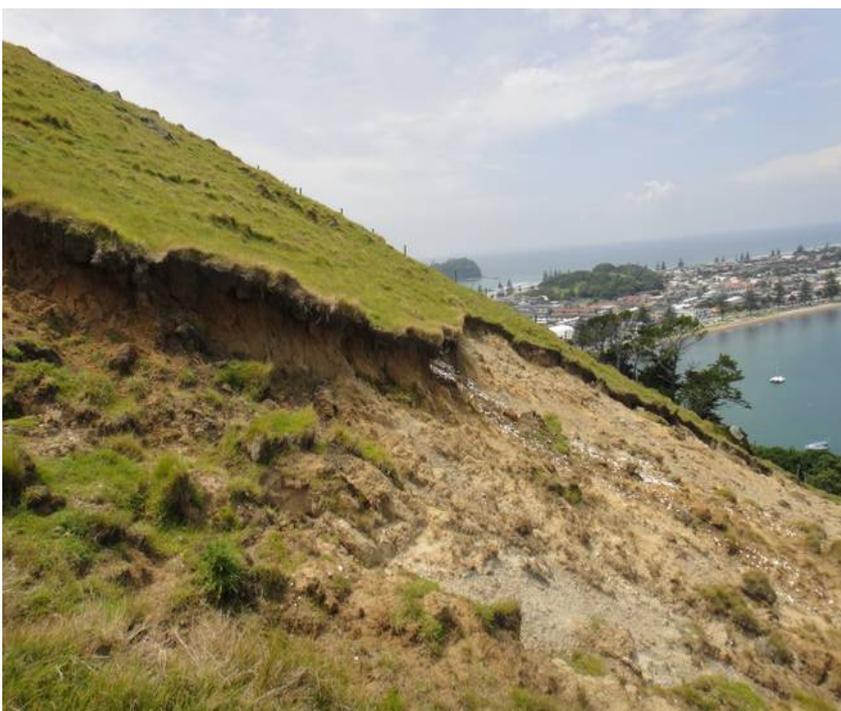
Photo 7.

Photo 7, below is of a historic (2005) slip on the north western slope, the crest of which continues to slowly migrate up-slope.

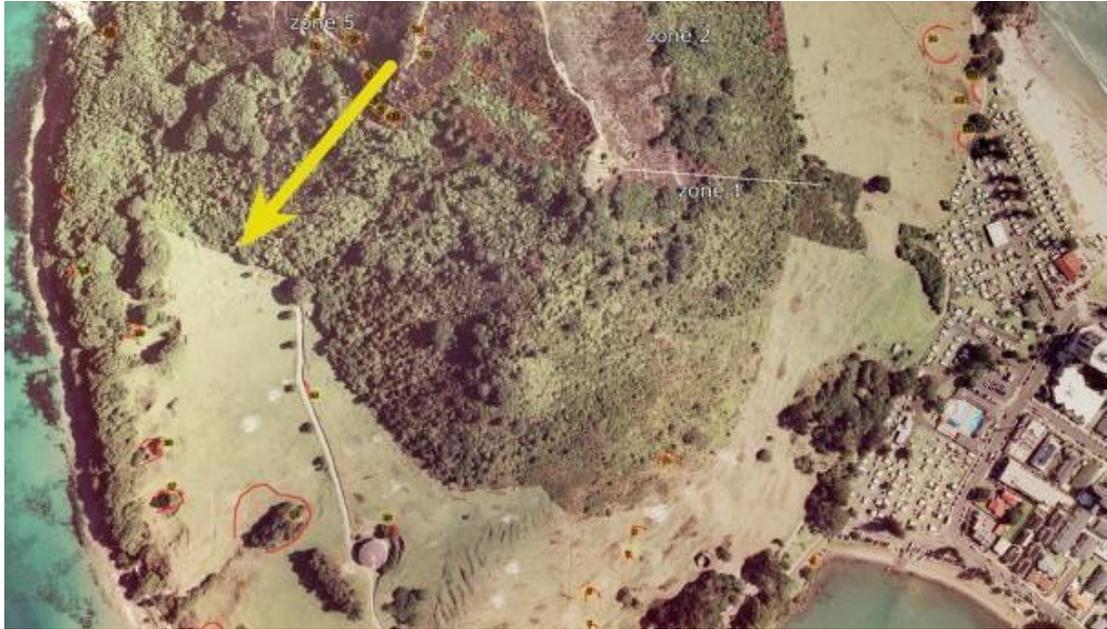
The next area to be walked over was the fence line indicated on the following photo. This proved interesting as the fence contains evidence of a number of rockfall impacts in an area which would probably not be thought of as particularly hazardous.

Photo 8; Fenceline walked.

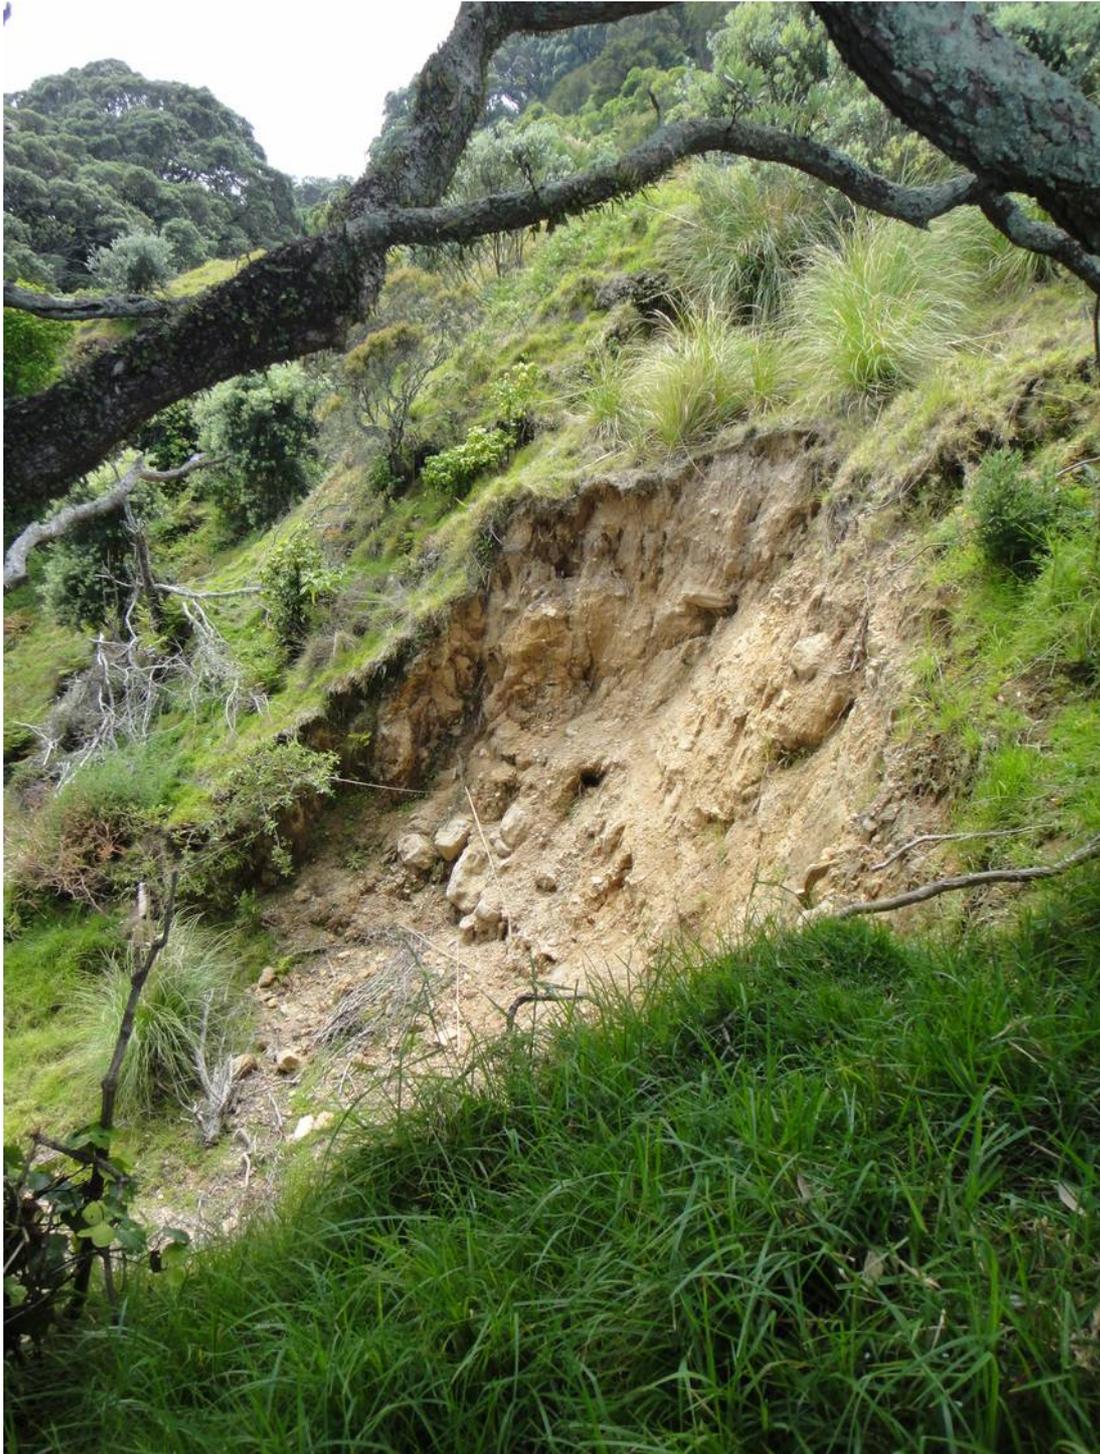
Photo 14

Photo 14, above, is of an actively eroding slope above the western base track. Boulders can be seen in the slope face which will continue to be a source of rockfall and risk to walkers on the track. The reason incidents are not reported more frequently is probably that most occur during inclement weather.

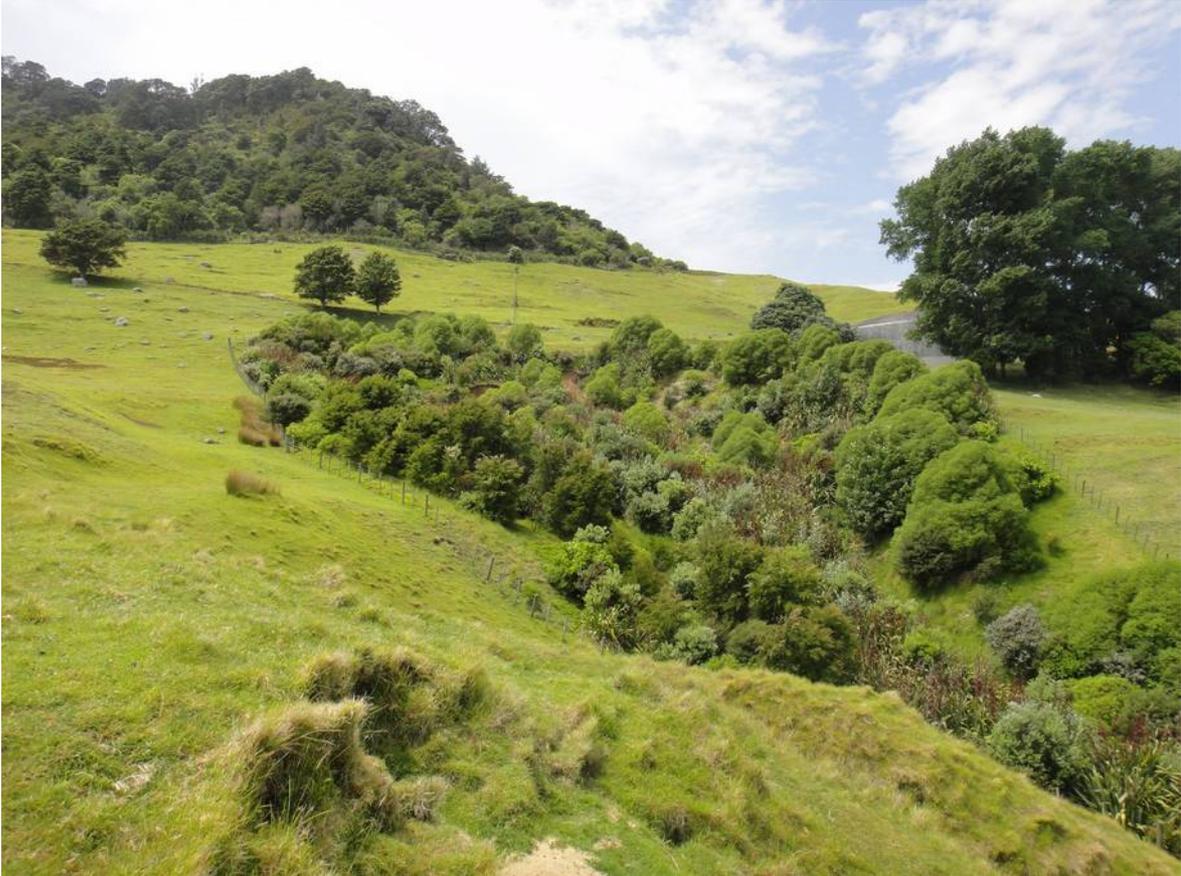
Photo 15

This gully is re-vegetating very nicely. Below is a reminder of it's appearance in 2005.

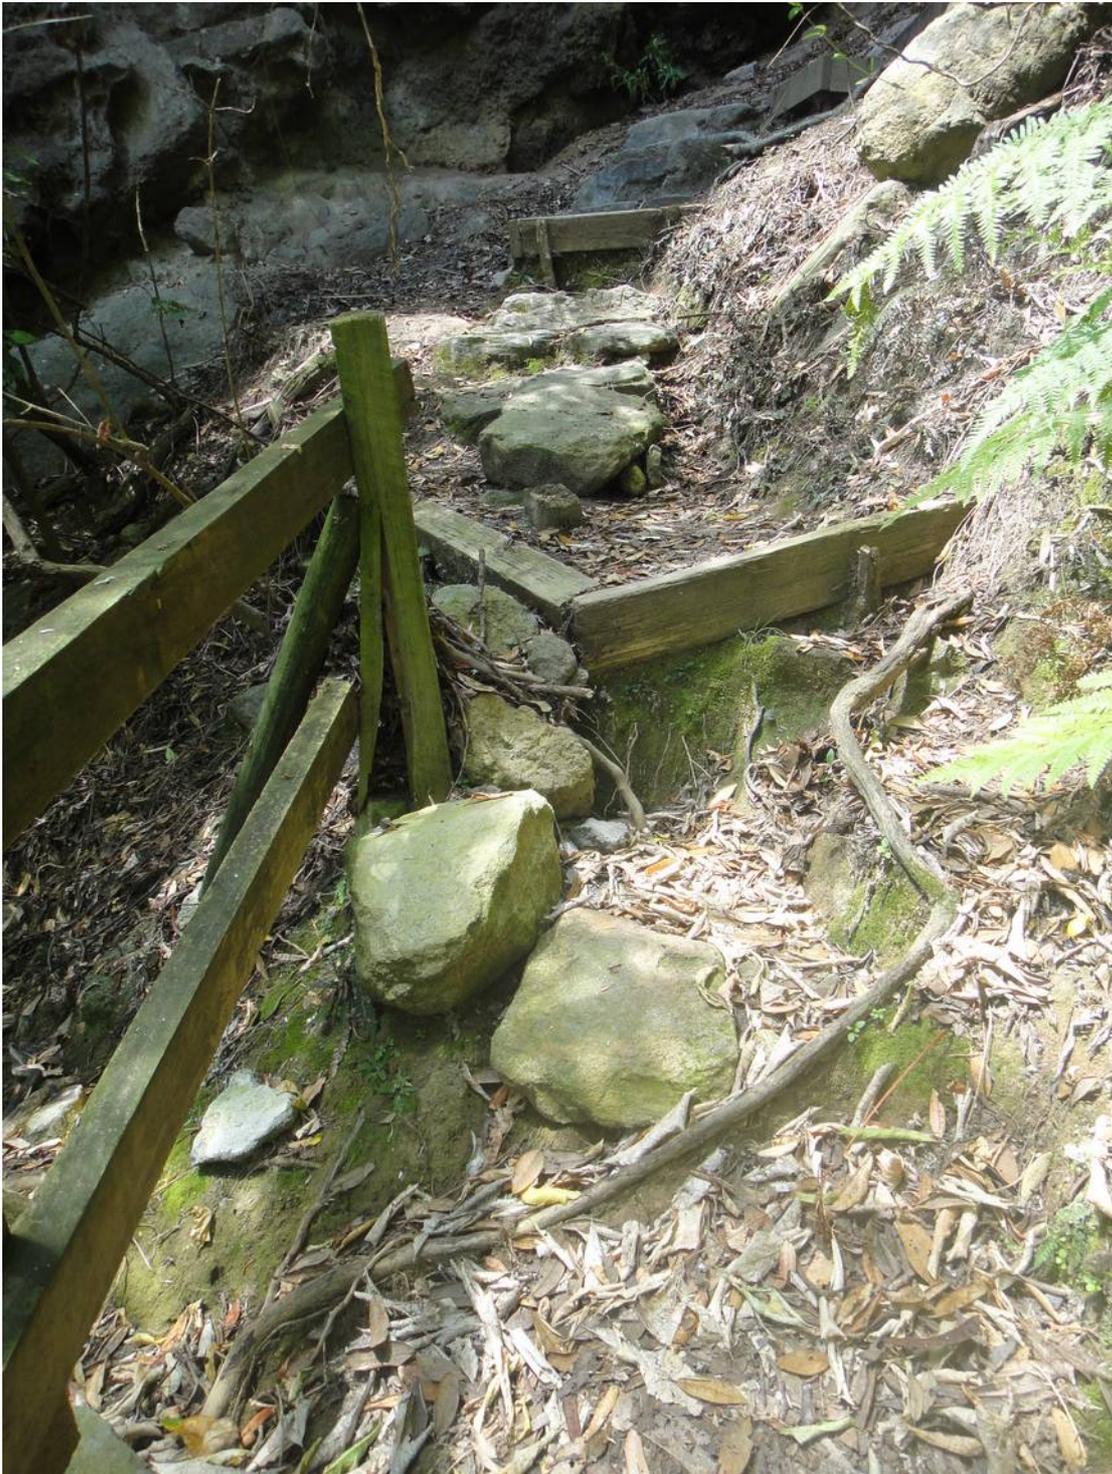
We next walked up the closed track which used to link the base track with the 4WD track. This track has been closed for around 10 years. It now contains significant evidence of damage and some rockfall.

Photo 17. Closed track linking base and 4WD on west side.

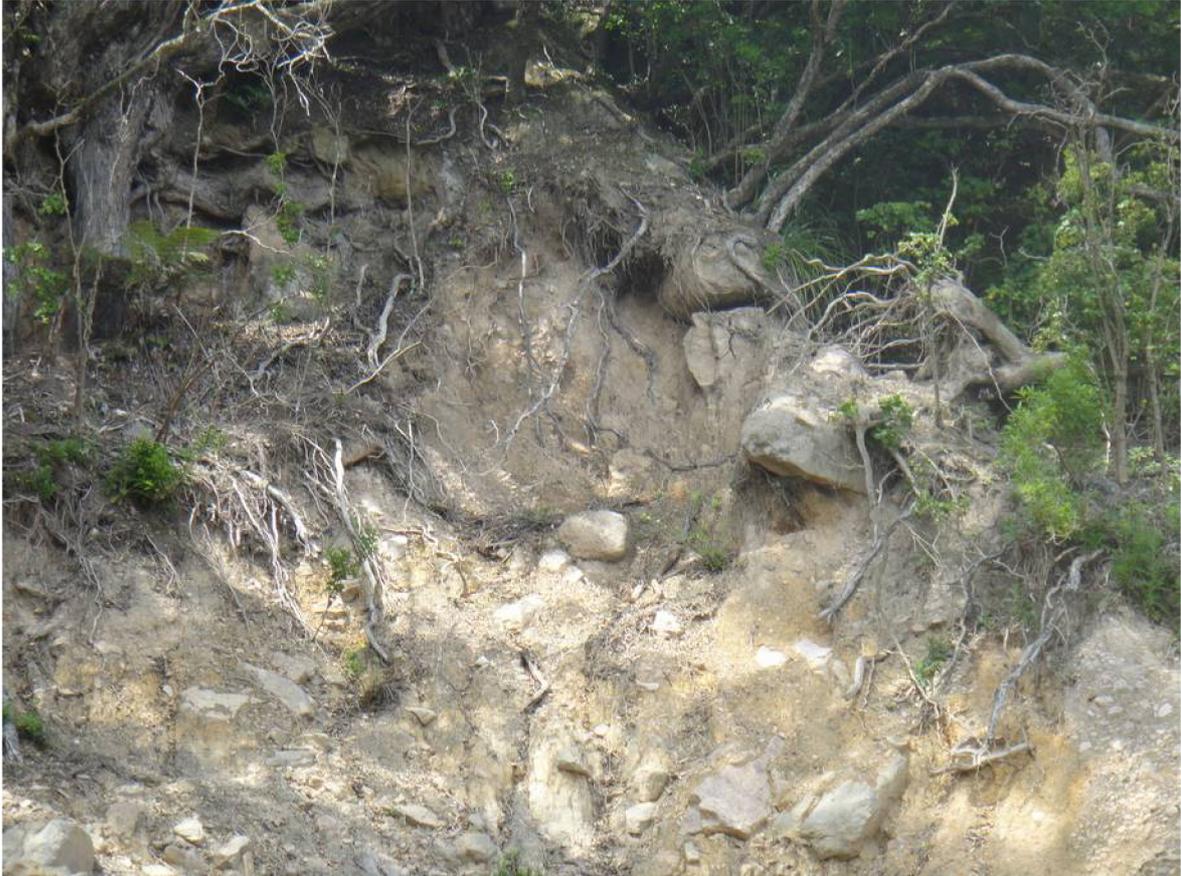
Photo 18

Just off this track is a large old soil slip which contains more eroding out boulders which are likely to fall on the base track. See photo 18, below.

Some of the soil slips on the lower slopes are at the point where a programmed rock scaling exercise could be of use in proactively removing the marginally stable boulders now protruding from the steep soil faces.
