GEOTECHNICAL

Tauranga District Council  
Private bag 12022  
Tauranga

### **Mauao Slopes; Monitoring Report for September 2012**

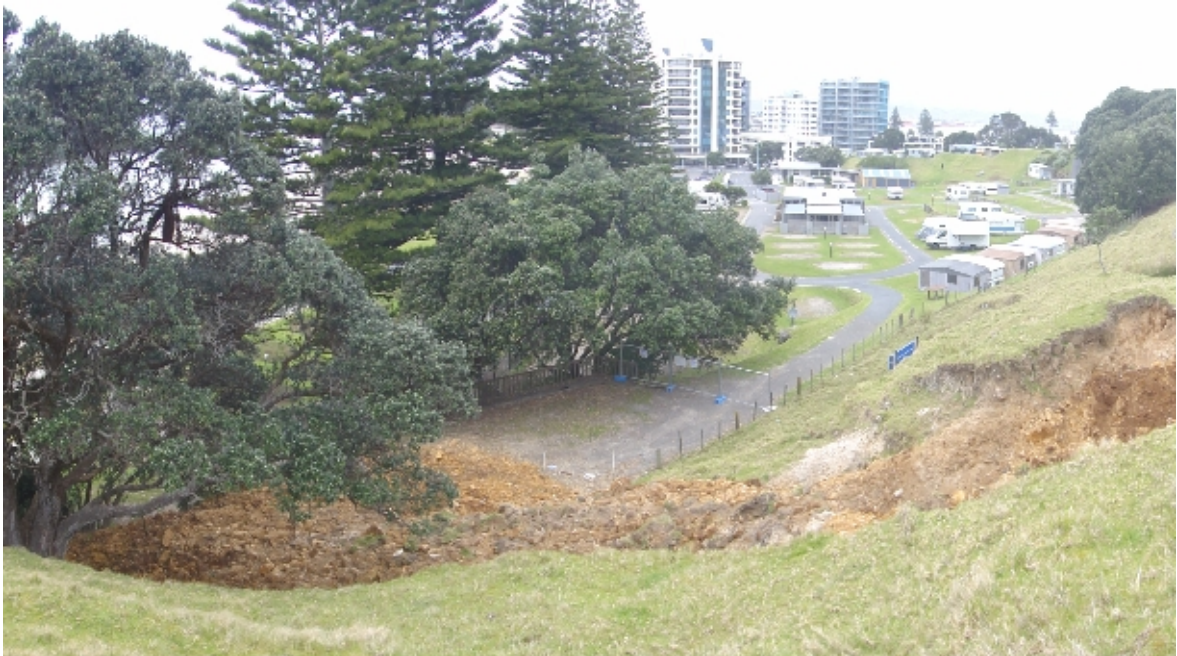
A slip over the base track just to the north of the campground has recently reactivated, resulting in a debris flow over the track and track closure, see photograph below. We understand this will be cleared when the material dries out a little and becomes easier to handle.

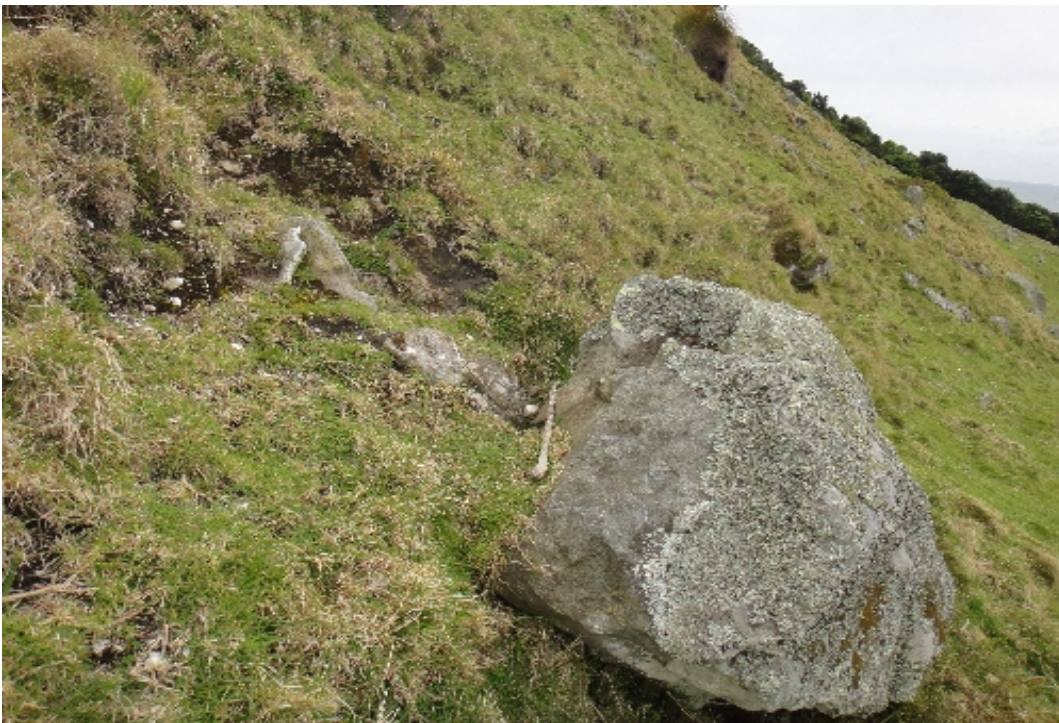
Since the last monitoring and subsequent meeting to discuss the new chalet locations, two of the chalets in the highest rockfall risk locations of the campground have been moved to less at risk locations.

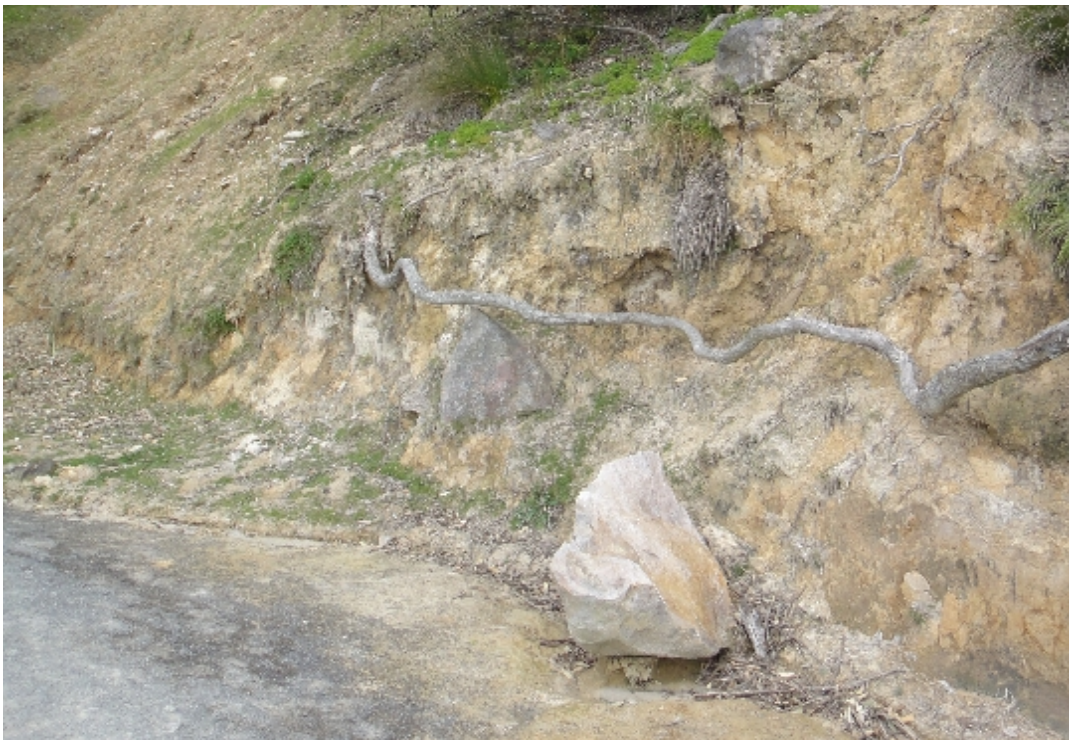
The section of slope in the photograph above, on the northern base track, has been active for many years. The photograph below is a rock which appears to have fallen from here recently.

This section of slope probably currently represents the highest concentration of rockfall risk to the base track. We would recommend that on the next monitoring visit this slope be scaled by the rope access team and assessed in more detail.

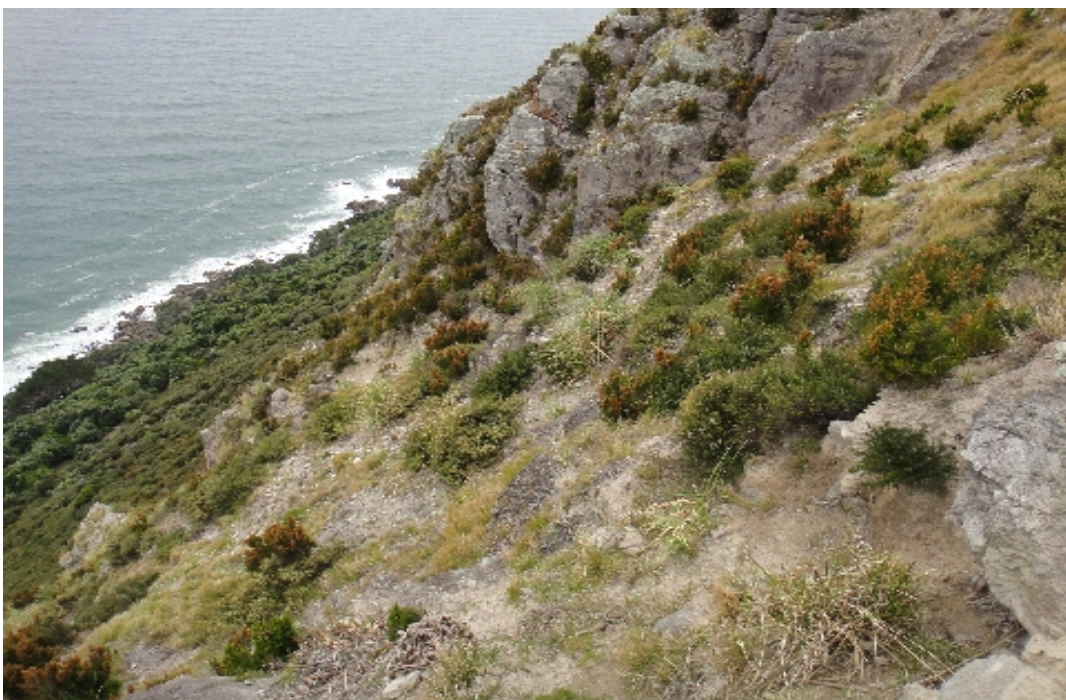
The photograph above is of a rock noted adjacent to the northern Oruahine track, probably fallen from above. We have always judged this to be the highest risk of all the tracks and continue to advocate that persons be strongly discouraged from moving around on the slopes above, which have much loose surface rock.

The photograph below is of steep ground directly above, where extensive scour and loose rock can be seen.

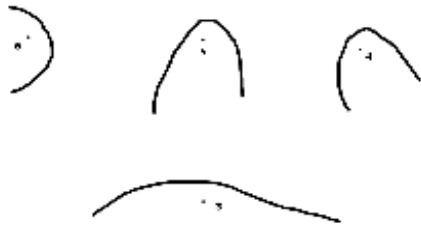
1a - The Camp Bluff

Distance measurement mm

Nov-03	Jan-04	Nov-04	Mar-05	Dec-05	Mar-06	Nov-06	Jul-07	Nov-07	Nov-08	Jun-09	Dec-09	Jun-10	Dec-10	Jul-11
3 → 4		5211	5209	5208	5208	5207	5208	5215	5210	5207	5208	5212	5209	5210	5206
3 → 5		4320	4320	4321	4321	4320	4323	4323	4319	4322	4322	4324	4324	4324	4320
3 → 6		5179	5180	5178	5178	5180	5181	5178	5178	5178	5180	5182	5183	5182	5178
4 → 5		2258	2260	2260	2260	2260	2260	2258	2259	2261	2260	2262	2263	2262	2263

Mar-12 Sept 12

3 → 4	5214	5206
3 → 5	4327	4320
3 → 6	5171	5182
4 → 5	2262	2263

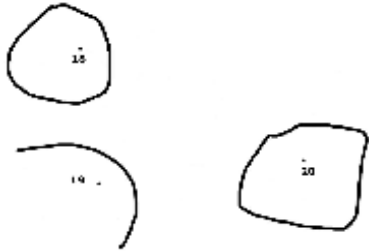
Block 5d

Mar-03	Nov-03	Nov-04	1/03/20C	Dec-05	Mar-06	Nov-06	Jul-07	Nov-07	Nov-08	Jun-09	Dec-09	Jun-10	Dec-10	Jul-11
18	→	19	5248	5265	5256	5256	5254		5253	5253	5255	5256	5255	5257	5254	5256
20	→	19	3380	3385	3373	3376	3376	3377	3375	3374	3376	3379	3378	3377	3378	3379
20	→	18	8038	8065	8050	8056	8050	8053	8053	8054	8057	8056	8062	8057	8052	8055

Mar-12 Sept 12

18	→	19	5248	5257
20	→	19	3378	3382
20	→	18	8050	8056
