GEOTECHNICAL

Mauao Slopes; Monitoring Report for May 2013

This letter is to report on survey benchmark monitoring and the site geotechnical walkover completed on 15 May. Our previous monitoring was in September 2012.

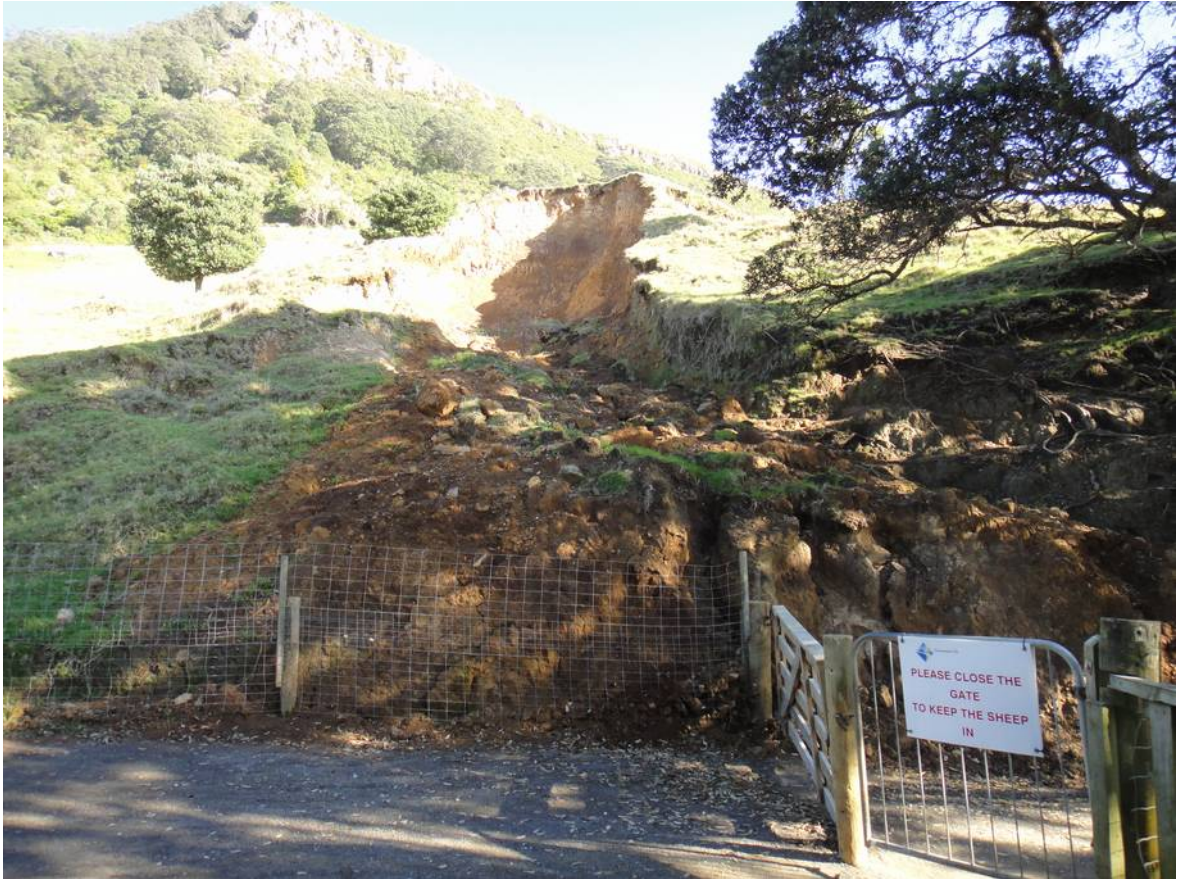
Photo 1; Slip adjacent base track immediately N of campground.

The slip over the base track just to the north of the campground has again reactivated, resulting in a debris flow over the track which has been cleared. Photo 1.

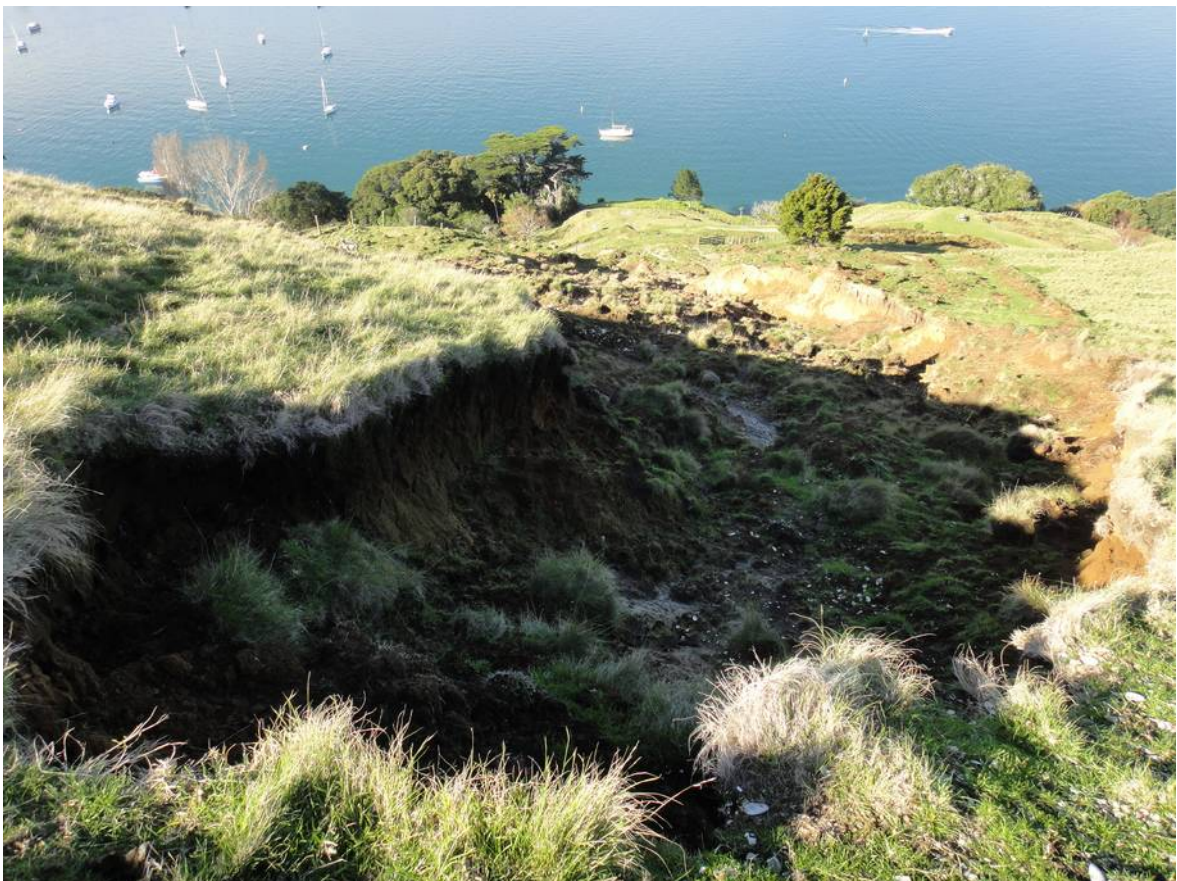
Photo 2; Slip reactivated on southern slope.

The large but shallow soil slip on the southern slope has also reactivated. Photo 2.

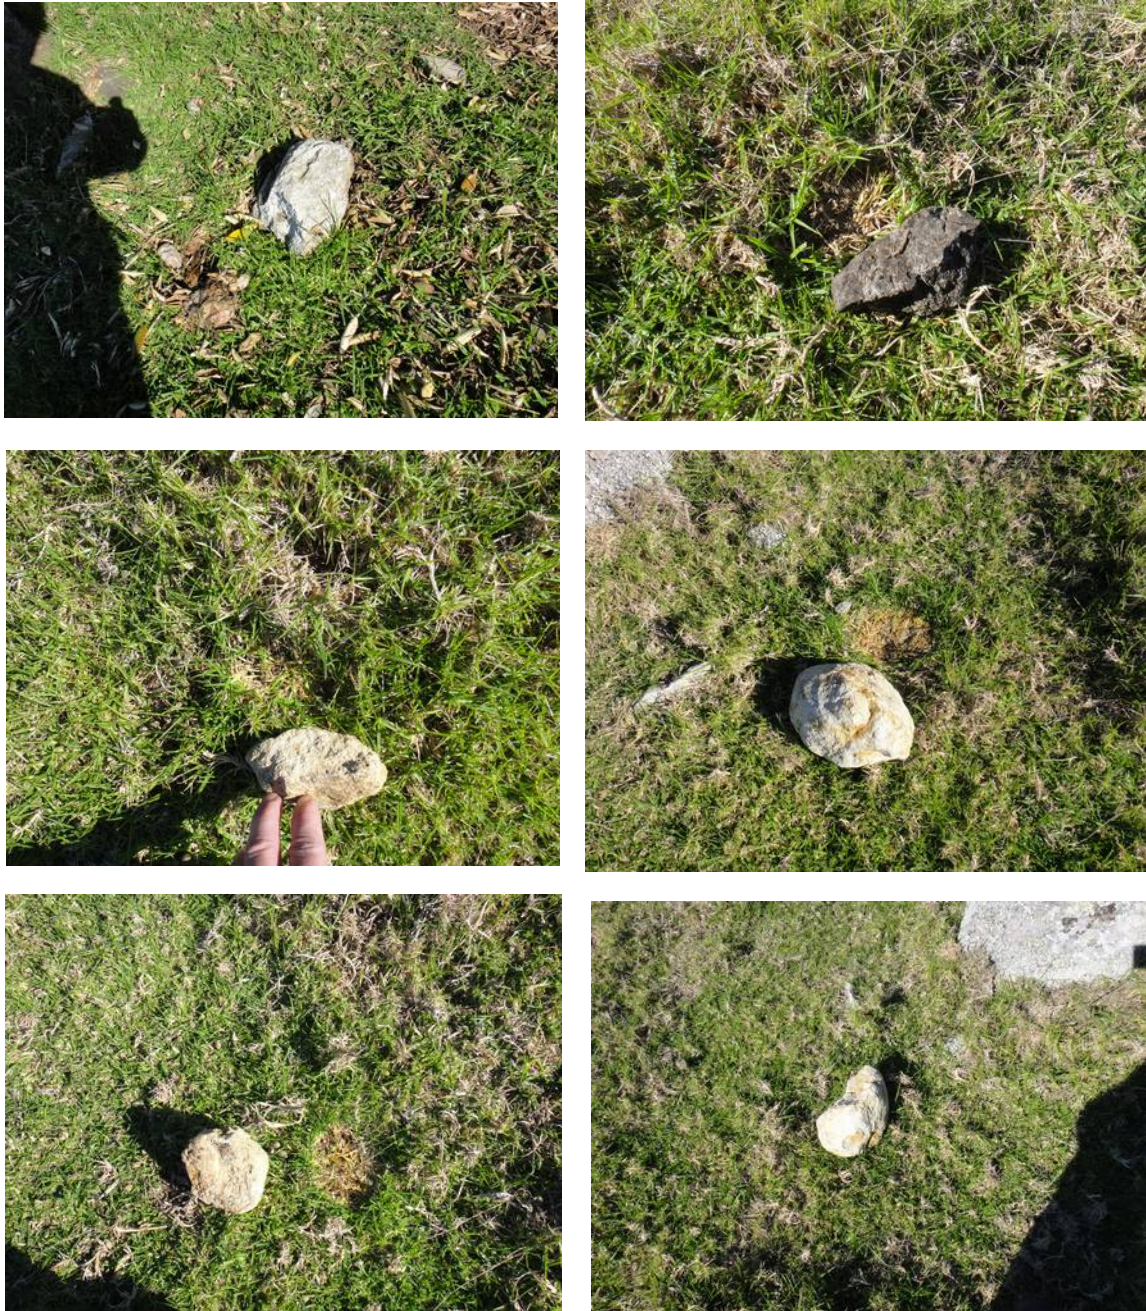
Photo 3-8; Recent small rock movements.

Whilst looking for recent rockfall, one technique used is to roll over any suspect rock to see whether there is grass underneath. This inspection found small rocks which appear to have moved recently and come to rest on the open paddocks below the Waikorere track:

This type minor rockfall is ongoing but usually difficult to identify. As pointed out many times previously it presents highest risk to persons on the Oruahine track.

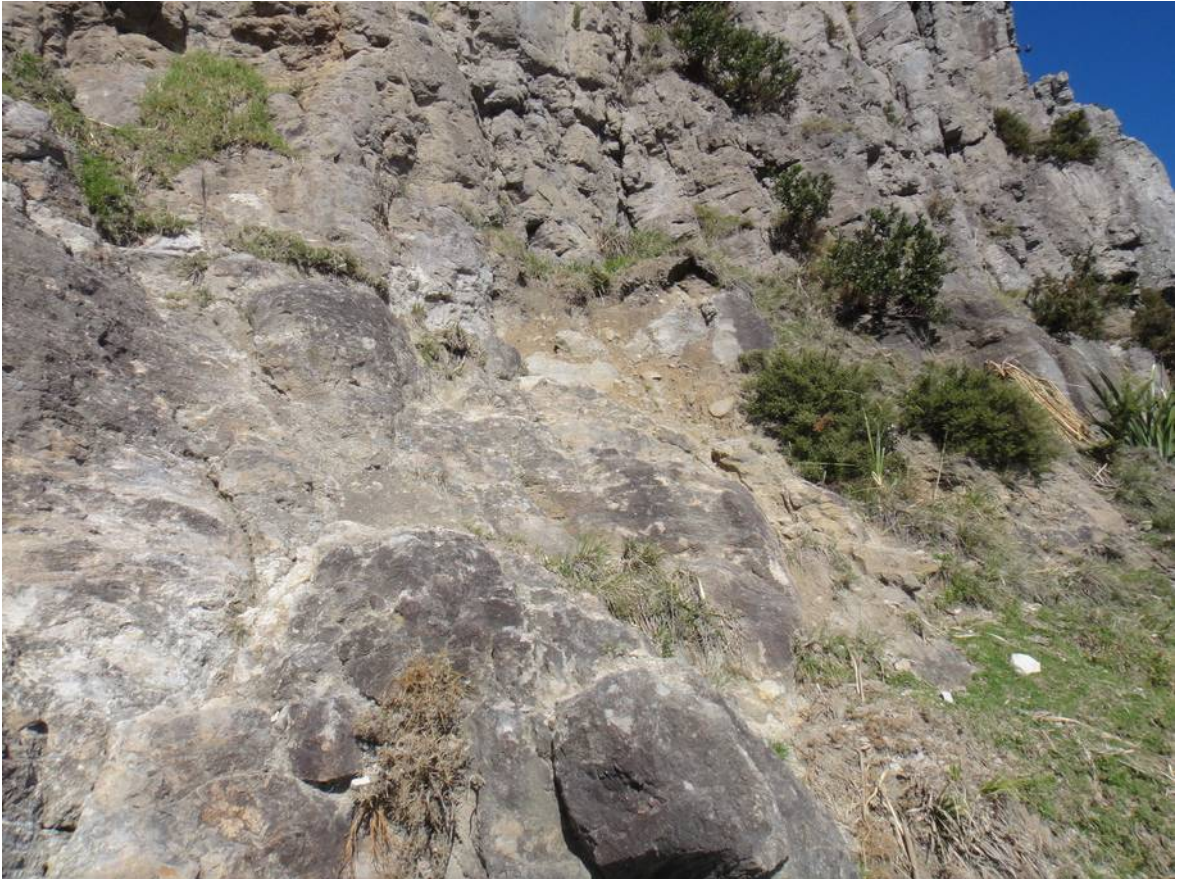
Photo 9; Small slip/rockfall source above Oruahine track.

The following photograph shows a small slip/rockfall source area immediately above the Oruahine track. Above the steep cliffs there are many more similar potential source areas.

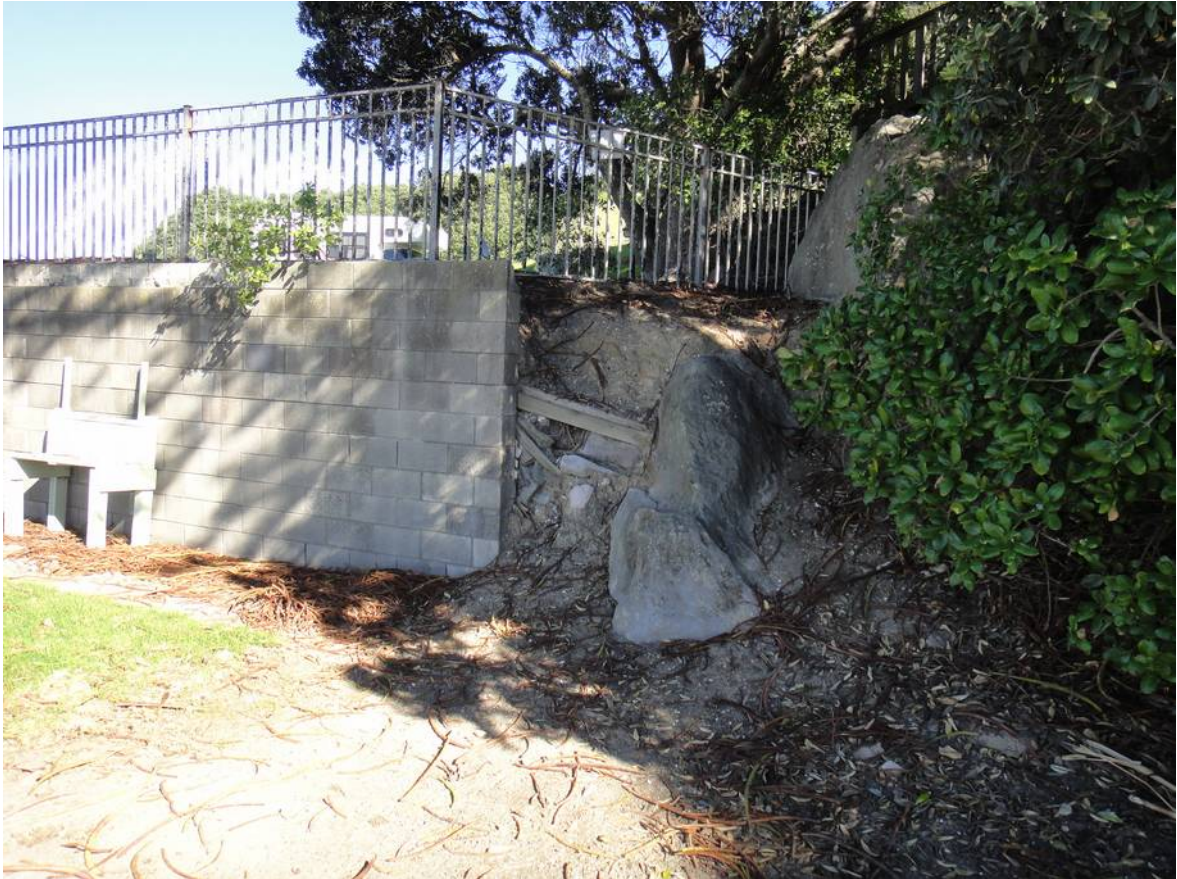
Photo 11; Retaining wall at northern end of campground.

The final couple of photos, 11 & 12 above, are of small retaining walls which could do with minor maintenance before they get any worse.

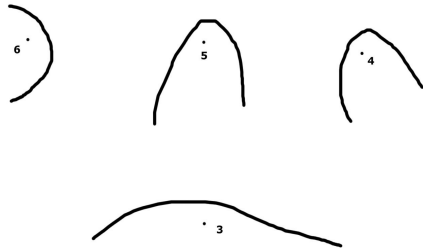
Area 1a; "Camp Bluff"

- 3 → 4
- 3 → 5
- 3 → 6
- 4 → 5

Distance measurement mm
