Mauao Slopes Earthquake Damage & Revised Risk Assessment

Client: Tauranga District Council

July 2004

Avalon Report No: 0453

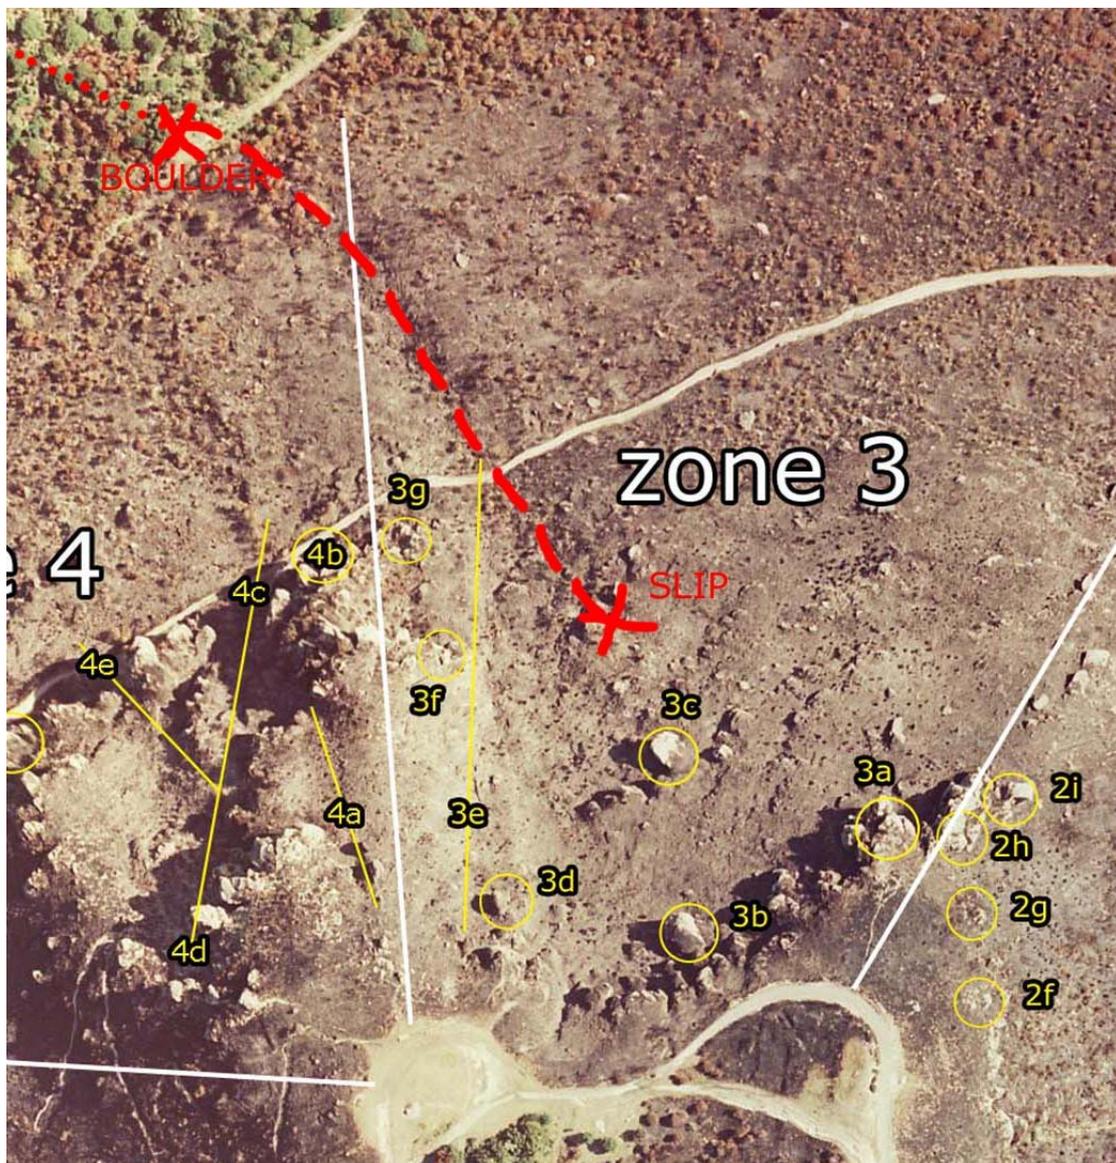
Photograph 1. Slip location and rockfall trajectory.

The most significant of these involved a few cubic meters of soil and rock and occurred in the colluvium on the slopes above the northern Oruahine track (zone 3), approximately mid way between column 3c and the intersection of gully 3e and the track. See the following photographs.

This slip released one boulder of around 0.6m³, a few around 0.3m³ and a few around 0.15m³, in addition to a quantity of soil and smaller rocks. This created a significant hazard.

A number of boulders up to 0.6m³ failed and were channelled down a gully (3e). This gully was proposed in previous reports as a potential location for a catch fence.

The recommended ongoing annual rock scaling/hazard monitoring program should be established to be undertaken towards the end of winter/early spring and catch fences should be investigated.

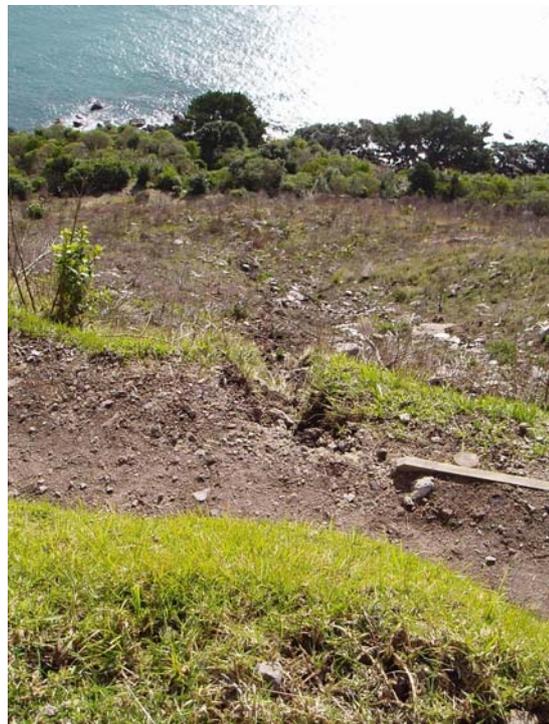
Photograph 3. Track impact damage

All but one (a 0.3m³) of the rocks crossed the Oruahine track (causing impact damage to the track).

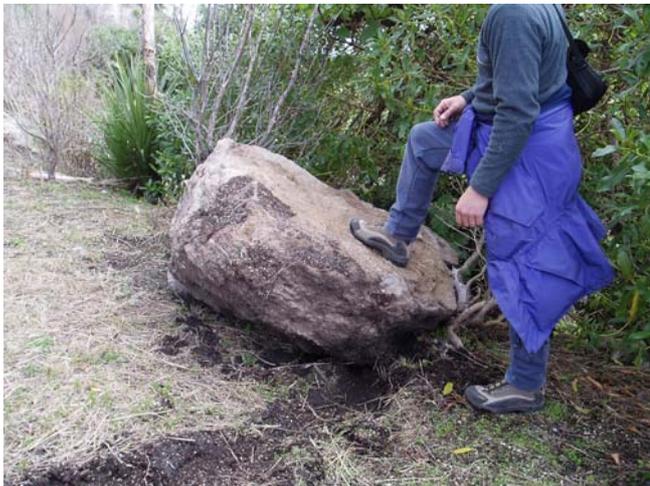
Photograph 4. The main boulder.

The 0.6m³ boulder came to rest just above the bushline having travelled around 85m vertically and 135m horizontally.

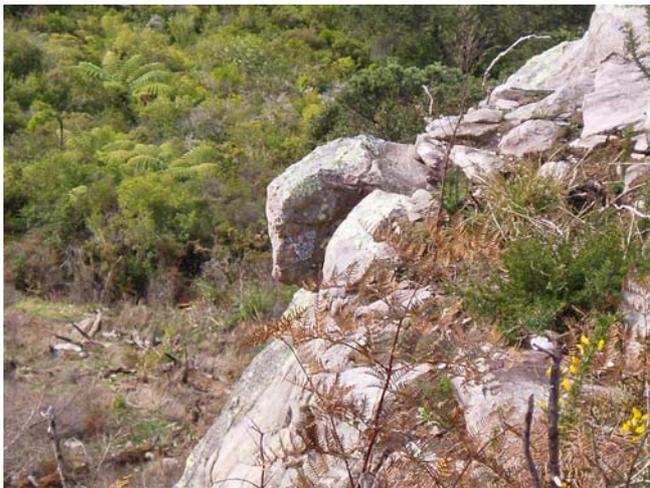
Photograph 5. Rock outcrop movements.

One in-situ boulder was found to have moved into a far less stable position due to the earthquakes. See photograph 5.

This is a rock of approximately 0.075m³, a few metres down from the crest of the bluff in zone 2, between 2b and 2c and has obviously been shaken outwards to the point where it appears very near toppling (similarly unstable boulders are relatively common but this ones position is definitely attributable to the recent events).

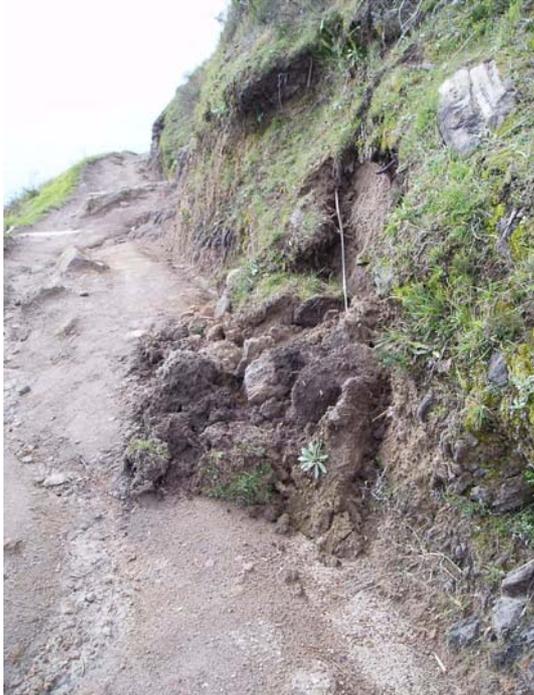
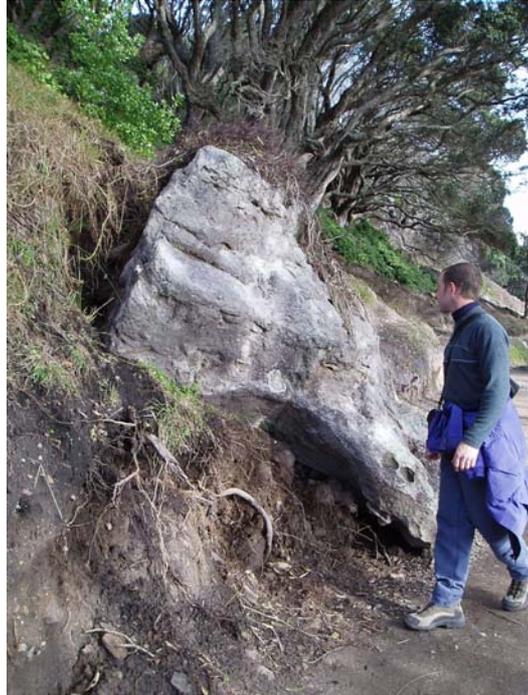
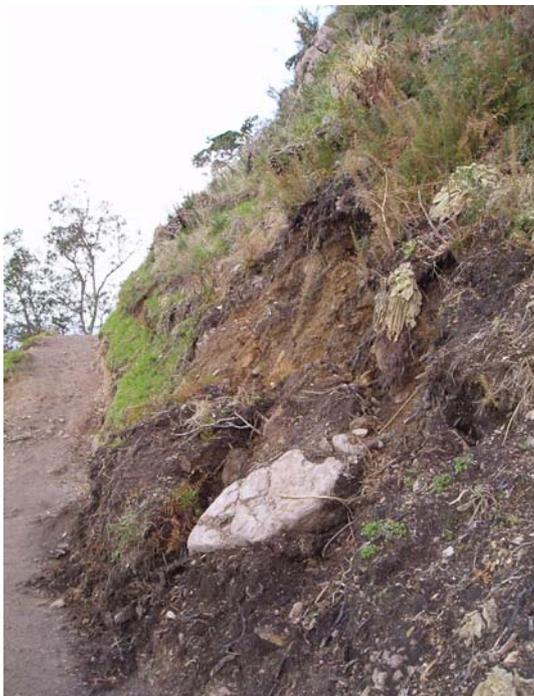
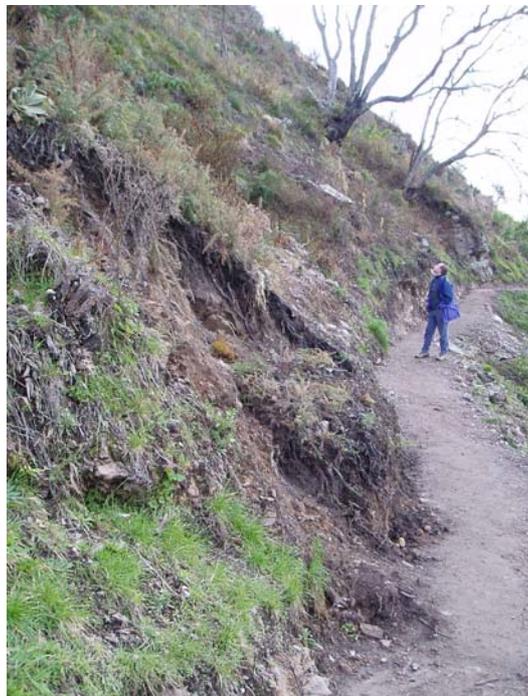
Photograph 6, 7, 8 & 9. Typical track cut slips.

At least fifteen individual small shallow circular overslips of 1m³ to 3m³ in volume were found. The slip material had failed from the colluvium exposed by the track cuts and debris now rests on the tracks. These track side slopes were over-steepened during track construction (to create a level track platform).

These slips generally pose little or no hazard to track users as they will be observed and persons could reasonably easily step out of the path of any active slip.

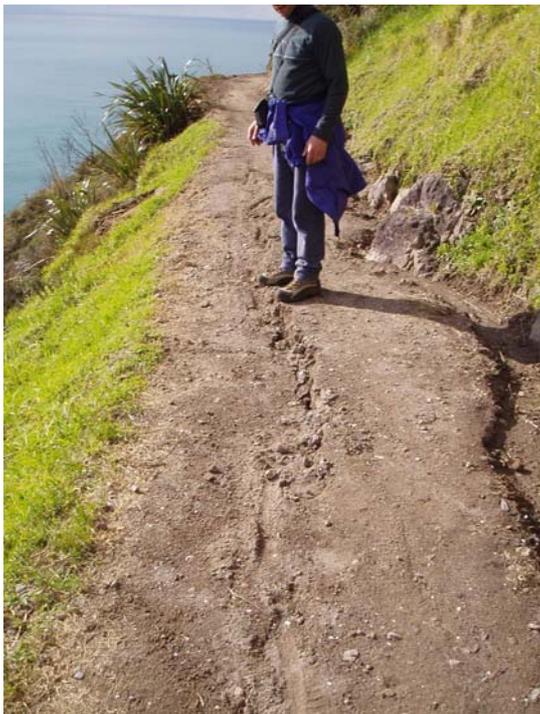
Photograph 12. 'Dropout' in north-western Oruahine track.

The photograph above shows a slip in the fill base on the north-western Oruahine track below the climbing crag.

Both these underslips dropped no more than 100mm before locking up and do not appear to present an immediate hazard. Had they failed completely some of the material released could potentially have threatened tracks below.

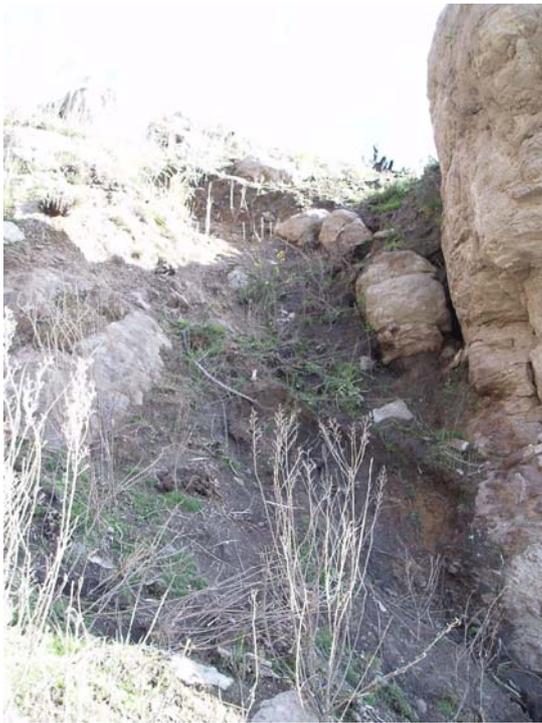
Photograph 13. Scoured colluvium, location 3f

Whilst inspecting for earthquake damage it was noted that, as anticipated, significant erosional scour and channelling has locally taken place in the colluvium.

Sand has been washed away locally leaving rocks in very marginally stable locations. A significant amount of rockfall must have been generated over the previous year via this process.

The slopes are now in a condition where a rock scaling operation would be very beneficial (the post fire rock scaling was in March 2003). The vast majority of rock to be removed could be removed by hand, without the use of crowbars etc.

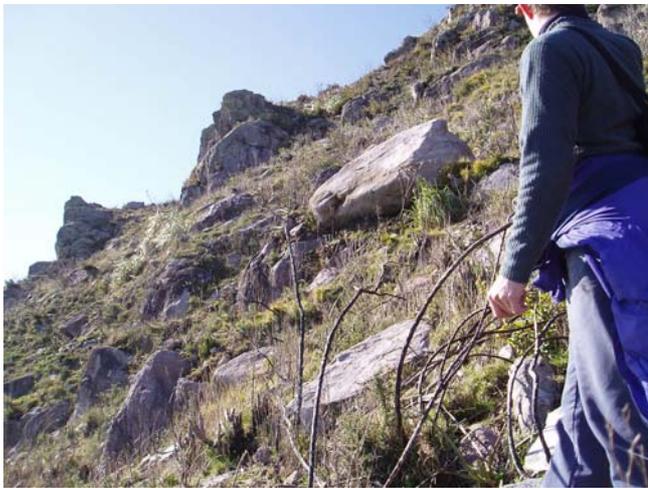
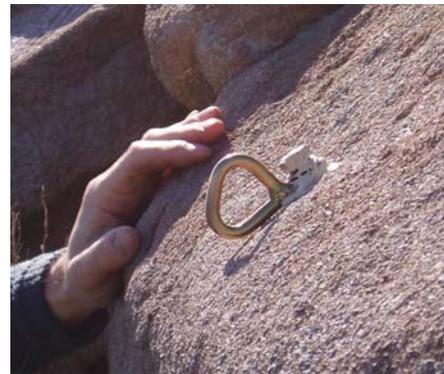
Photograph 15 a & b. Boulder at 4g and the eyebolt recently installed.

Whilst inspecting the slopes above the north western Oruahine track, above the popular rock climbing areas, we found a new eyebolt type anchor had been installed in the large boulder at location 4g. See the following photograph:

The boulder itself is more stable than it might appear (an unsuccessful attempt was made to move it using 2m bars during the March 2003 scaling operation).

The problem is that this eye could only be used for rope protection to allow persons to exit a climbing route via this colluvial slope, or possibly as a 'top roping' anchor. Either of these activities would be extremely likely to initiate rockfall and pose a completely unacceptable risk considering the public track lies directly on the fall line below.

It would be extremely difficult to use this anchor without initiating rockfall.

The anchor was removed by Avalon during our inspection.

Our investigation found newly installed climbers anchorages in locations whereby their use would most be likely to initiate rockfall. The risks posed (by human activity) may have been underestimated in the risk analyses to date. Any measures which can be taken to reduce the risk of human induced rockfall are highly recommended.
