Mauao Base Track Repair Options Assessment

Prepared for
Tauranga City Council
Prepared by
Tonkin & Taylor Ltd
Date
June 2017
Job Number
1002819

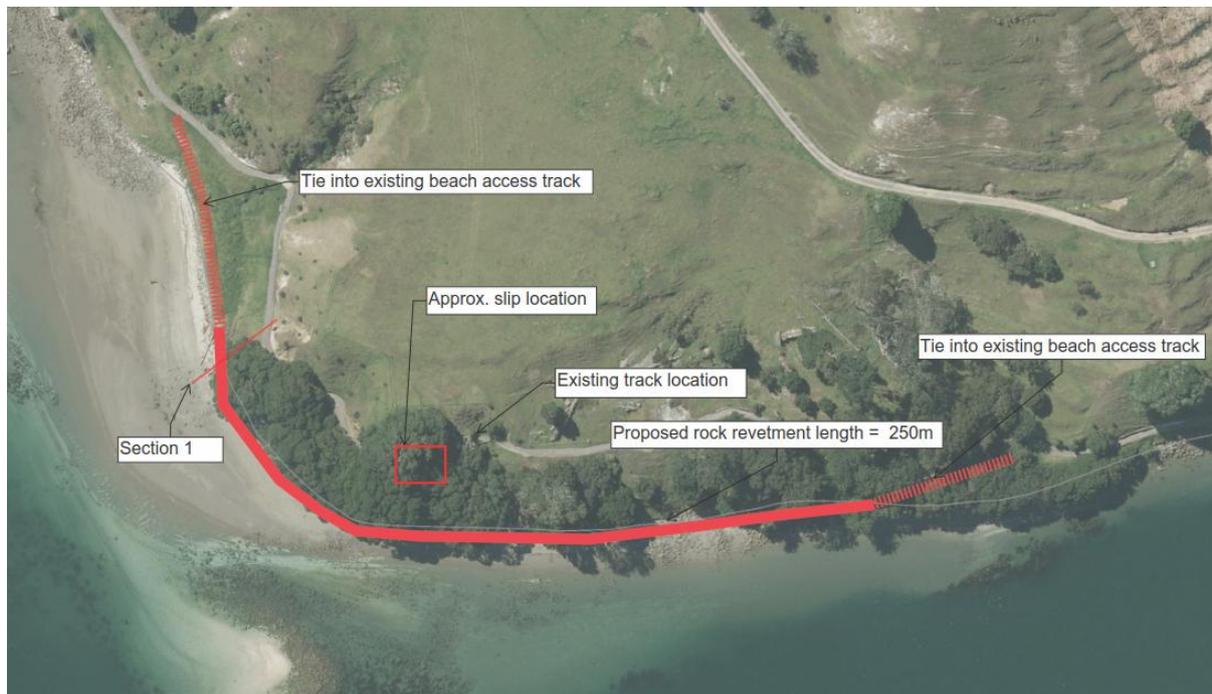
Sketch 5. New lower track with rock revetment.

- Excavation into existing ground to ensure the footing is below likely scour levels;
- Geotextile lining of the formation level;
- Compacted granular fill core covered by geotextile; and
- Underlayer and large diameter armour rock on the outside of the revetment with 1V:1.5H slopes.

The revetment track would tie into the existing beach access tracks at either end. These tracks are currently not suitable as Accessible tracks so upgrade works would be required to even out the gradients and widen the track.

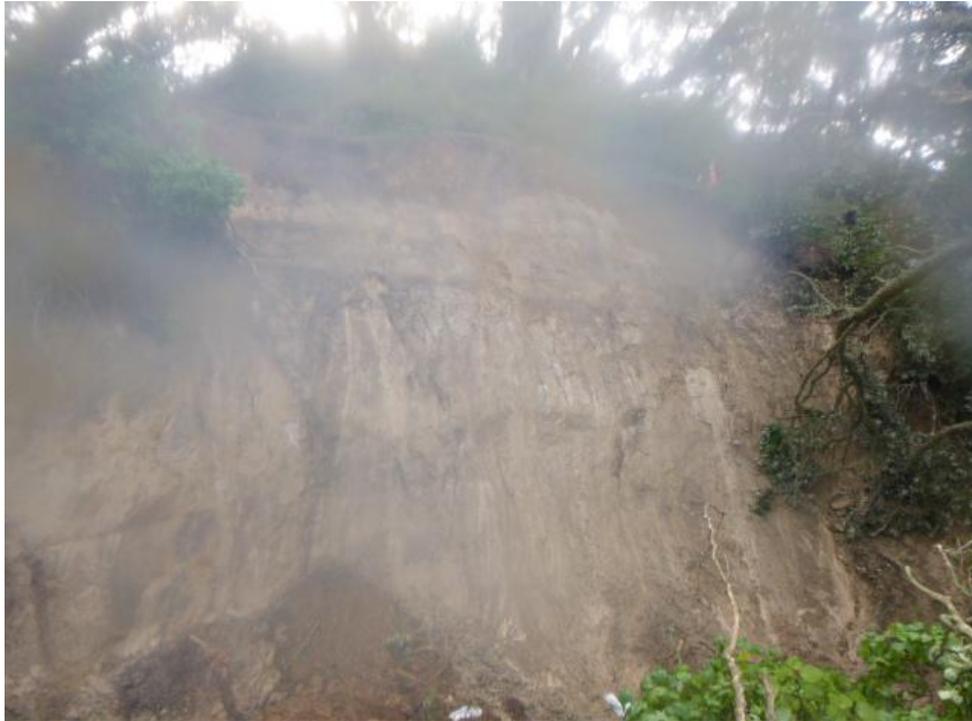
Photograph 1: View of the head scarp looking north.

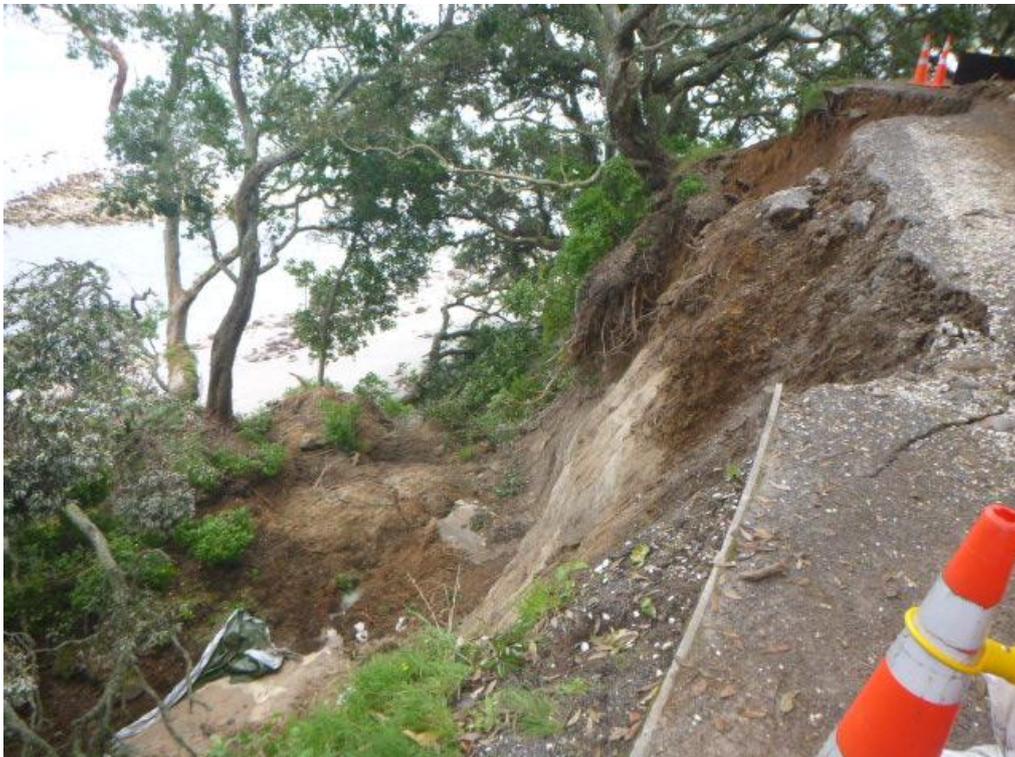
Photograph 2: View from the track adjacent to the head scarp looking west.

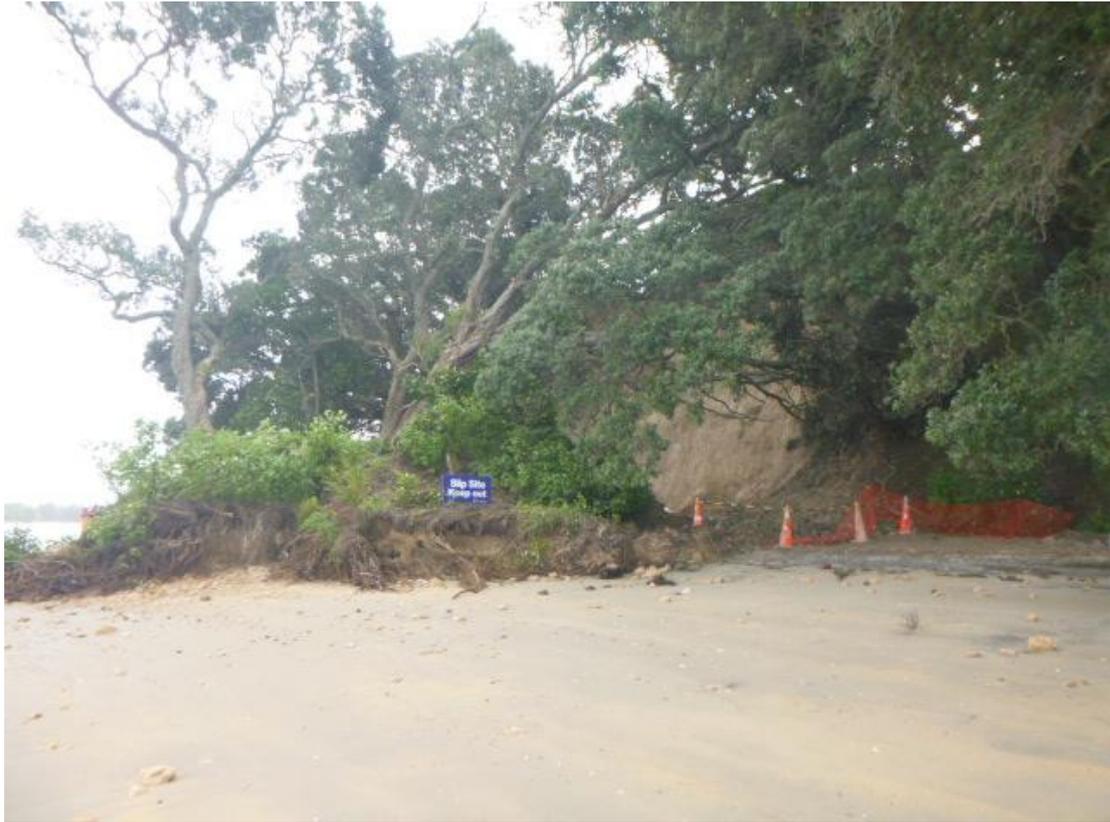
Photograph 3: Looking west towards the landslide with the debris in the foreground.

- The approximate volume of landslip debris based on our field laser survey is 400 m³;
- The landslip debris will be eroded over time by the natural beach processes;
- There are currently two large trees within the main debris section which may become a safety hazard to people walking along the beach if the trees die or become unstable due to erosion of the surrounding debris. This risk should be assessed by TCC; and
