## Memorandum

### Mauao Land Slip

#### Purpose and background

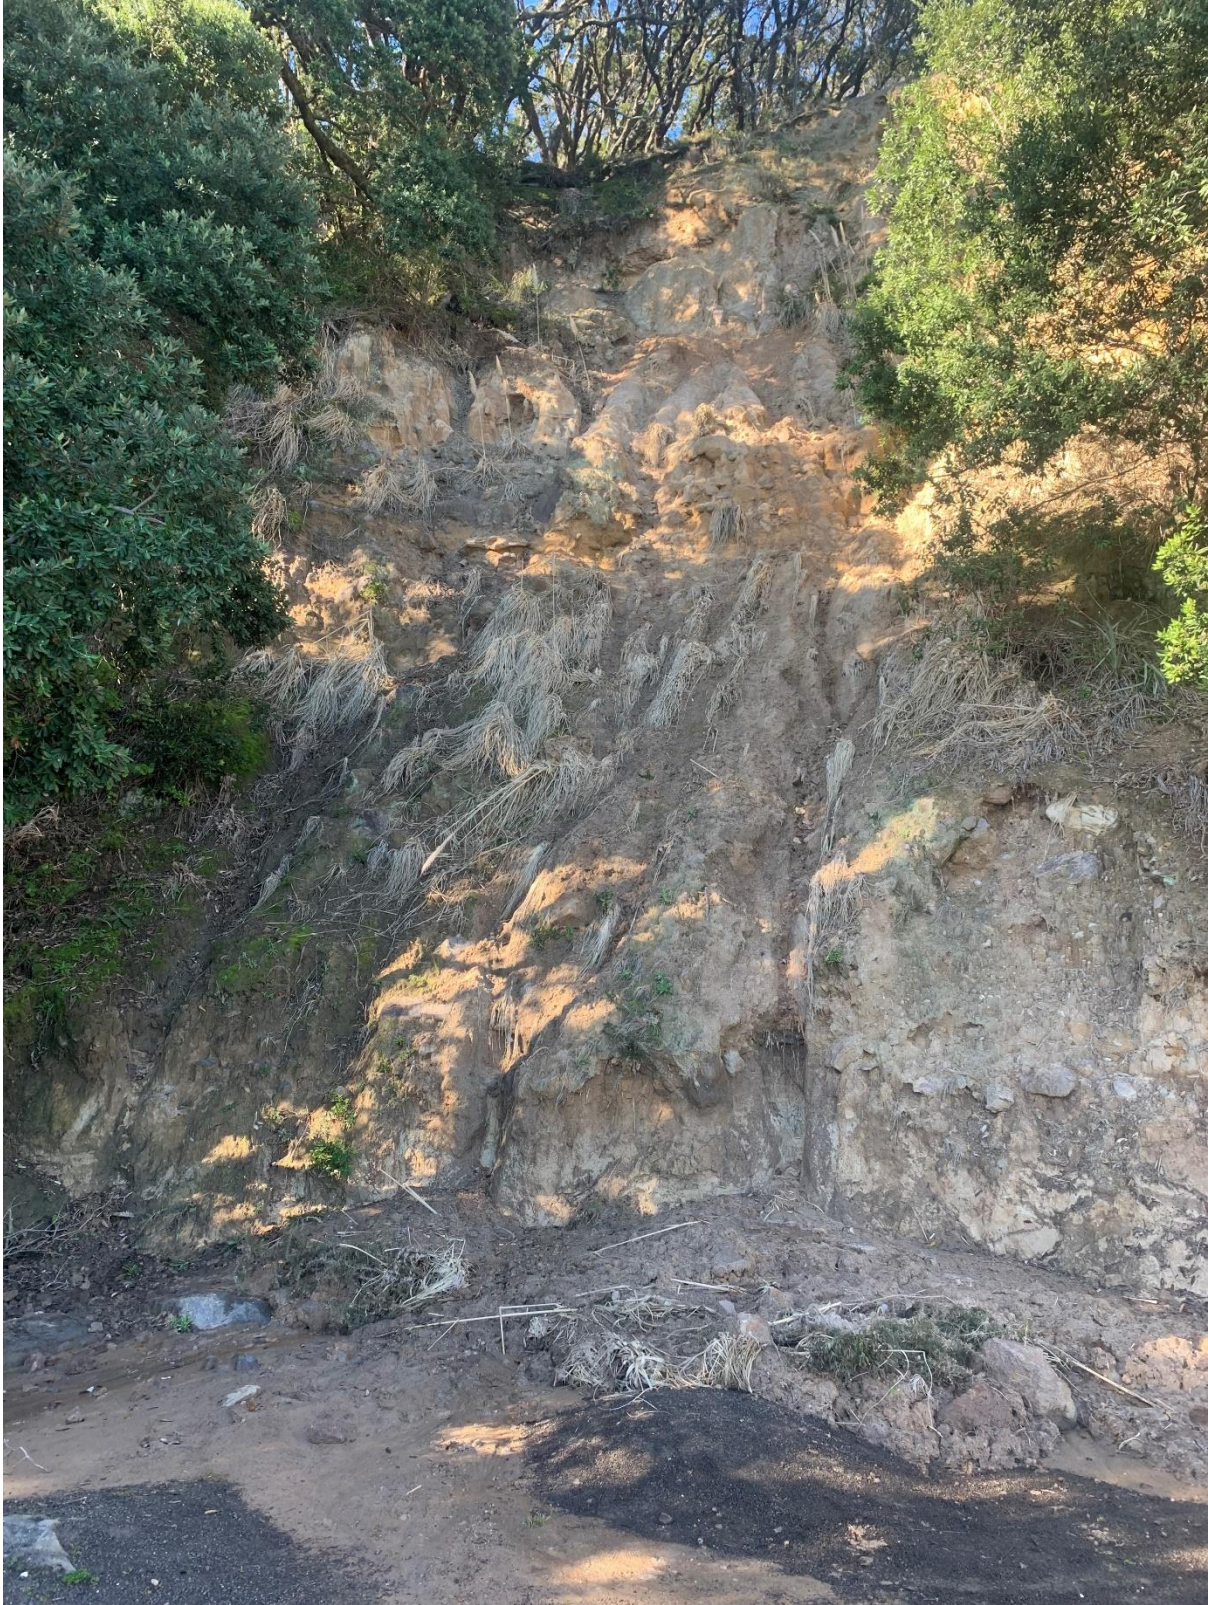
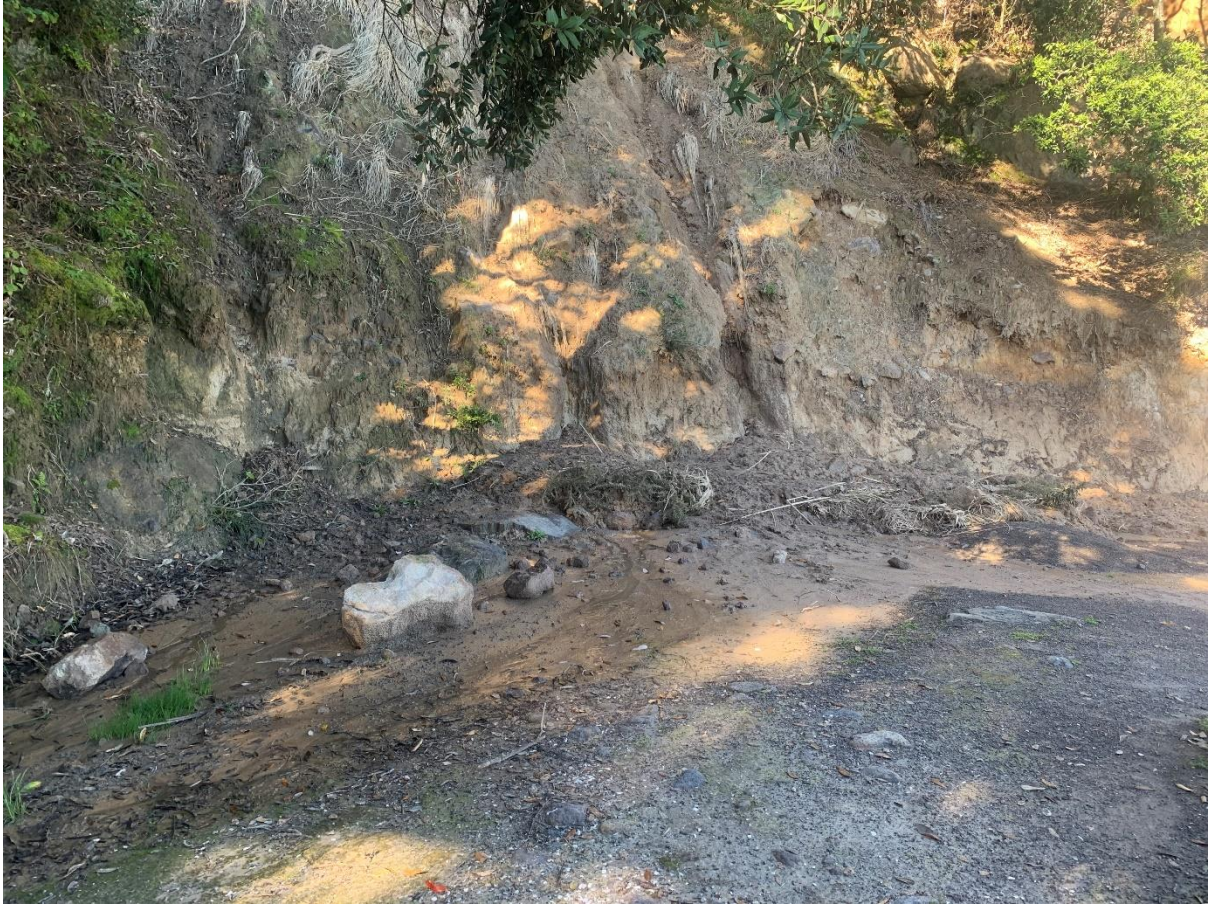
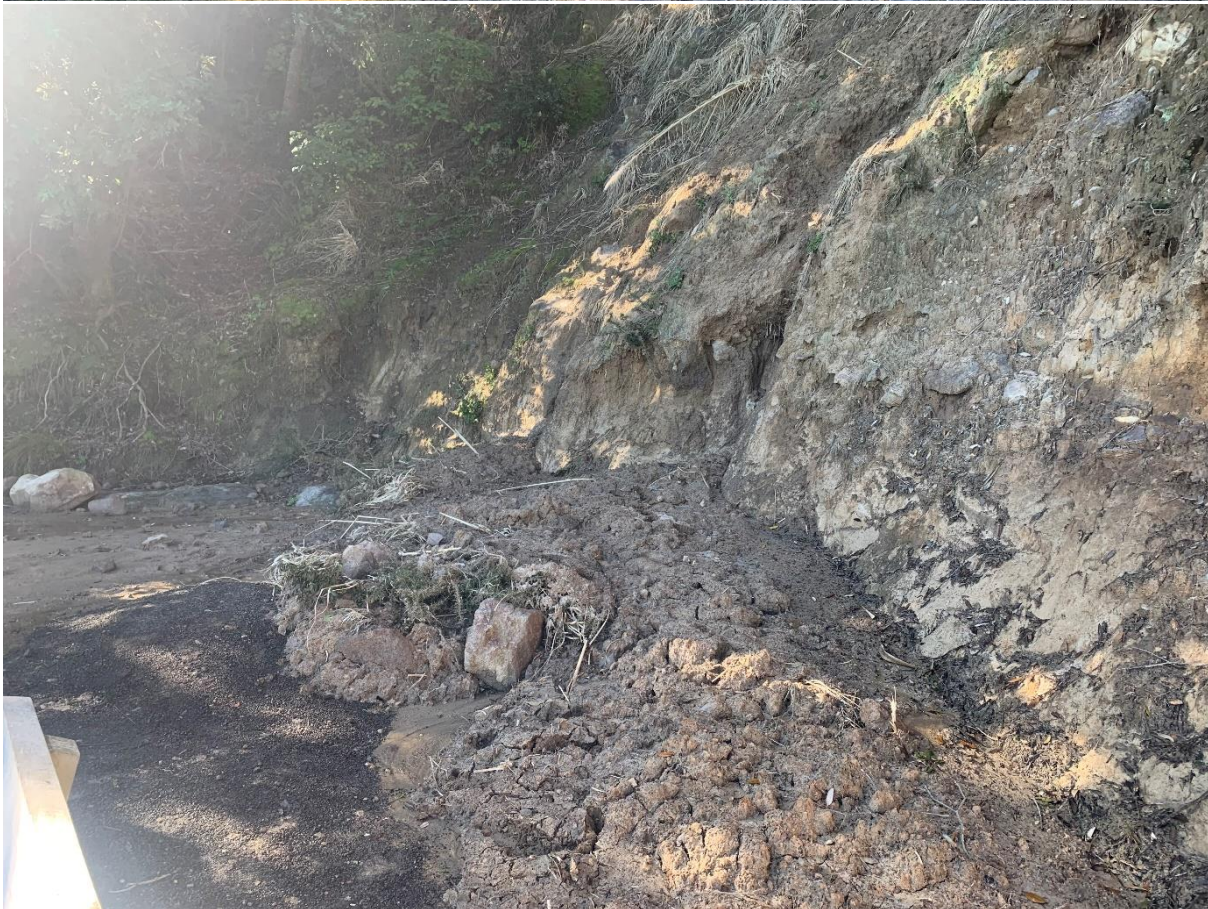
As the [Redacted] s 6(c) - Maintenance of Law has become aware of a worsening situation in relation to an old slip site near Te Kuia rock on Te Ara Tūtanga track.

The face of this slip is steep, and amount of material regularly being dislodged (including soil, clay, rocks and vegetation) is increasing with severe weather events.

This material being released from the face of the slip is reaching the track and creating an active hazard for people walking below.

Controls put in place since identifying the risk include removing the seats that were in the area to discourage the public from gathering in the area of the slip and putting in temporary fencing to prevent access close to the face of the slip.

To ensure ongoing public safety and to facilitate the aspirations of the Mauao Trust, its recommended that an engineered catch-wall is designed and constructed to stop any migrating material from reaching the track.
