Mauao Landslips – 29 January 2011

Concept Remedial Options for Large Slips
affecting the Base Track

Presentation to:
Mauao Steering Group - 03 March 2011

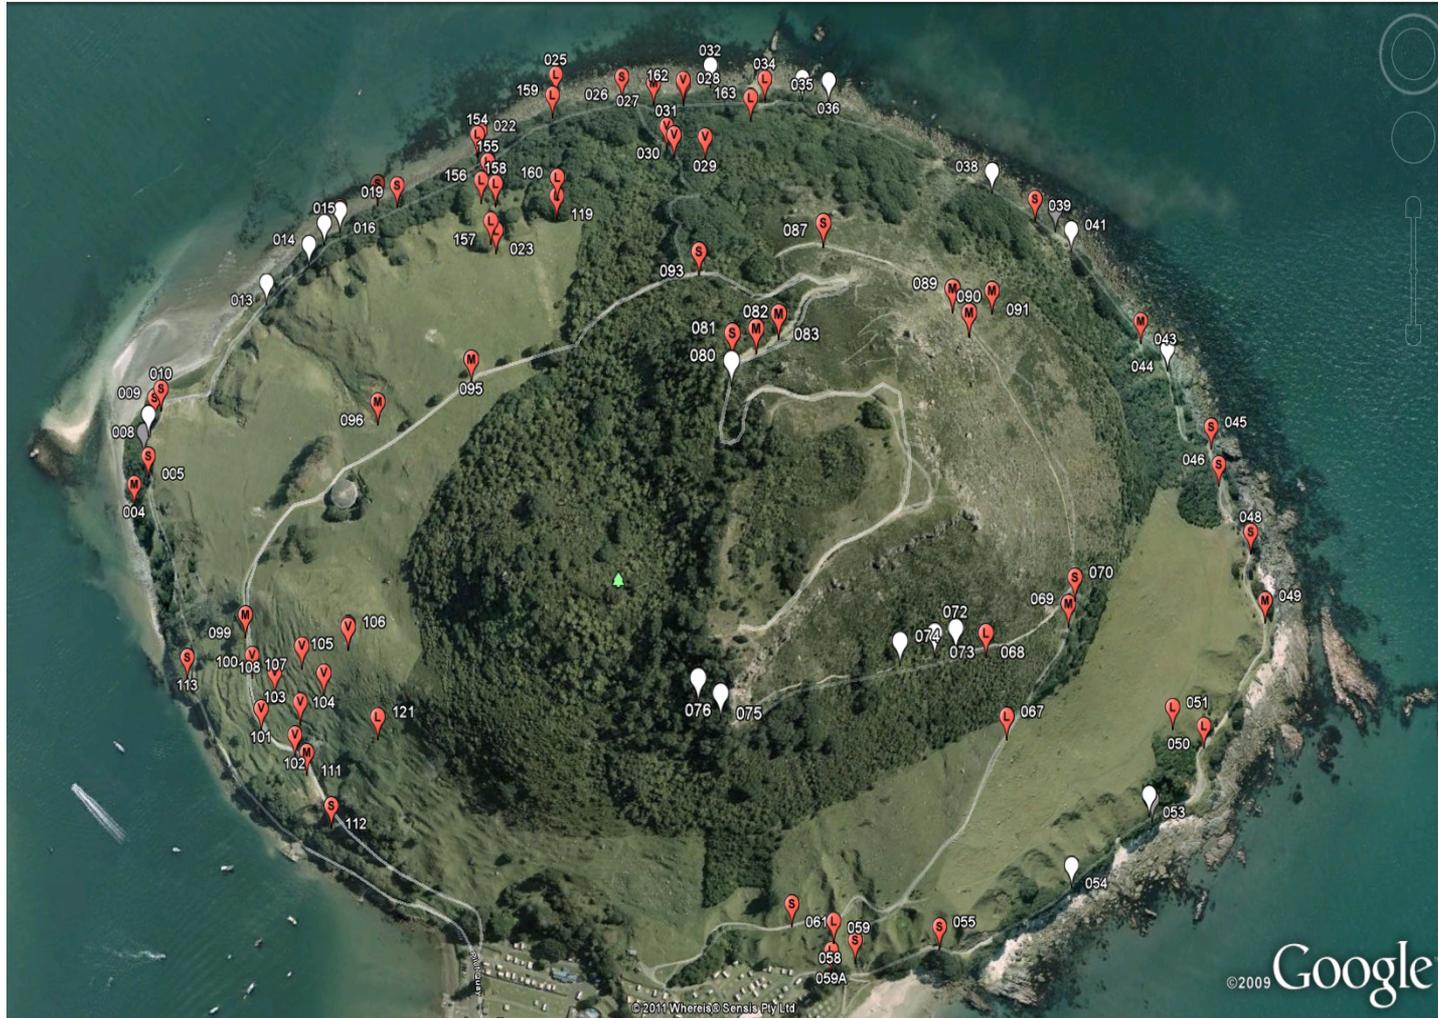
- Landslips occurred on 29 January 2011
- Initial Inspection by TCC staff - 30 January 2011
- Inspection by Tonkin & Taylor Ltd - 01 February 2011
- Presentation to Mauao Steering Group - 03 February 2011
- Landslips Classified by size:
 - 22 Minor (<1m³ debris)
 - 20 Small (1 to 5m³ debris)
 - 14 Medium (5 to 20m³ debris)
 - 7 Large (20 to 100m³ debris)
 - 2 Major (>100m³ debris)

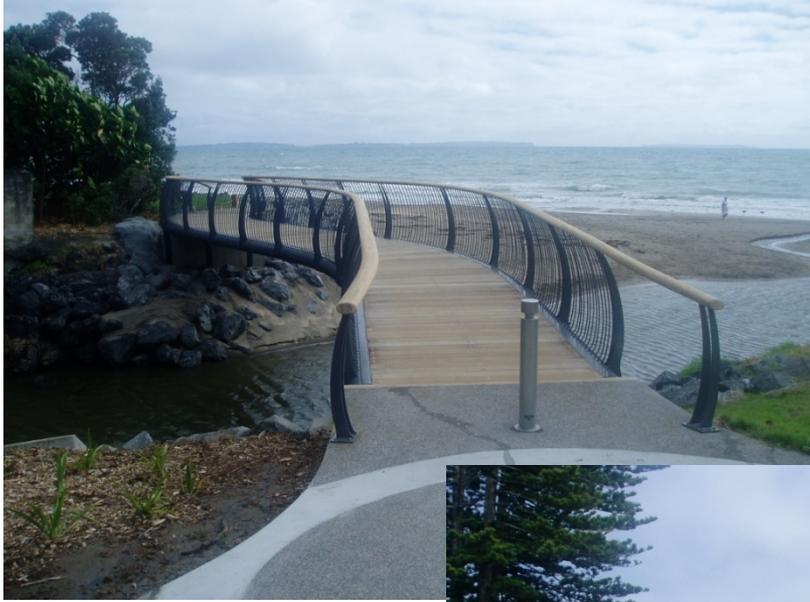
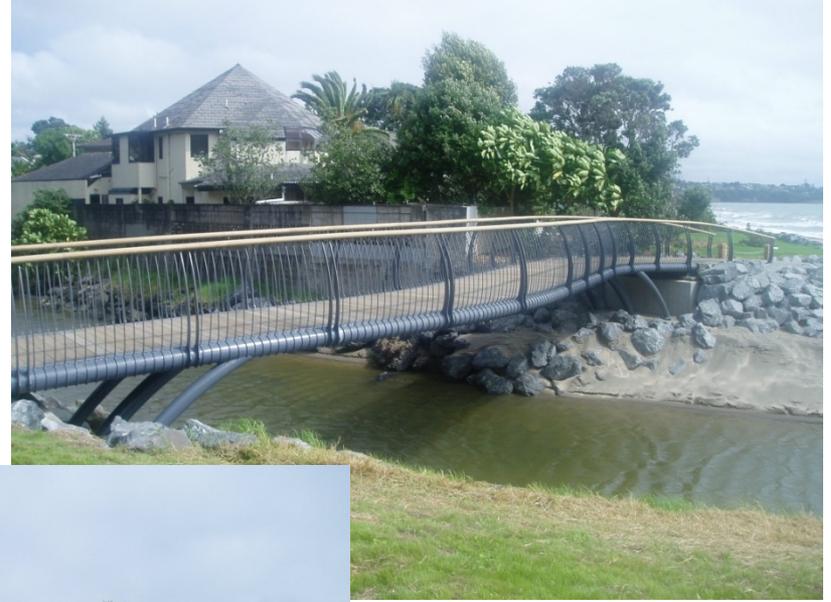
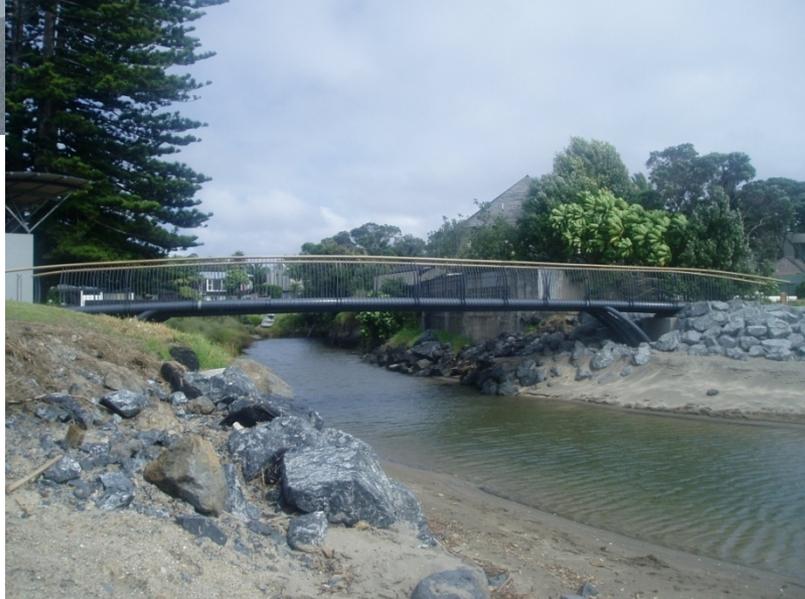
Footbridge

Plan view of footbridge
possible locations

Concrete culvert

Cross section of track
showing outfall

Option	Advantages	Constraints
Footbridge	<ul style="list-style-type: none"> • High level of safety • Built off site – short timeframe • Minimal works to slip required • Less disturbance to natural system • Feature / Aesthetic • Education • Re-use boulders to line channel 	<ul style="list-style-type: none"> • High Cost • Foundation construction • Future maintenance / inspection costs • Aesthetic
Culvert	<ul style="list-style-type: none"> • Reduced risk to users • Minimal works to slip required • Less disturbance to natural system • Minimal maintenance • Availability of existing culvert(s)? 	<ul style="list-style-type: none"> • High Cost • Construction of gabion walls or similar to support track either side of culvert • Rock protection below to dissipate stormwater runoff • Future maintenance – debris clearance • Aesthetic • Requires hand rail
Retaining Structure	<ul style="list-style-type: none"> • Minimal maintenance 	<ul style="list-style-type: none"> • High Cost • Safety – doesn't reduce potential risk from future slips • Import of materials to site • Requires hand rail
