Memorandum

To	[Redacted]
Copy	[Redacted] § 7(2)(a) – Privacy
From	§ 7(2)(a) ... Privacy
Office	Tauranga
Date	6 September 2024
File/Ref	2-9B441.03
Subject	Tauranga Landslide Study – Mount/Papamoa Update

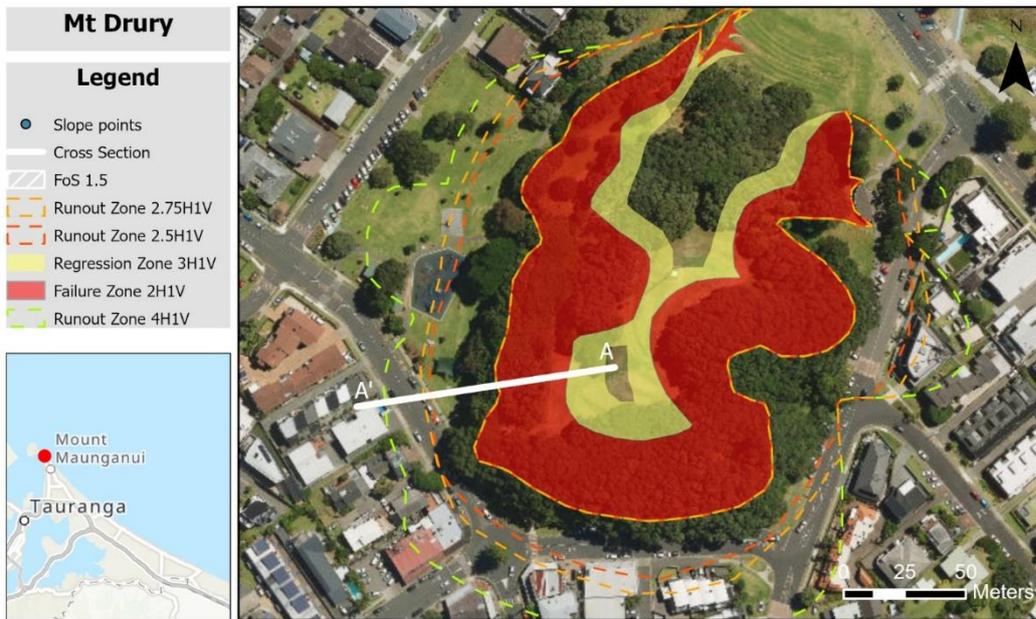
The results shown in Figure 1 indicate that for Hopukiore Mount Drury a runout distance equating to 2.5H:1V is appropriate for landslides initiated from the soil, ash and weathered rock debris in the upper part of the landform. This runout distance would also encompass potential rockfall initiated from the lower part of the landform, as we note that colluvium and rock boulders are visible around the base of Hopukiore Mount Drury and are within the 2.5H:1V runout zone.

Figure 1: Mt Drury landslide zones.

The slope runout distance was established from an analysis of the geomorphology and landform (Refer to Section 3.1). Figure 1 and Figure 2 display slope runout results for Hopukioire

Mount Drury and Papamoa, respectively, for 2.75H:1V and 2.5H:1V runout zones mapped in ArcGIS Pro and compared to existing 4H:1V runout zones.

The mapped failure zone is believed to represent typical landslide initiation points, generally on moderately steep to steep slopes, including rock slopes. Geomorphological evidence and knowledge of slope failures and runout in rock and soil slopes support revising the slope runout to 2.5H:1V (refer to Figure 1).

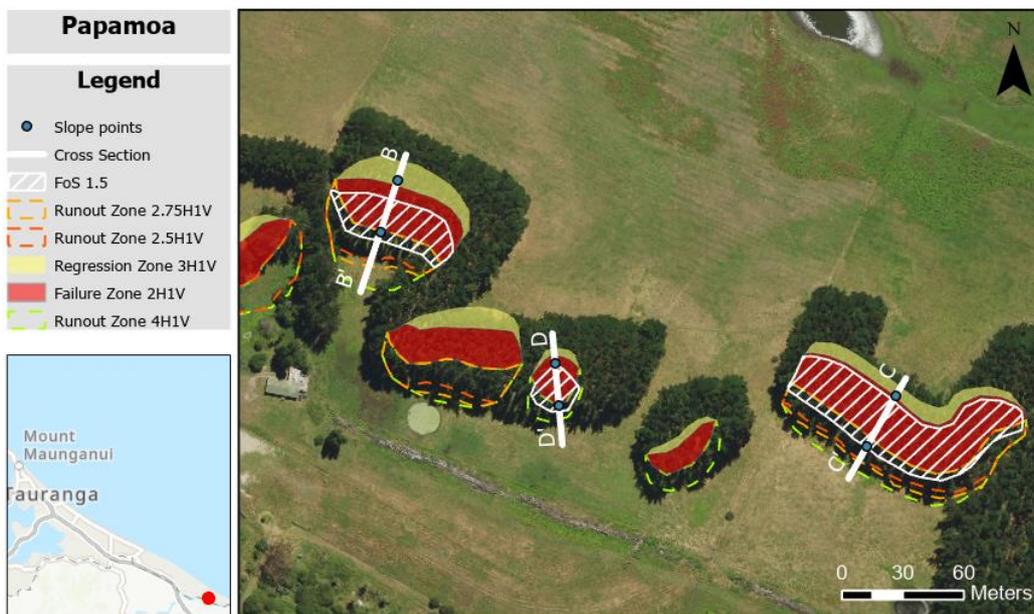
A range of runout distances were mapped and based on the geomorphology and landform, Figure 2 compares the 2.75H:1V and 2.5H:1V runout zones for Papamoa with the 4H:1V runout zones. This map also shows the extent of the slopes with a Factor of Safety (FOS) of 1.5, assessed using Slope/W. This comparison assesses the impact of different runout zone mappings in the sand dune landform. In areas D and C (Figure 2), the runout zones exhibit minimal differences.

Figure 2: Papamoa landslide zones.

The FoS of 1.5, as modelled in Slope/W for Te Tumu, encompasses the previously mapped failure zone shown in Figure 2. Based on our understanding of failure in sand dunes, the 4H:1V runout model overestimates the actual slope runout, which is likely to be less, around 2.5H:1V.
