Crime Prevention through Environmental Design Audit & Injury Prevention
through Environmental Design & Universal Access Assessment
Prepared for Tauranga City Council

12 January 2015

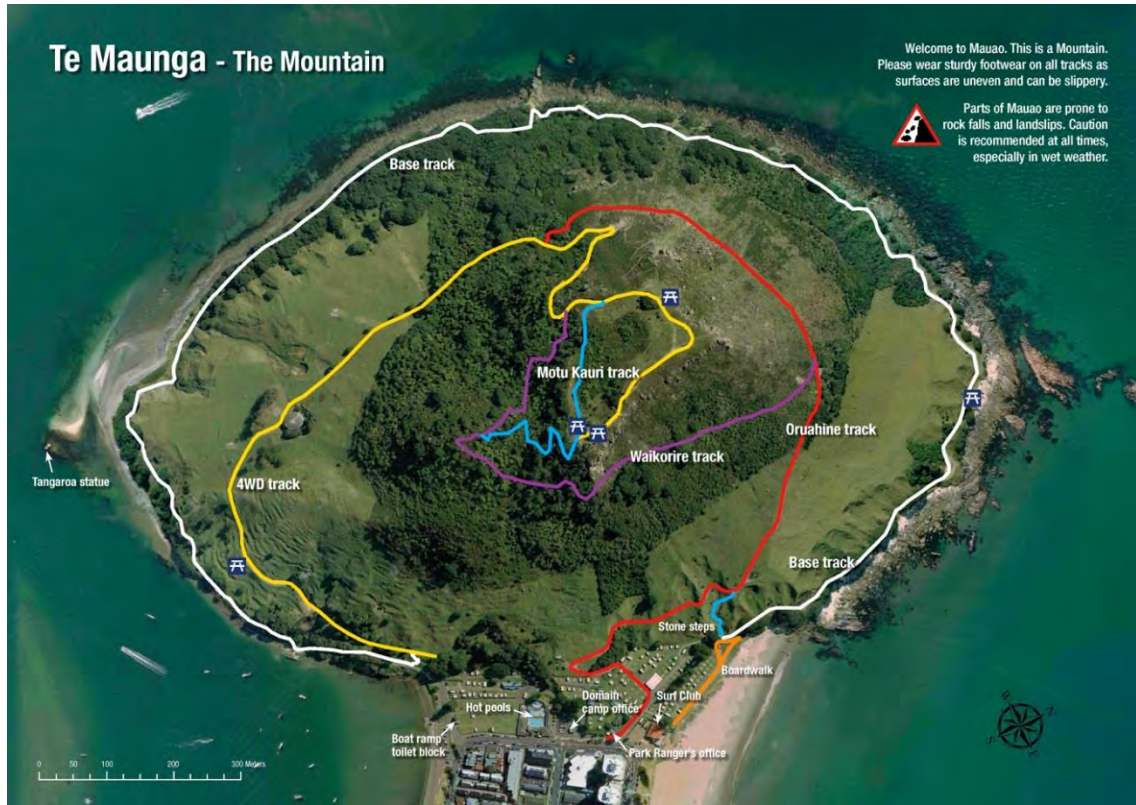
3.0 Part A – Crime Prevention Through Environmental Design

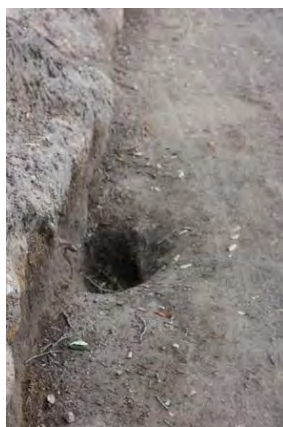
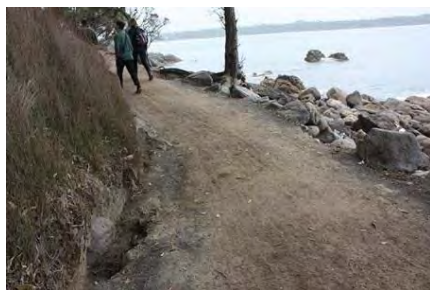
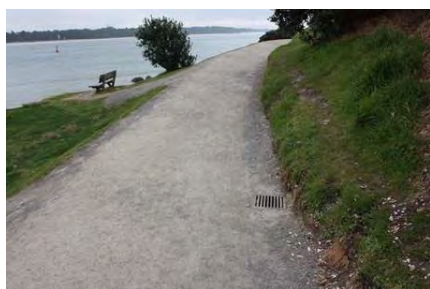
Figures 3, 4 and 5 Drainage holes on inward side of Base track and trial drainage cover

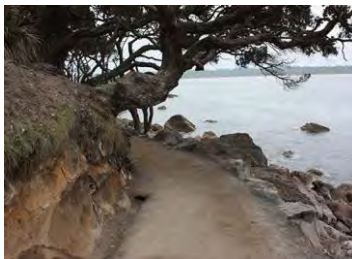
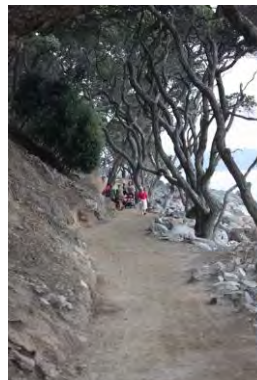
Figures 7 and 8 – Examples of pohutukawa branch projections over track

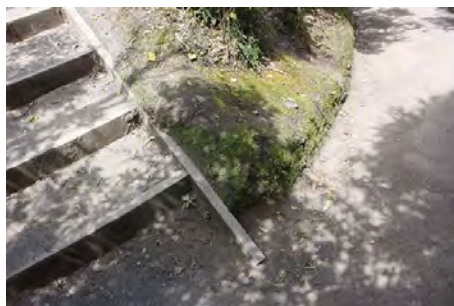
Figure 9 – Example of timber end of step protruding out into track corner

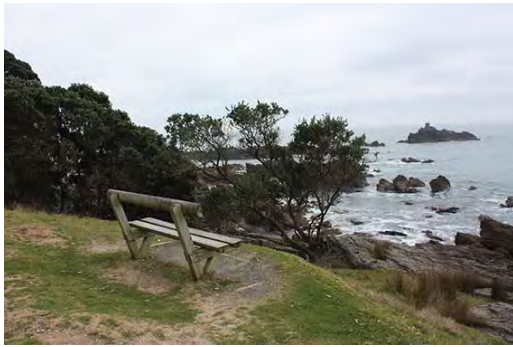
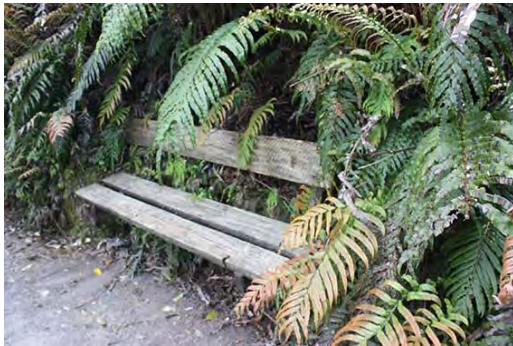
Figure 13 and 14 – Examples of timber seat at sides of track to allow for rest (Base track and Motu Kauri track)

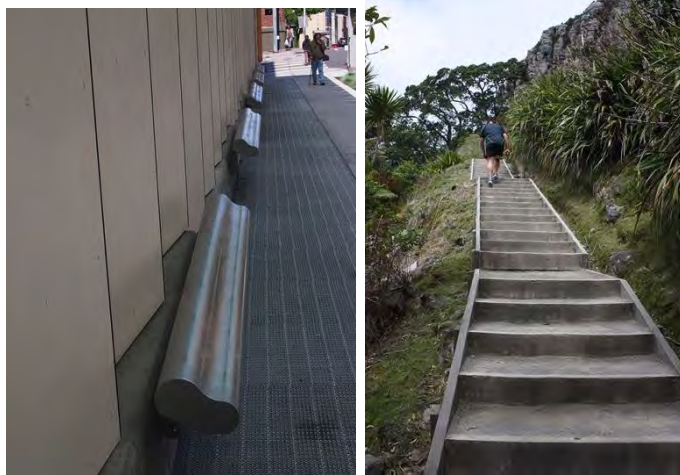
Figures 15 and 16 – Example of urban seat leaners (people remain slightly standing) and steps at Waikorire track

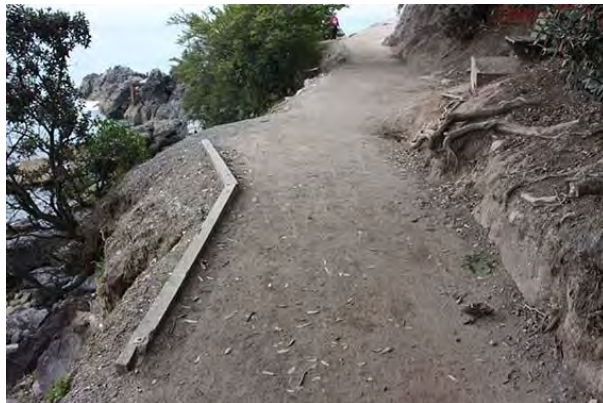
Figure 17 – Example of timber edge definition on Base track

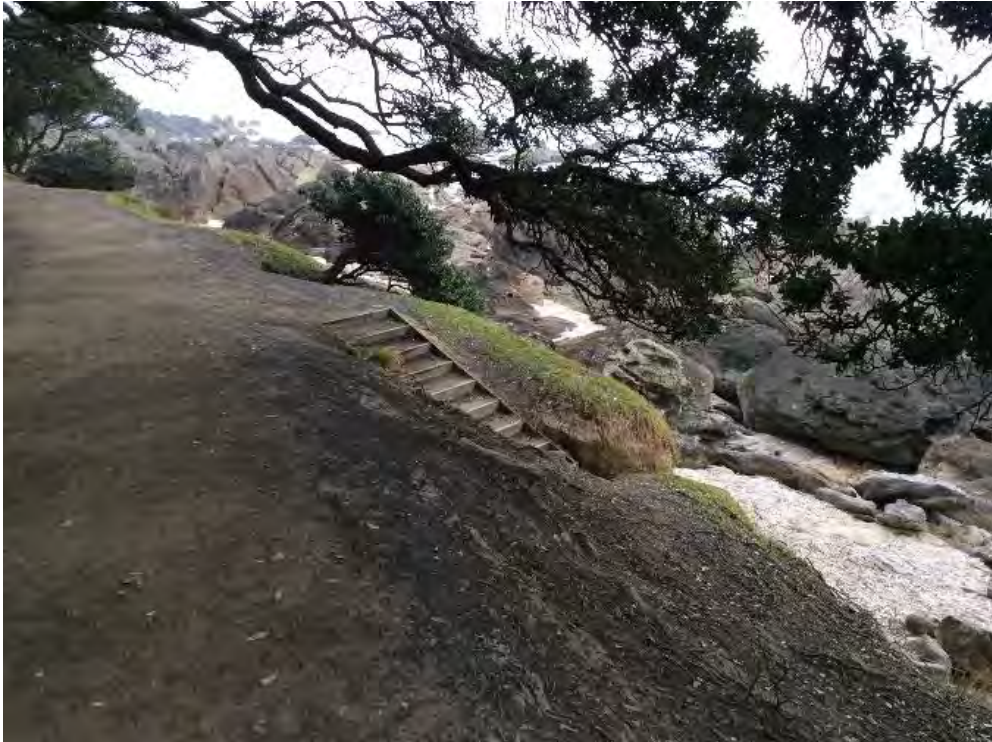
Figure 5: Formal access to Shelly beach lying beneath the base track. These steps are located in high visibility areas for safe access. Excess material can accumulate on the tread of the steps so it is recommended that this is maintained.

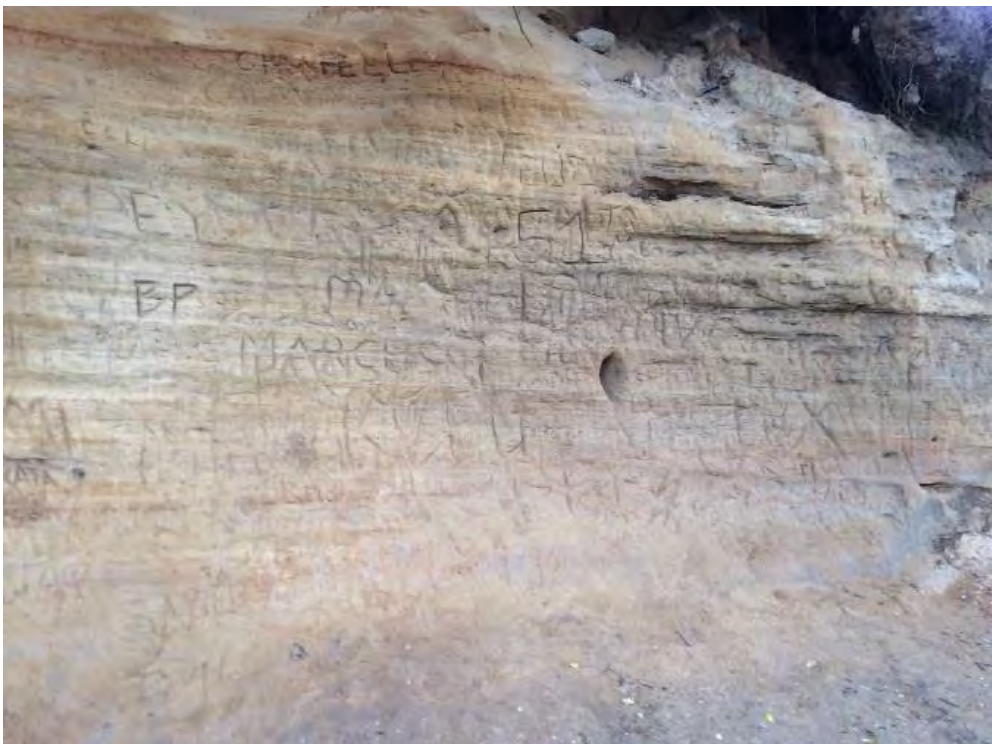
Figure 6: Exposed clay cliff faces to the inside of the track are subject to intentional gouging, particularly to chisel names into the clay. Over time this recedes the cliff face and causes instability. In one instance recently a costly stone retaining wall had to be installed to prevent collapse partly caused by this intentional gouging of the cliff face.

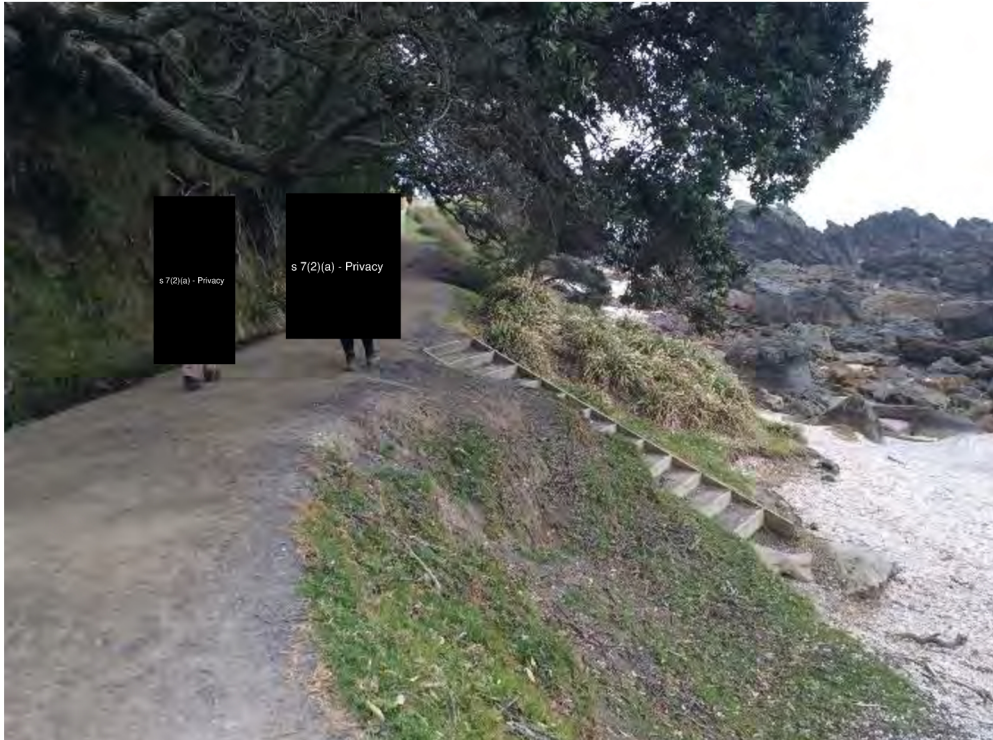
Figure 7: Formal access to Shelly beach lying beneath the base track. These steps are located in high visibility areas for safe access. Excess material can accumulate on the tread of the steps and gouging beneath the last step can occur so it is recommended that this is maintained.

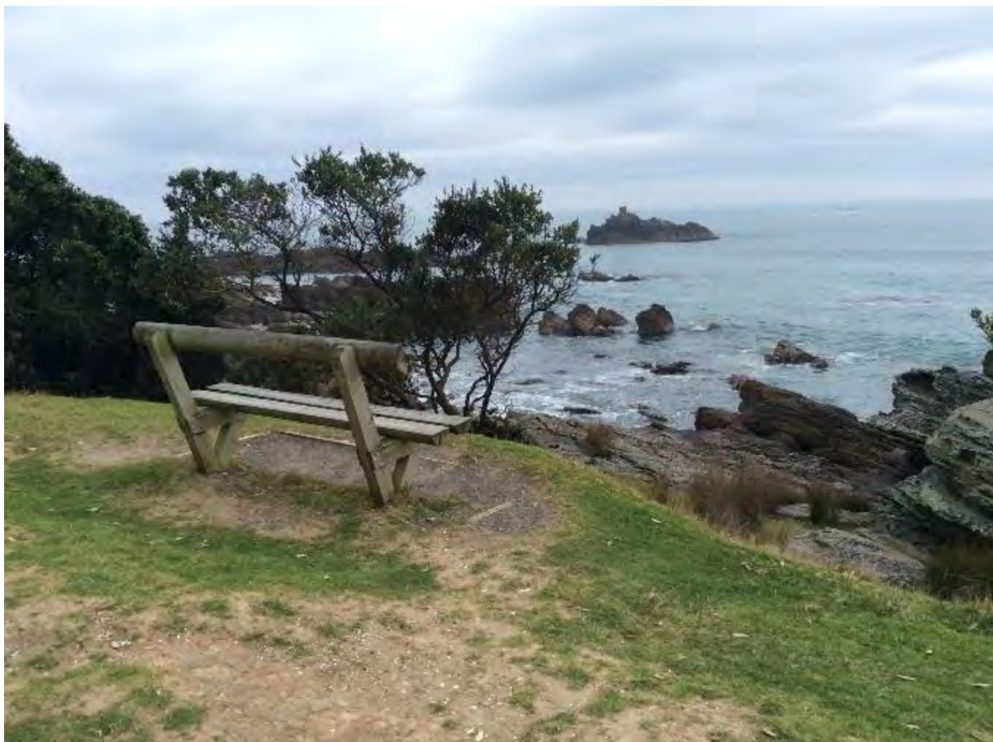
Figure 8: An older seat installed looking over the northern shore of Mauao. Seats of this age are to be removed in the near future and replaced with more modern seats.

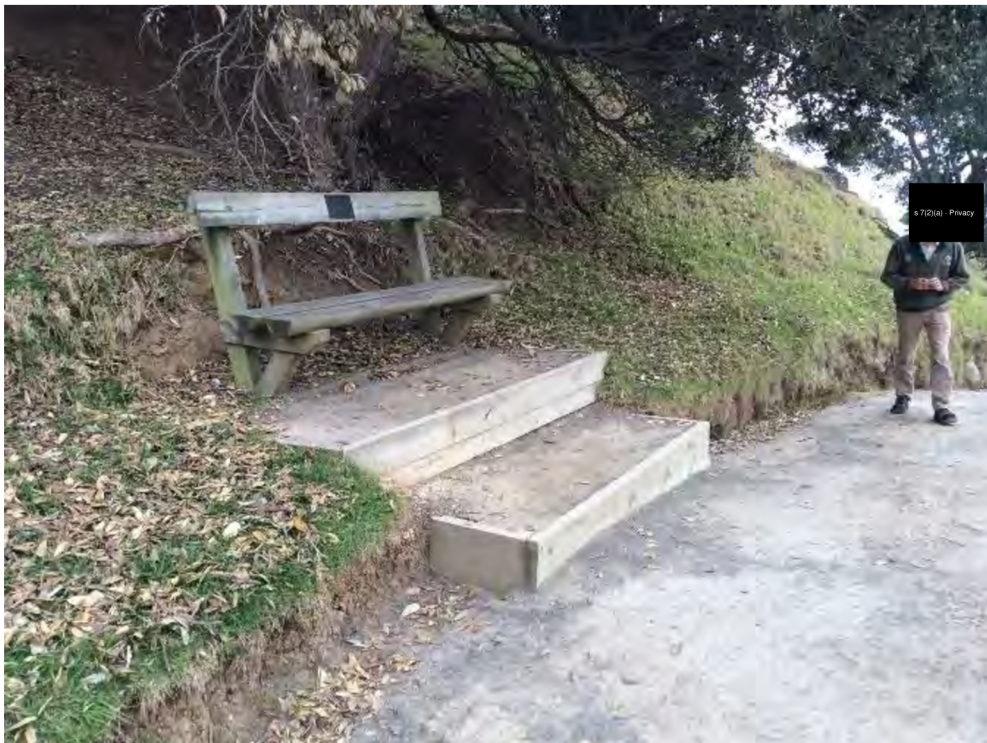
Figure 9: An older seat installed into the bank face looking over the northern shore of Mauao. Seats of this age are to be removed in the near future and replaced with more modern seats. The Park Ranger is looking to replace all memorial seats over time with wishes from iwi stating that Mauao is not a memorial site.

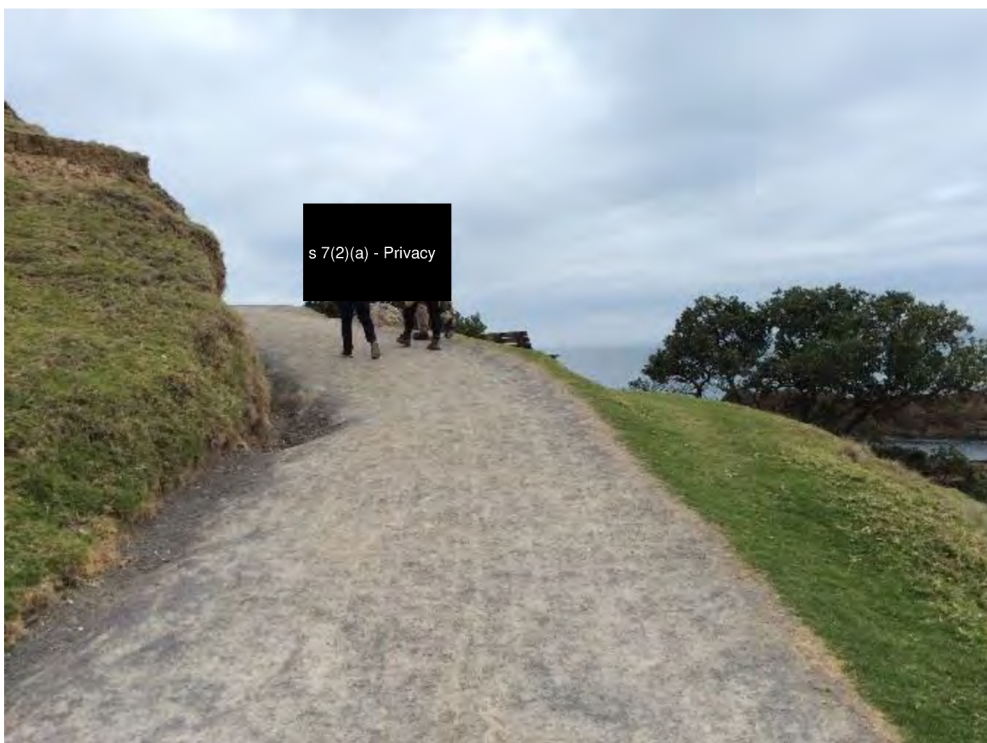
Figure 10: The grade along the base track is relatively easy, however at some points the grade is quite steep for a period of time, posing potential issues for wheelchair users in which Tauranga City Council states that the base track is suitable for.

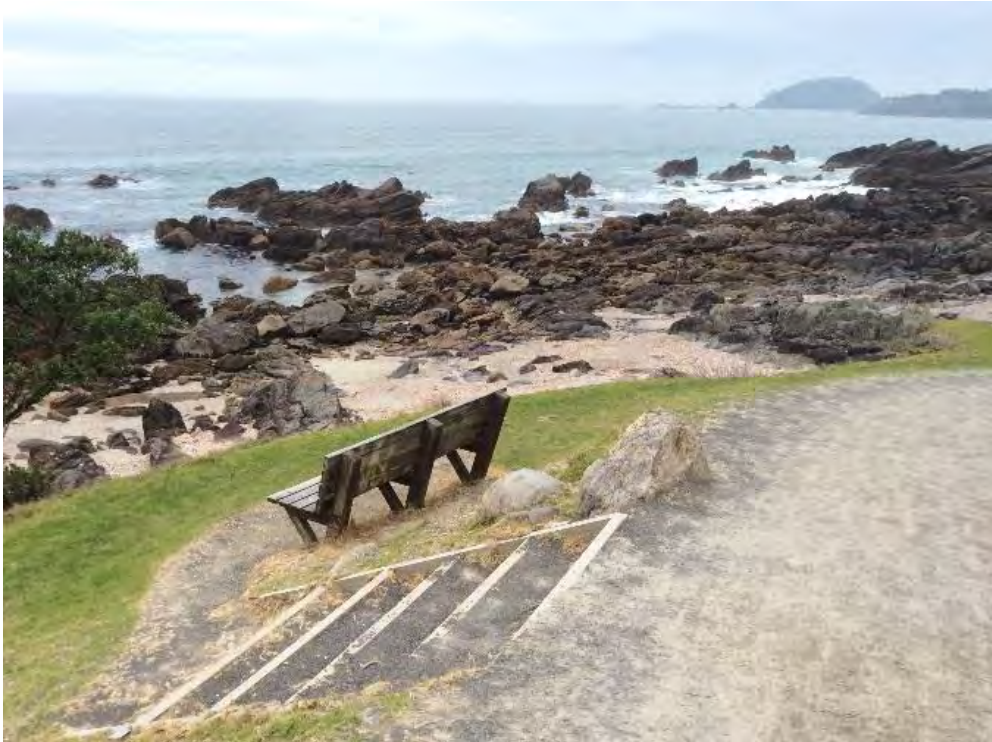
Figure 11: An older seat installed looking over the northern shore of Mauao. Seats of this age are to be removed in the near future and replaced with more modern seats.

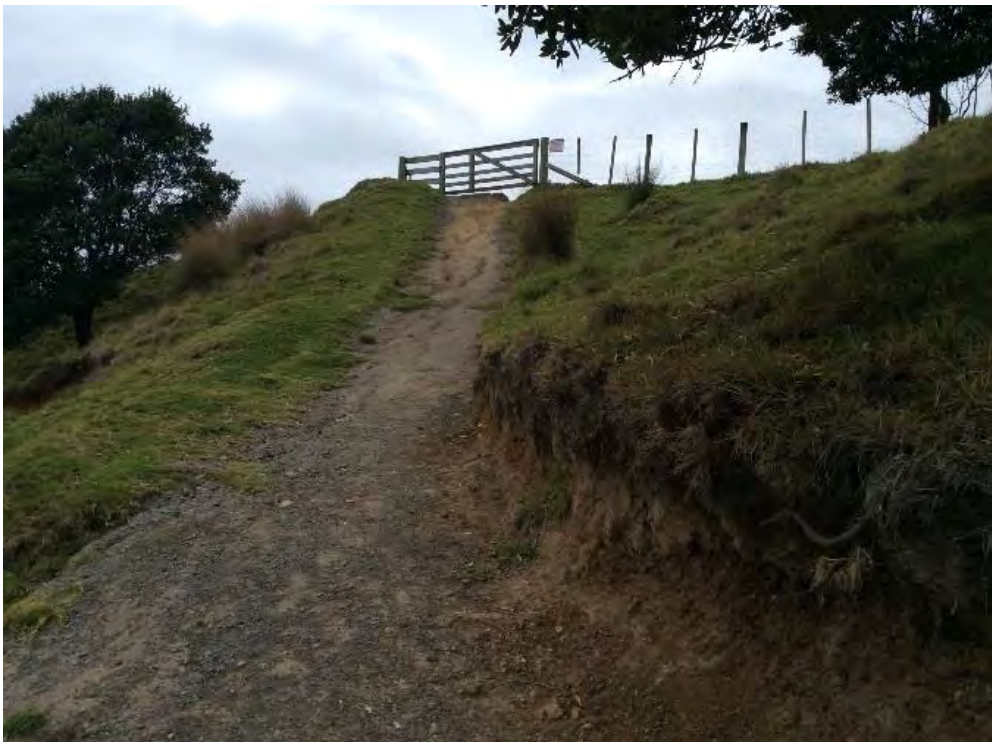
Figure 12: Users are accessing maintenance only tracks for alternative routes around and up Mauao. This can be dangerous with terrain and ground material not being suitable to traverse, however these areas, if upgraded have potential for more formalised alternative routes that create added escape routes.

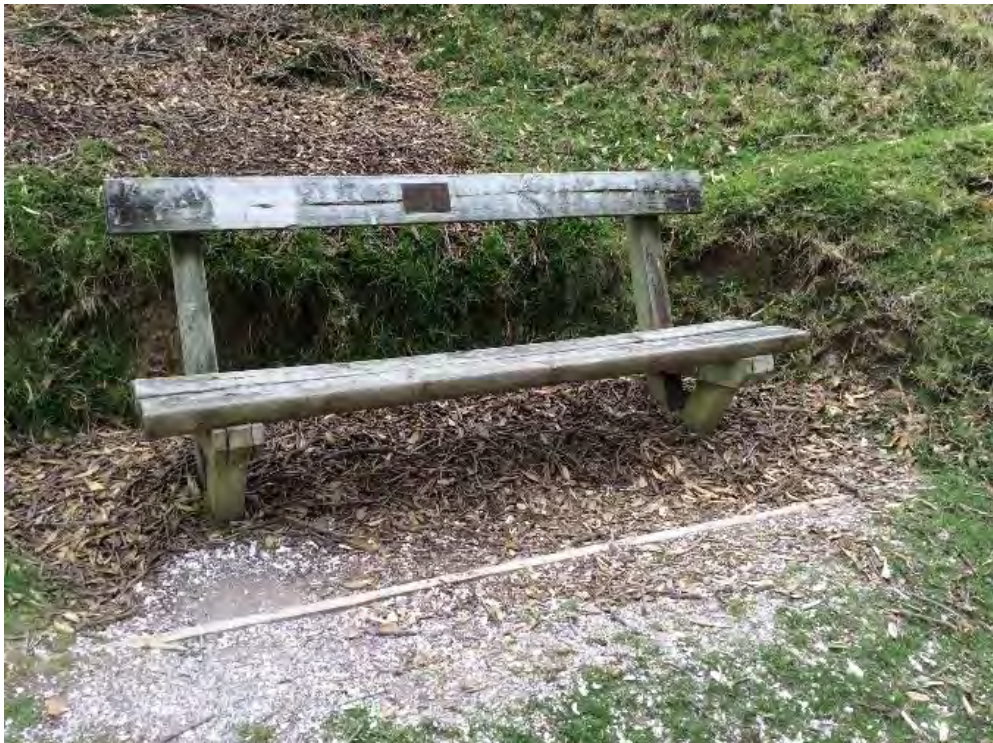
Figure 13: An older memorial seat installed looking over the northern shore of Mauao. Seats of this age are to be removed in the near future and replaced with more modern seats.

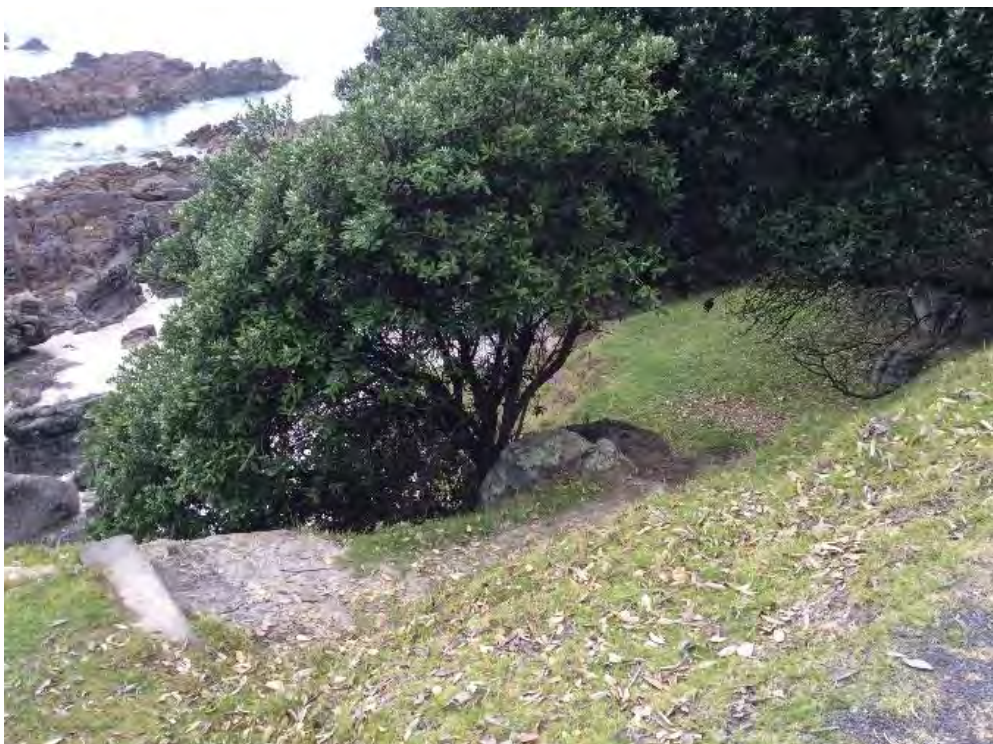
Figure 14: Historic access track to the beach at the northern tip of Mauao, beneath the base track.

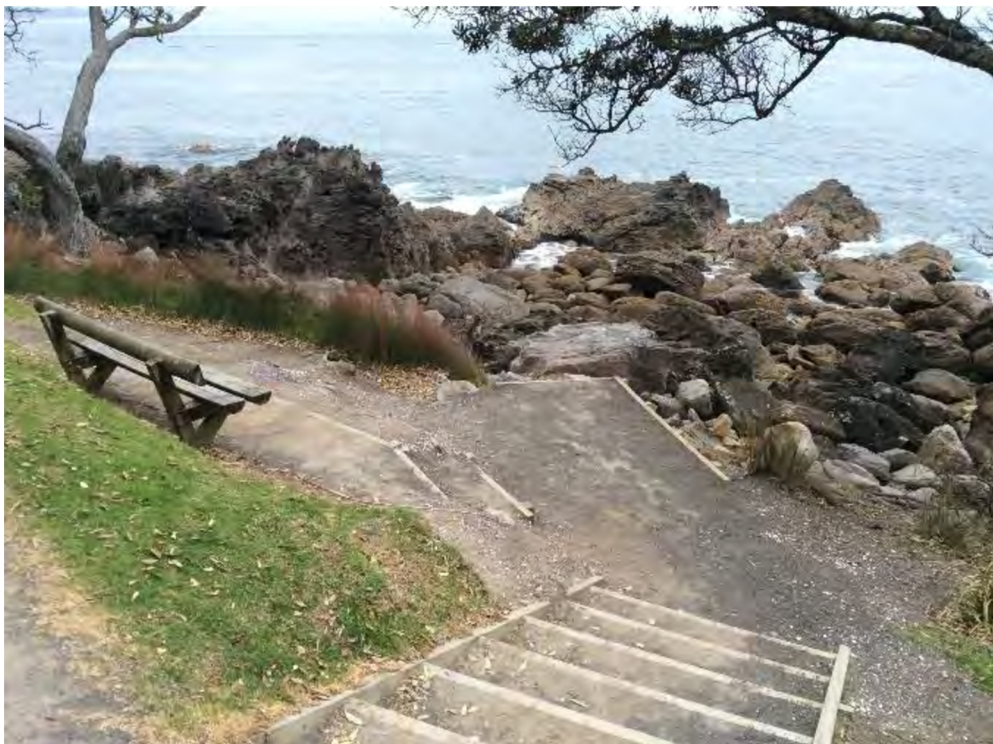
Figure 18: Seat at the base of steps which continue to the rocks on the shoreline. This seat overlooks the 'Ranui' wreckage site, in which the engine block still lies amongst the rocks and is visible at low tide. This seat will be replaced with a newer seat over time

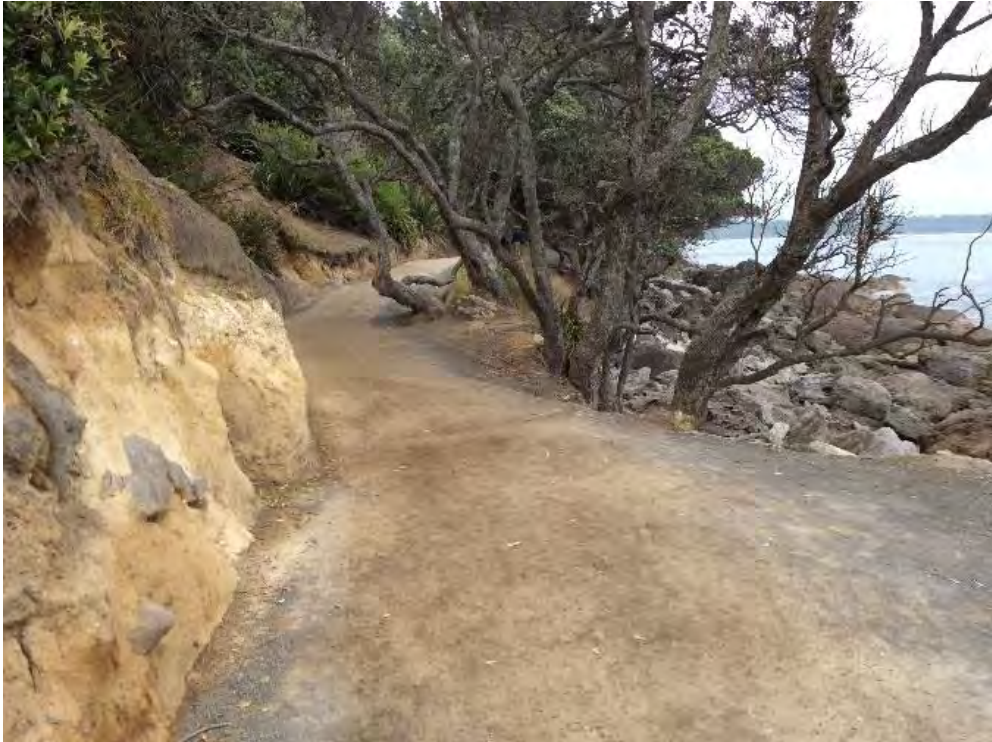
Figure 19: The low point on the base track has been elevated over time. In the worst of weather only there is minimal amounts of sea spray onto the track with can wash away some ground material.

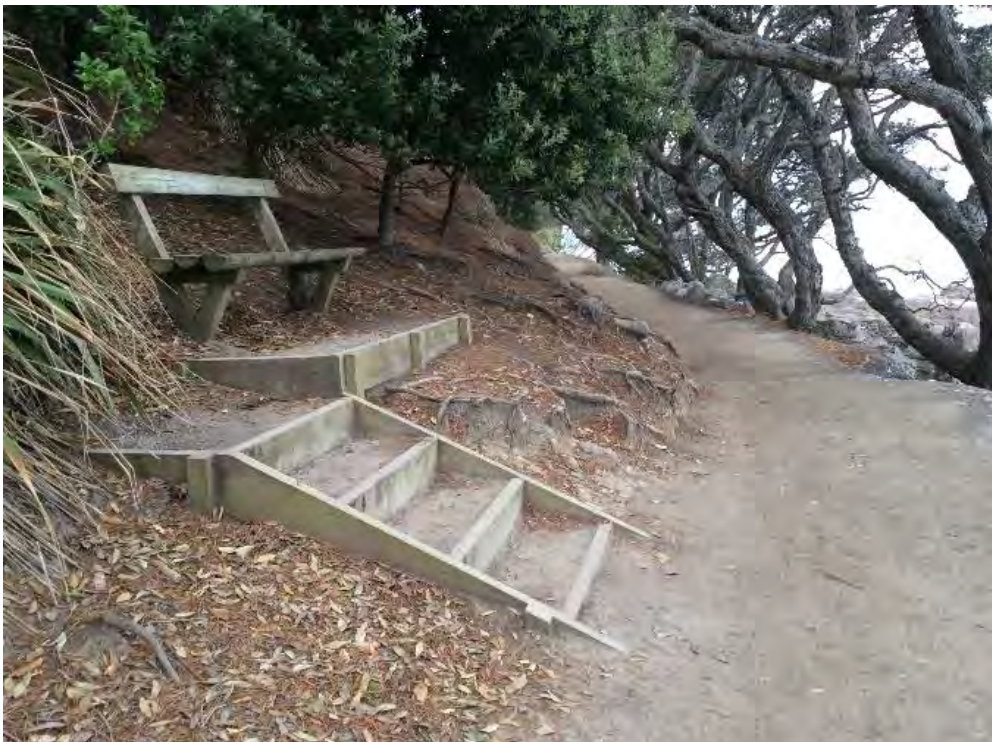
Figure 20: An older seat installed looking over the north-western shore of Mauao. Seats of this age are to be removed in the near future and replaced with more modern seats.

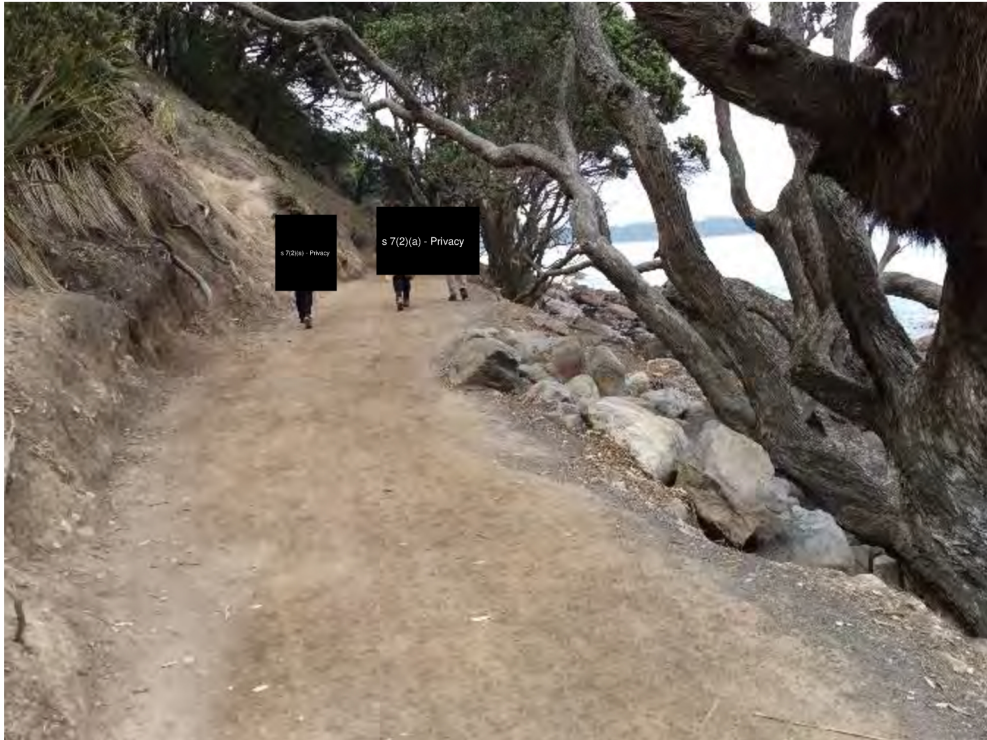
Figure 21: Along the track efforts have been made to remove any leaf litter and easily ignited vegetation within 1m either side of the track to reduce the risk of arson.

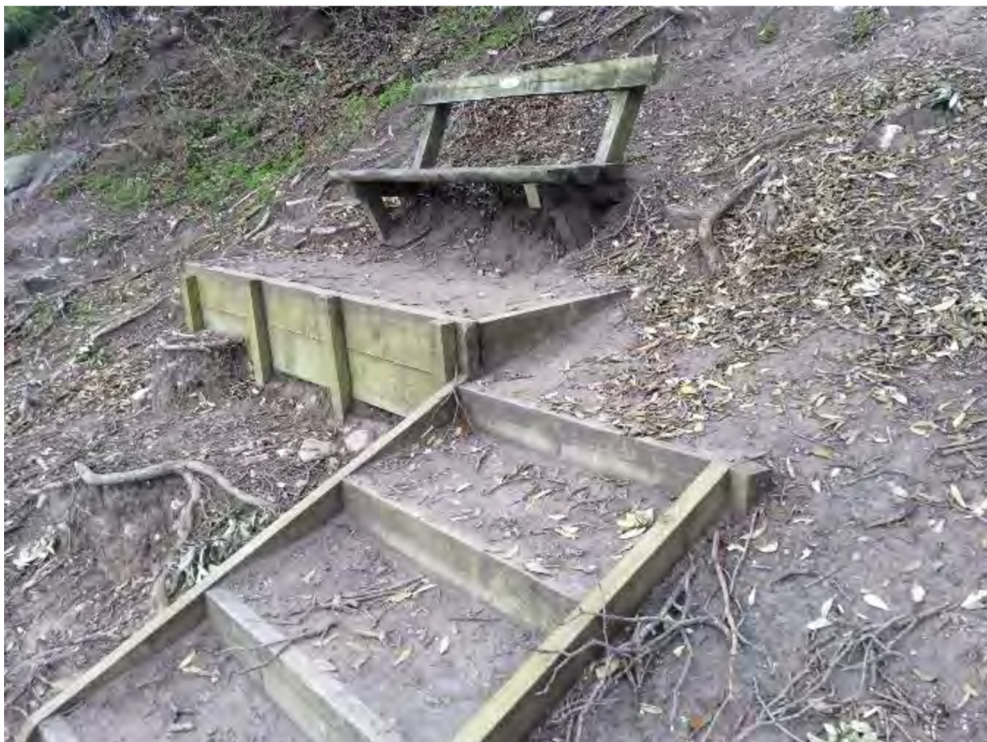
Figure 22: An older memorial seat installed looking over the western shore of Mauao. Seats of this age are to be removed in the near future and replaced with more modern seats.

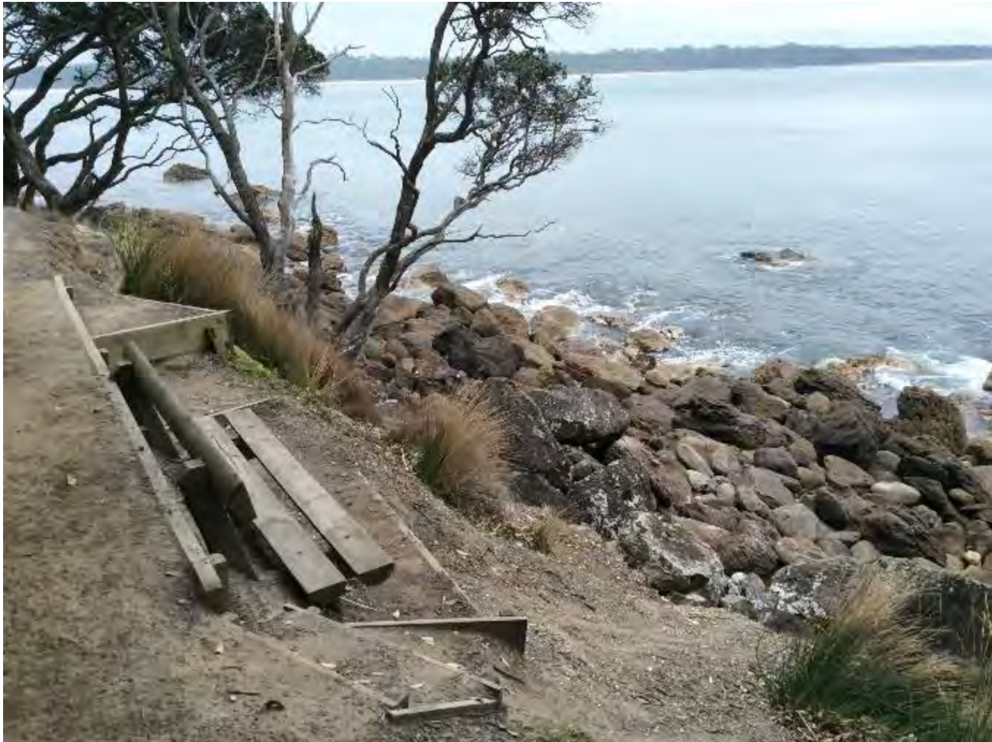
Figure 23: An older seat installed sunken down to track level looking over the western shore of Mauao. Seats of this age are to be removed in the near future and replaced with more modern seats.

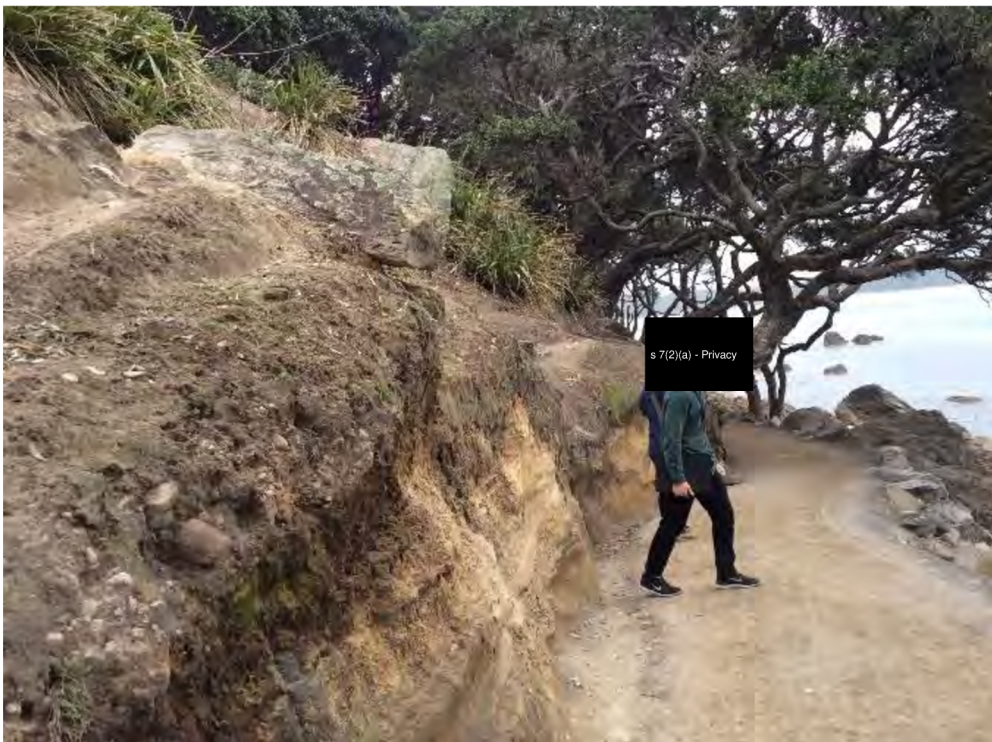
Figure 24: Along the track efforts have been made to remove any leaf litter and easily ignited vegetation within 1m either side of the track to reduce the risk of arson. This is the location where a fire was started in an arson attack on Mauao, burning through a large amount of bush cover.

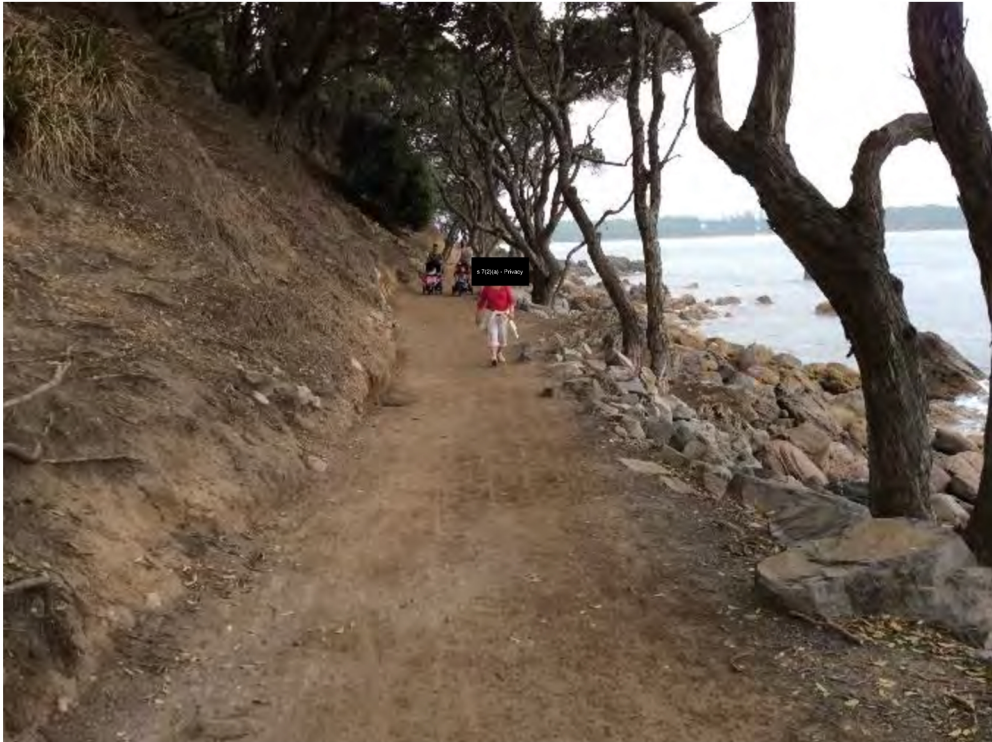
Figure 25: The base track is wide, well maintained with quality ground material and clear sightlines which provide a sense of safety and awareness.

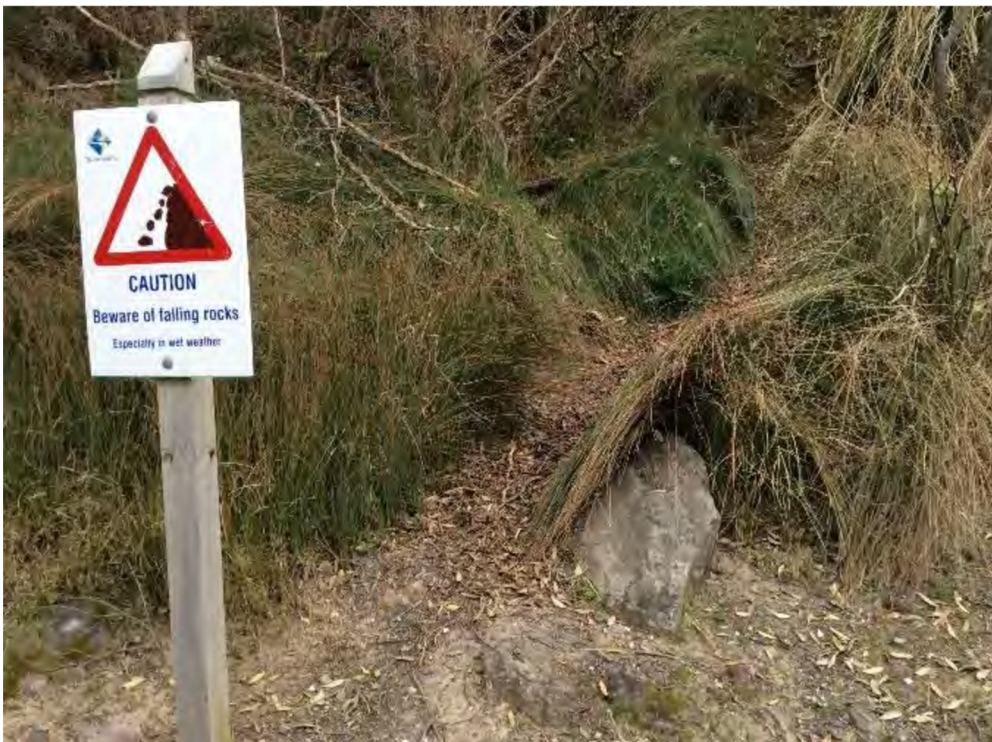
Figure 26: Sign notifying users of potential rock fall hazards in the higher risk areas. Similar signage could be used for other purposes, particularly indicating the safe use of the area as well as location of entries and exits as well as distances from these access points.

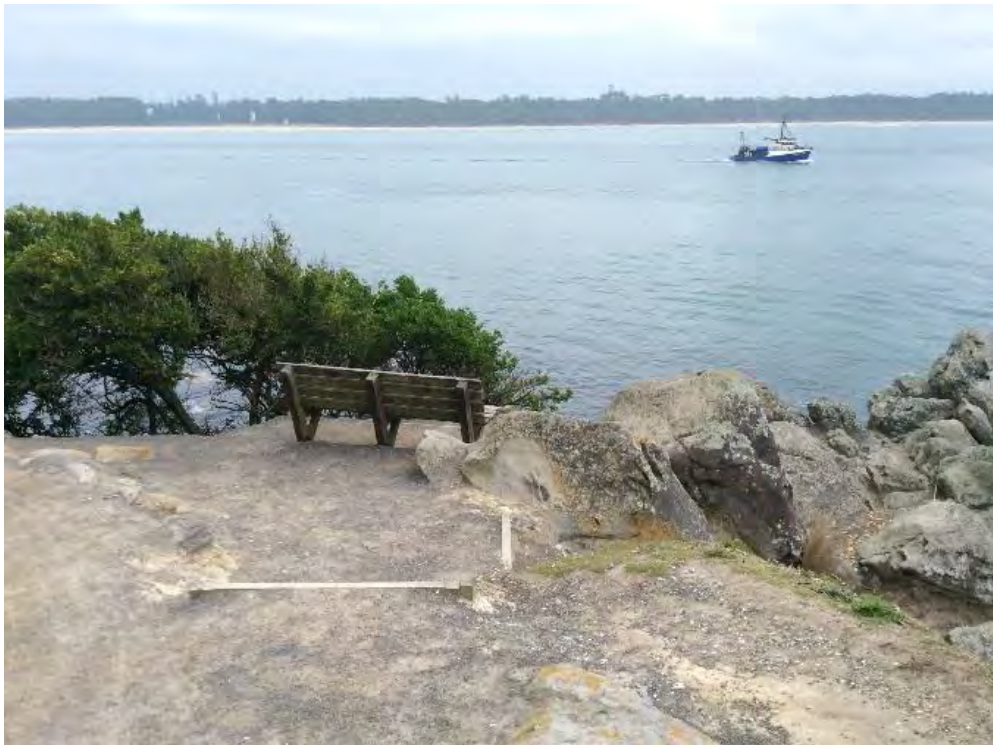
Figure 27: Seat looking over the western shore of Mauao out to Matakana island. Seats of this age are to be retained in the near future and replaced once older seats have been.

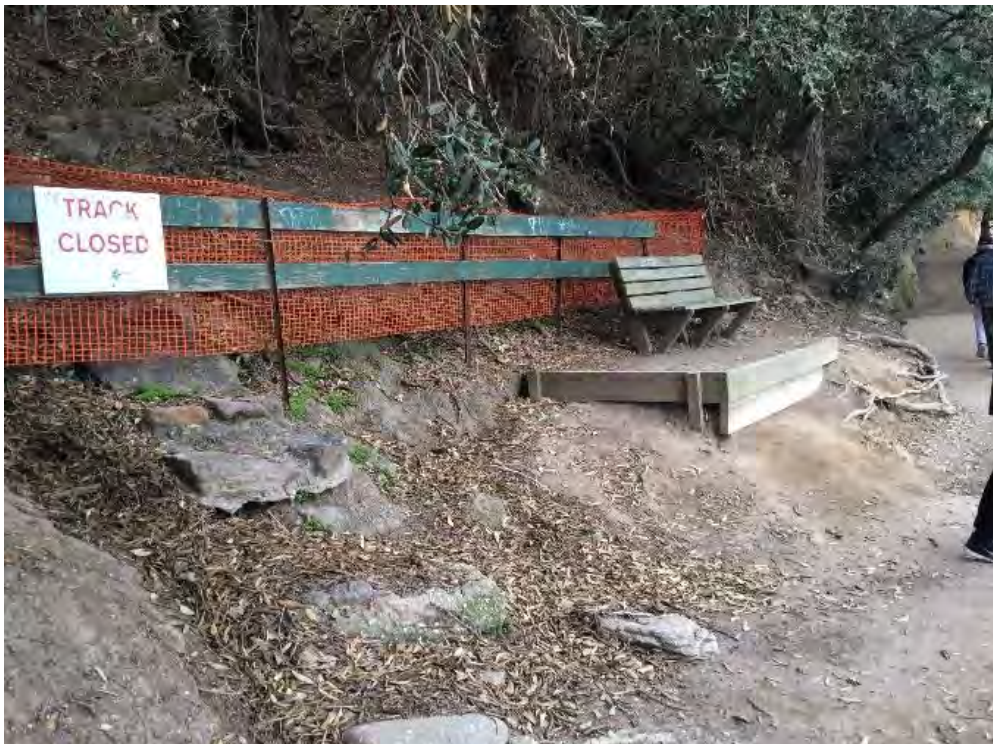
Figure 28: The use of fences and other blocking techniques to prevent users from entering closed tracks is not completely effective. It is recommended that alternatively informative signs on why the track is closed would be more effective of a deterrent from entering the track and is also less intrusive on the character of the walk.

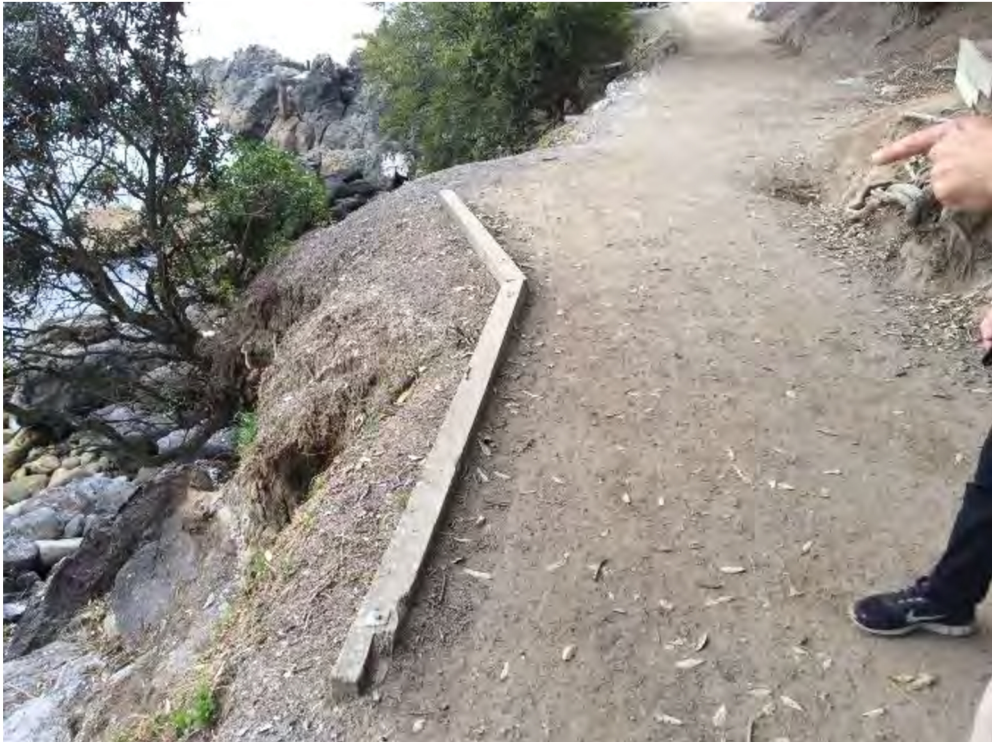
Figure 29: Edging boards are located along the edges of particularly narrow sections of the baser track or more high risk slip areas of the track to better define the edge of the track and reduce falls. It is recommended that other areas are assessed for possible installation of the edging boards to further improve safety.

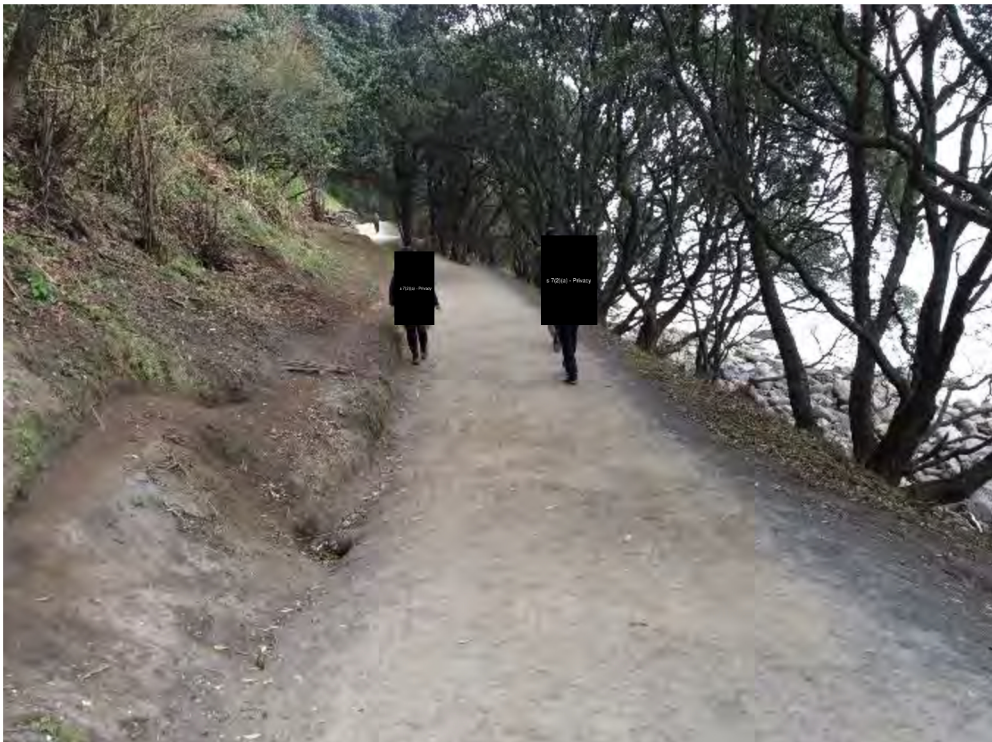
Figure 30: Informal tracks are formed along the edge of some sections of the track. This can become an issue if excessive damage upon the surface occurs, however currently it is not an issue and is hard to prevent when keeping vegetation away from the edge to reduce arson risk.

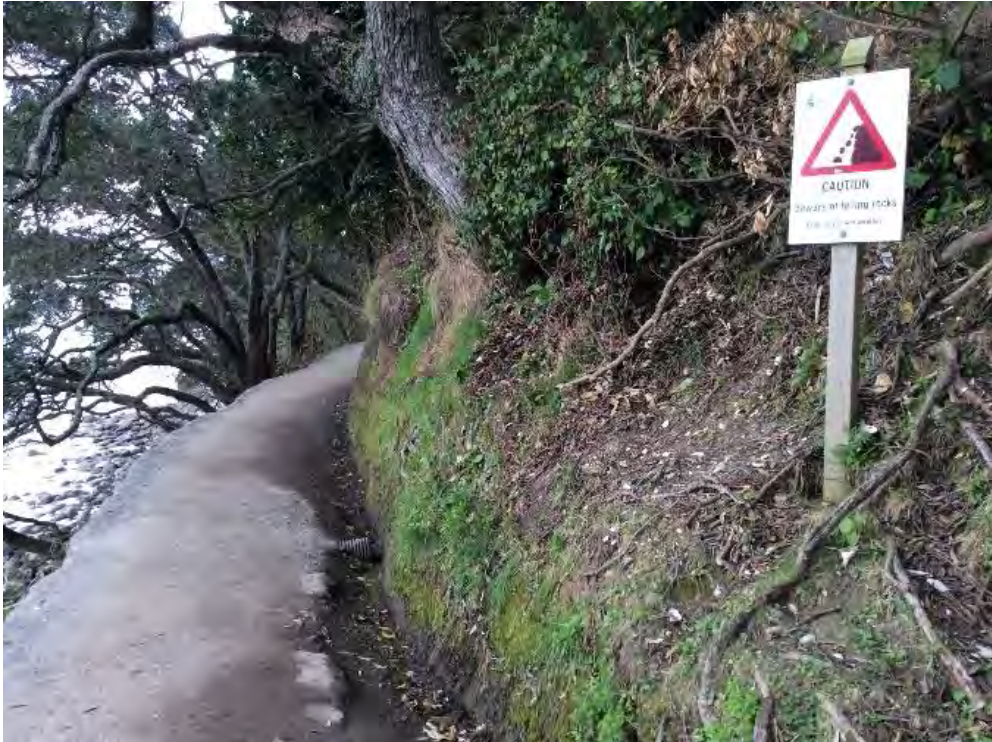
Figure 31: Some sections of the base track narrow considerably. It is recommended that potentials for widening is assessed to better accommodate users for greater safety and better views down the track for increased awareness of surroundings.

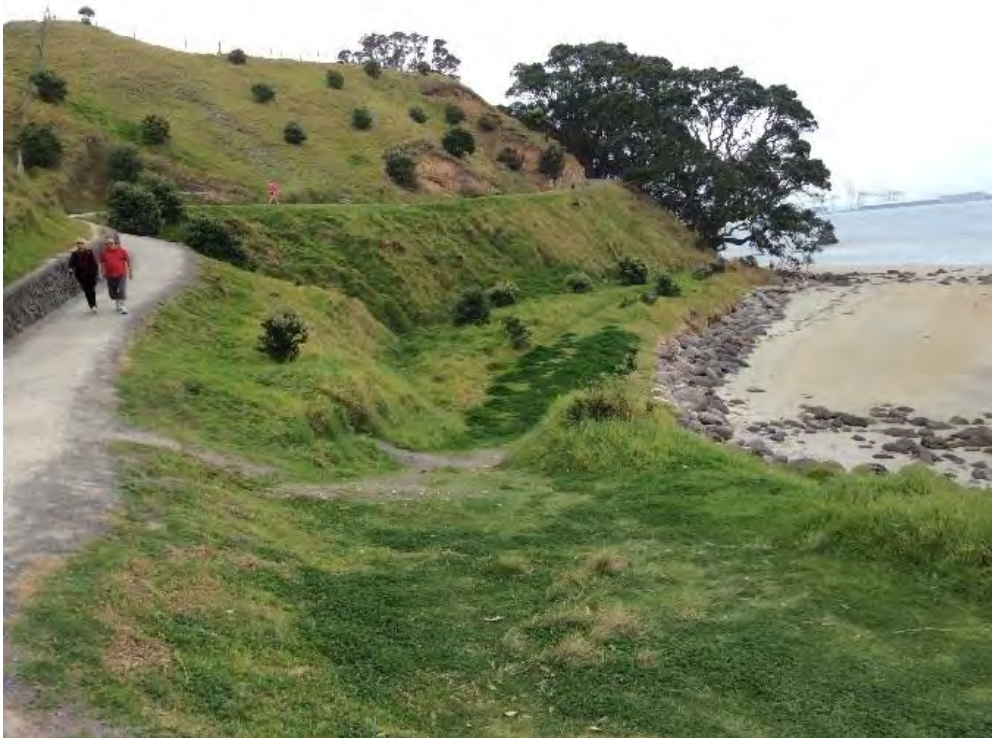
Figure 32: Access to the beach is informal but with clear sightlines, providing safe access whilst maintaining the natural feel of the walk.
