Crime Prevention through Environmental Design Audit & Injury Prevention
through Environmental Design & Universal Access Assessment
Prepared for Tauranga City Council

12 January 2015

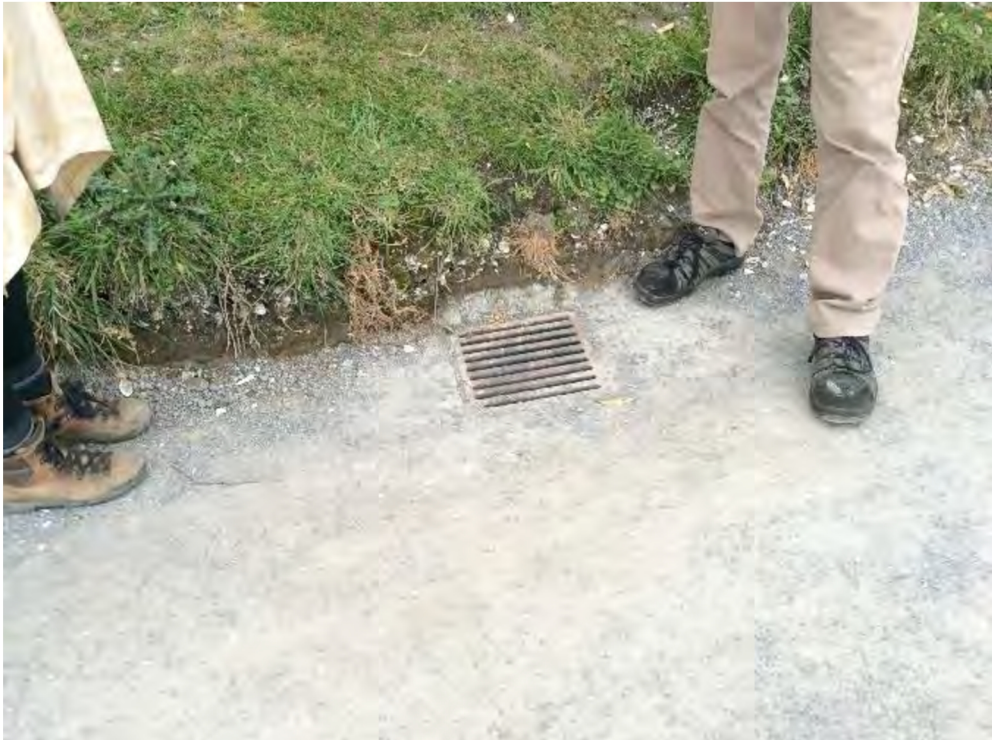
Figure 33: Drainage grate flush with the track is an effective, safe option for drainage as it eliminates any trip hazard as well as opportunity to intentionally damage drainage pipes.

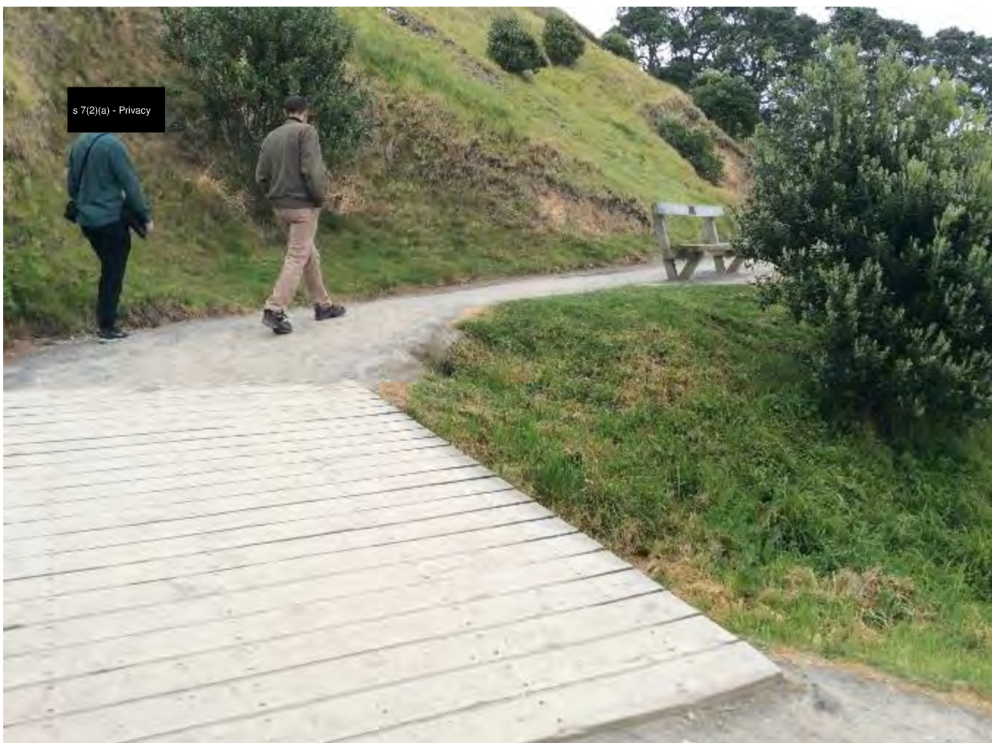
Figure 34: Small bridge that traverses a gully is one of the few built elements on Mauao's tracks excluding furniture.

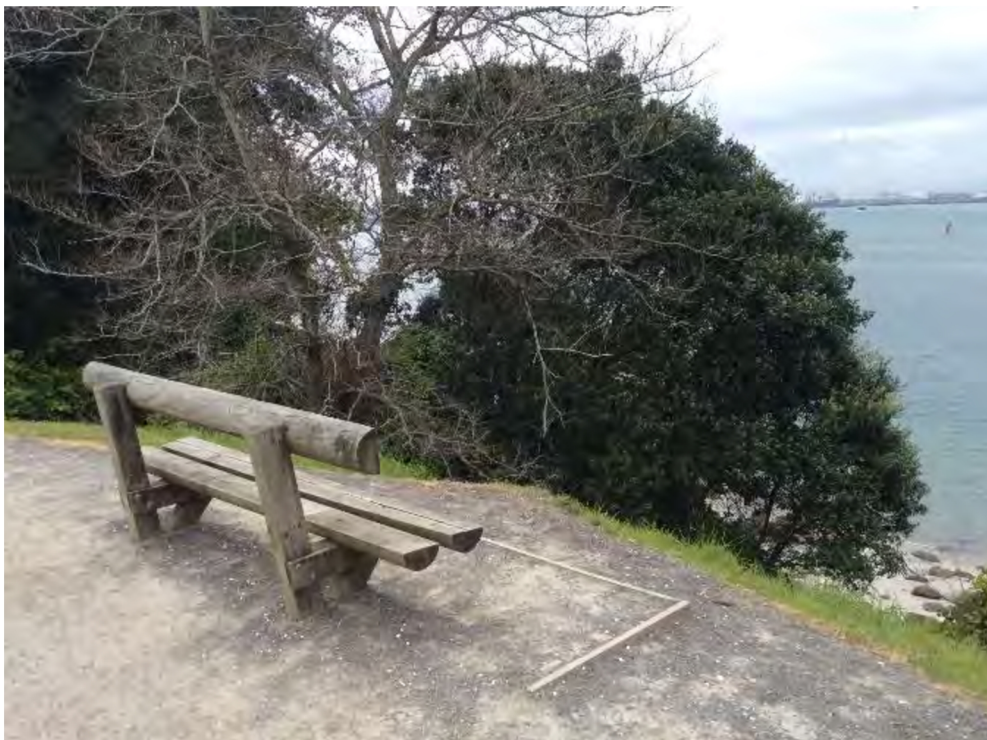
Figure 36: Seat looking over the southern shore of Mauao into Tauranga harbour. Seats of this age are to be retained in the near future and replaced once older seats have been.

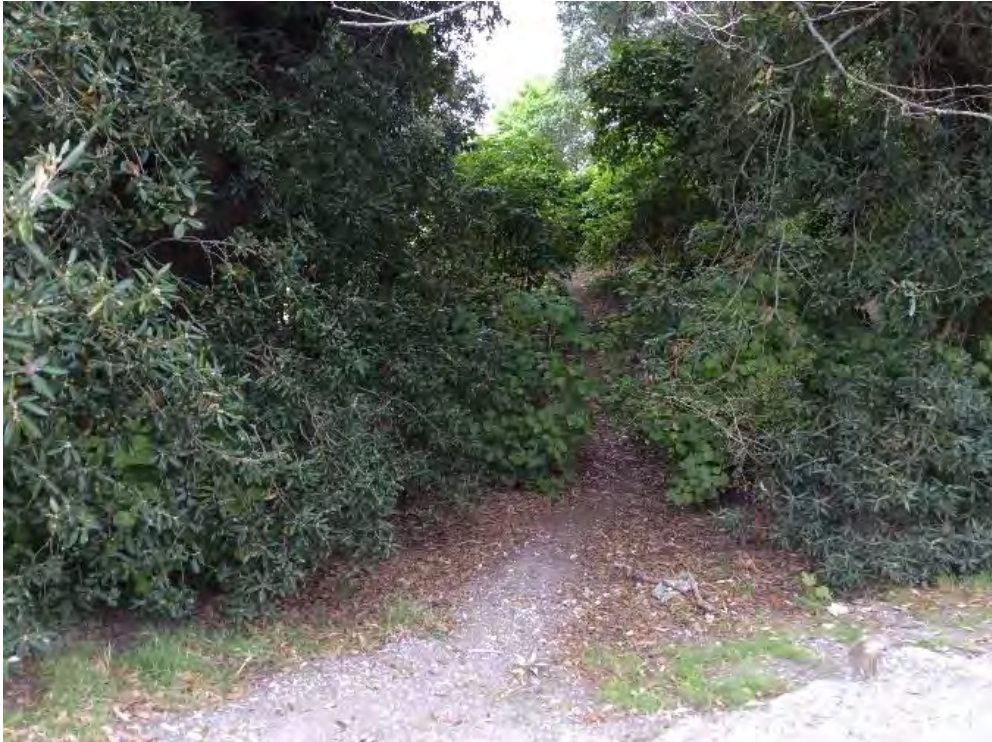
Figure 37: Informal beach access to the beach at the southern tip of Mauao. Due to the vegetation it provides an area for hiding so is recommended that vegetation be manicured in such a way that it opens sightlines and reduces opportunities for hiding.

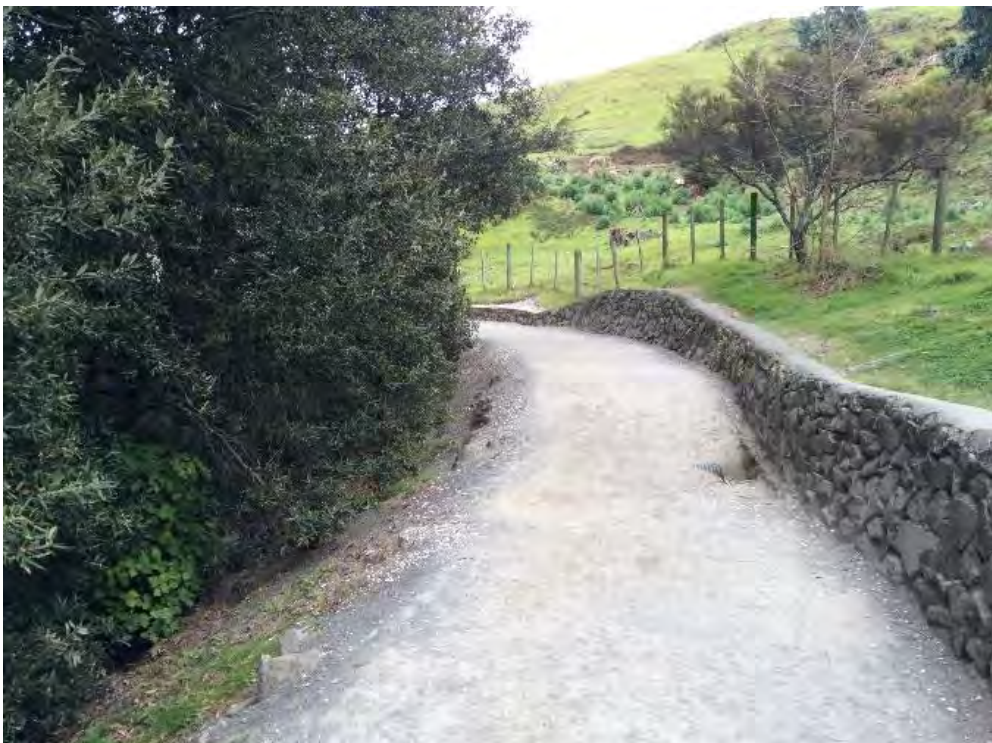
Figure 38: Vegetation obscuring sightlines along the base track. It is recommended that vegetation be manicured in such a way that it opens sightlines and reduces opportunities for hiding.

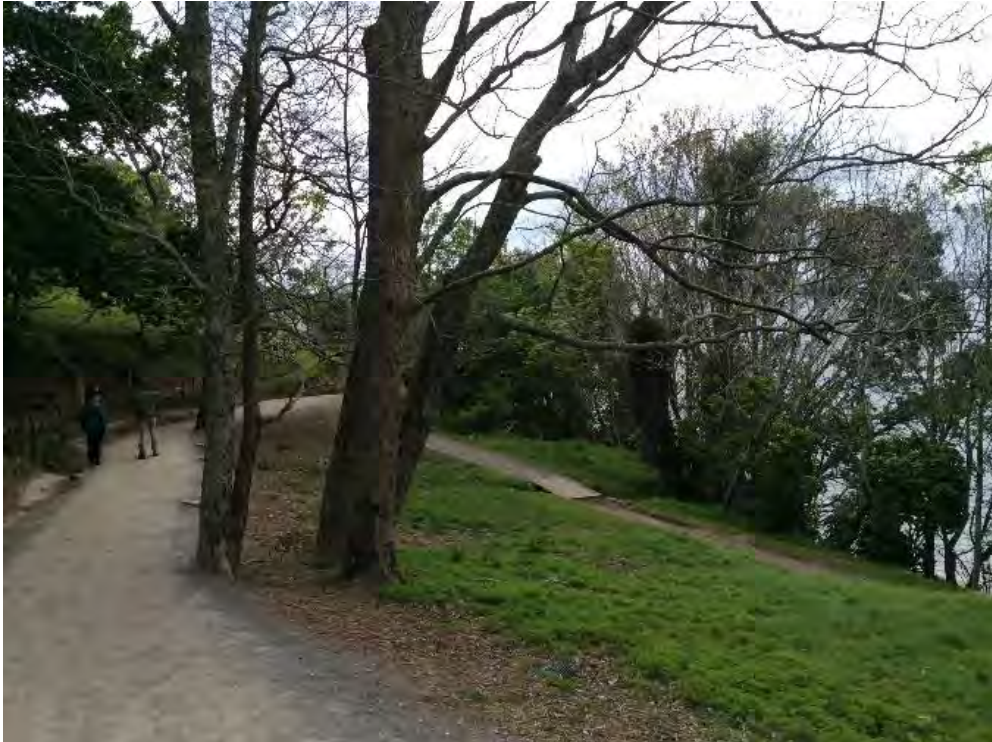
Figure 39: Base track and beach access path. The use of grass allows for clear sightlines, resulting in a good sense of safety for users of the base track as well as those using the beach access track.

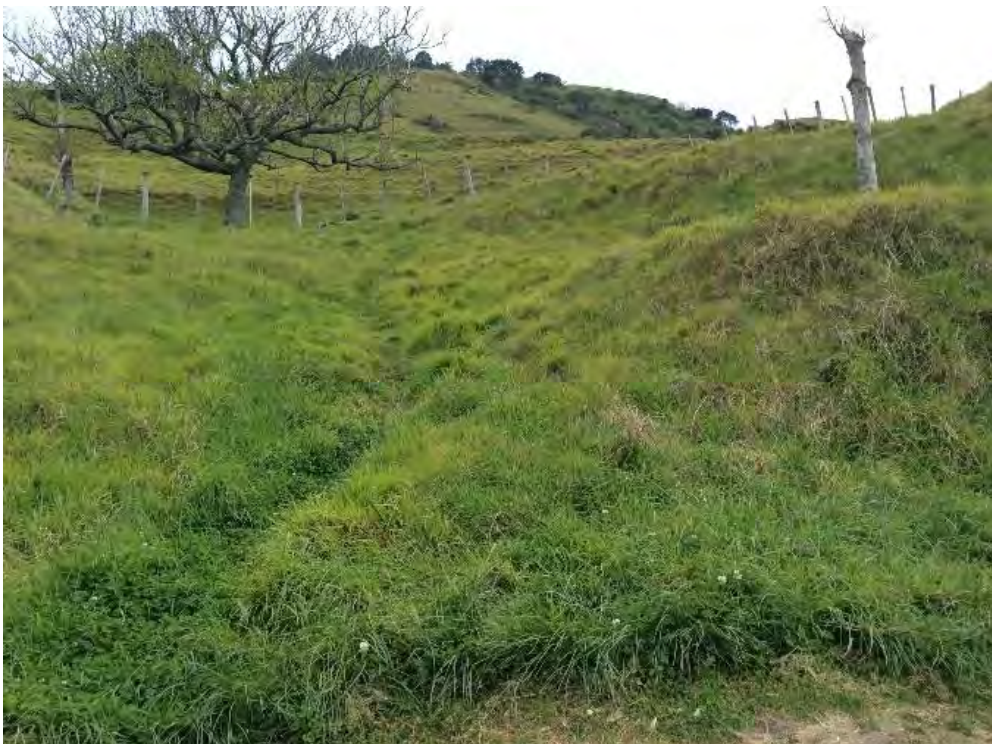
Figure 40: Informal access routes have been formed by users to link to other tracks on Mauao. These informal tracks have potential to act as alternative routes that increase safety and potential for escape in untoward situations. It is recommended that these routes are not shut off and possible formalisation of these tracks could be looked in to.

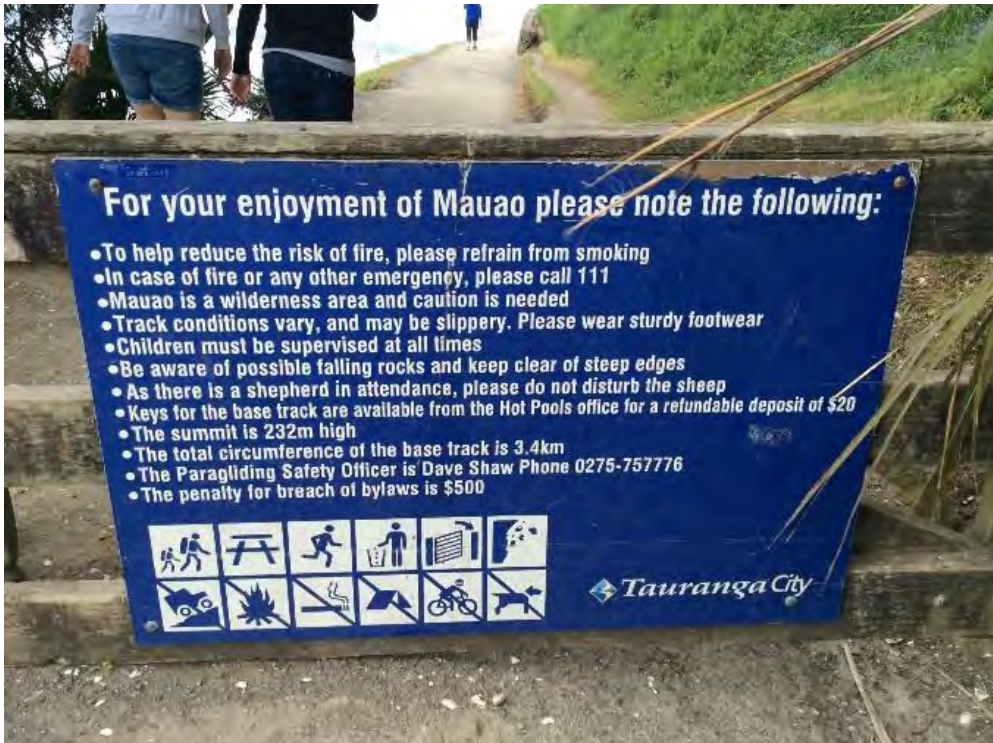
Figure 41: The signs contain a multitude of information, discouraging users to read all of the points. This can lead to improper use of the base track. It is recommended that these signs are reviewed with an aim to provide more concise and informative signs that are visually dominant resulting in a greater uptake of users abiding by the safety procedures.

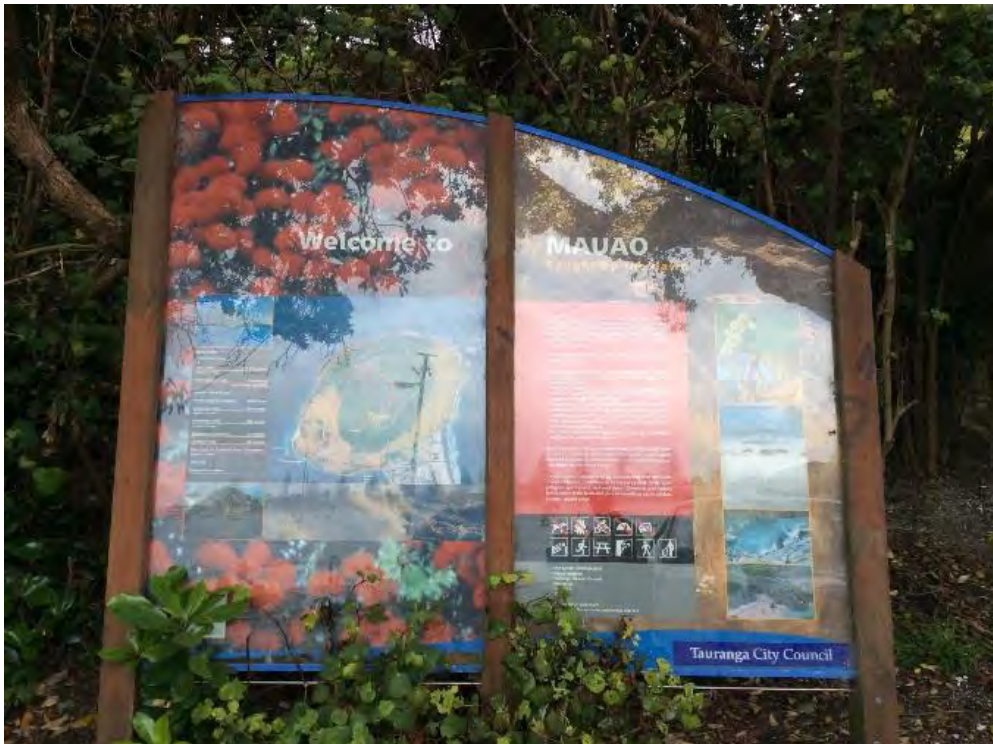
Figure 42: Information signs are located in relatively hidden areas, resulting in very few users reading the information. It is recommended that these signs are relocated into more visible areas, resulting in more users reading the information, This could bring about outcomes including reduced vandalism and encourages a sense of ownership

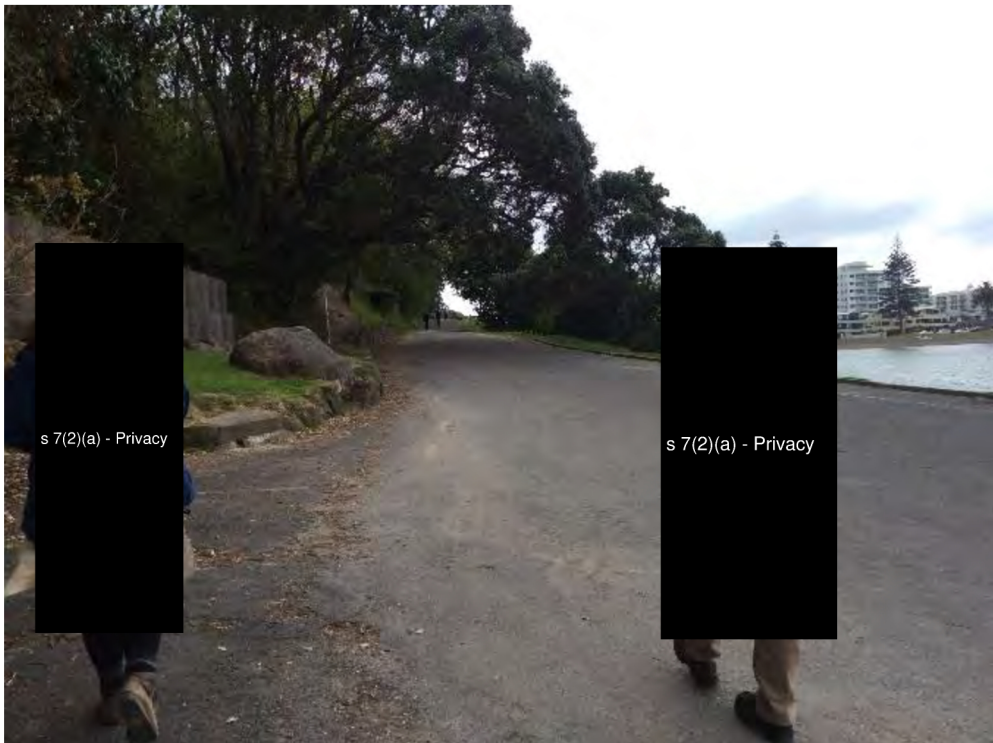
Figure 43: The road that links to the Pilot Bay entrance is not open to public vehicle use. It is wide with open sightlines, however does not provide any alternative routes for escape. The addition of lighting could improve the feeling of safety in this area at night.

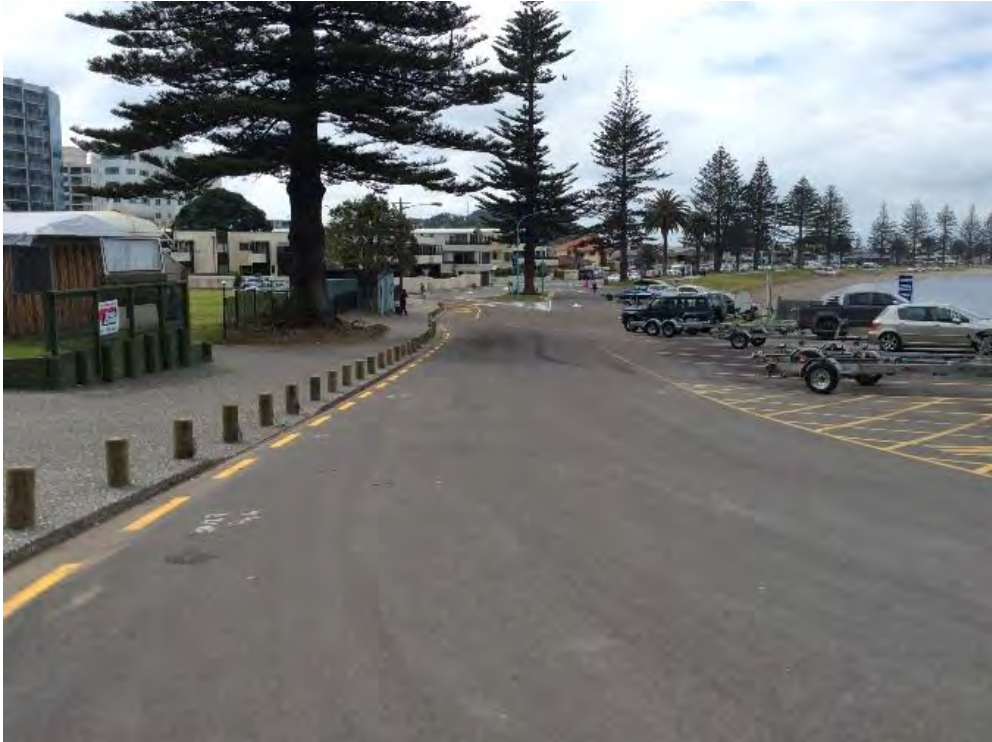
Figure 45: The road before the section closed off for public vehicular use leading to the base track is used for boat trailer parking. This allowance for boat trailer parking results in an extra wide road, providing extensive sightlines for a high sense of safety. CCTV is recommended to be mounted upon the toilet block at the edge of this road section.

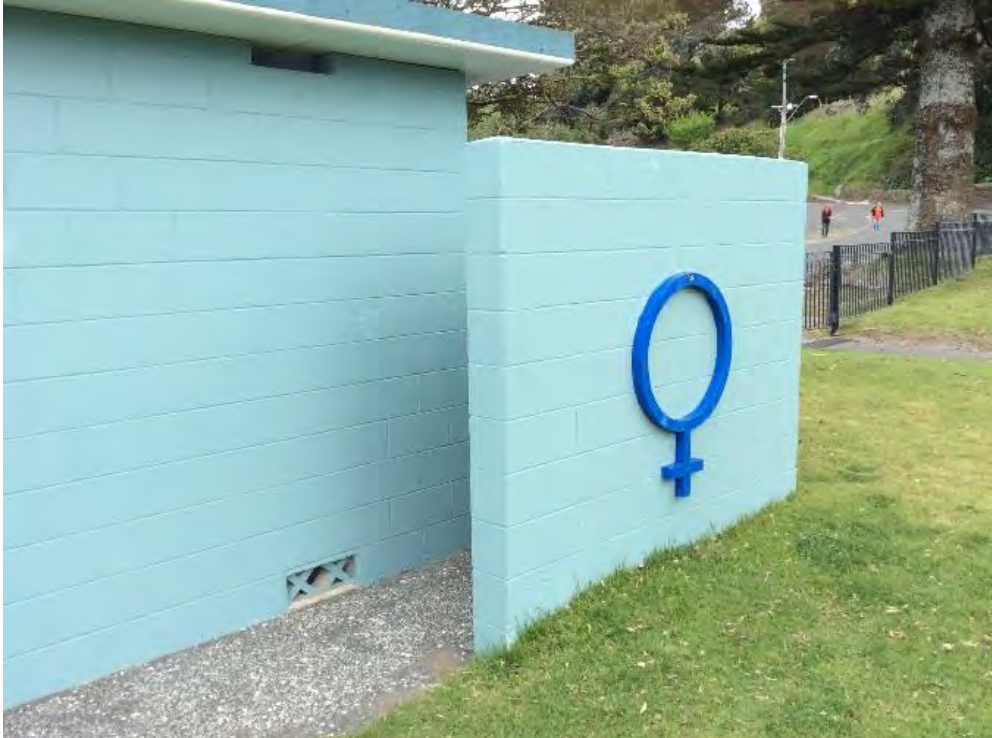
Figure 46: The toilet block that lies on the edge of the campground and the Pilot Bay entrance to the base track of Mauao. The return wall at the back of this toilet block provides a place to hide as well as vandalise. It is recommended that this return wall is removed to increase safety for users.

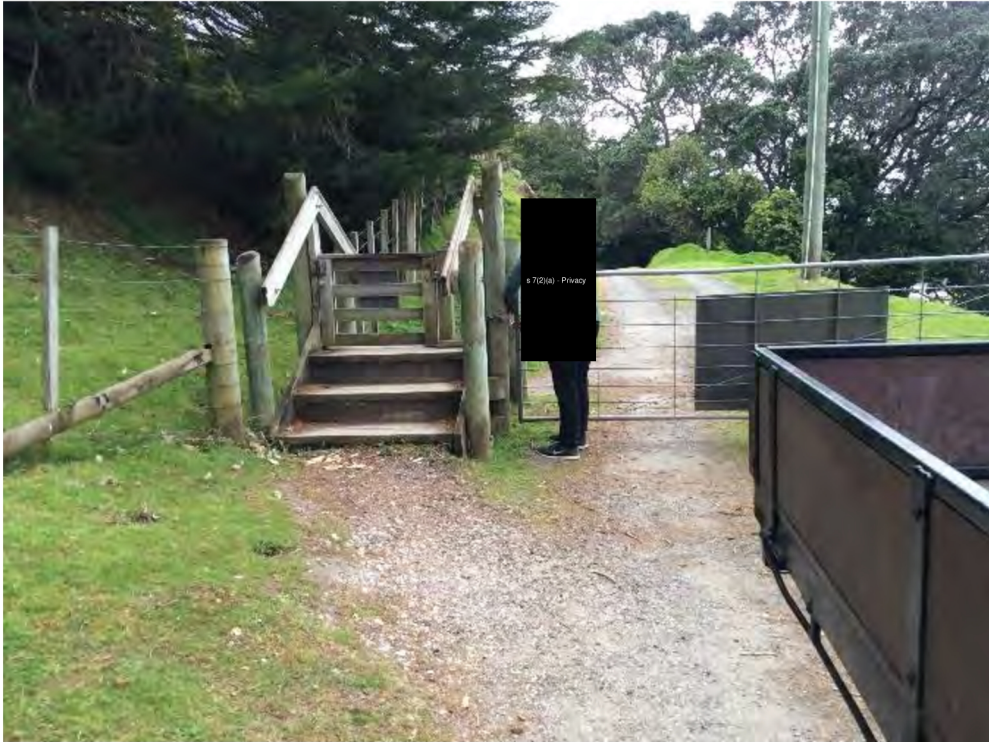
Figure 47: Access at the base of the 4WD track, located at the Pilot Bay side of Mauao includes both pedestrian and 4WD access. Pedestrian access is up steps and through a gate, located next to the 4WD access which is through a farm gate that is locked at all times. 4WD access is restricted to authorised persons only.

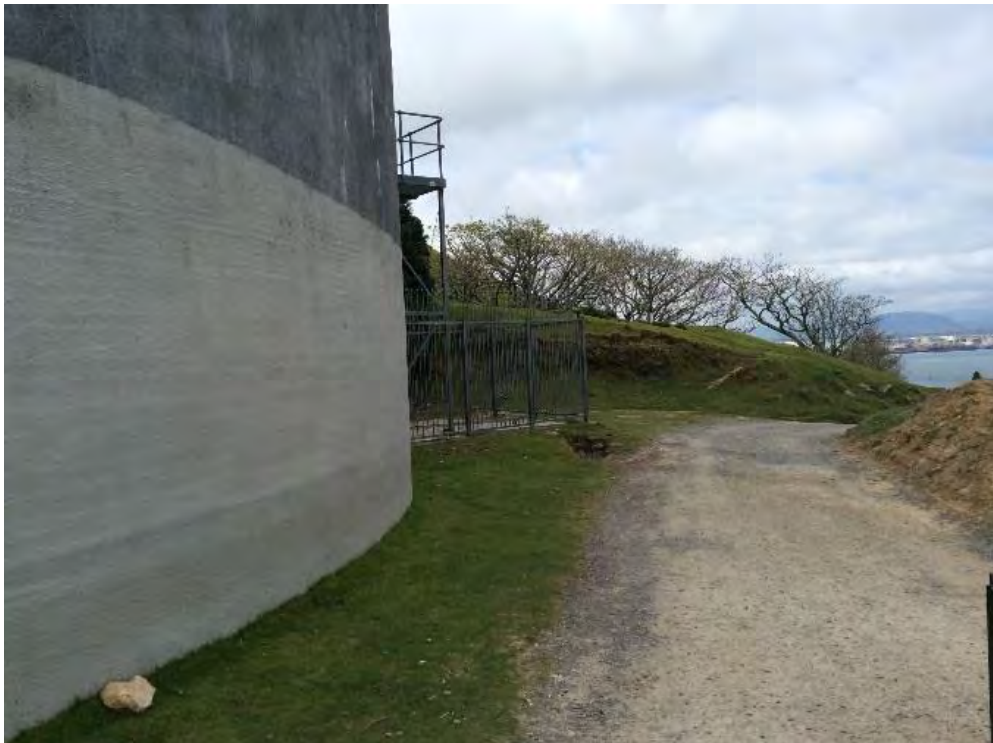
Figure 49: The water reservoir is subject to graffiti and vandalism on occasion. The current remedy is to paint over any graffiti at the first instance, this is not a more permanent and lasting solution. It is recommended to vegetate around the water reservoir to create a screen and barrier for anyone intending on vandalising it.

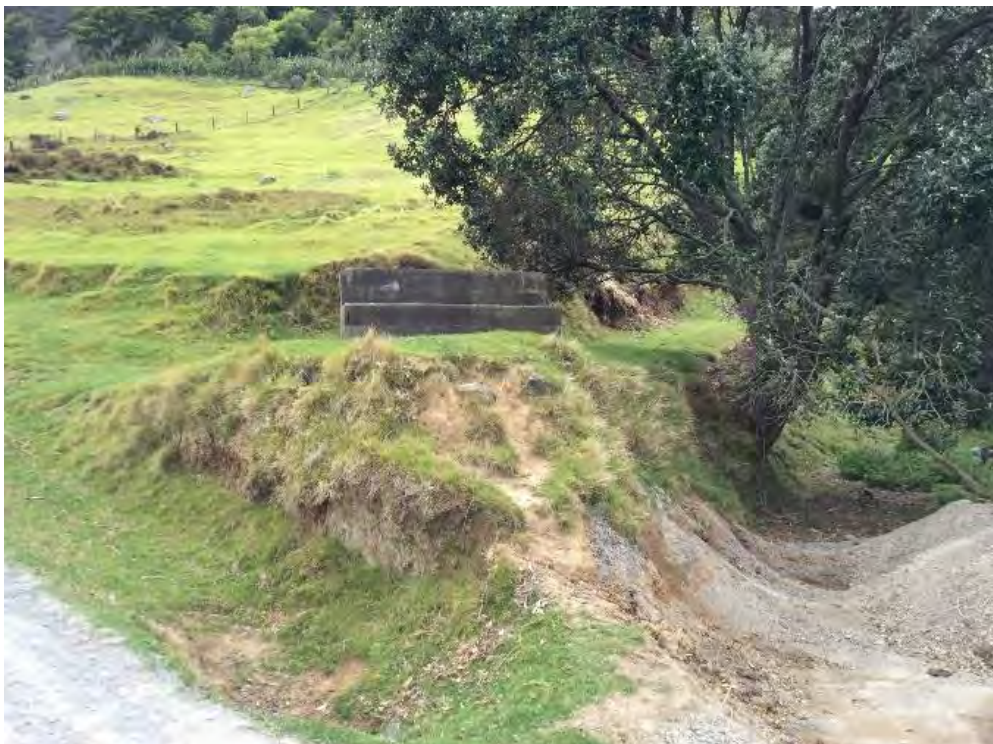
Figure 50: An old concrete seat has become a landmark and feature of the walk. It is recommended that this seat is maintained due to its significance and familiarity to users as well as its unique nature being made out of concrete.

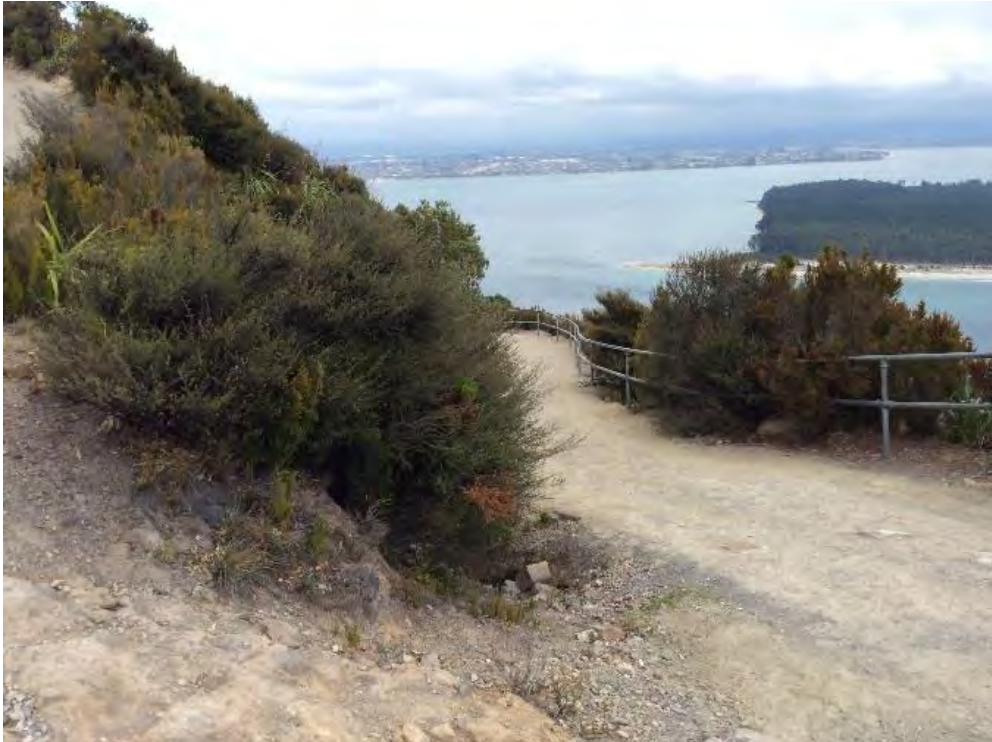
Figure 51: Leading up to the hairpin corner of the track access to the outside edge of the track has been stopped through the installation of hand railing. This was installed after a landslip revealed the steepness and instability of this edge.

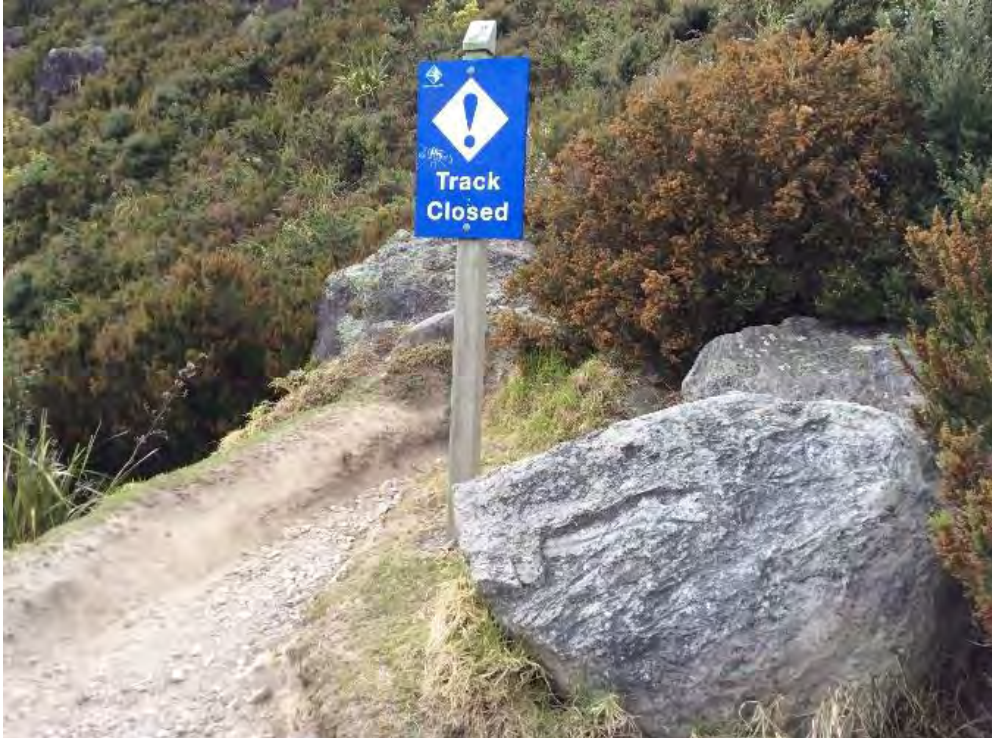
Figure 52: Highly visible sign notifies users that the track is closed. It is recommended that signage options be assessed with potential incorporation of more informative details incorporated into the sign e.g. 'track closed due to rock falls' to better inform and deter users from accessing the closed tracks.

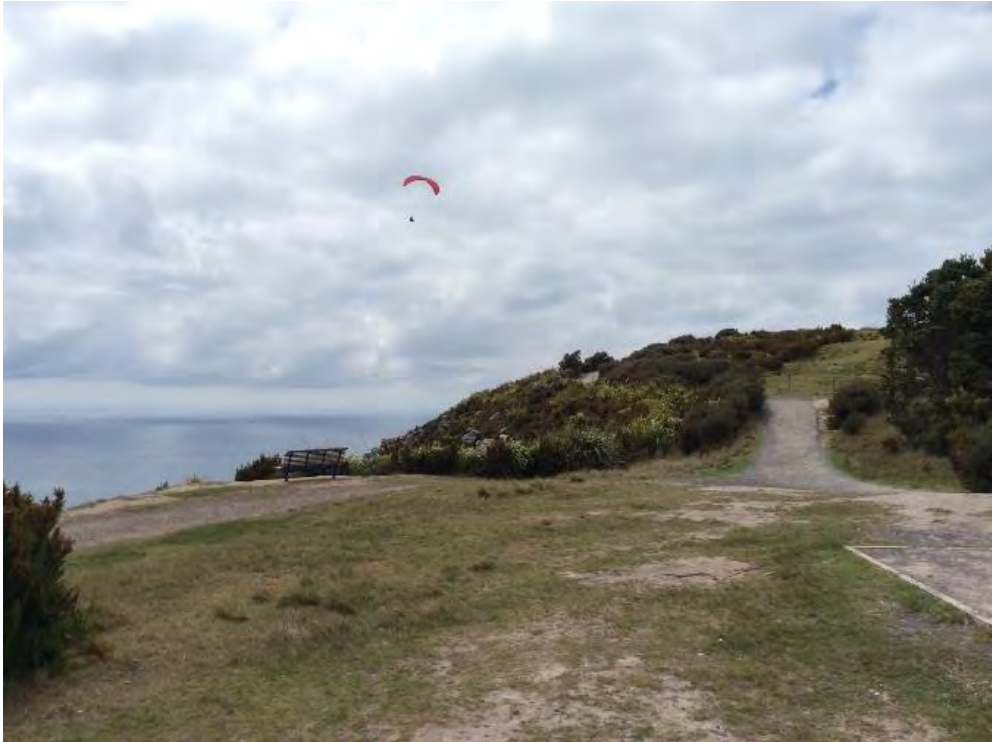
Figure 53: The clearing along the 4WD track leading up to the summit provides both good panoramic views as well as quality sightlines for a good sense of safety and knowledge of the surroundings.

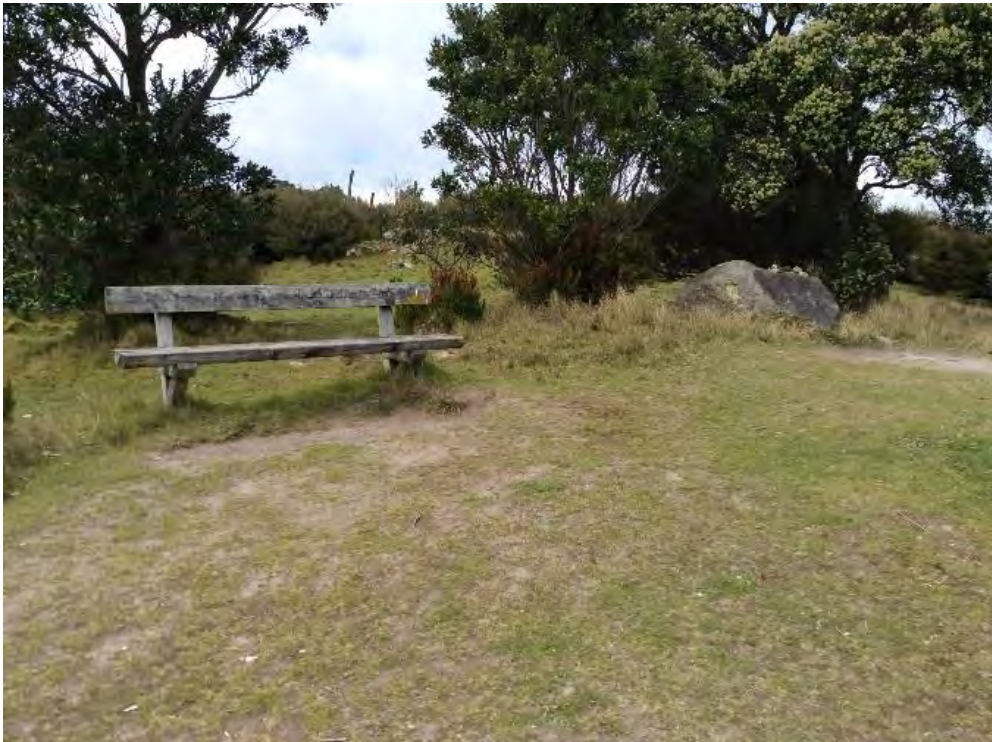
Figure 54: An older seat installed in the clearing along the 4WD track just beneath the summit of Mauao. Seats of this age are to be removed in the near future and replaced with more modern seats.

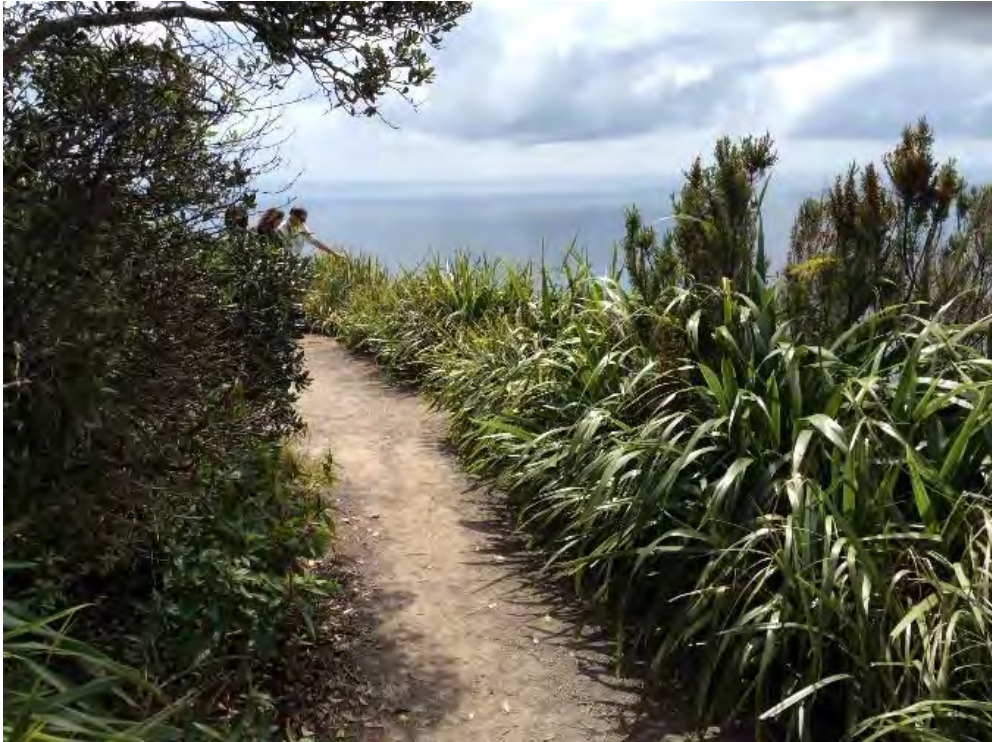
Figure 55: The viewing track at the summit of Mauao is lined with a soft border of mountain flax. This provides not only visual amenity but also added safety from slipping as well as hindering the ability to stray off the designated areas into hazardous areas.

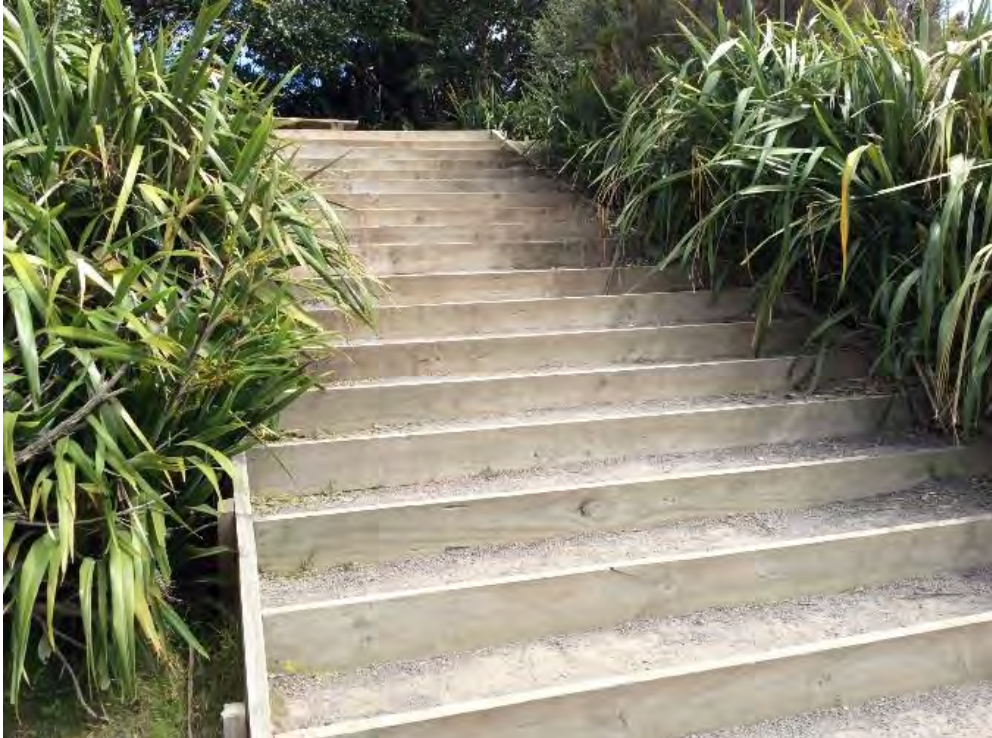
Figure 56: Stairs leading down to the viewing track at Mauao's summit are wide, well-constructed and maintained with mountain flax borders and quality ground material that reduces slipping. This promotes proper usage of the area by providing quality viewing spaces and access ways.

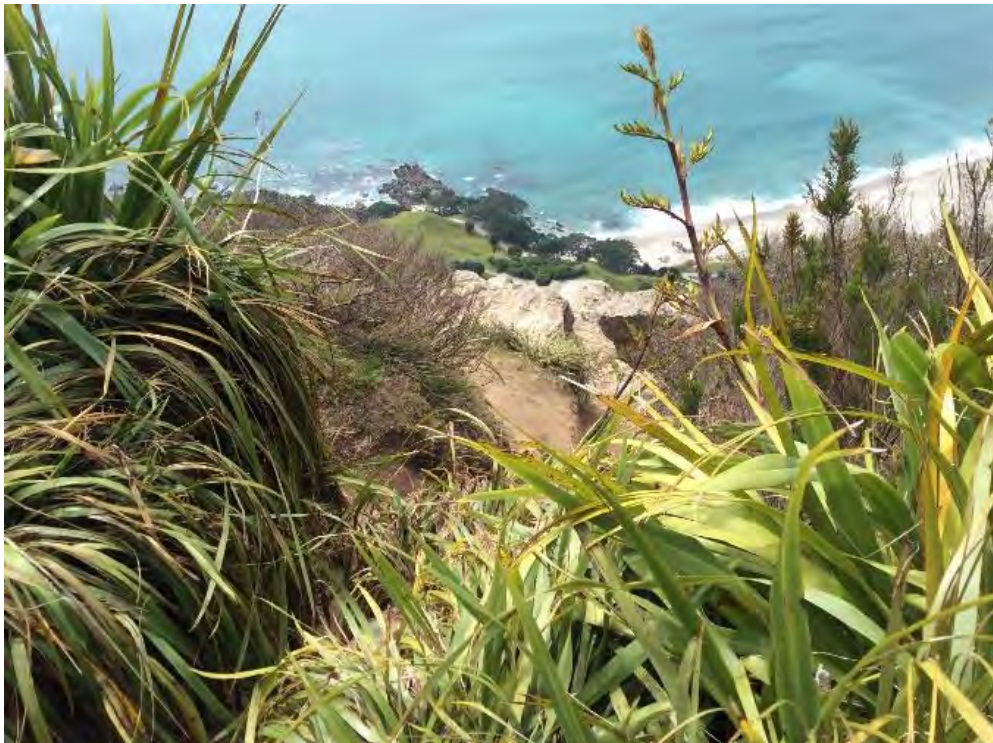
Figure 57: Some users have opened gaps in the mountain flax border to access dangerous viewing points along Mauao's cliff edges. It is recommended that these gaps in the mountain flax border are filled in to reduce opportunities to access these dangerous areas.

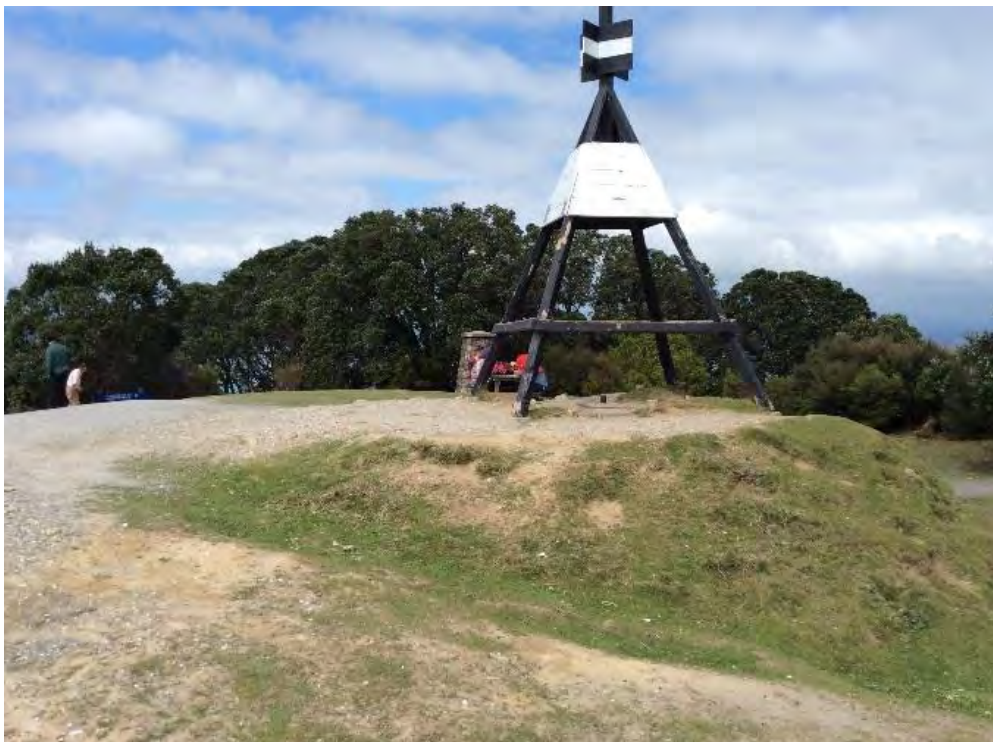
Figure 58: The summit of Mauao. The area is open and well maintained, providing a safe, highly visible area which deters any vandalism upon the summit marker.

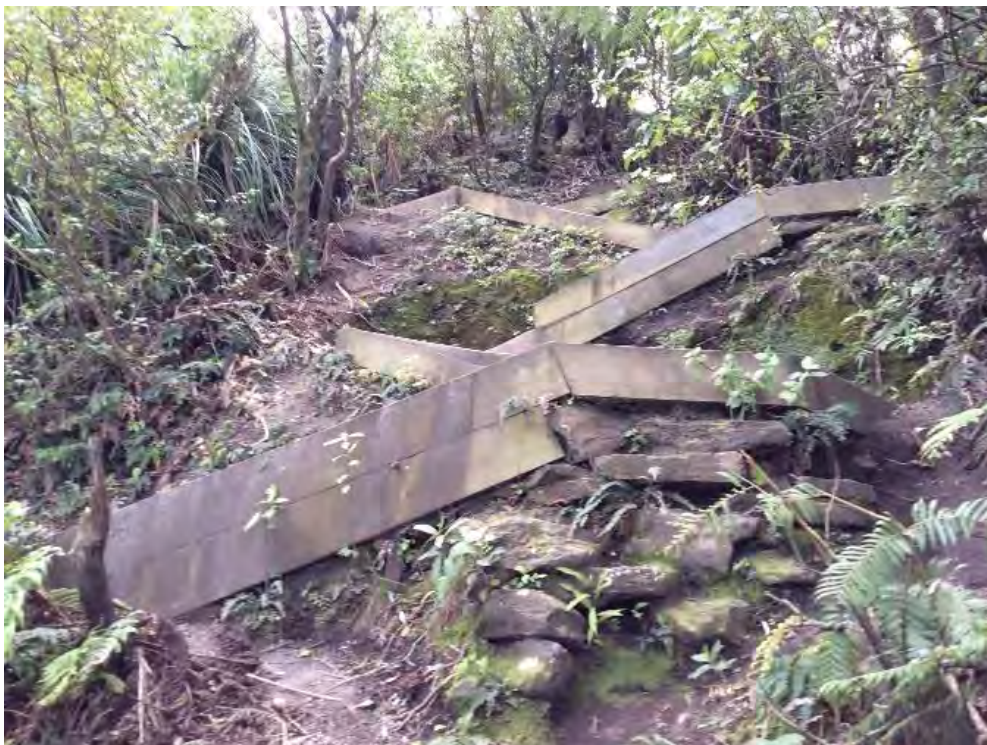
Figure 59: Connecting the Motu Kauri track to the Waikorire track there is a series of winding, steep steps through bush. It is recommended that the steps are maintained by removing any excess material and levelling the tread. Ensure that all wood is structurally sound and not rotting, if so, replace.

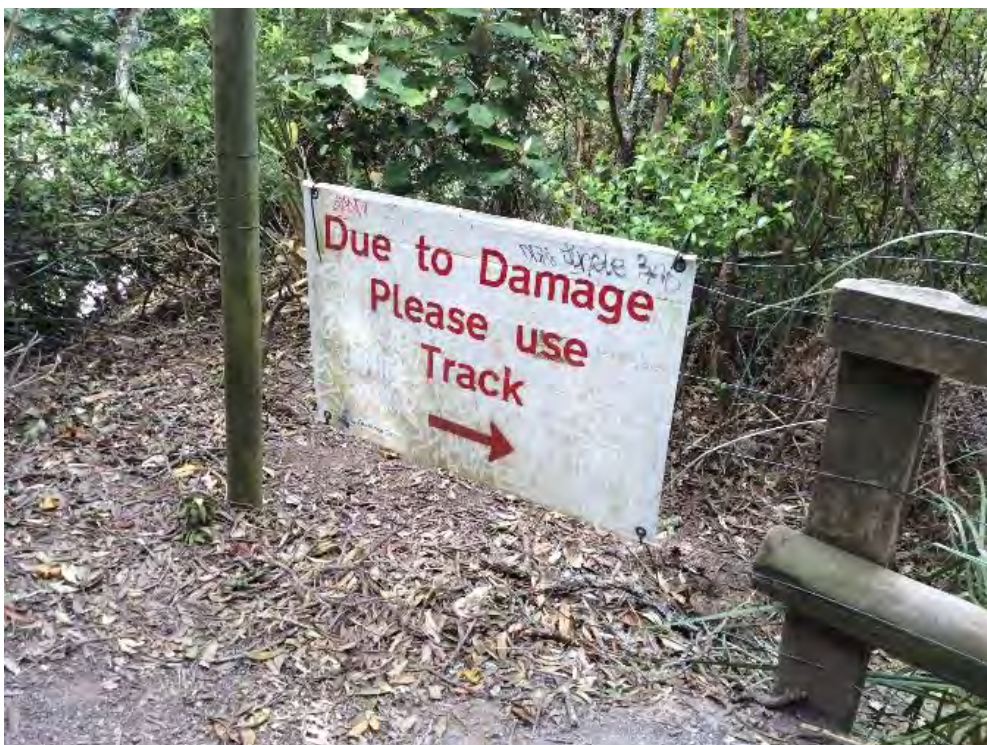
Figure 60: Signage and wire fencing used to prevent users from cutting through bush. This is quite unsightly and also relatively ineffective. It is recommended that border planting is installed to prevent cutting through the bush whilst providing amenity.

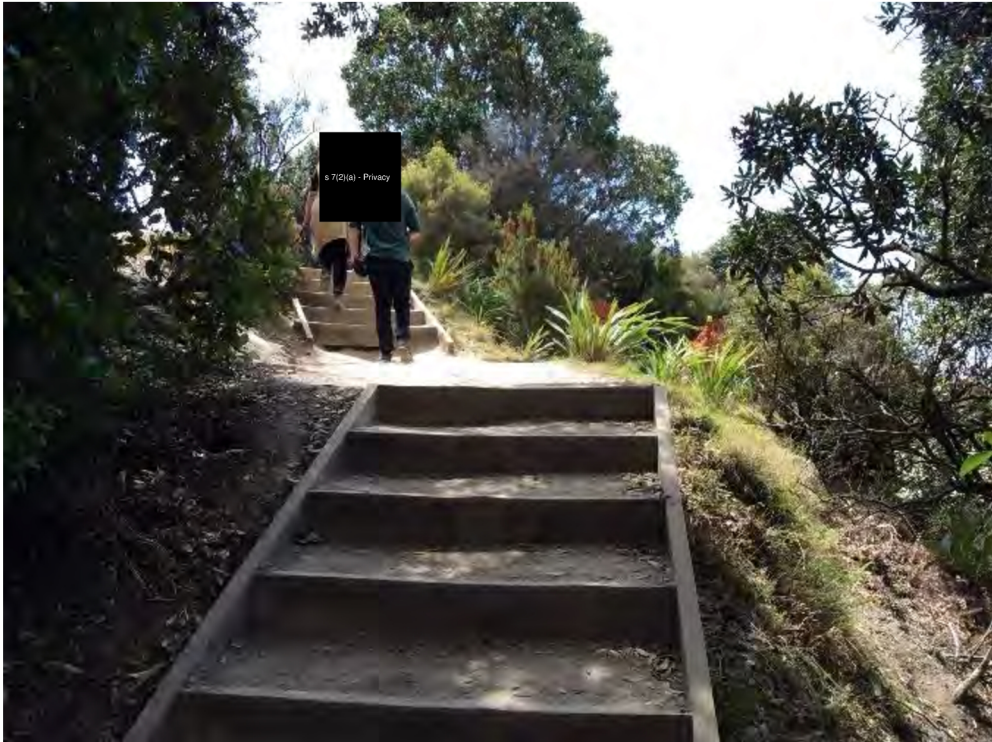
Figure 61: The final series of steps on the Motu Kauri track leading to the summit of Mauao. The steps are well constructed, with a good quality and well maintained ground surface. The absence of vegetation at the immediate border of the track provides greater sightlines for an increased sense of safety and less opportunities for hiding.

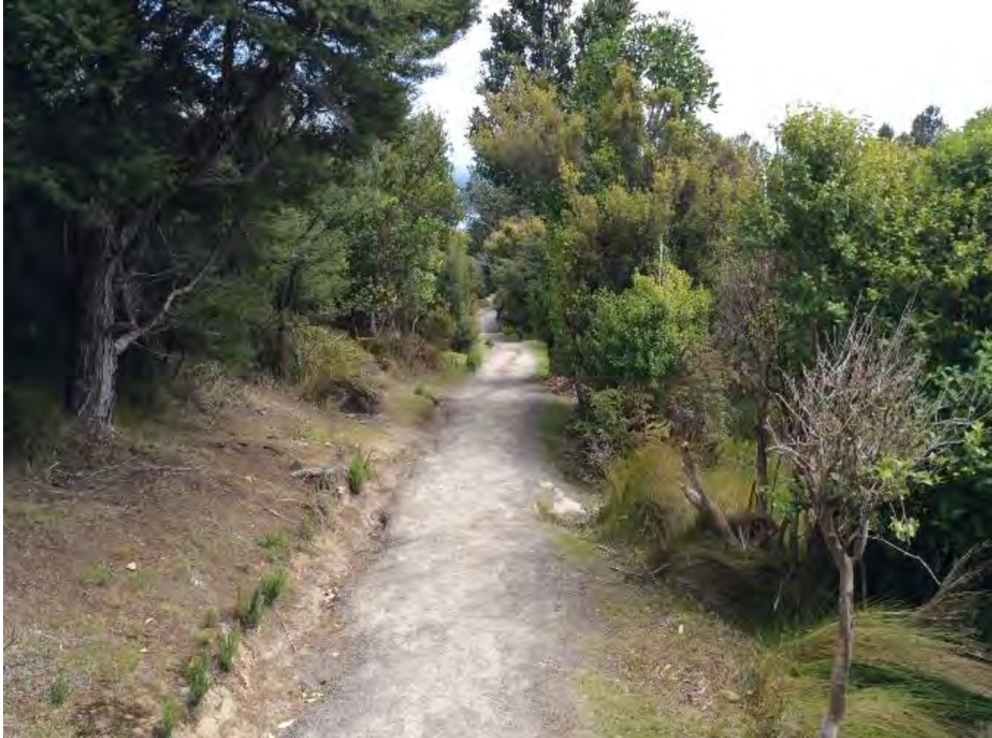
Figure 62: The track is rather narrow and runs through vegetation that is closely located to the track. There are some opportunities for hiding within this closely located, dense vegetation and it is recommended that vegetation is maintained close to the track to ensure best possible visibility while maintaining the bush track atmosphere.

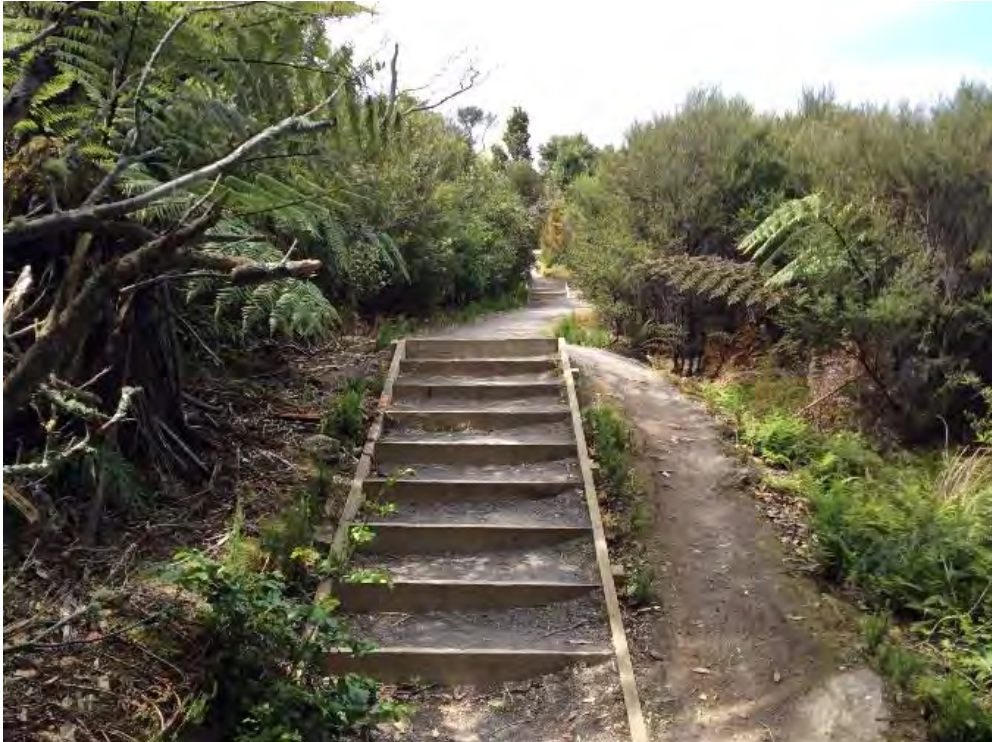
Figure 63: A short set of steps marks the access to the Motu Kauri track from the 4WD track, ascending to Mauao's summit. It is recommended that vegetation is maintained close to the track to ensure best possible visibility while maintaining the bush track atmosphere and excess build-up of material on the steps is removed.
