Crime Prevention through Environmental Design Audit & Injury Prevention
through Environmental Design & Universal Access Assessment
Prepared for Tauranga City Council

12 January 2015

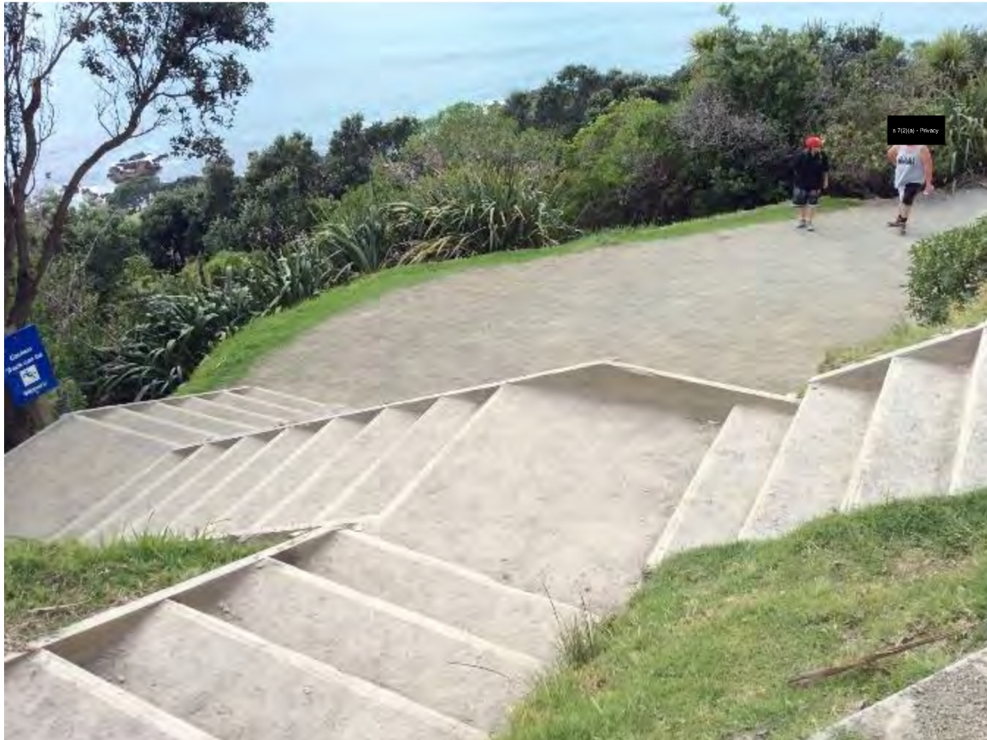
Figure 64: The Waikorire track links to both the 4WD track and the Oruahine track. The junction between the Waikorire track and the Oruahine track is marked with this wide set of steps which are well maintained and constructed.

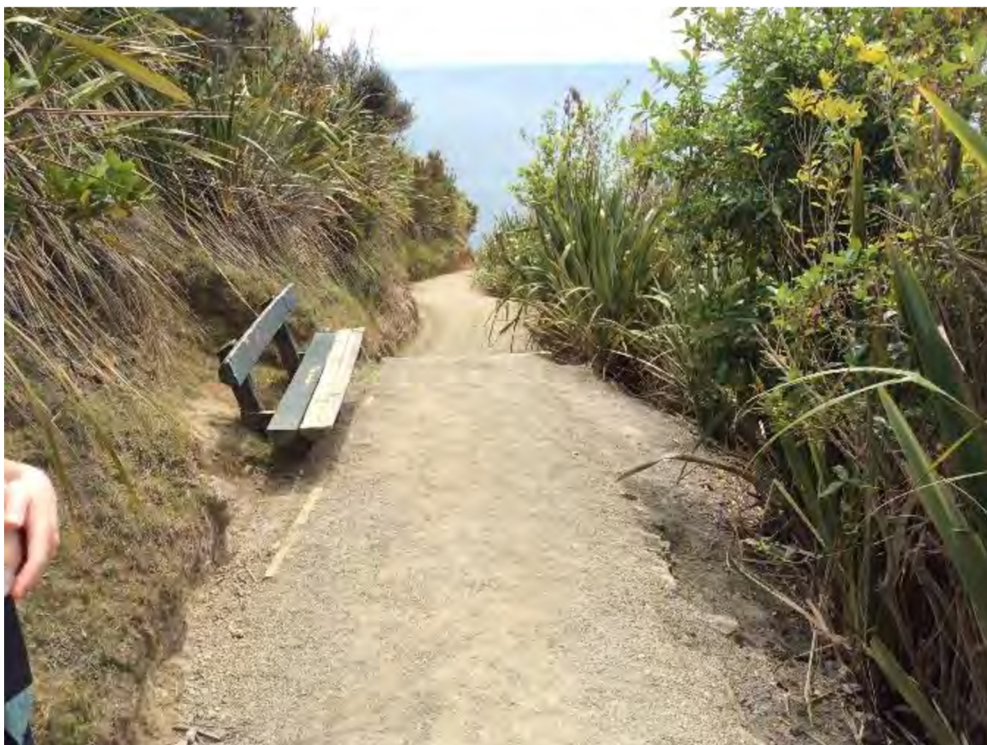
Figure 67: Rest areas, particularly seats are quite sparse in relation to the severity of steepness of the track which results in a greater need to rest at shorter intervals. Older seats like this are to be removed and replaced by newer seats in the near future.

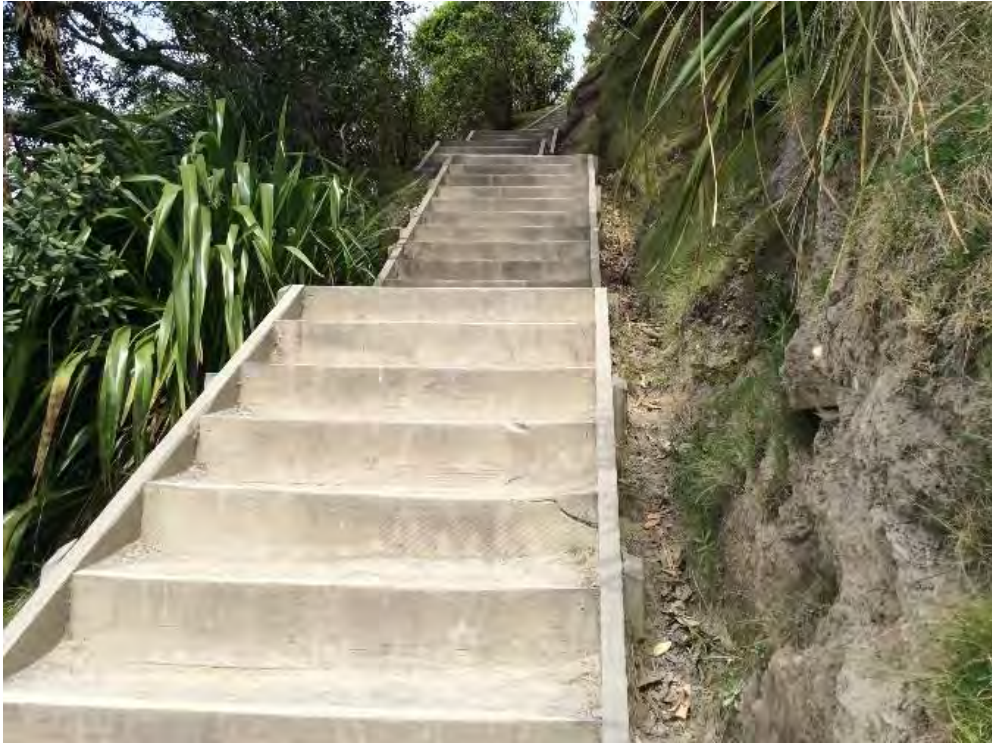
Figure 68: Access up Waikorire track from Oruahine track is via a constant combination of steps and landings, ascending steeply. The ground material is well maintained and the steps are well constructed. Sightlines along the track and out are clear, providing a sense of safety for users.

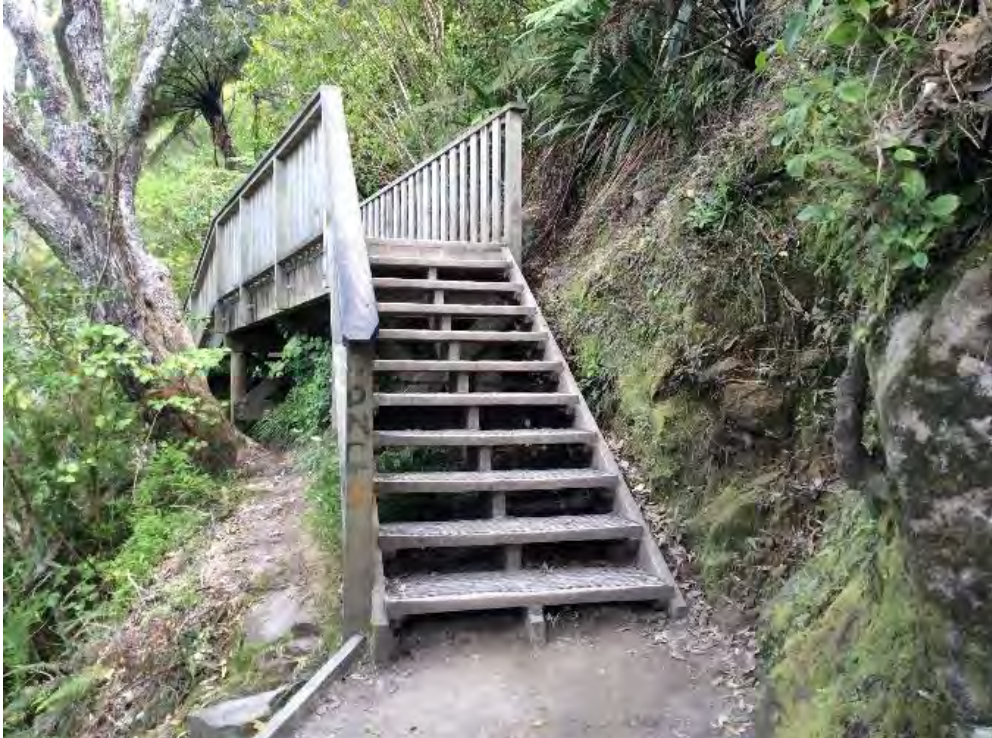
Figure 69: The bridge along the track is in good condition and is well constructed with good handrails and slip proofing. There is evidence of minor, old vandalism, however the design of the bridge is such that it provides very little areas for vandalism to occur or have a major effect.

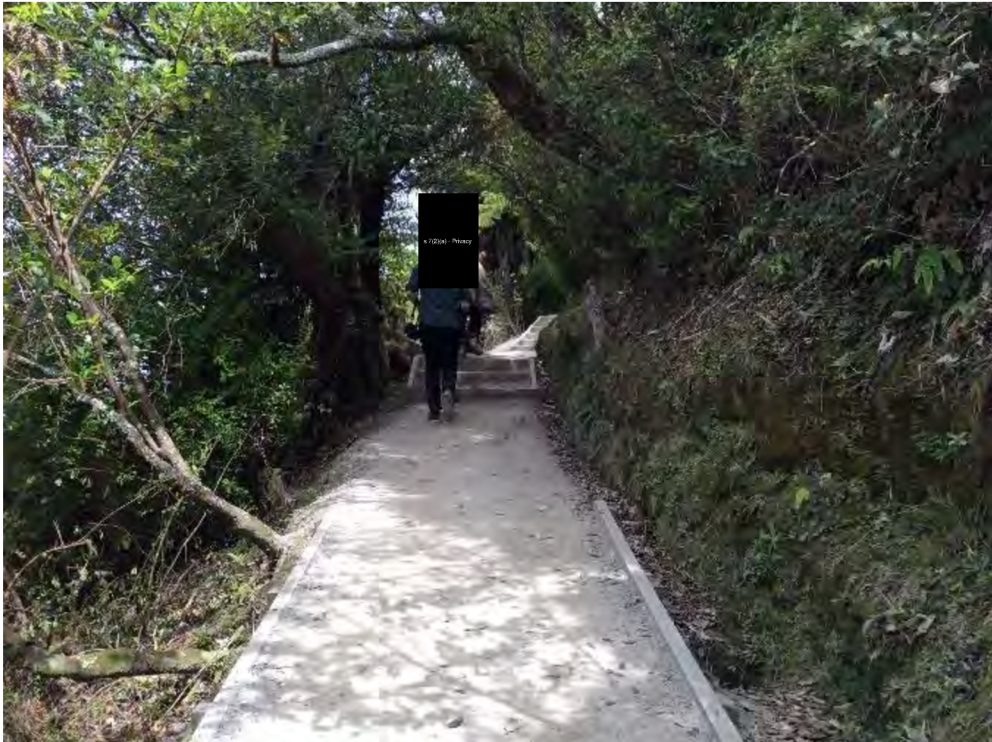
Figure 70: In sections of the track there is vegetation enclosing on both sides of the track, however sightlines along the track are good and the steepness of terrain off the track does not support opportunities for hiding so in this case the high sense of safety is still maintained.

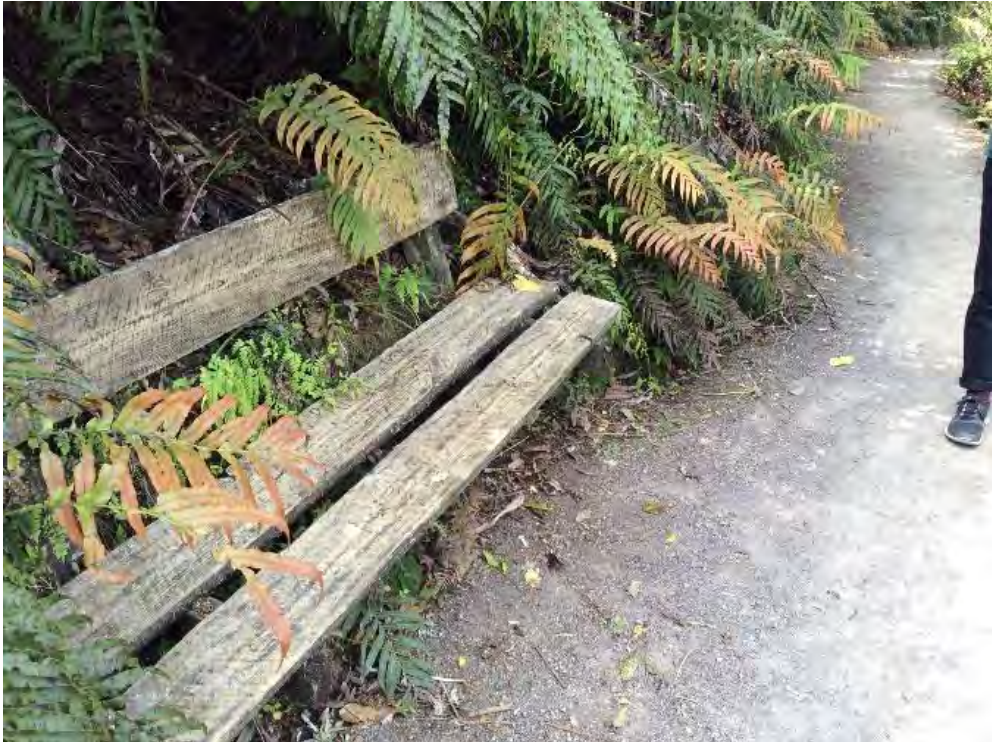
Figure 74: An older seat nestled into the vegetation along the narrow section of the Waikorire track between the connection to the 4WD track and the junction with the Motu Kauri track. Seats of this age are to be removed in the near future and replaced with more modern seats.

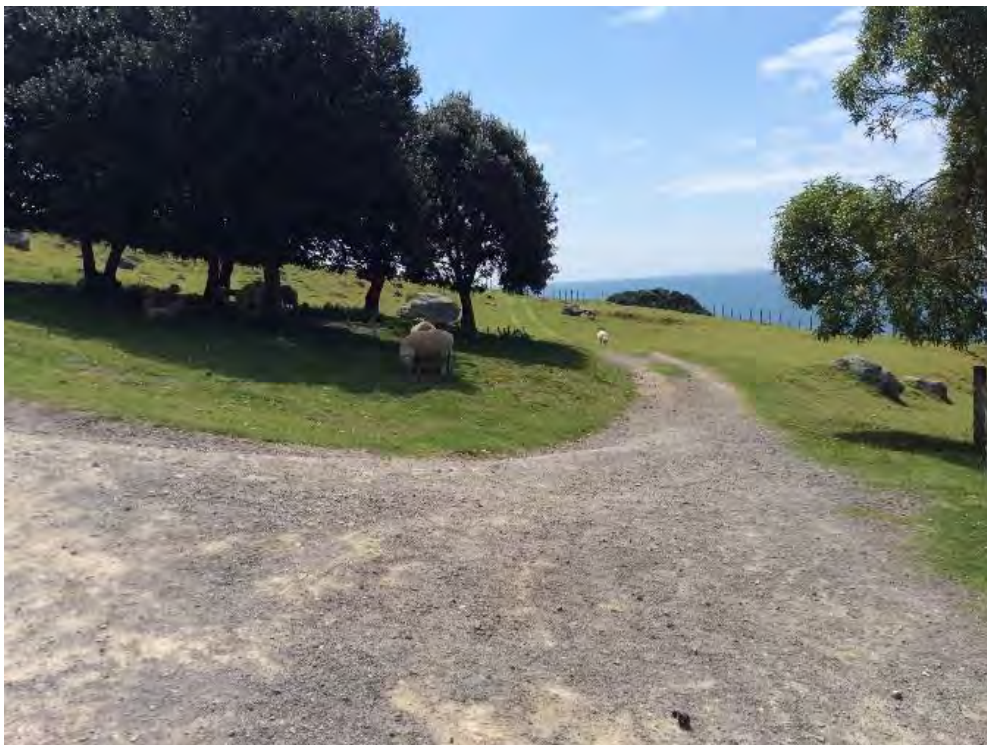
Figure 75: Access leading up to the junction with the Waikorire track is a gentle grade with a wide track, however, from the stone steps up to the junction the ground material is a GAP 40 chip. This results in a much higher frequency of slipping as the larger chip moves more freely. It is recommended that this chip is replaced with the finer gravel.

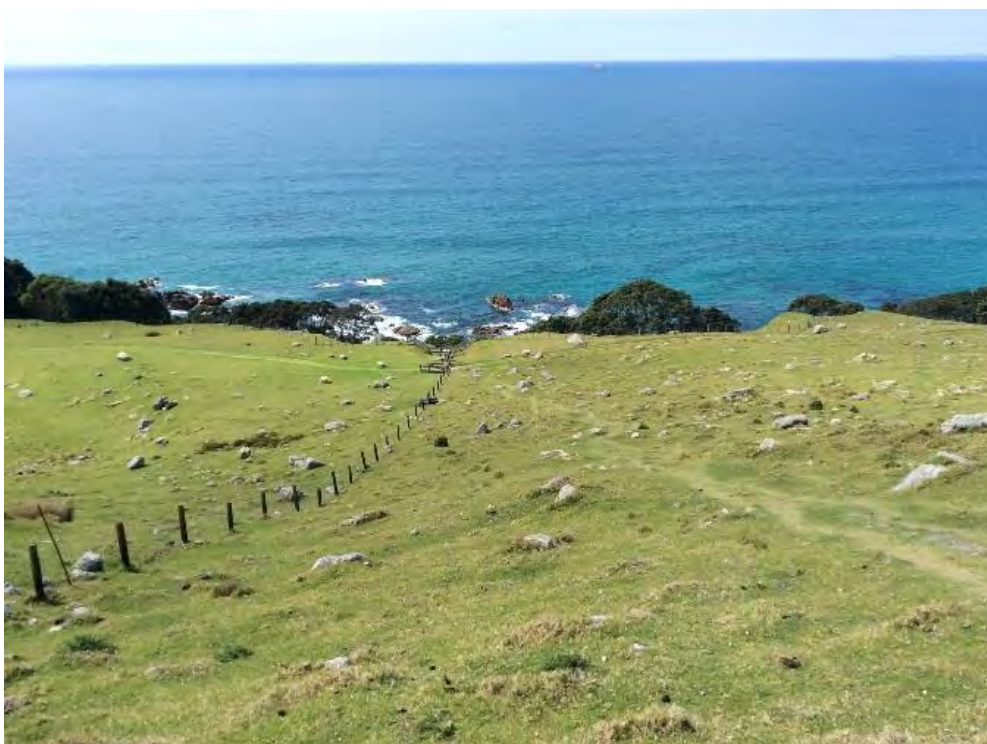
Figure 76: On the lower section of the track there are informal tracks that connect to the base track through farm land. These provide added escape routes and should be looked into for enhancement to add safety for those choosing to access informal tracks.

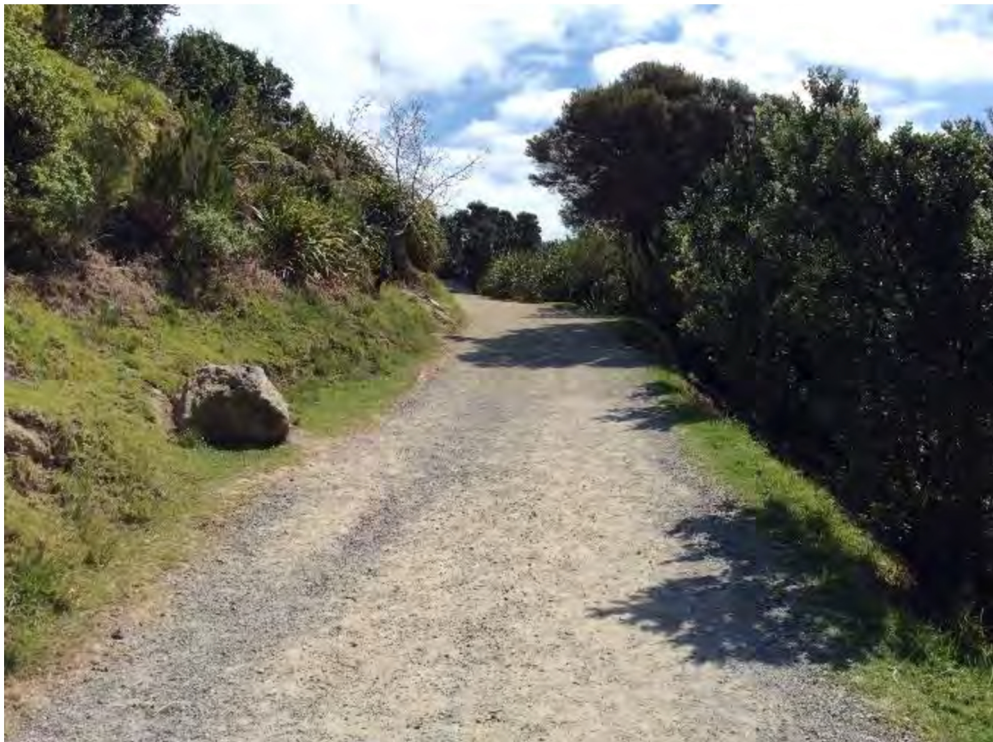
Figure 78: Access leading up to the junction with the Waikorire track is a gentle grade with a wide track, however, from the stone steps up to the junction the ground material is a GAP 40 chip. This results in a much higher frequency of slipping as the larger chip moves more freely. It is recommended that this chip is replaced with the finer gravel.

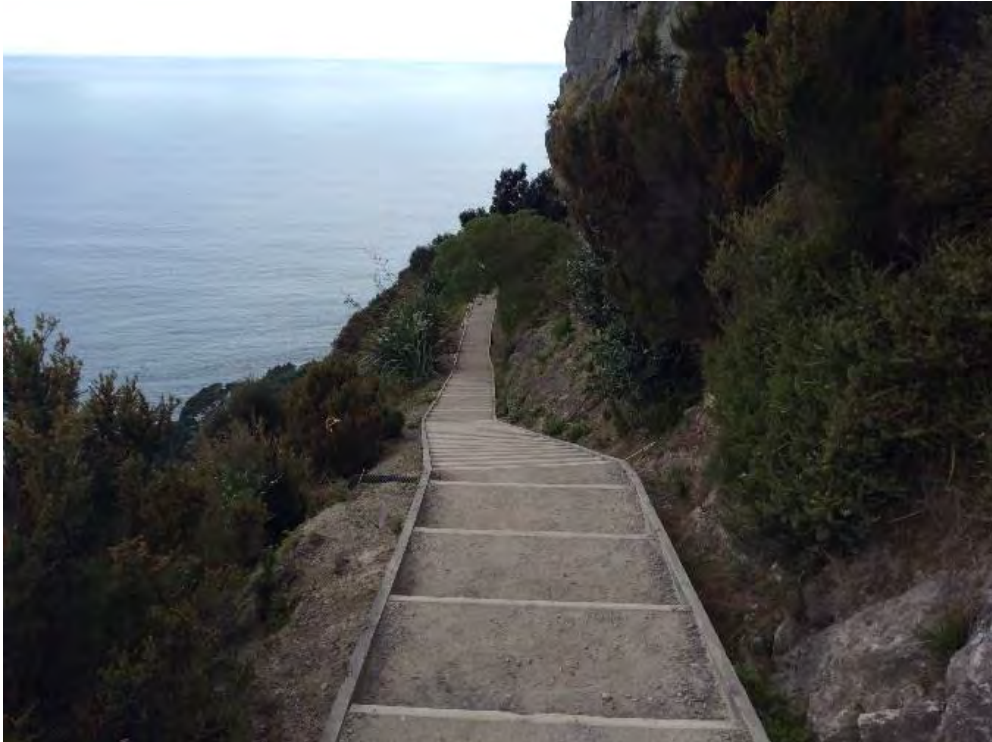
Figure 79: The upper section of the track consists of stairs that cascade down through a short section of bush and down an area on the cliff edge. The steps are well constructed with a good quality and well maintained ground material. Sightlines are clear for safety. Mountain flax is used as a soft border to define the steep cliff edge.
