# Tauranga City Council

## **Tauranga Landslide Slope Hazard (IDC Zones) Study**

### Addendum Report: Mount Maunganui / Pāpāmoa Update

Report No: TG 2025/5

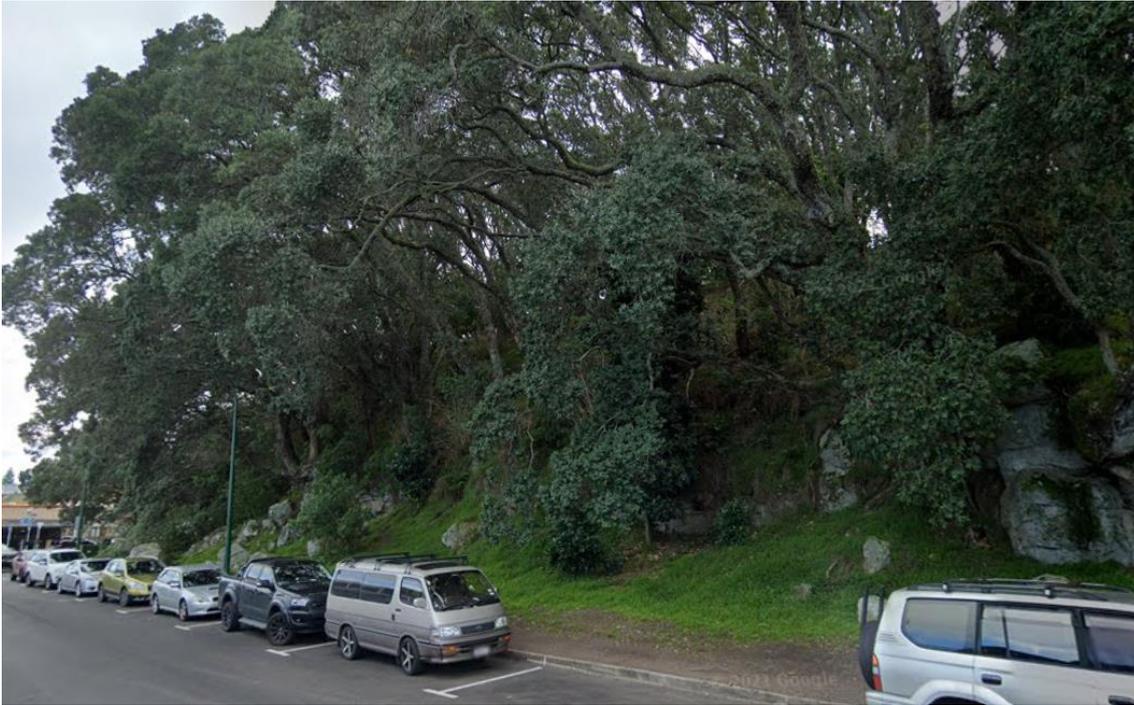
Figure 3: Rhyolite rock outcrops on the southern side of Hopukiore (Mount Drury) (Source: Google)

Rhyolite outcrops are particularly prominent along the southeastern and eastern flanks, where the rock is exposed at the surface (Figure 3). Near the summit of Hopukioire Mount Drury, boulders are embedded within a matrix of soil. In other areas around the summit, as well as on the northern and western slopes, the terrain is covered by a variable layer of ash, rock, soil, and sand, the thickness of which is not clearly determined.

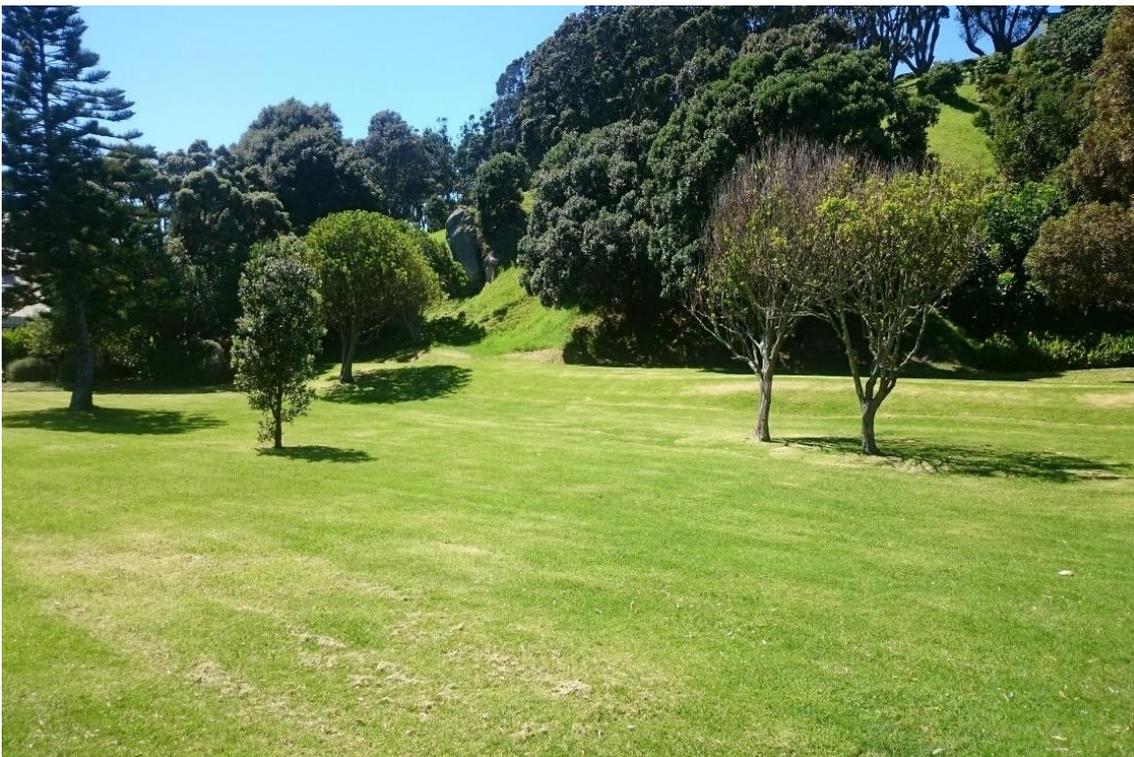
Figure 4: Colluvial deposits accumulated at the base of the dome Hopukiore (Mount Drury) (Source: <https://exploretauranga.co.nz/mount-drury-reserve/>)

At the base of Hopukioire Mount Drury, especially on the western side, colluvial deposits have accumulated. These deposits, comprising weathered rock fragments and volcanic material, reflect long-term geomorphic processes that have shaped the landform (Figure 4). The northeastern slope has been modified by anthropogenic activity, including terracing of the northeast slope, altering the natural slope profile.

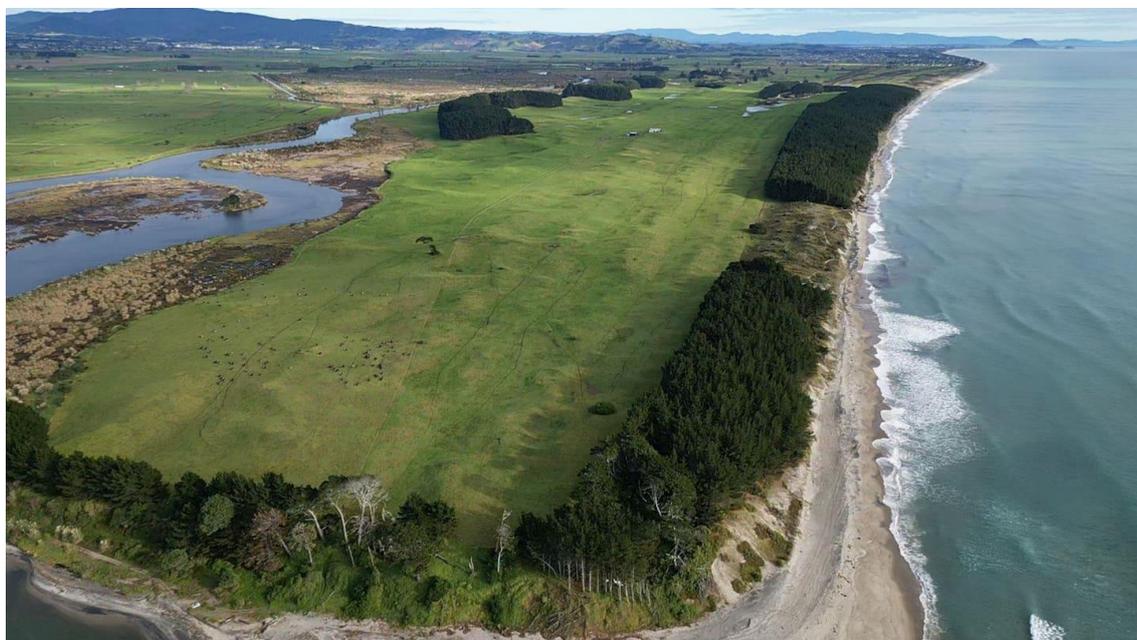
Figure 5: Sand dunes and the Kaituna River looking northwards from the Kaituna Cut to Te Tumu, Pāpāmoa (Source: Tauranga City Council)

Coastal processes such as longshore drift and progradation have shaped the foredune and backdune systems (Jenks & Brake, 2001; Dahm et al., 2005). The dunes typically form at or near the angle of repose (approximately 32° for uniformly-graded sand), with gentler slopes varying between the windward and leeward sides. The Te Tumu area includes vegetated dune faces exceeding 4 m in height, particularly near the Kaituna River (Figure 5). While vegetation enhances slope stability, these features remain sensitive to disturbance from human activity or increased water infiltration, which can trigger erosion or slumping.

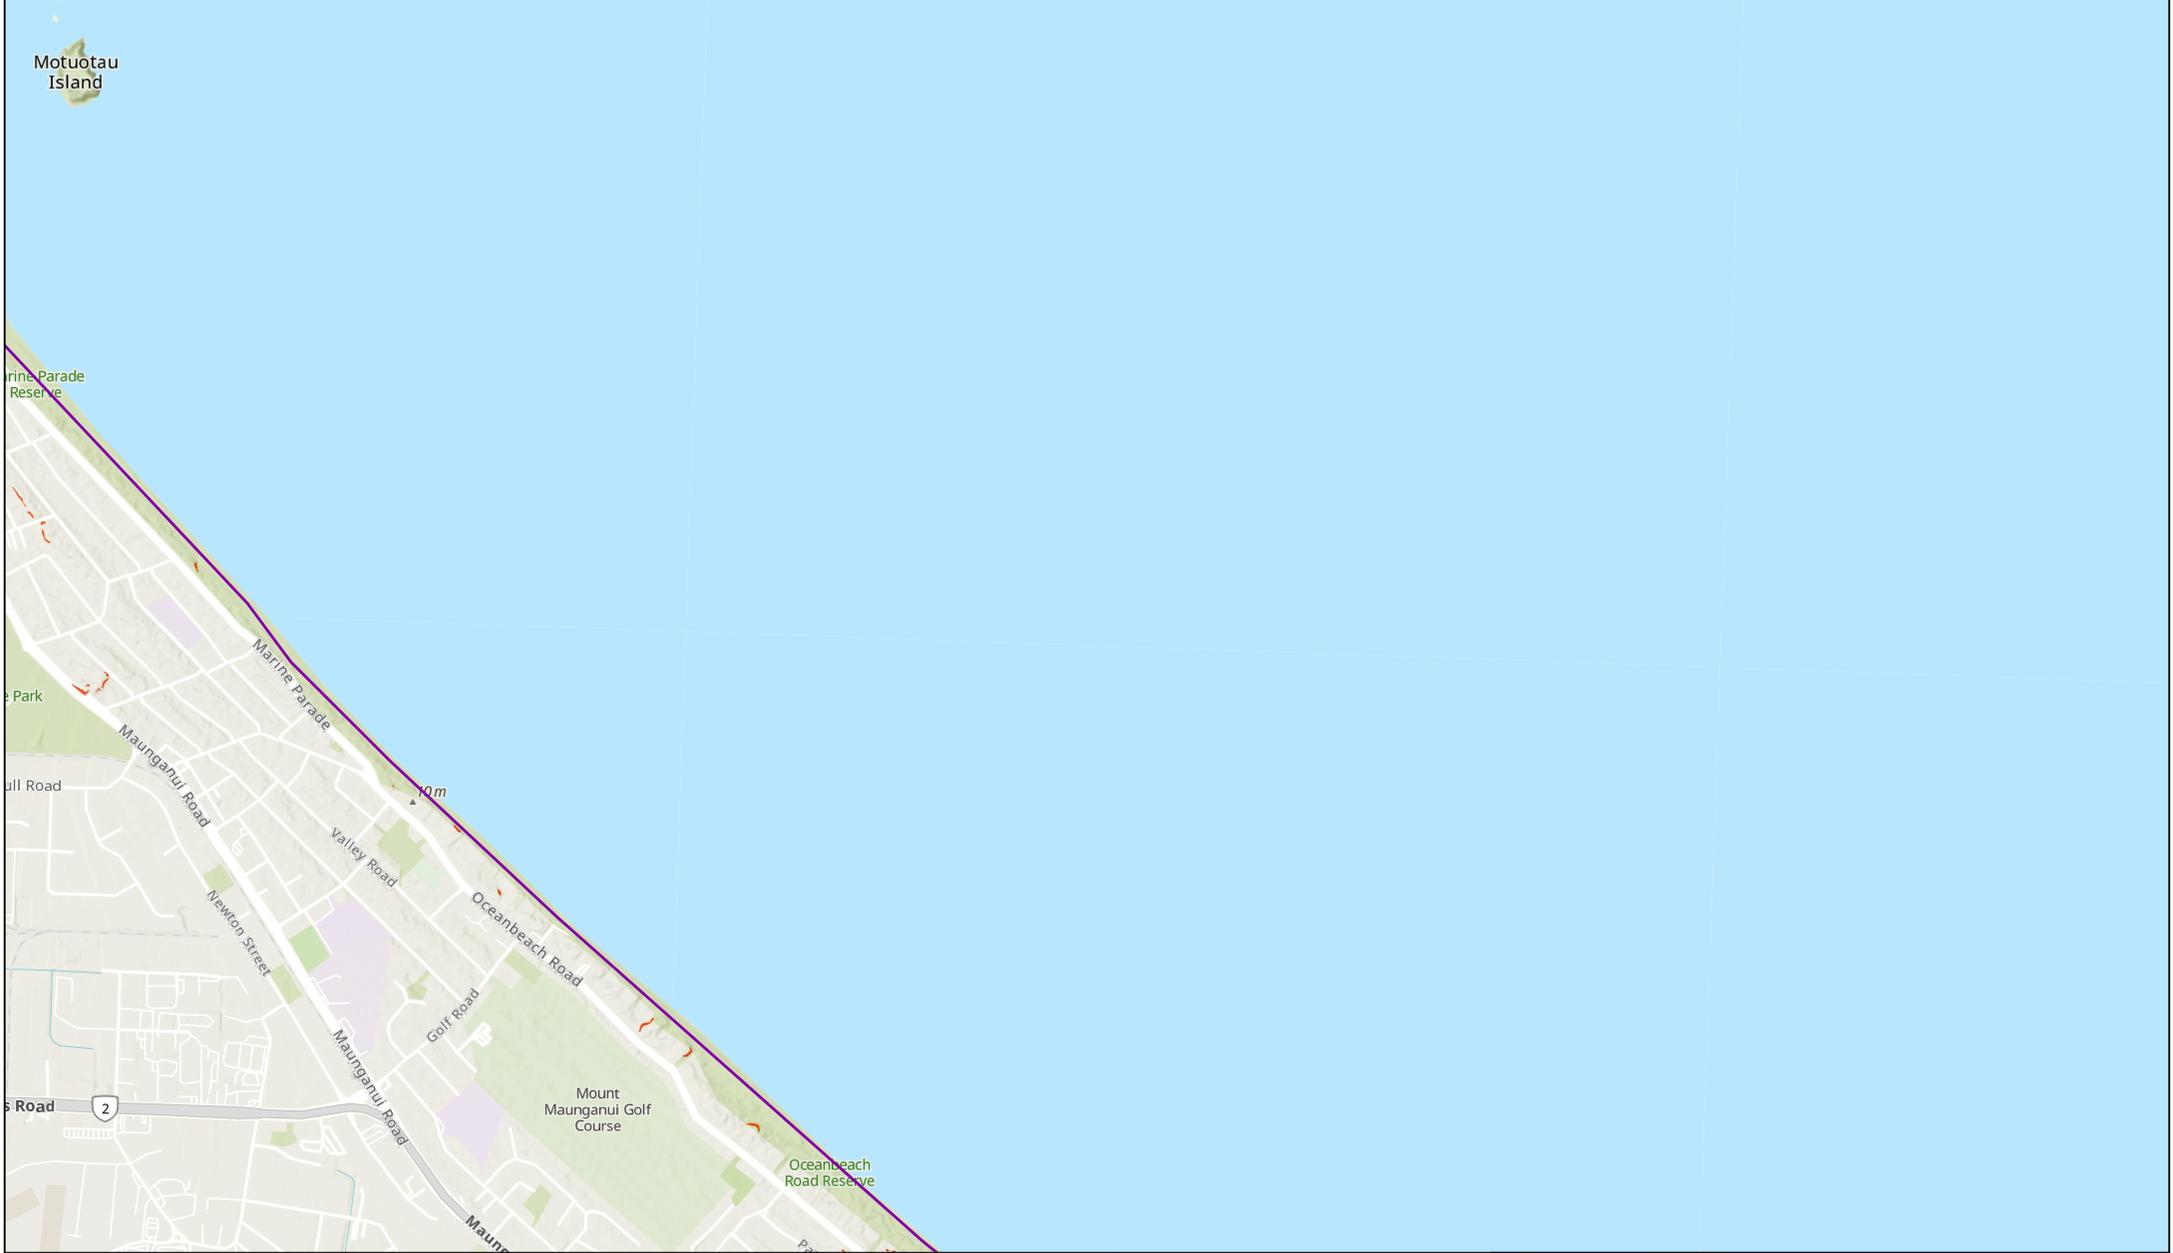
**Figure:**  
IDC Landslide Management Zones

- Failure Zone
- Regression Zone
- Runout Zone
- Study Area - 2025 Update
- Refer to 2023 Report
