136750 Redacted
Tree Asset Owner Approval – Application Form

A summary to date, including findings and recommendations as follows. You are welcome to discuss these within your wider team and let us know if there are any questions or thoughts before we finalise our report.

Tree Protection Plan
Excavation at Beachside Holiday Park,
Mount Maunganui, Tauranga
31st October 2023

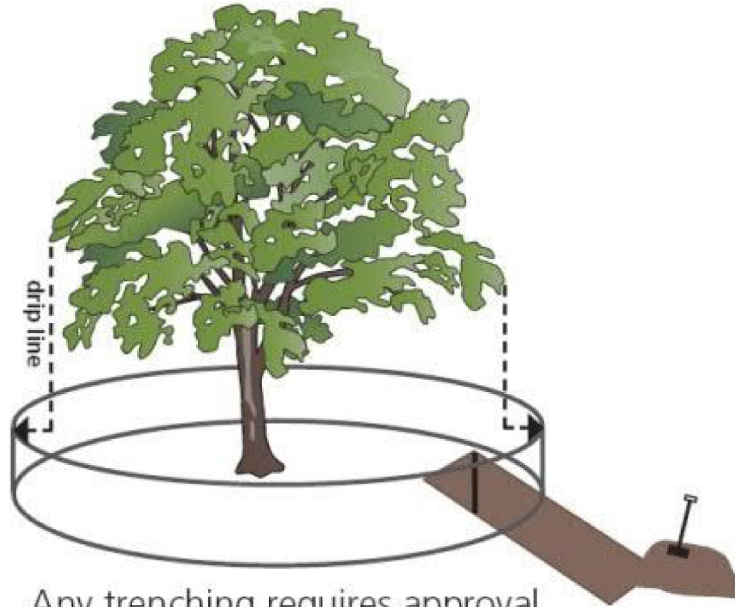
6.1 Tree Protection Zone

Tree protection fencing shall be put in place marking the TPZ prior to commencement. The TPZ shall be 1m outside the extremities of the tree's drip-line¹ unless otherwise approved by the monitoring arborist. Please see the Tree Protection Plan Map found in Appendix 6.2 of this report for clarification.

Any trenching requires approval.
Trenching may be permitted on
the extremities of the TPZ.
